AC NO: 20-82

# ADVISORY CIRCULAR

**SUBJECT:** MAINTENANCE INSPECTION NOTES FOR FAIRCHILD HILLER F-27/FH-227  
SERIES AIRCRAFT

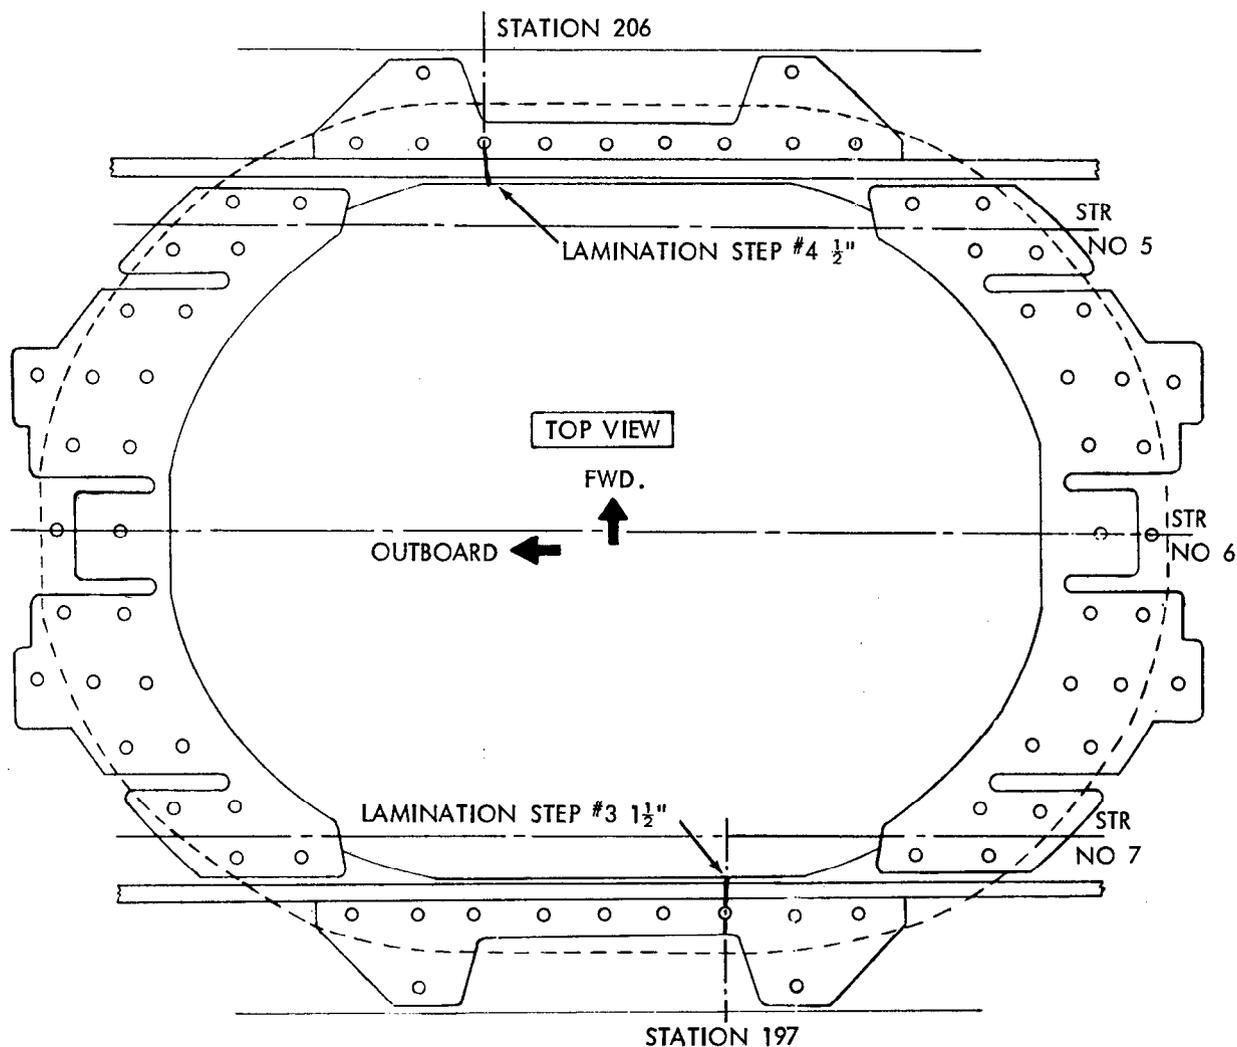
FIGURE 1. CRACKS IN WING FUEL ACCESS DOOR LAND AT WS 197 AND WS 206.

On a routine inspection of an FH-227 series aircraft, two cracks,  $\frac{1}{2}$ -inch long each, were found in the No. 1 fuel access door land screw-holes (Ref. Fairchild Hiller Service Bulletin FH 227-51-1). Total aircraft time 12,830 hours. Time since inspection 150 hours. Time since last X-ray 465 hours.

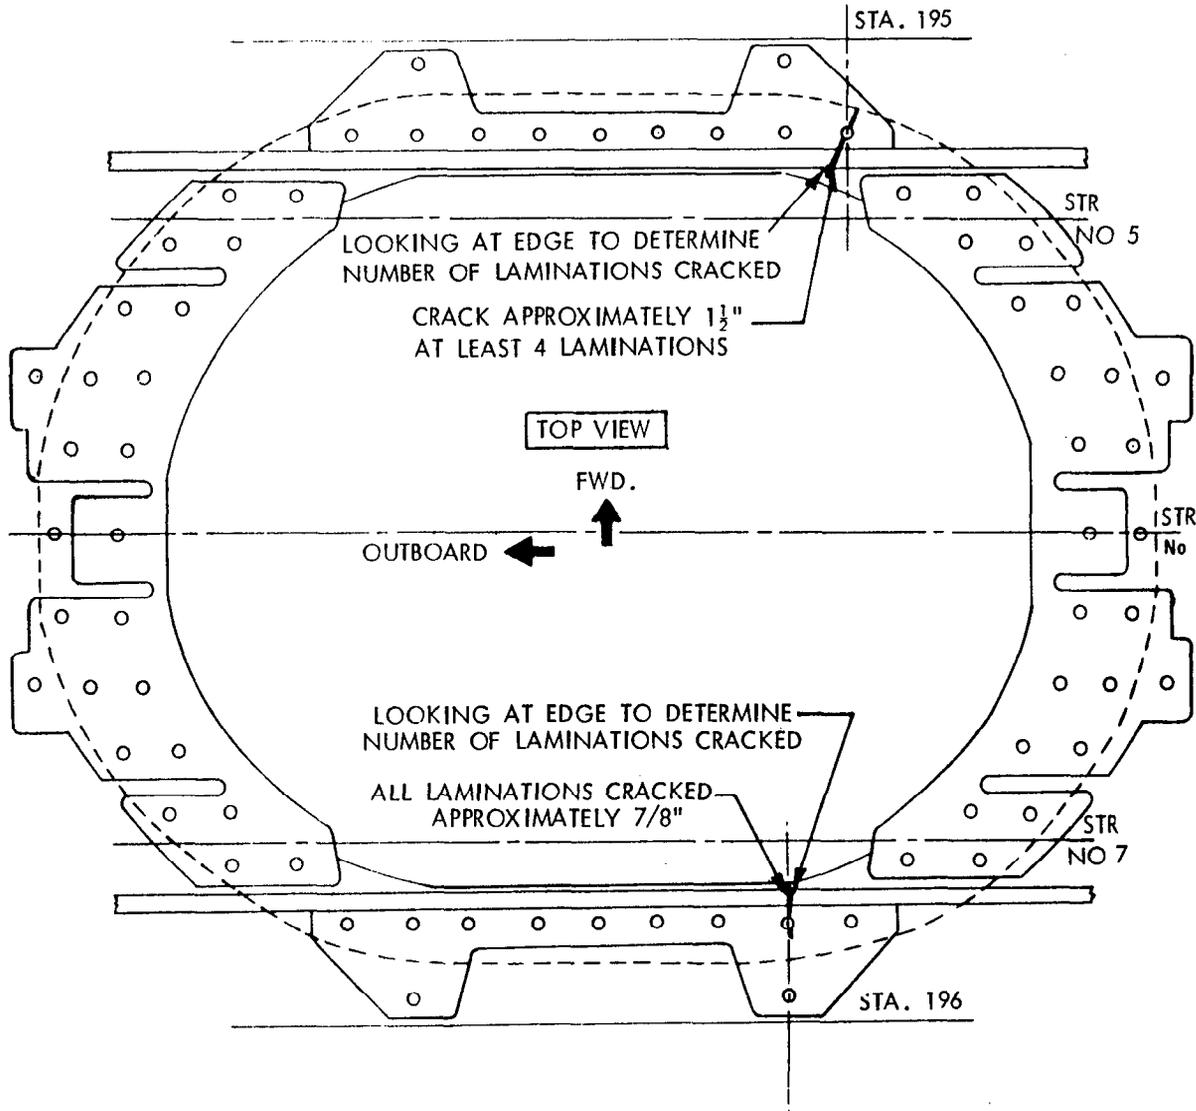
FIGURE 2. CRACKS IN WING FUEL ACCESS DOOR LAND AT WS 195 AND WS 196.

On a routine inspection of an FH-227 series aircraft, two cracks, 1/2-inch and 7/8-inch long, were found in the left outer wing panel at the screw-holes in the No. 1 fuel access door land. (Ref. Fairchild Hiller Service Bulletin FH-227-51-1). Total aircraft time 12,257 hours. Time since inspection 132 hours. Time since last X-ray 1,143 hours.
