**Motorcoach Median
Crossover and Collision
With Sport Utility Vehicle
Hewitt, Texas
February 14, 2003**

NTSB/HAR-05/02

**NTSB/HAR-05/02
PB2005-916202
Notation 7727A
Adopted July 12, 2005**

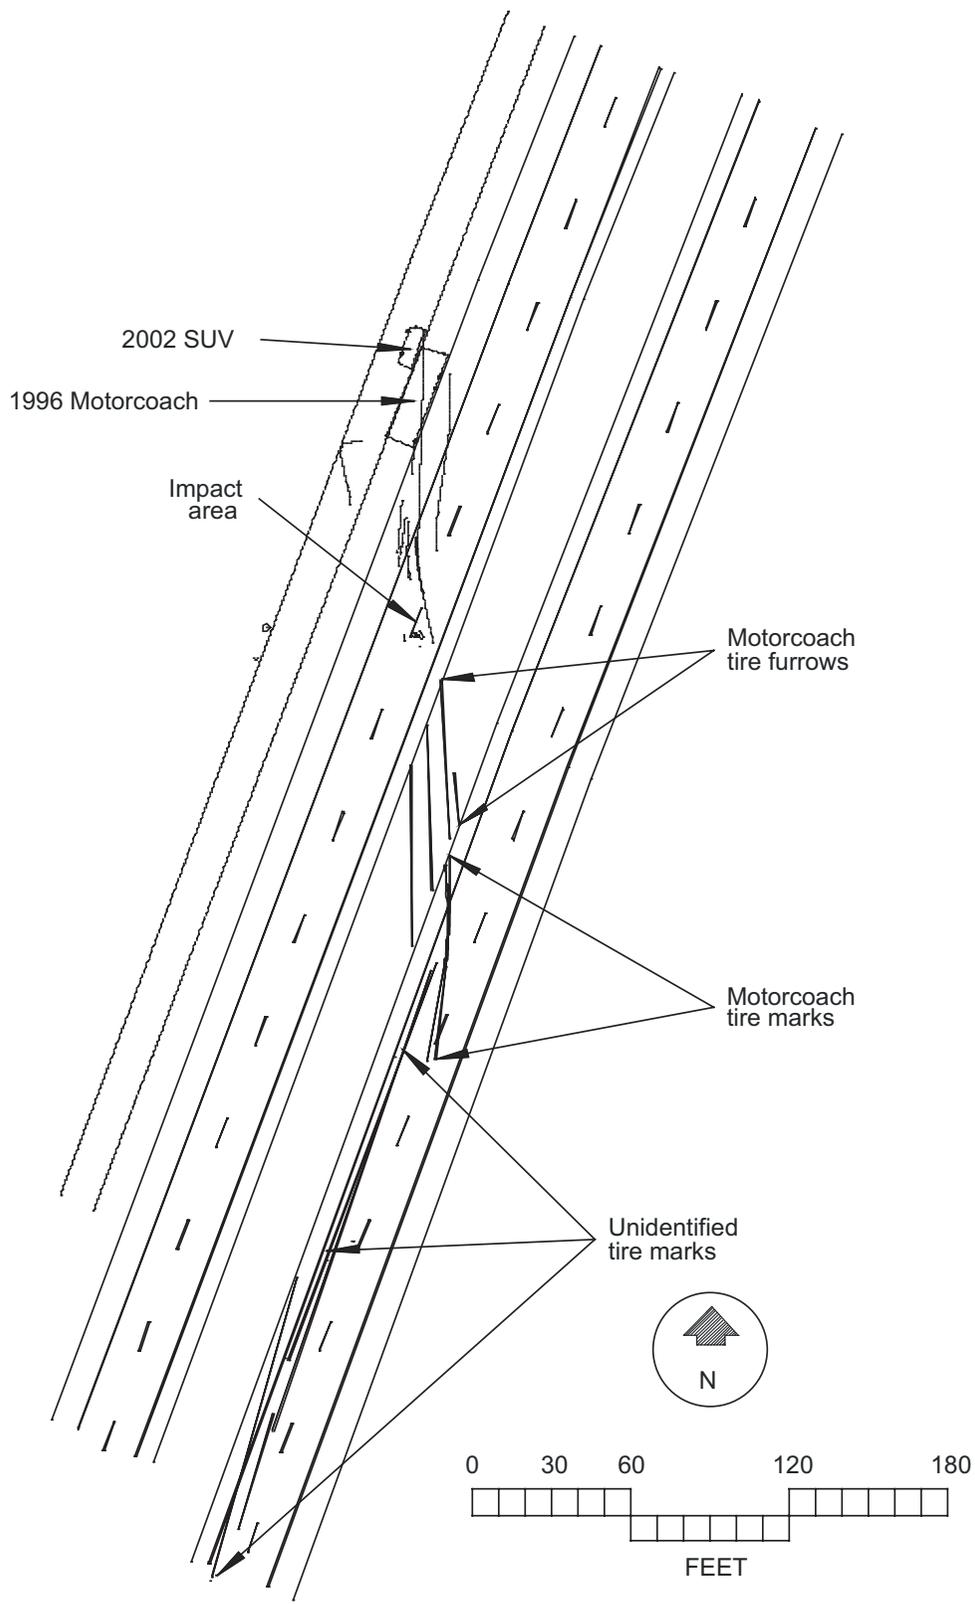
Figure 1. Accident scene. (Source: Texas Department of Public Safety)

The bus driver stated that he observed brake lights appearing in the traffic ahead. He believed at first that the brake lights indicated traffic was slowing, but as he got closer, he saw that the traffic had slowed almost to a complete stop or had stopped. He stated that he was in the right lane, where the queue was longer, so he decided to move into the left lane to avoid having to stop more quickly. He stated that he initially braked normally, slowed, and steered to the left, when another vehicle ahead also moved to the left, requiring the bus driver to brake harder. The rear of the bus then began to skid to the right. He said he reduced brake pressure and steered to the right to attempt to straighten the bus and regain control, but the bus continued to travel to the left into the median. (See figure 1.)

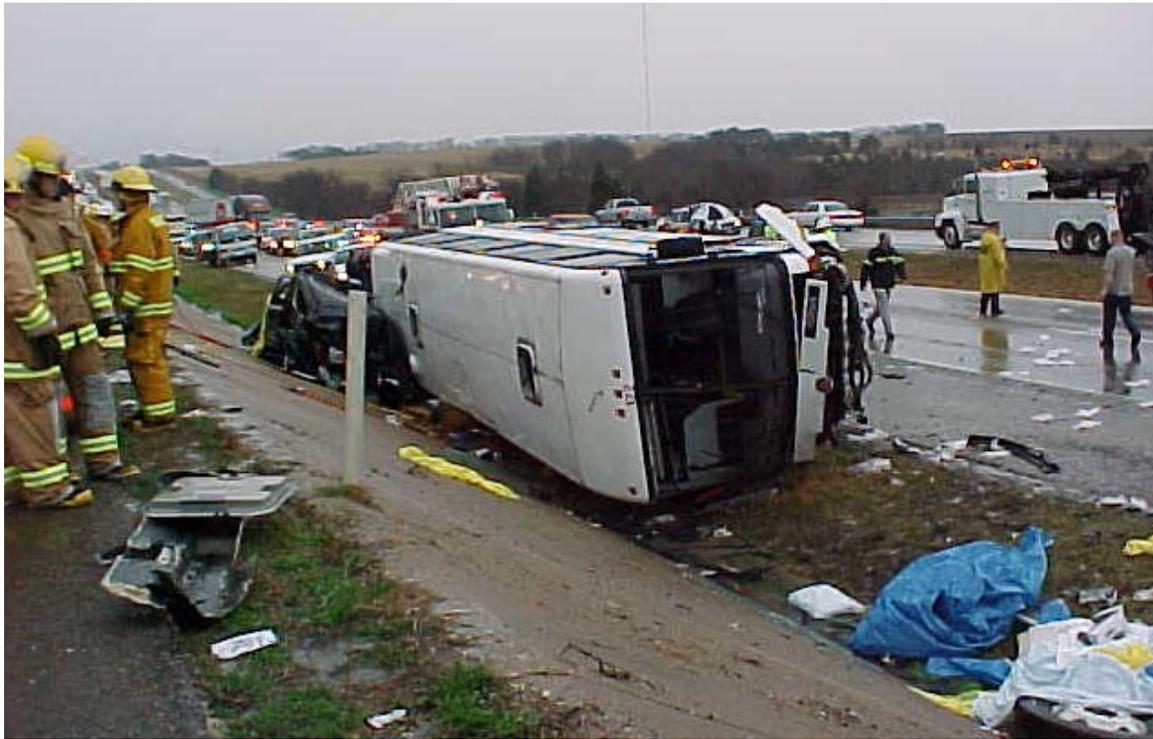
Figure 2. Motorcoach postaccident position.

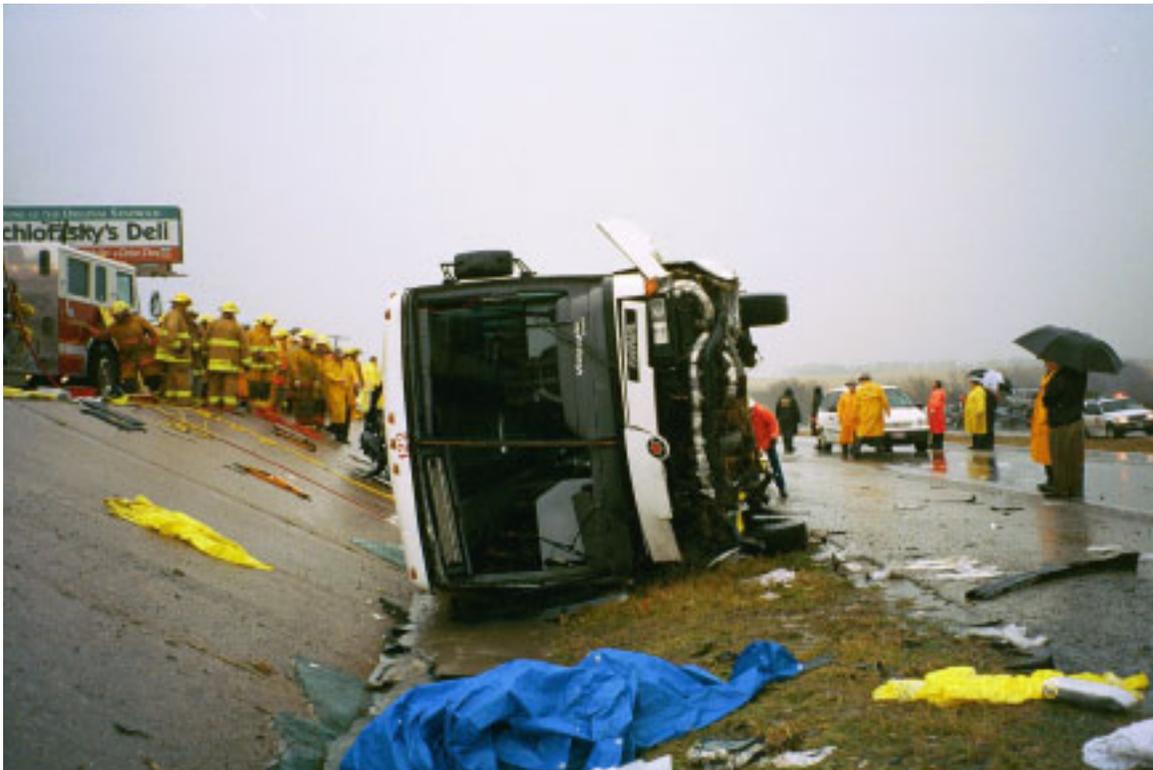
The right side of the motorcoach came to rest over a drainage ditch that was filled with 12 to 14 inches of rainwater (see figure 5), in which several of the ejected passengers were submerged. Witnesses said these passengers were assisted in keeping their heads above water until they could be extricated; in one instance, a rescuer gave a passenger a piece of tubing to use as a snorkel to breathe. Because autopsies were not performed,¹ it could not be determined whether the fatally injured passengers who were ejected died from their injuries or from drowning; the coroner found that all sustained blunt force trauma.

Figure 5. Drainage ditch filled with water beneath motorcoach.

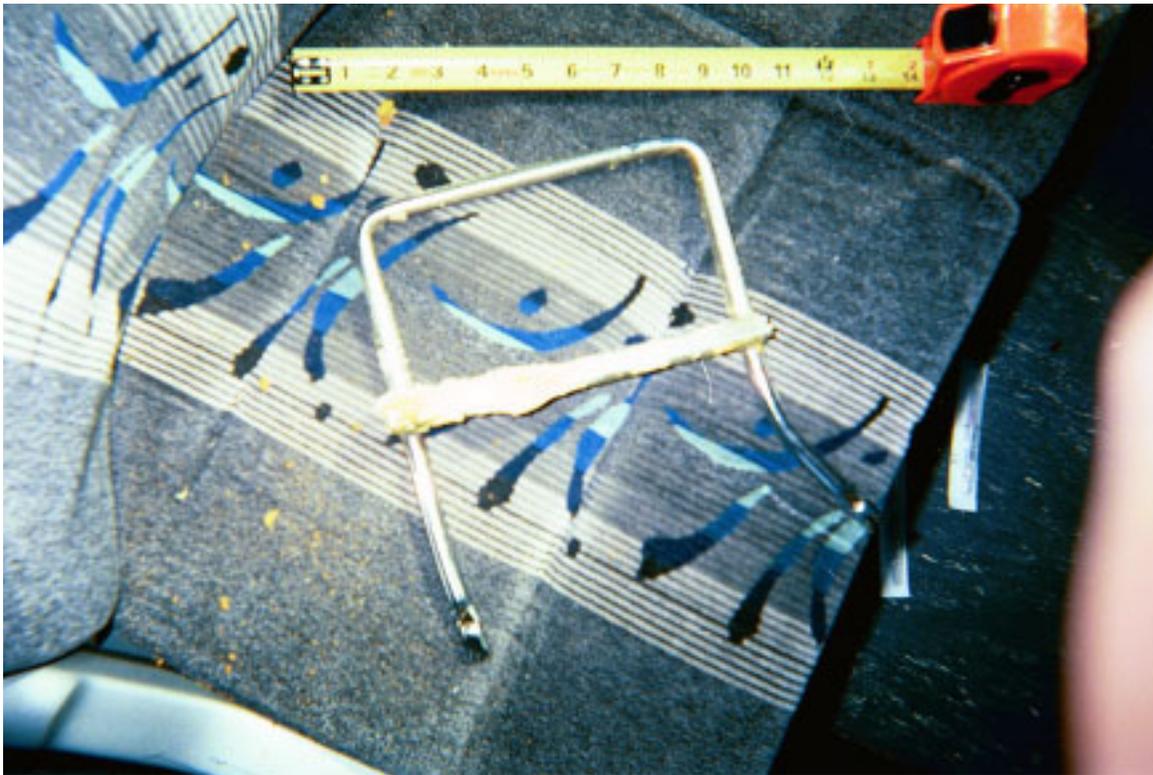
Damage to the motorcoach's interior was minimal. The headrest on the seventh row, right aisle seat, was bent forward. The interior padding on many of the headrests on the aisle had worn away, such that the headrests consisted of only a metal pipe frame covered by fabric. (See figure 6.) The headrests on the window seats had 2.5 inches of foam rubber padding covering the metal pipe under the fabric. The manufacturer's service manual did not provide information regarding headrest padding.

Figure 6. Interior of headrest without padding.

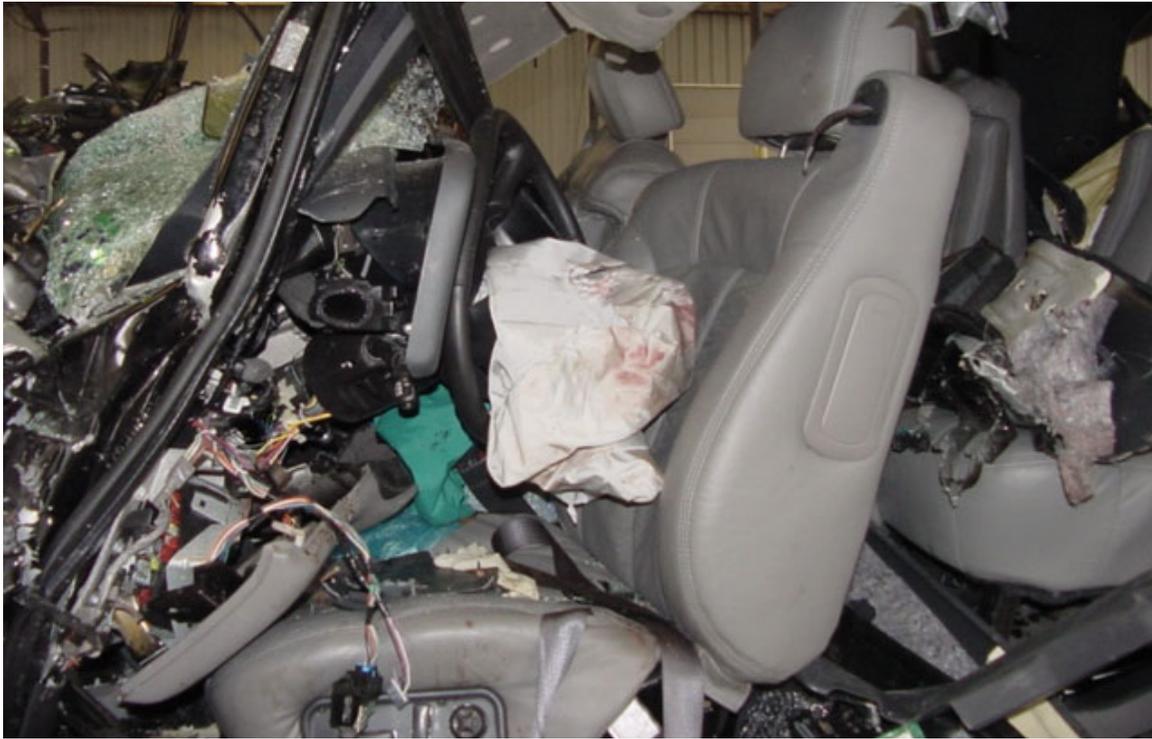
The Suburban's dashboard was pushed rearward to within several inches of the front seats. (See figure 7.) The space between the passenger seating area in the rear and the front seat remained intact. (See figure 8.) The front airbags deployed during the accident. Emergency responders cut the lap/shoulder belts from the driver and two passengers during their extrication.

Figure 7. Suburban front seating area damage.

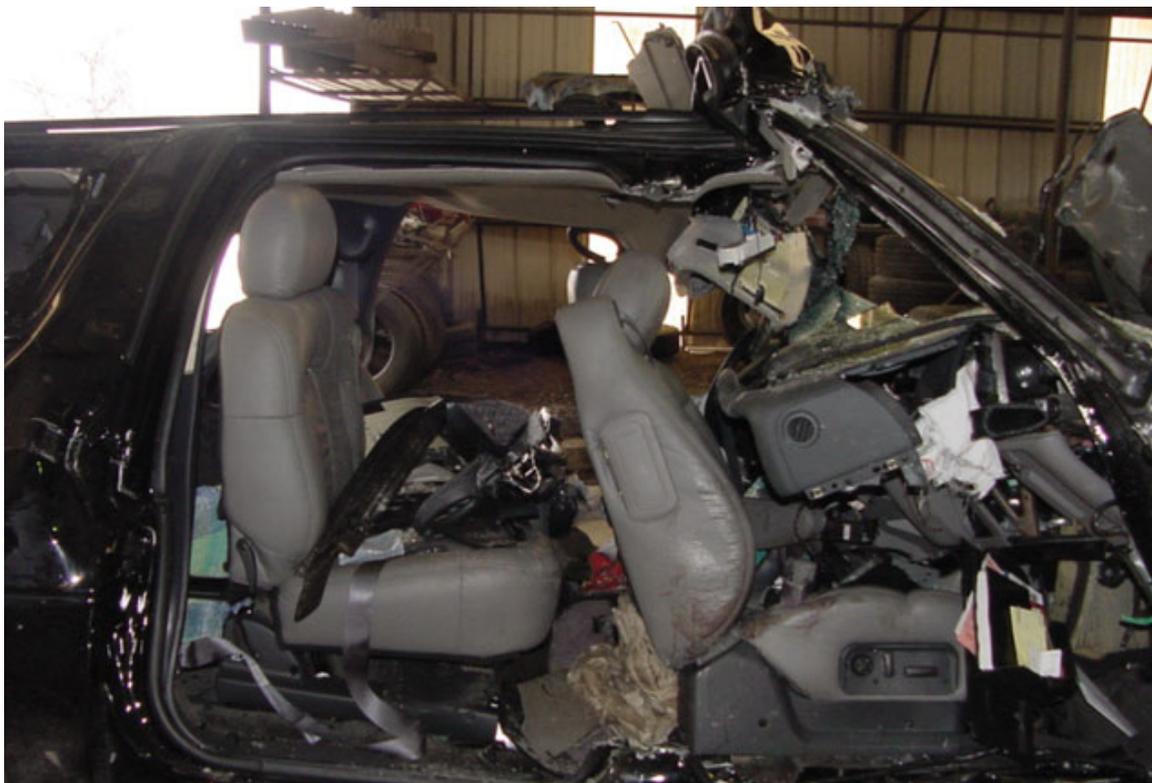
Figure 8. Suburban rear passenger seating area.

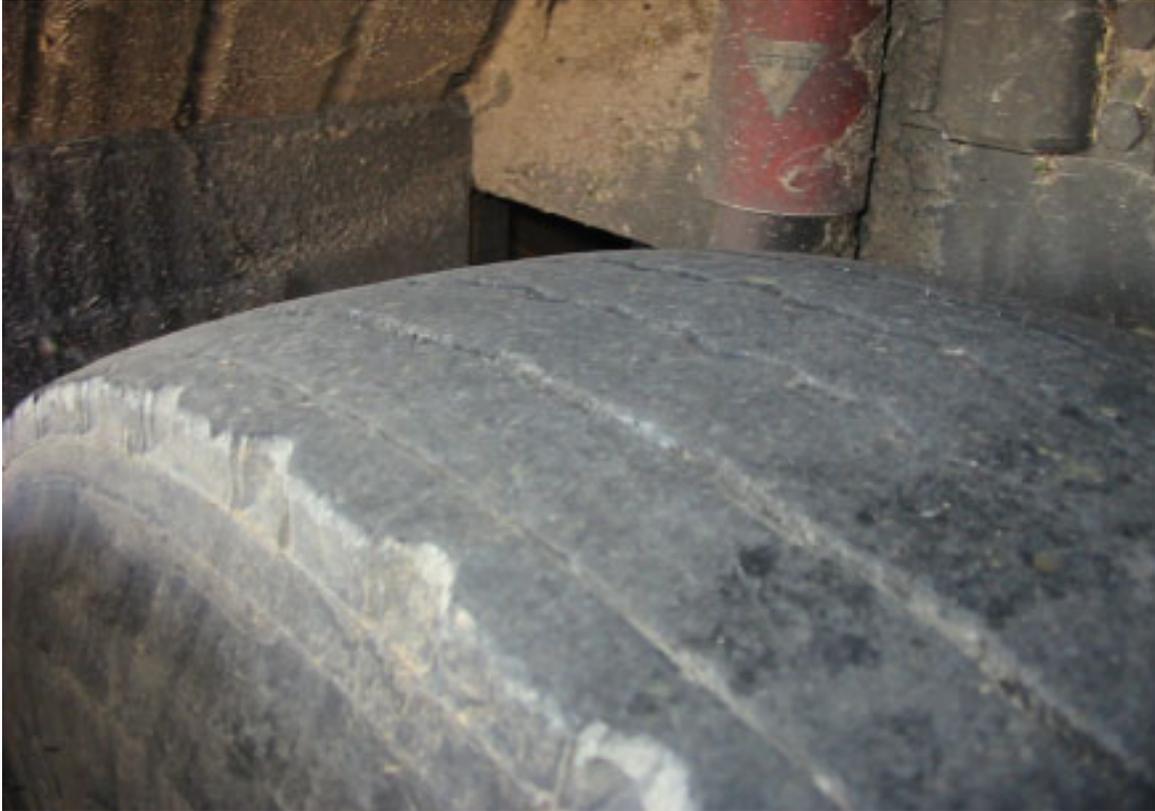
Tires. The manufacturer-recommended tire pressures were 115 pounds per square inch (psi) for the steer axle and 95 psi for the drive and tag axles. Table 3 shows the tire inflation pressures and tread depths measured during the postaccident investigation (see figure 9).

Figure 9. Left drive axle tire treads.

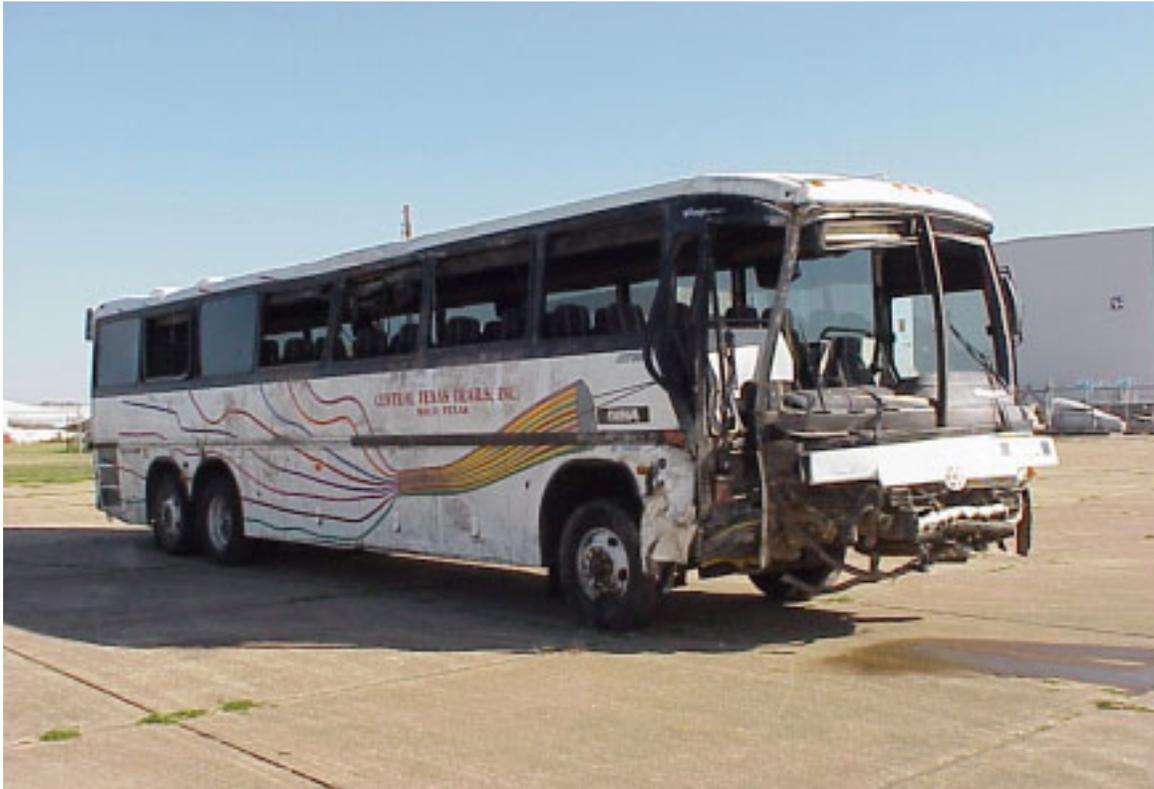
passenger loading door was displaced to the rear about 30 inches. (See figure 10.) The impact also damaged the body panels and the frame support structures between the loading door and the front wheel opening, pushing the front wheel opening rearward 6 inches. From the front of the bus, the maximum deformation to the windshield frame was 33 inches rearward at the right-front corner.

Figure 10. Motorcoach damage.

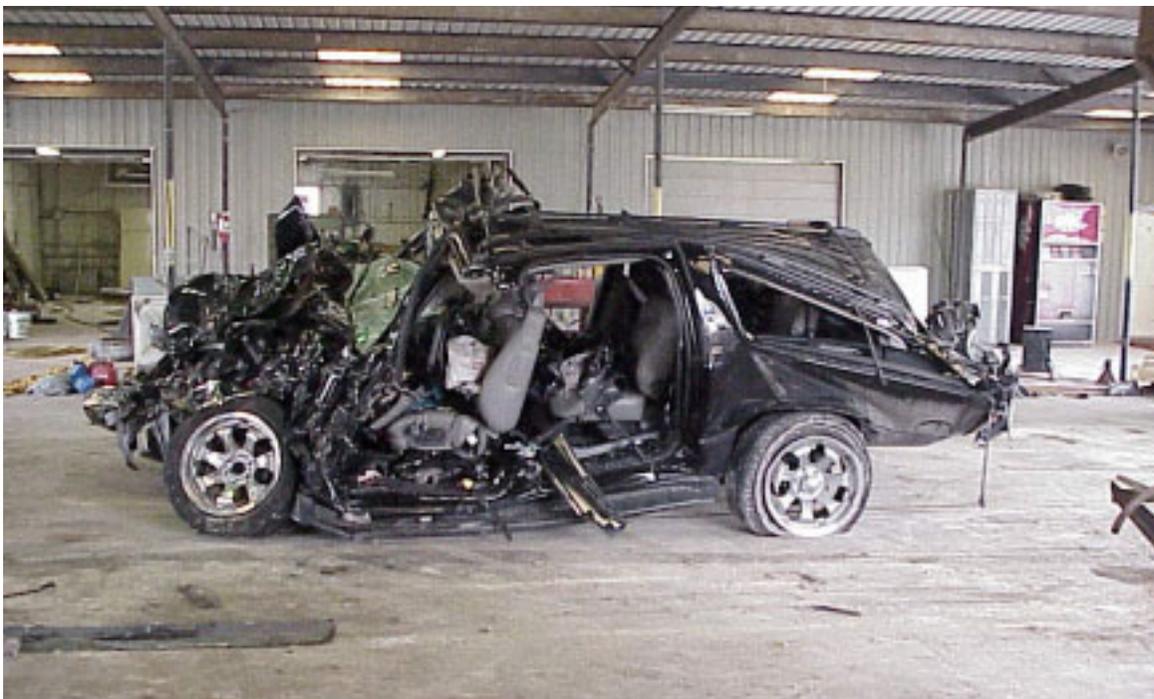
Damage to the Chevrolet Suburban encompassed the entire vehicle. The two primary areas of contact damage were to the left side of the front end and to the rear section of the roof panel. (See figure 11.) The maximum penetration to the front end was 68 inches. The left side of both axles had shifted rearward, with the greatest displacement to the front axle, which moved about 8 inches; the rear axle moved about 2 inches rearward. Near the end of the accident sequence, the right side of the motorcoach made contact with the roof panel of the Suburban. The vehicles came to rest with the motorcoach's roof panel against the right side of the Suburban. As a result of the contact, the left-rear corner of the Suburban's roof panel was crushed downward about 19 inches and was displaced to the left about 15 to 18 inches. It is unknown whether recovery or extrication efforts altered the measured damage from the original postcrash configuration.

Figure 11. Suburban damage.

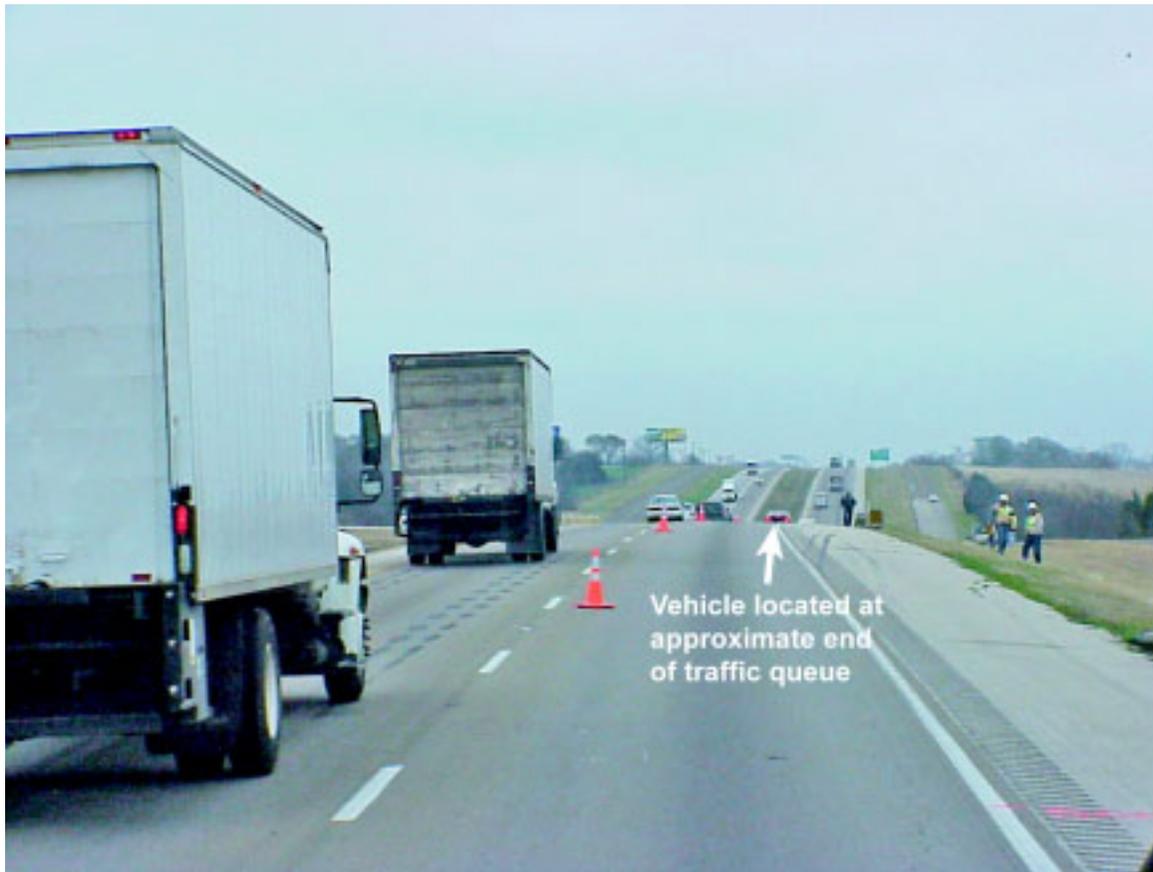
Safety Board investigators indicate that, from a distance of 767 feet, a motorcoach driver could see a 4-foot-high vehicle stopped in the right lane of the interstate at the approximate end of the traffic queue. (See figure 13.) This sight distance, as measured, did not take into account limitations in visibility due to the hard rain falling at the time of the accident.

Figure 13. Sight distance to approximate end of traffic queue available to motorcoach driver in right lane.

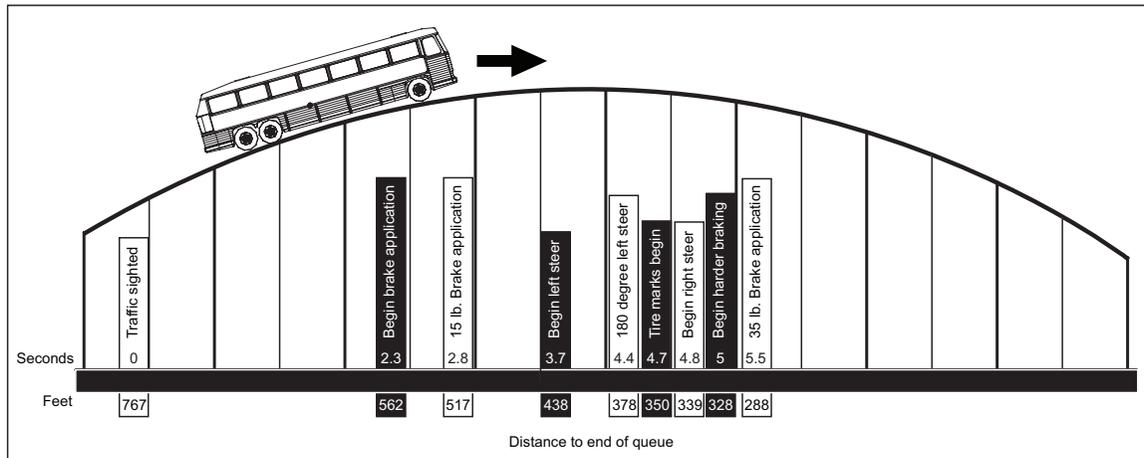
which time the drive wheels likely locked (the tires would have started sliding) and began to skid. (See figure 14.) Given the speed of the motorcoach, the distance it would have traveled during perception and braking, and the sight distance available, the driver had about 2.0 to 2.3 seconds to detect the stopped traffic, decide what to do, and begin to brake. AASHTO utilizes a 2.5-second perception reaction time for all stopping sight distance calculations in its *A Policy on Geometric Design of Highways and Streets*, stating that “for approximately 90 percent of the drivers (in the Johansson and Rumar study)⁶² a reaction time of 2.5 seconds was found to be adequate.”⁶³ Thus, the driver reacted appropriately (his reaction was not delayed), especially given that the driver did not expect to stop on an interstate. Even had the rain not reduced the driver’s visibility, he still would not have had enough time to react to the traffic ahead and safely stop the motorcoach. The Safety Board concludes that, based on the sight distance available to the driver and the time at which the driver began to apply the brakes and steer to avoid traffic ahead, his reaction was not delayed or impaired.

Figure 14. Time and distance available to bus driver.

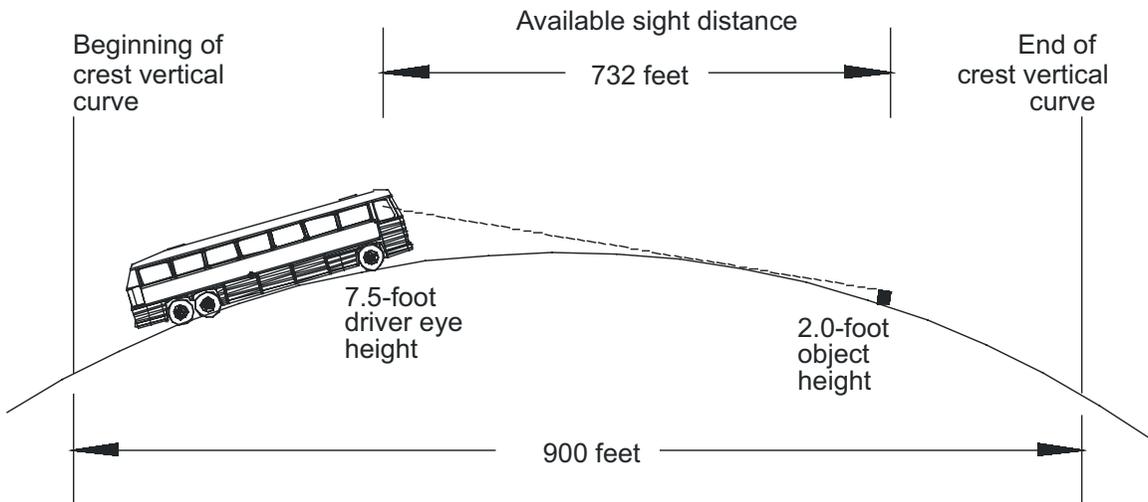
Figure 15A. Available sight distance for a motorcoach.

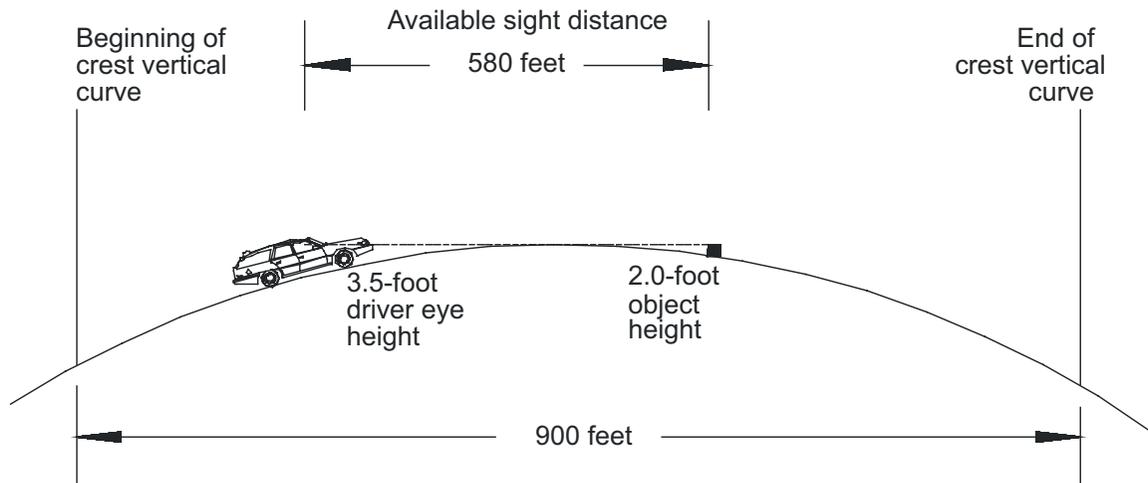
Figure 15B. Available sight distance for a passenger car.
