**U.S. Towboat *Robert Y. Love*  
Allision With Interstate 40 Highway Bridge  
Near Webbers Falls, Oklahoma  
May 26, 2002**

**Highway/Marine  
Accident Report**

**NTSB/HAR-04/05**

**NTSB/HAR-04/05  
PB2004-916205  
Notation 7654  
Adopted August 31, 2004**

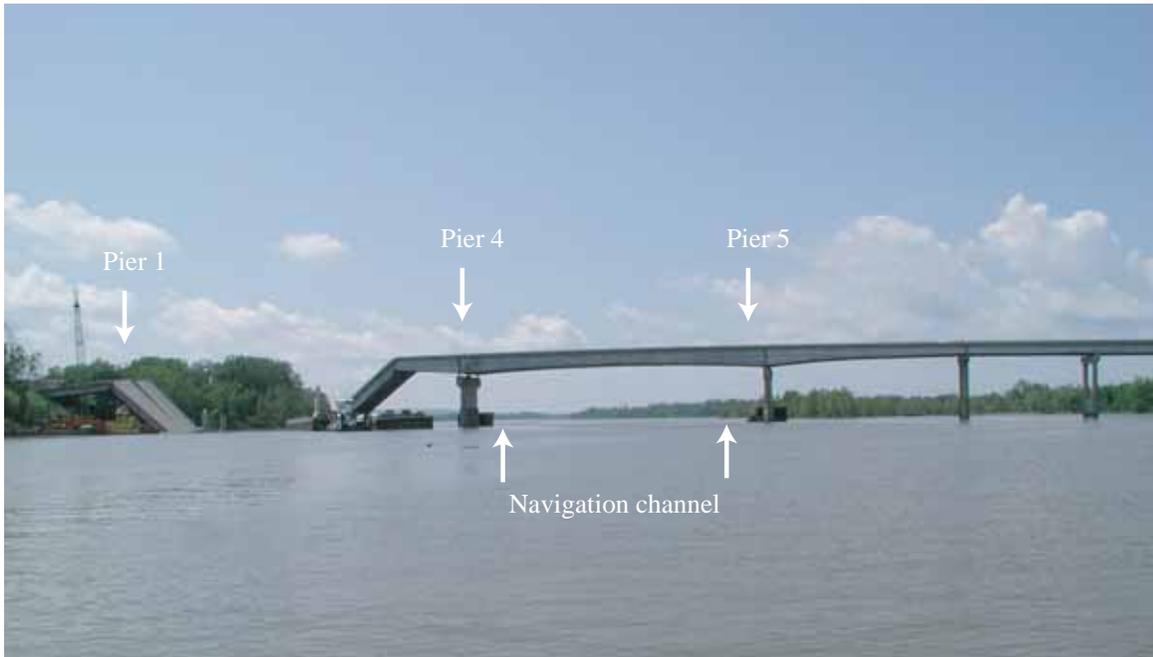
highway bridge (I-40 bridge) and land in the water. They also saw a collapsed section of the bridge deck hanging at an angle from the bridge and resting on the bow end of the barges in the tow. (See figures 5 through 7.)

**Figure 5.** View of accident scene from downstream (southern) approach to bridge.

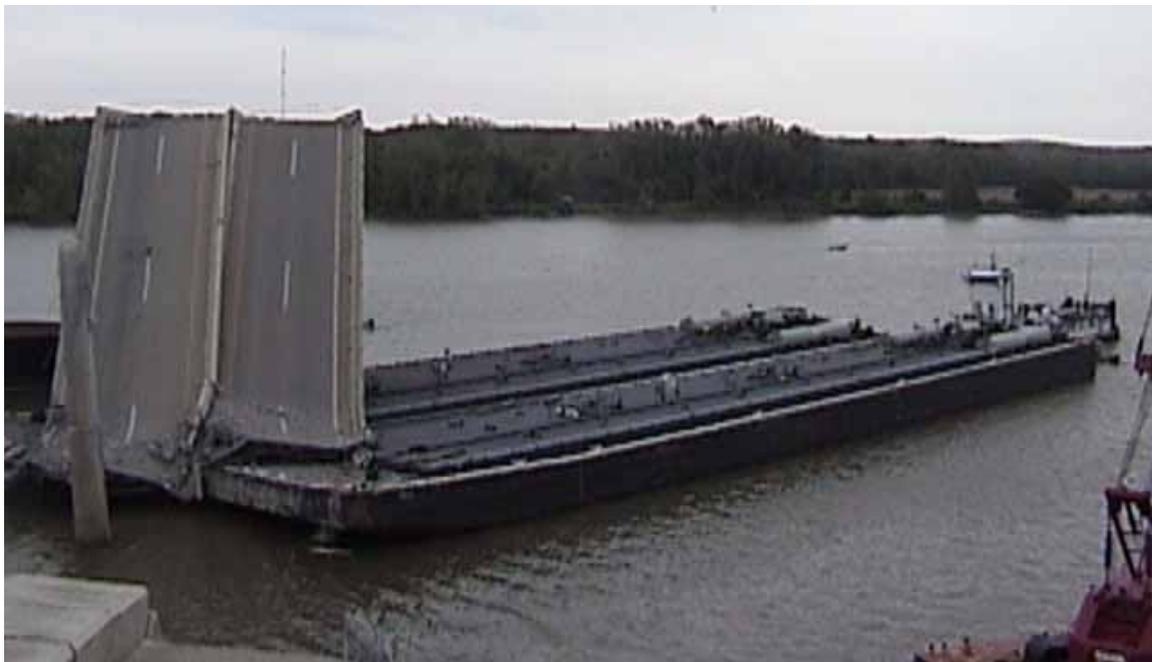
**Figure 6.** View of accident scene from edge of remaining eastbound span.

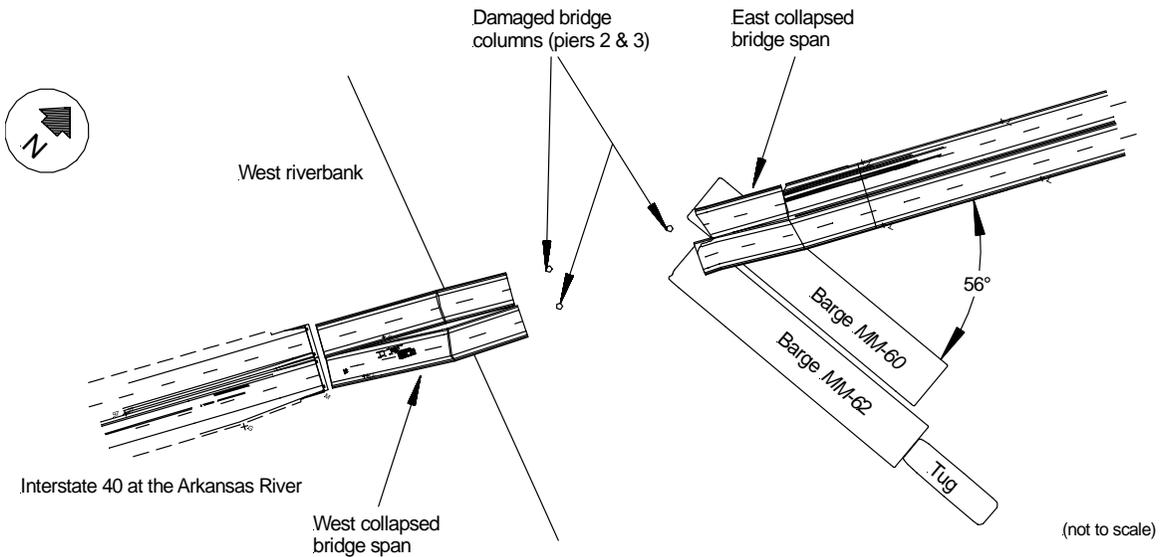
**Figure 7.** Accident damage.

The impact collapsed a 503-foot section of the bridge and two piers. During the repair to the bridge, the Oklahoma Department of Transportation (ODOT) operated a separate detour for the I-40 traffic in both directions. The westbound detour was 8 miles and added an additional 4 miles to the trip. In addition, traffic had to negotiate four right-angle turns and traverse two railroad crossings<sup>19</sup> while passing through two small cities. The eastbound detour was about 78 miles and added an additional 30 miles to the trip.

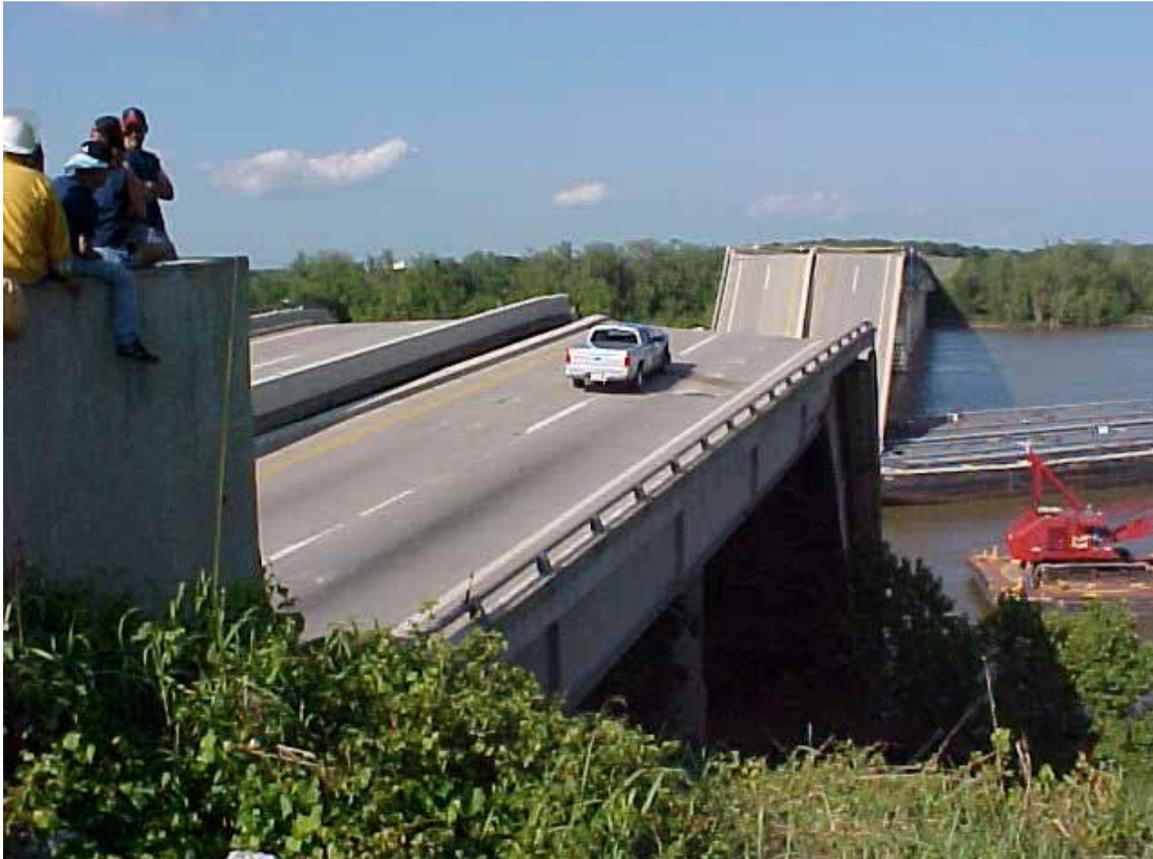
**Figure 9.** Eastbound pickup that drove off bridge onto collapsed span but stopped before driving into void.

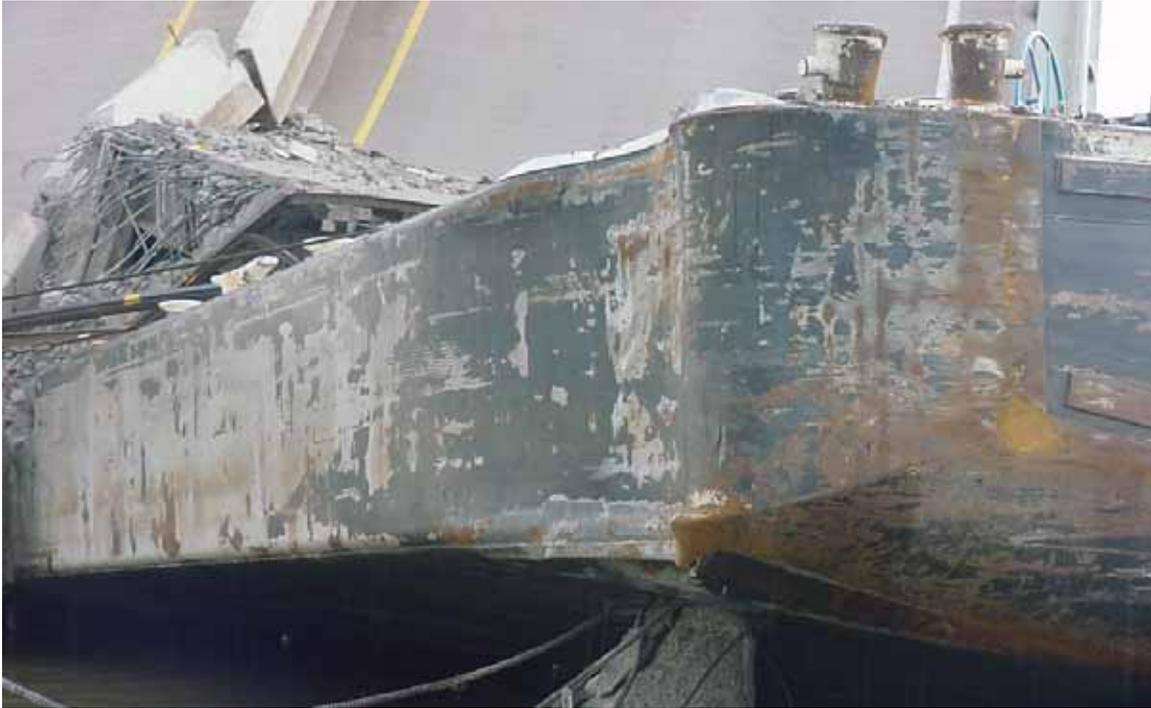
**Figure 11A.** Port side of headlog of barge *MM-60* showing the indentation made by south column of pier 3.

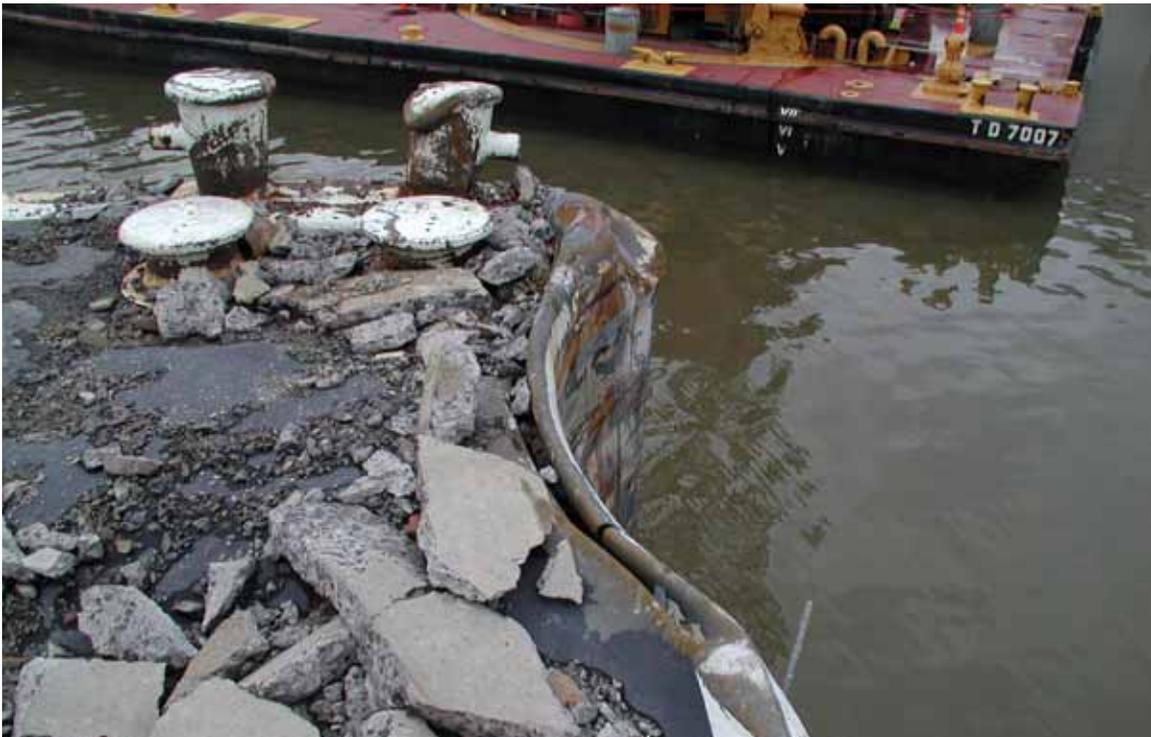
**Figure 11B.** Overhead view of indentation.

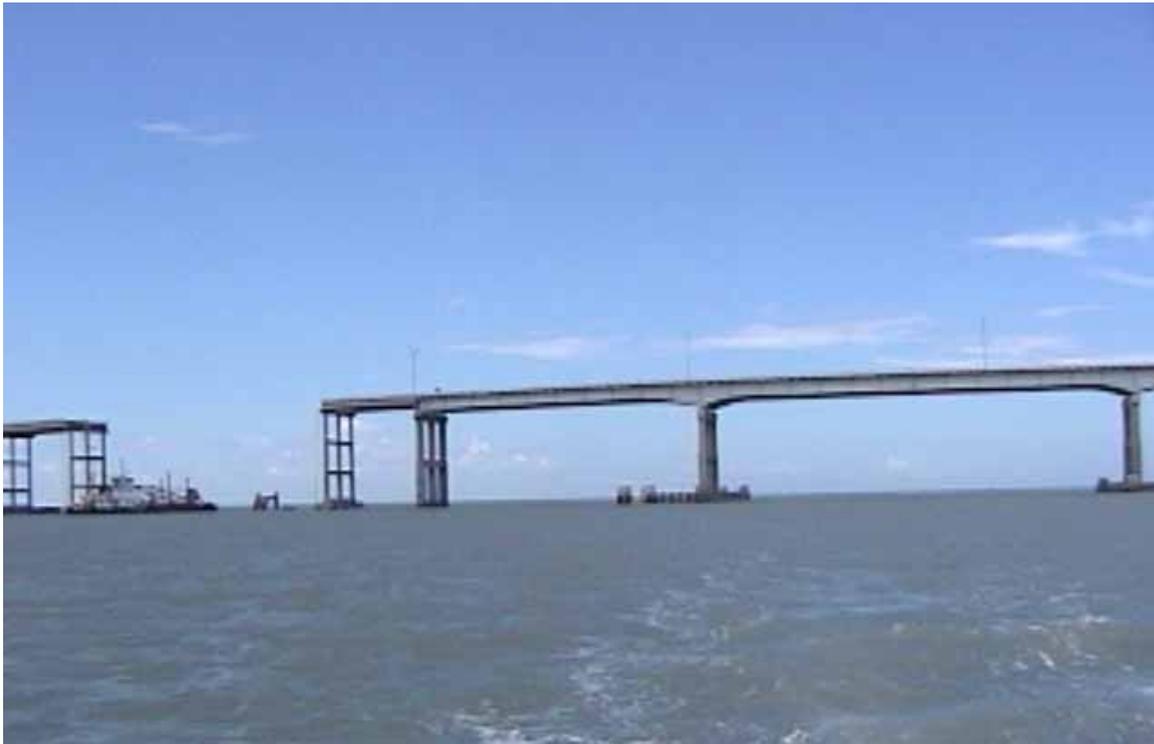
**Figure 18A.** Channel piers and damaged piers and collapsed section.

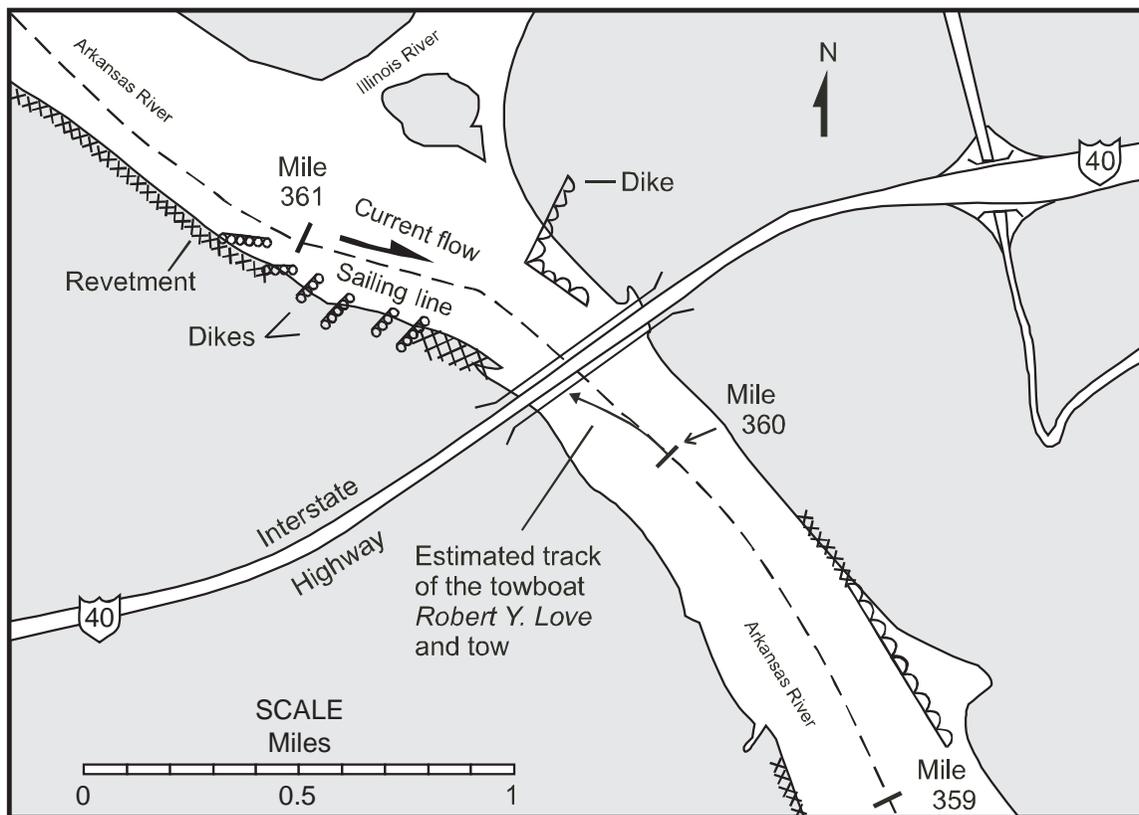
**Figure 19.** Estimated track of towboat *Robert Y. Love* as it approached I-40 highway bridge.

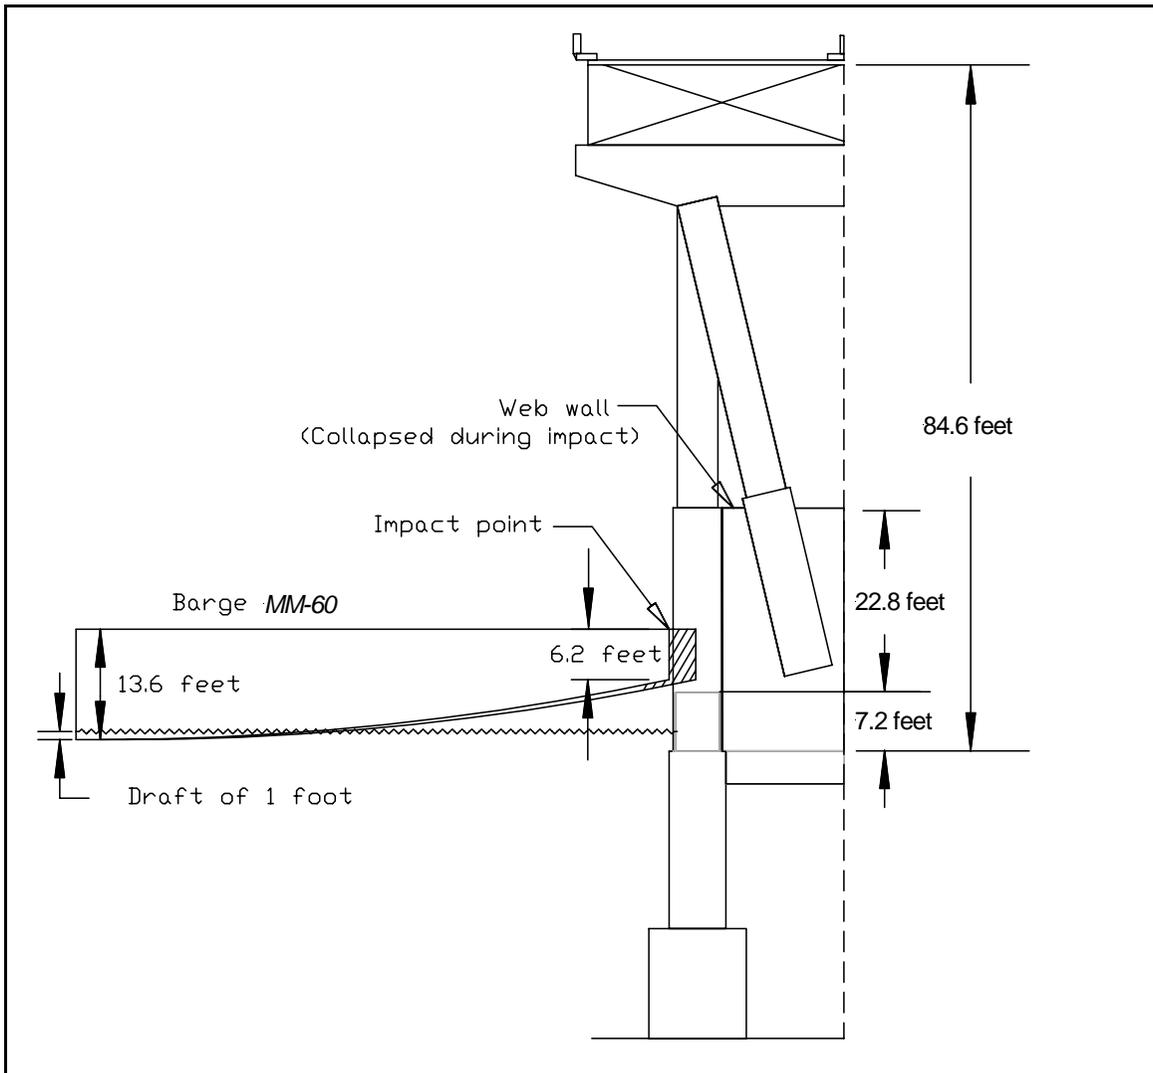
After the captain's incapacitation, the vessel continued in a left turn and struck pier 3, about 201 feet west of the navigation channel, at an approximately 56-degree angle. (See figure 19.) The Safety Board calculated the kinetic energy of the tow to be 4,498.79 kip-ft (1,000 foot-pounds). (See appendix B for detailed calculations.) Pier 3 was not, nor was it required to be, designed to withstand a concentrated horizontal load of that magnitude,<sup>85</sup> and therefore collapsed. The spans on either side of pier 3 collapsed with it, damaging pier 2 and causing the west column and web wall to collapse. (See figure 20.) In total, 503 feet of bridge deck fell into the river and onto the barges.

**Figure 20.** Impact of barge *MM-60* with south column of pier 3.
