Cape Lookout National Seashore
O'BOYLE - BRYANT HOUSE
**HISTORIC STRUCTURE
REPORT**

2004
Historic Structure Report
O'Boyle- Bryant House
CAPE LOOKOUT NATIONAL SEASHORE
Cape Lookout Village
LCS#: 271581

Historic Structure Report

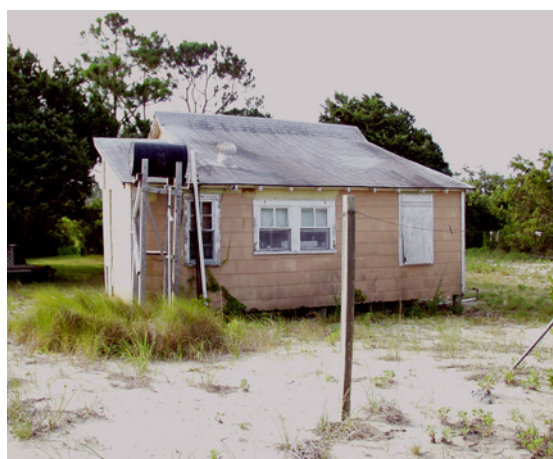
Figure 25 View to south of O'Boyle-Bryant House, showing elevated water tank. (NPS-SERO-CRS, 2002)

Against the northern end of the rear wall of the house is a wooden structure on which a small elevated metal water tank is mounted. Too high to function as a cistern, this tank is used to provide water for an outdoor shower and for flushing the broken toilet inside the house.

- repair and maintain garage;
- repair or reconstruct elevated water tank at rear of house;
- remove modern structure in front yard;

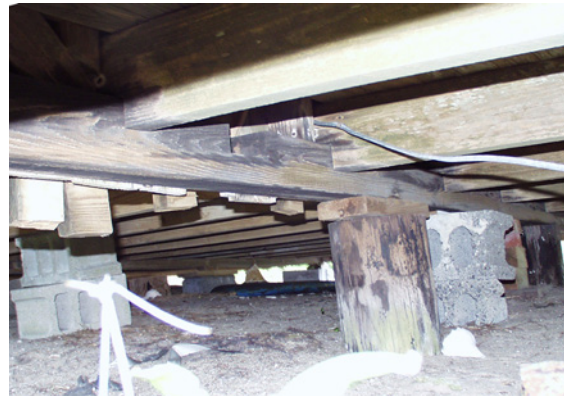
Figure 27 View of front sill of original house. Original siding extends below the bottom of the sill to left of center in this image. (NPS-SERO-CRS, 2002)

at the rear of the house has been severely damaged by termite infestation. Floor joists for this historic addition are around 1- 3/4" by 5- 5/8" as are those in the post- WWII bathroom extension.
