# Failure Analysis of Sapphire Refractive Secondary Concentrators

Failure analysis was performed on two sapphire, refractive secondary concentrators(RSC) that failed during elevated temperature testing. Both concentrators failed from machining/handling damage on the lens face. The first concentrator, which failed during testing to 1300 °C, exhibited a large *r*-plane twin extending from the lens through much of the cone. The second concentrator, which was an attempt to reduce temperature gradients and failed during testing to 649 °C, exhibited a few small twins on the lens face. The twins were not located at the origin, but represent another mode of failure that needs to be considered in the design of sapphire components. In order to estimate the fracture stress from fractographic evidence, branching constants were measured on sapphire strength specimens. The fractographic analysis indicated radial tensile stresses of 44 to 65 MPa on the lens faces near the origins. Finite element analysis indicated similar stresses for the first RSC, but lower stresses for the second RSC. Better machining and handling might have prevented the fractures, however, temperature gradients and resultan

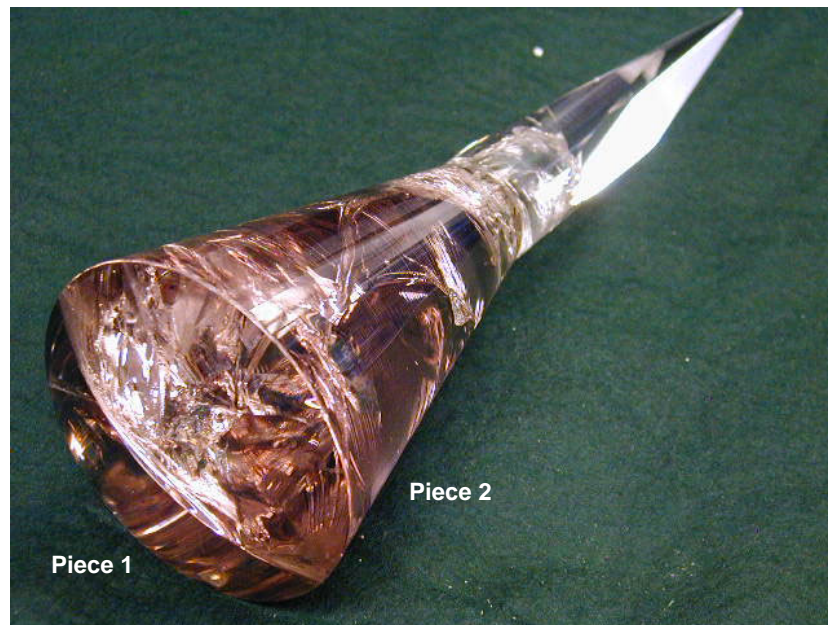
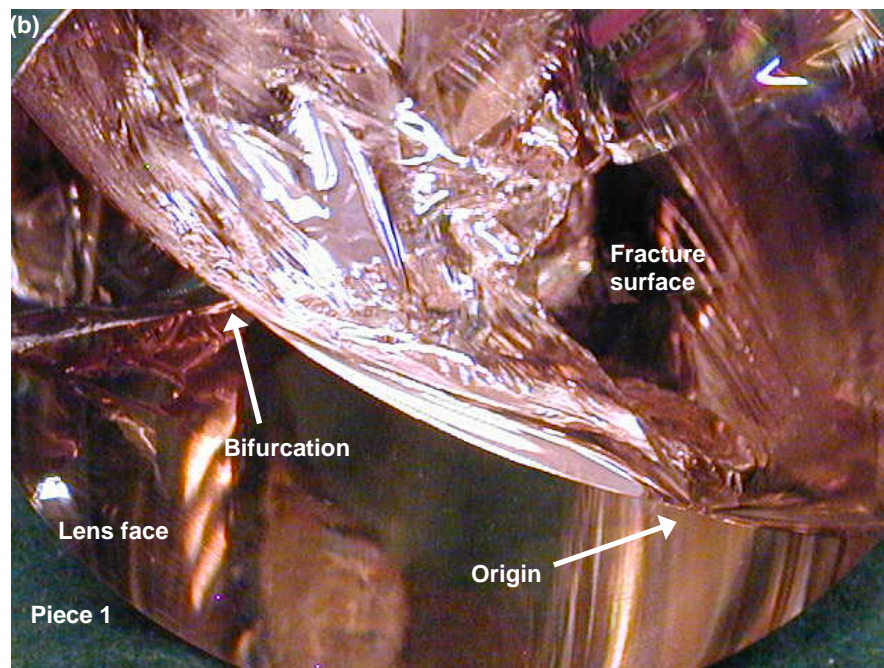
Figure 5.—(a) Overall view of RSC no. 1, the first solar concentrator, after testing. The lens diameter is 89 mm (3.5 in.) and the overall length is 284 mm (11.2 in.). (b) View of the fracture surface face of the bottom half (piece 1) showing the fracture origin and bifurcation that is located 44 mm away from the origin.

As shown in Figure 5(a), the lens face and cone are fractured near the mid-plane of the lens face and downward into the body to the extractor. There is a mixture of cleavage and conchoidal fracture and some crack bifurcations. As will be shown later, fracture started on the face of the lens and propagated downward into the cone body and extractor.

Besides the severe cracking, Figure 5(a) also shows that the cone region of the lens exhibits a rose hue when viewed on the cone sides, with thicker regions appearing darker than thinner regions. When viewed down the lens axis, a light-brown hue is exhibited in the uncracked regions, and rose hues in the severely cracked regions, probably from side light being reflected out the lens face. The rod region and a heavily cracked region of the cone are still clear.

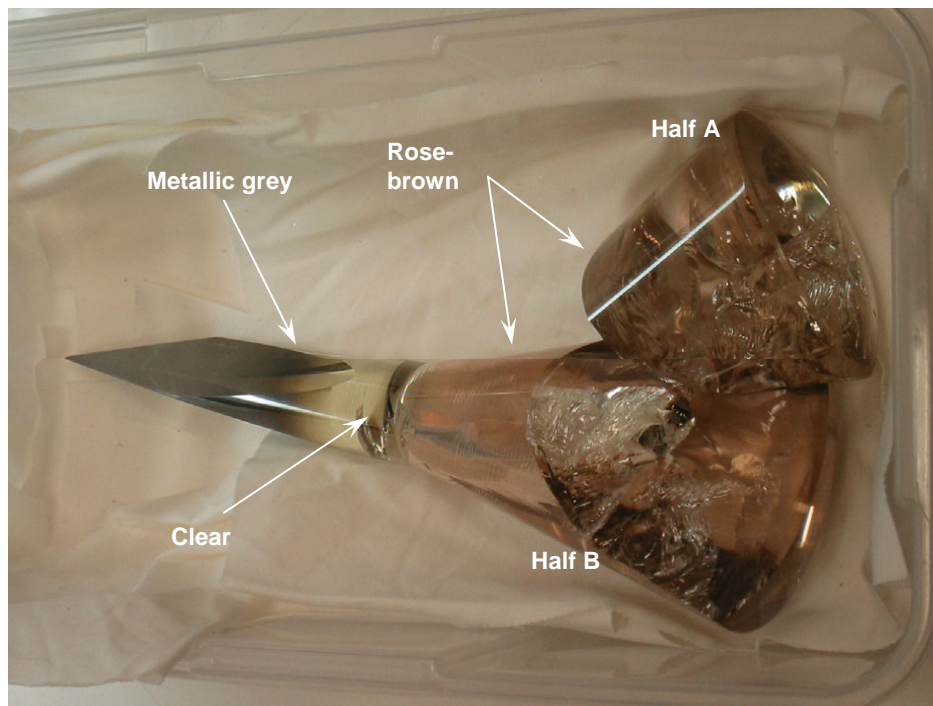
Figure 6.—RSC no. 2 after removal from the test rig. It has broken into two pieces. Cracks at the neck are also visible. The cracks in the neck and extractor are extensions of the main fracture in the cone body. The lens diameter is 89 mm (3.5 in.) and the overall length is 284 mm (11.2 in.).

As shown in Figure 6, the fracture started on the face of the lens and propagated downward into the cone body and extractor. The primary crack split the lens face and cone body near the mid-plane down to the extractor. Several *r*-plane bifurcations branch from the cone sides. The main crack rotated onto the *c*-plane after traveling ~15 mm into the extractor.

Besides being severely cracked, the cone region of the lens exhibits a translucent, lighter rose-grey hue as compared to the first RSC, with thicker regions appearing darker than thinner regions. The lighter color is likely a result of the lower temperature (and power) level. The end of the cone and the rod region just after the cone are clear whereas the remaining portion of the rod is an opaque dark gray.

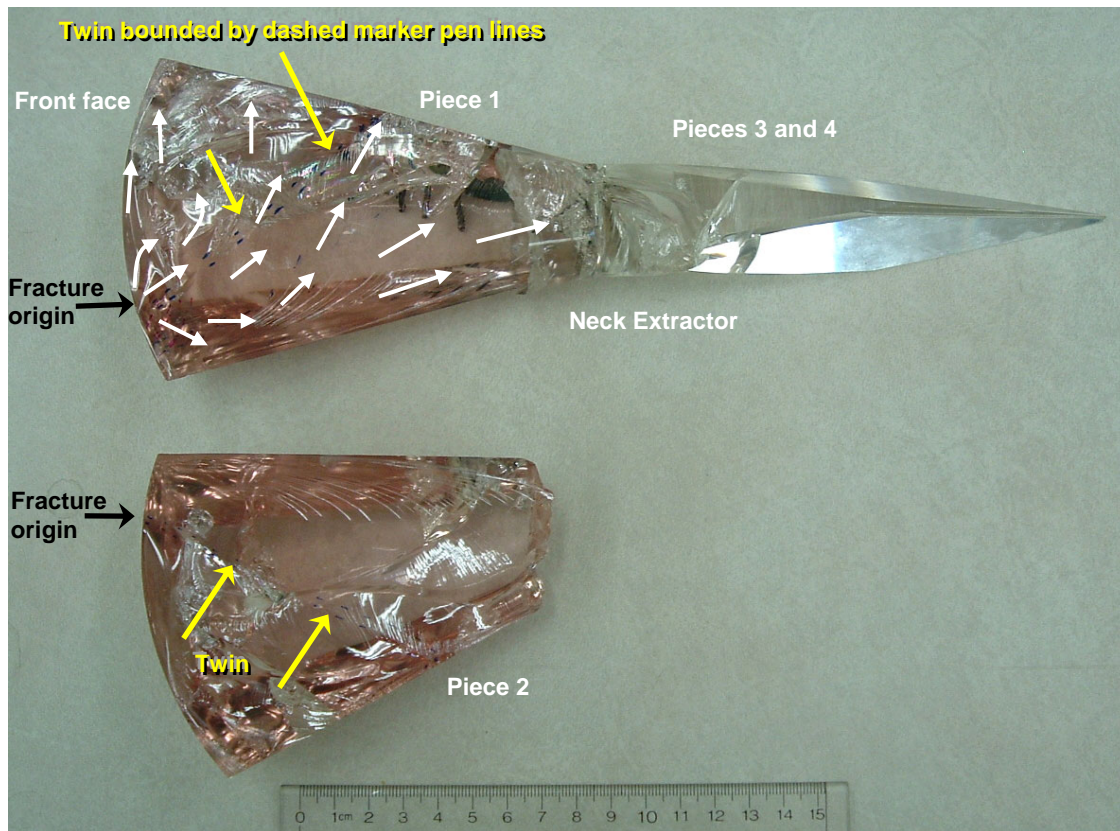
Figure 7 shows the four main pieces that concentrator no. 1 broke into after removal and some subsequent handling for the fractographic analysis. The origin is on the curved front face, about 20 mm away from the rim. There also is a large twin that extends diagonally all the way through piece 1 and which penetrates partially through piece 2. This twin was incidental and did not cause fracture.

Figure 7.—Concentrator RSC no. 1 fractographic analysis. Fracture started from the fracture origin on the front face and propagated (white arrows) into the cone body and onwards to the neck and extractor. The initial main fracture was almost perfectly radial and close to the *m*-plane in orientation. All the cracking in the neck and cone body can be backtracked to the one fracture origin. An incidental twin ran entirely through piece 1 from the lens front face through to the cone side and out the back of the cone. One end was close to but not exactly at the fracture origin site (2.3 mm away). There were minor perturbations in the main crack when it reached the twin plane indicating that the twin was in the RSC before the crack ran through it. The twin was very shallow in piece 2. It ran from the lens face right through the side of the cone, but did not extend very far below the fractured surface. The insert shows how subsequent handling caused the extractor to split into two pieces that separated from the cone body.

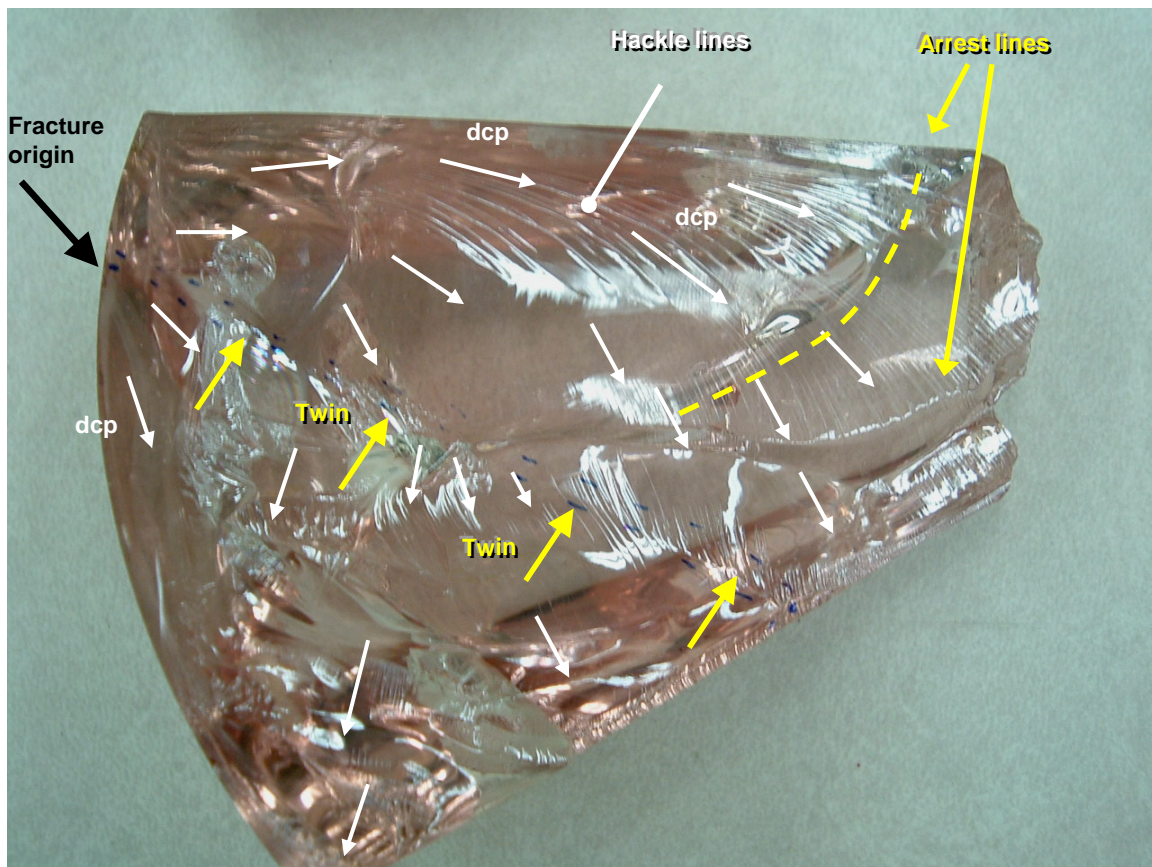
Figure 8 shows a close-up of piece 2 revealing some of the classic fracture surface markings such as twist hackle, cleavage step hackle, Wallner and arrest lines. The fractographic analysis of single crystals is covered in detail in Reference (Ref. 7). It should be borne in mind when viewing this and the following figures that reflections and translucency make photographing single crystals difficult. In the examples below, some regions are shown with several views with different lighting to bring out various details. Failure occurred from the fracture origin site and extended parallel to the  $m$ -plane. The main crack plane emanating from the origin contains hackle lines that extend from the lens face to the extractor on one side. This is a distance of ~5 in., and the crack nearly cleaves the cone into two segments that attached at the extractor rod. On the other side of the origin, the crack cleaved the lens cone only to a depth of ~2 mm along the lens before splitting, moving off the  $m$ -plane and forming a confluence of cracks at a variety of angles.

Figure 8.—Piece 2 of RSC no. 1. The small white arrows show the local direction of crack propagation (dcp) as identified by hackle lines, Wallner lines (not labeled), and arrest lines. These facilitate the determination of the crack propagation direction and the fracture origin. The twin runs diagonally across this view as marked by yellow arrows. Its left end comes very close to but is not coincident with the fracture origin. The main crack was perturbed slightly when it traversed across the preexisting twin.

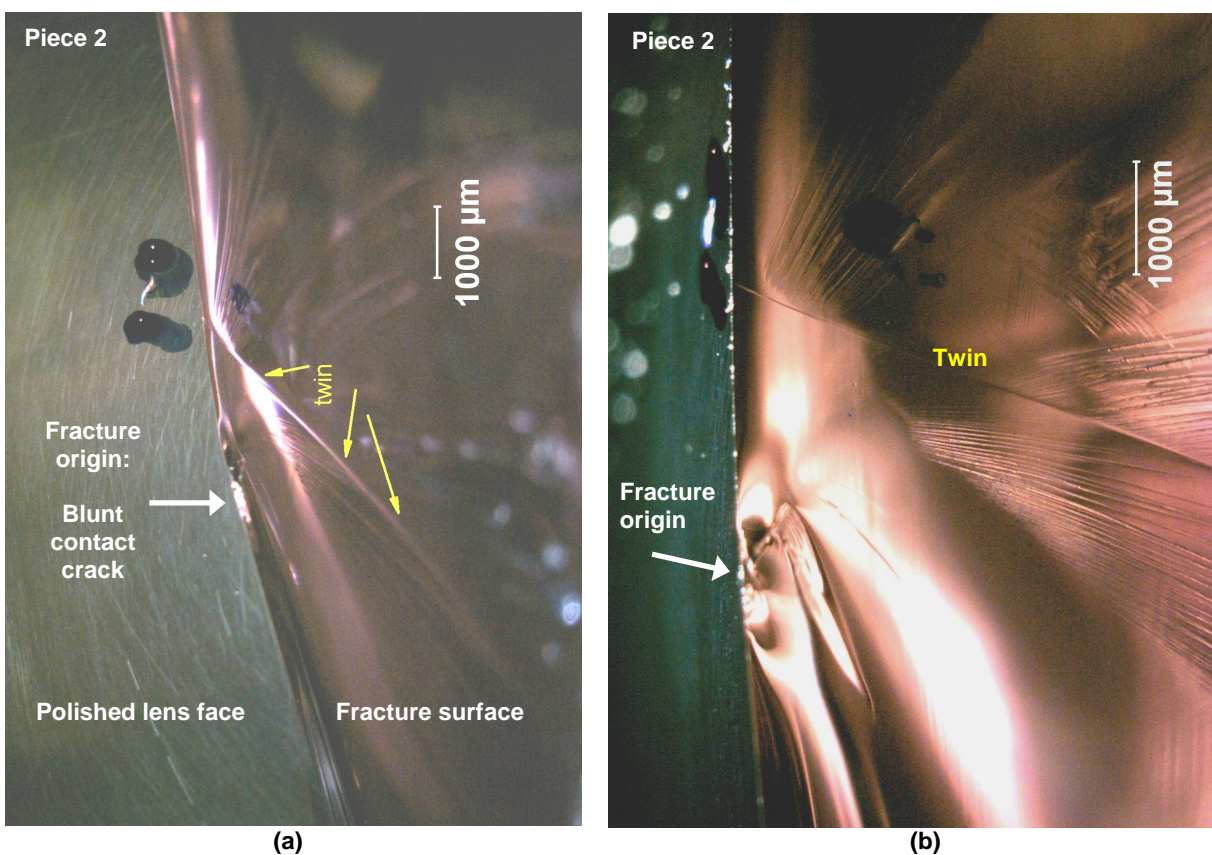
Figures 9 to 12 show that the failure origin is on the lens face, about 20 mm away from the rim. These views were taken with different lighting at different angles. The origin is a large, partially formed Hertzian cone crack, that extended from one of two partially polished impact divots or “bruises” measuring ~ 0.1 and ~ 0.2 mm in diameter, as shown in Figure 12. The cracks associated with the bruises are quite large, ~ 0.5 mm, and the damaged region can be seen with the unaided eye. Contact damage usually has two forms depending upon the sharpness or bluntness of the offending impactor (Ref. 7). Sharp impactor contact damage usually has a small concentrated damage crater with a star like array of cracks radiating outwards. Blunt impactor damage has a conical or ring shape. Often it may be a partial ring shape such as shown in Figures 10 and 11. From the size of the ring crack, it may be deduced that the impact object had a diameter greater than 0.5 mm.

Figure 9.—Close- up views of piece no. 2 of RSC no. 1 with about the same orientation as in Figures 7 and 8. Minor polishing scratches are revealed by the lighting in (a). (b) is a close up of (a).

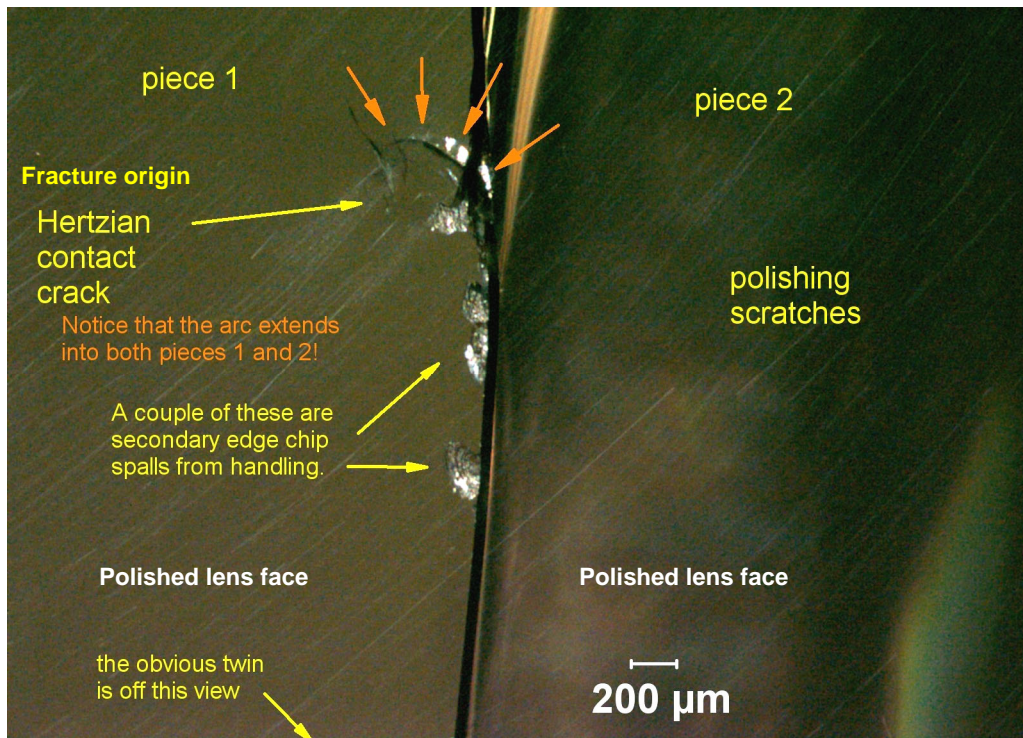
The Hertzian crack likely formed due to impact with a hard blunt object during the grinding or early polishing steps. As Figure 12 shows, final polishing created some microscratches around the bruises. These would not have been present if the impact had occurred *after* the final polishing phase. Better care would have eliminated this failure source.

Figure 10.—This view shows the curved polished face of pieces 1 and 2 of RSC no. 1 held together at the origin site. The orange arrows highlight the Hertzian (blunt impactor) contact crack.

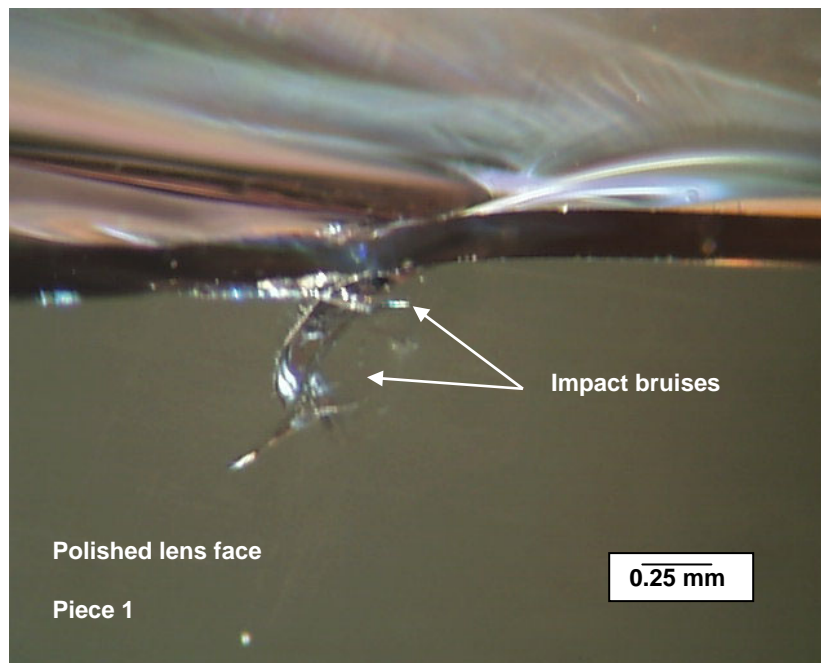
Figure 11.—View of piece 1 of RSC no. 1 showing cracks extending from bruises on the lens face. The sites of the impact bruises are marked in this view, but they are more obvious in the next figure which has different lighting.

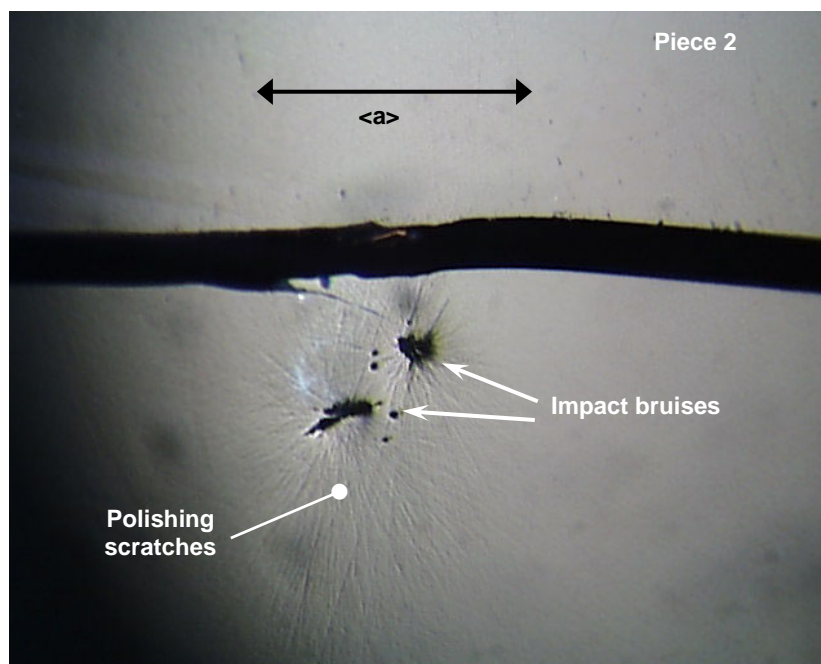
Figure 12.—Surface lighting of the bruises revealing polish scratches in the polished face of RSC no. 1. The residual scratches that radiate from the contact sites imply that the impacts occurred prior to the final polishing of the face. Final polishing caused micro scratches to radiate outward from the damage sites.

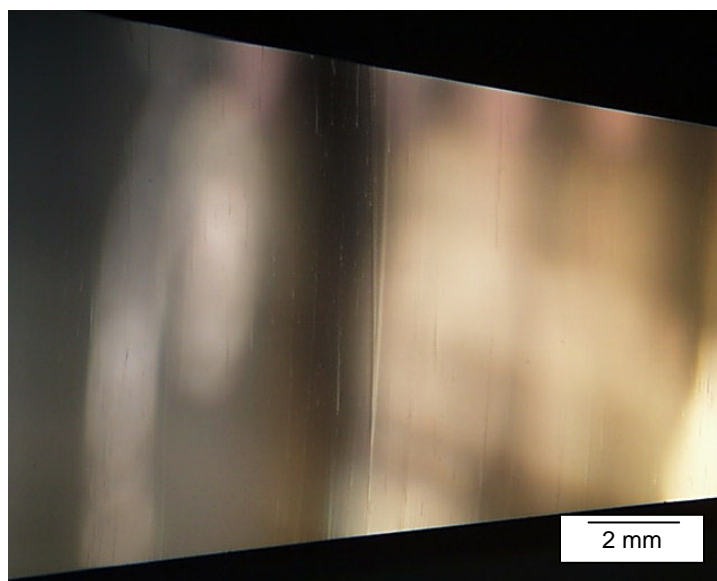
In addition to the bruises, large remnant scratches from the rough machining were noted on the lens faces, Figures 10 and 11, but also on the shaft, Figure 13. Another scratch approximately 2.3 mm from the rim on the lens face extends along nearly  $\frac{3}{4}$  of the perimeter and can easily be seen with the unaided eye, Figure 14. Also apparent are some semi-polished chips on the edge between the lens face and the cone, as shown in Figure 15. Ideally, better machining and polishing should be performed. Poor polishing, such as that observed, is referred to as a “short finish” and generally results in a very large variation in the measured strength (Ref. 8).

Figure 13.—Grinding marks along extractor shaft of RSC no. 1.

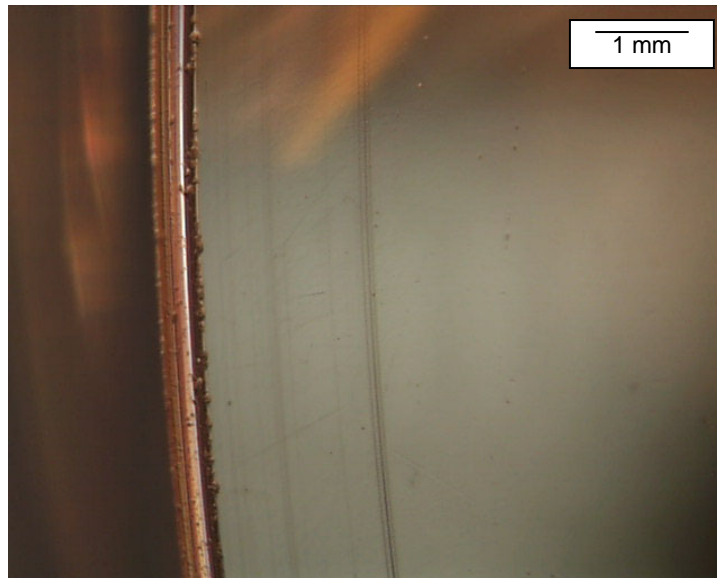
Figure 14.—Grinding damage and scratches on the lens face near the rim of RSC no. 1.

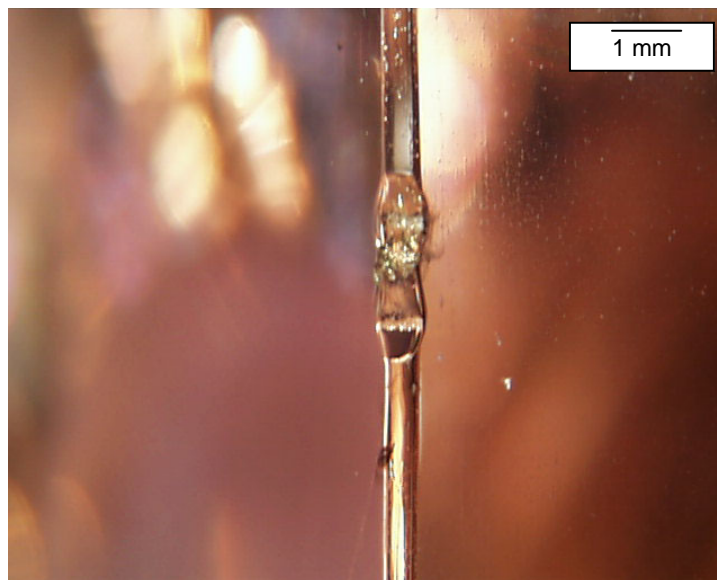
Figure 15.—Chips on the rim of the lens of RSC no. 1.

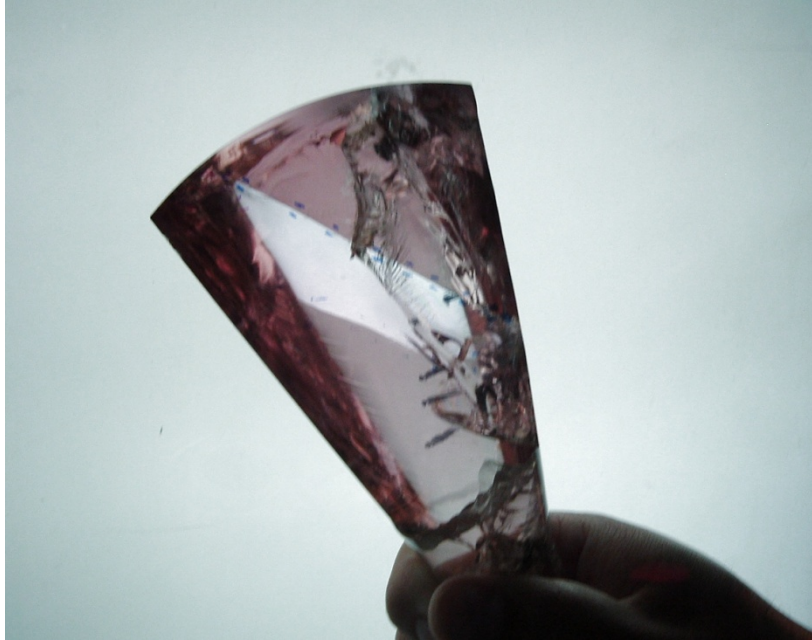
The twin that was observed running through RSC no. 1 is shown in Figures 7, 8 and 16, but it appeared to have been incidental. It could not be determined where it initiated. It was more obvious in piece 1 and it penetrated completely through the piece. It was seen over all surfaces with the naked eye. It extends only partially into piece 2. It is also visible on piece 2 primarily by how it affected the main crack propagation. Additional twins that were detected in the front face of piece no. 1 are shown in the Appendix.

Figure 16.—A prominent twin (the light colored band) ran through the body of piece 1 of RSC no. 1. This is a view of the piece through crossed polarizers.

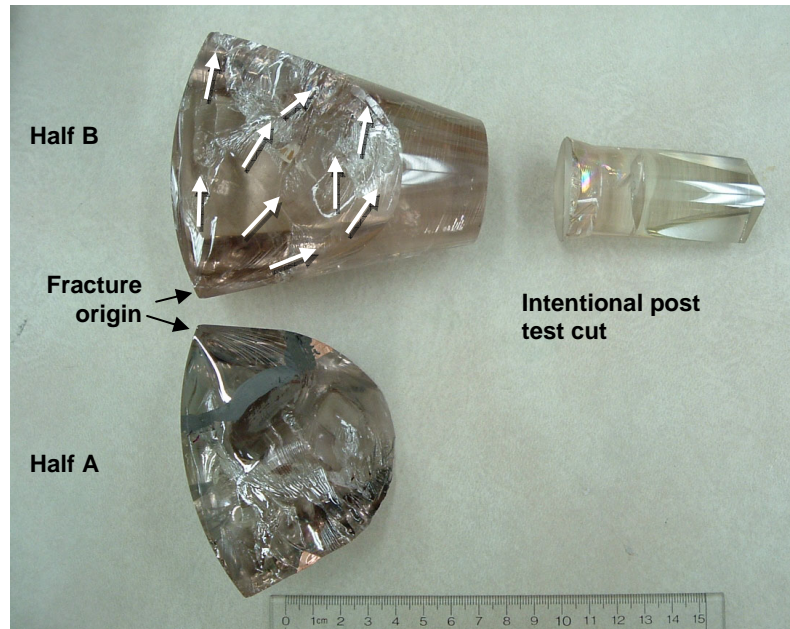
Figure 17 shows fractured RSC no. 2, which was intentionally sliced after the test in order to facilitate chemical analysis and fractographic examination. Hereafter the two halves of the conical body are referred to as half A or half B as shown in the figure. The main crack plane emanating from the origin contains twist hackle and cleavage step hackle that extend from the lens face to the rod neck and extractor. Once entering the rod extractor, the crack turned onto the *c*-plane, nearly cleaving the rod.

The crack path down the cone is parallel to the *m*-plane on one side and ill-defined on the other, and separates the cone into two halves. At ~17 mm from the origin along the side, the crack bifurcated once onto the *r*-plane. This bifurcation was followed by several others, one of which exited the cone, causing a portion of the lens to separate diagonally from the rest of the cone. Along the lens face, the crack extended along the *r*-plane until the middle of the lens, where it propagated in a conchoidal fashion. The first bifurcation occurred onto an *m*-plane at ~17 mm along the face. This was followed by second and third bifurcations at ~22 and ~30 mm (shown later in Figure 22(a)). The third bifurcation extended to edge of the lens, whereas the first two stopped within the concentrator.

Figure 17.—Concentrator 2. The white arrows show the direction of crack propagation.

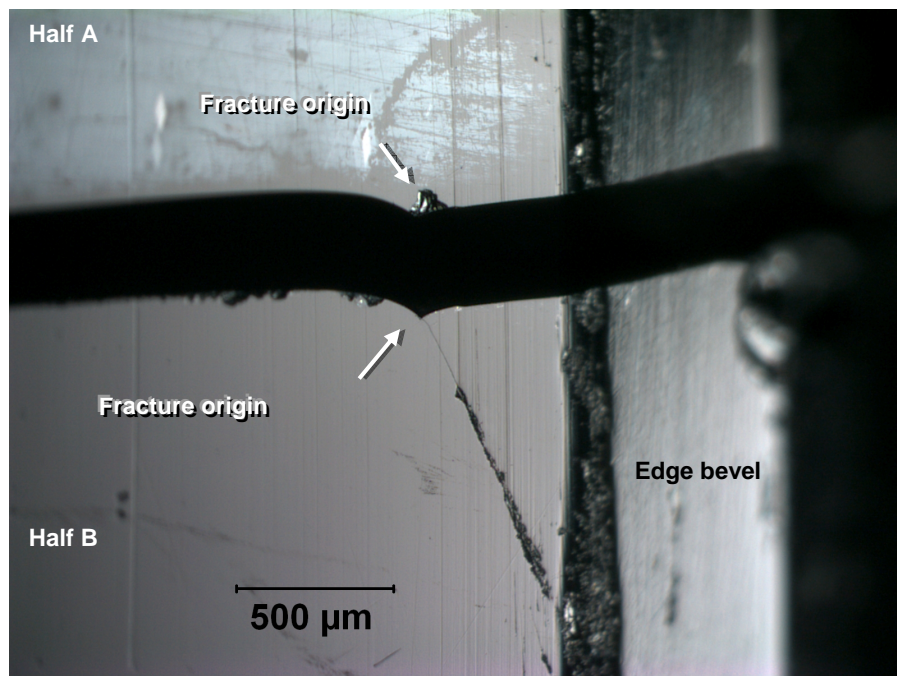
There was a single fracture origin on the lens face that was located only 0.5 mm away from the rim bevel and 1.3 mm away from the cone side wall as shown in Figures 17 and 18. It is not known whether this site was coincident with a shoe contact site as shown in Figures 2 and 3. On half B the origin is clearly identified as a large curved scratch. Close up views of half B are in Figures 19 and 20 which show the curved scratch in more detail.

Figure 18.—View of curved forward face of RSC no. 2. Fracture started from a curved scratch best seen on half B on the bottom. Note the secondary chipping on both halves along the main fracture plane.

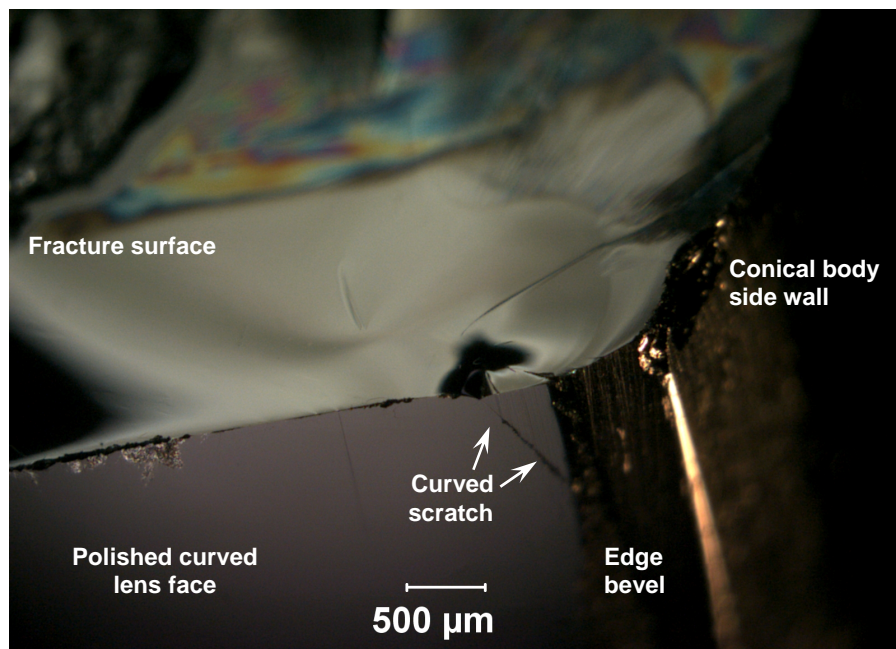
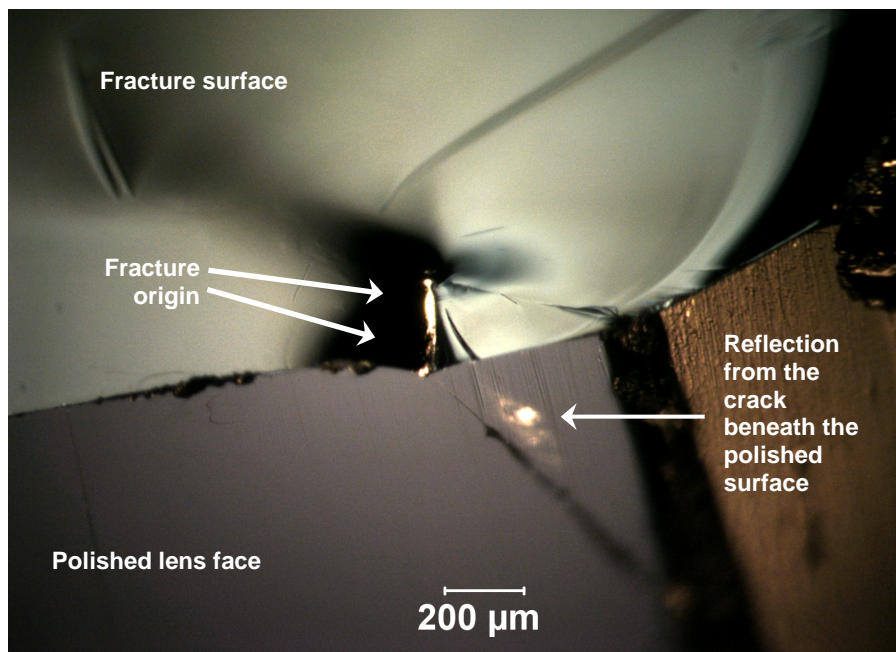
Figure 19.—Stereo optical microscope views of half B of RSC no. 2. The piece has been tilted so that both the fracture surface and the polished curved lens face can be seen. (b) is a close up of (a).

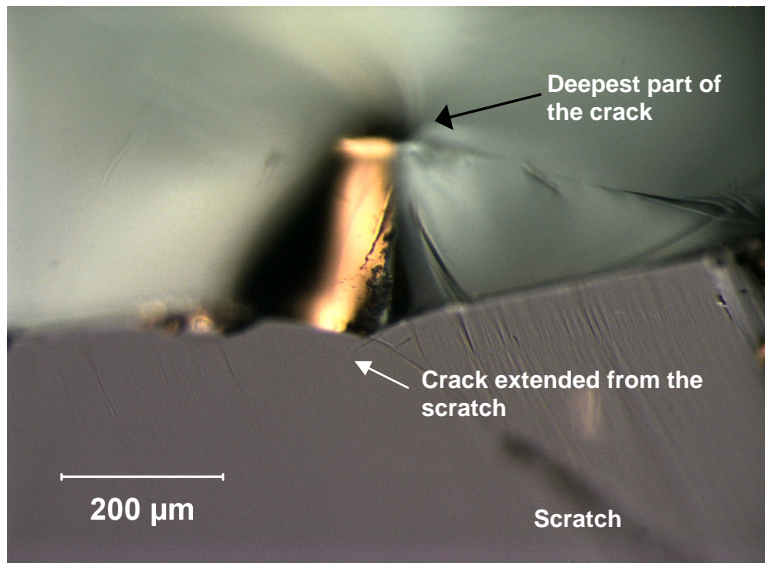
Figure 20.—Detail of the fracture origin of RSC no. 2, in half B. A crack extends from the scratch region (out of focus in this view) which is characterized by tell tale short lateral spall cracks. The crack created underneath the scratch extended upwards and curved to the left in this view (small arrow). The crack penetrates at least 250  $\mu\text{m}$  deep beneath the polished surface into the lens body. Lens fracture started from the deepest point of the crack indicated by the black arrow. In this view, light reflections from the subsurface curved crack face cause shadows and bright reflections.

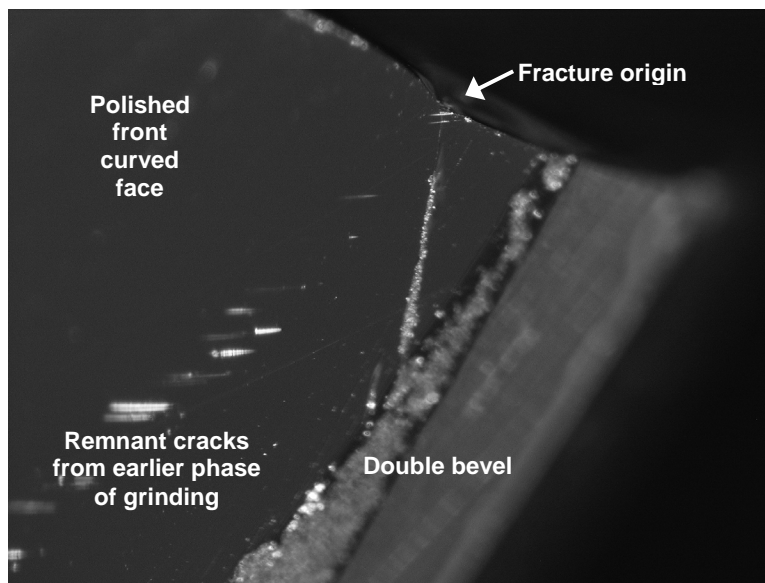
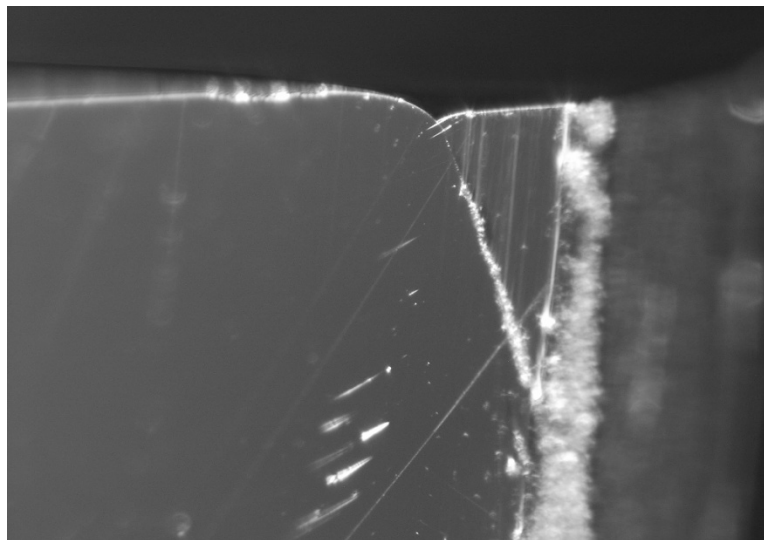
Figure 21.—Two views of the same area of the polished face and edge bevel of half B of RSC no. 2 revealing additional irregularities besides the curved scratch. Notice how adjusting the lighting in (b) can bring out some scratches that are not visible in (a).

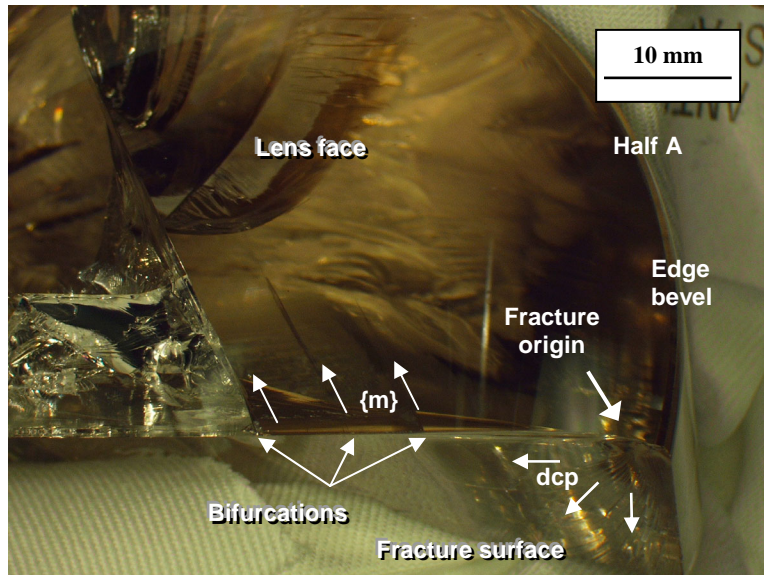
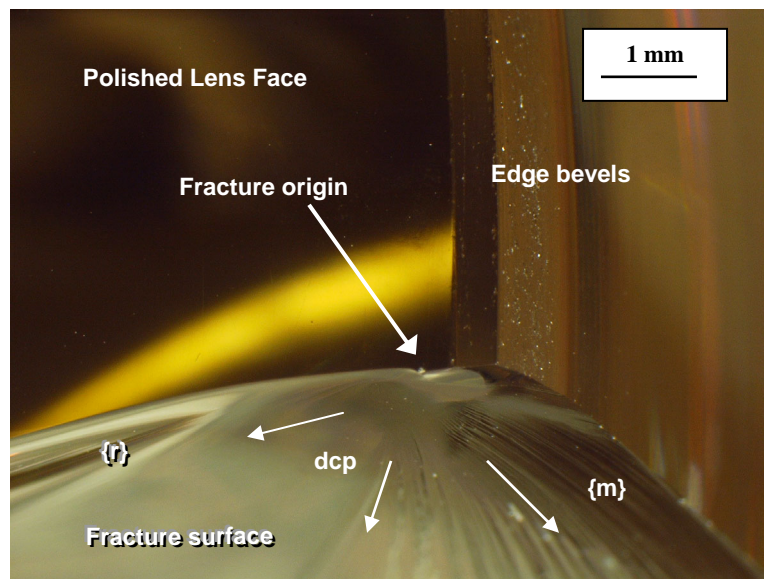
The matching half A of concentrator 2 is shown in Figures 22 to 25. The crack from the scratch is less clearly evident and attention is drawn to what appears to be a pit at the origin site. No trace of the apparent pit existed on half B. The “pit” is probably secondary chipping after the main fracture occurred or it may have been a small initial pit that was enlarged by secondary chipping. The scratch is the primary flaw.

Figure 22.—Views of the fracture origin area in half A of RSC no. 2 showing both the fracture surface and the polished front surfaces. Bifurcations onto the  $\{m\}$  plane are evident in (a). The first two do not extend very far into the body, but the third causes a main crack to form all the way through the body. (b) shows radiating hackle lines on the fracture surface that point back to the origin site. “dcp” is direction of crack propagation.

Both of the crack fronts running along the  $m$ -plane (Fig. 22(b)) and  $r$ -plane (Fig. 22(a)) bifurcate at ~17 mm. Figure 22(a) shows several short bifurcations that are in a row, but these all arrested after a short propagation into the cone. The first significant bifurcation occurred at 30 mm from the origin. The bifurcation distance of ~17 mm combined with  $A_b = 7.0 \text{ MPa}\sqrt{\text{m}}$  and equation 3 implies a fracture stress of ~65 MPa. The larger distance (30 mm) gives a stress estimate of 51 MPa using equation 3. This also is a very low stress, but again, these estimates are supported by the observation that the flaw at the fracture origin was rather large and deep.

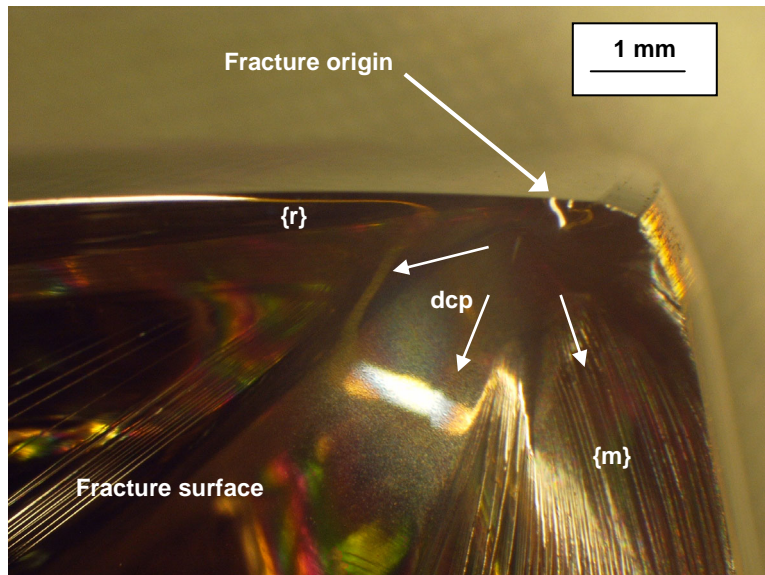
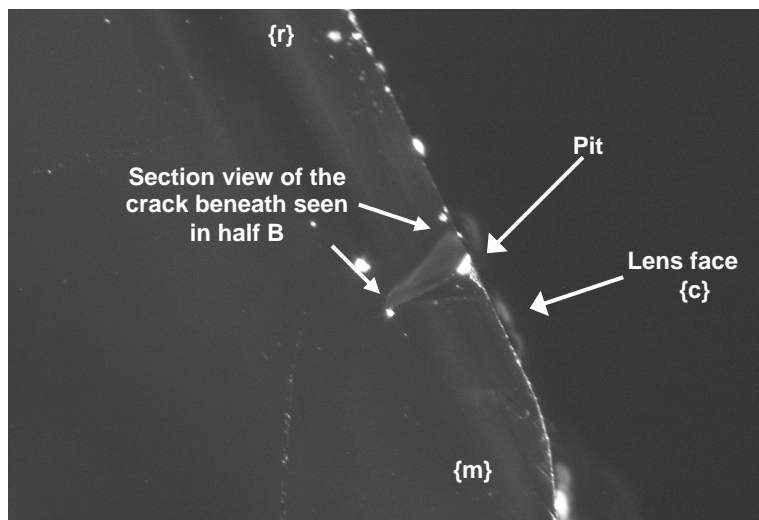
Figure 23.—View of fracture surface of half A of RSC no. 2 showing hackle lines that formed on  $\{r\}$  and  $\{m\}$  planes on either side of the origin.

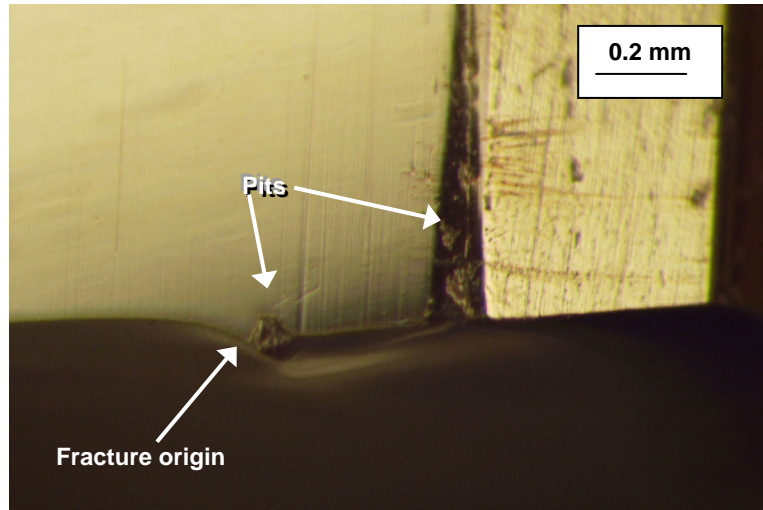
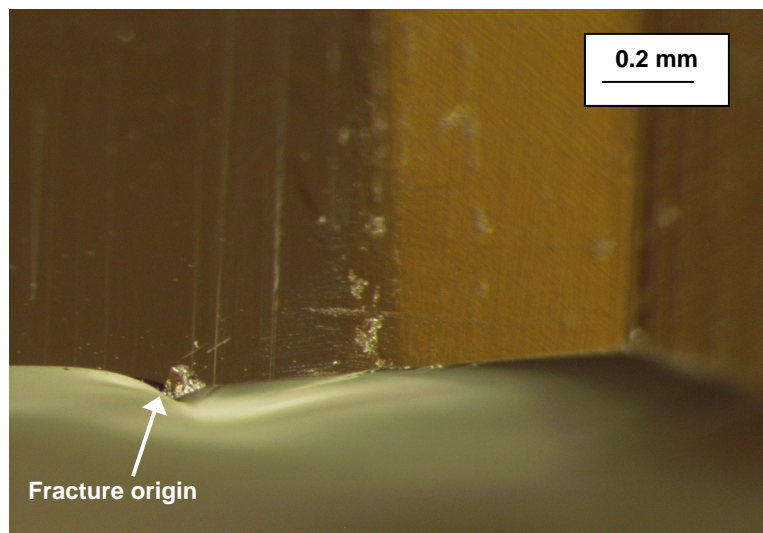
Figure 24.—Two views with different illuminations of lens face of half A of RSC no. 2 showing surface scratches, pits, and the fracture origin site.

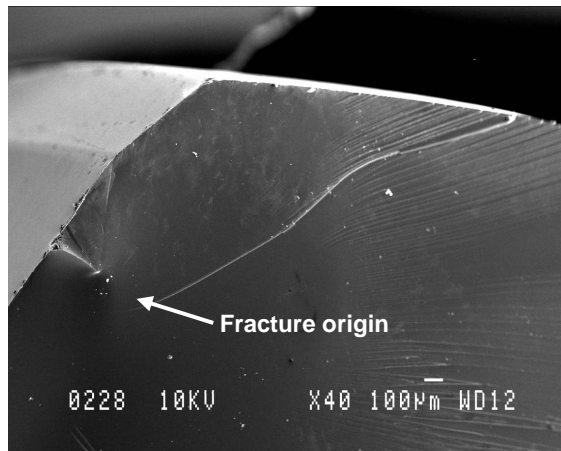
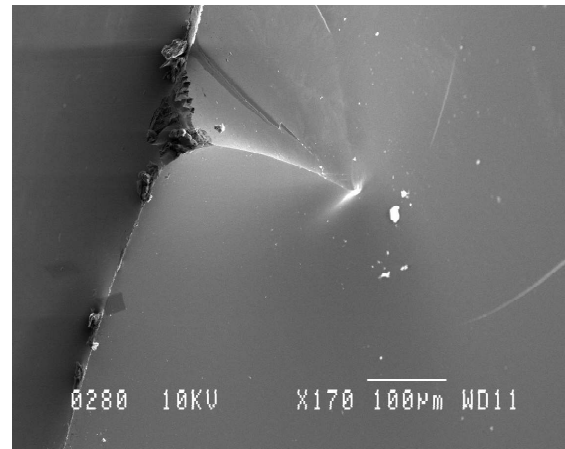
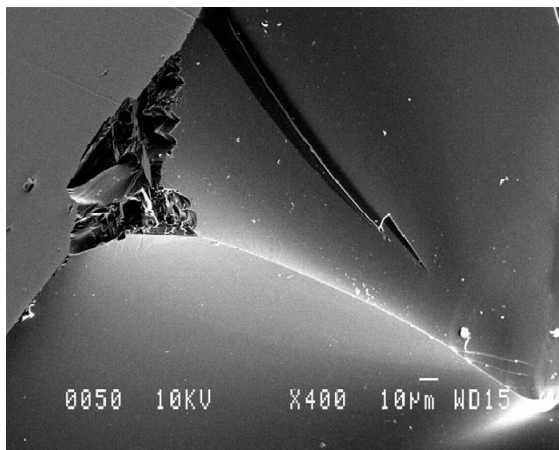
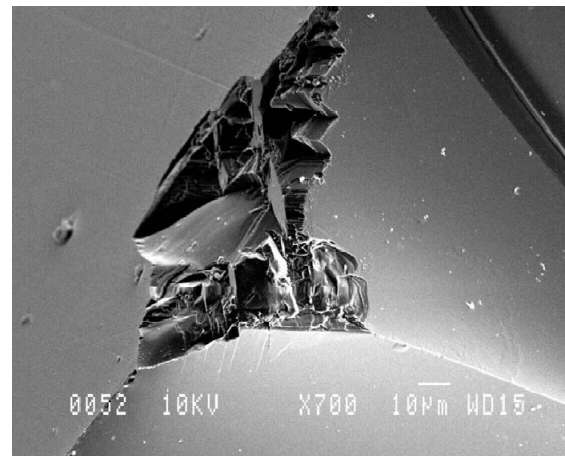
Figure 25—SEM close-up views of the origin in half A of RSC no. 2. (b) to (d) are close up views. The origin is the crack that penetrated beneath the polished surface. The “pit” is probably secondary chipping although genuine pits were noted elsewhere in the vicinity.

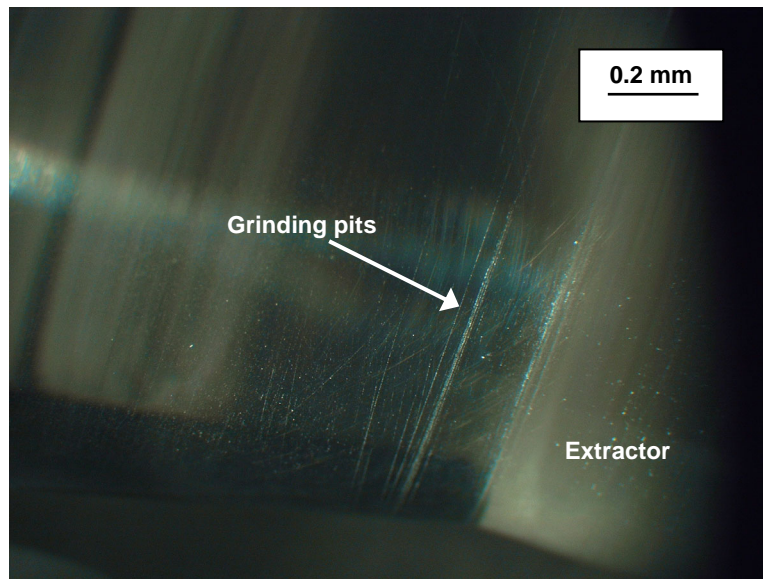
In addition, occasional, large remnant scratches from the initial rough machining stages can be noted on the lens, rod and cone, as shown in Figures 26 and 27. Several other features in the vicinity of the origin were also detected as shown in Figure 28, but they appeared to be incidental micro twins.

Figure 26.—View of lens cone and rod of RSC no. 2 showing surface scratches (grinding damage) prior to testing.

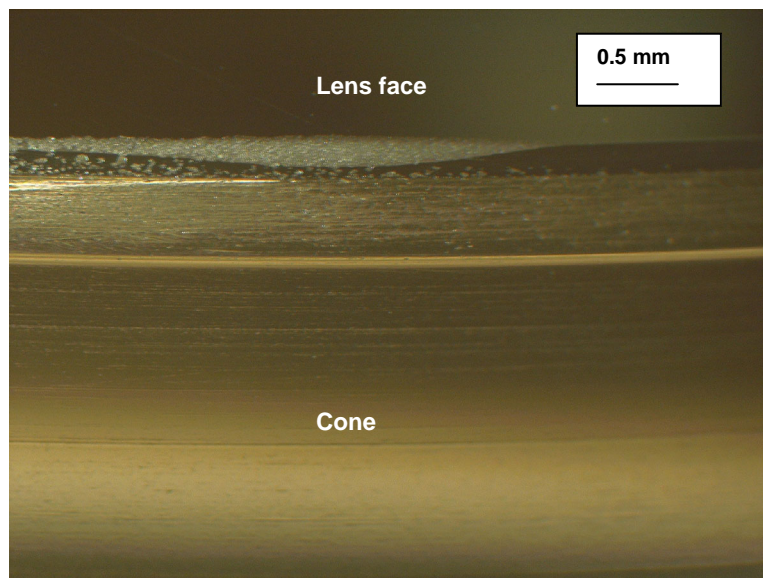
Figure 27.—View of RSC no. 2 cone and bevel showing heavy pitting and surface scratches (grinding damage) prior to testing. Notice the two step uneven bevel.

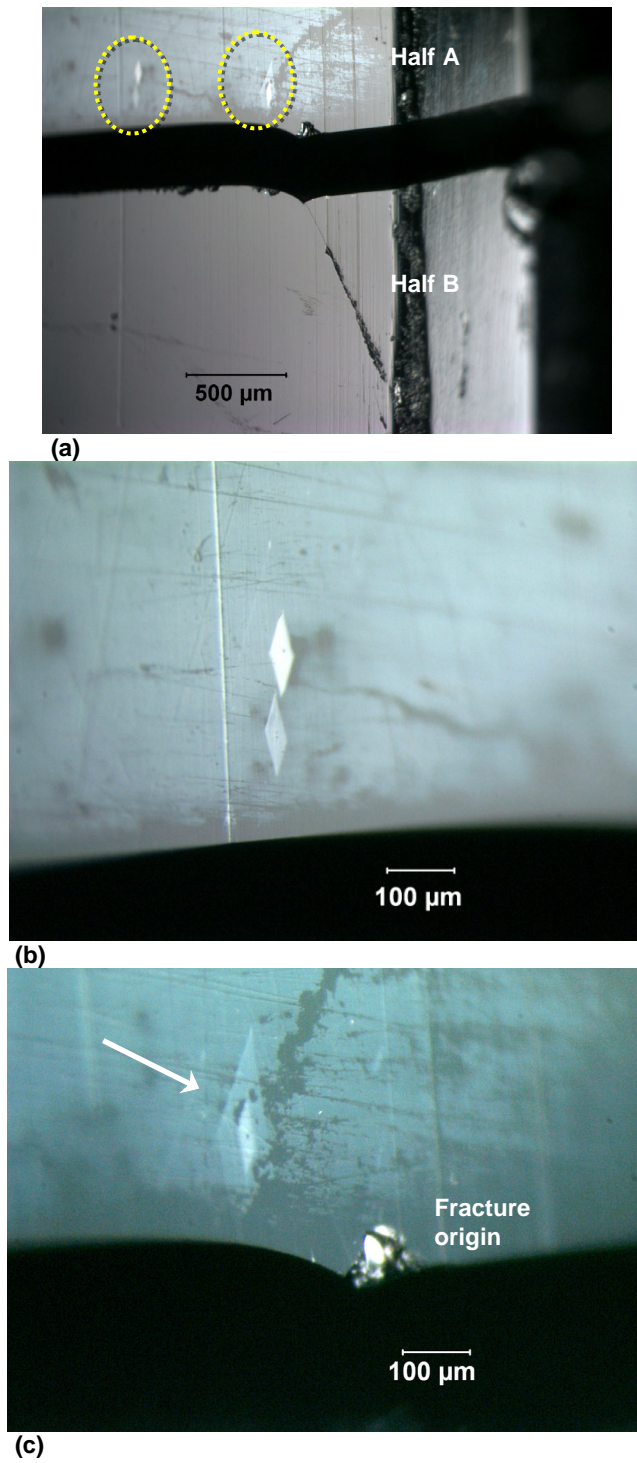
Figure 28.—Odd features detected on or just underneath the surface in half A of RSC no. 2 near but not actually at the fracture origin site. (a) shows the overall origin area with arrows marking the strange features. (b) and (c) are close up views.

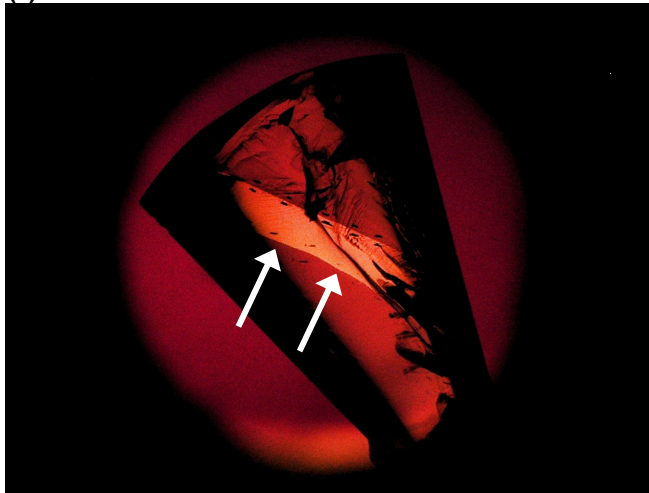
Figure A1.—Classic style Polariscope. (a) The component is placed between the polarizer eyepieces and the illuminated polarizing screen. (b) is a picture of piece 1 of concentrator 1. The photo was taken by a digital camera focused through one eyepiece. The very large twin appears as a light colored band running diagonally through the piece (white arrows). It is not a fracture plane.
