# Failure Analysis of Sapphire Refractive Secondary Concentrators

Failure analysis was performed on two sapphire, refractive secondary concentrators(RSC) that failed during elevated temperature testing. Both concentrators failed from machining/handling damage on the lens face. The first concentrator, which failed during testing to 1300 °C, exhibited a large *r*-plane twin extending from the lens through much of the cone. The second concentrator, which was an attempt to reduce temperature gradients and failed during testing to 649 °C, exhibited a few small twins on the lens face. The twins were not located at the origin, but represent another mode of failure that needs to be considered in the design of sapphire components. In order to estimate the fracture stress from fractographic evidence, branching constants were measured on sapphire strength specimens. The fractographic analysis indicated radial tensile stresses of 44 to 65 MPa on the lens faces near the origins. Finite element analysis indicated similar stresses for the first RSC, but lower stresses for the second RSC. Better machining and handling might have prevented the fractures, however, temperature gradients and resultan

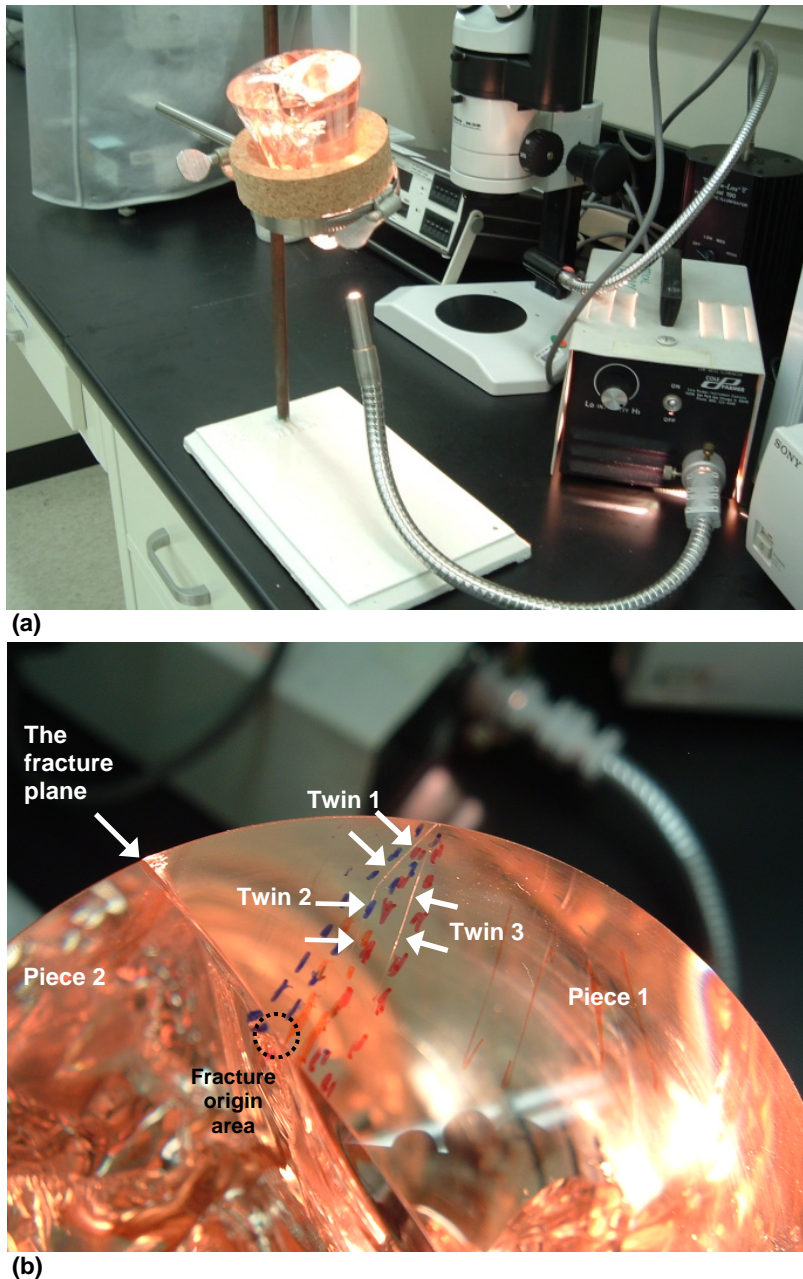
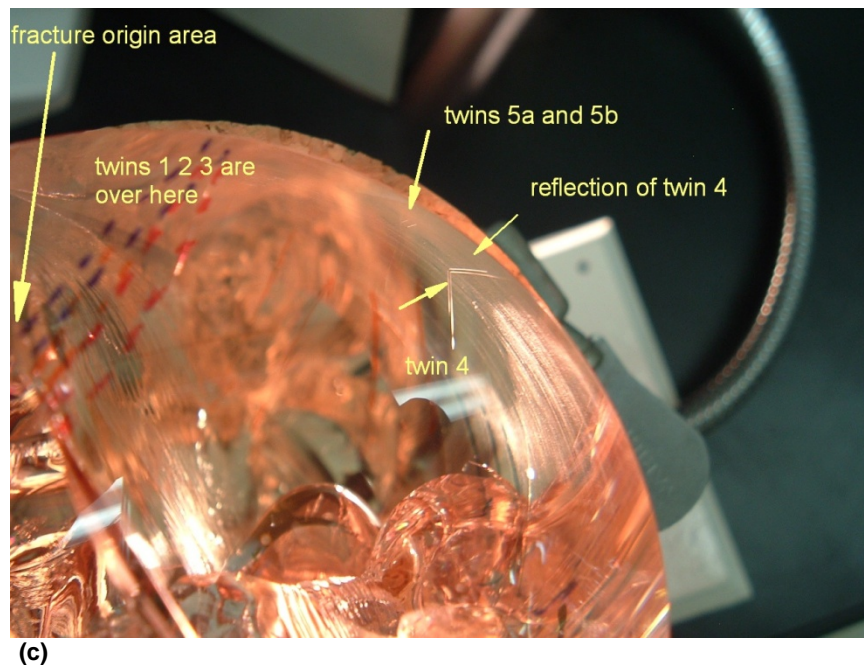
Figure A3.—Transmitted illumination was used to detect small twins. (a) shows the two pieces of concentrator 1 mounted in a soft cork ring on a common ring stand. A fiber optic light source was directed up through the body. (b) shows a digital camera photograph of the front face of RSC no. 1. Color felt tip dashed marker lines were marked on the surface to bracket two twins, which are the very thin white lines marked by the white arrows. (c) shows other twins on the same surface. The lighting and component orientation has to be changed to accentuate each twin set since it is difficult to get all twins visible at the same time. Twins 5a and b are tiny short segments. Twin 4 is longer.
