NATIONAL TRANSPORTATION SAFETY BOARD

HAZARDOUS MATERIALS ACCIDENT REPORT

RUPTURE OF A RAILROAD TANK CAR
CONTAINING HAZARDOUS WASTE
NEAR CLYMERS, INDIANA
FEBRUARY 18, 1999

**NTSB/HZM-01/01
DCA99MZ004
PB2001-917002
Notation 7329
Adopted March 5, 2001**

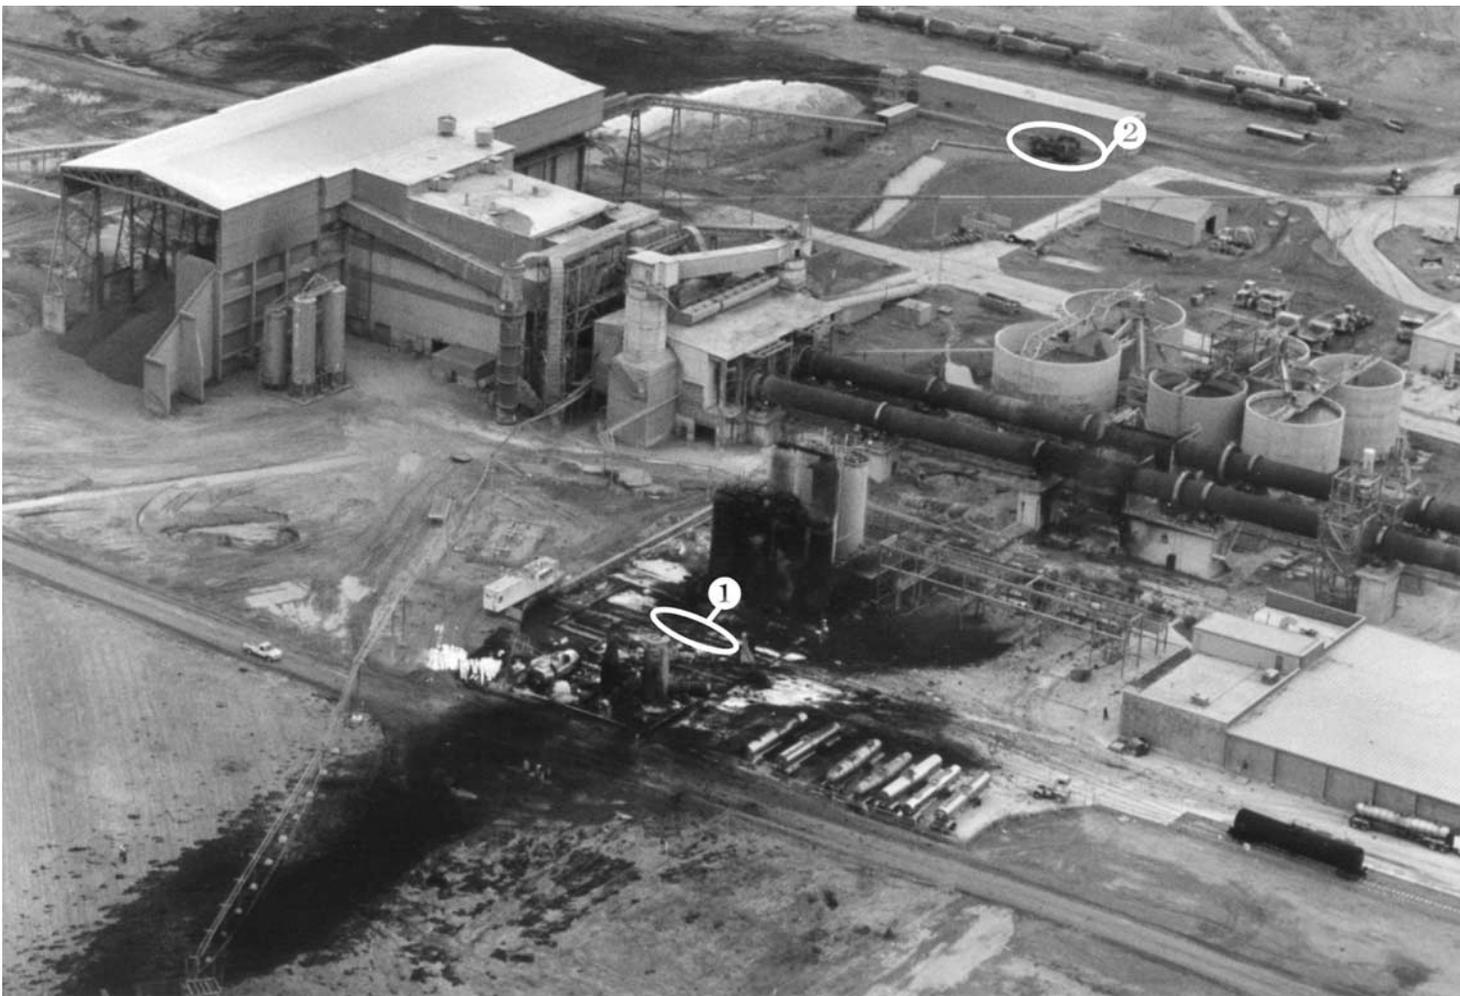
Figure 4. Essroc plant after the accident; #1 indicates preaccident position of UTLX 643593; #2 indicates location of bulk of tank car after the accident. *(Photo courtesy of Logansport Pharos-Tribune newspaper)*

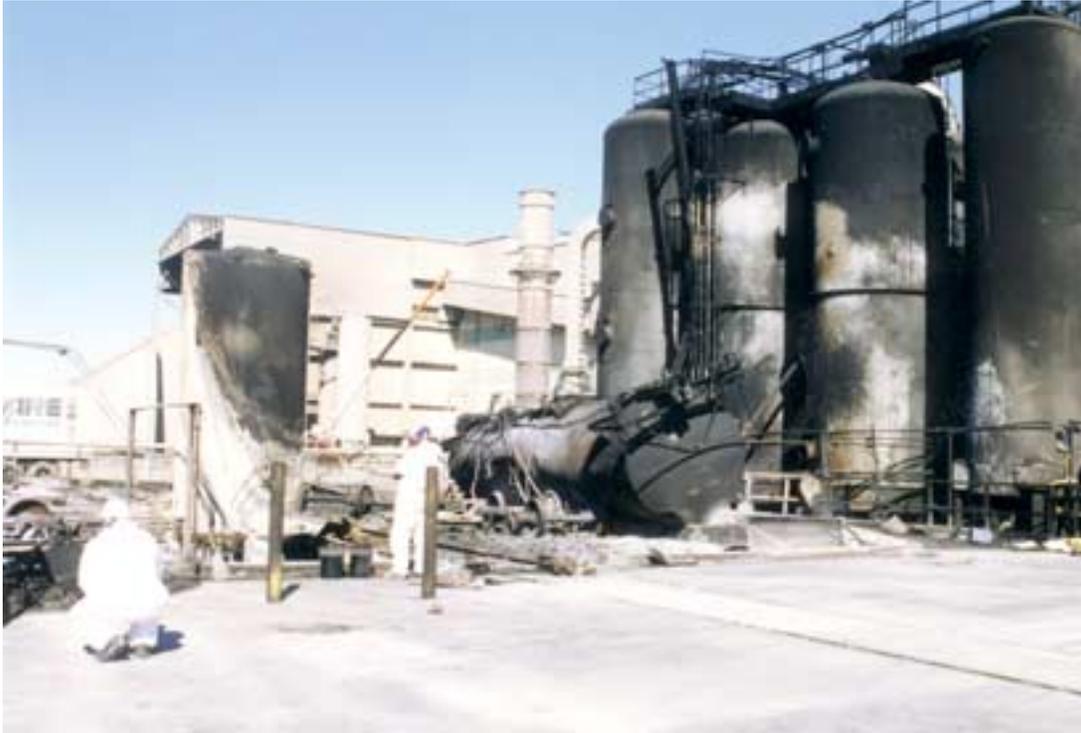
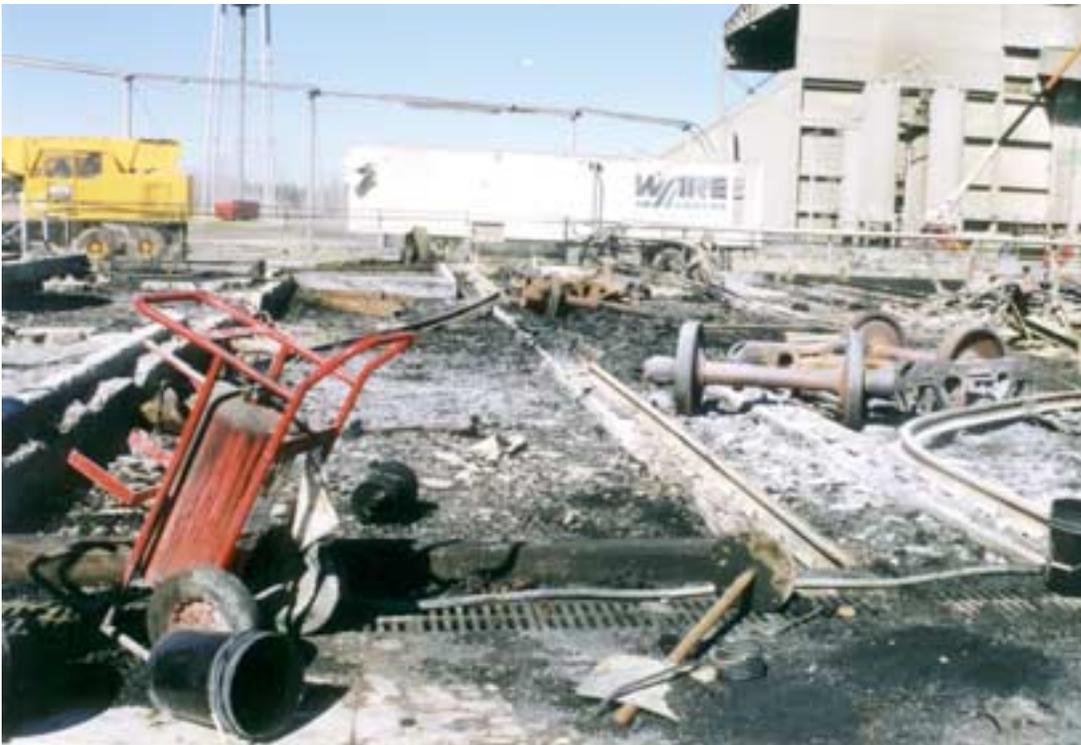
Fixed storage tanks along the east and west sides of the offloading area exhibited fire and heat damage, as well as impact damage from flying debris. The damaged areas on all these tanks were directly exposed to the offloading station where UTLX 643593 had been. The four tanks along the west side included two 12,000-gallon fuel oil tanks and two 7,500-gallon tanks containing a blending agent for the TDI matter waste. All four of these tanks were destroyed. A 2,000-gallon tank containing toluene was blown from its original position between UTLX 643593 and the cargo tank trailer into the fuel oil tanks on the west side of the offloading area. Fire had blackened 4 of a group of 10 storage tanks on the east side of the offloading area. The remaining six tanks, although partially shielded, also had some blackening and heat damage. (See figure 5.)

Figure 5. Essroc loading rack area after accident. (NTSB)

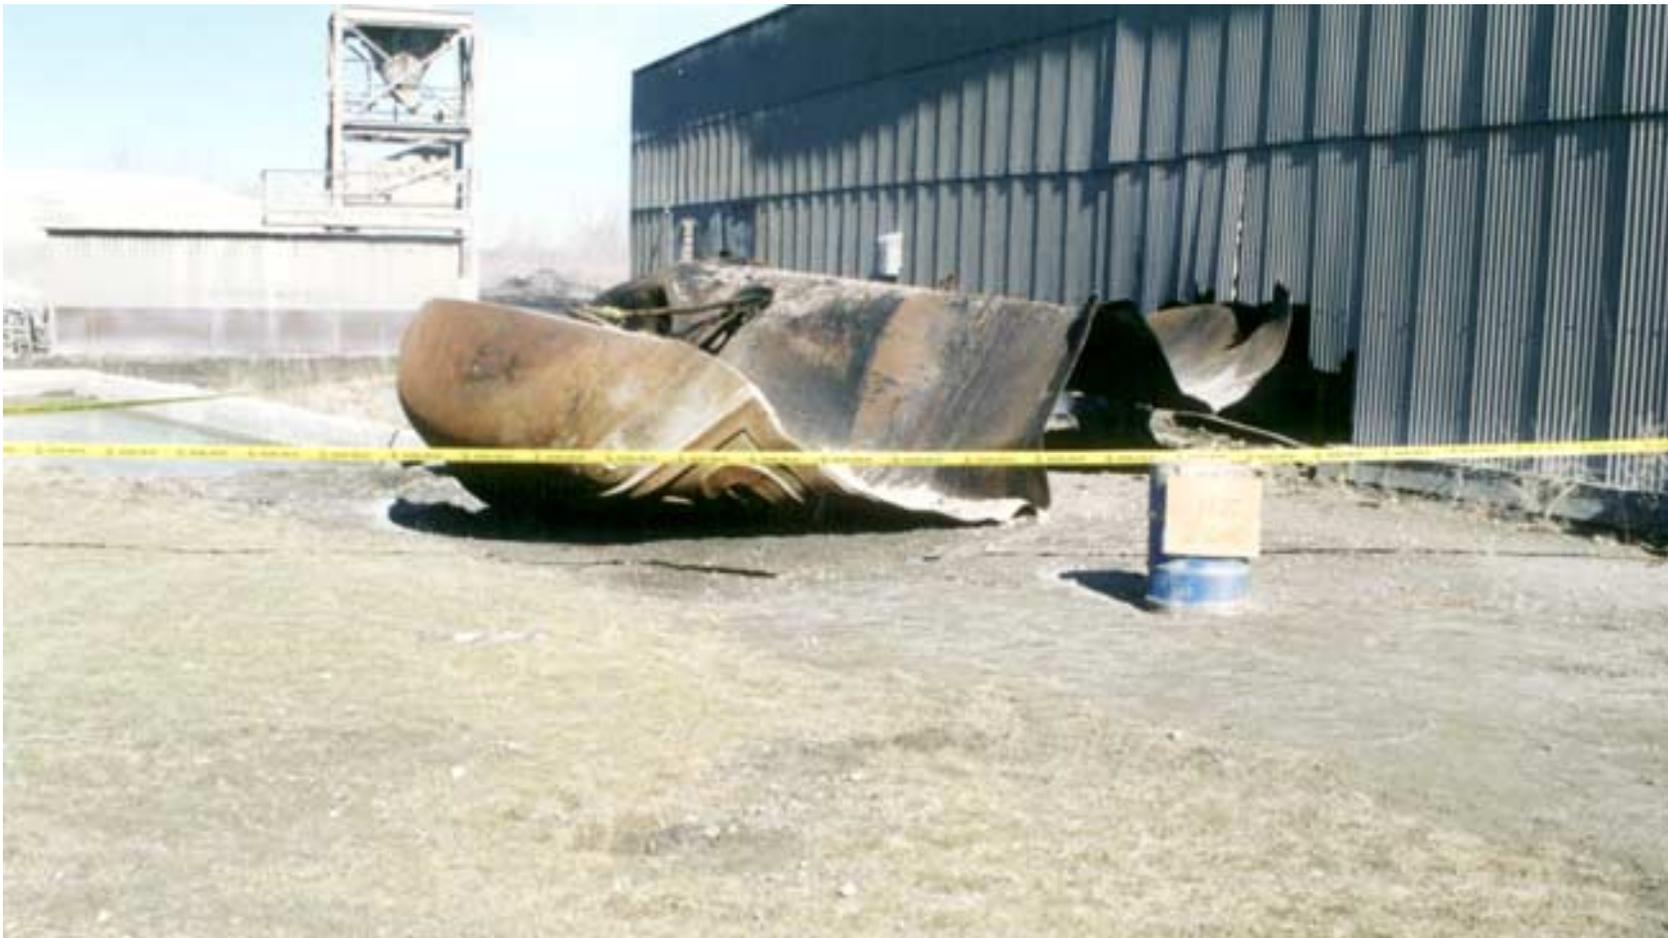
Figure 6. Remains of UTLX 643593 tank after accident. (NTSB)

There were fractures along the bottom centerline of the tank that had propagated on a shear plane, typical of the shear-face tensile fractures in ductile materials.¹² Toward both head ends of the tank, transverse tearing through the tank plate was observed, creating two sections of the tank barrel that appeared flattened. The fractures observed were not along welds in the tank. The bottom portion of the tank toward the B-end had crumpled and folded over on itself. Measurements of the plate thickness along the fracture surfaces showed that “necking down” deformation had reduced the wall thickness below the nominal thickness of 0.5625 inch.

No pitting, corrosion, blistering, or other visual signs of deterioration were observed on the internal tank surface. No breaches or cracks were observed in the tank, including the area of the tank covered by the external heating coils. The outline of the external heating coils from discoloration of the tank metal was observed on the internal tank surface at both the A- and B-ends. The discoloration was more pronounced at the A-end.

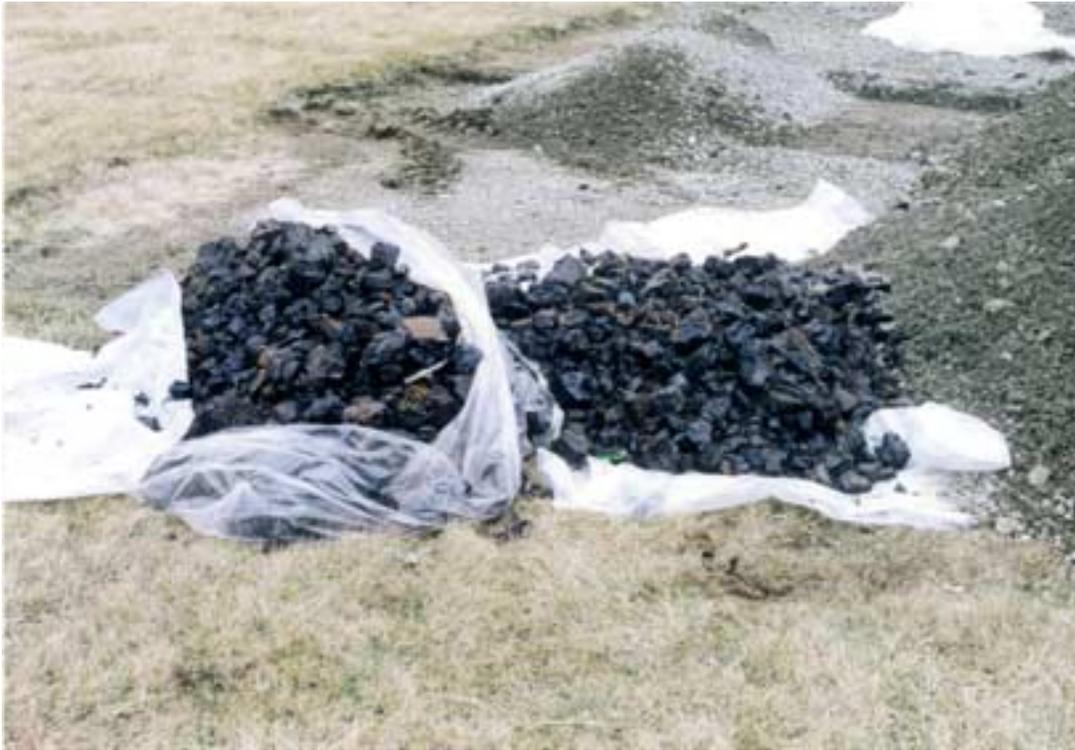
Numerous solid chunks of the TDI matter waste material were scattered throughout the large field to the west and north of the offloading station. (See figure 7.) Some pieces of these solids showed indications of burning while others did not. Samples of these solids were obtained for analysis. A retired Olin/Arco employee who had 34 years' experience with the production and handling of TDI and who came to the accident scene as a consultant for Olin told the Safety Board that he was surprised by the number of small chunks of TDI waste on the ground. He identified these chunks as polymeric TDI. He stated that for the polymeric TDI to be in that form, it had to have been a solid block or slab in the tank car when the accident occurred. He further stated that if the polymeric TDI had been in a fluid state in the tank car at the time of the accident, he would have expected the polymeric TDI to have a “stringy” appearance or to be “sort of strung out like you’d throw something out and it’d freeze in the air.” He also observed that some of the polymeric TDI appeared to be burned and showed indications of exposure to water, which he attributed to moisture in the air. He stated that he found the offloading

Figure 7. Solid TDI matter waste gathered from debris field after accident. (NTSB)

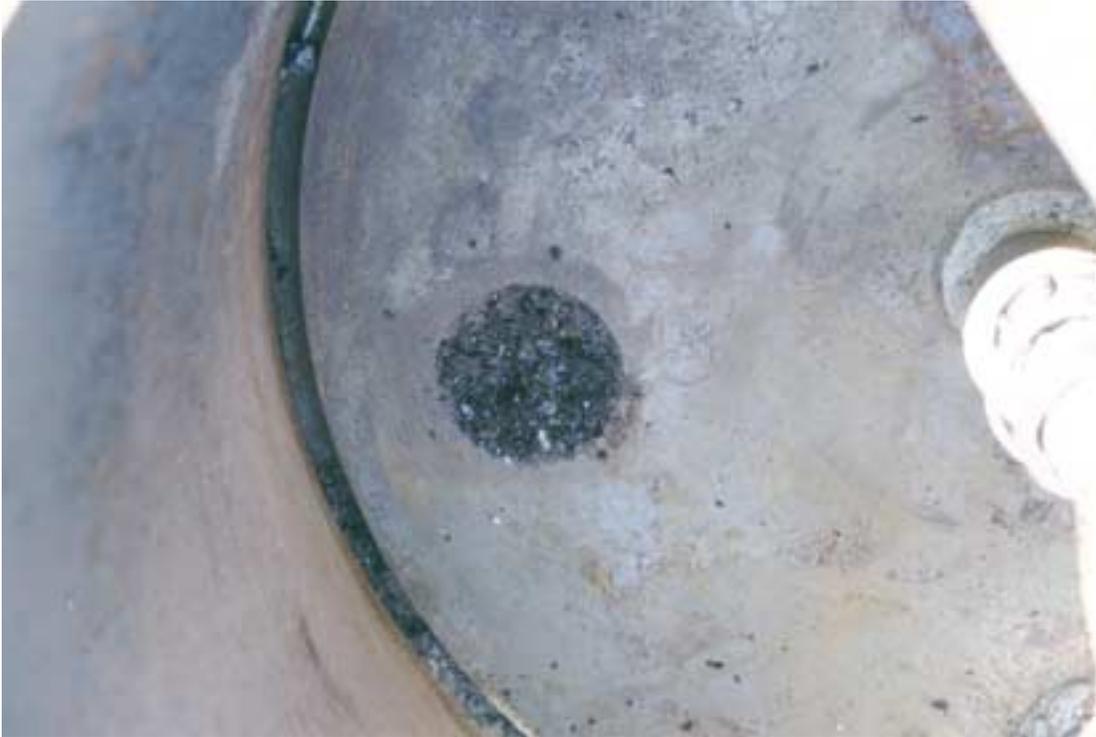
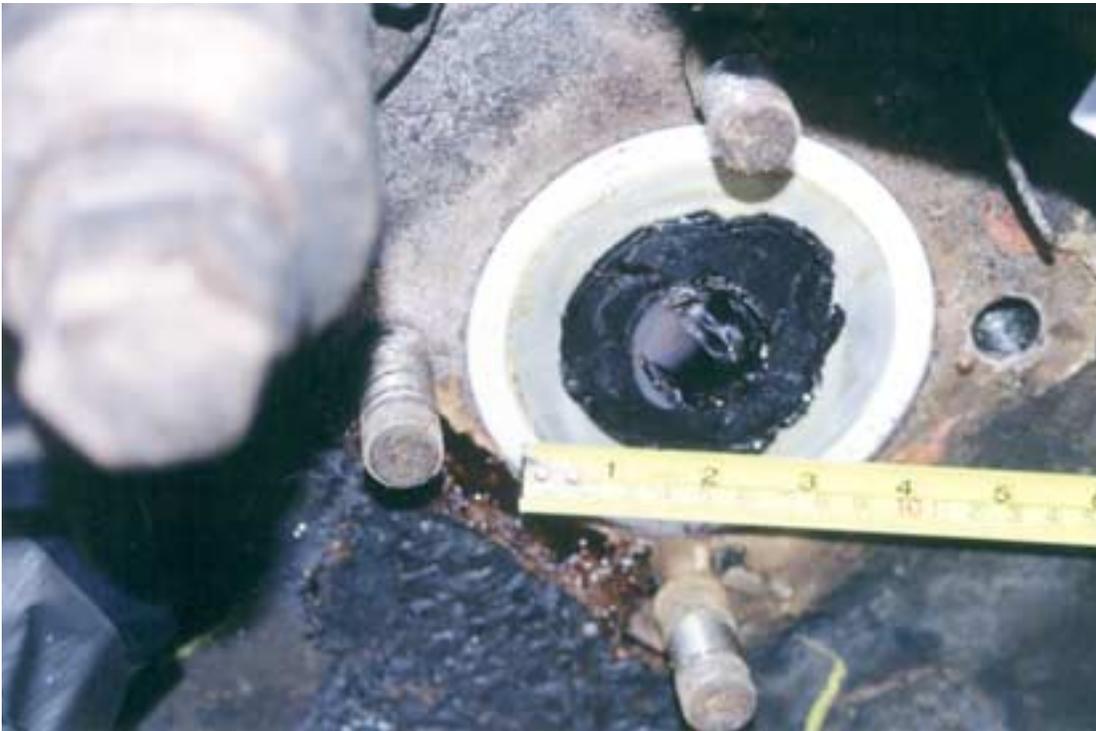
Figure 9. Top photo shows plugged opening in UTLX 643593 manway coverplate for pressure relief valve as viewed from the interior of the tank. Bottom photo shows view of plugged valve from the dome side of the manway cover. (NTSB)

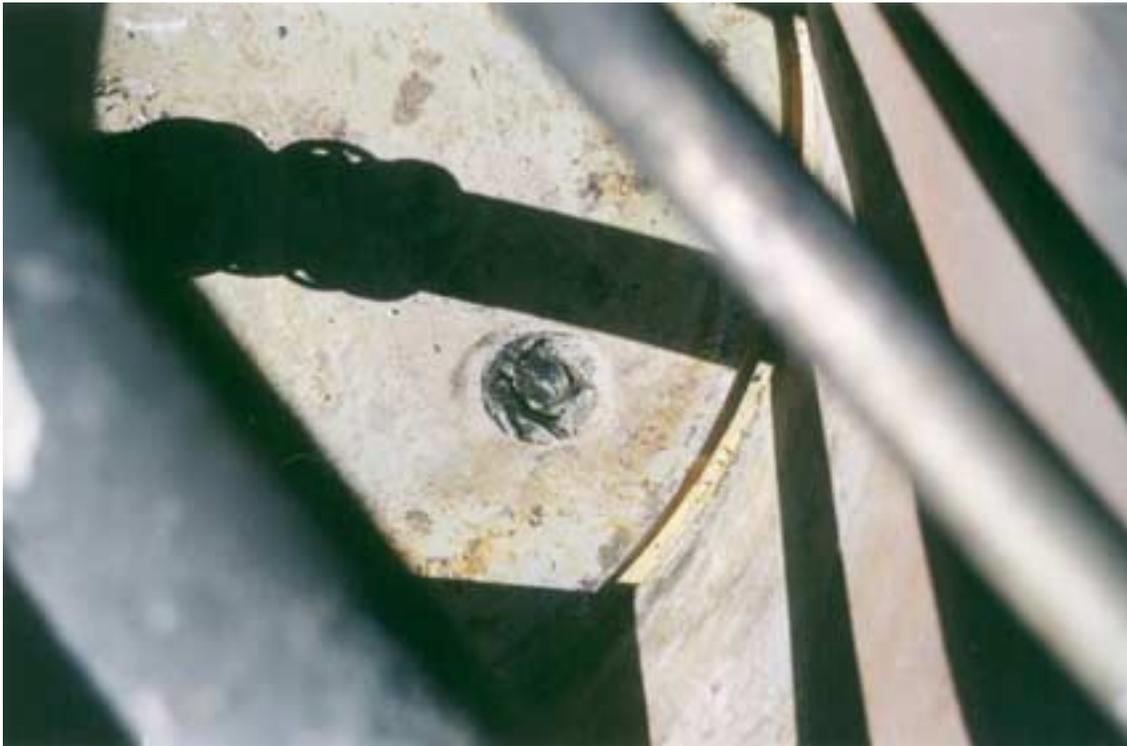
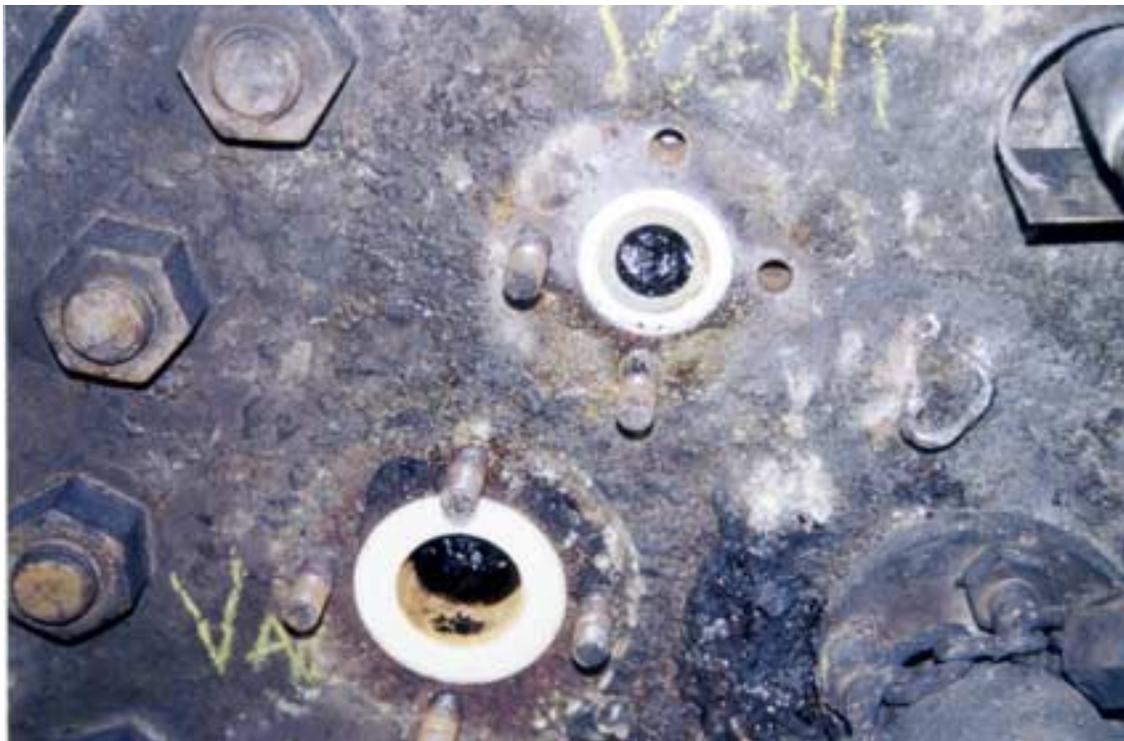
Vapor Valve. The handle for the 1-inch vapor valve was not in the fully open position. The orifice through the manway coverplate was completely plugged with TDI waste. When investigators removed the valve, they noted that the inlet at the base of the valve was completely plugged with TDI waste. They disassembled the valve. TDI waste was molded to the interior of the valve; the waste completely plugged the valve from the inlet flange to the outlet flange. (See figure 10.)

Vacuum Relief Valve. The orifice through the manway plate was plugged with TDI waste. The waste did not completely fill the orifice and came to within 1 inch of the exterior side of the manway coverplate. (Refer to bottom photo of figure 10.) No waste material was observed in the body of the valve.

Figure 10. Top photo shows plugged opening in UTLX 643593 manway coverplate for vapor valve as viewed from the interior of the tank. Bottom photo shows plugged openings in manway coverplate for vapor (higher) and vacuum relief (lower) valves from the dome side of the manway cover. (NTSB)

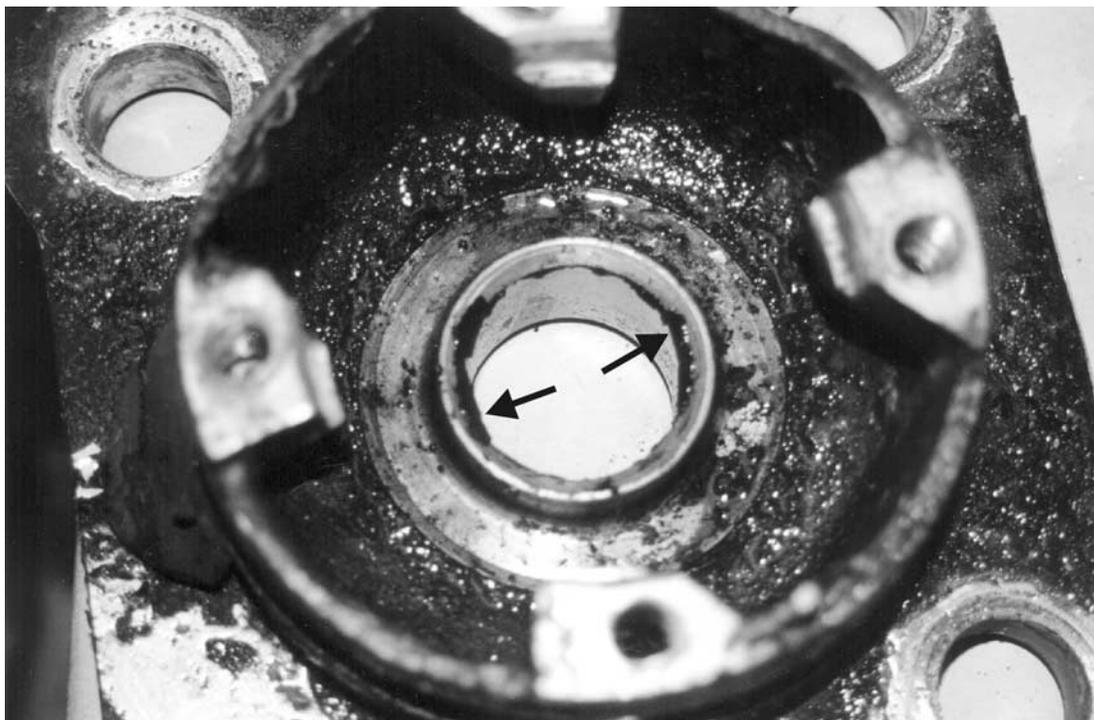
Following the pressure tests, the pressure relief valve was completely disassembled. The interiors of the valve and the spring were free of chemical debris and exhibited no indications of mechanical damage or corrosion. The two O-rings that had been removed from the pressure relief valve were examined and tested for brittleness. The large O-ring had a permanent set or deformation on the sealing surface with the valve. No set or deformation was noted on the small O-ring. Durometer measurements on the new O-rings and the two O-rings removed from the relief valve were taken and compared. Durometer readings for the new O-rings ranged from 70 to 74 (considered normal); the

Figure 11. Pressure relief valve fitting. Arrows show debris on the valve seat. (NTSB)

reading for the O-rings removed from the pressure relief valve ranged from 80 to 97 (indicating increased hardness and brittleness).
