UNITED STATES
DEPARTMENT OF LABOR
MINE SAFETY AND HEALTH ADMINISTRATION
COAL MINE SAFETY AND HEALTH

REPORT OF INVESTIGATION
Underground Coal Mine
Nonfatal Entrapment
July 24, 2002

Quecreek #1 Mine, ID No. 36-08746
Black Wolf Coal Company, Inc.
Quecreek, Somerset County, Pennsylvania

RELEASE DATE: August 12, 2003

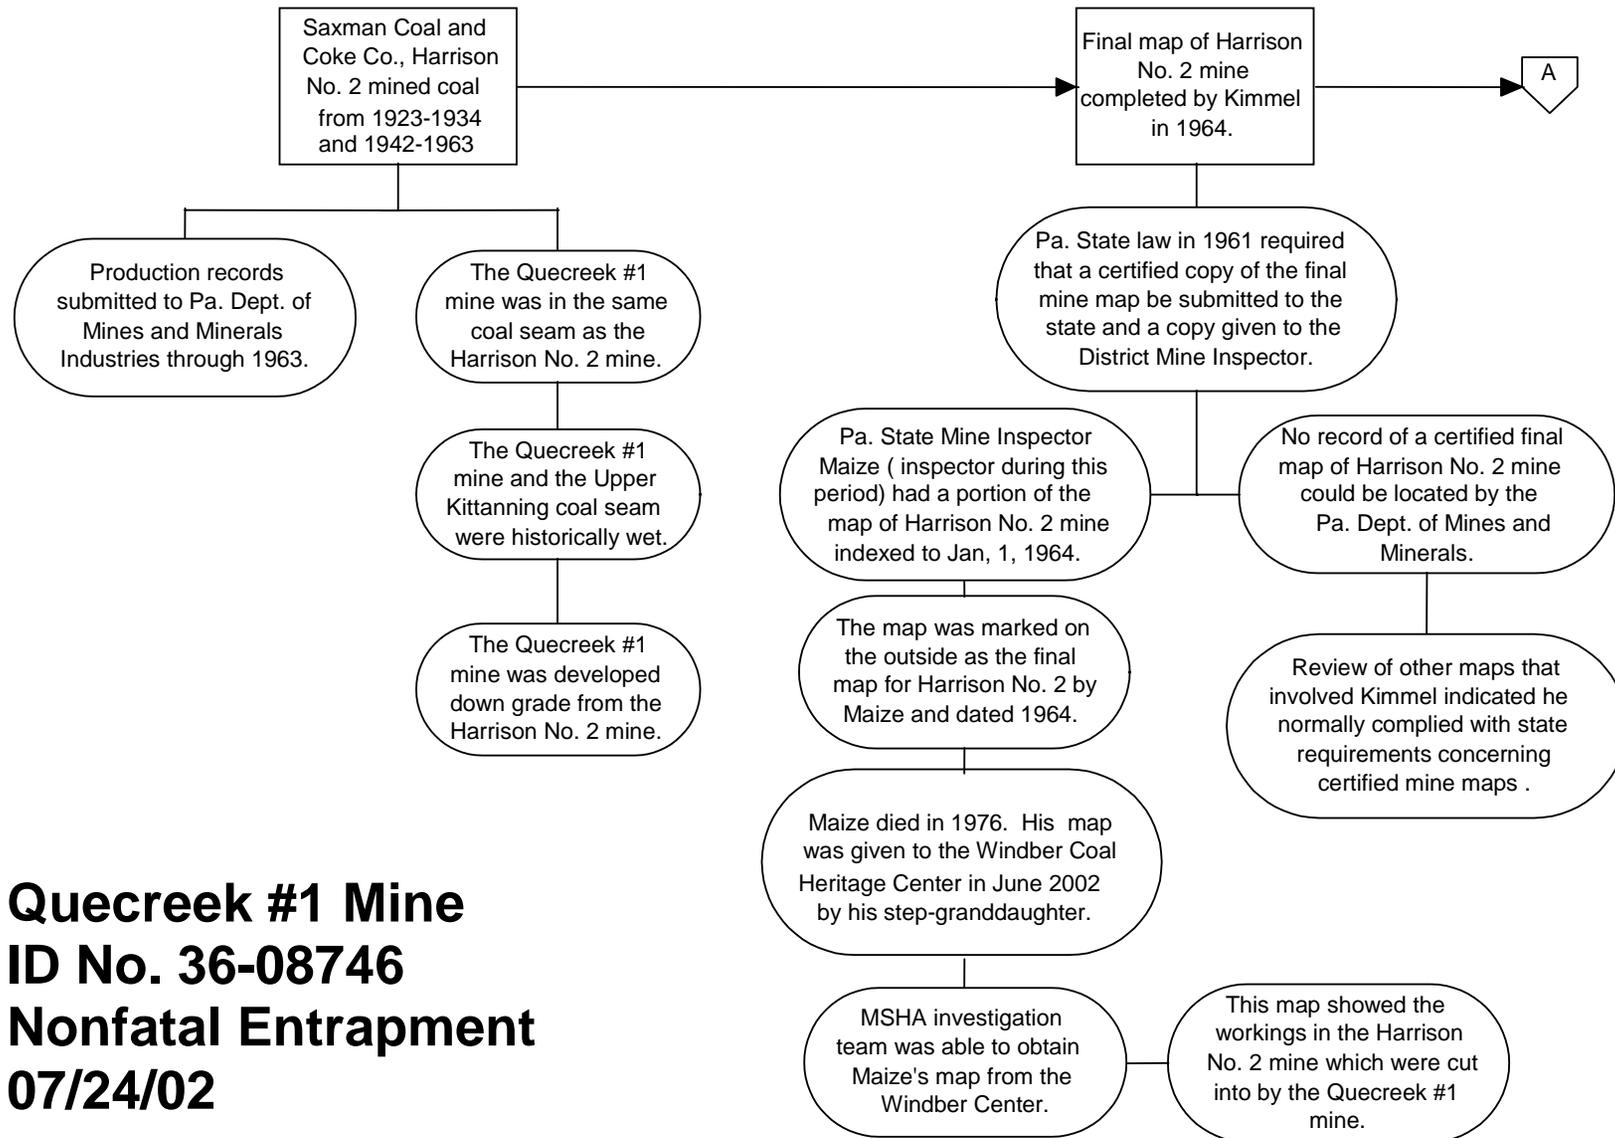
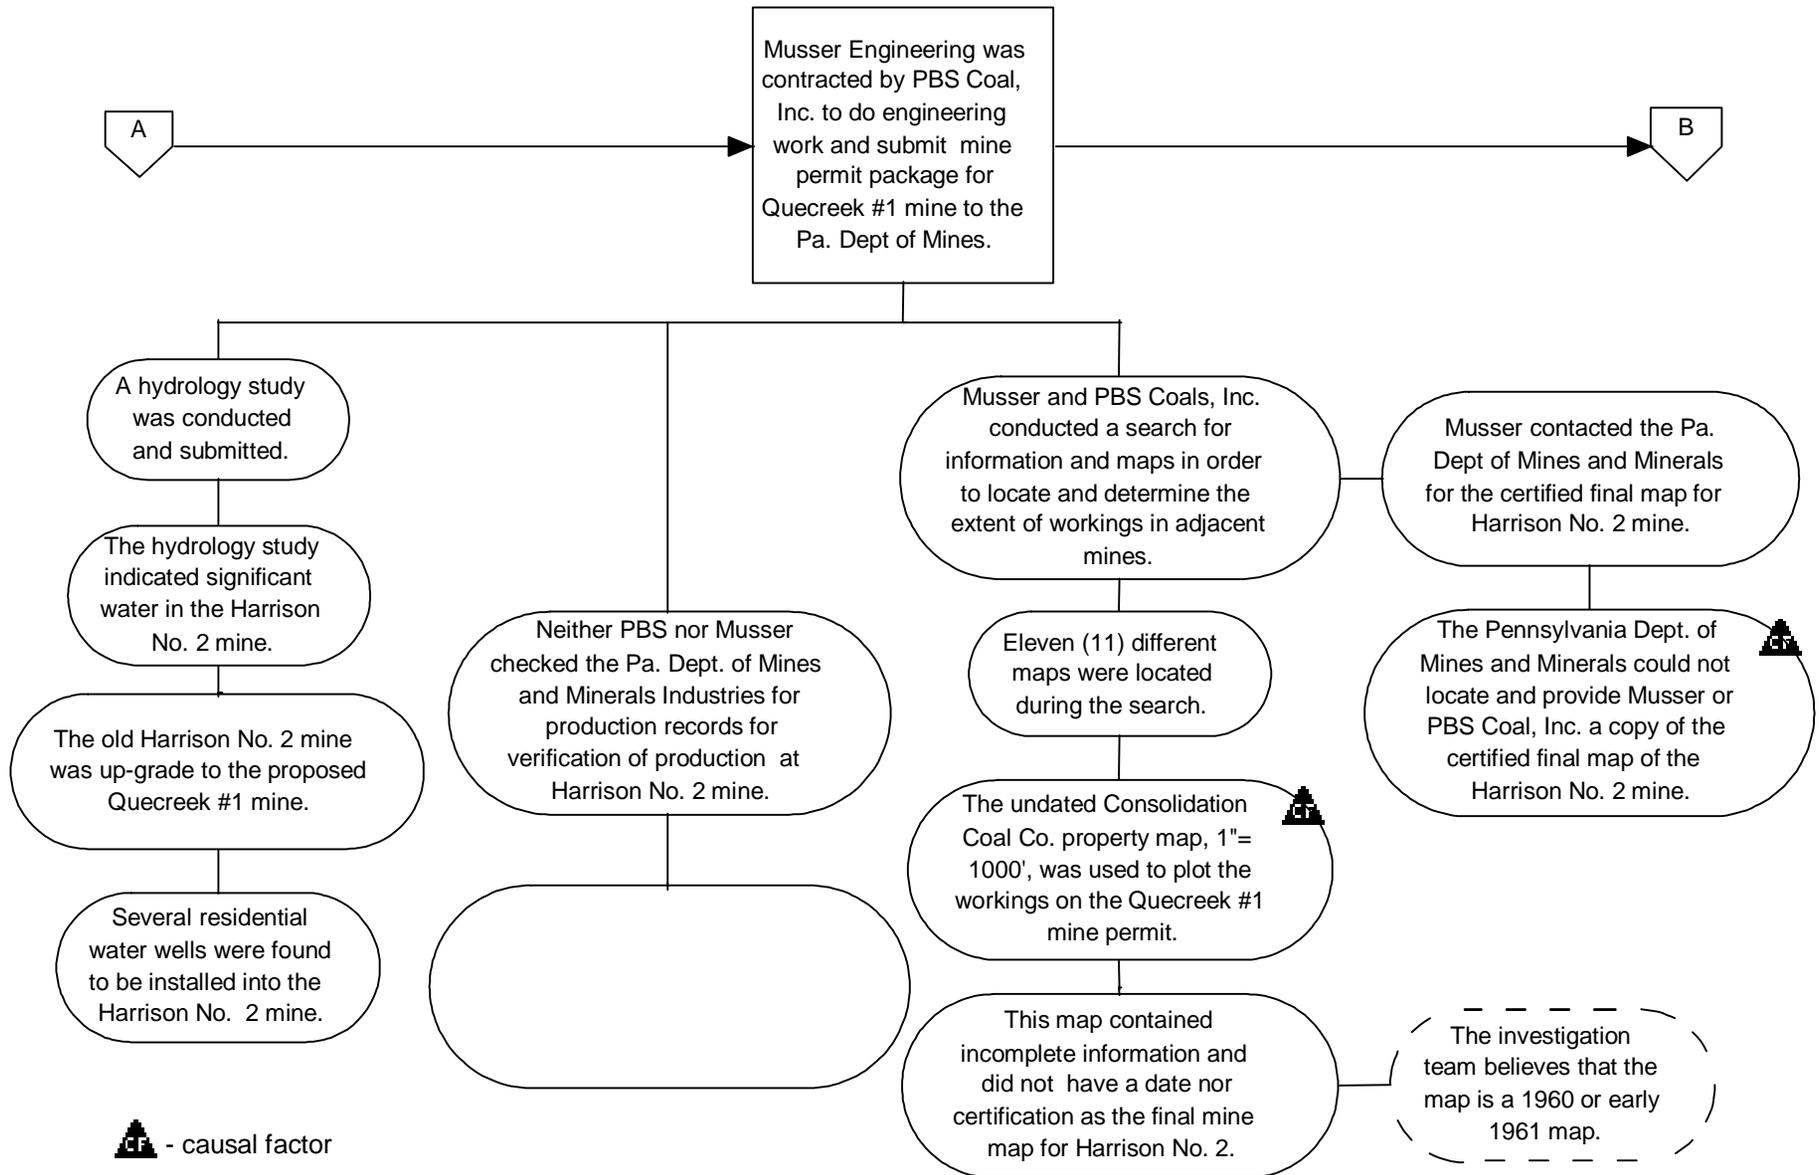
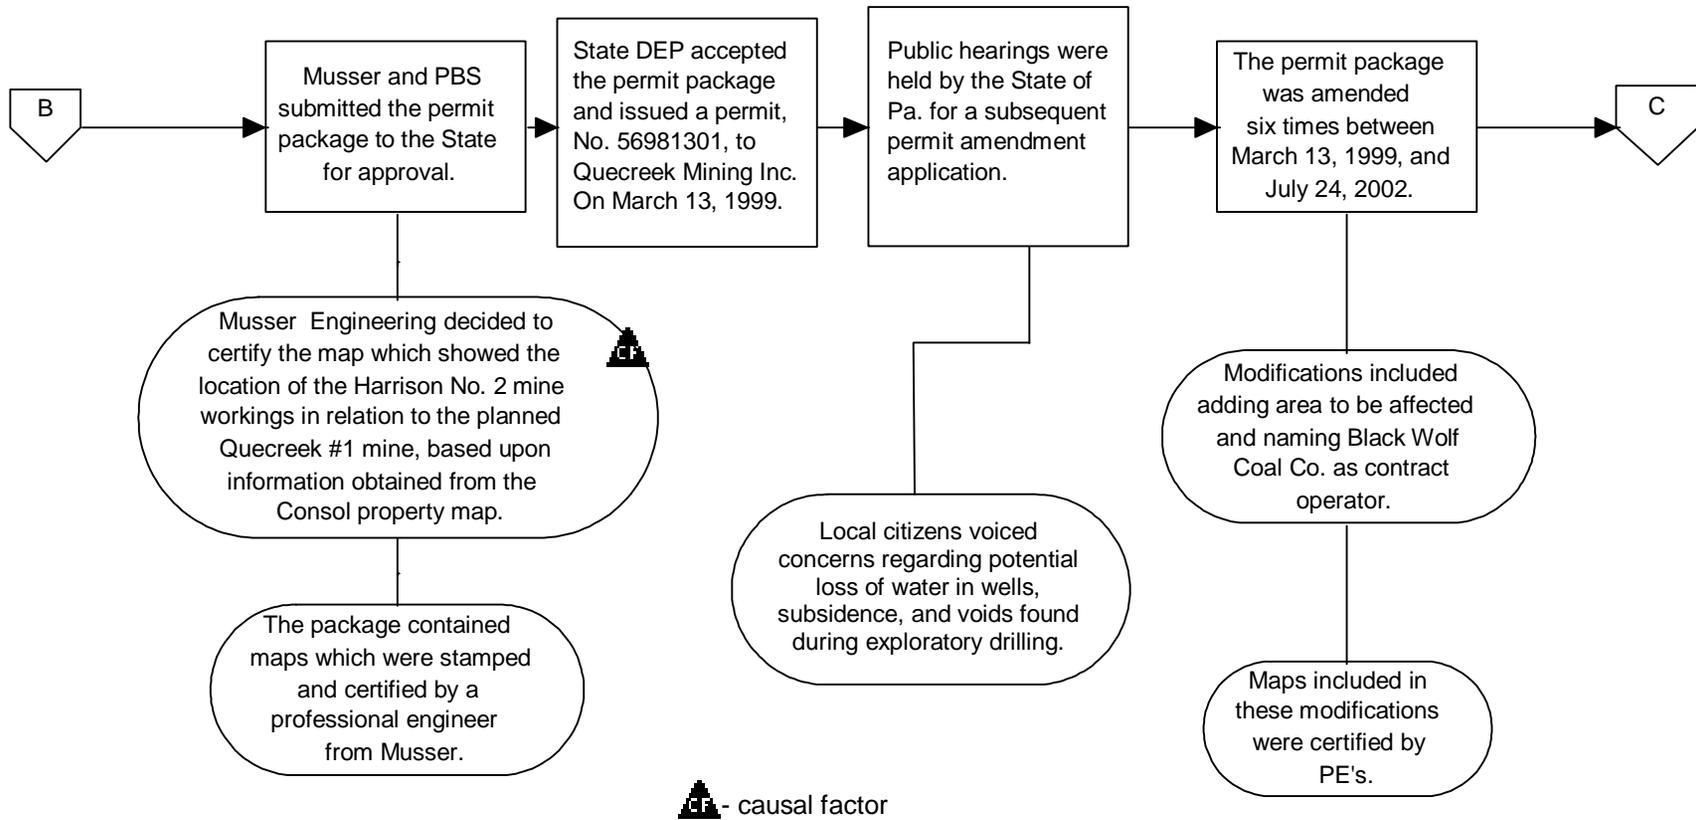
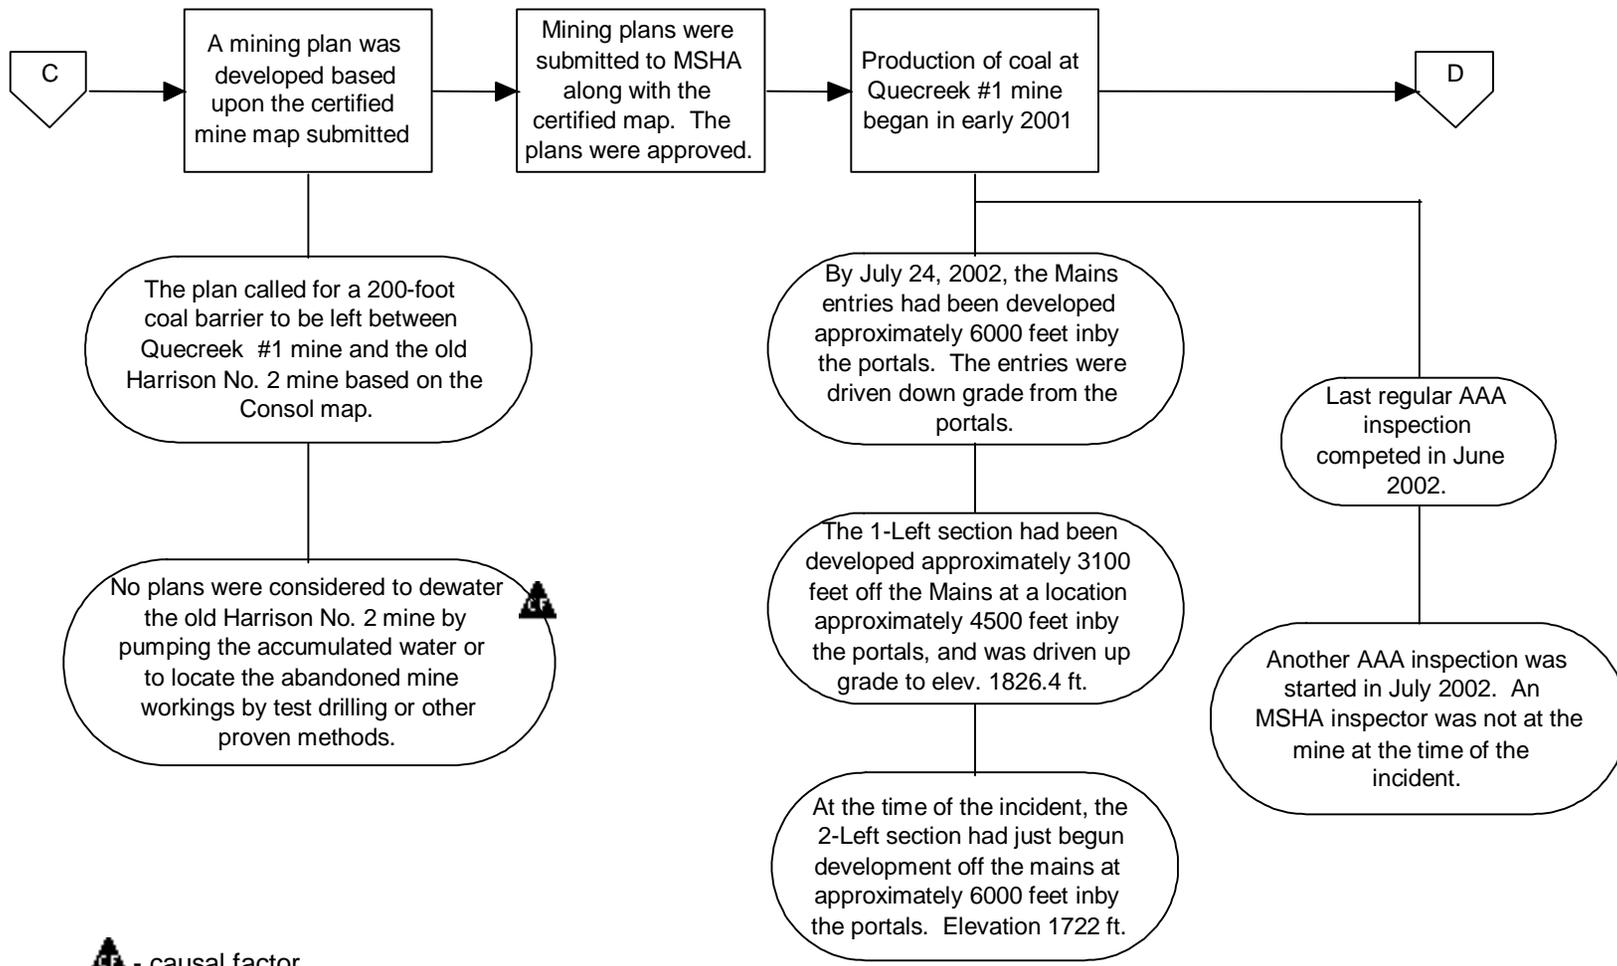
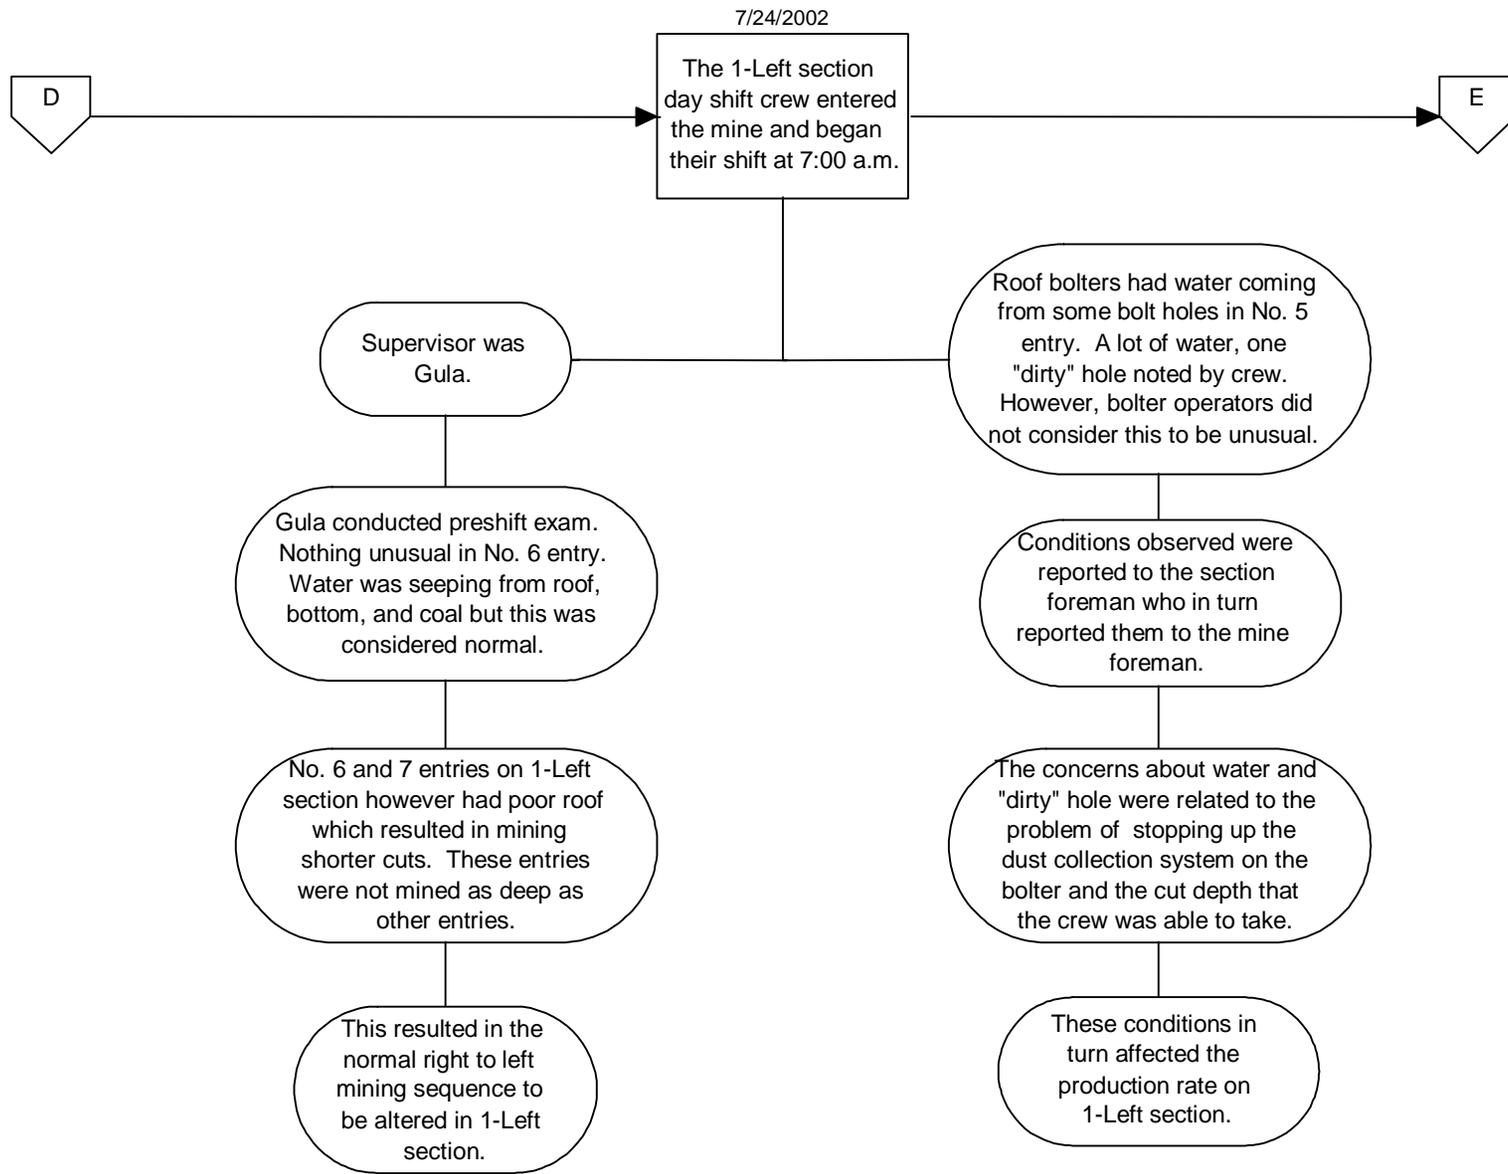
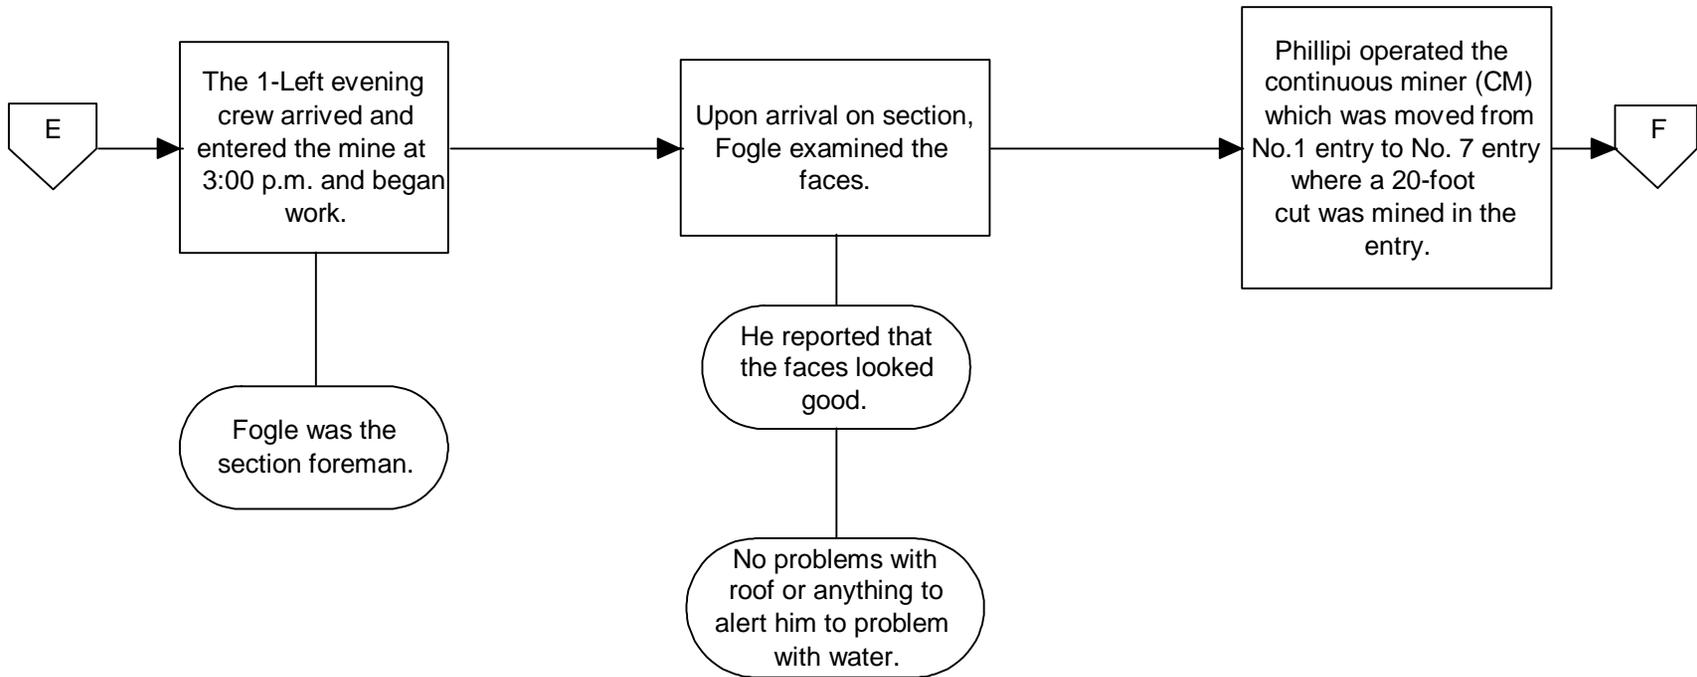
ROOT CAUSE ANALYSIS OF BREAKTHROUGH

The primary cause of the water inundation was the use of an undated and uncertified mine map of the Harrison No. 2 mine that did not show the complete and final mine workings. Using this map led to an inaccurate depiction of the Harrison No. 2 mine workings on the Quecreek #1 mine map required by the Mine Safety and Health Administration and on the certified mine map submitted to the State of Pennsylvania during the permitting process. The root cause of the accident was the unavailability of a certified final mine map for Harrison No. 2 mine in the State of Pennsylvania's mine map repository.

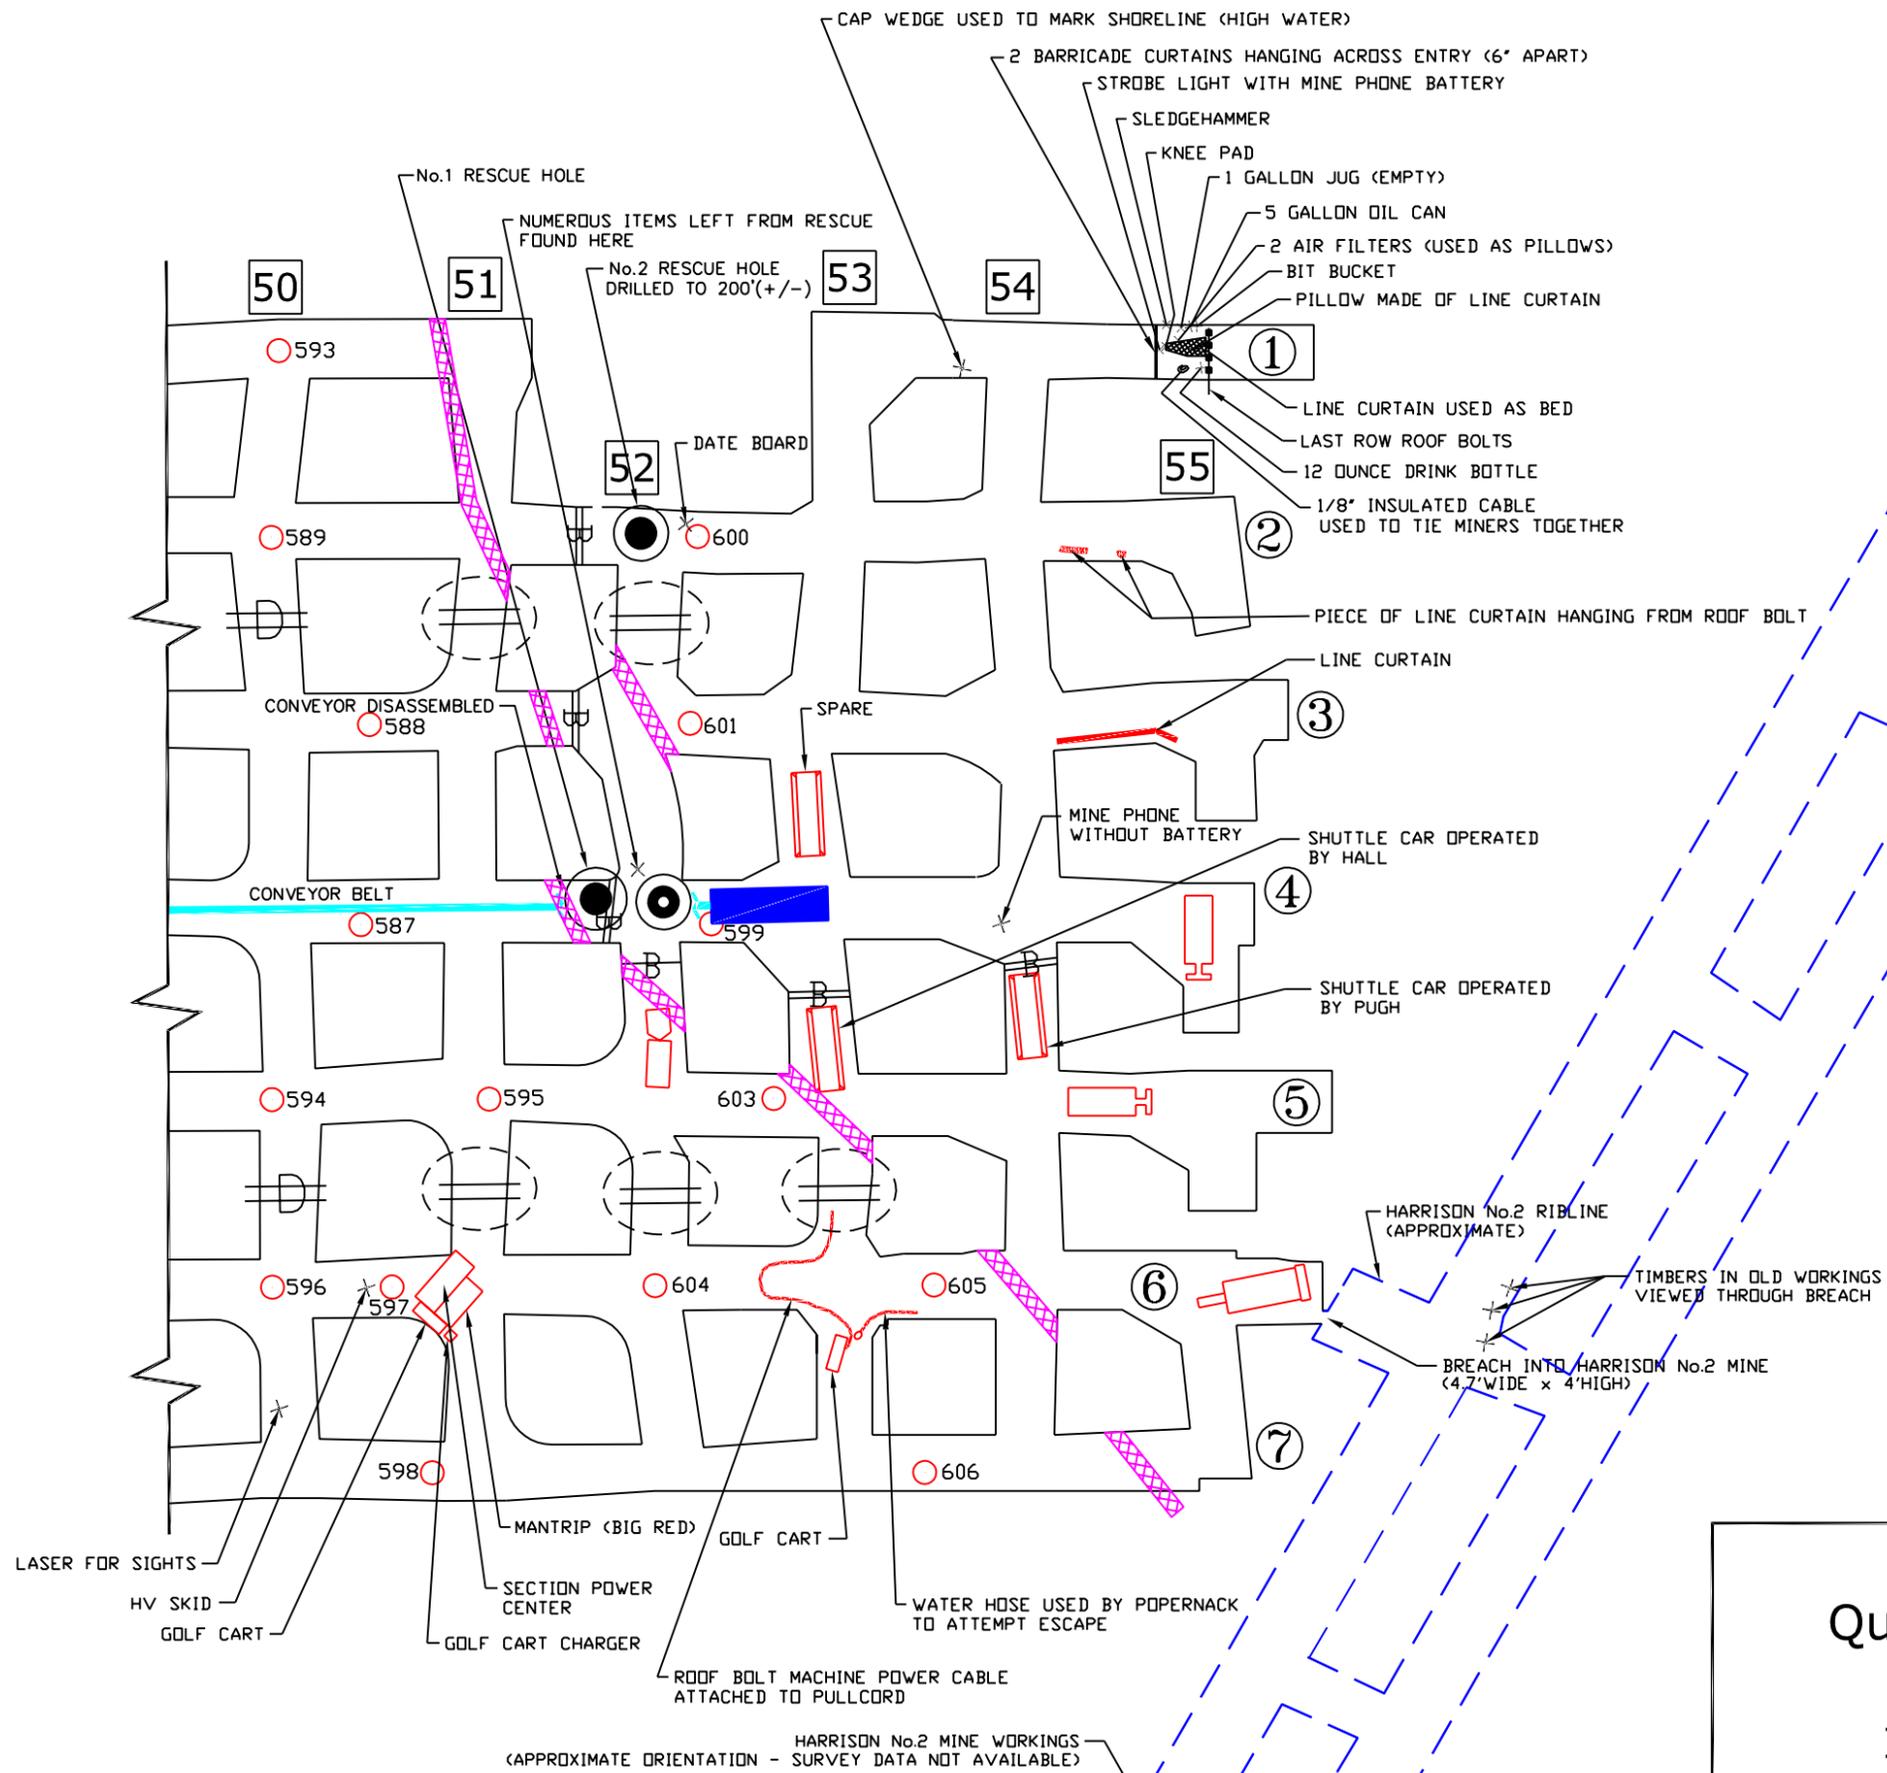
Map 9
Quecreek #1 Mine
Damage on
1-Left Section
Scale: 1"=60'

from approximately No. 51 crosscut in No. 1 entry to just outby No. 55 crosscut in No. 7 entry. [See [Appendix C](#) for a discussion of geologic factors and conditions and [Appendix G, Map 9.](#)] Water from roof bolt holes increased in frequency and quantity near and inby the fault line. Roof conditions worsened and required the use of straps and longer resin bolts near the fault. Two cable bolts were installed in No. 50 crosscut of No. 4 entry. These were the only cable bolts installed inby No. 37 crosscut. No. 1 entry was not mined from Nos. 51 to 53 crosscuts due to the roof conditions. As the section was advanced, nearly every shift encountered these adverse conditions associated with the fault in at least one entry due to its diagonal orientation.

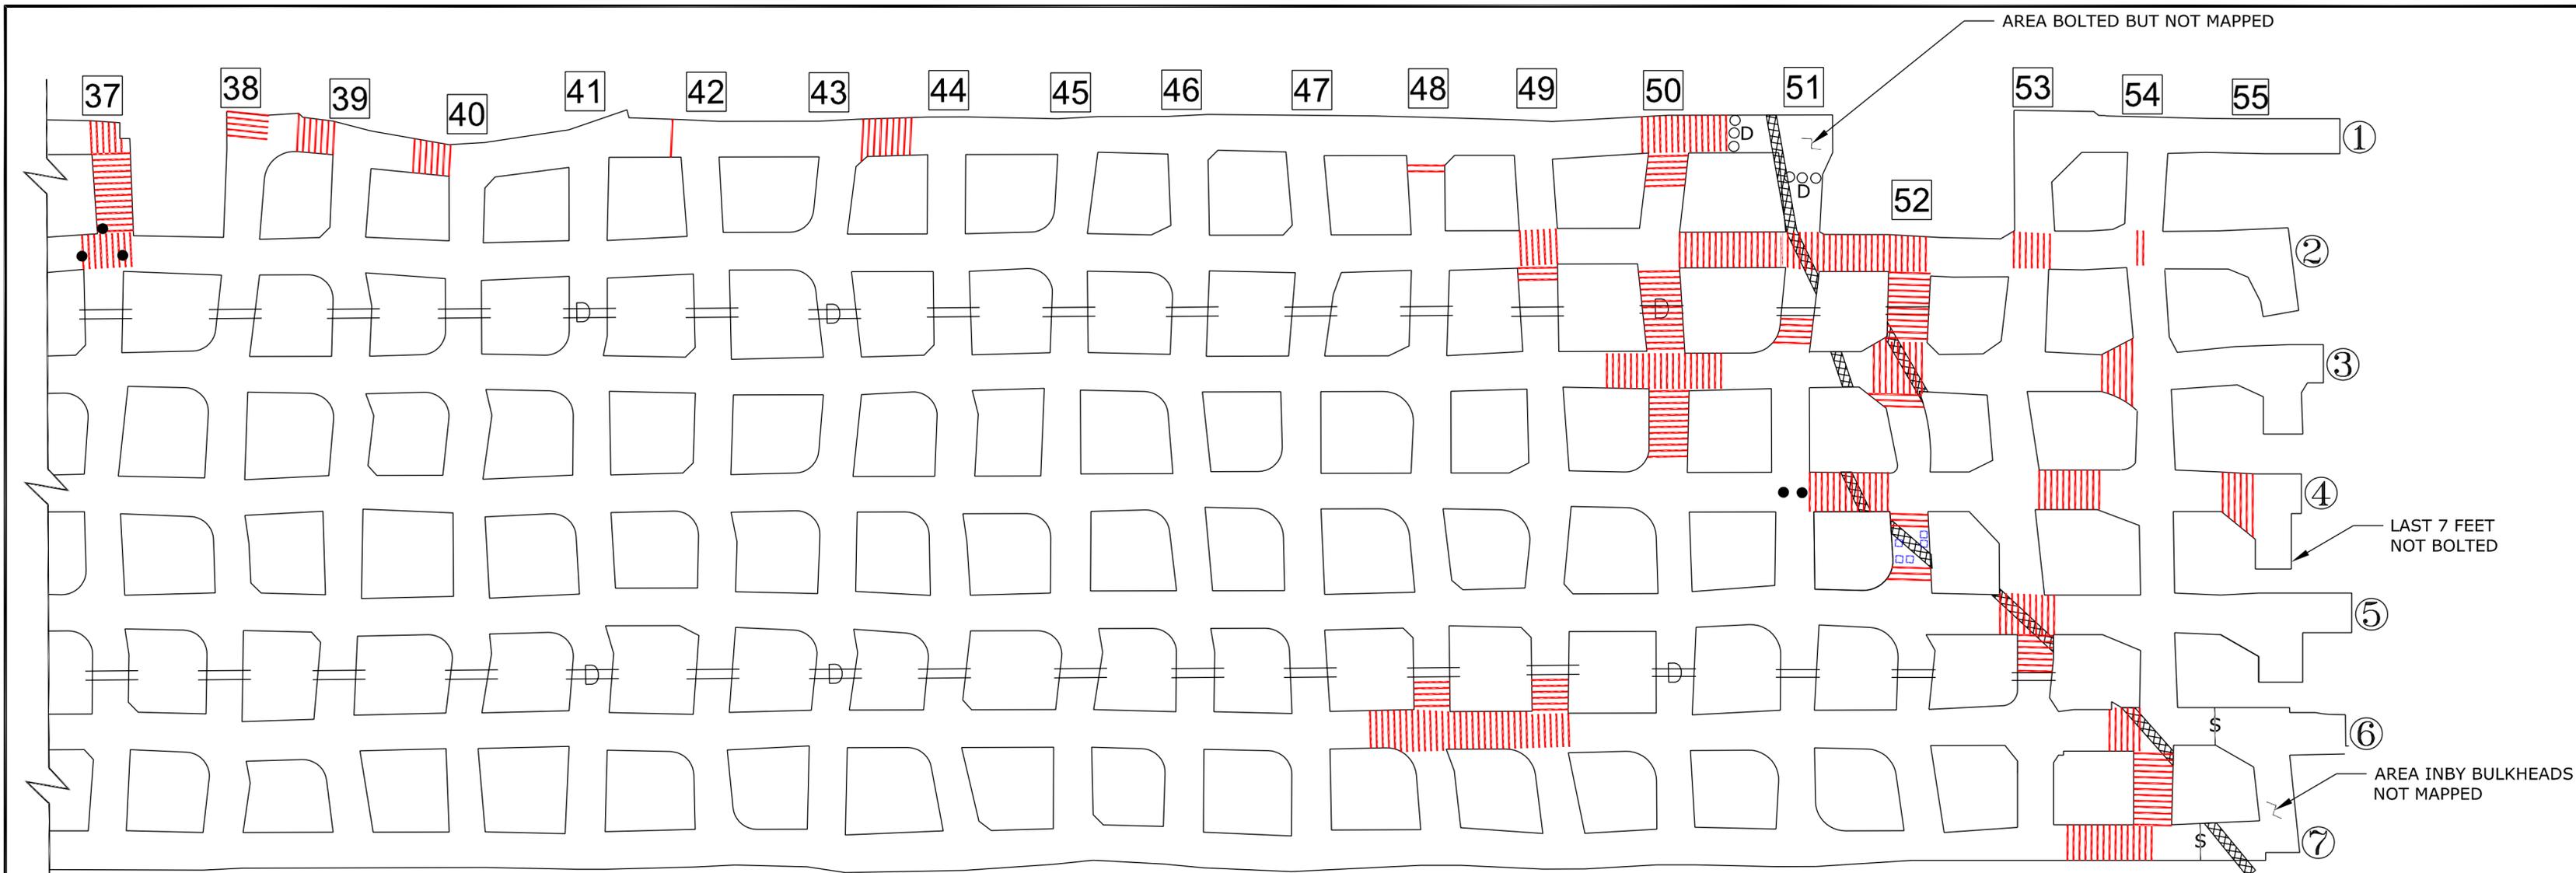
Map 10
Quecreek #1 Mine
Roof Support
on 1-Left Panel
Scale: 1"=50'

At approximately No. 18 crosscut, roof conditions required the installation of cribs in No. 5 entry and the crosscut was not mined between Nos. 1 through 4 entries. Statements indicated that an increase of water flowing from roof bolt holes occurred near No. 20 crosscut. Other statements indicated that the increased water was encountered mid-panel, at approximately No. 27 crosscut. Mining advanced through the wetter area and conditions returned to normal until No. 37 crosscut where No. 1 entry was not mined for one crosscut due to poor roof conditions. Eight- to twelve-foot-long cable roof bolts, longer resin bolts (48 and 72 inches long), and straps were installed in this area. [See [Appendix G, Map 10](#) for roof support information.]

NOTE:
 ALL AREAS EXCEPT WHERE NOTED OR WHERE STRAPS ARE PRESENT: 42" & 48" FULLY-GROUTED RESIN ROOF BOLTS ON 4'x4' OR 4'x5' PATTERN. GOOD ROOF, NO DEFECTS EVIDENT.
