Intensity Distribution and Iseismal Maps for the Nisqually, Washington, Earthquake of 28 February 2001

Open-File Report 02-346

2002

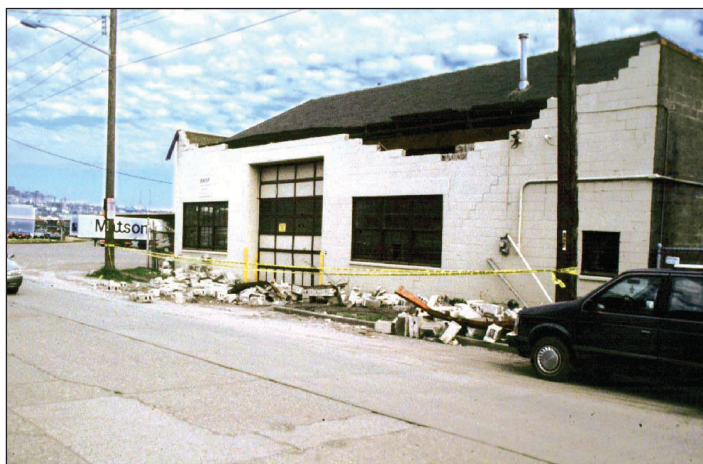
Seattle (Sodo and Harbor Island) (RCII=7.6, MMI=8) (Zip Code 98134; 47.590N, 122.326W)—Many buildings were damaged in Sodo along 1st Ave. South from South Jackson St. to South Hanford St. Along this stretch cracked or collapsed walls, fallen parapets and broken windows were common in old buildings (fig. 12; fig. 13). Notable damage included collapsed unreinforced masonry walls at the Seattle Chocolates building and at the Acme Tool and Specialty building and a collapsed front facade at the Starbucks Headquarters building.

Figure 12. Partial collapse of URM building wall, Sodo neighborhood of Seattle.

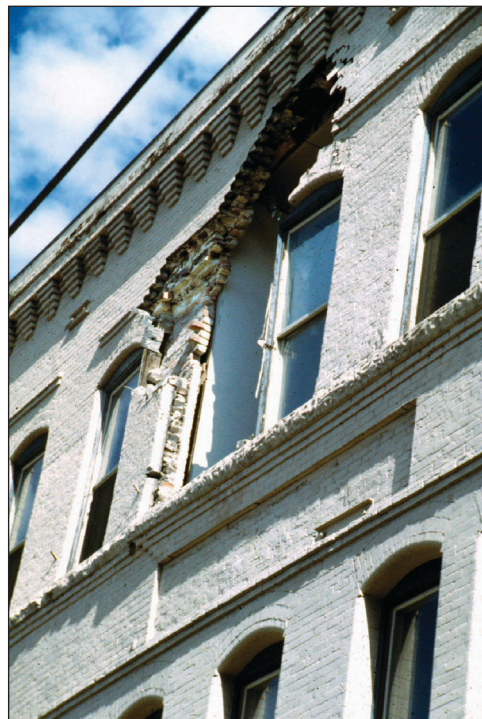
Figure 13. Damage to upper wall of URM building, Sodo neighborhood of Seattle.

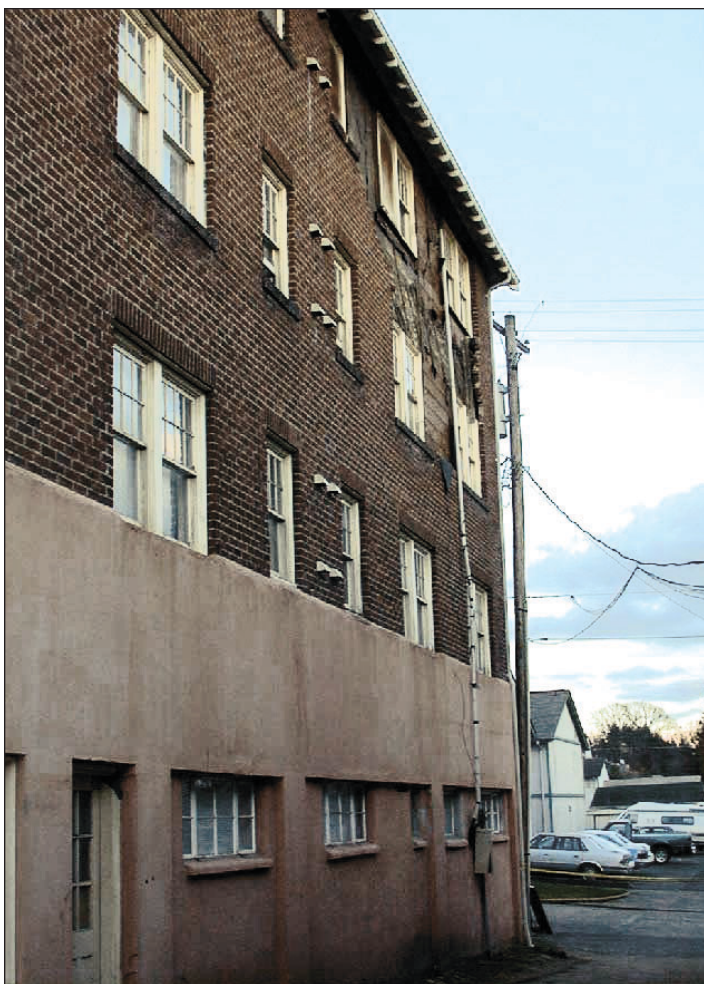
Figure 15. *Brick veneer was peeled from the upper wall (near street) of this apartment building in Chehalis.*

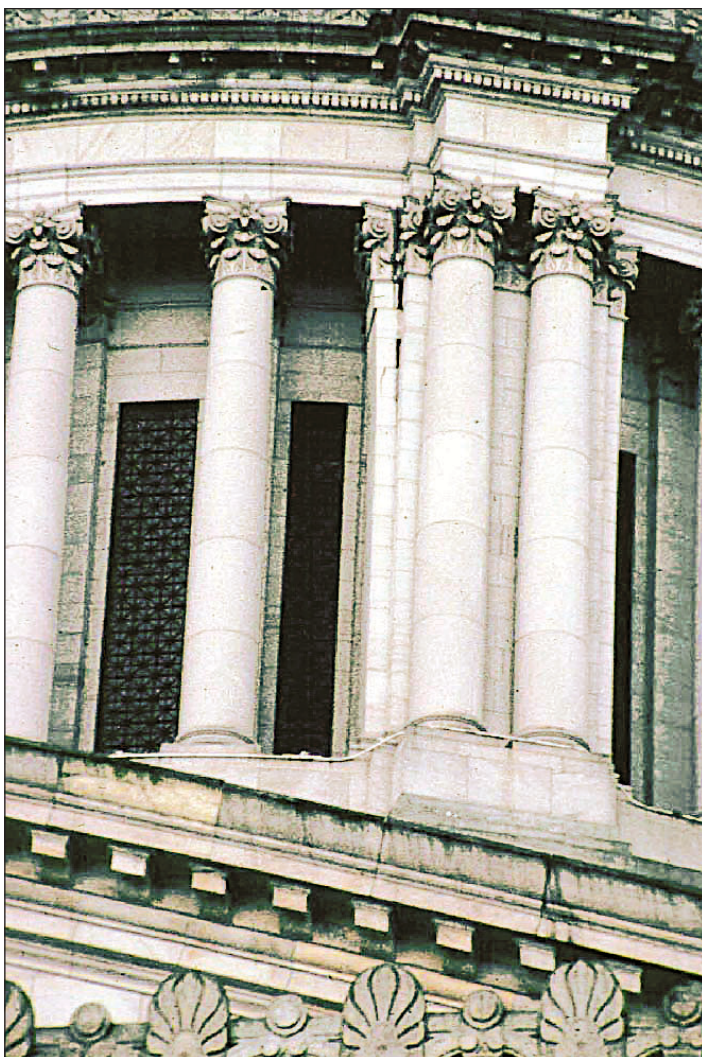
Olympia (RCII=7.3, MMI=7, except MMI=8 in Capitol Hill) (98501; 47.003N, 122.878W)—The Capitol Legislative Building was damaged and the legislators forced to move out. There was cracking in some of the ribs of the dome, and “severe cracking of the nonstructural sandstone pilaster from one of the exterior masonry buttresses supporting the dome.... Significant differential movement occurred between the drum [cylindrical wall below the dome] and the lower masonry portion of the building... As a result of the movement of the drum and the dome, horizontal cracking of the architectural plaster occurred at the base of each [of the] interior masonry buttresses” (Pacific Earthquake Engineering Research Center

Figure 16. *Damaged pilaster on State Capitol building, Olympia.*

(PEER), p. 8-11; see our fig. 16). Inside the building one chandelier outside the Senate was found hanging from its safety chain and both House and Senate chambers were littered with plaster from the ceilings (Seattle Times (Web), March 5, 2001). A photograph shows a fourth-floor office knee-deep in folders and papers (Seattle Post-Intelligencer (Web), March 1, 2001).
