**NASA Technical Memorandum 102679**

# **Unique Failure Behavior of Metal/Composite Aircraft Structural Components Under Crash Type Loads**

**Huey D. Carden**

**May 1990**

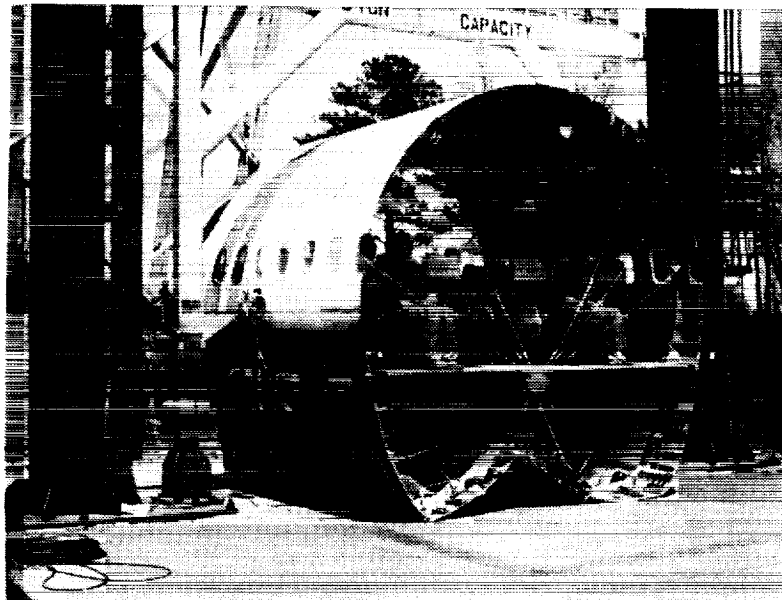
(a) Section from forward of wing.

Dynamic tests.- Structural damage and behavior of the transport aircraft structures resulting for the 20 ft/s drop tests is shown in figure 8(a) and (b). The damage to the transport sections was confined to the lower fuselage below the floor level. Under the vertical impact of 20 ft/s, all seven of the frames ruptured near the bottom impact point. Plastic hinges formed in each frame along both sides of the fuselage at about 50 degrees up the circumference from the bottom contact point (See figure 8(c)). The upward movement of the lower fuselage was approximately 22-23 inches at the forward end and 18-19 inches at the rear for the section taken from forward of the wing location (figure 8(a)) whereas in the section from aft of the wing location (figure 8(b)) the crushing was about 14 inches forward and 18 inches in the rear. Although the aircraft structures are metal and the failures discussed above involve plastic deformations with some tearing of the metal rather than brittle fractures, the general observed failure pattern and locations for the transport fuselage sections will be shown to be quite similar to the results of the composite frames and subfloors discussed later.

Figure 8. - Structural damage to metal aircraft structures.

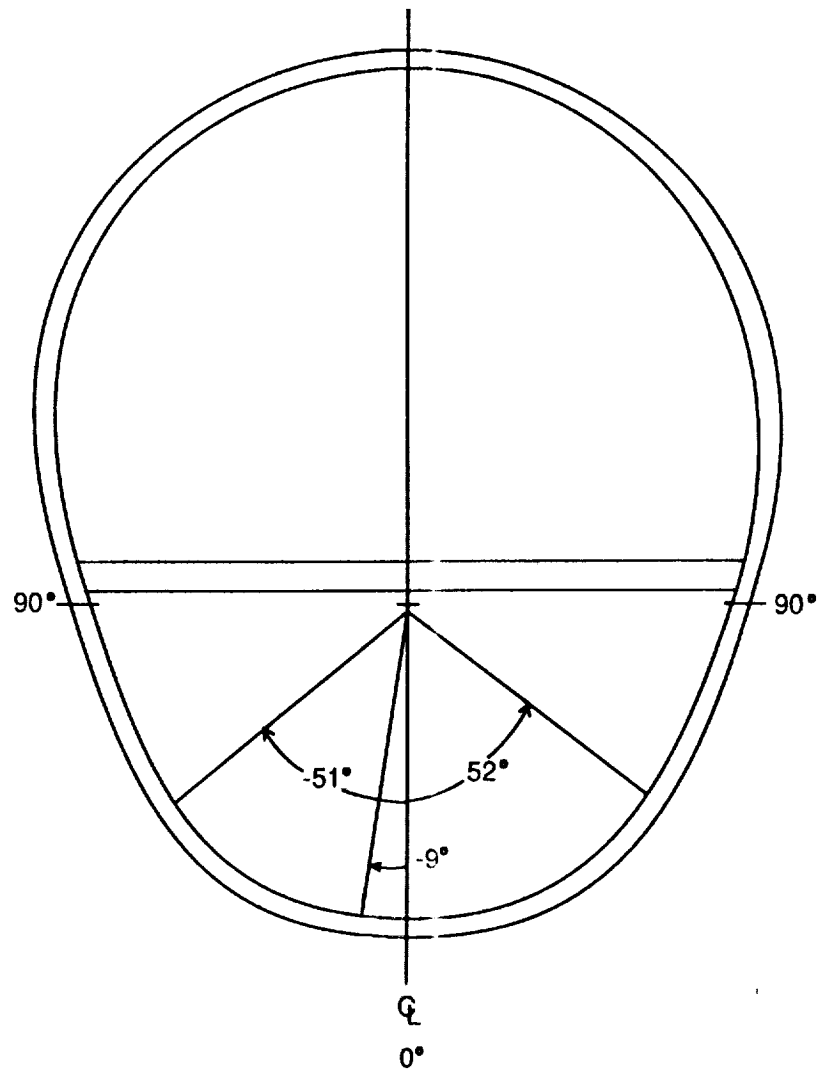
(c) Angular location of failures.

Figure 8. - Concluded.

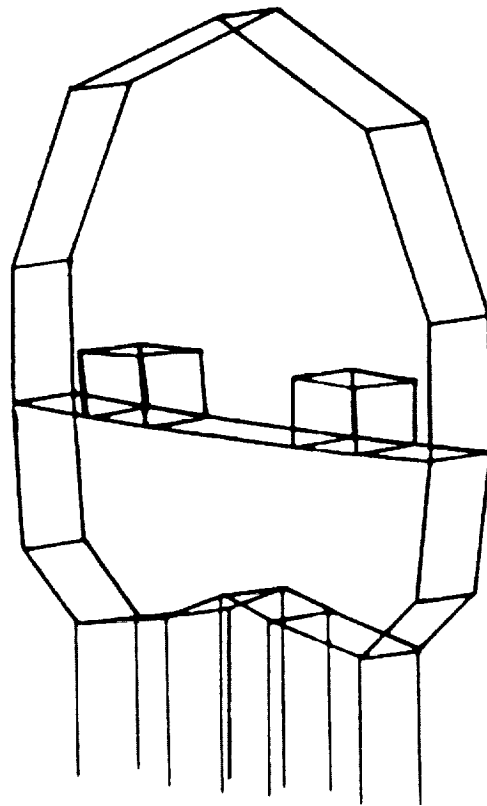
The predicted deformation pattern of the two frame model is shown in figure 10. As may be noted, the overall impression from the analytical model deformation pattern is quite similar to the visual behavior seen in the experiment shown in figure 8. The full section behavior was basically contained in the two frame model.

Figure 10.-Computer graphics showing analytical failure of metal transport section.

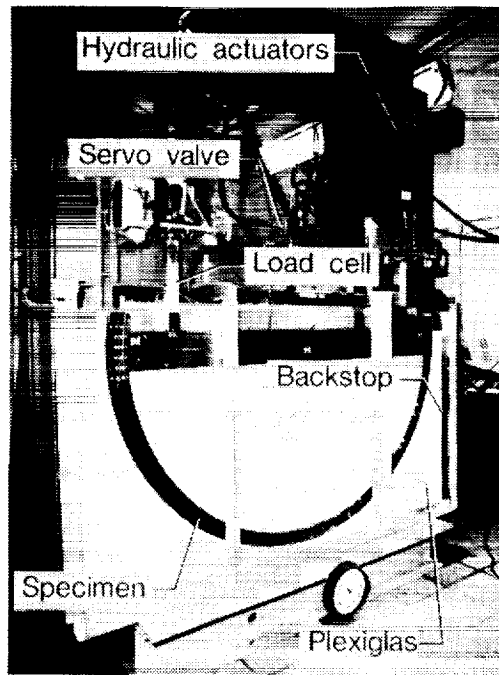
(a) Static test apparatus.

Static tests.- Figure 11 presents static results from reference 25. A photograph of the static test apparatus in figure 11(a) shows that the splice plate was at the load point, thus, the frame failed just outside the doubler splice plate area by a complete fracture across the Z-section. Load-deflection data and the location of failures of the frame are shown in figure 11(b). The load-deflection data show a saw-toothed behavior under the essentially linear behavior of the frame up to initial failure, and subsequent loading of the frame after failure being at a new, reduced stiffness for the frame as a result of that failure(s). Photographic data in figure 11(c) shows that the initial failure was induced by a local buckling of the frame

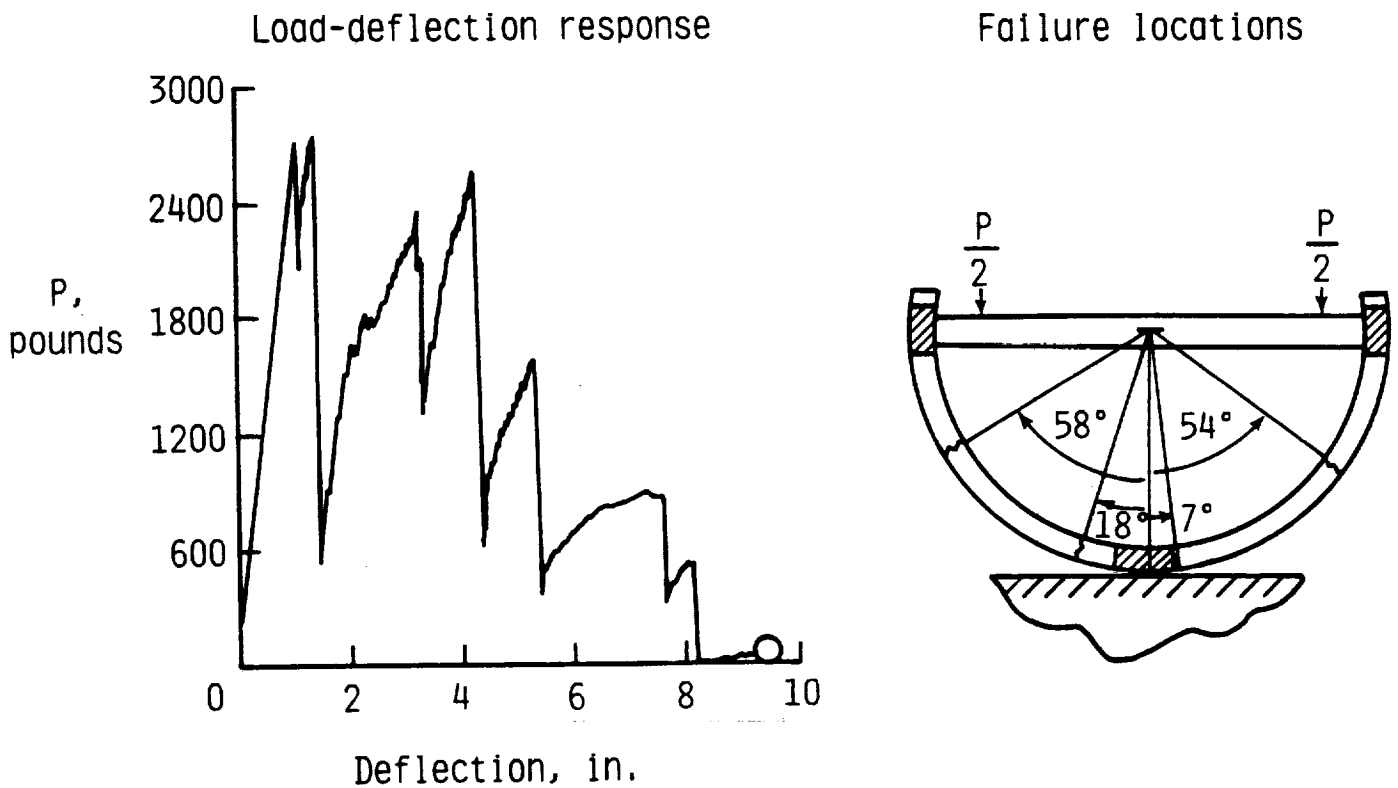
(b) Load-displacement and failure locations.

which occurred at about 18 degrees from the bottom loading point outside the splice plate area. Second and third fractures occurred up the side again at about 54 and 58 degrees under continued loading as may be noted in the sketch at the right of figure 11(b). The sequence of events was: local buckling near the splice plate induced out of plane deformations which led to a fracture of the section, the ends then remained in contact (jammed together under the compressive loads in the frame), the point of fracture moved vertically essentially in a guided manner until two additional fractures occurred farther up the frame.

Figure 11. - Static results from tests of single composite Z-frame.

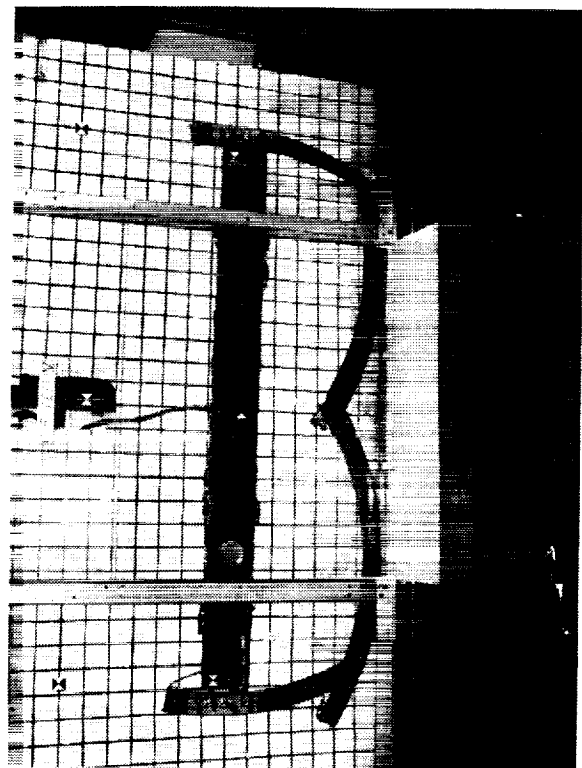
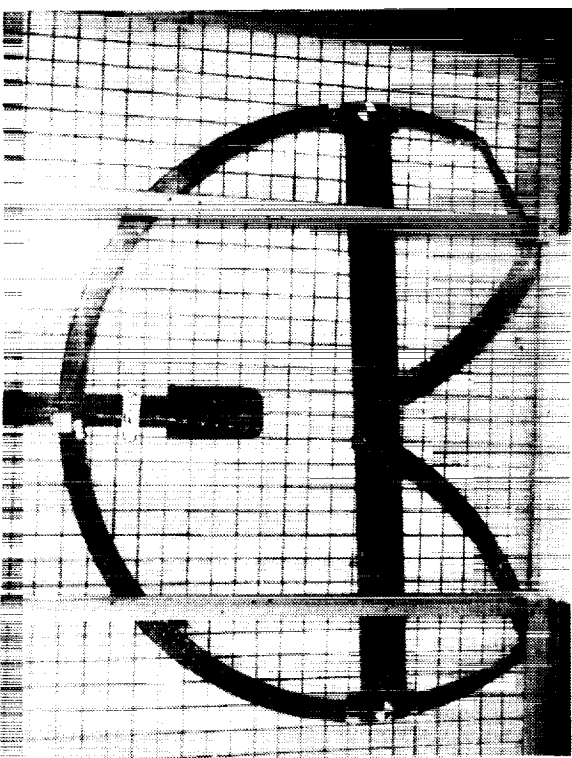
(a) Photographs of failed frames.

Dynamic tests.- Figure 13 presents results from reference 26 on the dynamic studies of the response of composite frames. As noted in figure 13(a) or (b), the splice plates joining the segments of the frame are 45 degrees up the circumference from the point of impact. As shown in figure 13(b) complete failures (fractures) of the Z-section frames occurred at the bottom and approximately 60 degrees from the bottom. Potentially, it appears that the presence of the splice plates may have influenced the locations by moving the top failure points up a few degrees to about the 60 degree locations.

Figure 13. - Behavior of composite Z-frame under dynamic loads.

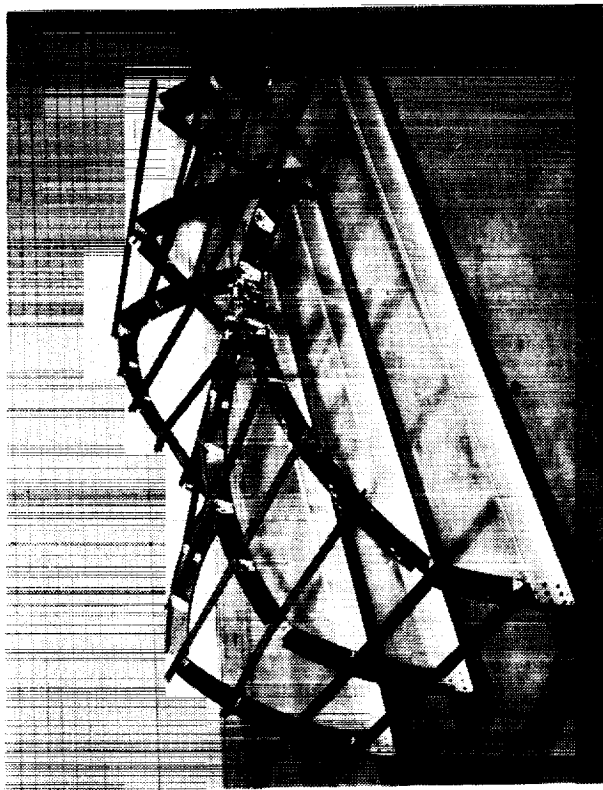
(a) Failed skeleton subfloor.

Static tests.- Figure 14 presents experimental results (Reference 27) of the skeleton subfloor specimen following a static test. As noted in figure 14(a) and (b), failures on the three Z-section frames occurred at 13 discrete locations. Unlike the unnotched single Z-frame, the failures in this specimen occurred at notches (which served as stress risers) in the frame through which the stringer passed. However, as shown in figure 14(b) the failures were still near the point of load application (approximately 12-14 degrees) and at other circumferential locations of approximately 55 degrees. In the absence of skin material, twisting and bending out-of-plane occurred with the frames. The stringers had minimal effect on the subfloor response with the exception of maintaining the lateral spacing of the three Z-frames.

Figure 14. - Behavior of composite skeleton subfloor under static loading tests.

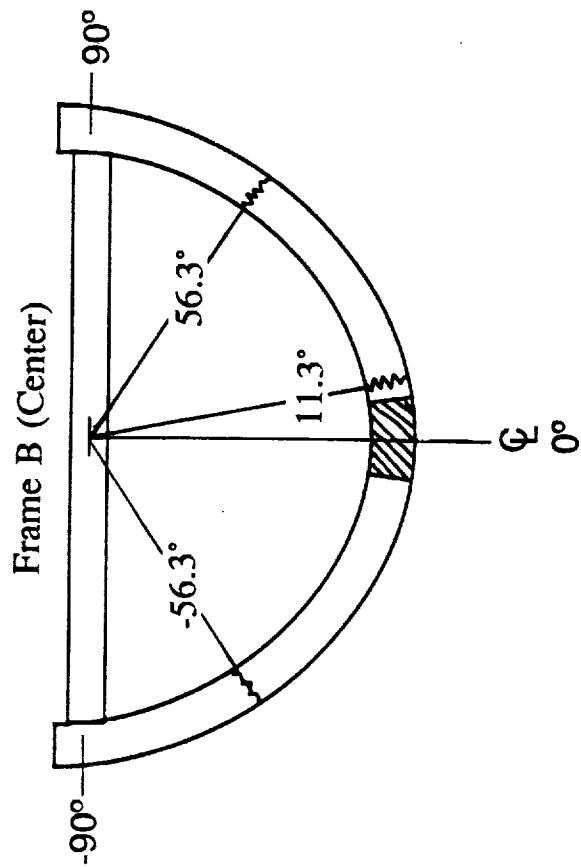
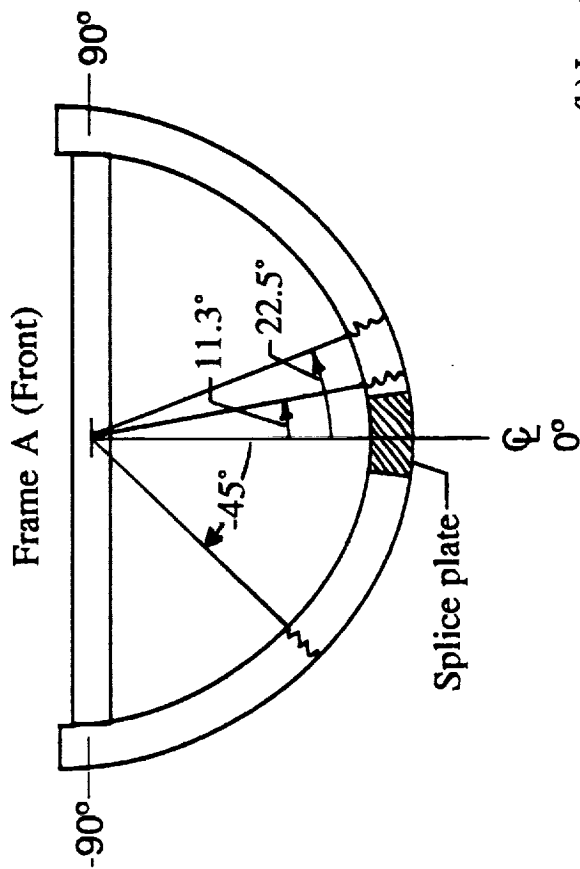
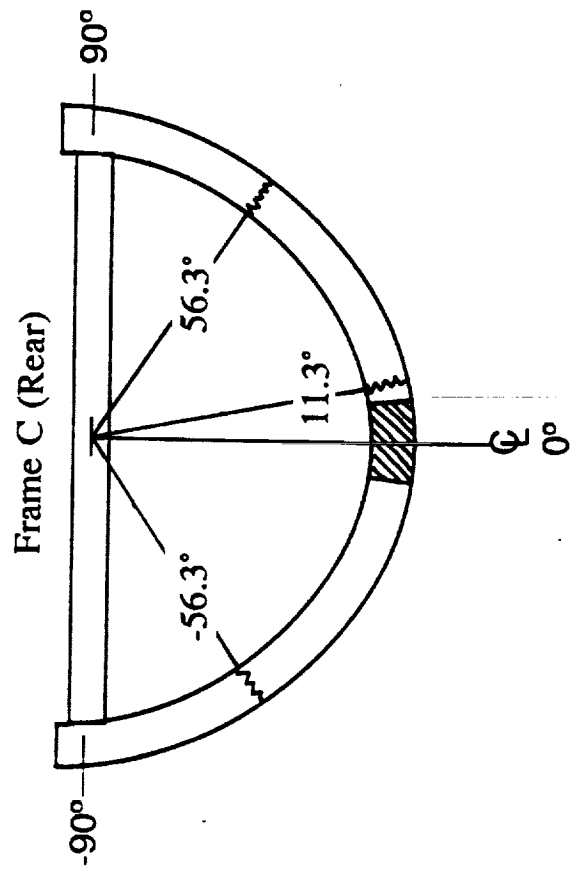
(b) Location of failures.

subfloor specimen after the test. Points of failure of the frames in this specimen are indicated in figure 16(b). Again the points of failure are at/near the impact point (within 12 degrees) and circumferentially at about 56 degrees up both sides of the frame on the middle and back frame and 45, 12 and 22.5 degrees on the front frame. It was observed that the subfloor impacted first on the front area which possibly explains the 12 and 22.5 degree fractures being different from the other locations. Again all three frames were involved in the failures. Some delamination of the frames from the skin was evident but the skin remained intact. Figure 16(c) is a normalized strain distribution (just prior to first failure) measured on the first (end) frame during the dynamic test. A comparison of the distribution to the moment distribution of Figure 12(b) and (c) and the strain distribution in Figure 16(c) shows essentially identical shape as the single frame and skeleton frame distributions. As was the case for the skeleton subfloor maximums at 0 degrees and at approximately 50 to 55 degrees agree well with the analytically predicted locations on the frame.

Figure 16. - Behavior of skinned composite subfloor under dynamic loading tests.

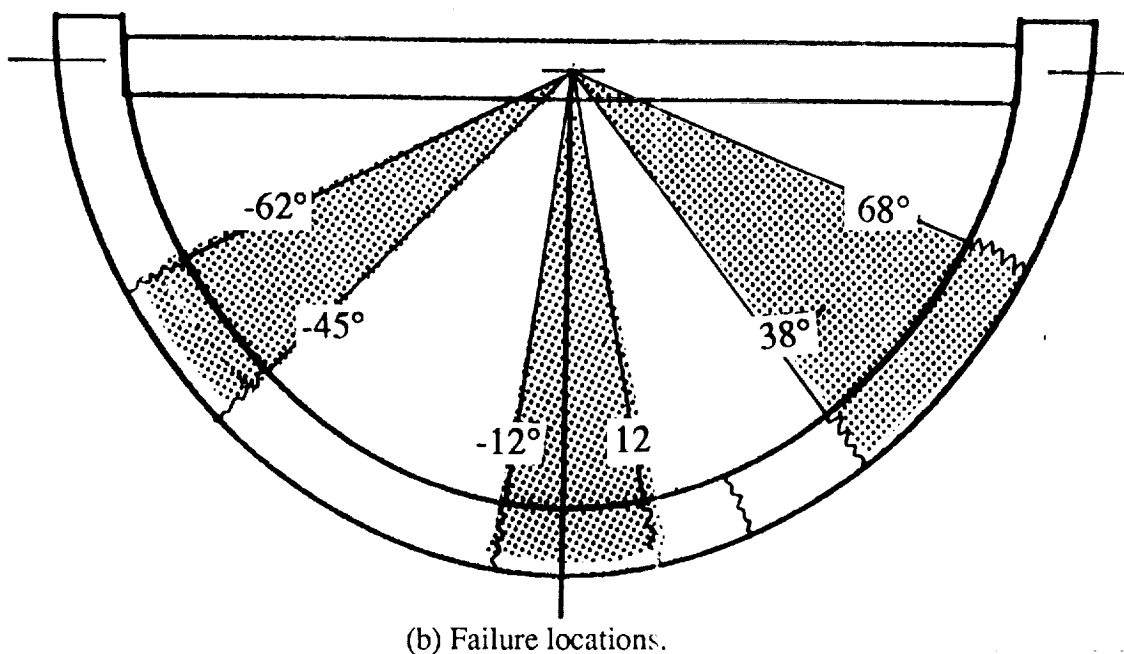
(b) Failure locations.

The response behavior determined during the studies of full-scale aircraft sections, fuselage frames, and subfloors are summarized in figure 18. Figure 18(a) shows normalized moment distribution on a representative frame of the various specimens and Figure 18(b) shows the failure locations which were noted from static or dynamic tests. The visual impression is quite striking among the various specimens. It is suggested that from the results of simpler frames to the more complex subfloors and full-scale sections, a strong similarity is evident in the failure behavior of the structures. The structures share in common the generally circular or cylindrical shape, the normal

loading situations, and what appears to be a similar pattern of failure behavior. Analytical models of frame structures under vertical loads have moment distributions which have maximums at the point of loading and at approximately 45 to 50 degrees (depending on boundary conditions) around the circumference from the ground contact point. Failures of the structures were noted at these same locations. Such observations can help dynamists gain a better understanding of what to expect from such structures in crash loading situations, can guide designers of new structures to better account for the vertical crash loads, and allow better energy absorption to be included in the new designs. Additionally, the observations can help analysts better model the aircraft structures for predicting the failure responses and behavior under crash situations. The latter task is a difficult and challenging one, not only for composite structures but for metal structures as well. Studies are currently underway to improve the analysis capabilities of code and to add composite elements to finite element libraries such as the DYCAST program. In addition, new analysis approaches are being explored through grants to universities as an extension of NASA Langley Research Center's efforts.

Figure 18. - Comparison of nondimensional analytical moment distribution predicted by finite element frame model and observed failure locations on metal and composite fuselage components and structures.
