**US Army Corps  
of Engineers**

CERL Technical Report 99/54  
June 1999

# Potable Water Pipe Inspection at Westover Air Reserve Base, Chicopee, MA

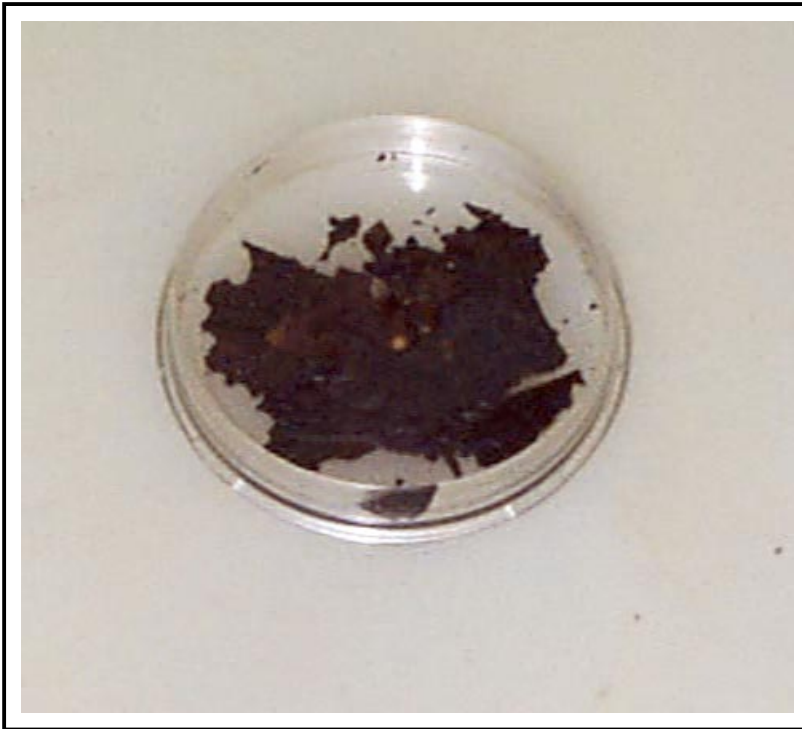
CERL investigators examined the coating materials in the petrie dishes. The material in the first petrie dish was soft and pliable, and appeared to be partially cured lining material (Figure 1). It was the same thickness and color as the inner lining material of the pipe previously examined. The several pieces stuck together and had to be pulled apart for examination. The material in the second petrie dish appeared to be fully cured (Figure 2). It was black in color with a thin, smooth layer of cementitious material on one side. A small portion of the inner coating material was removed for microscopic evaluation by chipping it off with a chisel and hammer. Examination of the coating pieces removed showed a much thicker layer of cementitious material, and a much rougher cementitious surface than the samples in the petrie dish.

Figure 1. Uncured coating recovered following flushing.

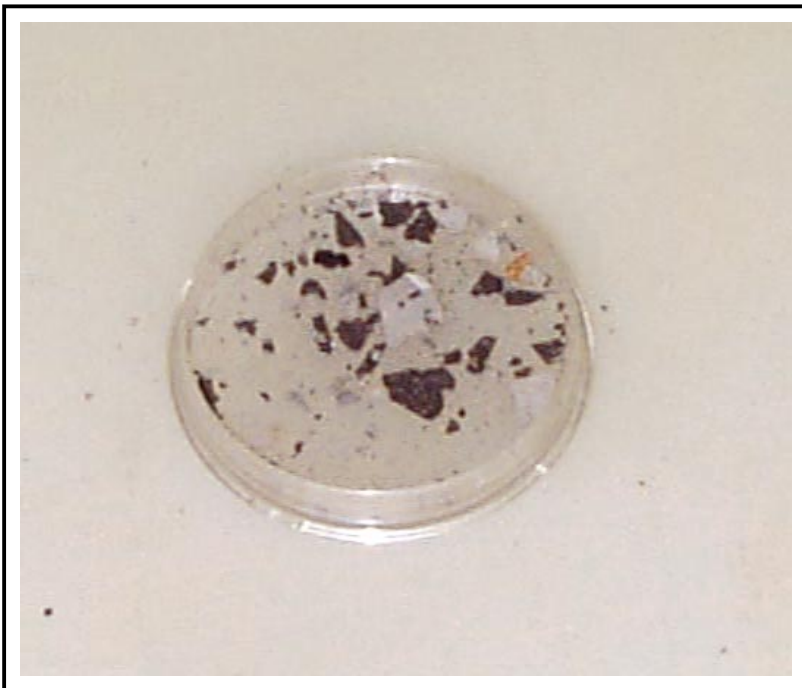
Figure 2. Cured coating recovered following flushing.

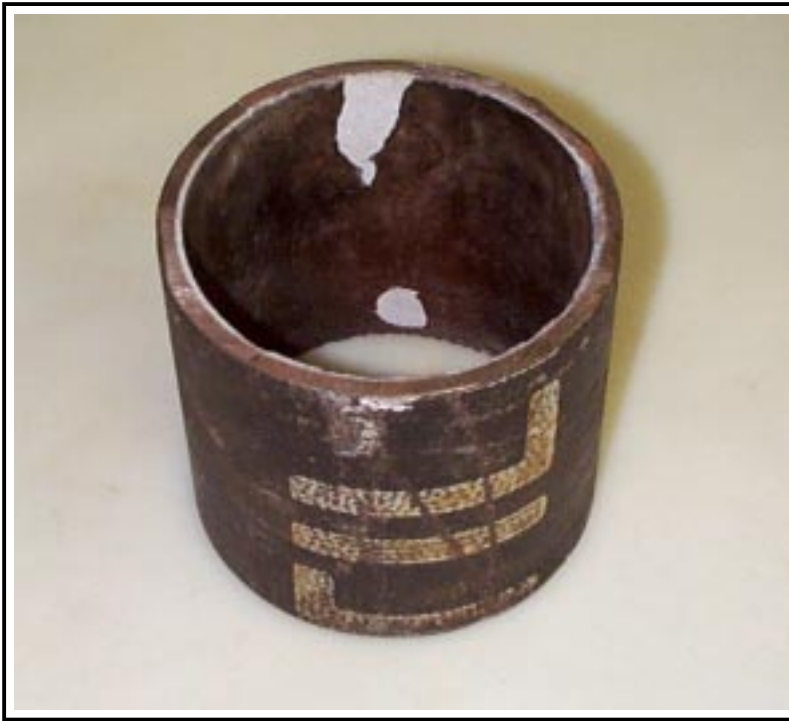
To evaluate the susceptibility of damage to the pipe lining due to sudden impact, the outside of the pipe was struck with a sledgehammer. A small portion of the inner liner popped off at the point of impact. The piece that popped off had the same thin coat of cementitious material on it as was seen on the sample in the second petrie dish. The cementitious material remaining on the inside of the pipe appeared unaffected (Figure 3). This indicates that sudden impact will cause the inner asphalt-epoxy liner to separate, leaving bare cement. The asphalt epoxy inner lining material from the pipe provided to CERL and the two different materials provided to CERL in the petrie dishes were also examined using scanning electron microscope elemental analysis. This analysis confirmed that all of the materials were also chemically the same.

Figure 3. Inside of pipe sample where struck with sledgehammer.

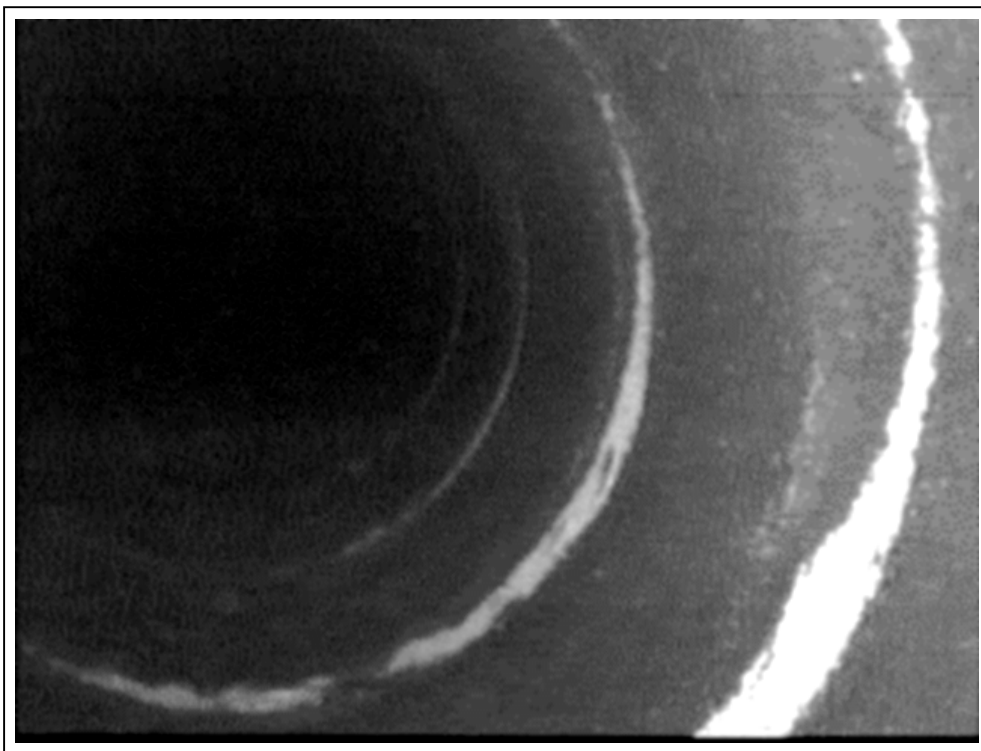
At some locations, sections of pipe contained a series of consecutive rings of coating loss (Figure 7). This occurred in one or two lengths of pipe, from joint to joint, while the other surrounding lengths of pipe are not affected. In some sections, areas of coating loss were intermittent (Figure 8).

Figure 7. Rings of coating loss.

2. Poor quality control was exercised during the installation of the interior lining by the pipe manufacturer. The series of consecutive rings of coating loss in some pipes, and the linear strips of missing coating in others, indicate improper cure of the lining material. Improper cure occurs when manufacturer-specified proportions the epoxy resin and hardener are not maintained during manufacture, or when the components are not adequately mixed prior to application. The observed patterns indicate that it is likely that there was a problem with the mixing during the pipe manufacture process.

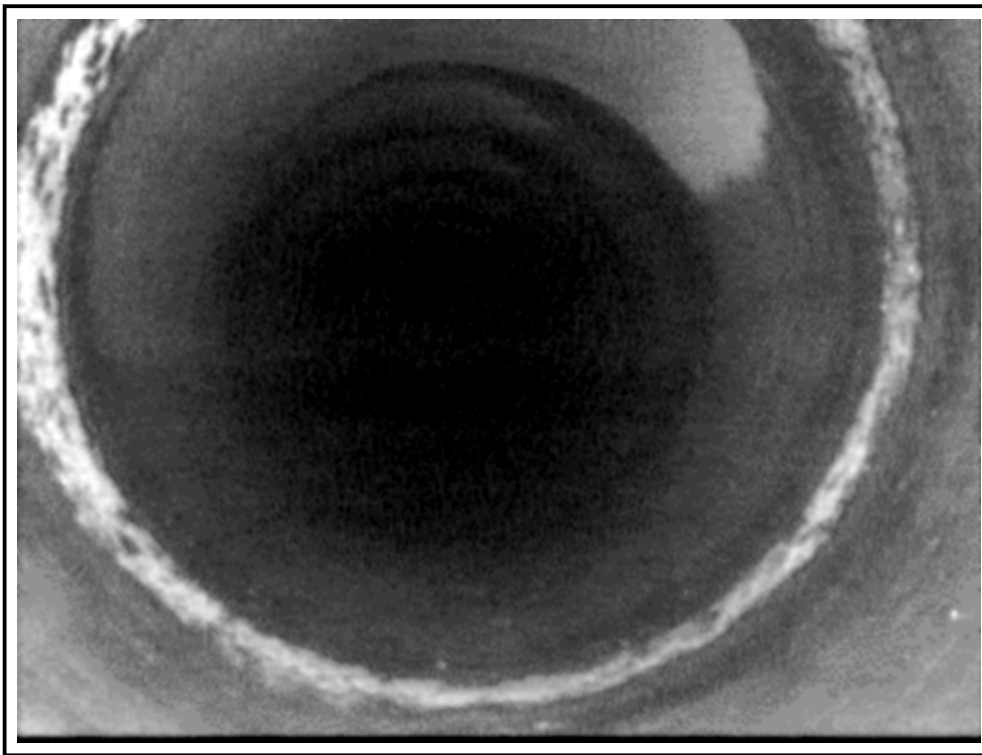
Figure 8. Period losses of coating on seen on the top of photo.

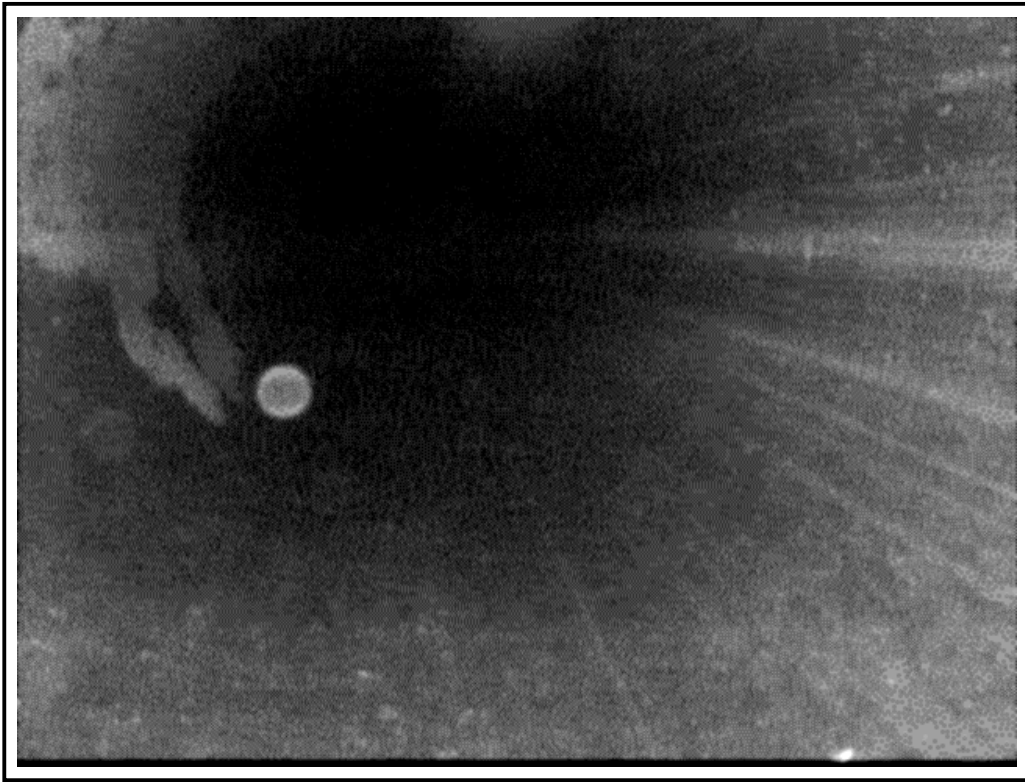
Some inspected sections showed evidence of scouring from a pigging operation (Figure 11). It appears that gravel may have lodged between the pig and the pipe wall as the pig went through the main. The coating appears scratched but the scratches do not appear to penetrate the thickness of the coating. Large coating losses are evident on the left side of Figure 11.

Figure 11. Scouring by pig evident from parallel lines scratched in coating.

4. Note that Westover used “soft” pigs to avoid damaging the system during the cleaning operation. The pigging operation conducted by Westover did cause some scouring of the pipe liner due to pieces of gravel being trapped between the pig and the pipe main wall. However, this scouring could not have caused the degree of damage to the lining observed during the Scooter video inspection of the water mains.

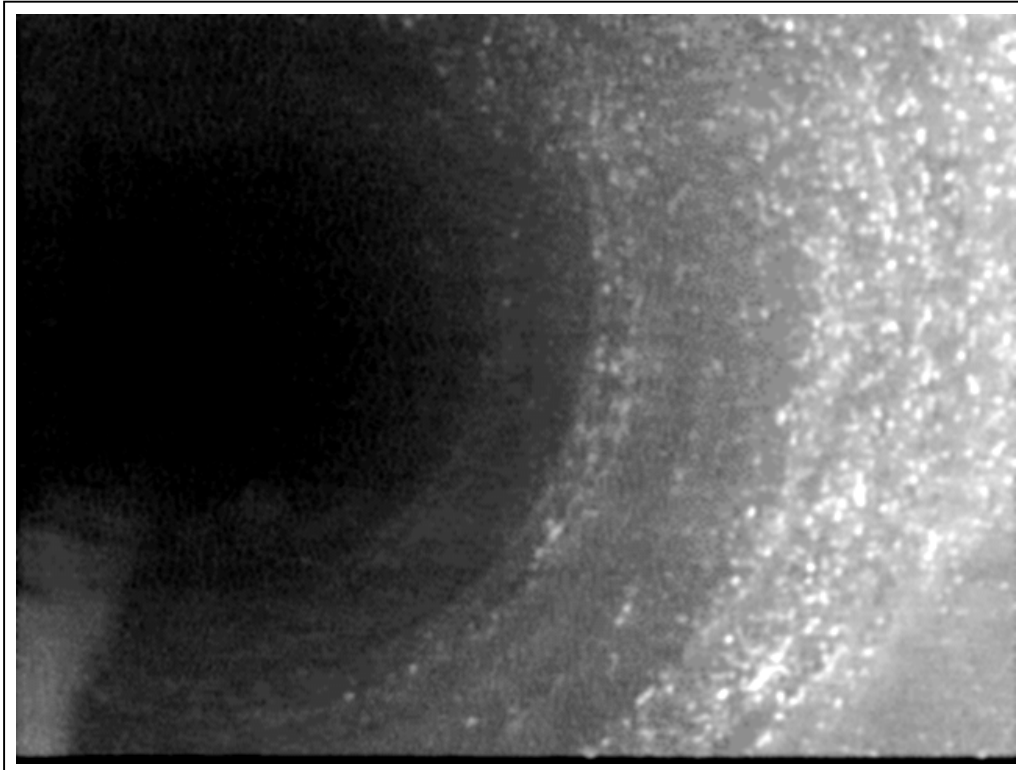
Inspection revealed occasional holidays in the lining (Figure 12). Holidays (typically very small pin-size holes in a coating) always occur in coatings. However, the holidays observed in the Westover water mains are not pin-hole size; they are much larger. Such large holidays may occur due to lack of wetting of the substrate during manufacture, too thin an application of the coating, or dirt and other foreign objects adhering to the cement substrate during manufacture.

Figure 12. Holidays in the coating.

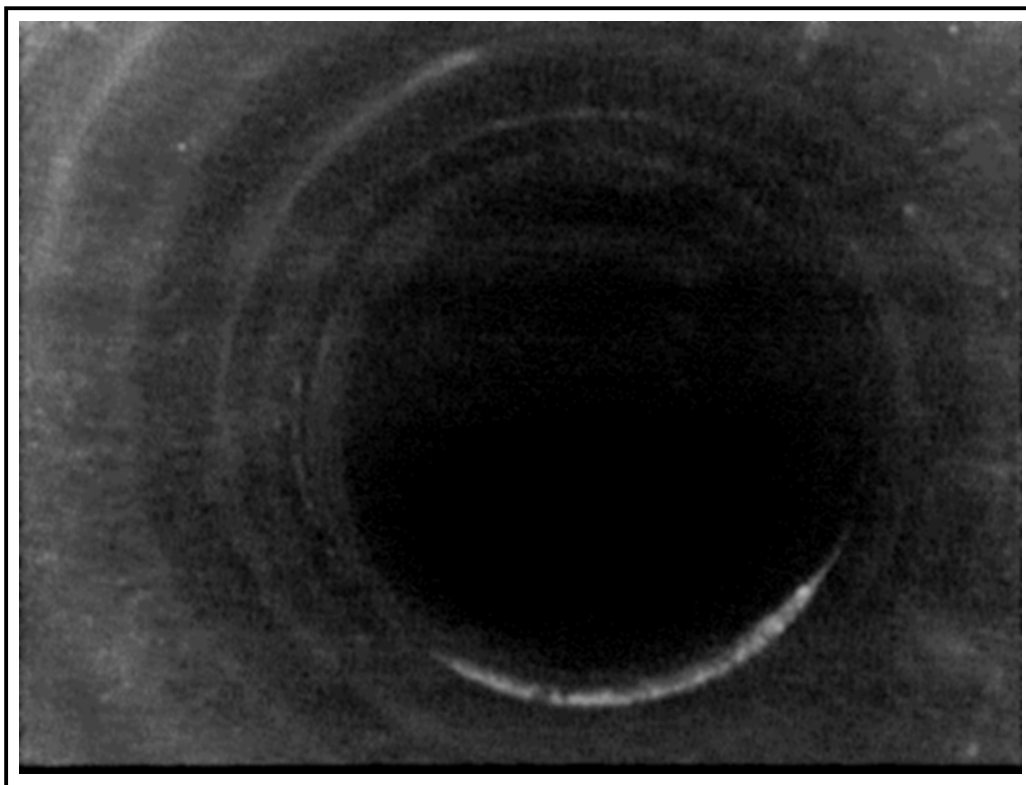
All welded joints are clearly visible in the video (Figure 13). The joints are frequently misaligned, and are always missing coating. A close-up view of one joint shows large tubercles that would indicate significant corrosion (Figure 14).

Figure 13. Pipe joint welded off center.

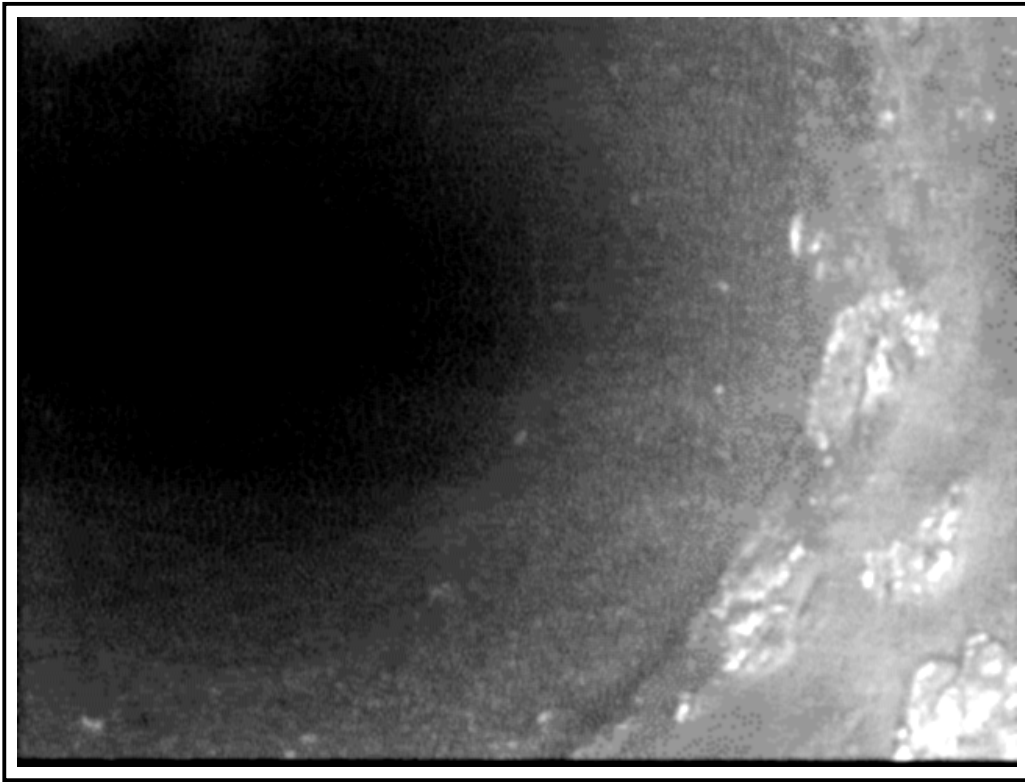
Figure 14. Corrosion on a pipe joint is evident on the right side of photo.

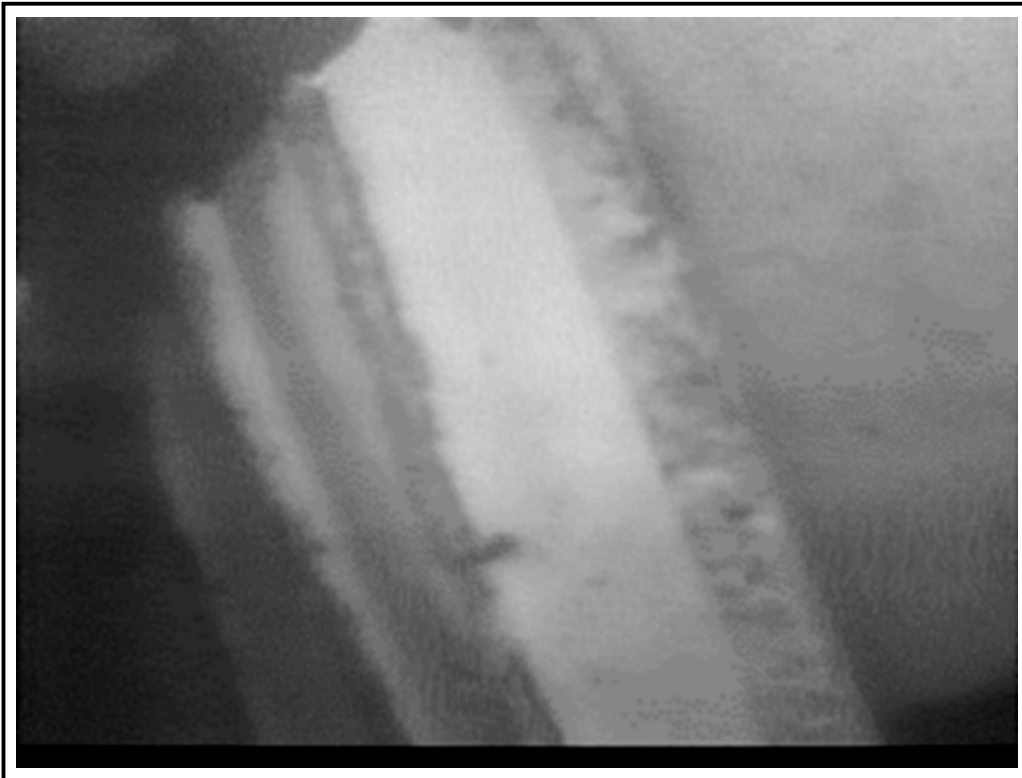
The inspection showed a problem with debris in the mains at some locations. At the corner of Eagle and Hanger, a piece of plastic material lodged in the line would not allow the camera to enter the main (Figures 15 and 16). The plastic was close enough to the entry point that attempts were made to reach in and pull the piece out of the pipe. However the plastic was wedged too tightly to move in any direction. Silt was evident in water lines (Figure 17). A few isolated pieces of gravel were observed in the mains (Figure 18). No dense concentrations of gravel were observed. The system dead ends were dirtier than the rest of the system. A few more pieces of gravel and a more silt were seen there than were seen in the mains.

Figure 15. Plastic wedged in pipe.

Figure 16. Different view of plastic wedged in pipe.

3. The flushing and pigging done by Westover ARB was effective in cleaning most of the debris out of the mains. A small quantity of debris still exists in the system. If one large piece of plastic shipping material was found during the Scooter inspection, it is statistically probable that several more were left in the remaining uninspected parts of the system. There is some silt and some gravel in the system, but not a significant amount.

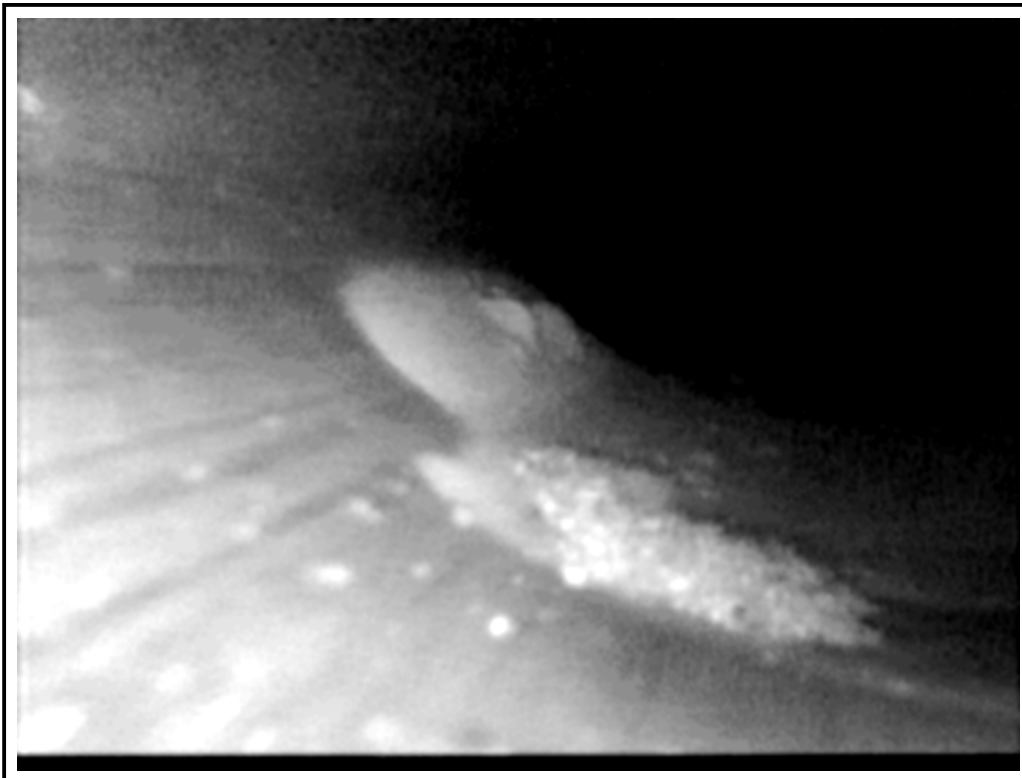
Figure 17. Silt resting on pipe bottom.

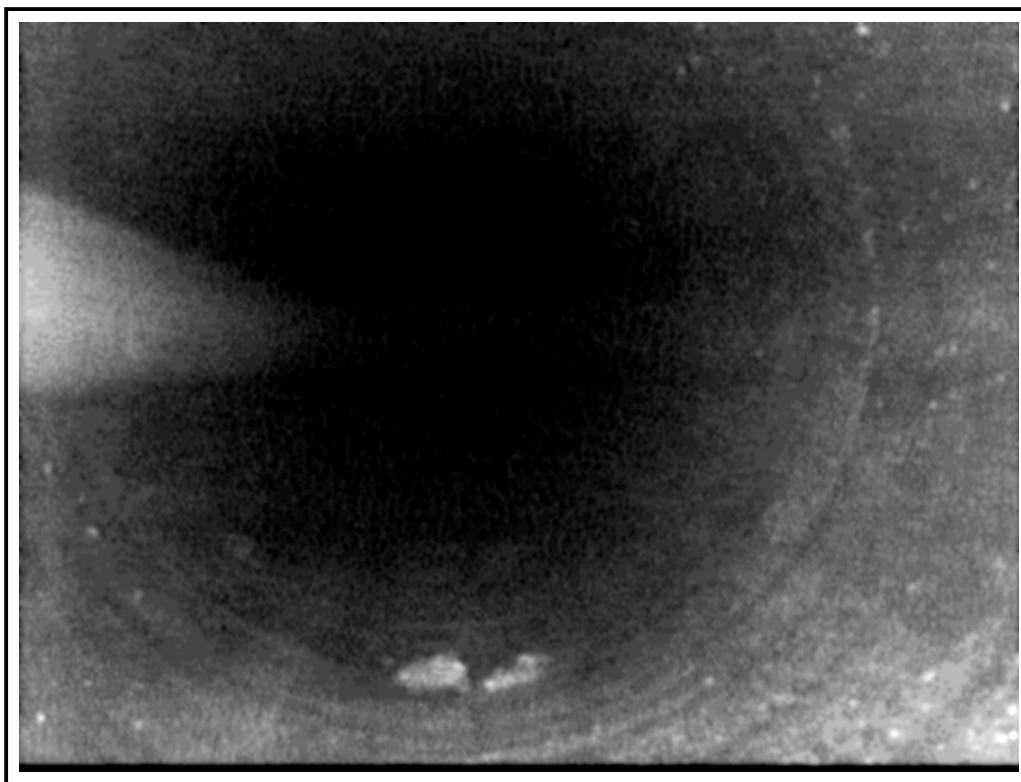
Figure 18. Two rocks resting on pipe bottom.
