Debris/Ice/TPS Assessment And Photographic Analysis For Shuttle Mission STS-34

Charles G. Stevenson
NASA/Kennedy Space Center

DEBRIS/ICE/TPS ASSESSMENT
AND
PHOTOGRAPHIC ANALYSIS
OF
SHUTTLE MISSION STS-34

October 18, 1989

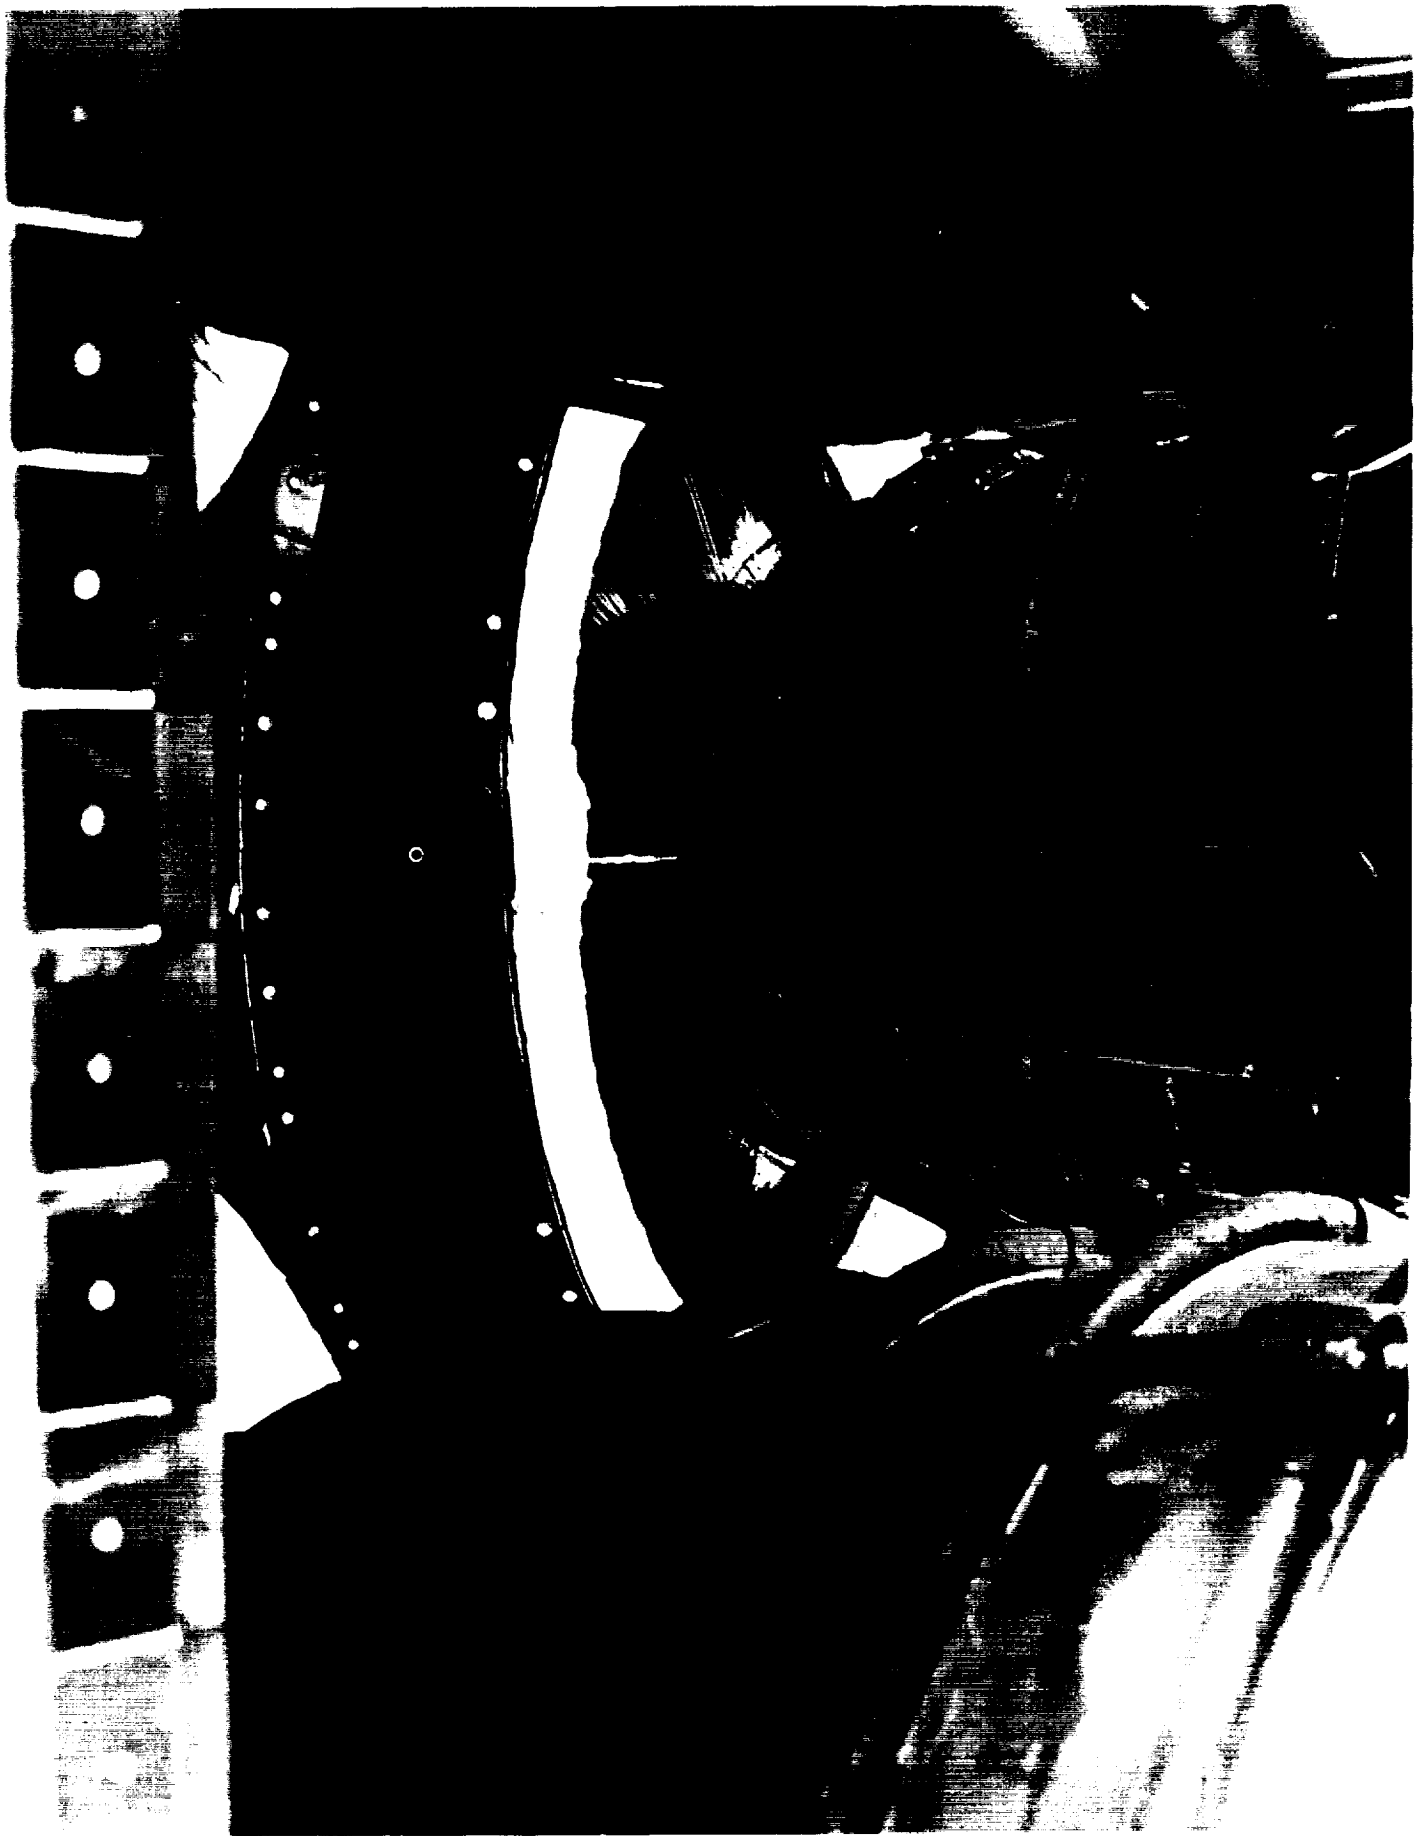
Condensate is visible on SSME #1 engine mounted heat shield.
Very little frost has formed on the nozzle interface.

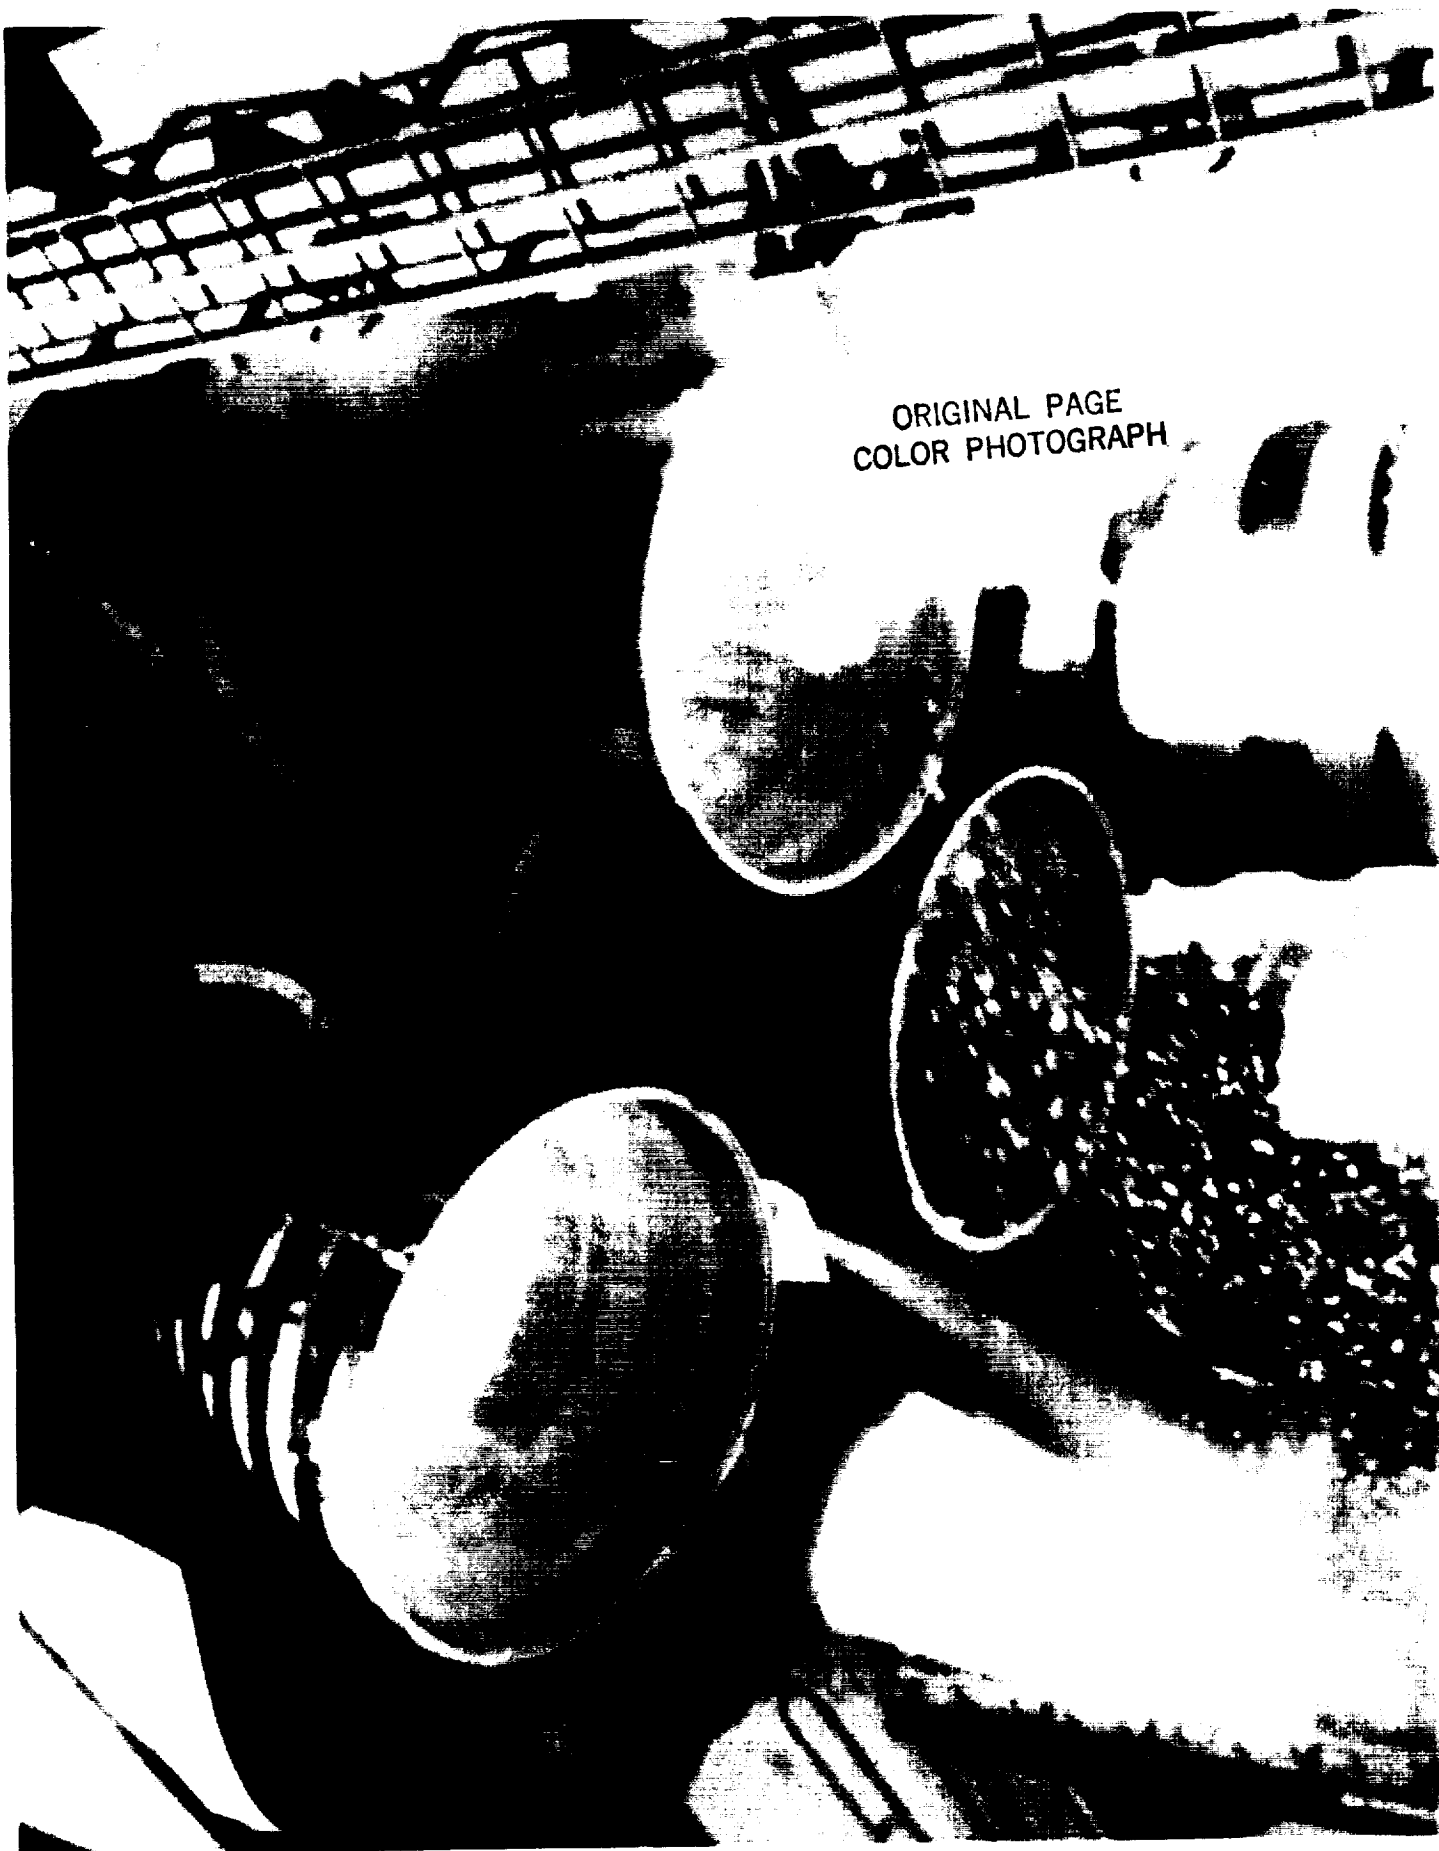
Orange 'flash' occurred in plume of SSME #1 just after T-0. GOX clouds drift past SSME #3 during LO2 T-0 umbilical retraction.

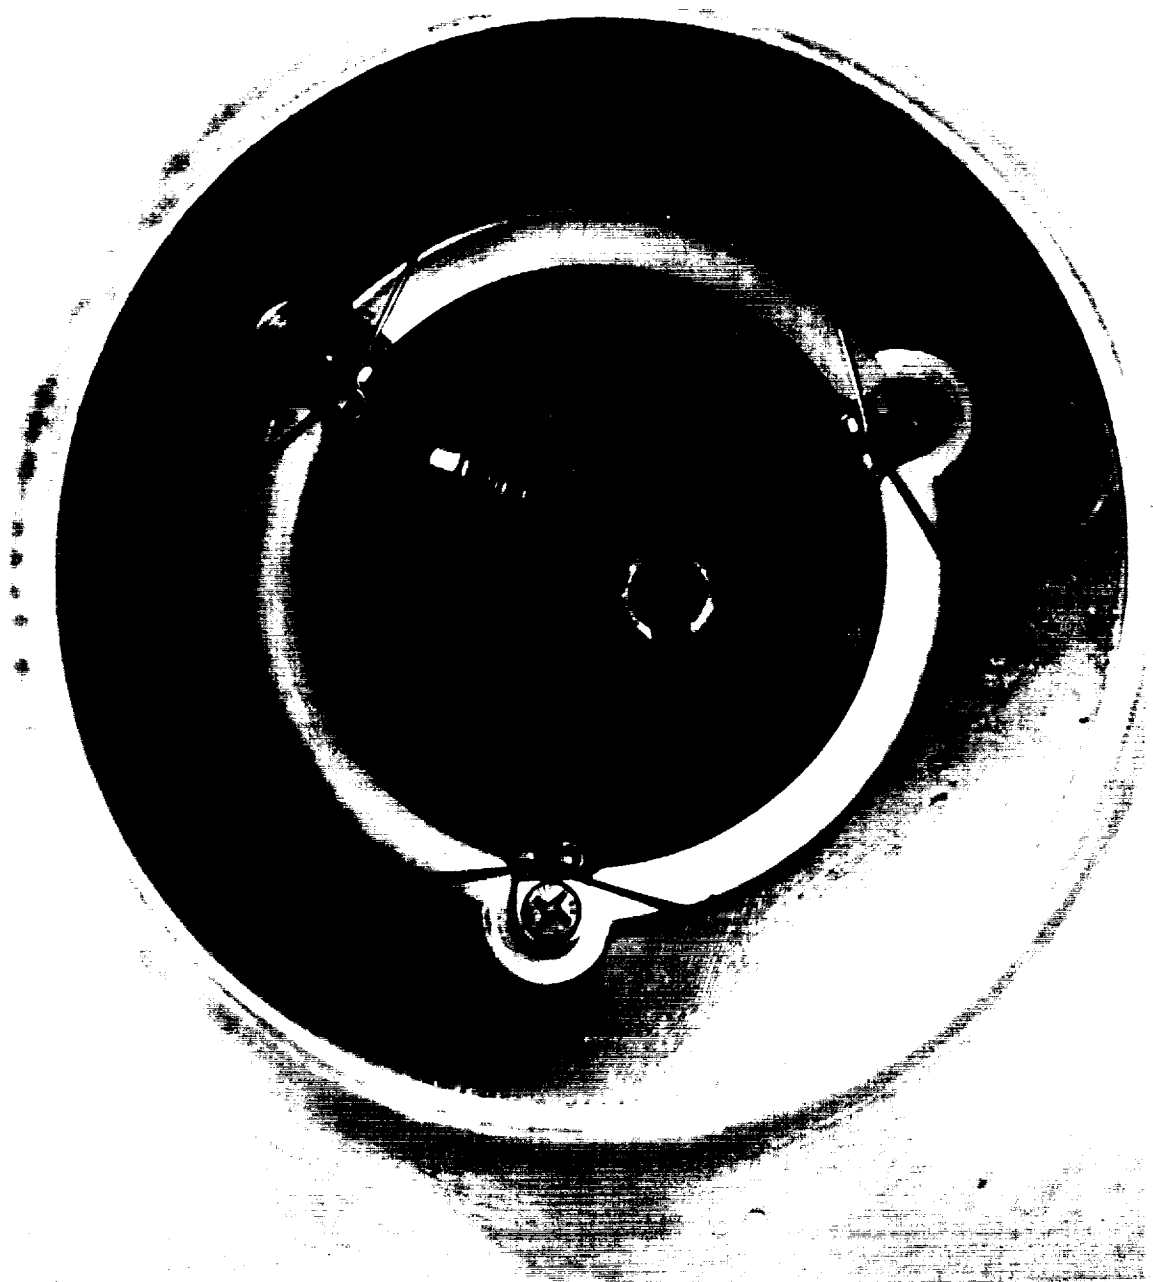
During pyro removal, a stop-bolt from the forward attach point EO-1 bolt's centering mechanism was found to be compressed and bent. The damaged assembly was removed for analysis. Fragments from the EO-3 ordnance device fell onto the runway when the LO2 ET/ORB umbilical door was opened. The debris was a result of the ball fitting ordnance plunger failing to seat properly.

EO-3 ordnance device debris plunger failed to seat properly
