TWR-17592 VOL. VII

Space Shuttle Production Verification Motor 1 (PV-1)
Field Joint Protection System
Final Report
Volume VII

10 December 1990

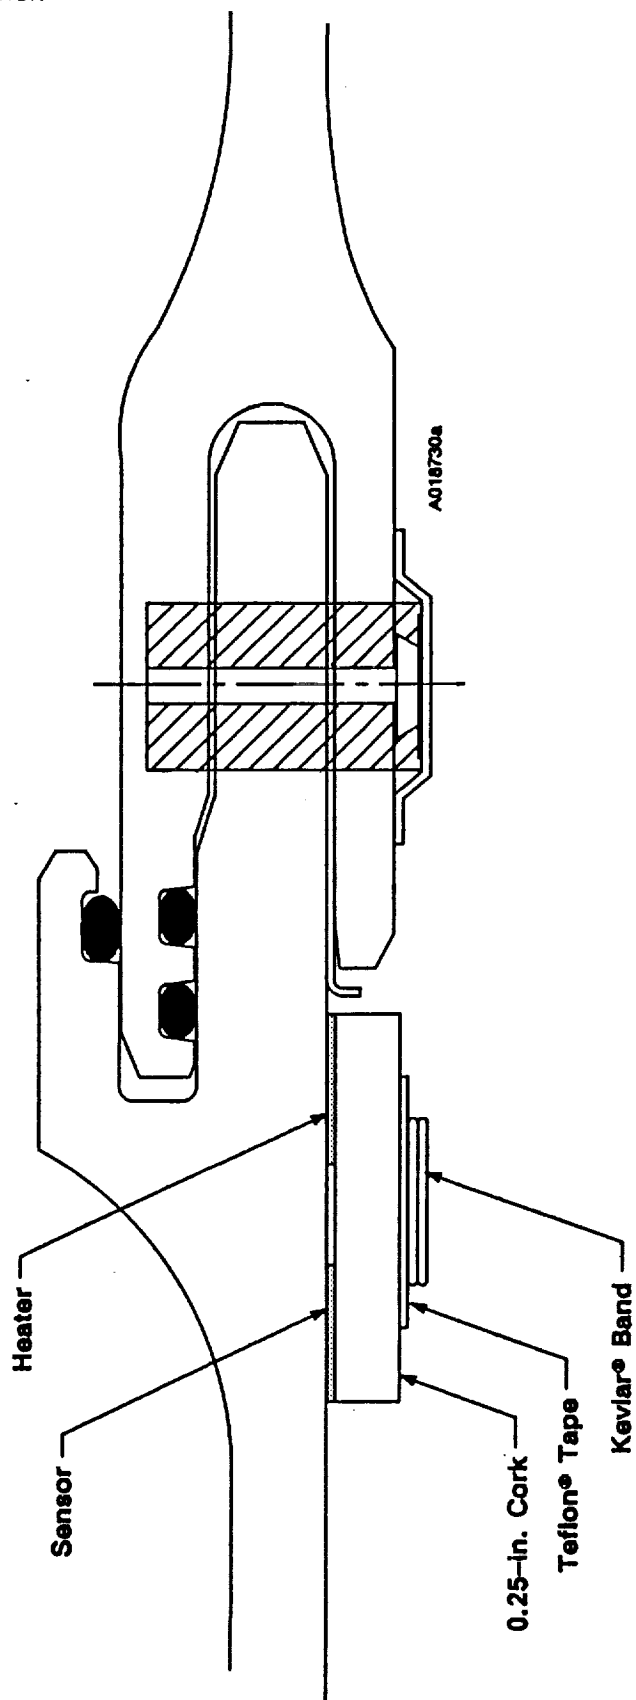
Figure 1. Simplified Field Joint Protection System

Field joint seal temperatures were maintained using a simplified field joint protection system (FJPS), shown in figure 1, consisting of heaters and sensors only. The heaters consisted of primary and redundant chemically etched foil circuits which were superimposed upon one another and laminated in Kapton and fluoroethylene polymer Teflon. Adjacent to the heaters were two temperature sensor assemblies, each containing two resistive temperature devices (RTD). These were covered by a 0.25-in thick strip of cork held in place by a single Kevlar strap.

The simplified FJPS was in excellent condition with no signs of abnormal heat effects on the cork strip or Kevlar band. No anomalies were observed on the FJPS.
