# Abandoned Cold Storage Warehouse Multi- Firefighter Fatality Fire

Worcester, Massachusetts

USFA-TR-134/December 1999

This is Report 134 of the Major Fires Investigation Project conducted by Varley-Campbell and Associates, Inc./TriData Corporation under contract EME-97-CO-0506 to the United States Fire Administration, Federal Emergency Management Agency.

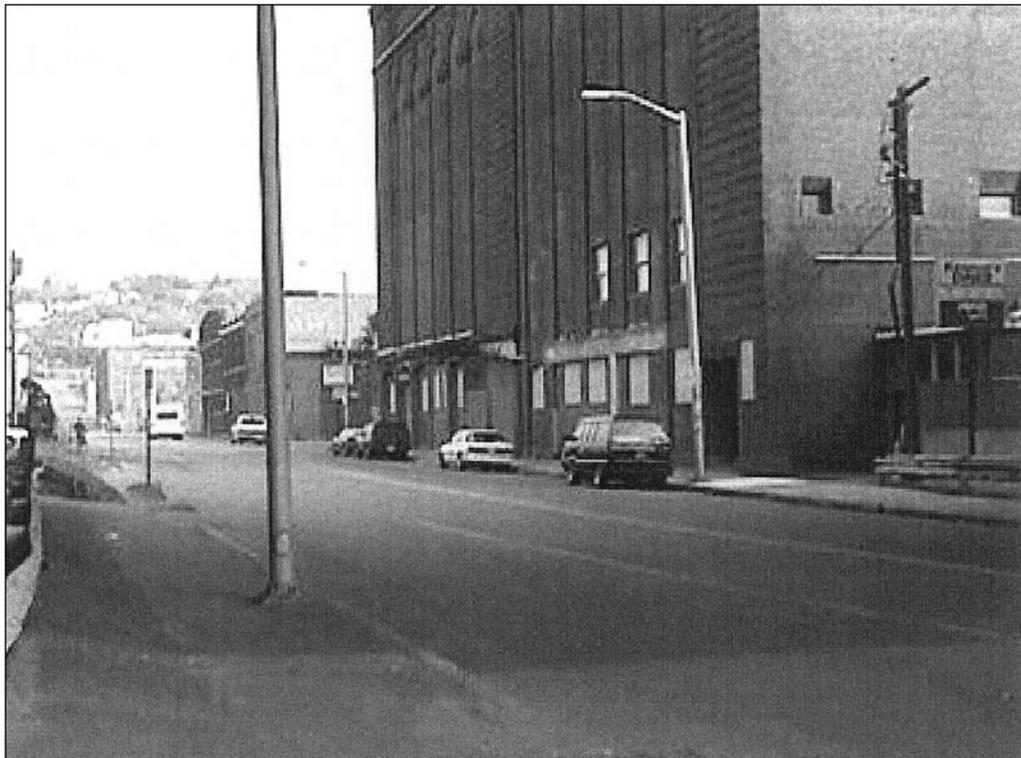
**Warehouse D/A Corner**

Exterior units reported a six foot crack in the brick wall at the top of the D/A corner, and the warehouse's structural integrity was in question. Firefighters recalled hearing several "booming" noises that shook the building. At 1951 hours, fire vented through the roof of B-building. Heavy fire was reported with flames 30 to 40 feet above the roof.

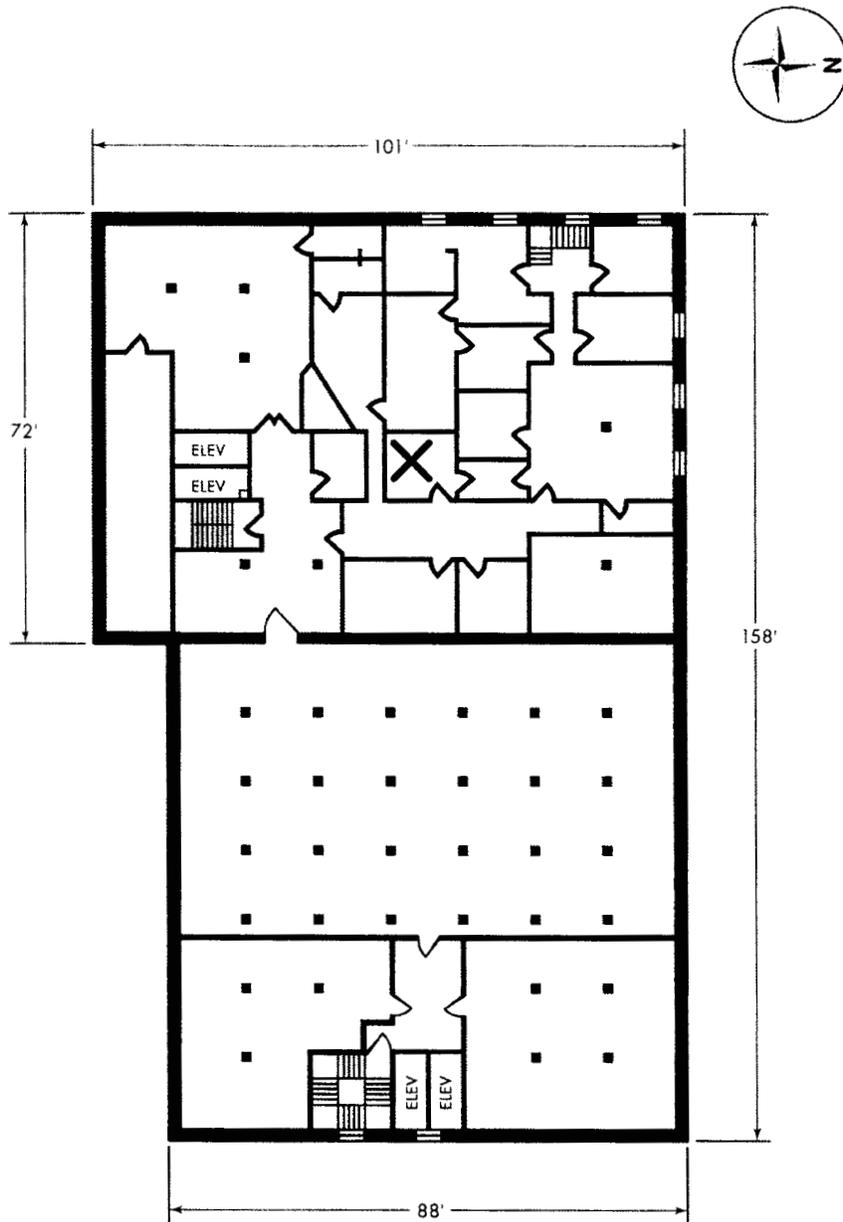
## Room of Origin

The area of origin was discovered to be in an office on the second floor of B-building. (See Appendix E) The cause was determined to be an accidentally overturned candle used to light the room. This happened during a fight between a homeless man who resided in the space and his homeless girlfriend who had recently moved out. She returned to the warehouse in the later afternoon of December 3rd to pick up some belongings and encountered her former boyfriend. A brief shoving match caused the lit candle to fall off a milk crate and into a pile of clothing. Attempts to beat out the flames were unsuccessful, and the fire fed on the combustibles strewn around the room.

The initial report from Ladder 1 on the second floor describes a “room full of fire” in B-building beyond the door in the party wall. This location is some 30 feet from the room or origin, so a one room fire had enough time to engulf the entire floor. A sustained flow of 1000 GPM for 20 minutes had virtually no effect on the fire, and conditions deteriorated around attack crews. (See Appendix E – Room of Origin.)

X Room of Origin

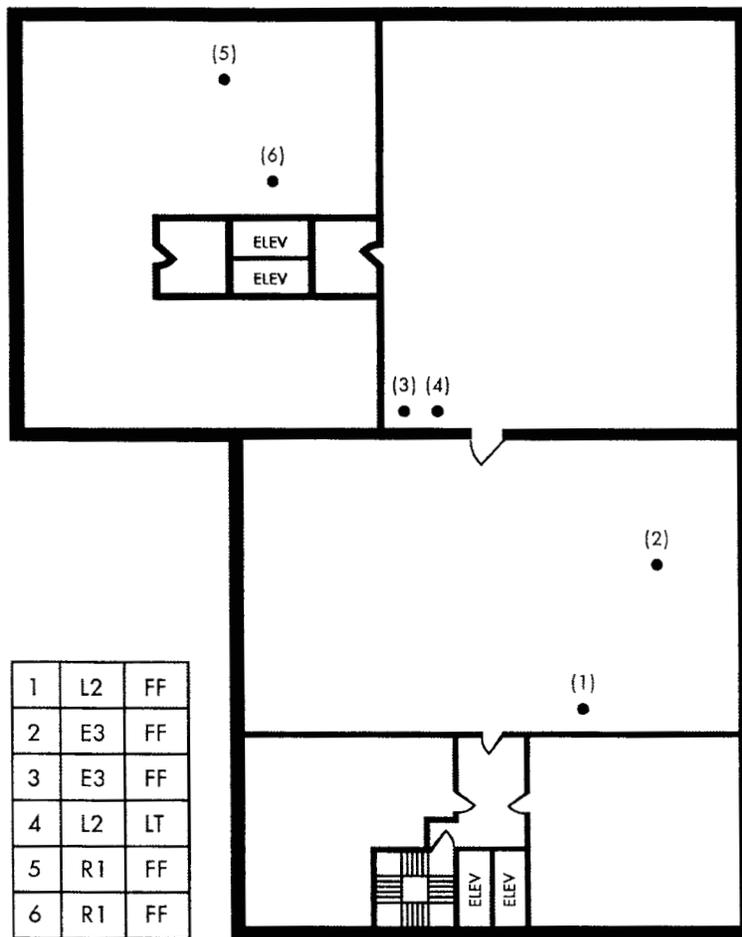
## Fifth Floor Fatality Locations

1	L2	FF
2	E3	FF
3	E3	FF
4	L2	LT
5	R1	FF
6	R1	FF

Note: The marked locations are where the remains were recovered on the 2nd Floor. Their actual locations on the 5th Floor are unknown.
