**EVACUATION PATTERN
ANALYSIS OF A SURVIVABLE
COMMERCIAL AIRCRAFT CRASH**

**FEDERAL AVIATION AGENCY
Aviation Medical Service
Research Division
Civil Aeromedical Research Institute
Protection and Survival Branch
Oklahoma City, Oklahoma**

MAY, 1962

The evacuation pattern of 99 of 106 survivors of a jet transport crash involving a post crash fire is described, factors possibly effecting the suffocation and ultimate death of 16 passengers are listed and photographs and diagrams are presented.

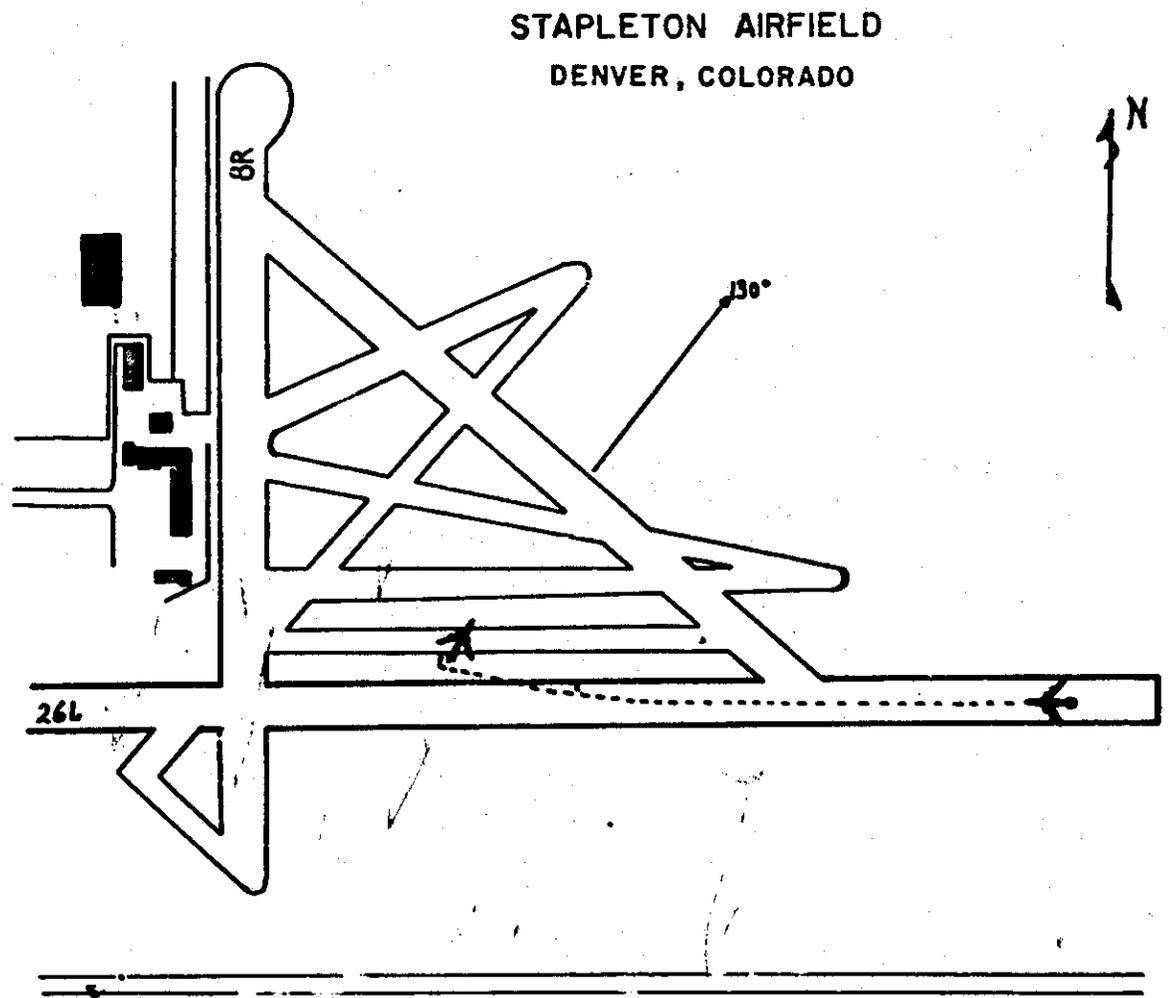
FIGURE 1

According to witnesses, the plane touched down normally within fifteen hundred feet of the rear end of the runway and proceeded down the runway in a straight line for several hundred feet, before it began to veer off to the right. As it skidded off the runway, it gradually yawed to the right and slid almost sideways across open ground, striking a panel truck - killing the driver. Toward the end of this gradual deceleration, the aircraft struck the sheer edge of an incomplete taxiway, on which the aircraft finally came to rest (Fig. 1).

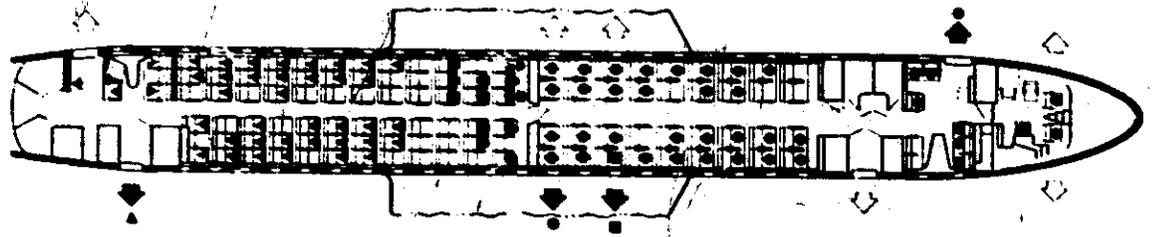
FIGURE 6.

vides an interesting picture (Fig. 6 — it was impossible, due to legal complications, to obtain information from some of the survivors and therefore, the seating diagram is not complete). There were thirty-six passengers and five crew members in the forward cabin-cockpit area; three exits were available in this accident for evacuation of these forty-one persons — a ratio of one exit for each 14 persons.

Seventy-nine passengers and two crew members occupied the tourist compartment, for which there was only *one* exit (a service door) available for evacuation. *All of the fatalities were in this rear compartment*, whose ratio of exit to occupants was 1:81, as compared to 1:14 in the forward compartment.

In attempting to determine why all of these sixty-seven tourist passengers were unable to evacuate the aircraft through this one exit, several major factors bear scrutiny; (1) the width of the aisle between the rows of triple seats in the tourist section was 15.5 inches, or approximately two thirds of the 22 inch aisle width in the first class section. This narrow aisle width in the tourist cabin would require that the evacuating passengers stand in single file, while waiting to move toward the exit at the rear of the aircraft, (2) there were no over-wing or

window exits available within the tourist cabin, (3) a floor-to-ceiling partition separated the tourist cabin from the first class section, effectively blocking from the view of the tourist passengers any sight or sign of the over-wing exits available in the first class cabin, and (4) there was no placard or indication on the aft side of the partition to indicate the existence and availability of emergency exits in the first class cabin.

(6) Requirements and regulations governing the number and location of exits in transport aircraft be re-evaluated in relation to aisle width, passenger capacity and cabin compartmentation.

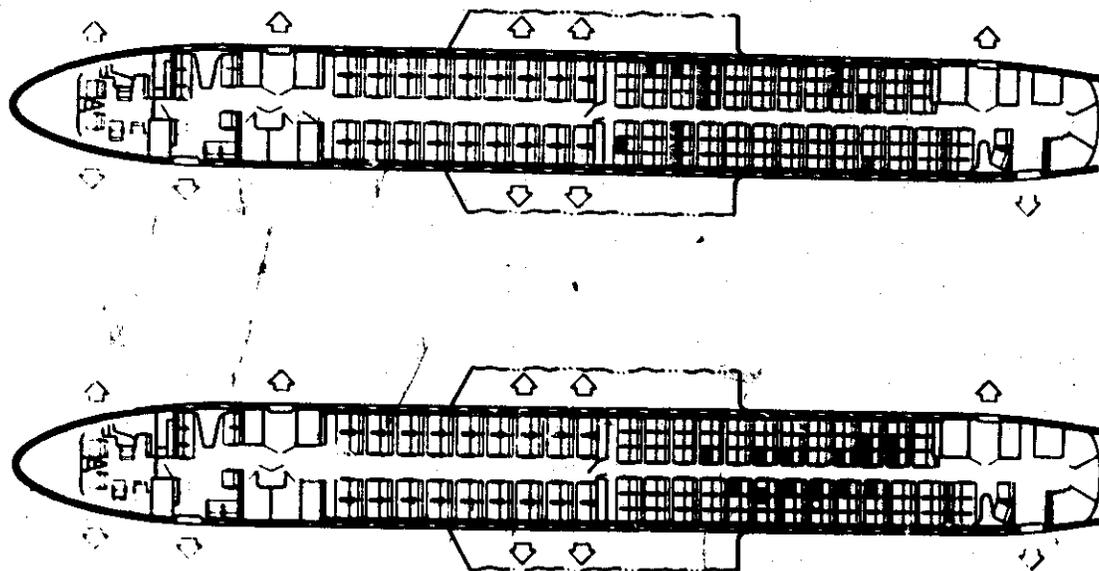
FIGURE 7.

During the routine CARI investigation of this accident, in cooperation with the Civil Aeronautics Board, it was determined that the persons, who had succumbed from carbon monoxide poisoning while attempting to evacuate the tourist section, died in the seats shown in the lower portion of Fig. 7; these were not the seats for which they had been ticketed. It is of interest that these seats in which they died are predominantly spaced at random along the aisle. This indicates that these persons must have left their own seats and were attempting to move down the aisle toward the rear exit when they were overcome; it may be assumed that they collapsed into, or sat down in these seats to try to regain their senses and to await clearing of the aisle.

The upper portion of Fig. 7 shows the assumed location of the fatally burned persons, according to the recollections and statements of rescue personnel given during the official hearing several weeks after the accident. The variation between the location of the fatally injured persons, according to the memory of rescue personnel, as compared to the locations determined by findings of experienced investigators at the scene of the accident (as shown in the lower portion of Fig. 7), is easily apparent; this would appear to indicate that information obtained from witnesses who have been involved in a psychologically shocking experience — such as the removal of human bodies from an aircraft — should be treated with utmost caution.
