U.S. Fire Administration/Technical Report Series

# Fire Apparatus/Train Collision

Catlett, Virginia

USFA-TR-048/September 1989

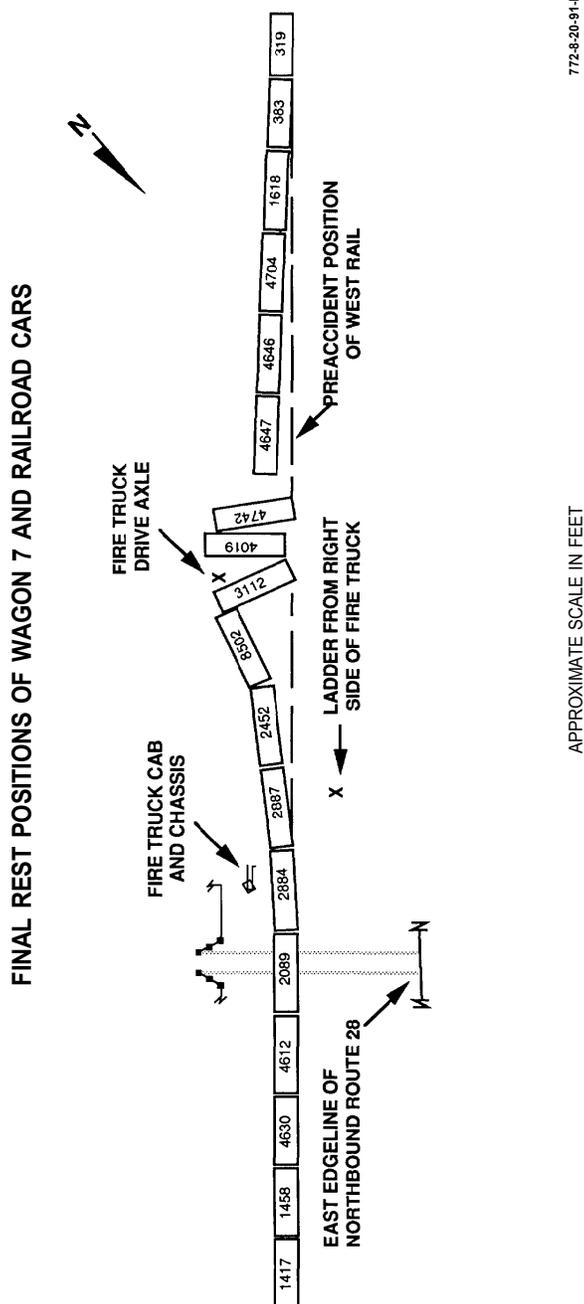
## Diagram Showing Final Rest Positions of Wagon 7 and Railroad Cars, and Chart of Type of Rail Car, Number, and Order in Train

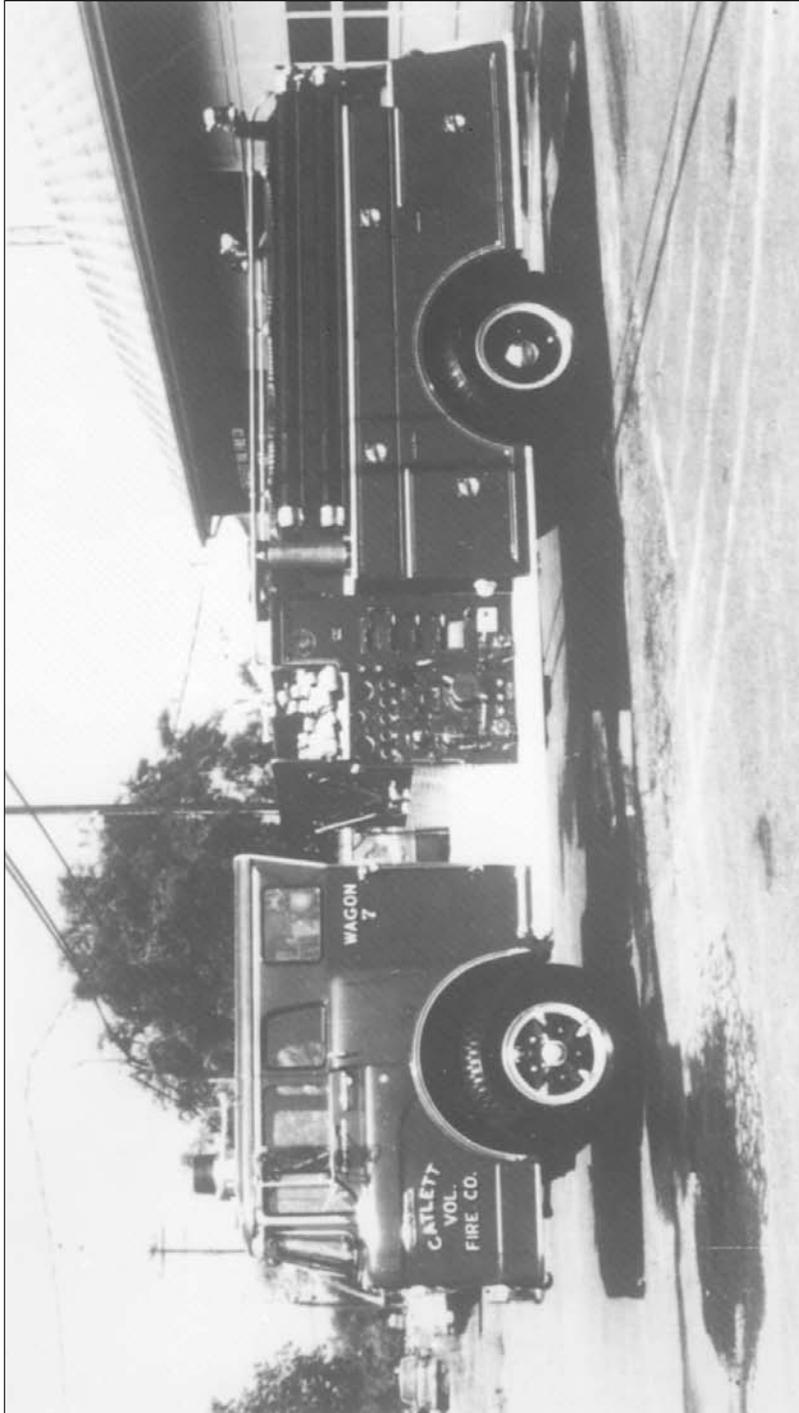
**Left side of Wagon 7**

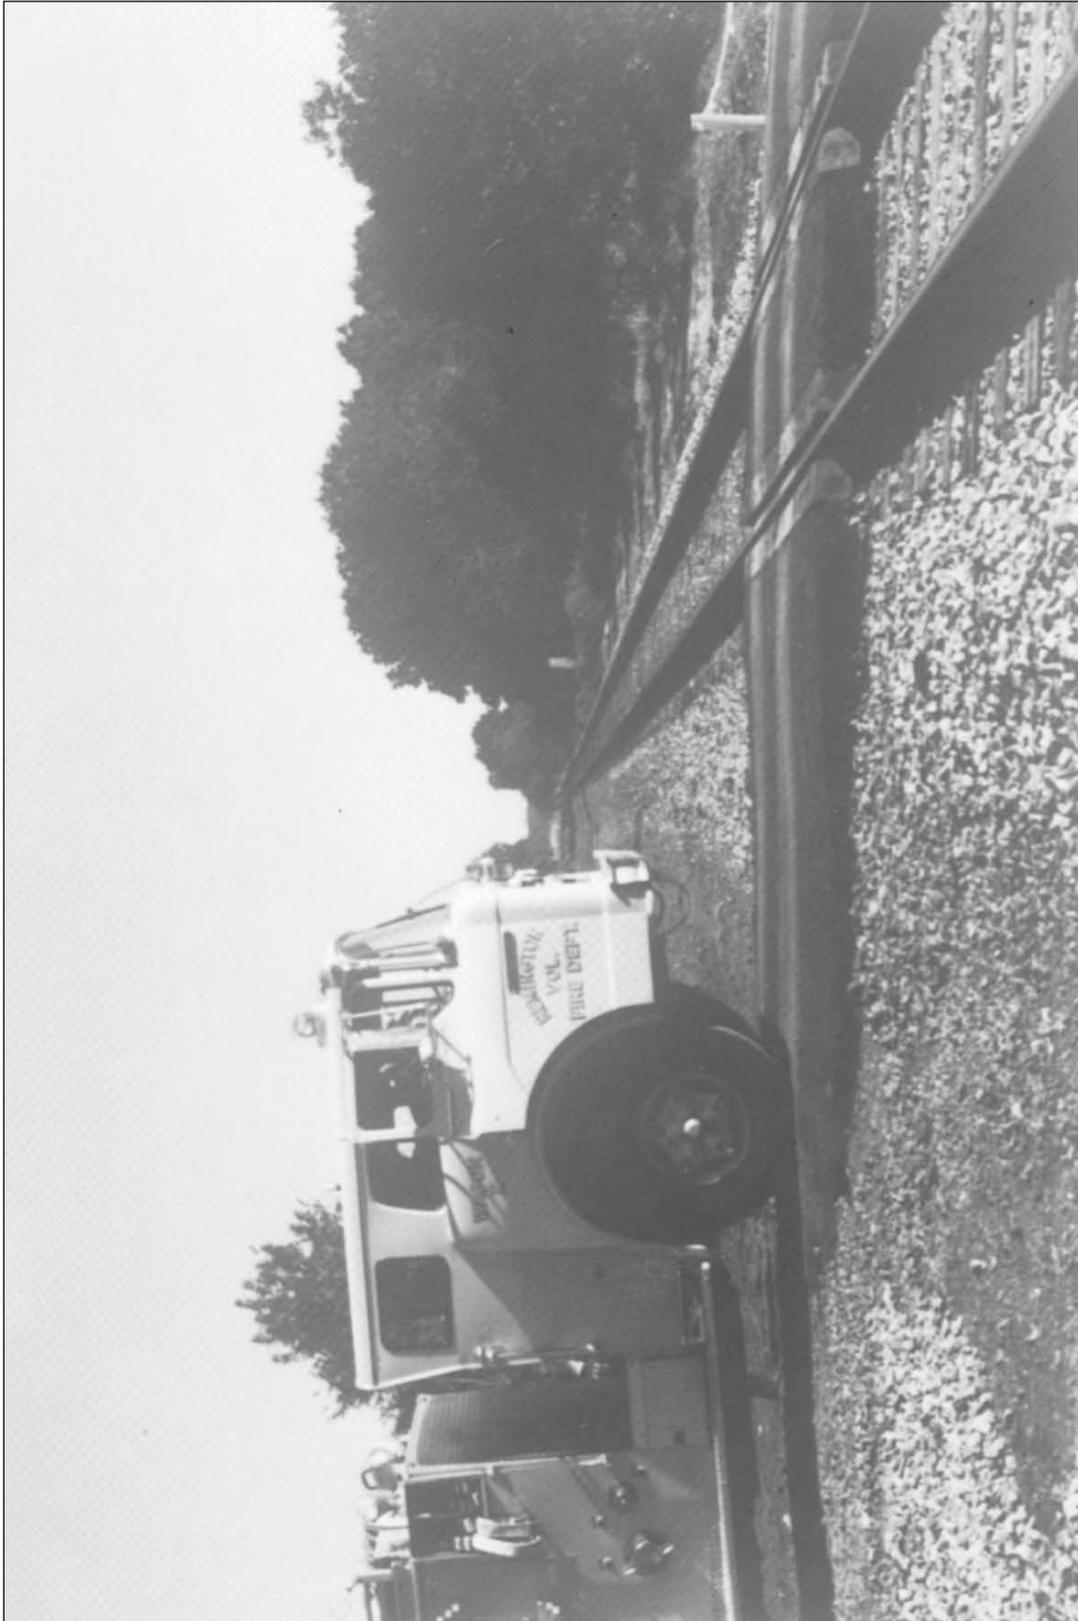
Wagon 2 at accident crossing – camera facing north

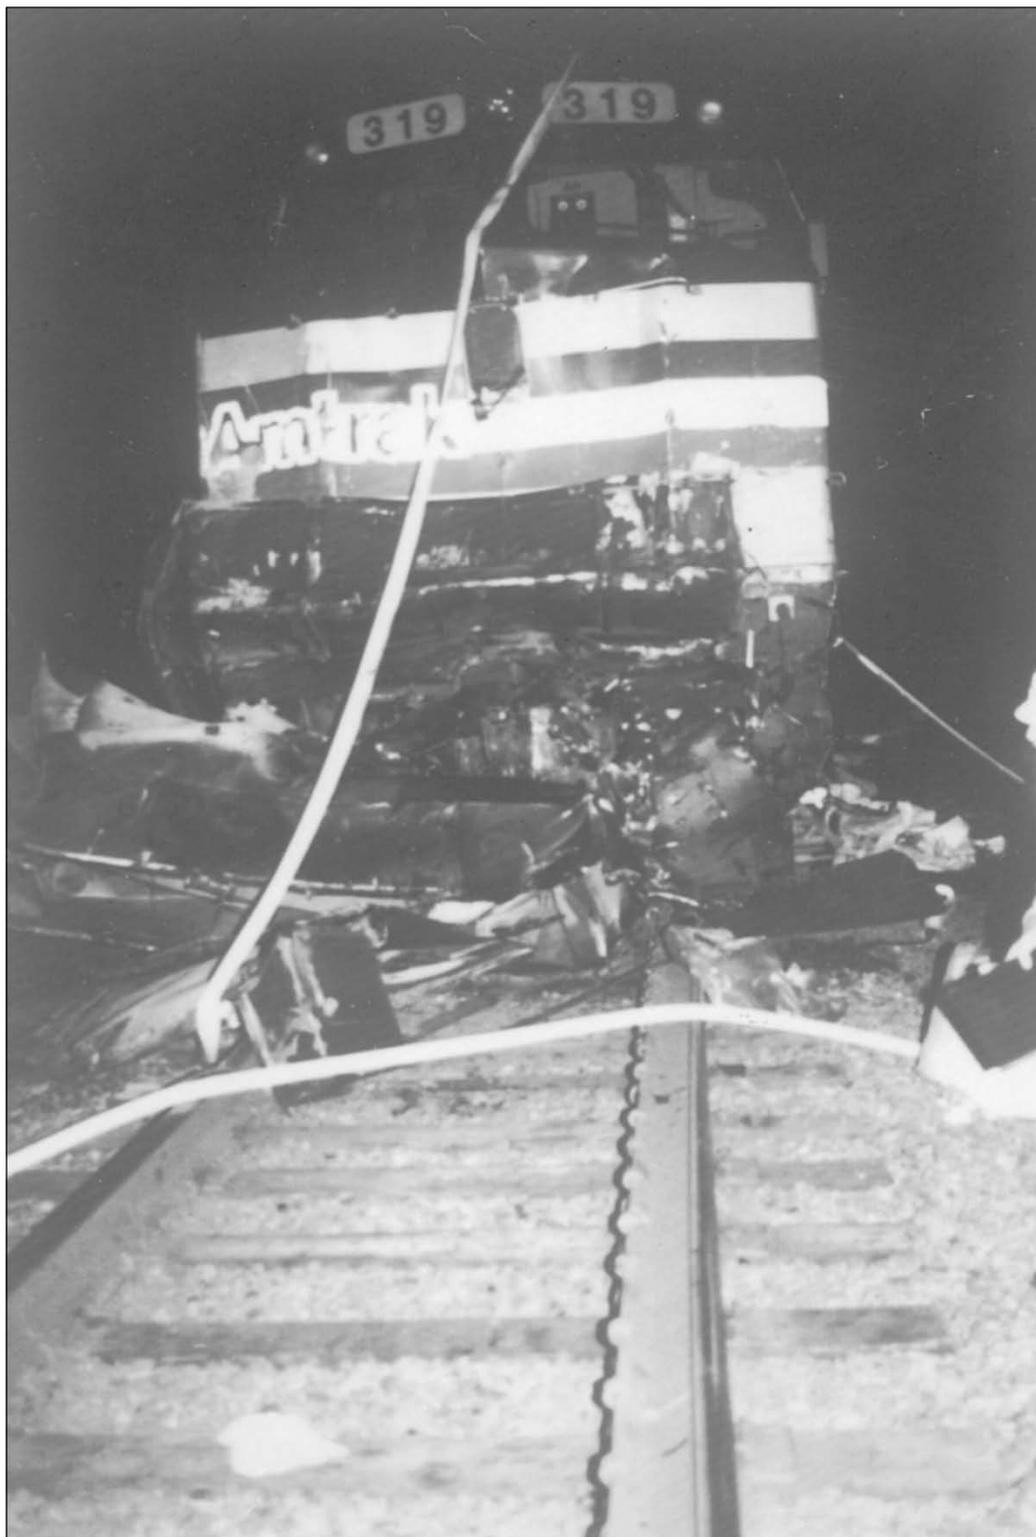
**Front of locomotive 319**

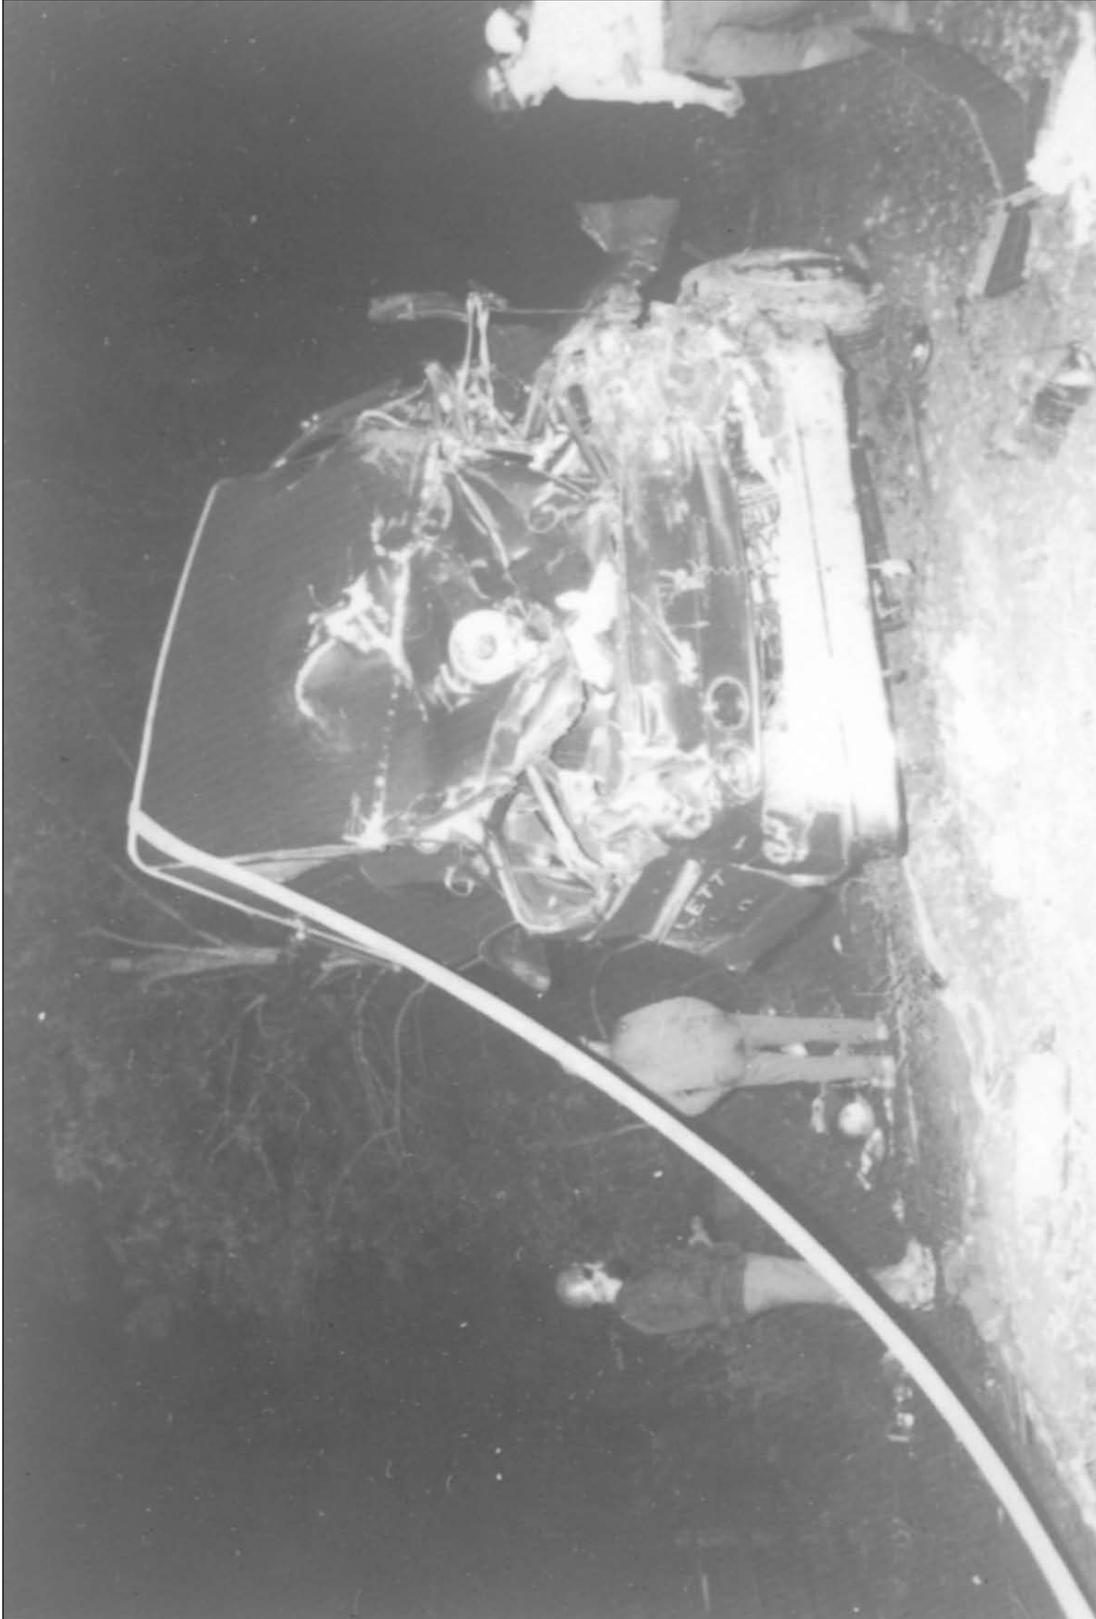
Cab of Wagon 7 – camera facing southeast

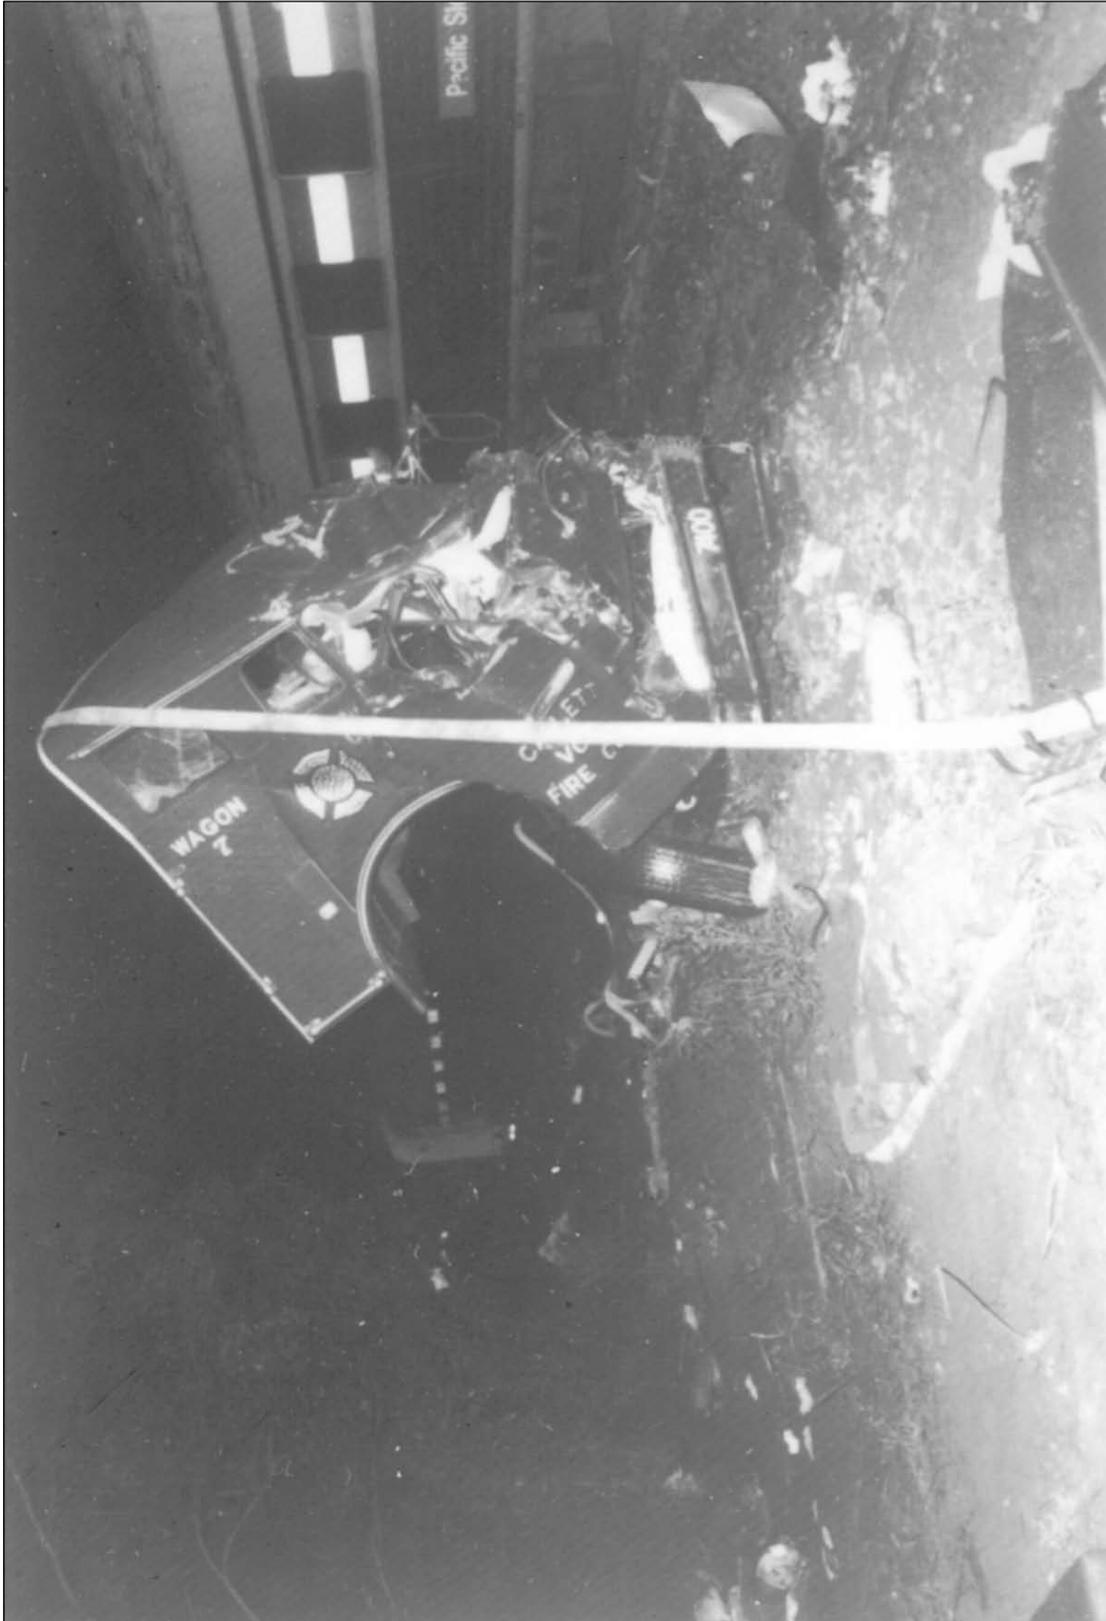
Cab of Wagon 7

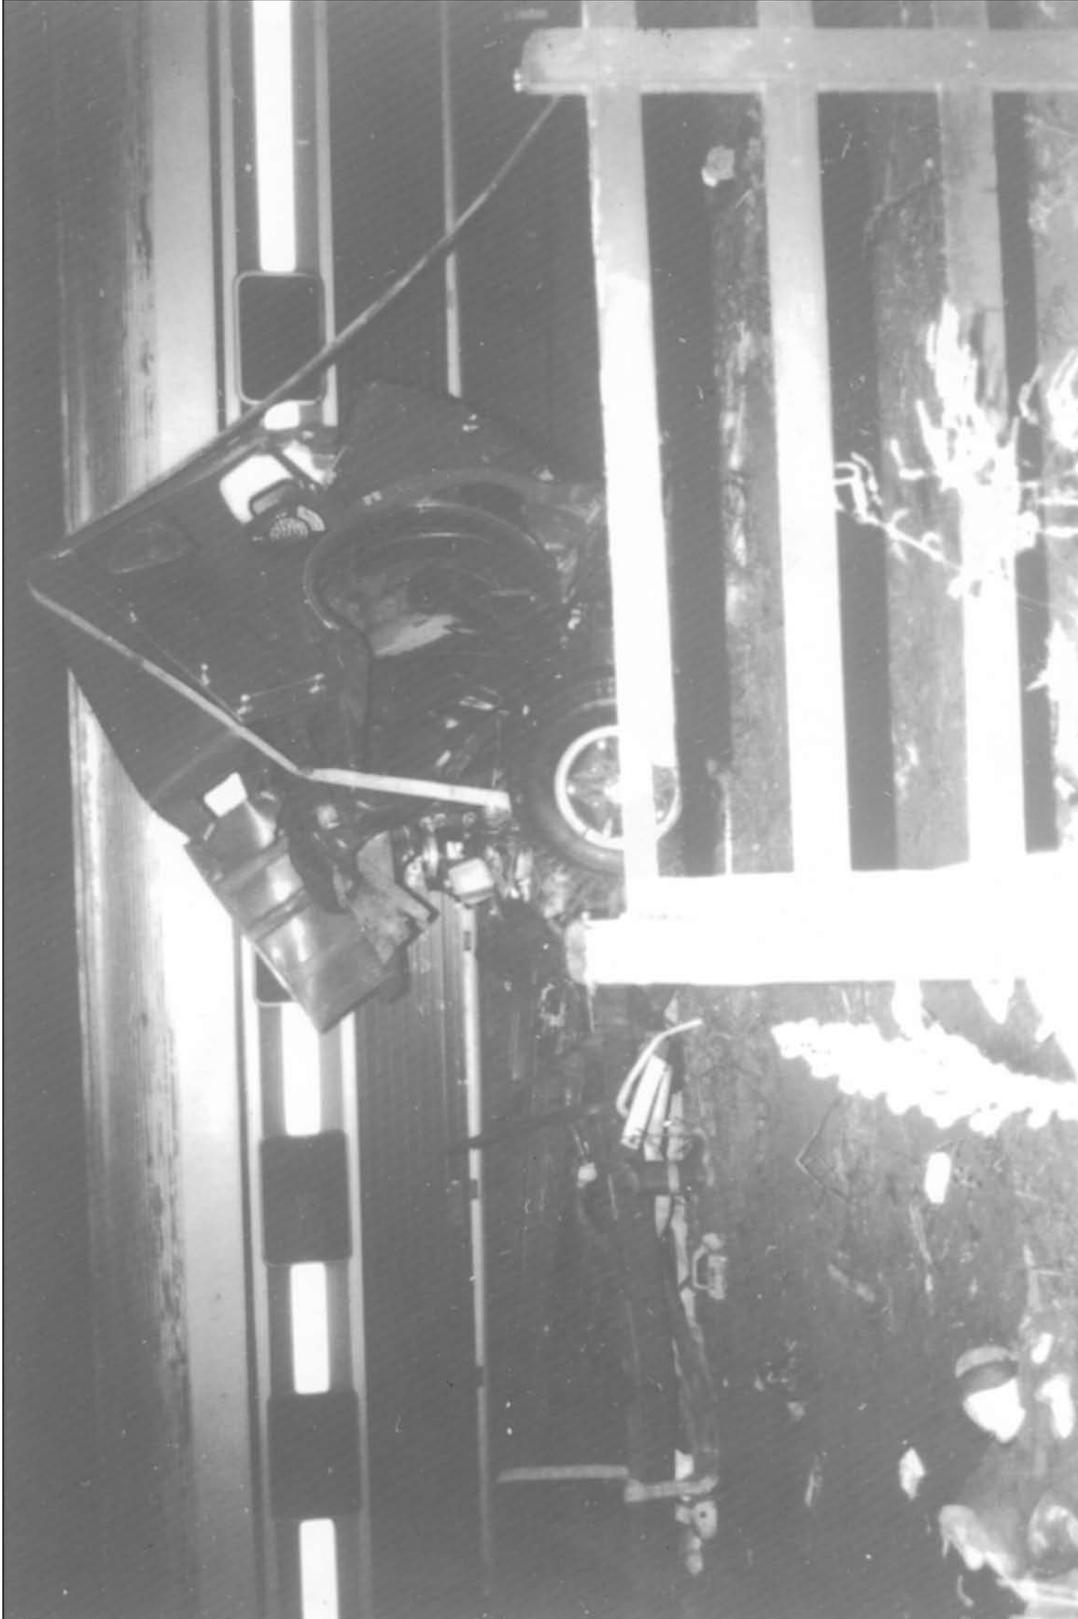
**Cab and chassis of Wagon 7  
Southwest corner of fence around private residence is in the center foreground.**  
NOTE: Injured firefighters were found in the area at the bottom left of the photo.

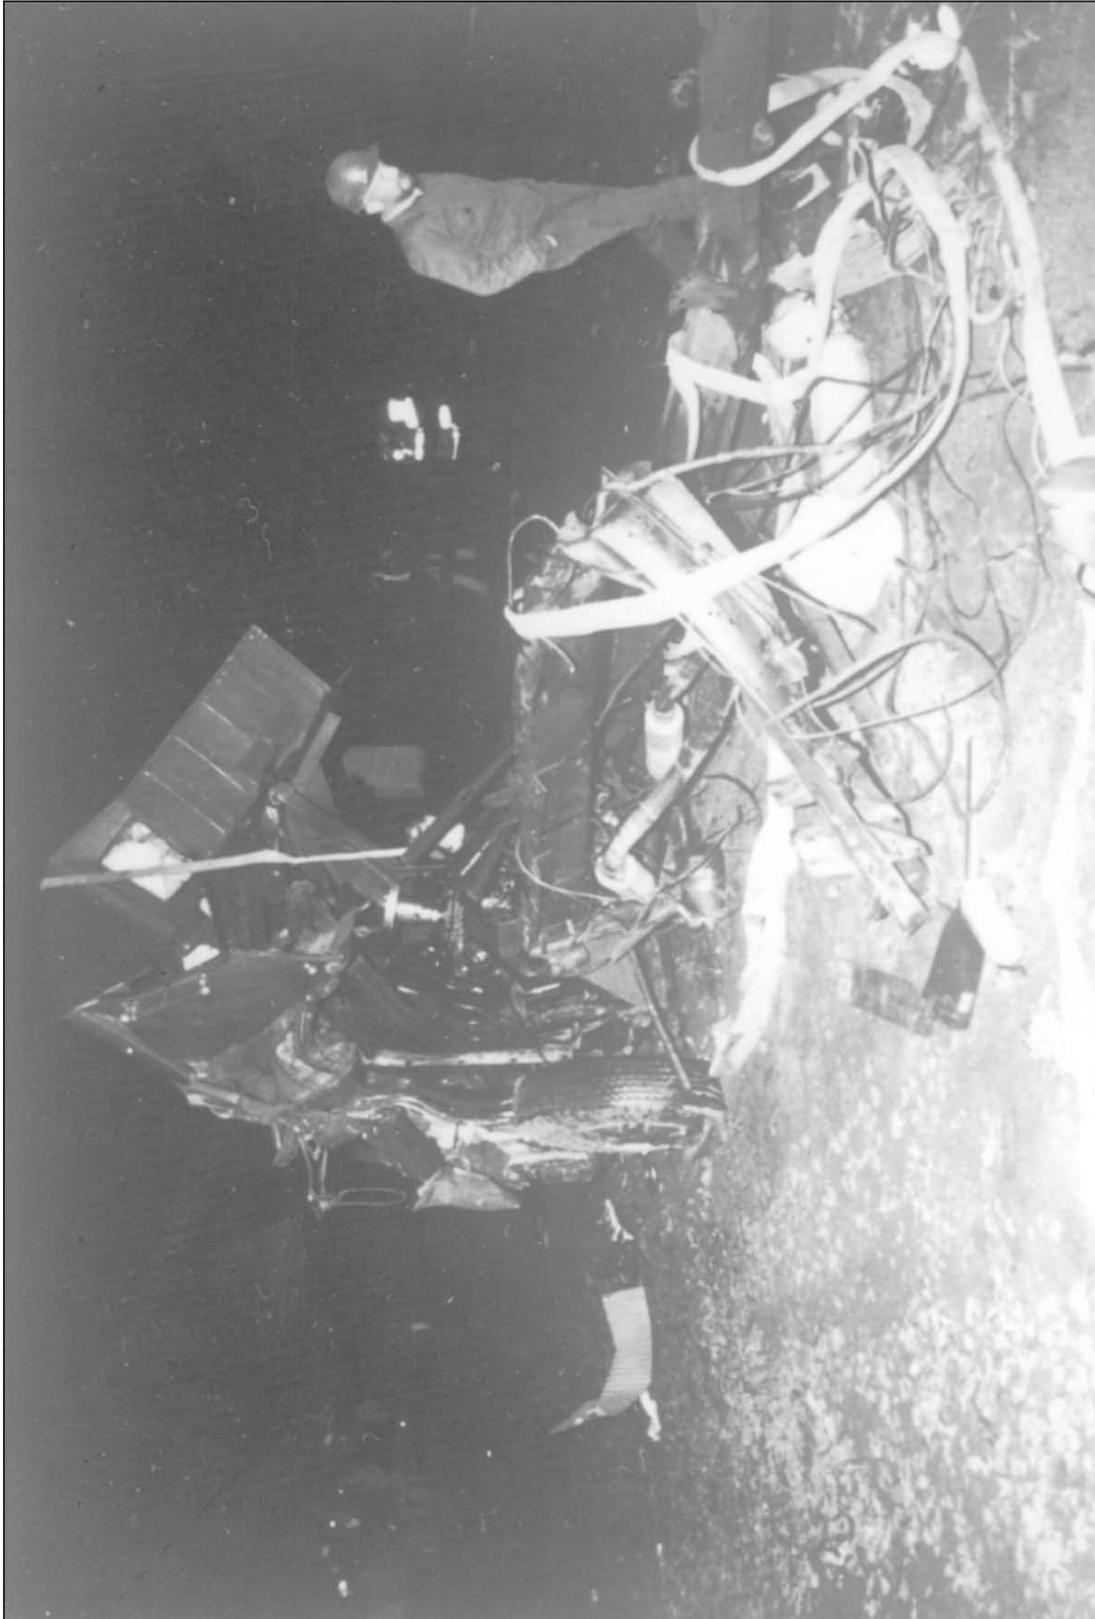
The brunt of the collision was directed at the rear of the vehicle, at about the rear axle. When the collision occurred, the cab and chassis of the Catlett pumper rotated counterclockwise 450 degrees and came to rest about 80 feet southeast of the crossing. The lead locomotive stopped about 965 feet past the crossing with the left side of Wagon 7’s hose body wrapped around its front end. Most equipment and the rear bodywork were scattered along the collision area. Gasoline fires that broke out near the second locomotive and several derailed cars were extinguished by other firefighters responding to the emergency. The primary fuel for these fires was from the fuel tank aboard Wagon 7, which ruptured in the crash.

Chassis and cab of Wagon 7

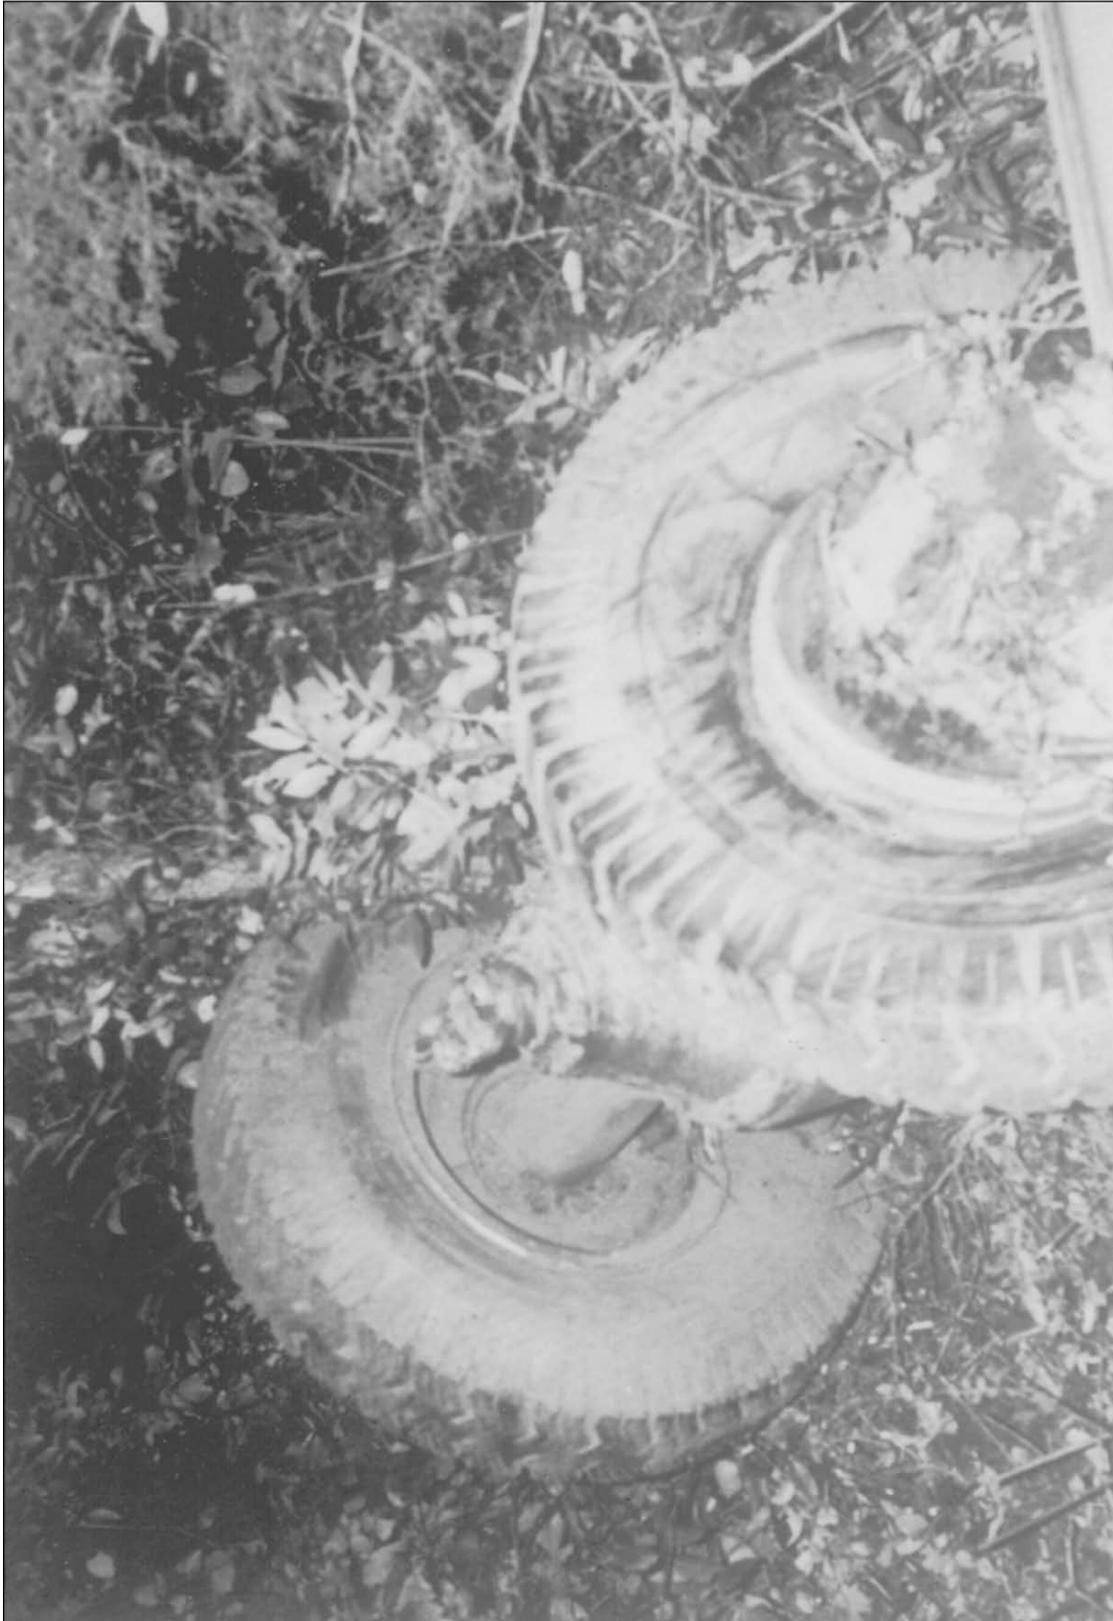
Closeup of fire truck drive axle

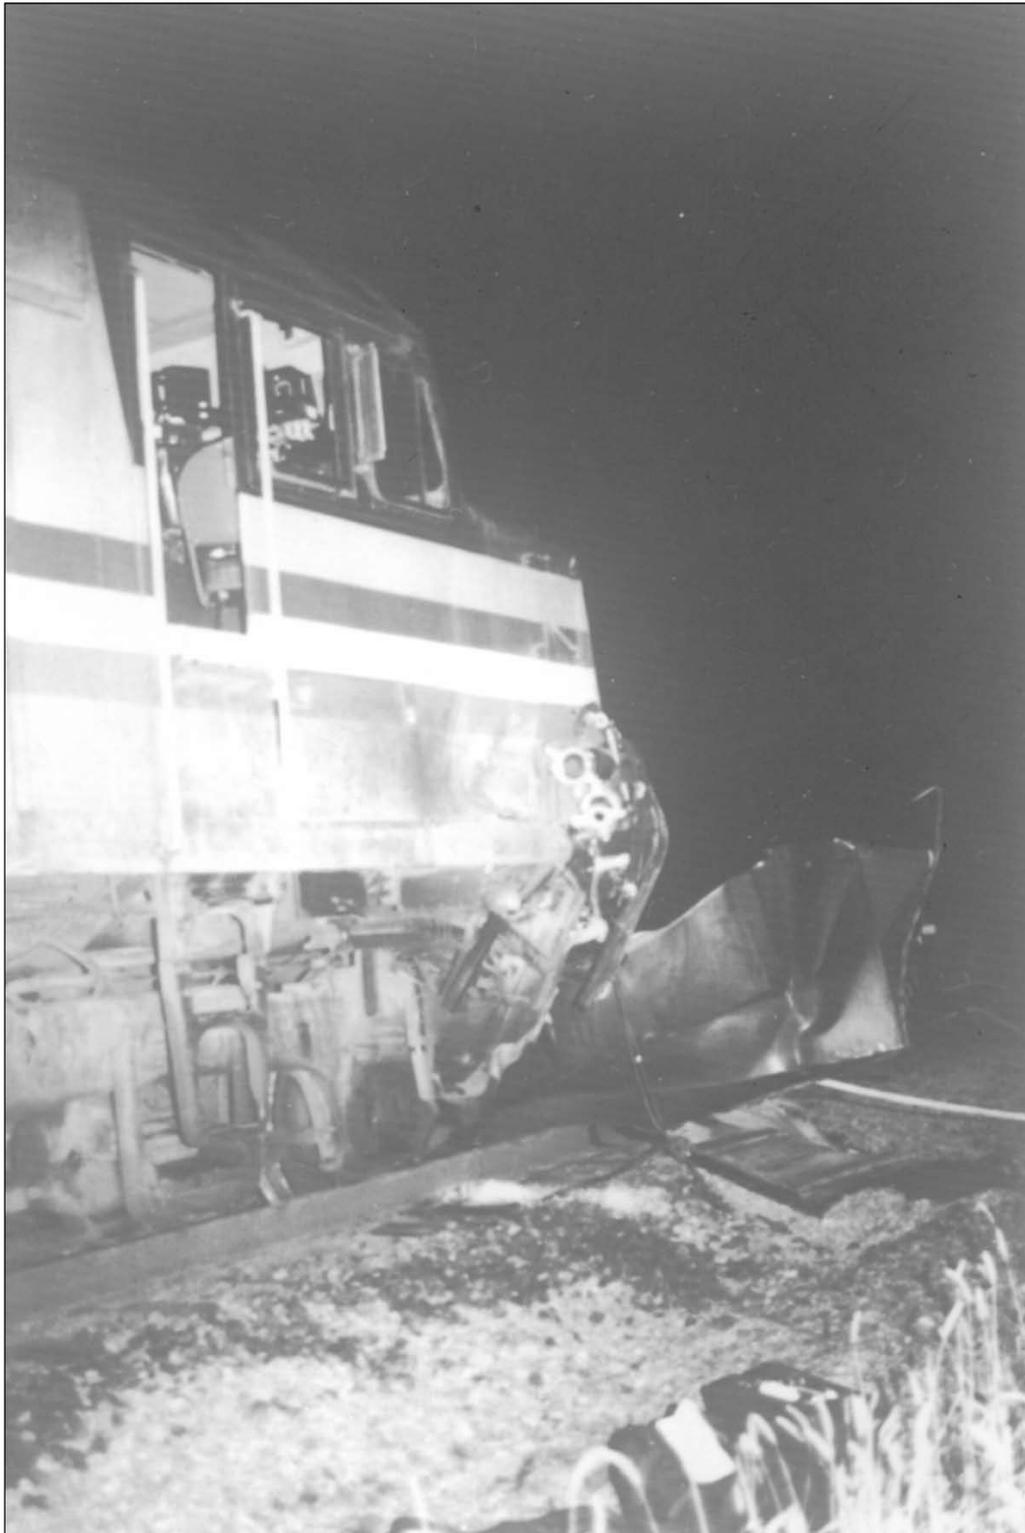
**Right front of locomotive 319**

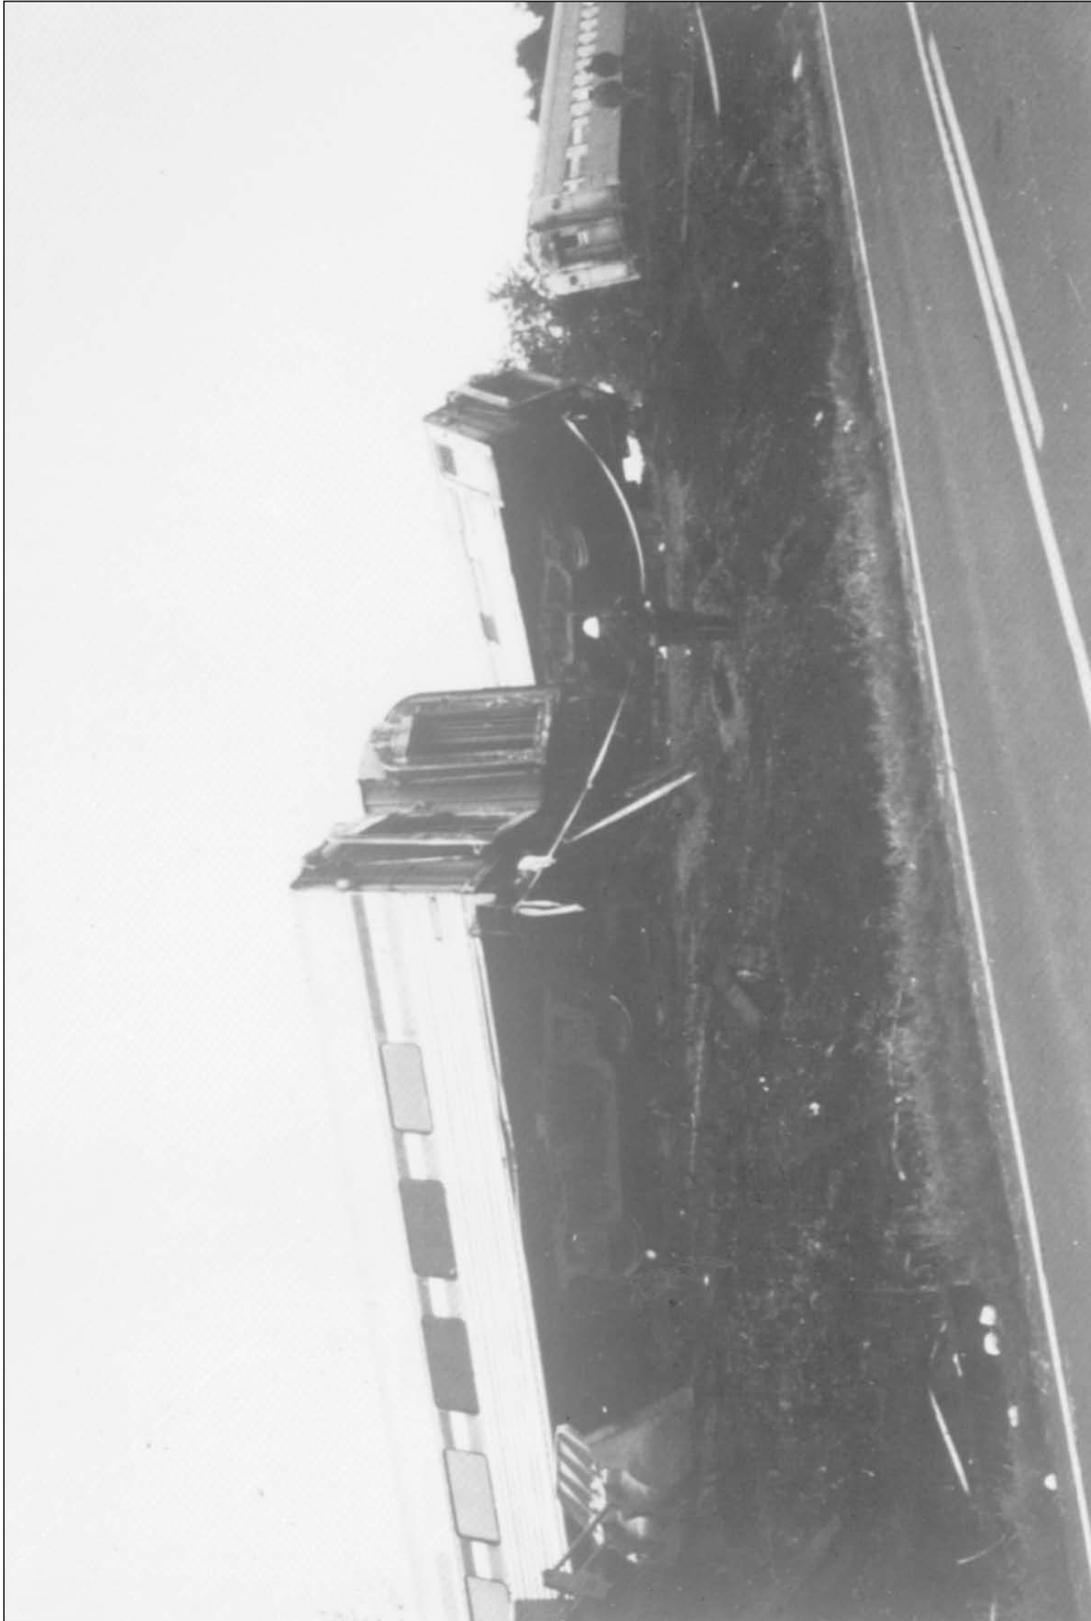
West ends of cars 3112, 4019, and 4742

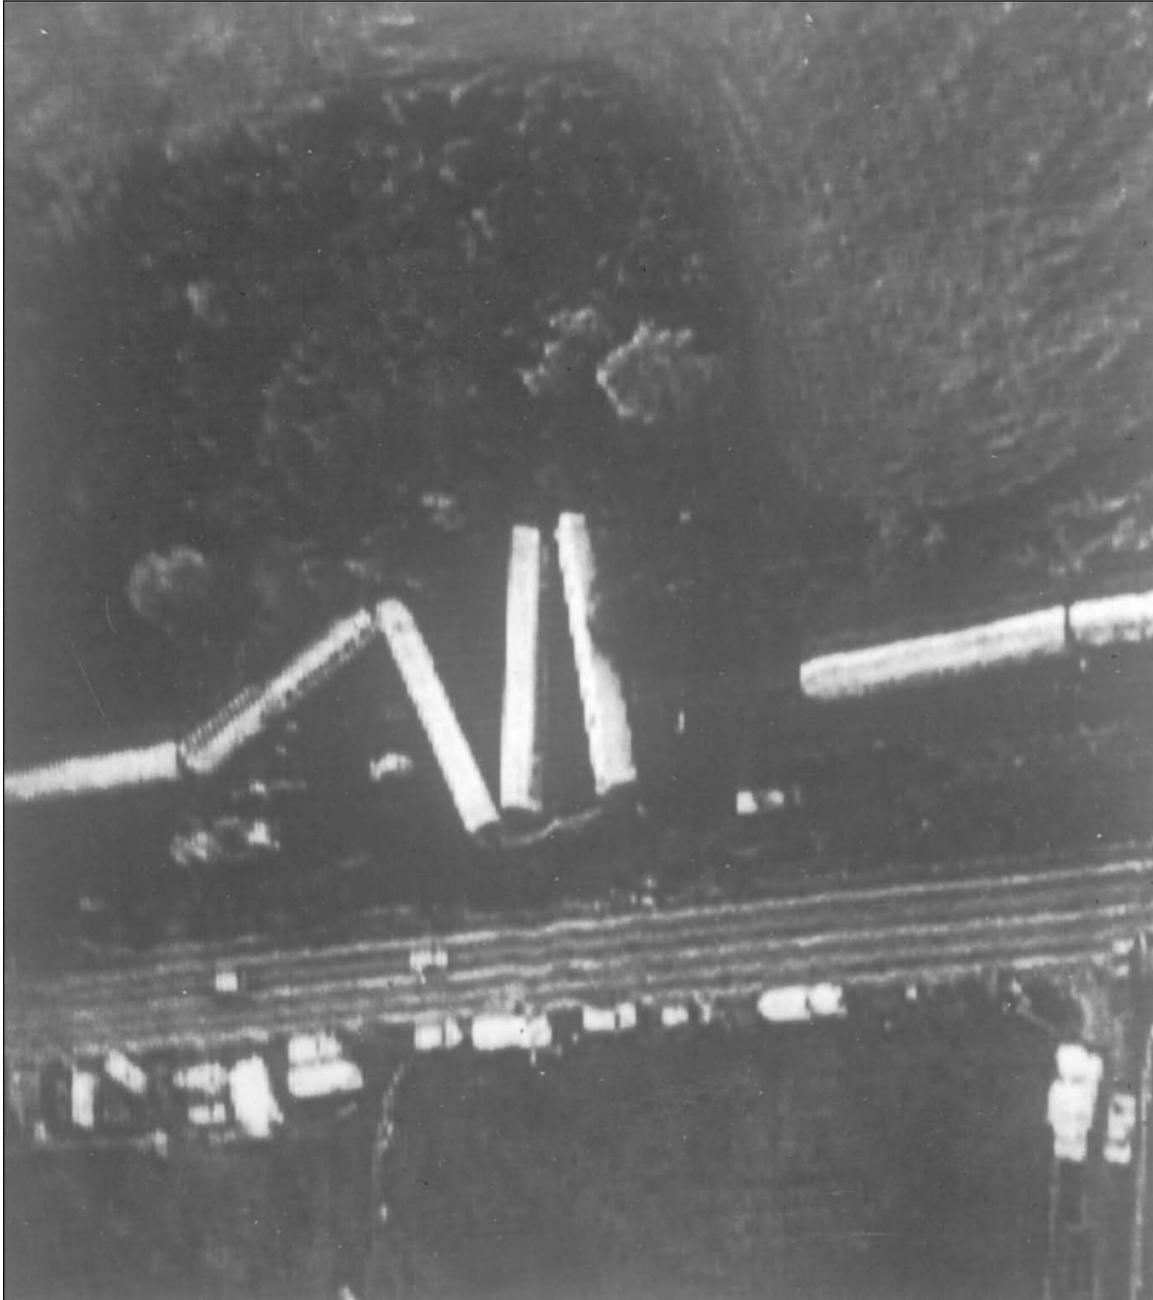
Aerial view of accident site

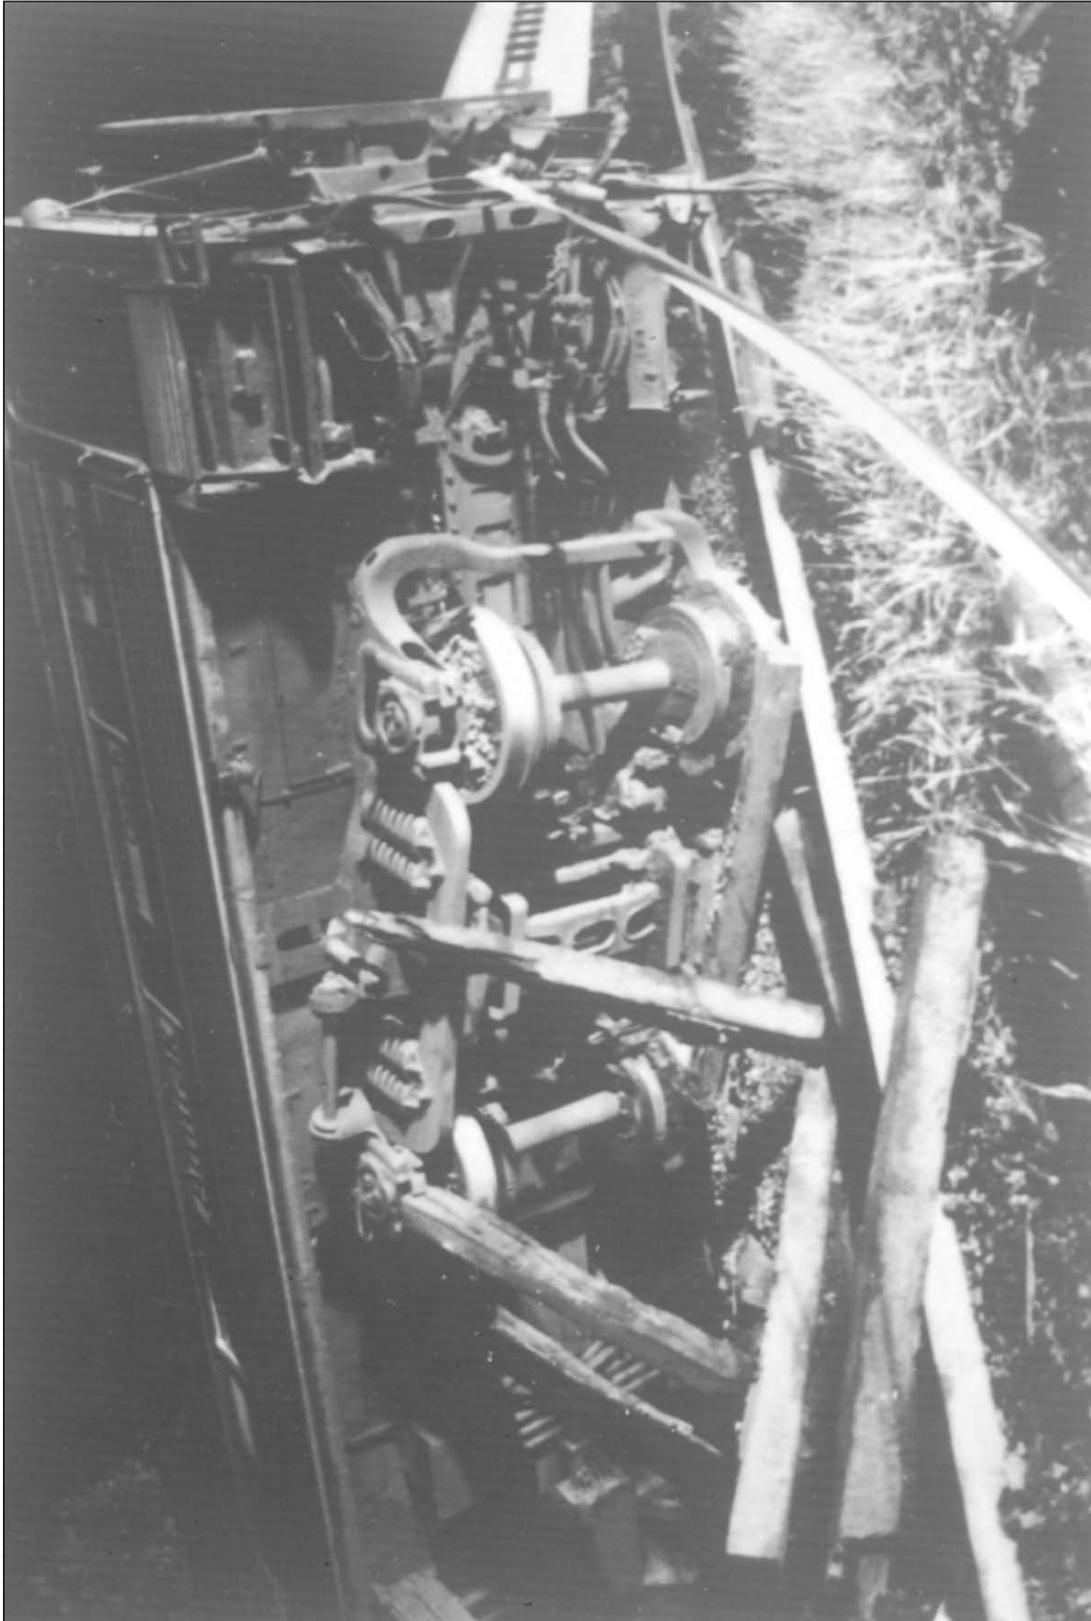
North side of car 4742

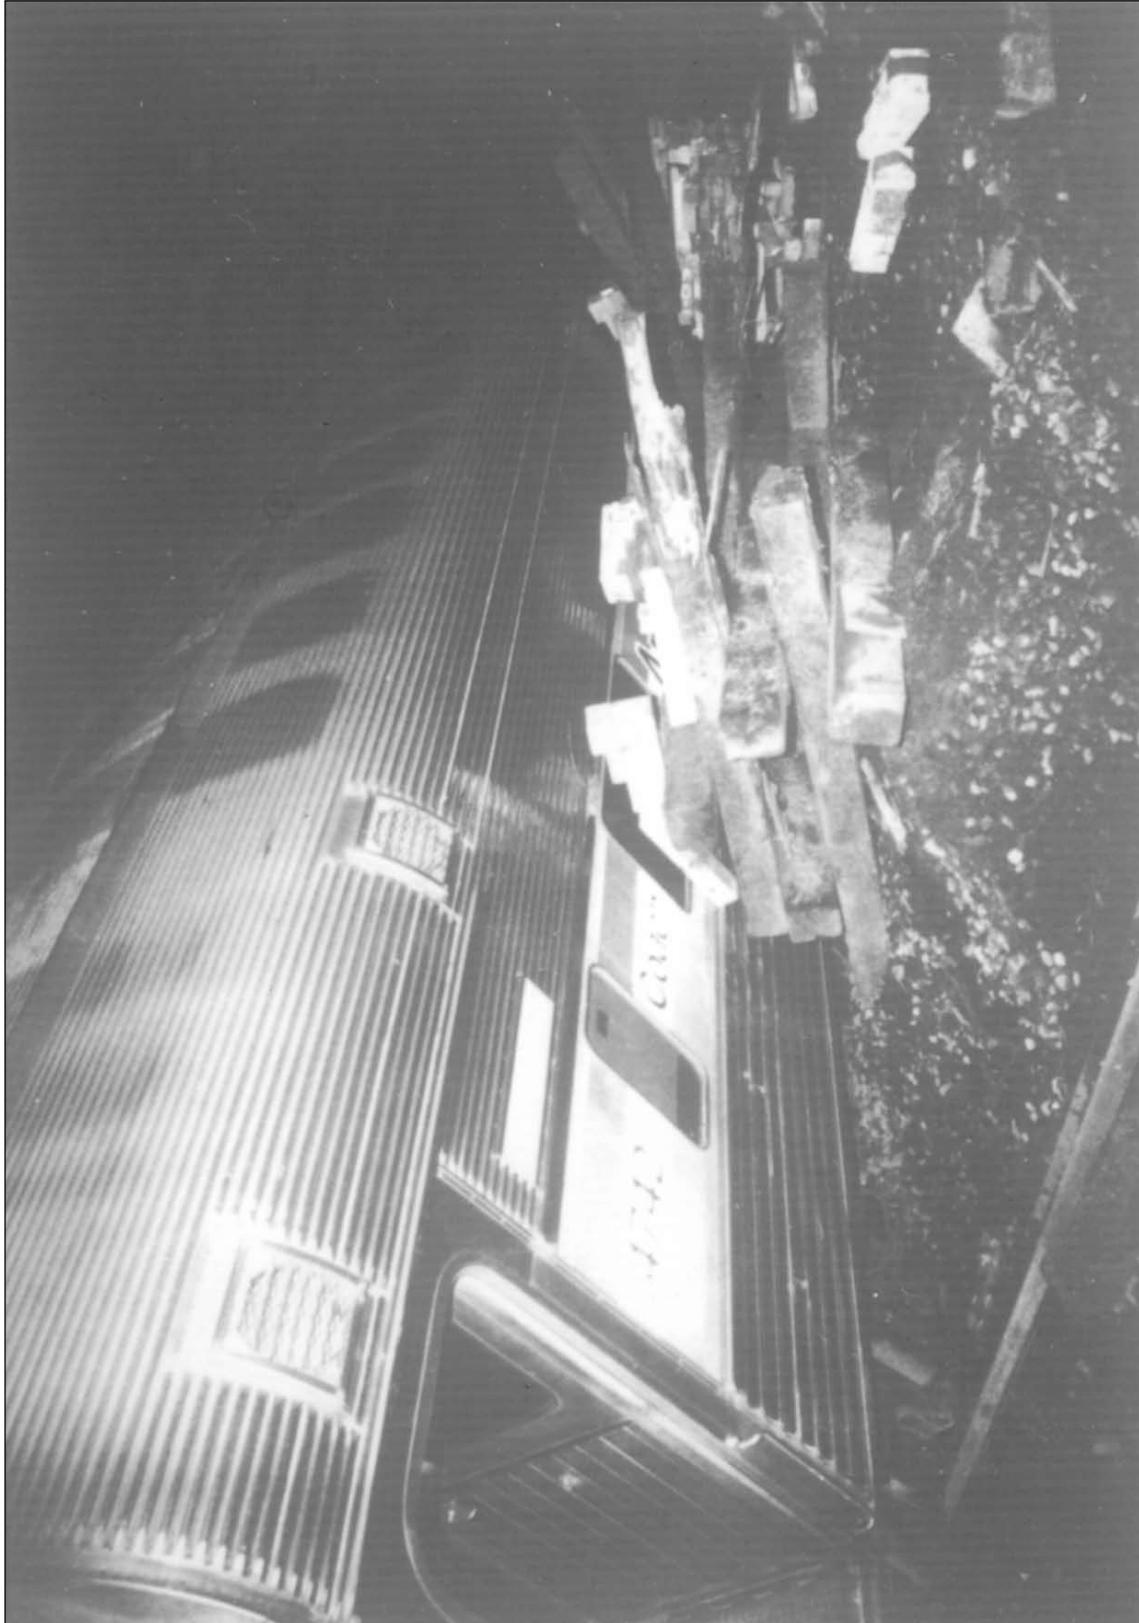
South side of car 4742
