U.S. Fire Administration/Technical Report Series

# Fire Apparatus/Train Collision

Catlett, Virginia

USFA-TR-048/September 1989

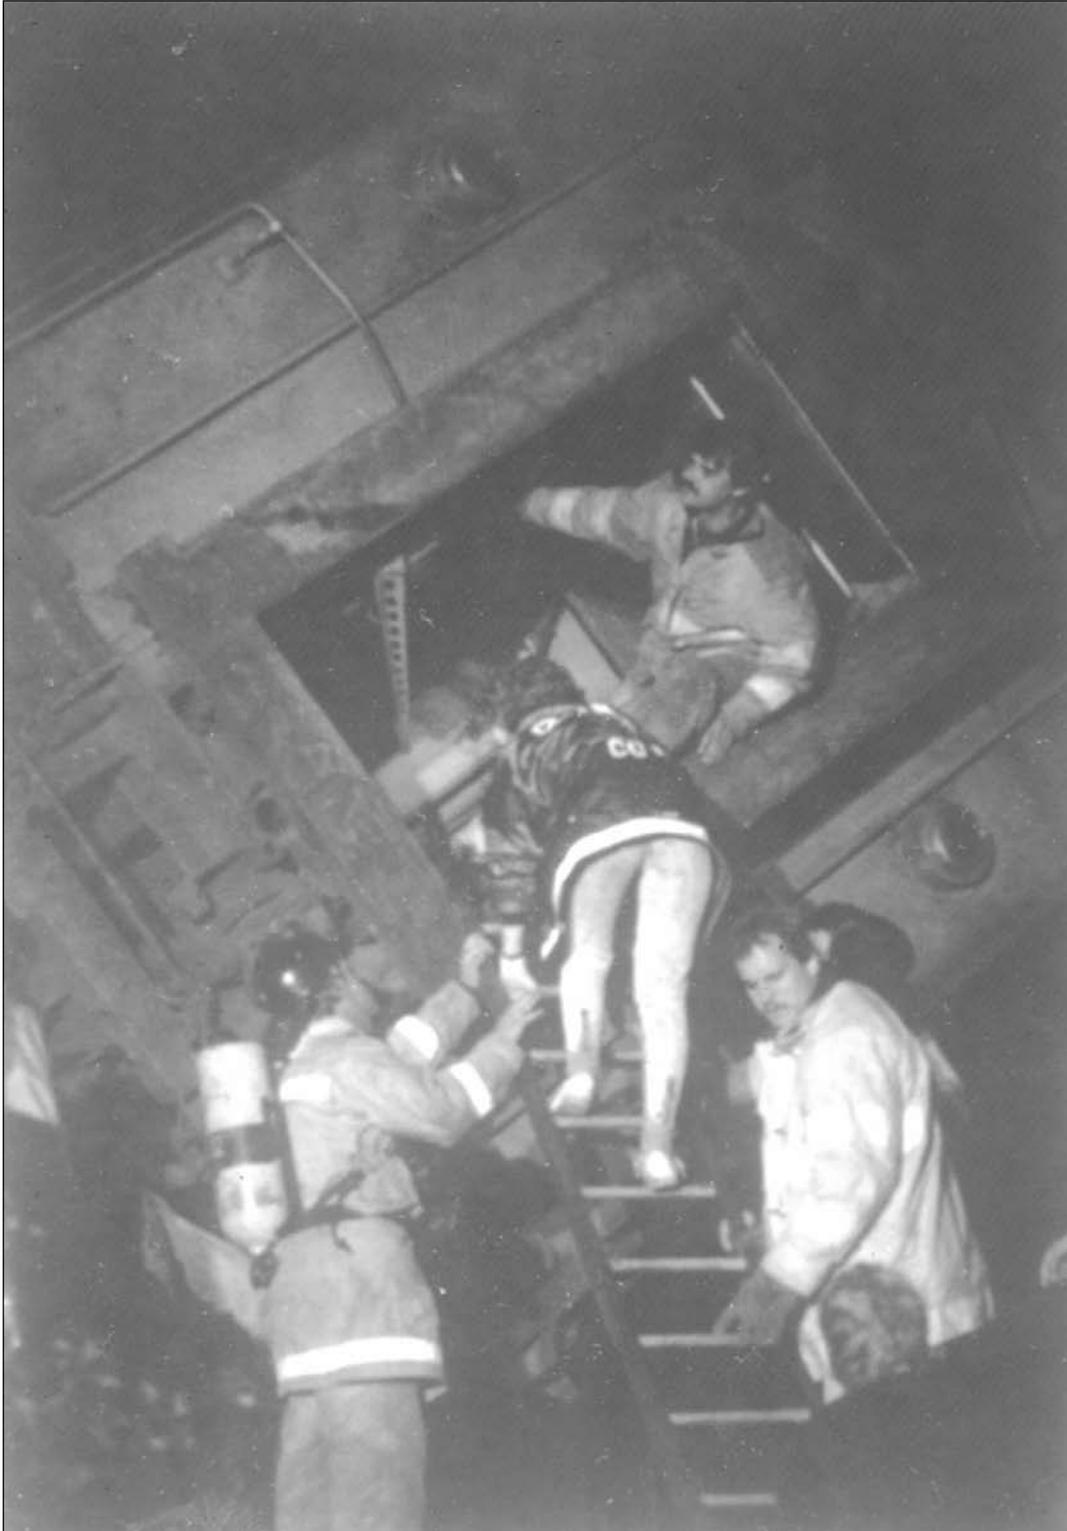
**Evacuation operations from west end of car 4742**

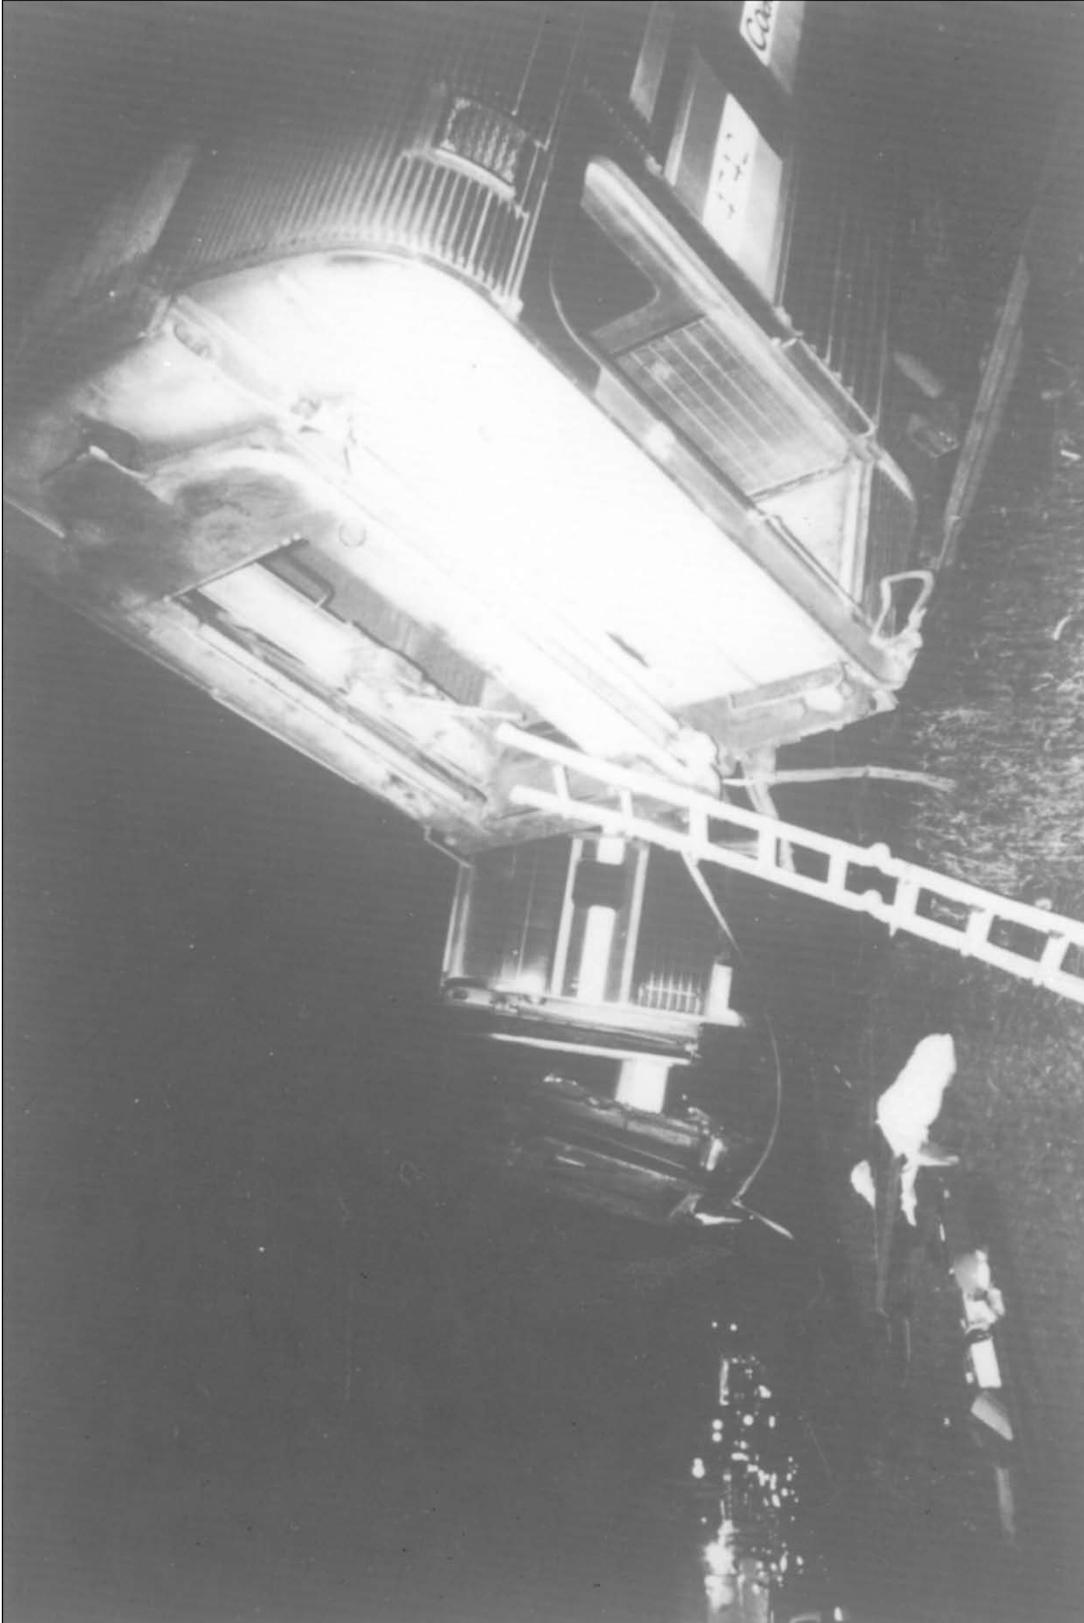
West end of car 4742

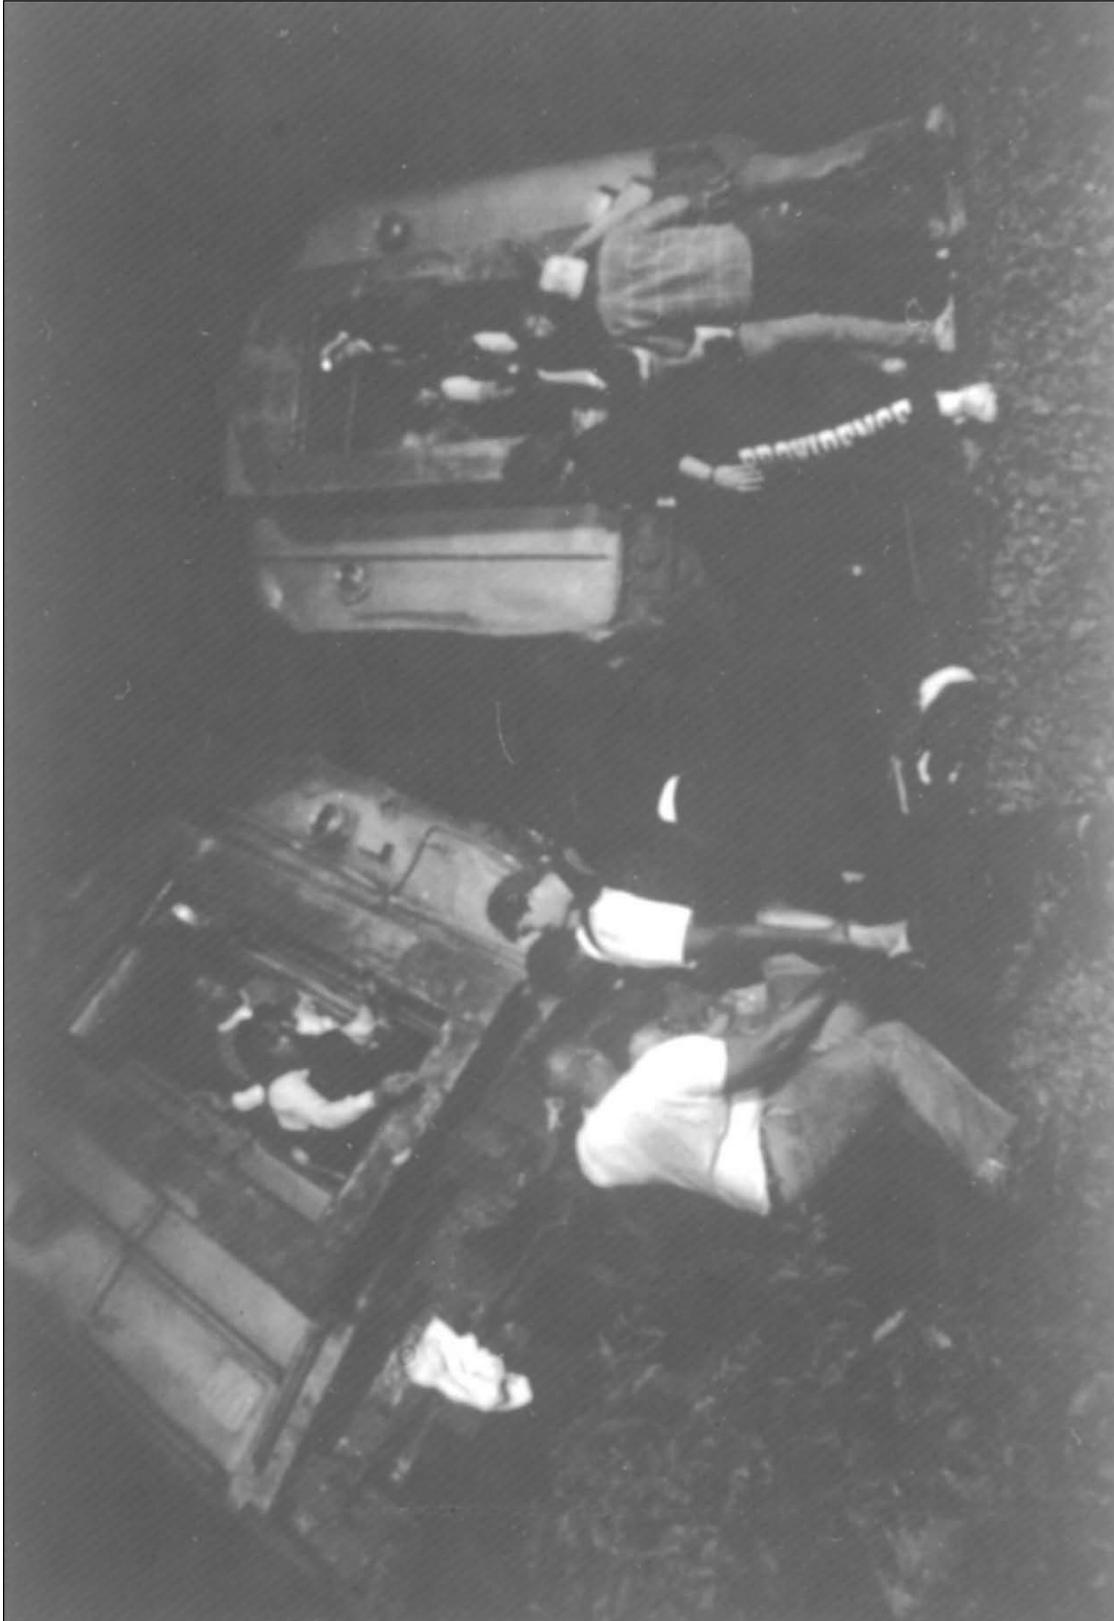
Evacuation of passengers from west ends of cars 4019 and 3112
