U.S. Fire Administration/Technical Report Series

10 Million Dollar Marina Fire

Bohemia Bay, Maryland

USFA-TR-026/January 1989

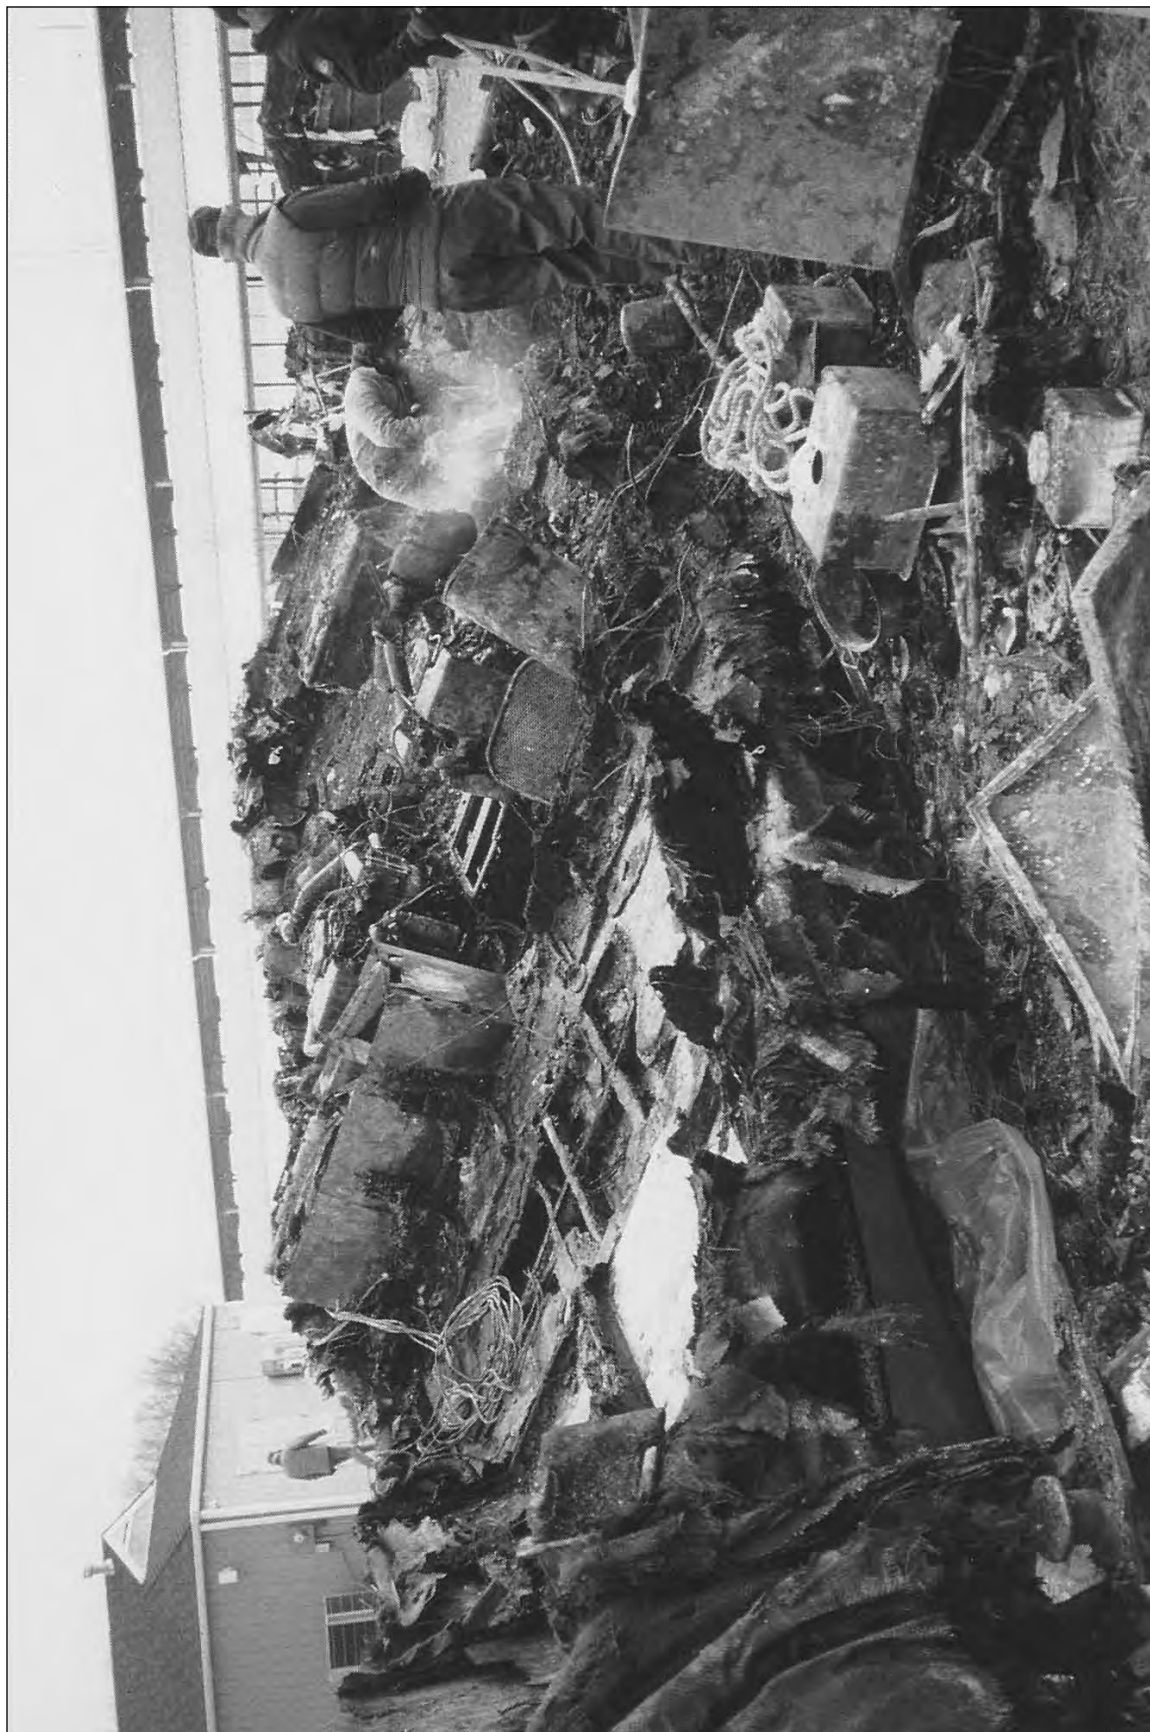
3. Raised hull being examined by fire investigators (with boats typical of those that burned in background)

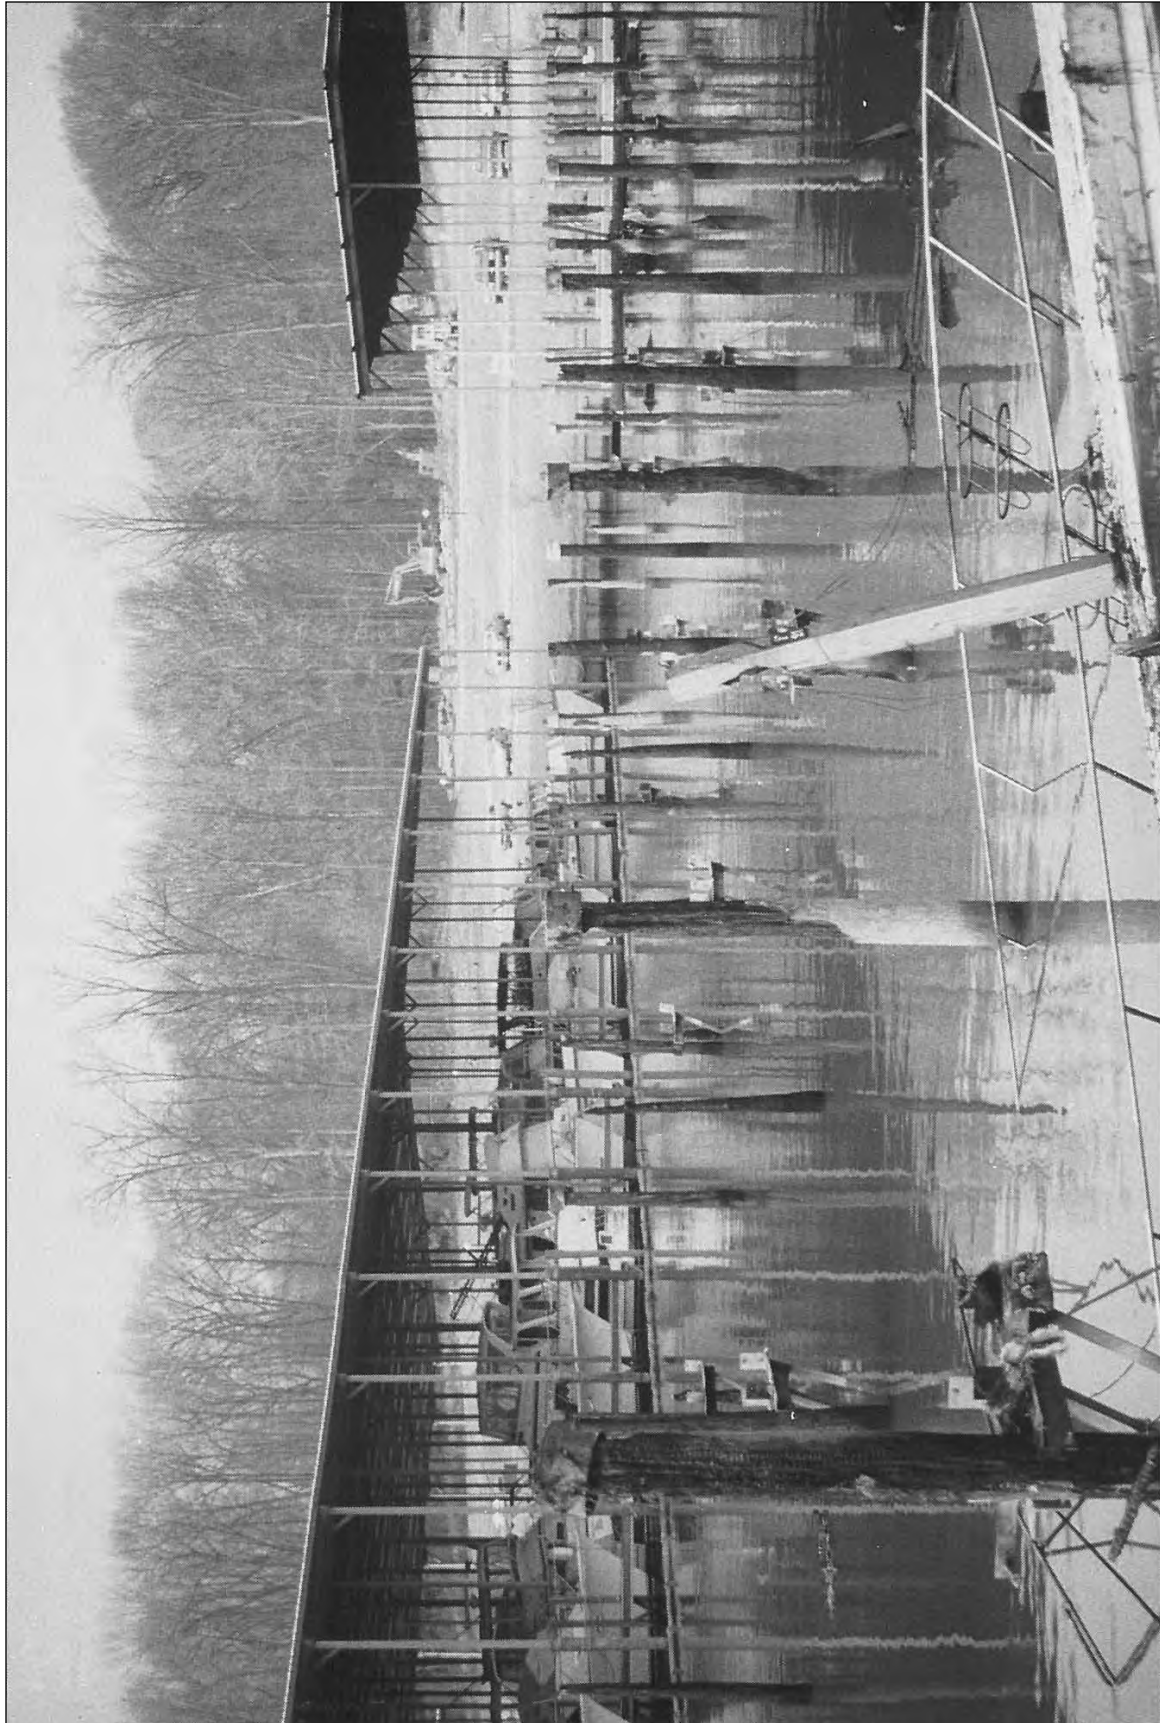
Approximately two-thirds of the metal structure of 'F' dock (250 feet) had to be removed before any investigative or salvage operations could begin. Even though the structure itself did not burn, the foundation was weakened and could no longer be used because of supporting piers burning.

Most of the finger piers, pilings, and walkways between slips 9 and 23 on 'F' dock were destroyed. Sixteen vessels were sunk. One vessel located at 'F' dock received heavy damage and two at 'C' dock received substantial damage as a result of fuel burning on the water. Approximately 100 boats received light damage from soot and burning embers. Their cleaning proved much more difficult and expensive than first thought.

4. Burned piers of 'F' dock

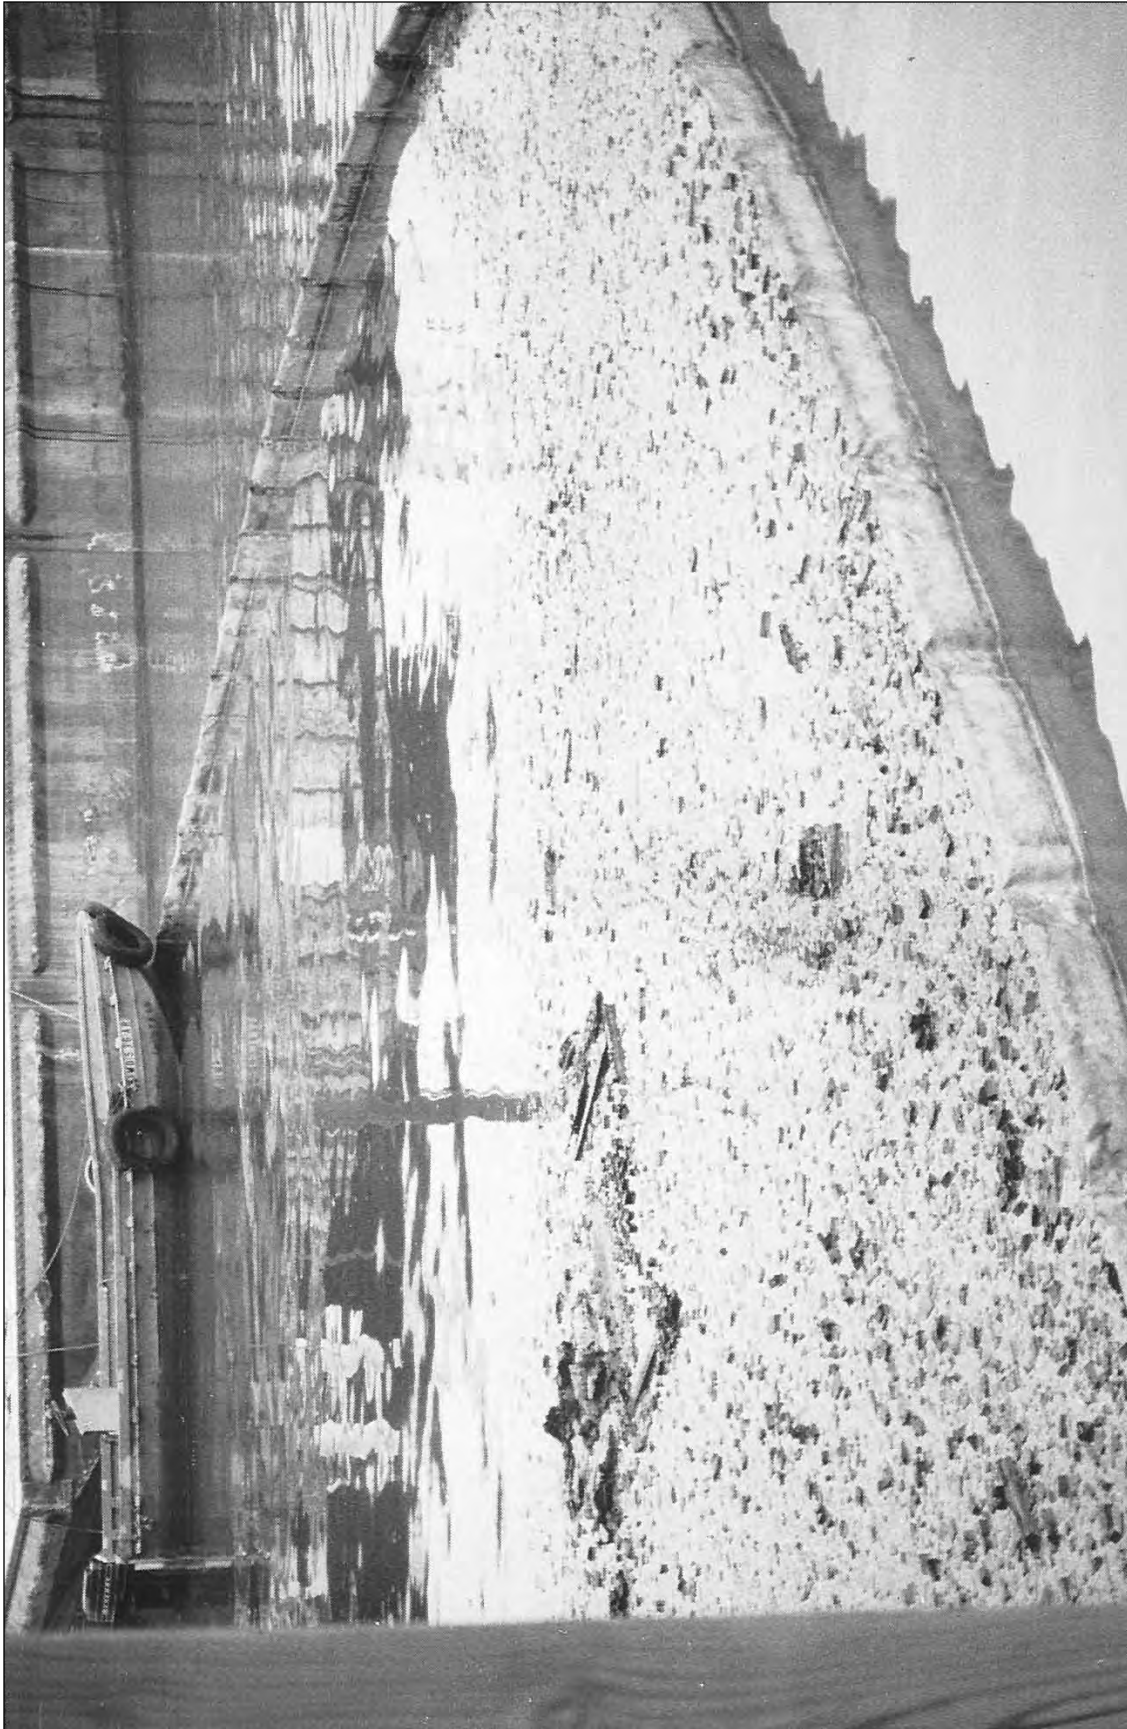
The possibility of surface fuel and burned debris reaching the river created an immediate need for a massive cleanup and containment operation. This operation involved containment ponds throughout the marina complex and daily maintenance of these ponds by several cleanup crews. Several weeks were required to complete the operation, which cost 286,000 dollars.

18. Equipment used for containment ponds.
