# Five-Fatality Highrise Office Building Fire

Atlanta, Georgia

USFA-TR-033/June 1989

Investigated by: Charles Jennings

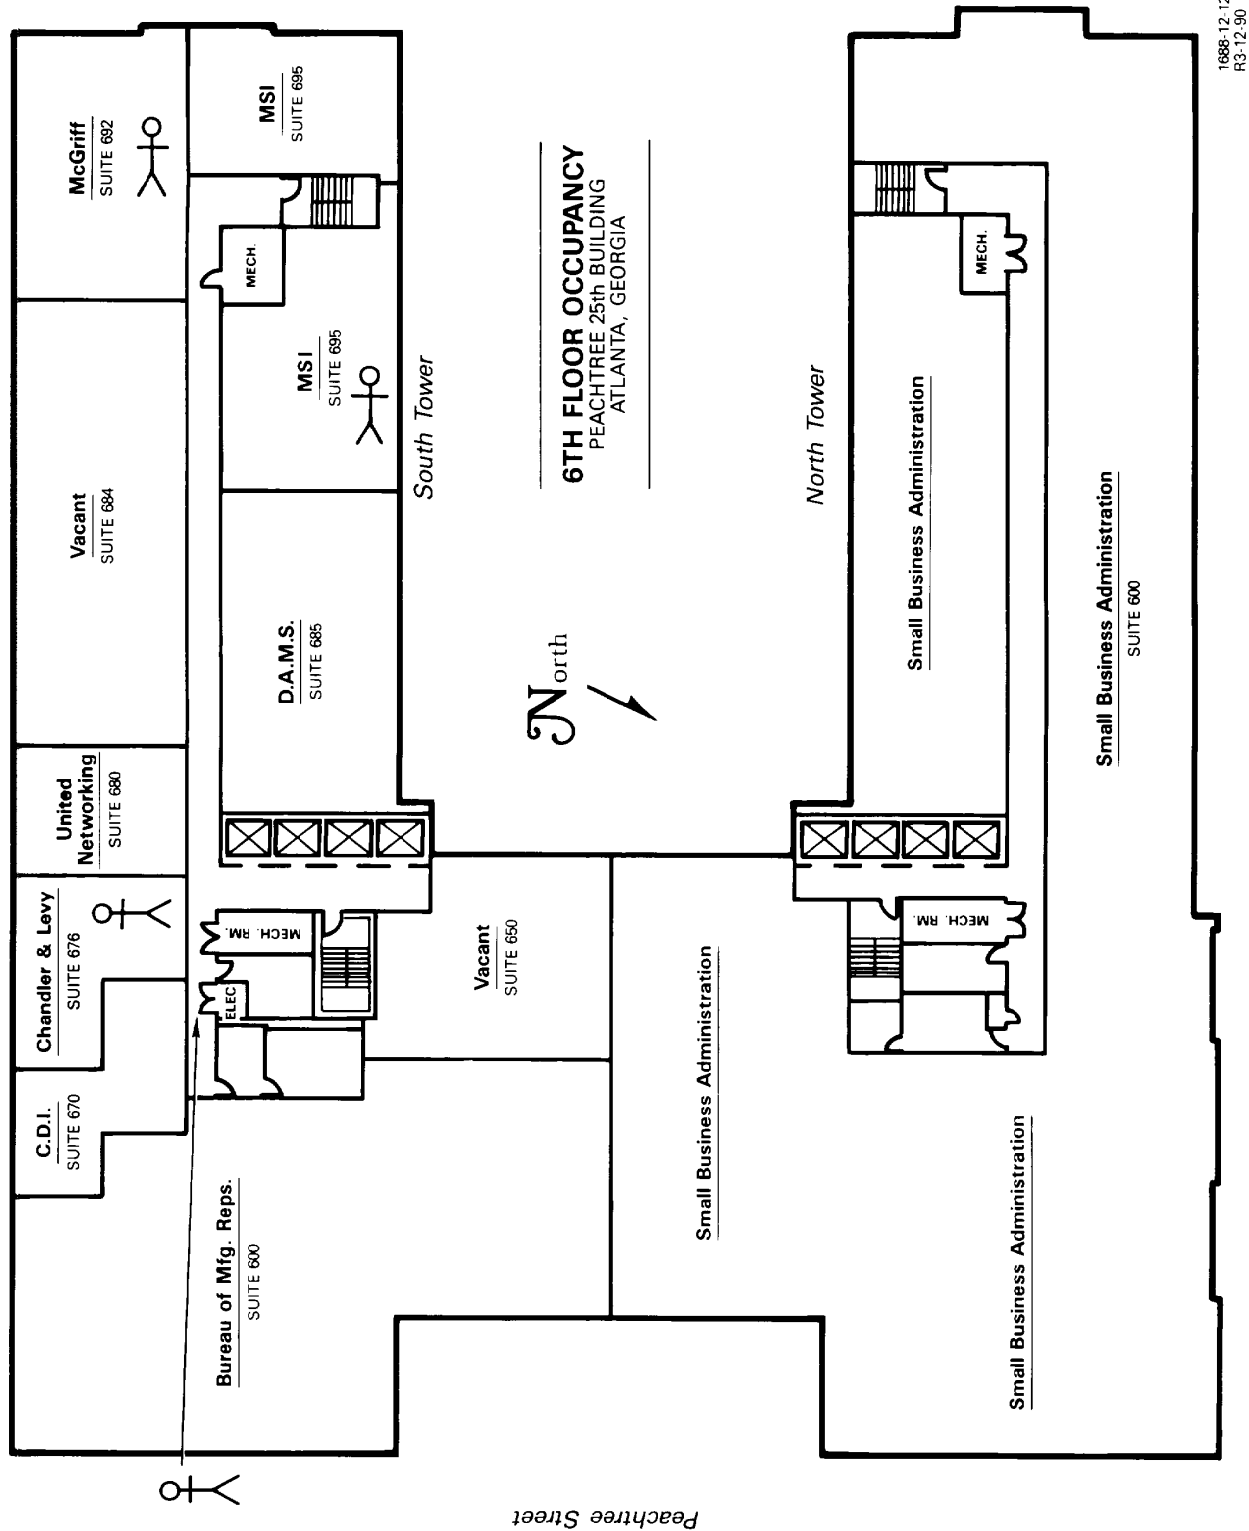
### Sixth Floor Plan Showing Location of Victims

A worker who was directly across the hall from the electrical closet (Suite 676) remained in his office and did not break a window. This worker was found dead after the fire.

The one occupant who remained in his office throughout the fire without breaking a window died from smoke inhalation. Heat apparently never reached an excessive level in this office – there was no damage to plastic items stored on bookshelves near the ceiling.

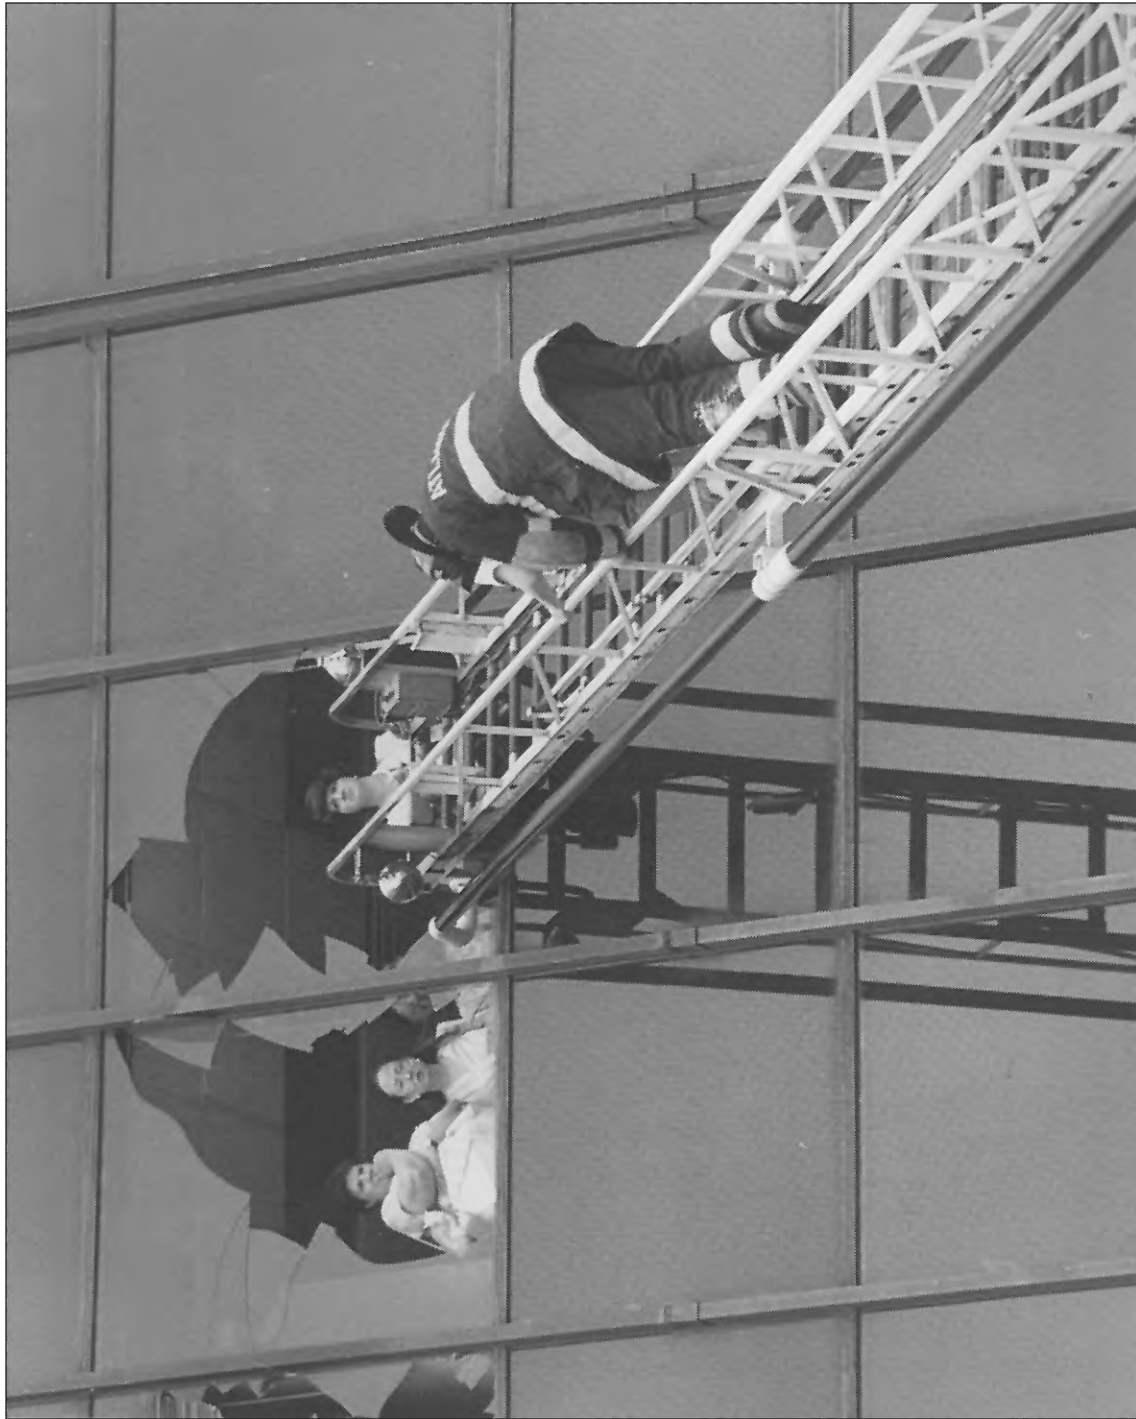
1. Rescue by aerial at front of building.

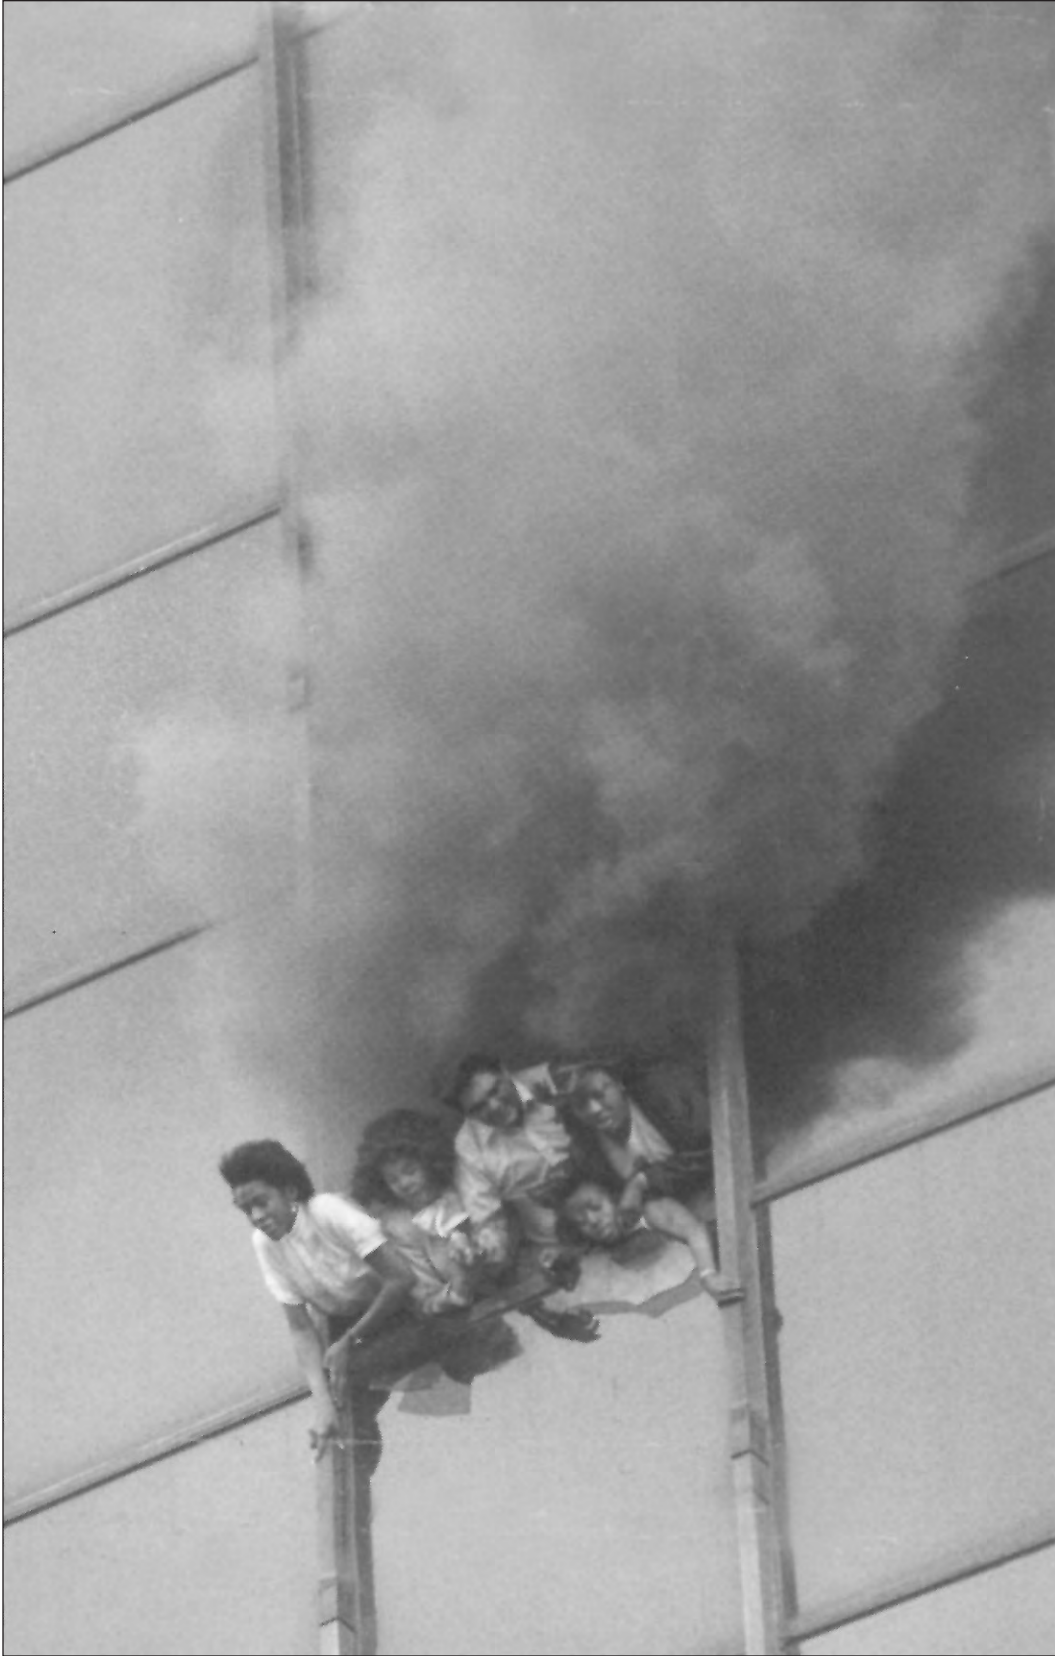
2. Victims awaiting rescue on south side of building, sixth floor.

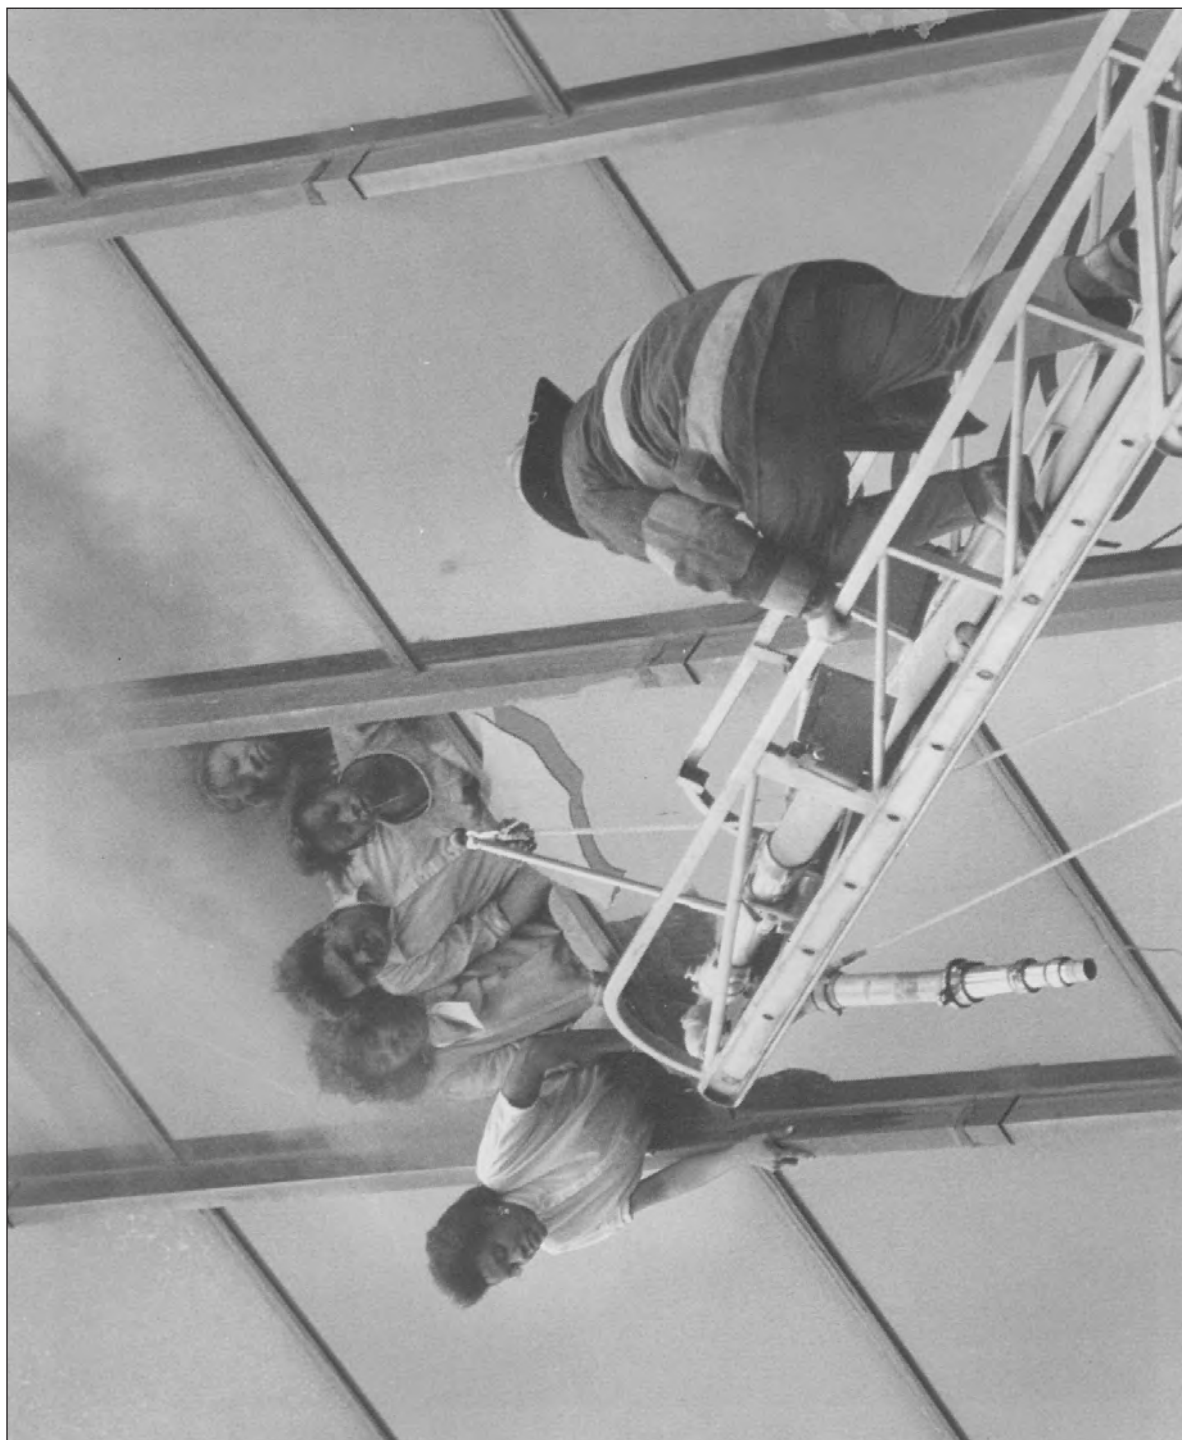
3. Firefighter ascending aerial to rescue victims on south side.

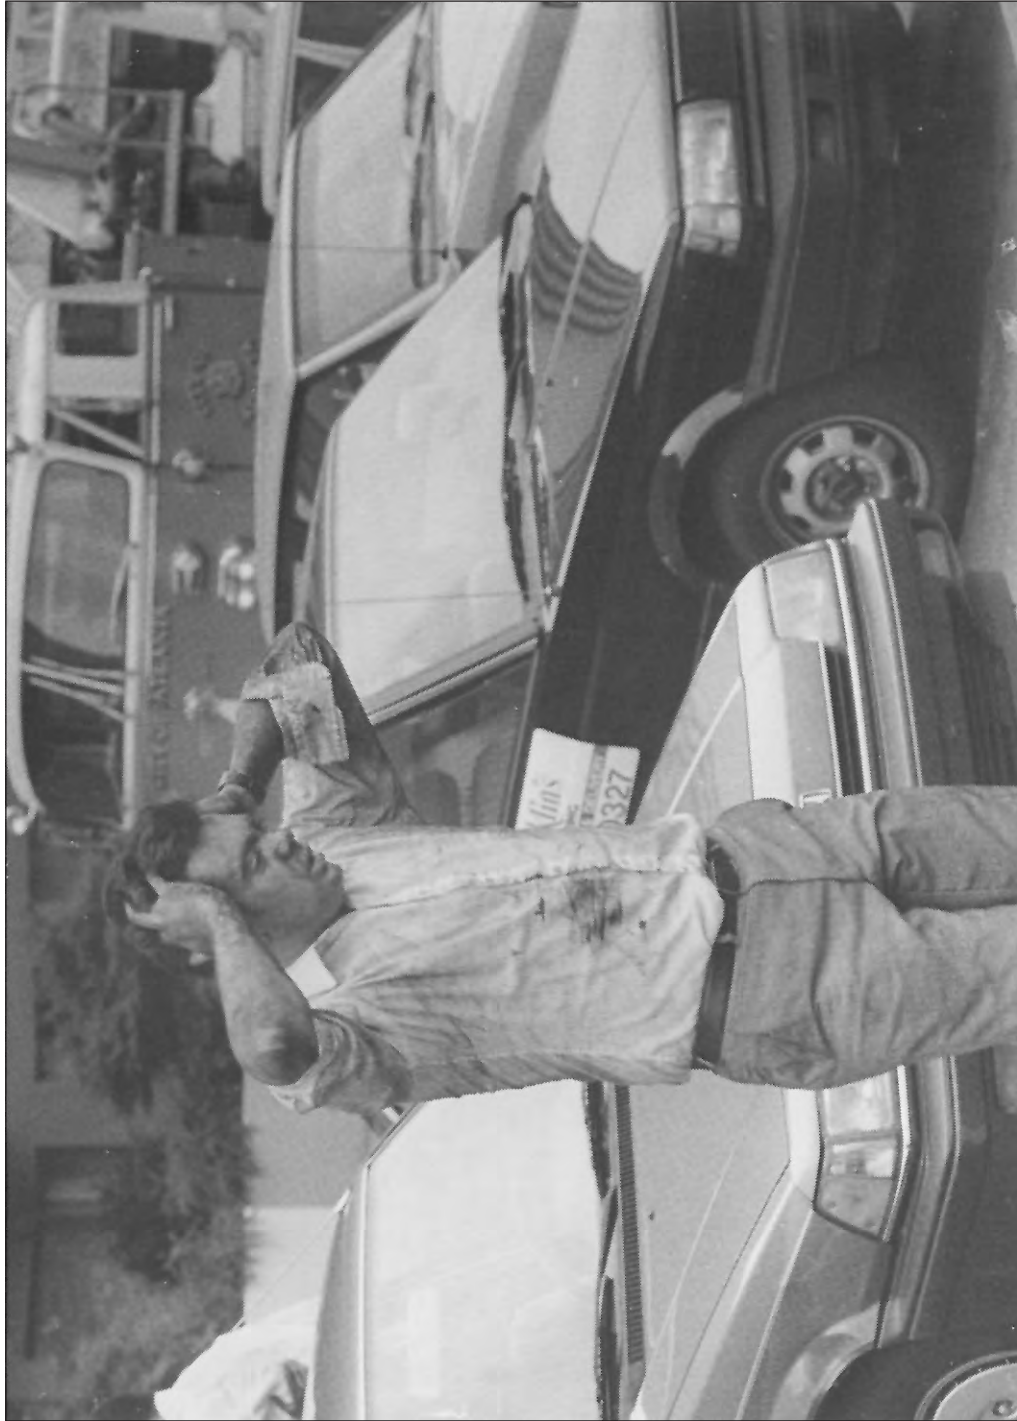
4. Victim reacts after being rescued, note truck company at front of building.

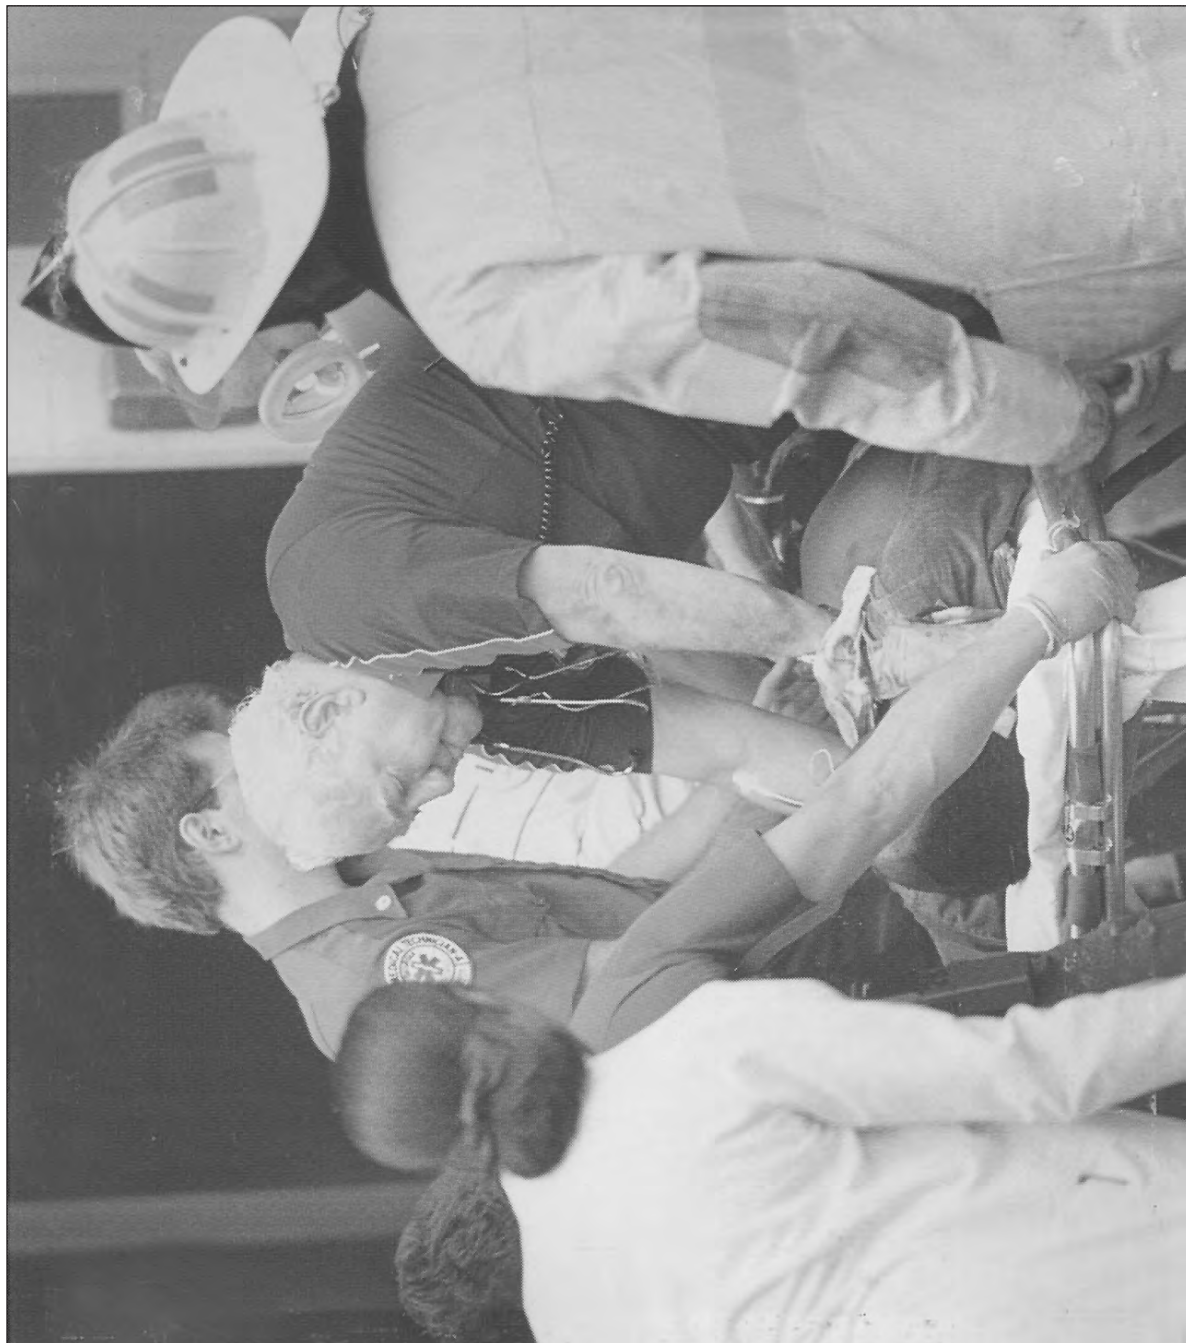
5. Resuscitation attempt on victim removed from rear of sixth floor.

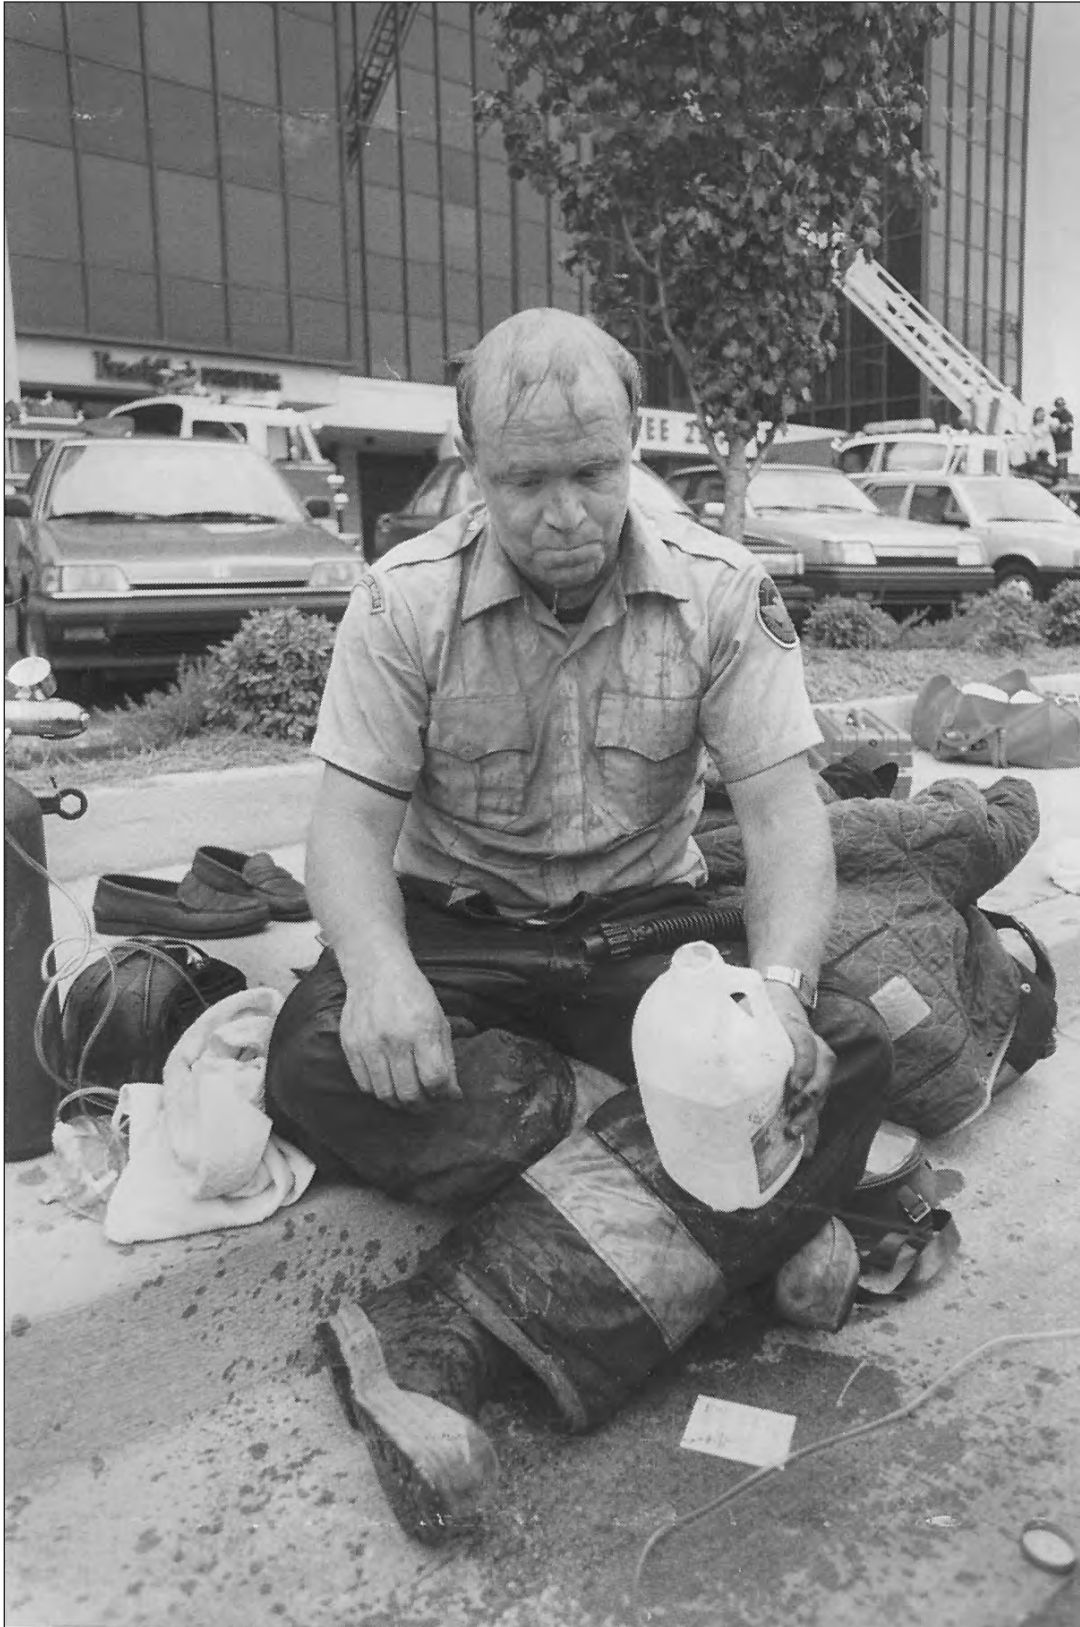
6. Firefighter rests after making rescues over ladder.  
(Note apparatus placement in background.)

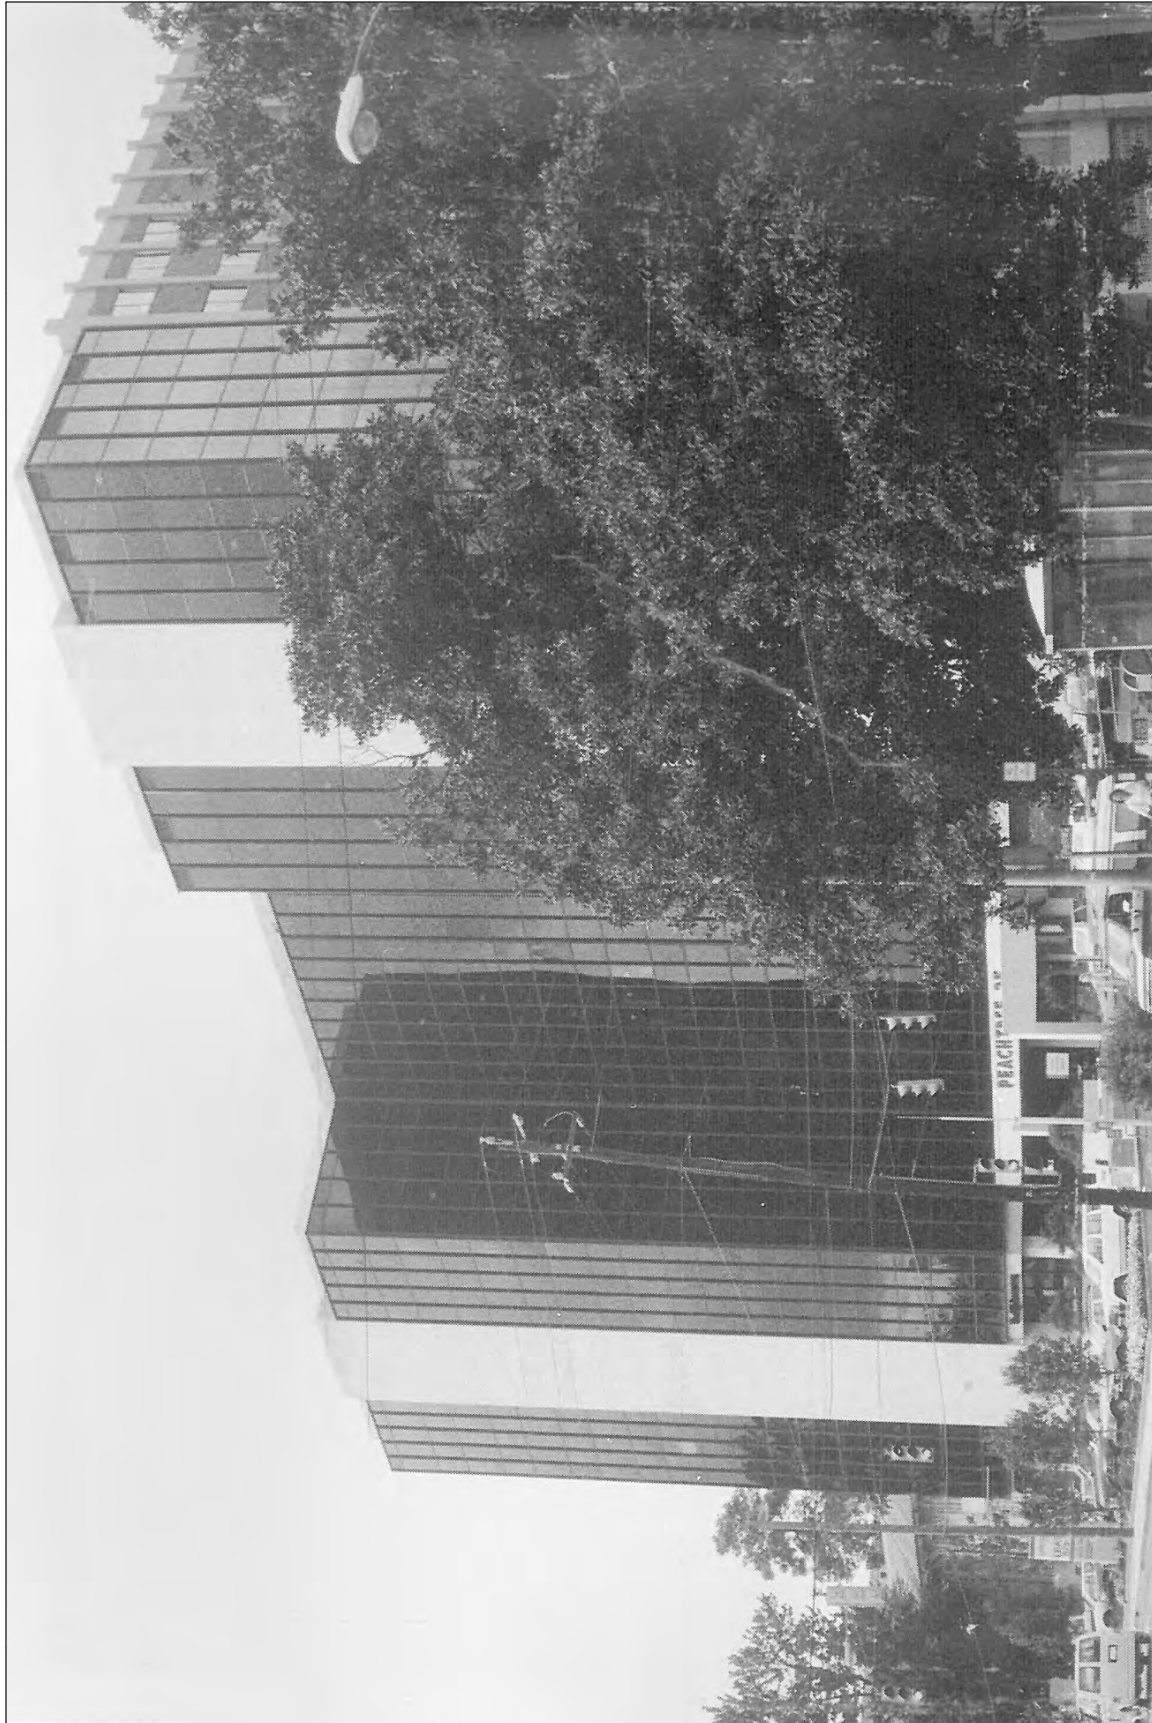
The South Tower, where the fire occurred, was completed in 1969. It was of fire resistive concrete construction and had panel walls of black glass held together with aluminum mullions. Windows ran from approximately two feet above the floor to slightly below the ceiling line. The spaces above the ceiling and below the windows were covered with opaque black glass panels to create a uniform façade. The front of the structure was finished in black glass and gave the appearance of a single building (see photo 7 in Appendix H).

7. Front of building.

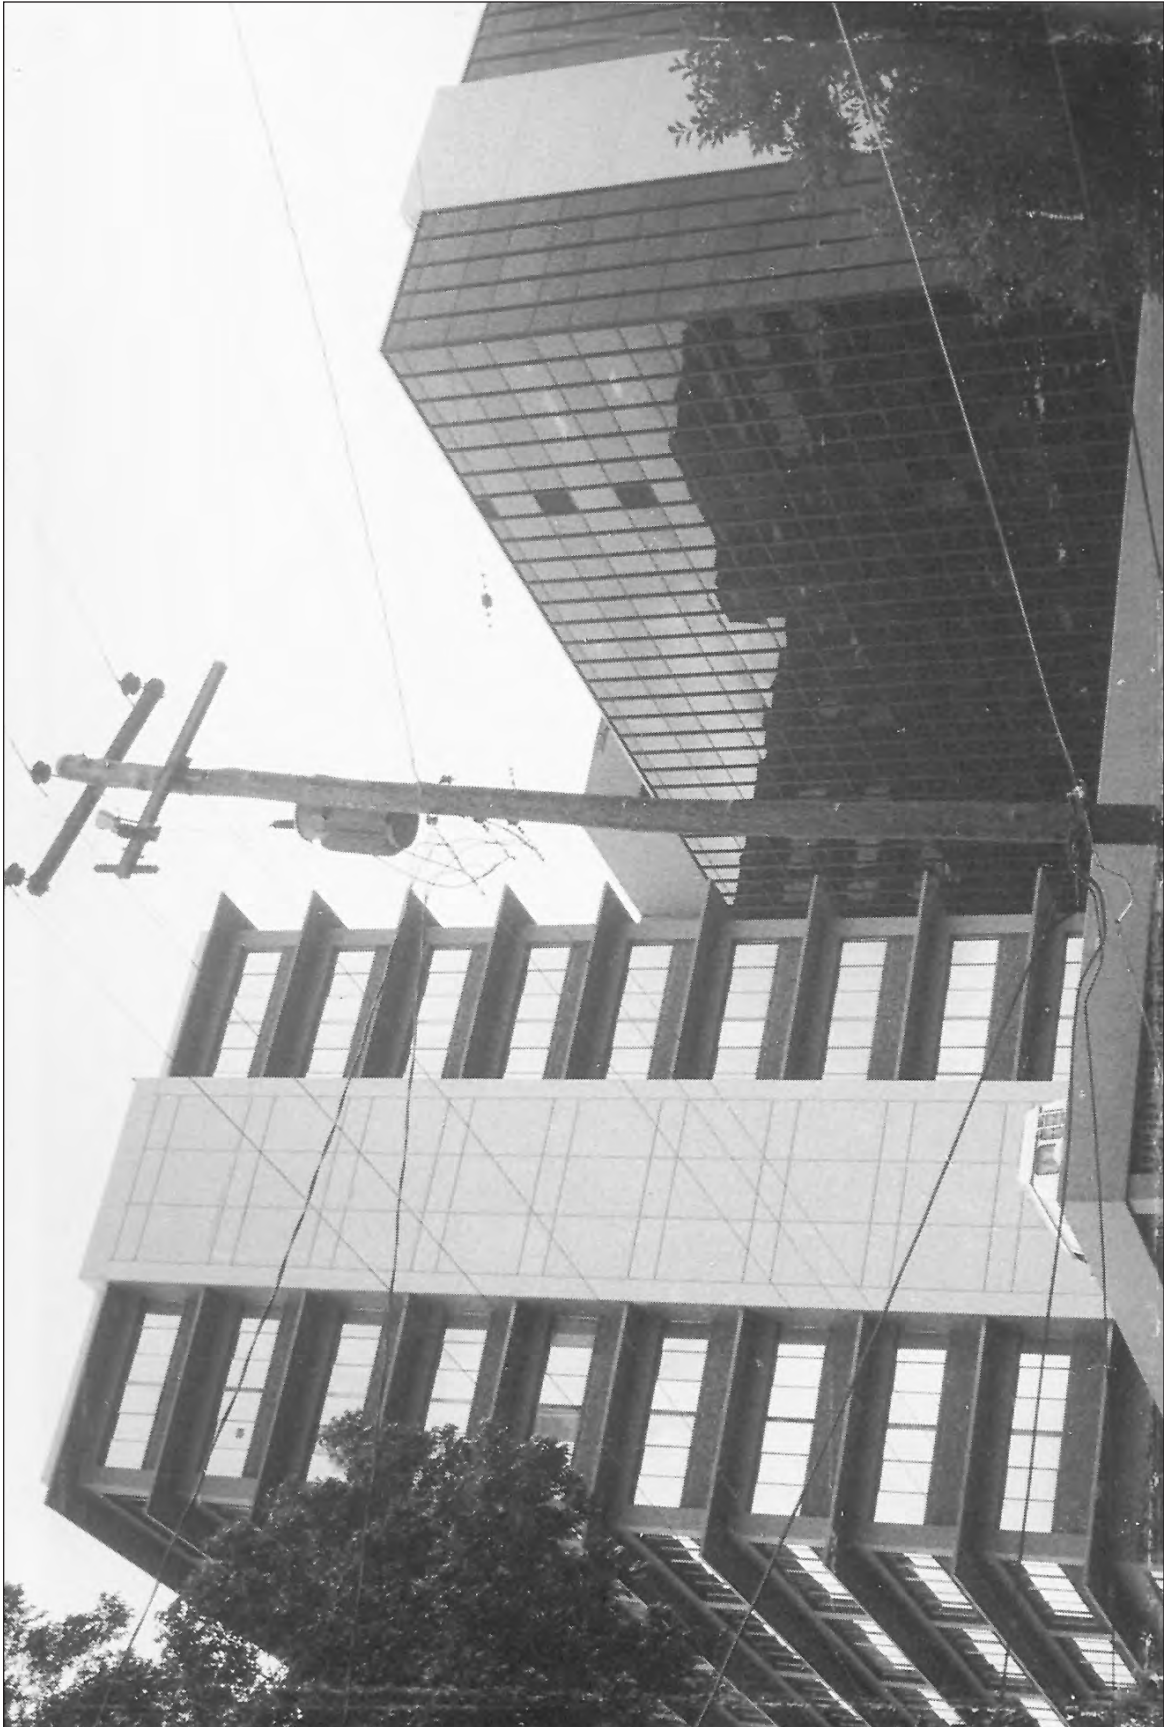
8. Rear of building showing differing construction of North and South Towers.

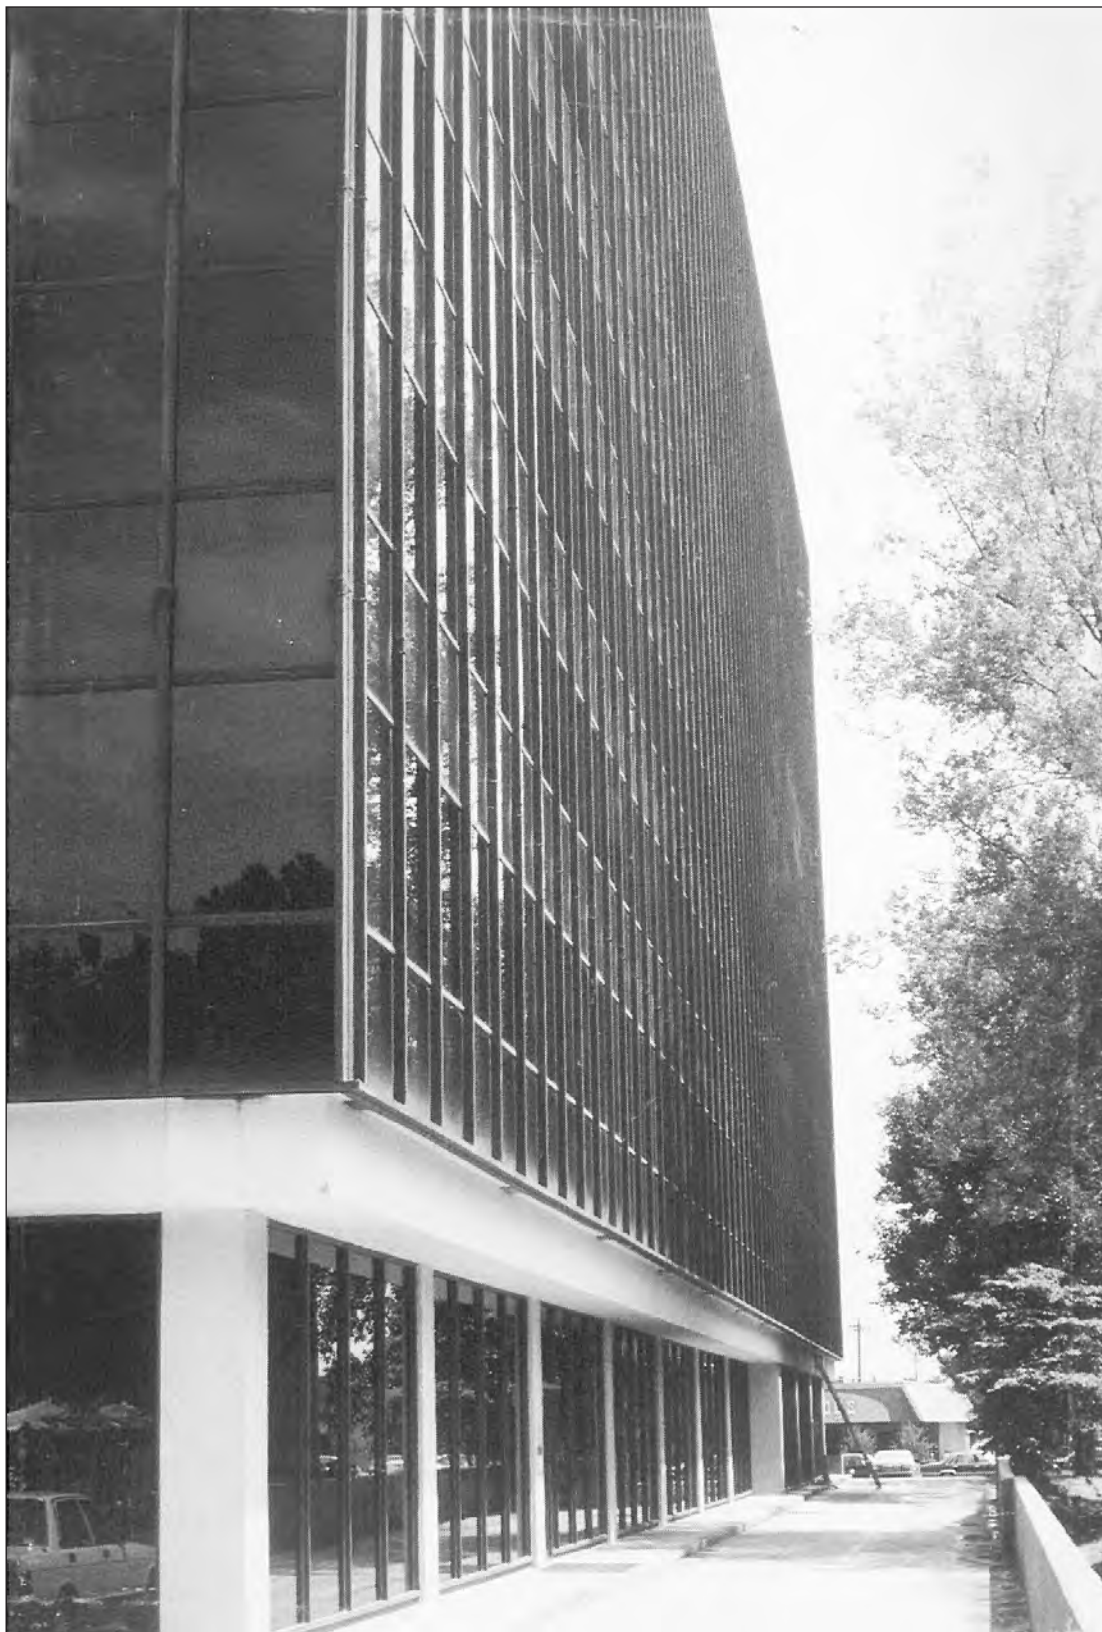
**9. South side of building, showing driveway, looking toward front of building (Peachtree Street). Woman who jumped landed on this driveway.**

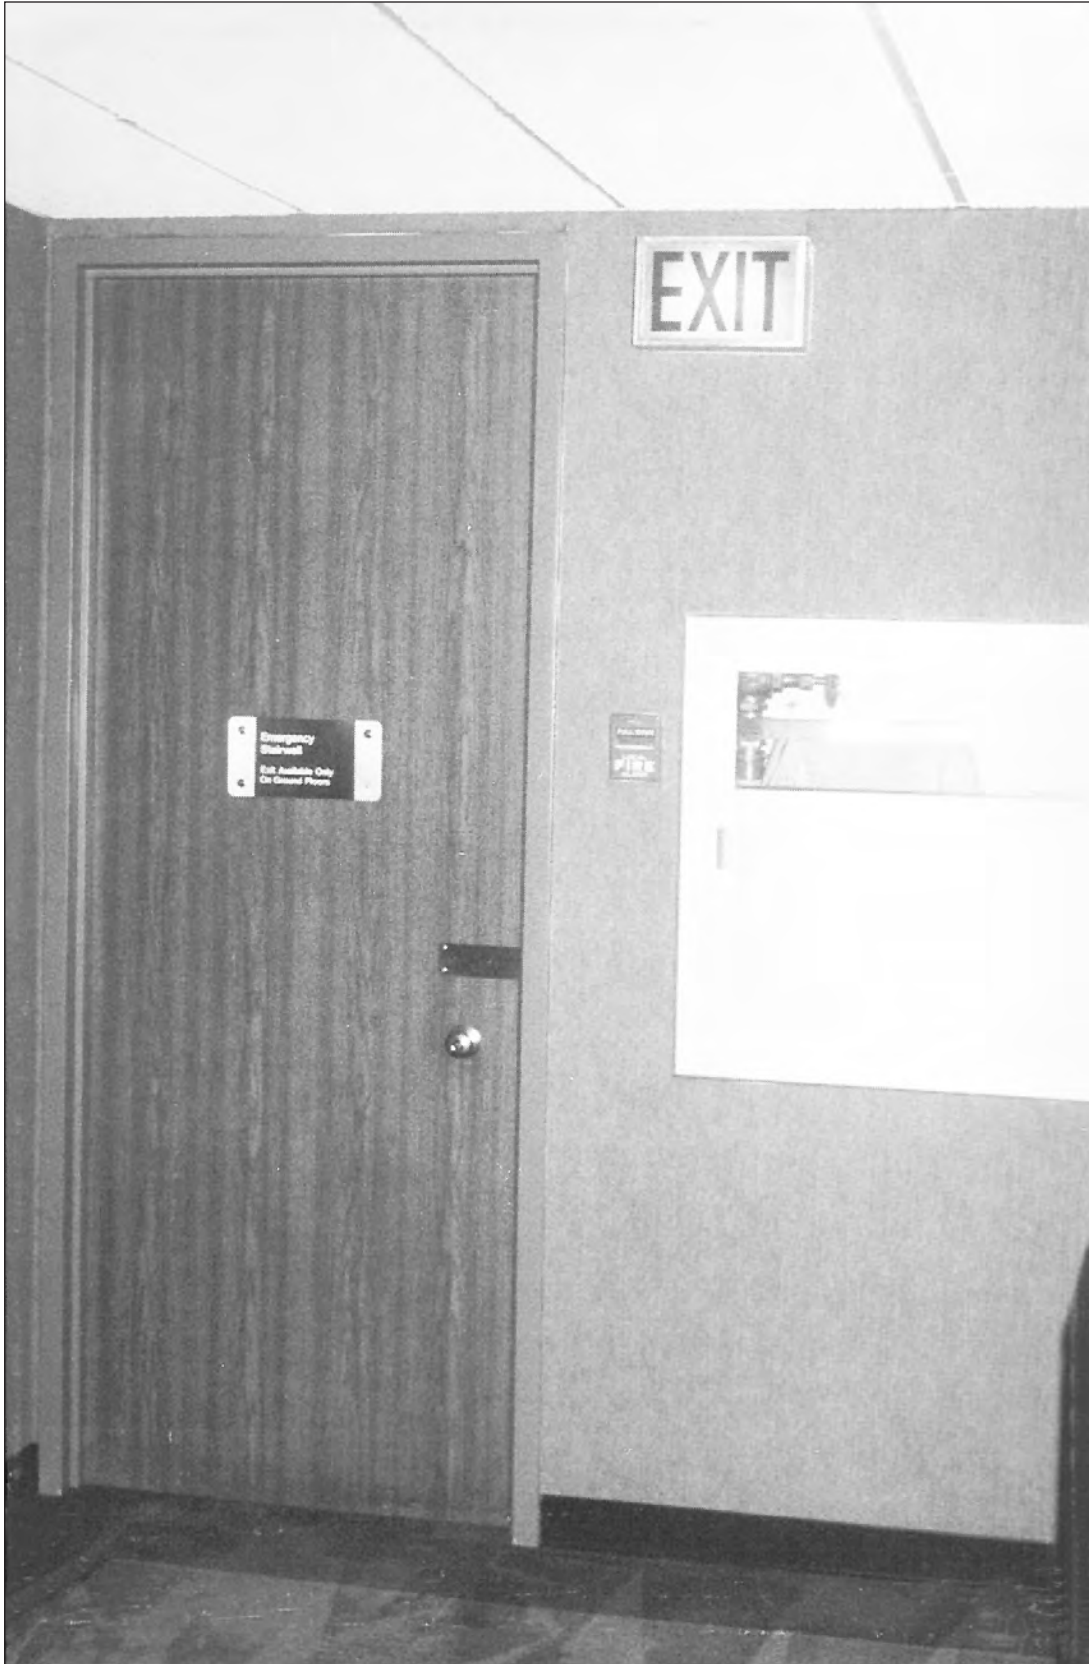
10. Typical exit arrangement at rear of floor, South Tower.

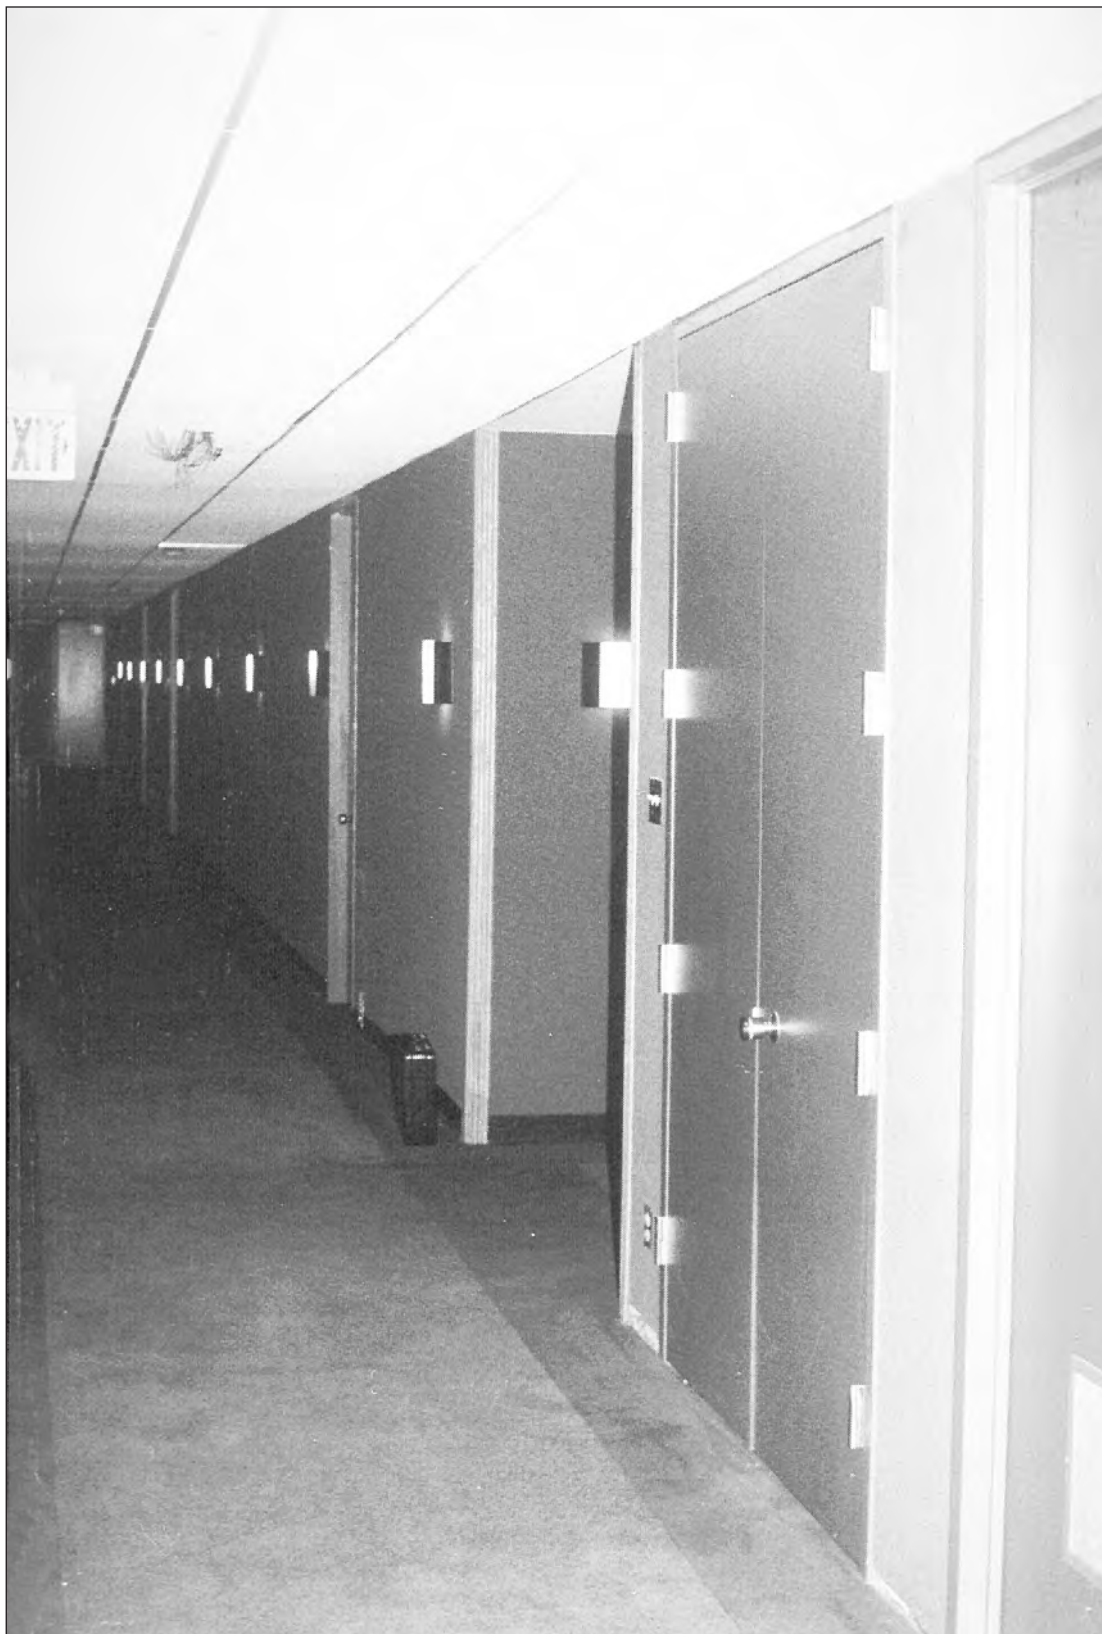
The electric closet where the fire started opened directly onto the exit corridor. When the fire erupted, it immediately blocked the corridor, keeping most victims away from the two exits serving the floor.

11. Fifth floor corridor looking toward rear of building. Electrical closet is in foreground. Elevator lobby and front stairway are around the corner to right.

Separation of hazardous areas such as electrical rooms should be considered as a retrofit item in structures where a fire or similar situation could be expected to cause an immediate threat to the ability of occupants to reach exits.
