# Five-Fatality Highrise Office Building Fire

Atlanta, Georgia

USFA-TR-033/June 1989

Investigated by: Charles Jennings

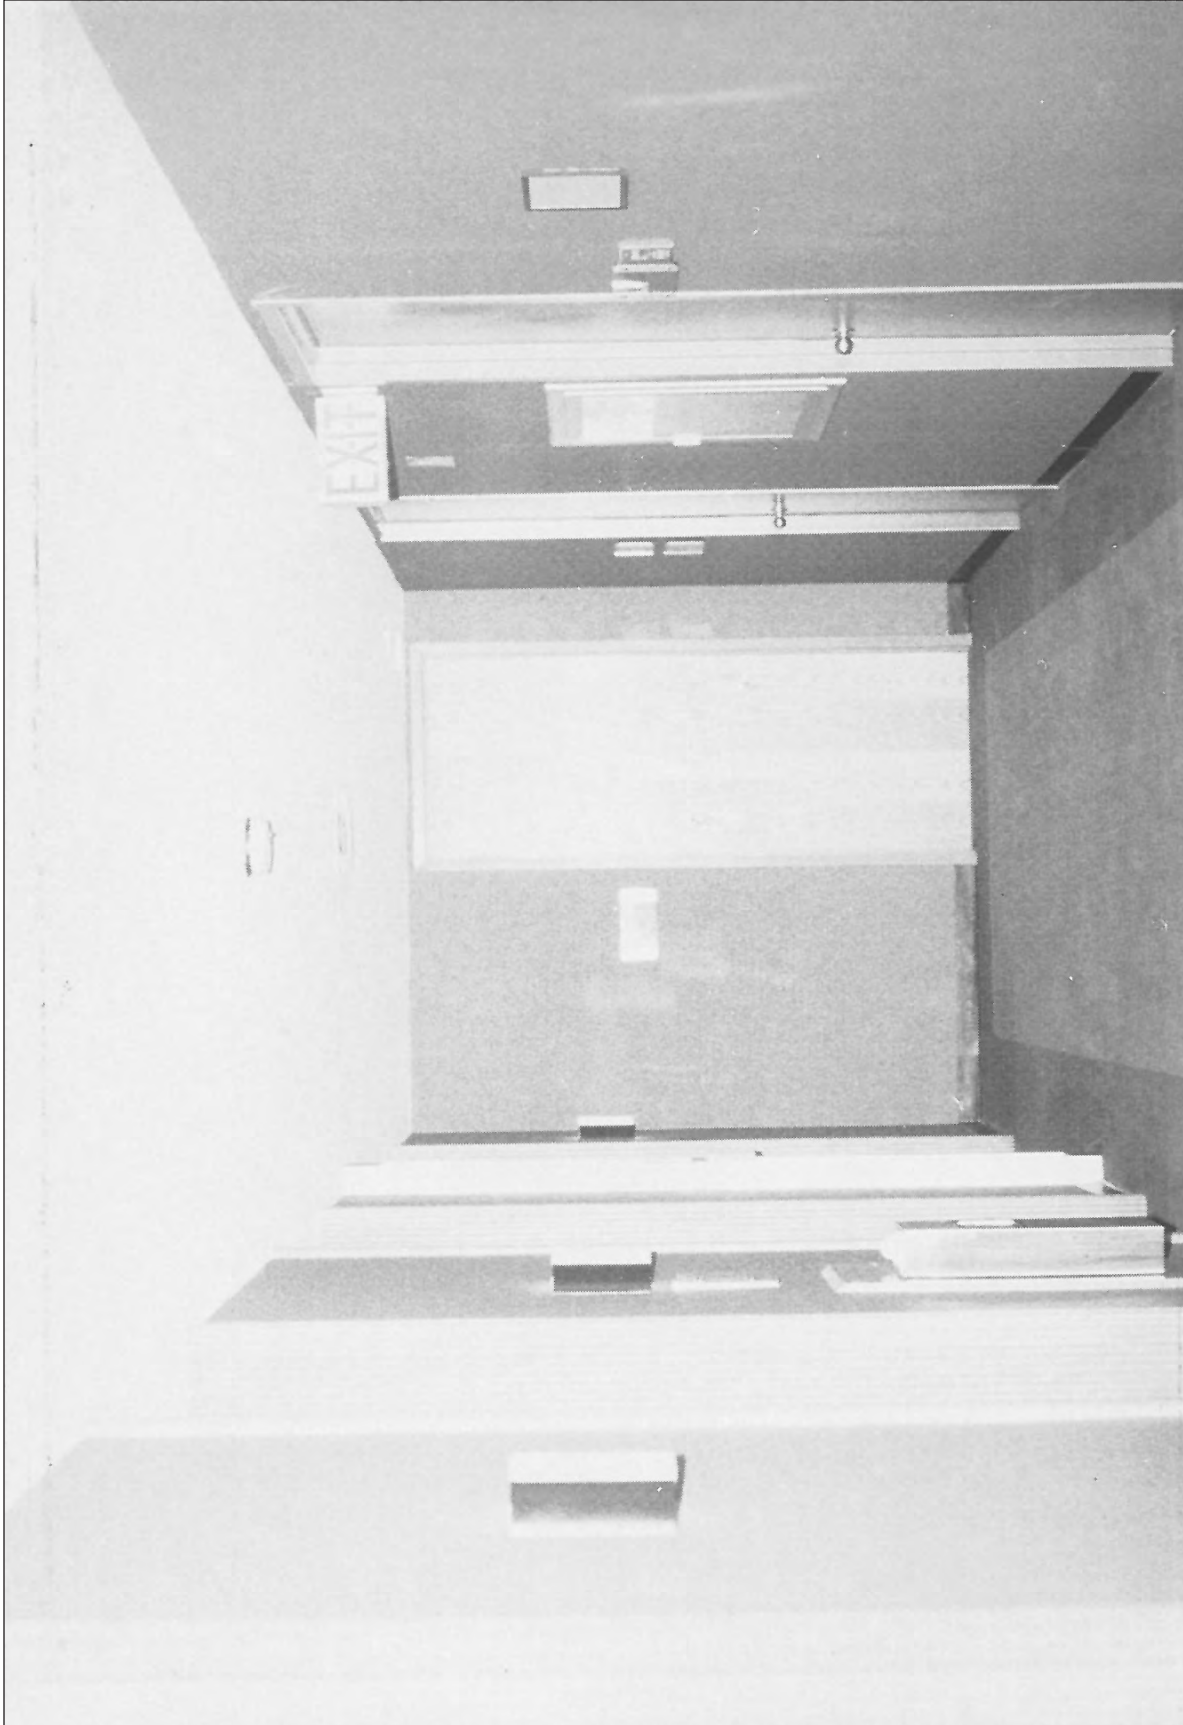
12. Elevator lobby on fifth floor, elevators are to left, exit is to the right. Smoke detectors were not installed on the sixth floor.

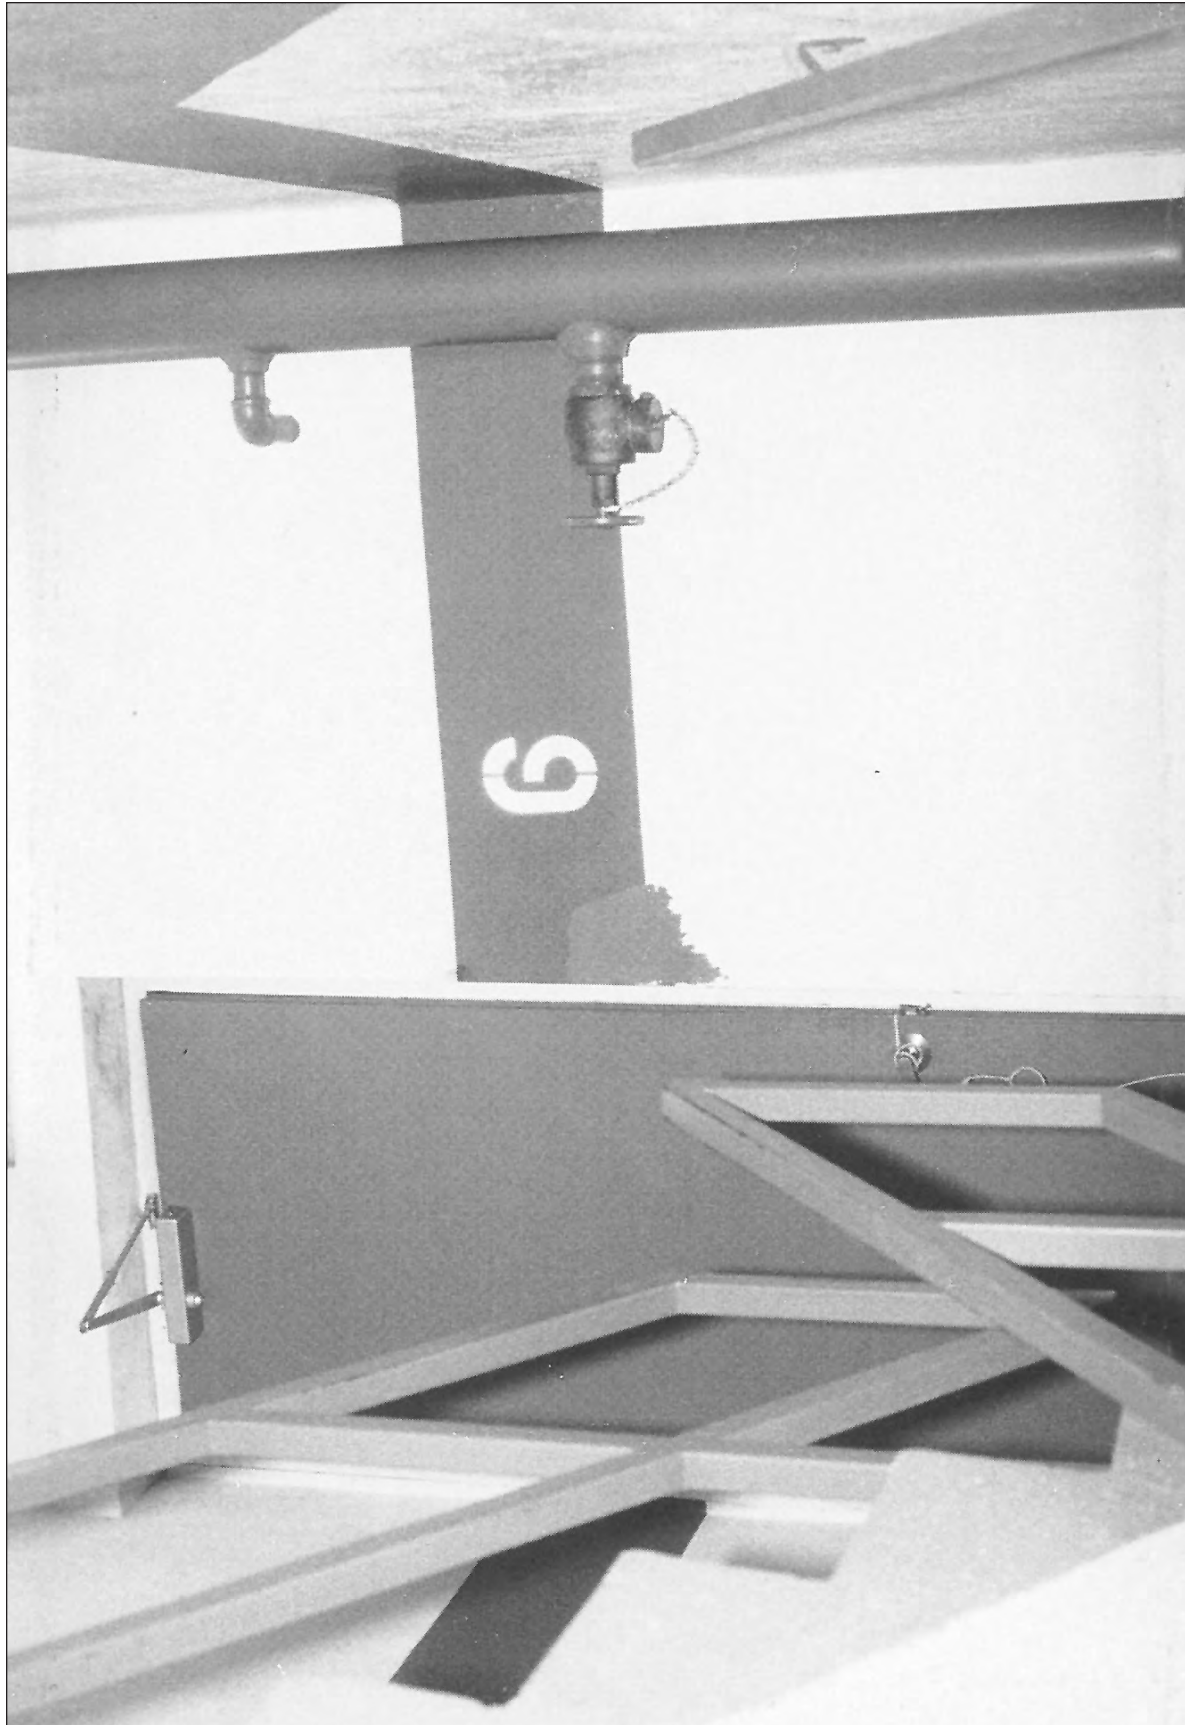
13. Front stairway, South Tower looking at door to sixth floor.
