U.S. Fire Administration/Technical Report Series

Gasoline Tanker Incidents in Chicago, Illinois and Fairfax County, Virginia

Case Studies in Hazardous Materials Planning

USFA-TR-032/March/May 1989

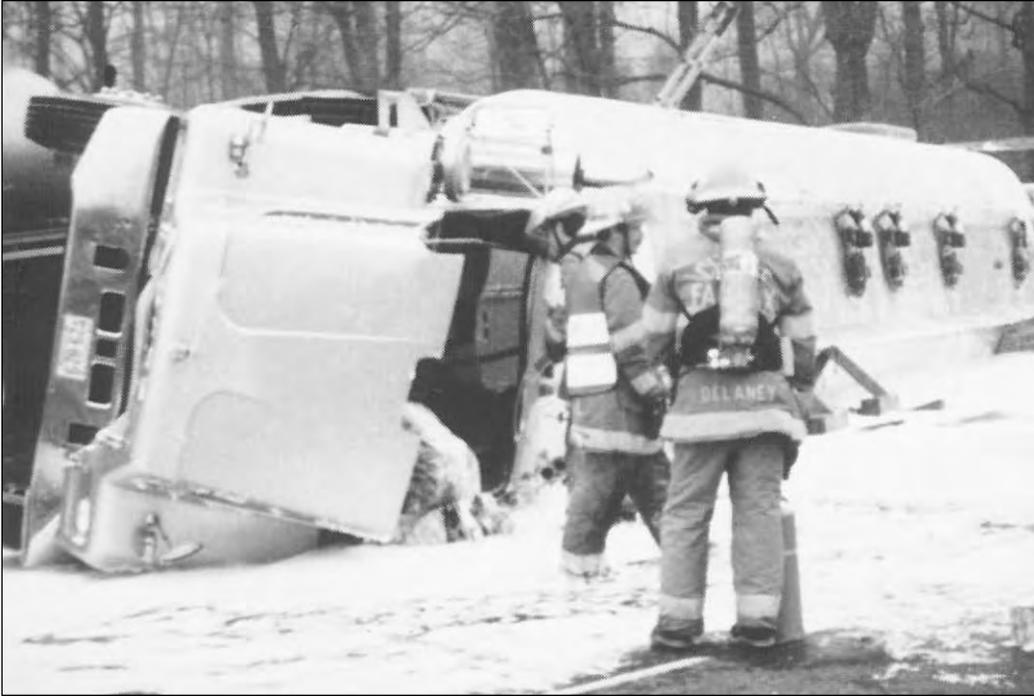
1. Overturned tanker showing dome covers.

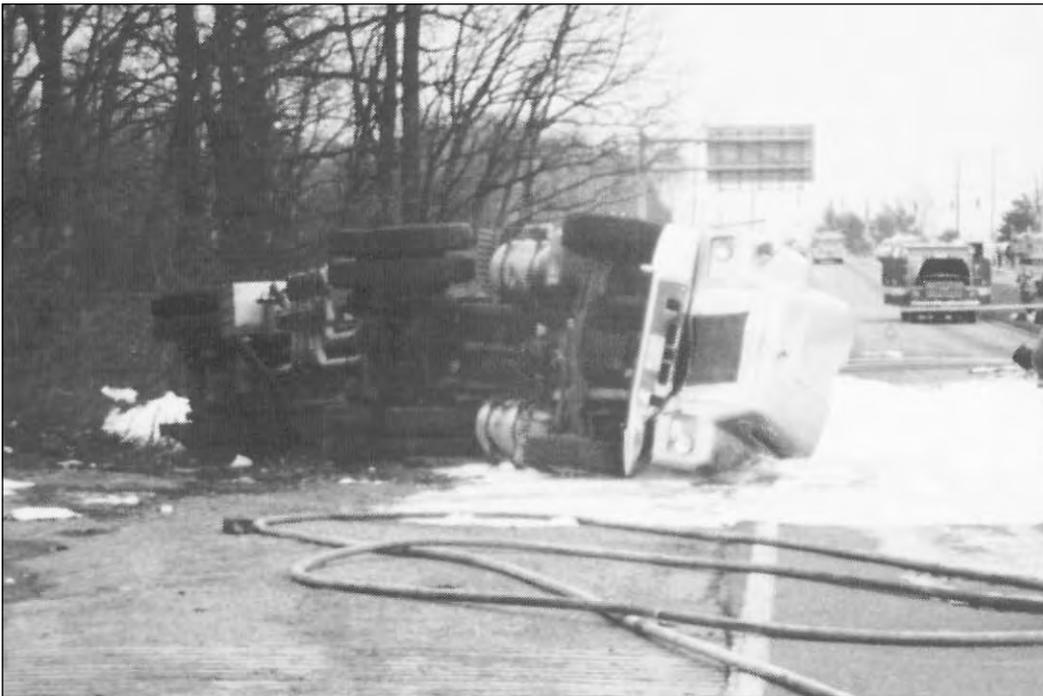
2. Tanker, sprawled on roadway; Hazmat unit is in background.

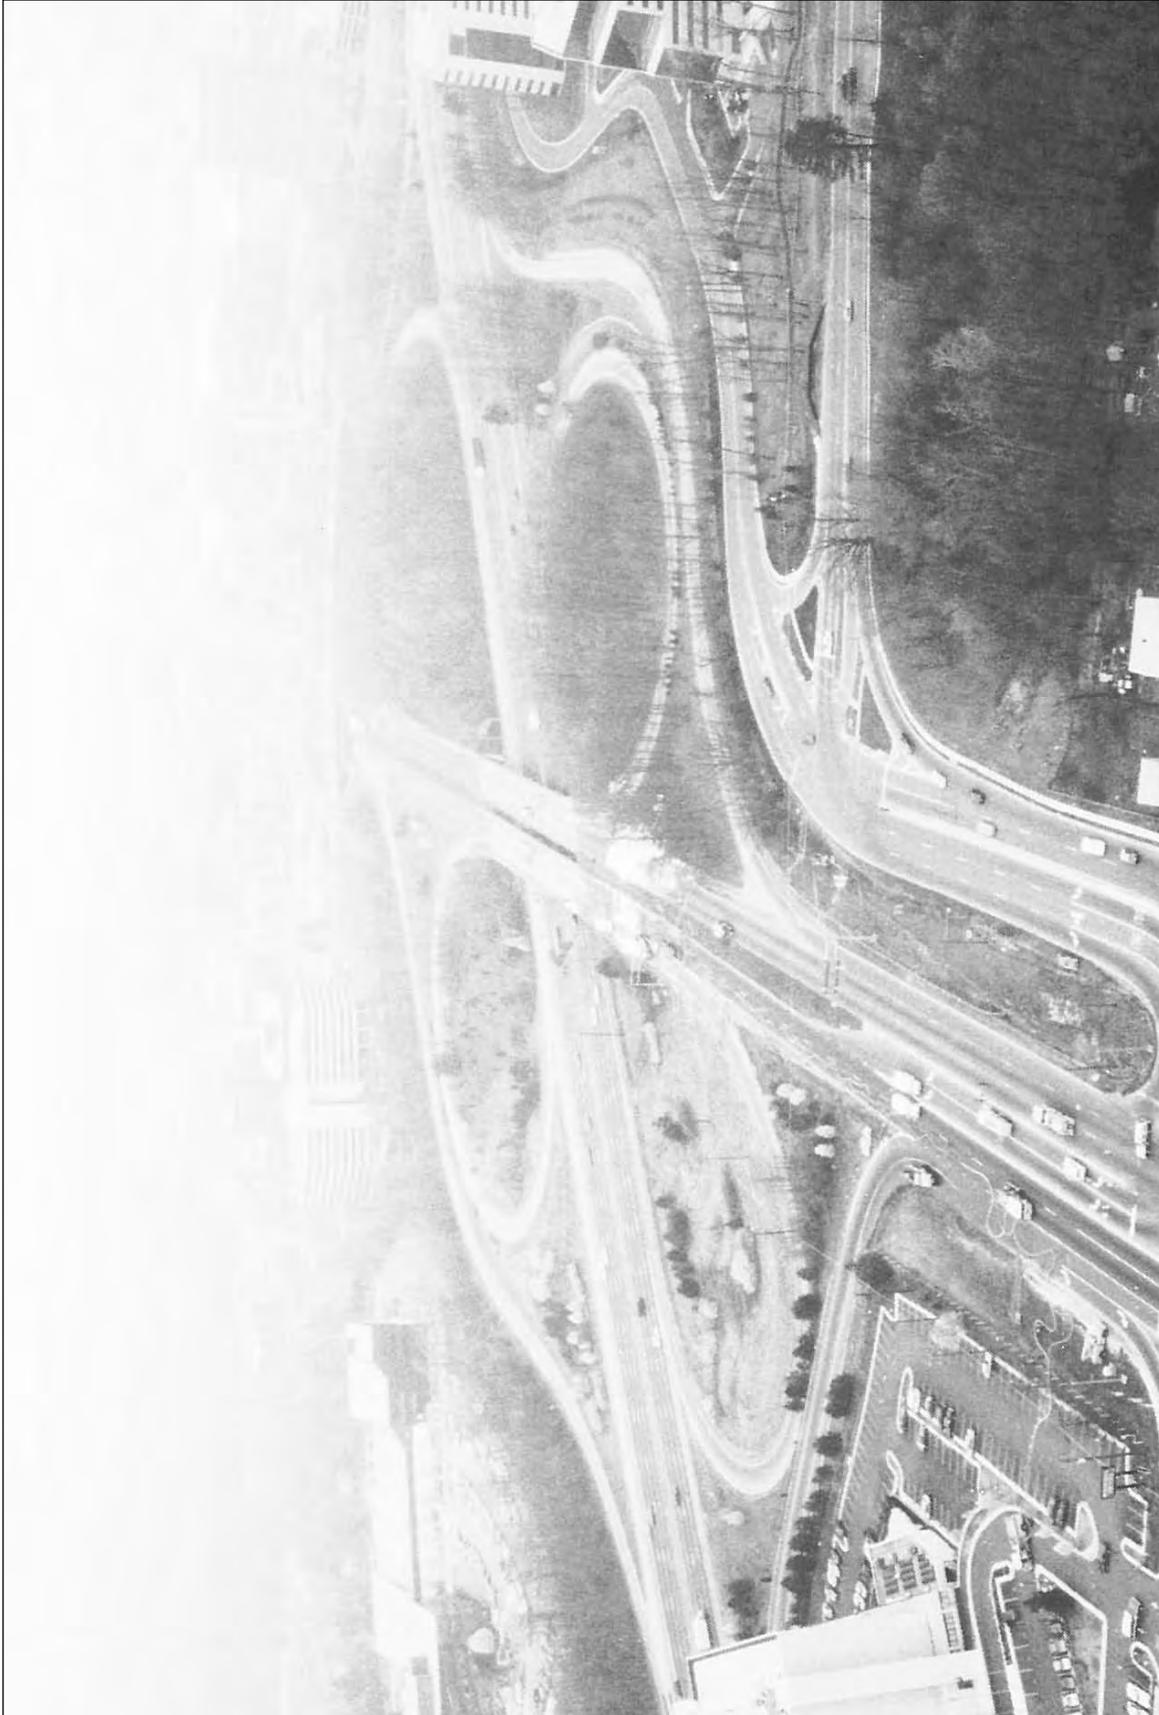
3. Aerial view of accident scene. I-495 across center of photograph, Route 7 runs vertical in center of photograph.

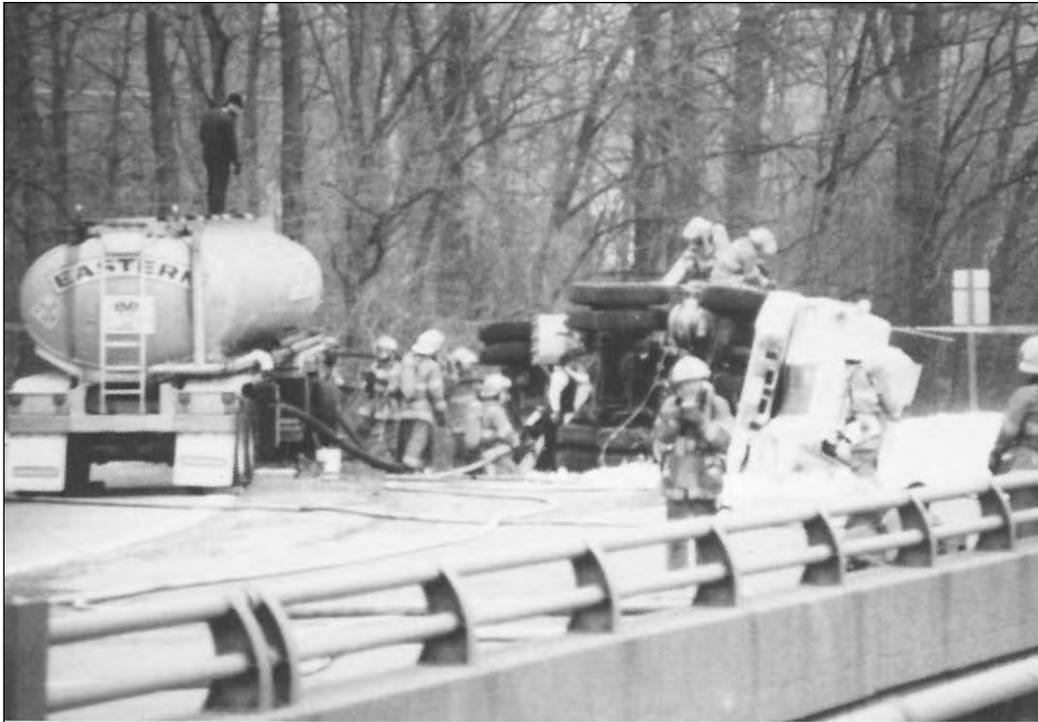
4. Second tanker pumping fuel from the overturned tanker.

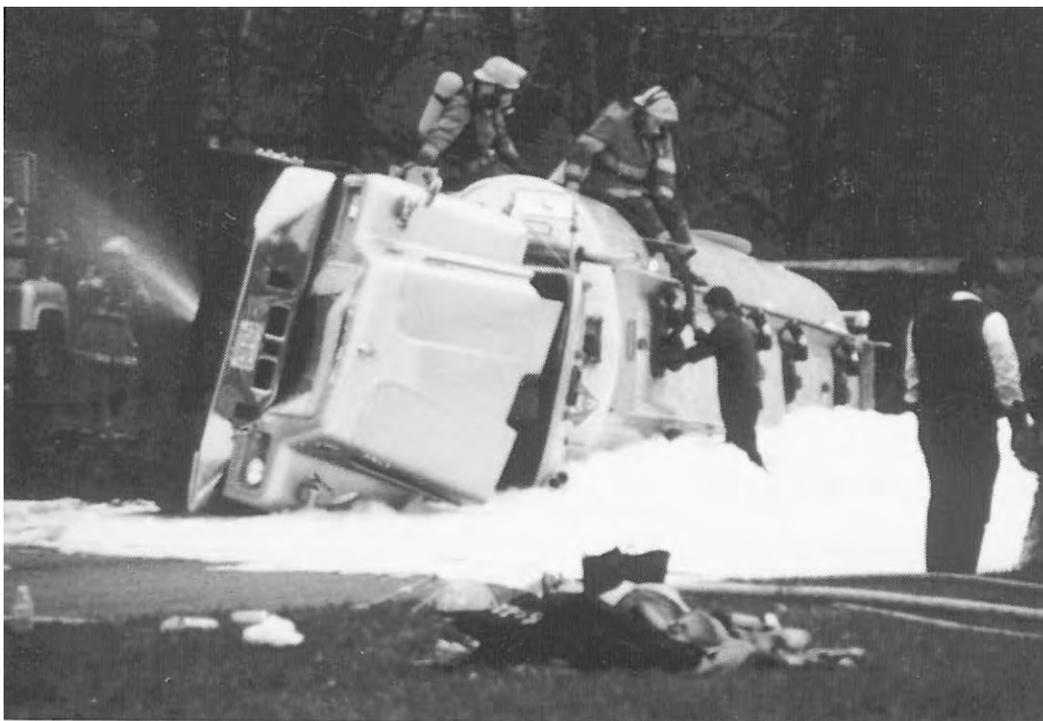
Because of the position of the tanker and the fact the dome covers were damaged, it was decided that the best way to remove the product would be by cutting a hole in the side of the tank (see Fairfax County Hazmat Response Team Manual, Appendix D).

5. Contractor personnel complete off-loading operation. Firefighters atop tank are at position of hole that was drilled. Note water spray directed at exhaust pipe of the recovery tanker.

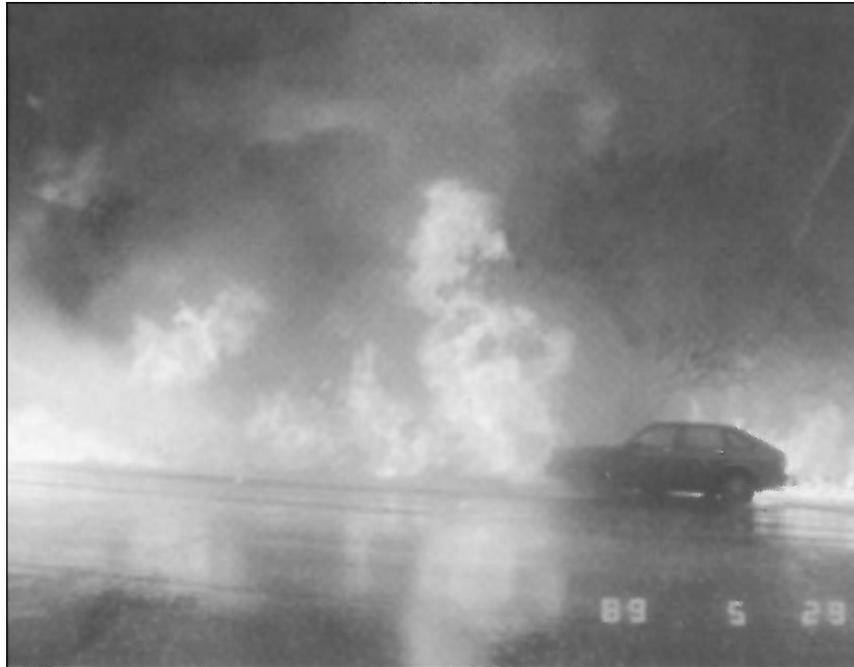
1. Fire conditions along Fullerton Street between tanker and "el" tracks.

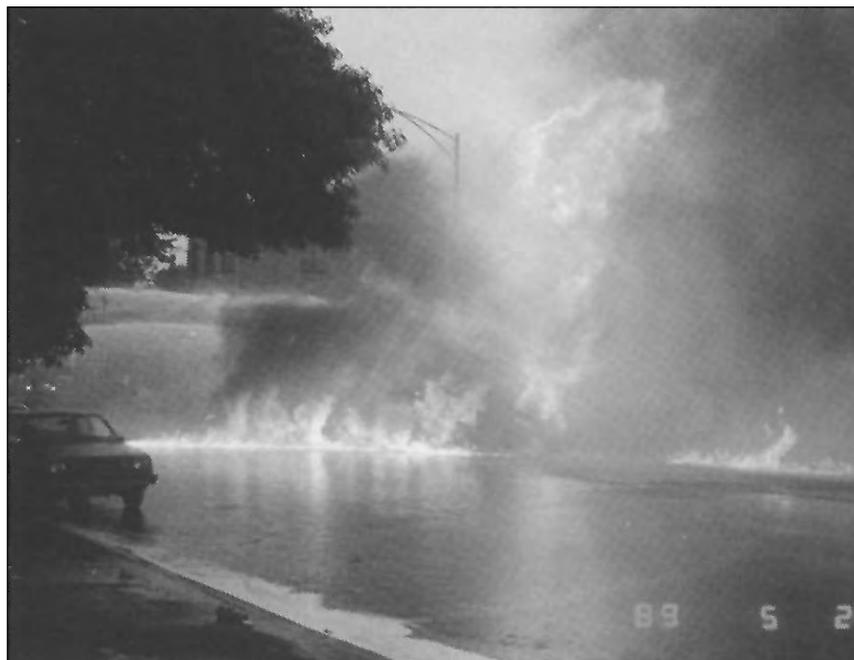
2. First streams (arrow) in operation on tanker; two-story exposure building is obscured by fire and smoke.

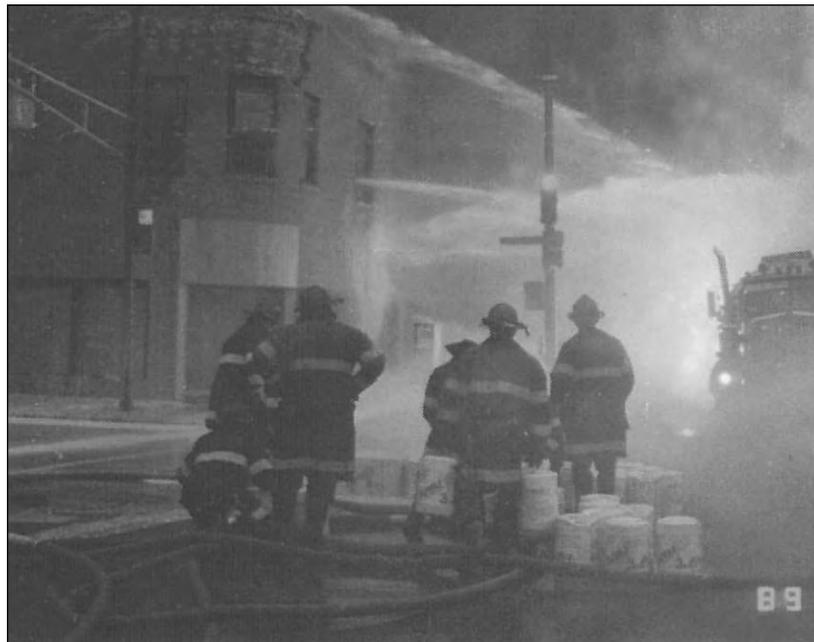
4. Firefighters operate foam handline to control spill fire. Note streams directed at exposure and tanker, including from second floor of exposure.

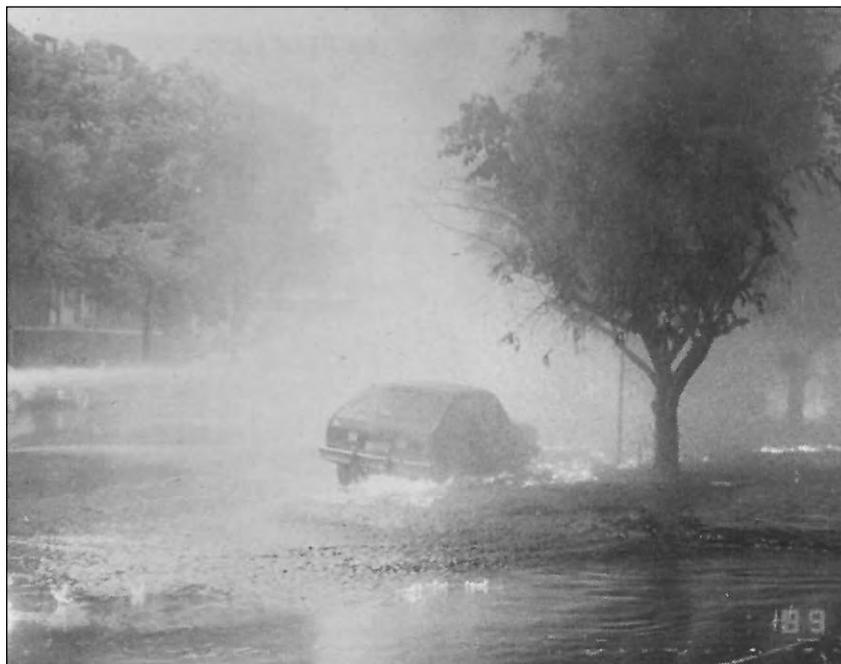
7. Spill fire flares up as it flows around parked car. Note runoff in foreground.

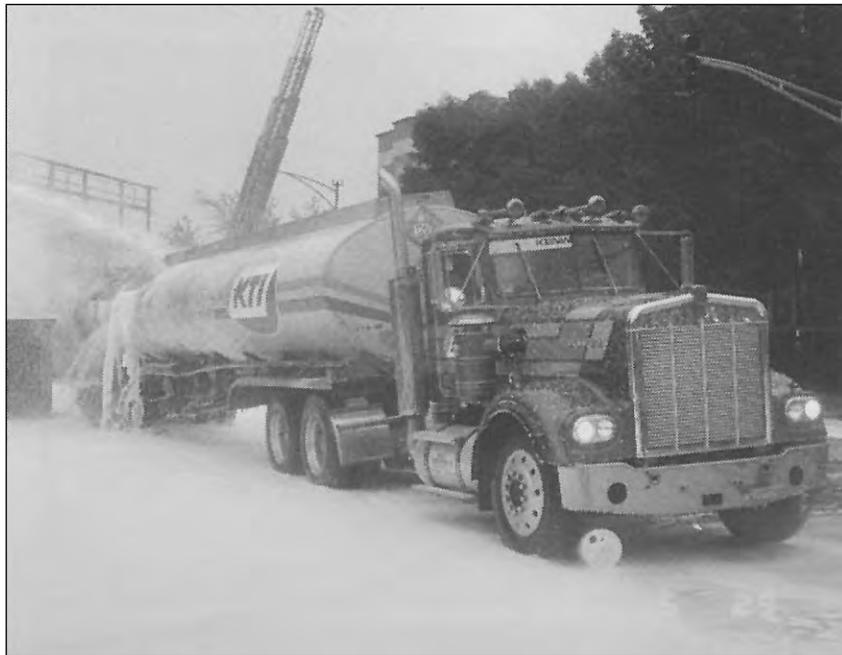
10. Fire out, but product continues pouring from tank trailer.

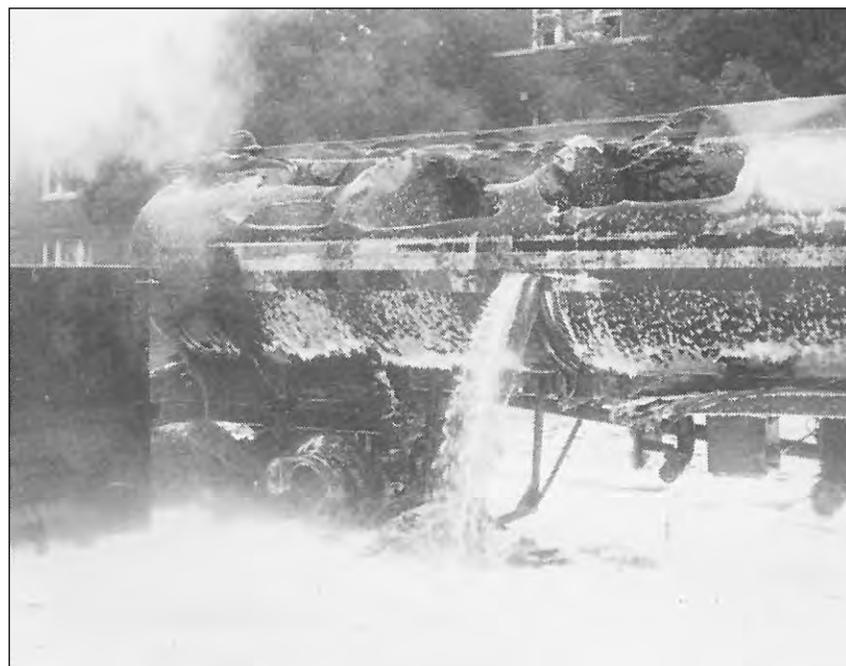
The foam blanket was maintained while the tanker was off-loaded through normal means using the intact piping below the tank trailer. The aluminum over the three sections of the tank trailer had burned away in the fire. The rear tires on the side of the tanker that was ripped open were also burned, but the other set of rear tires remained intact.

12. Damage to rear of tank trailer; gasoline still pours from puncture.

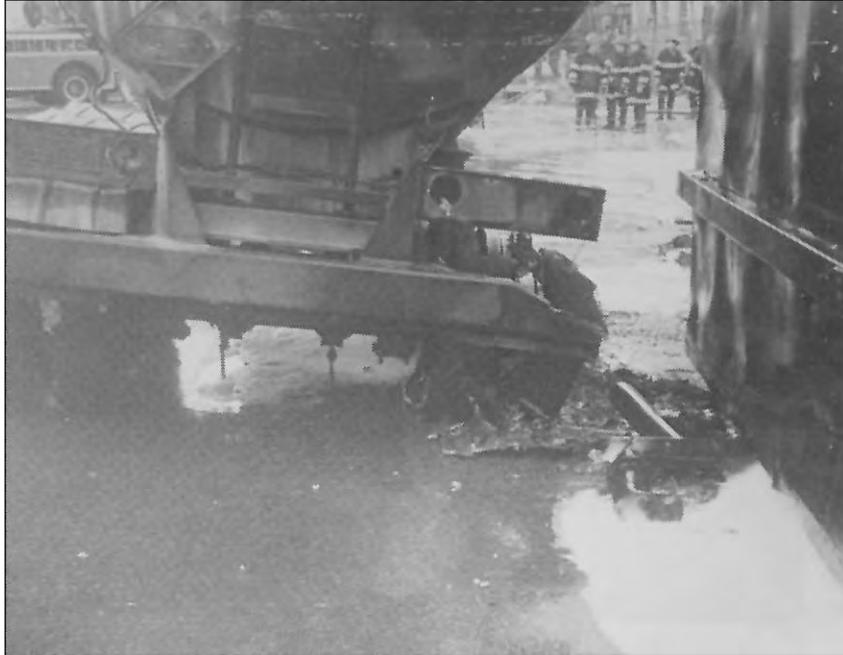
13. Rear of tanker, left side are intact.

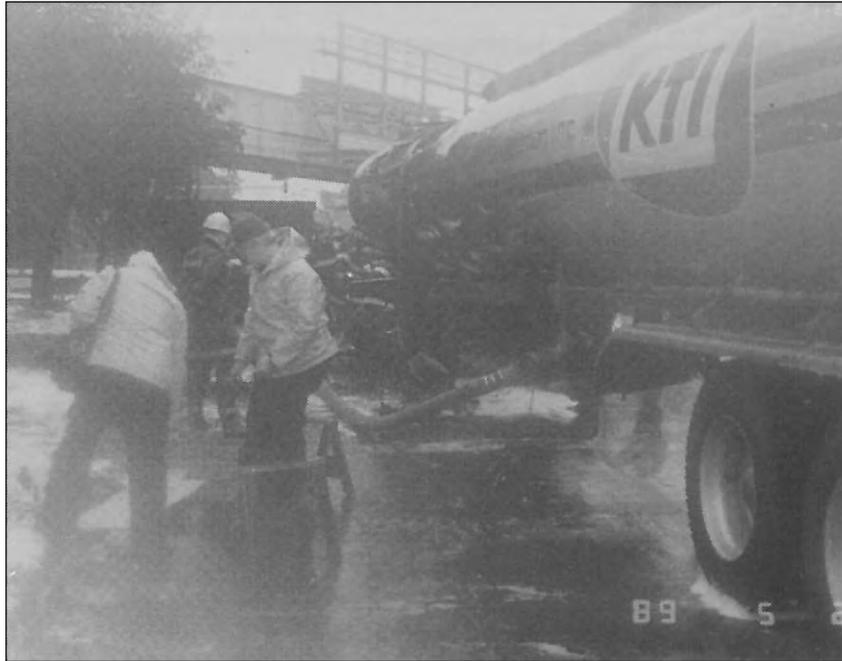
Sewers in the area were checked for explosive vapors, but none were found. As a precaution, fire hydrants in the area were opened to flush the sewers.

15. Off-loading in progress, water department employees check manhole for explosive vapors.

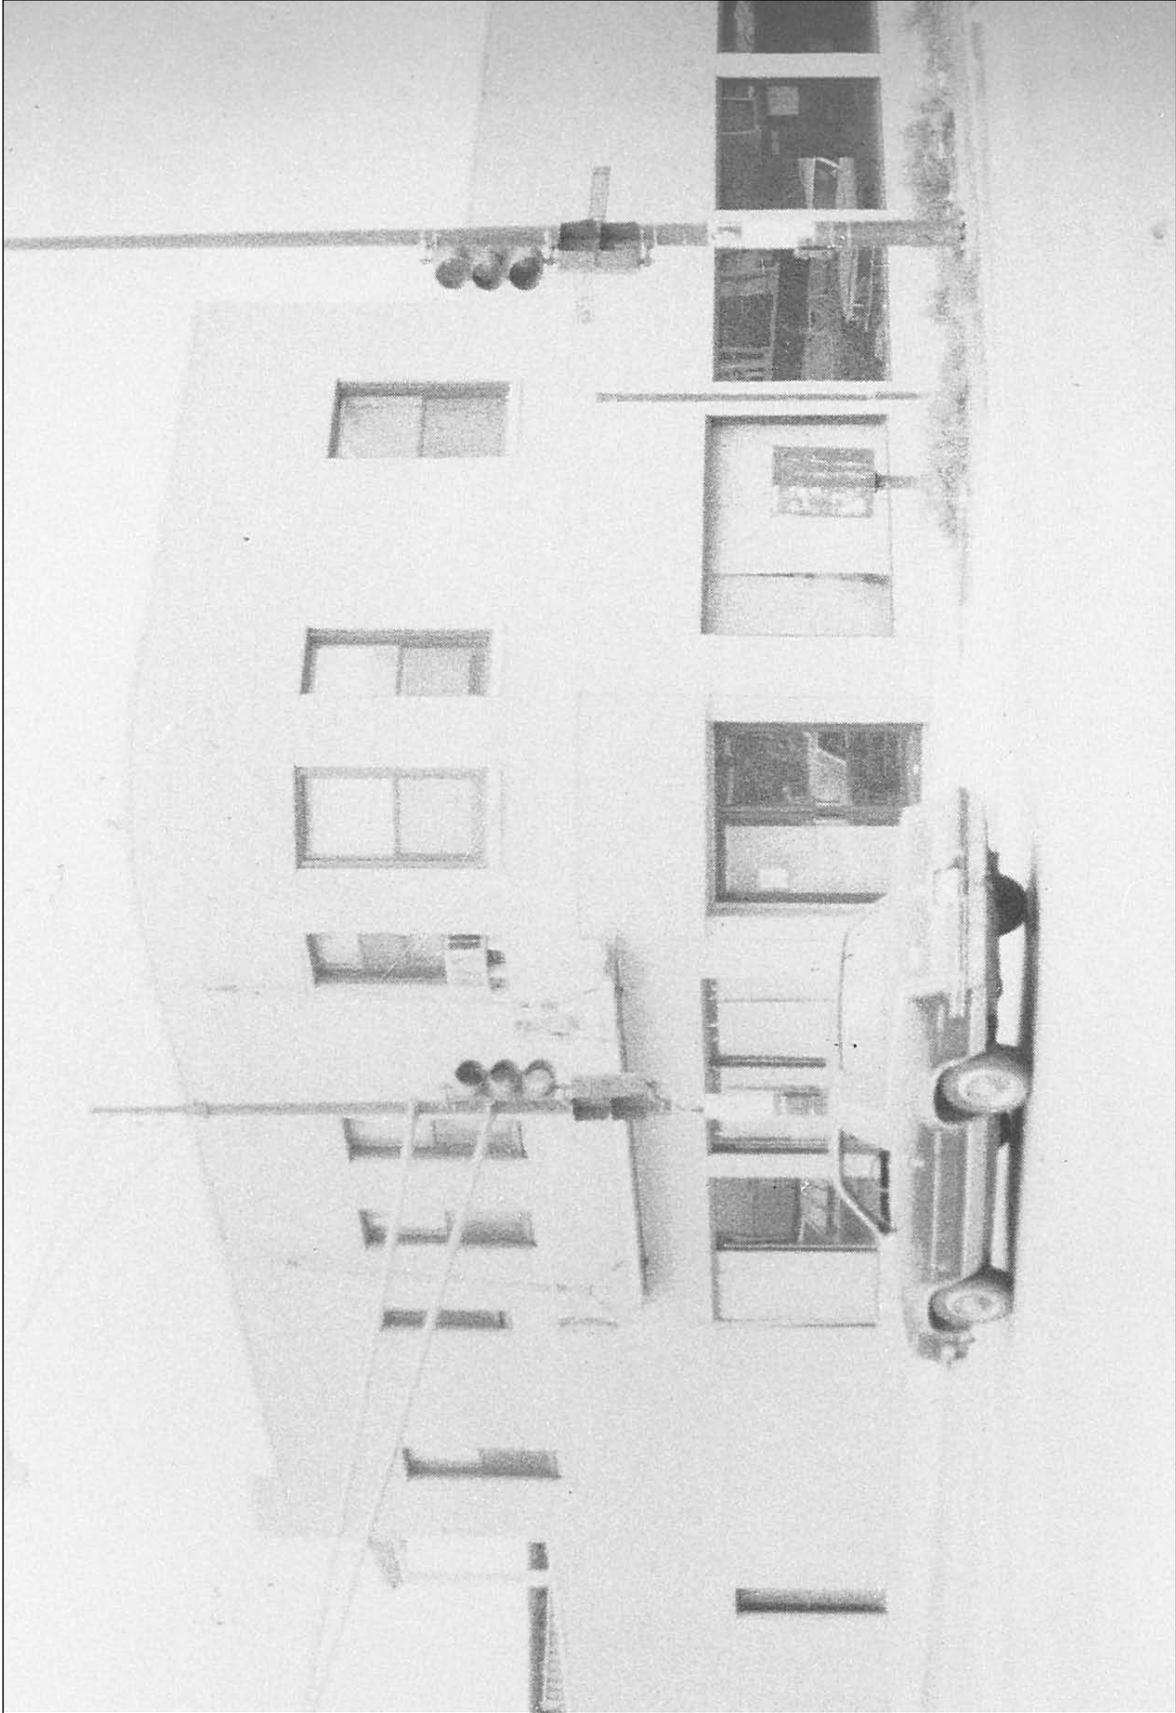
16. Primary exposure building weeks after the incident. Note reflection of dumpster in windows on right hand side.
