U.S. Fire Administration/Technical Report Series

Logan Valley Mall Fire

Altoona, Pennsylvania

USFA-TR-085/December 1994

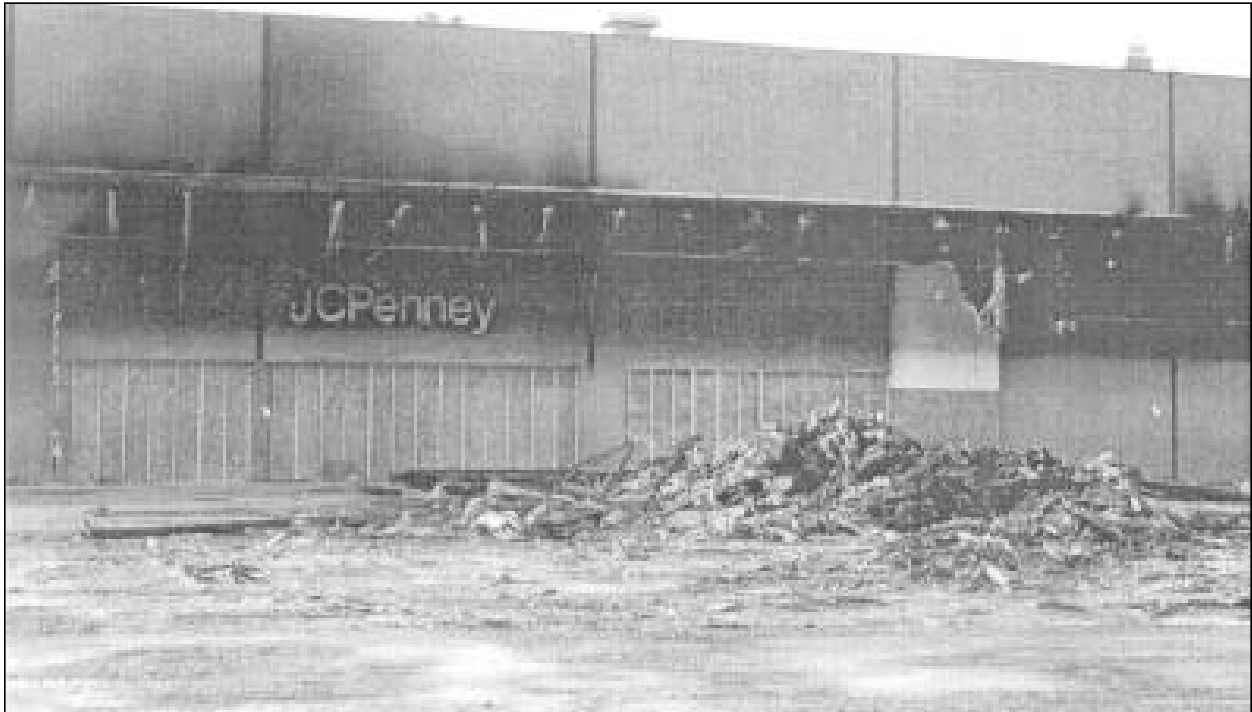
fire department actions, the tempered glass covering these openings did not fail during the fire. While not a rated fire wall due to the three openings, this wall was a significant factor in stopping the westward fire travel. The J. C. Penney side of the wall had automatic sprinklers spaced along the openings and the wall. All head spacings were on an ordinary hazard basis. The fire did not cause any heads to operate. No sprinkler heads protected the mall side of the wall and wall openings.

**Photo 1. East wall of the J. C. Penney Store where the westerly fire travel was stopped.
Roof line of covered mall is identified by the dark black horizontal line.
Glass entrance and show windows are behind the chipboard
and wood studs.**

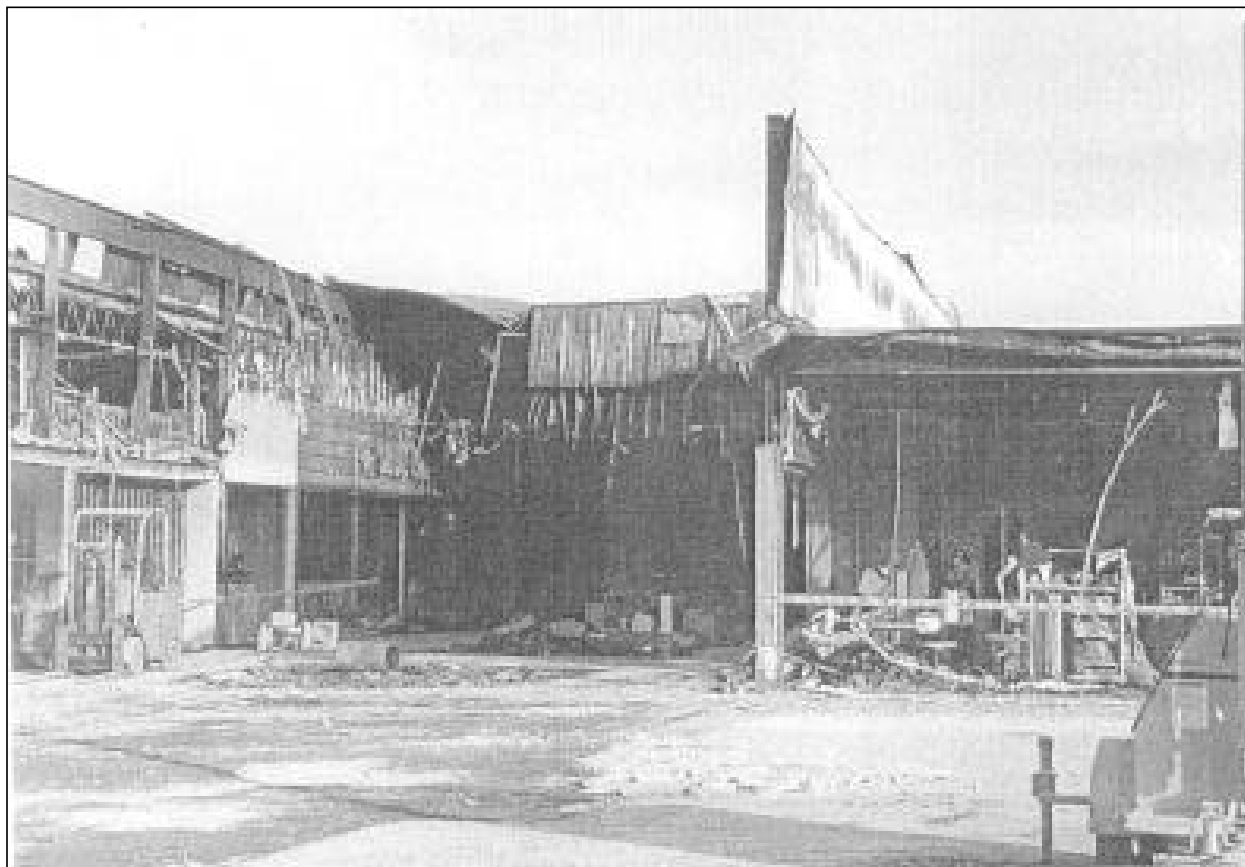
Photo 2. Covered mall to the east of the Murphy store and some of the stores adjacent to the covered mall. The three different roof heights and construction features are illustrated. The tenant separation wall for the right hand store has been removed.

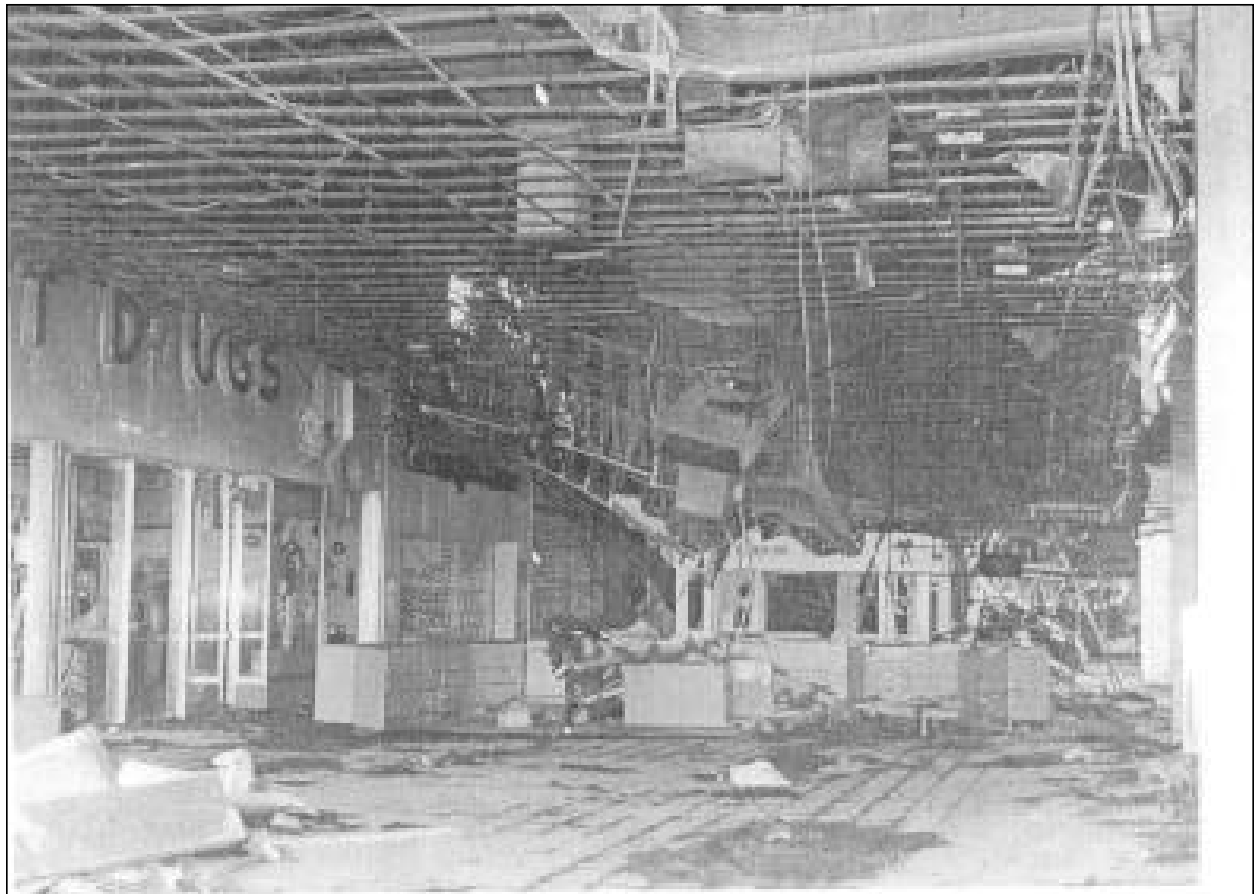
Photo 3. Looking east into the covered mall from about where the forklift is located in Photograph 2. The ceiling tiles were removed during the fire and the floor debris was removed before the photograph was taken.

Note the partial roof collapse in the background.

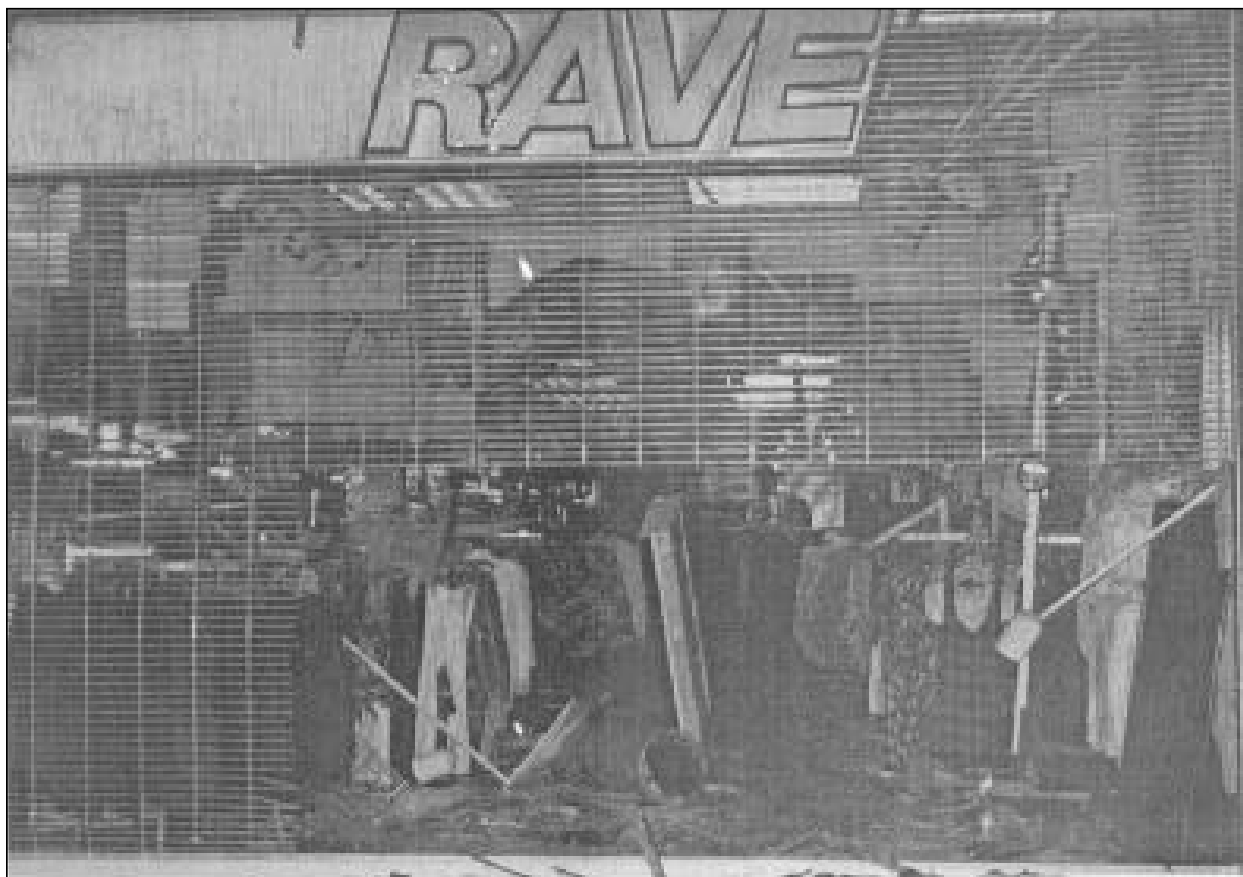
Open grill security separations allowed the free passage of smoke and heat into stores from the common, covered mall. This contributed to smoke and water damage to the stores contents. Additionally, the forcible entry through these separations was more difficult and time consuming than for stores with solid separations. Smoke damage in a retail store is often as costly as direct fire damage. Controlling smoke travel is an important element in limiting damage. Rated fire resistance in the separation is not as important as a solid separation with minimal unprotected penetrations. NFPA 101, Life Safety Code, does not require separation between the covered mall and the tenant stores, but does require automatic sprinklers and a "smoke control system" within the covered mall. These systems were not present in this incident.

Photo 4. Store on the south side of the covered mall. Typical of the forcible entry work performed on the security grill and the damage to goods. This store had automatic sprinklers and the sprinkler heads at the front entrance operated.

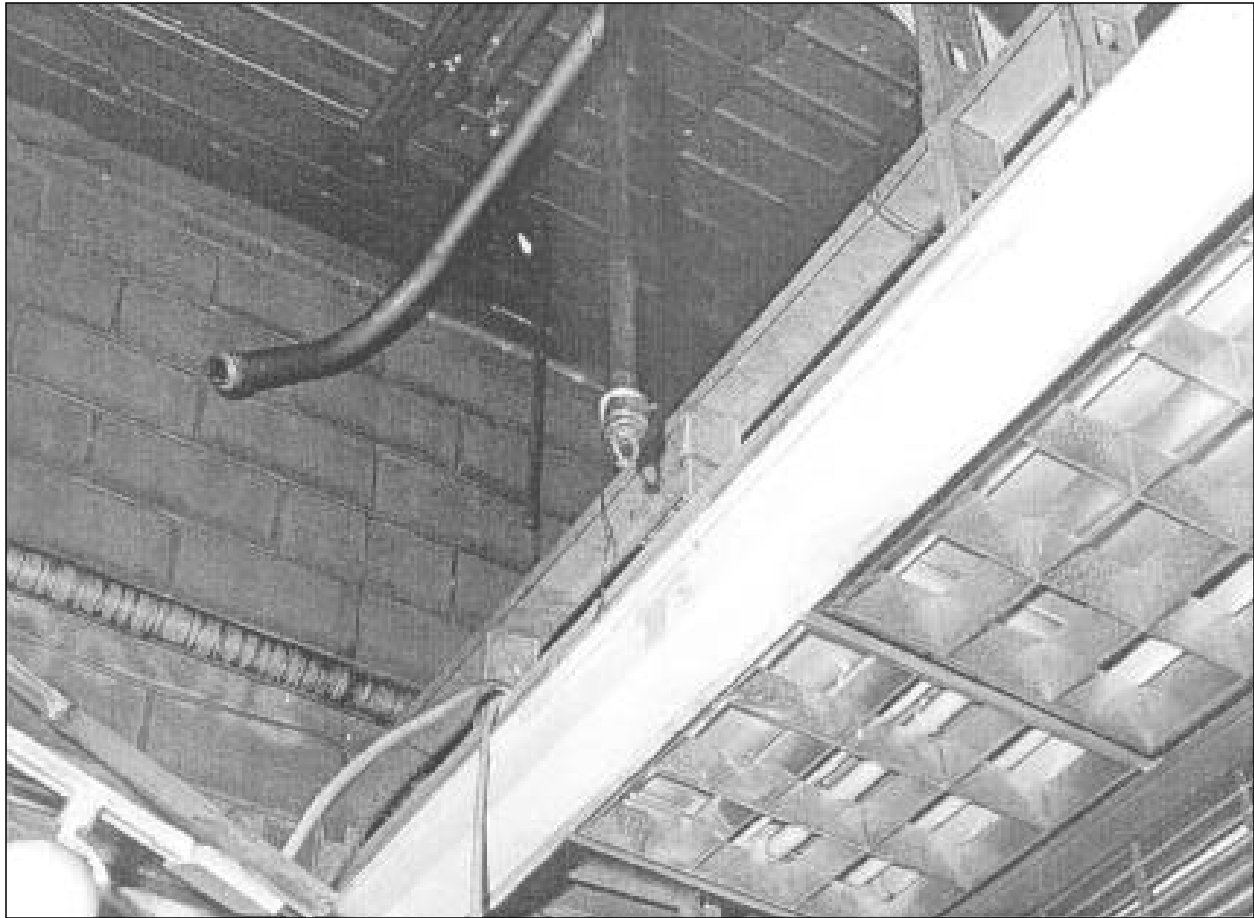
Photo 5. Open sprinkler head inside the store in Photograph 4. The ceiling tiles and grid around the head were removed before the picture. Typical concrete block tenant separation wall and metal deck roof construction in the older section. Interior tenant construction has used wood studs for the metal ones.

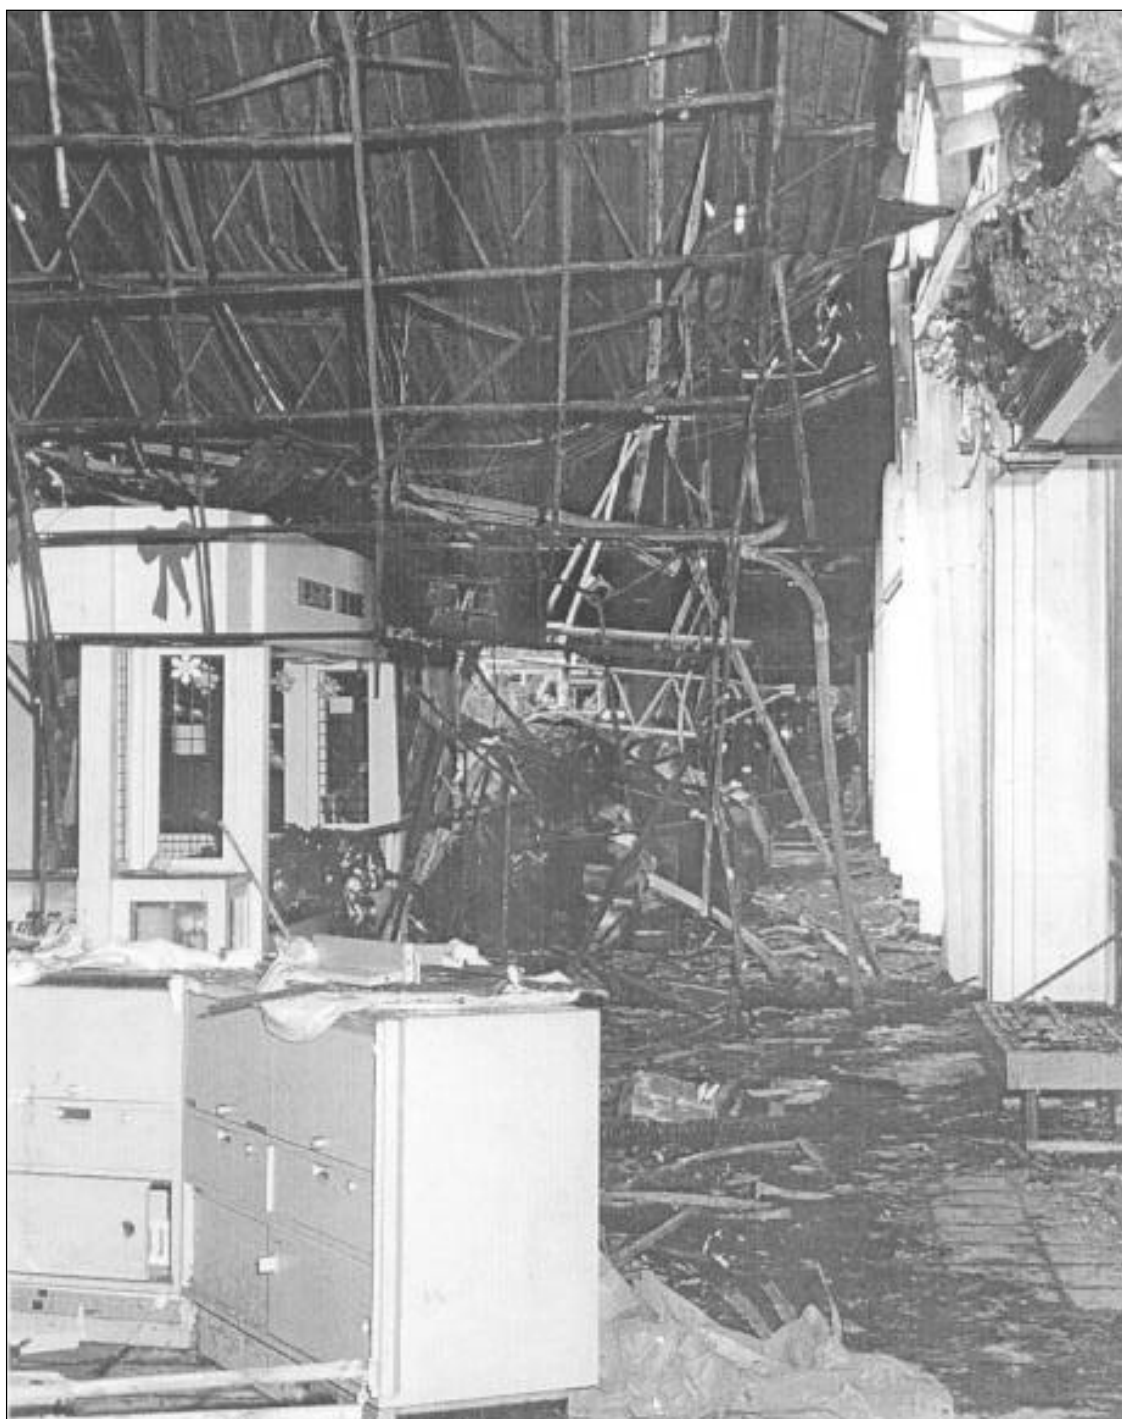
The fire damage and collapse of the covered mall roof was attributed to fire spreading under the metal deck roof. The fuel for this fire was the melted and vaporized asphalt from the adhesive and vapor barrier above the metal deck and under the roof insulation. This flammable vapor leaked into the building through the seams in the metal deck where it ignited. This combustion melted and vaporized more asphalt, creating a self-sustaining fire under the roof deck. The undamaged combustible kiosks at floor level further support this observation and also document the effectiveness of firefighter tactics and operations in this area.

Photo 6. Moving further east in the covered mall, the counters in the foreground are also in Photograph 3. This area is where the metal roof began a partial collapse. The goods in the kiosks were either stored before the fire or removed prior to the picture.

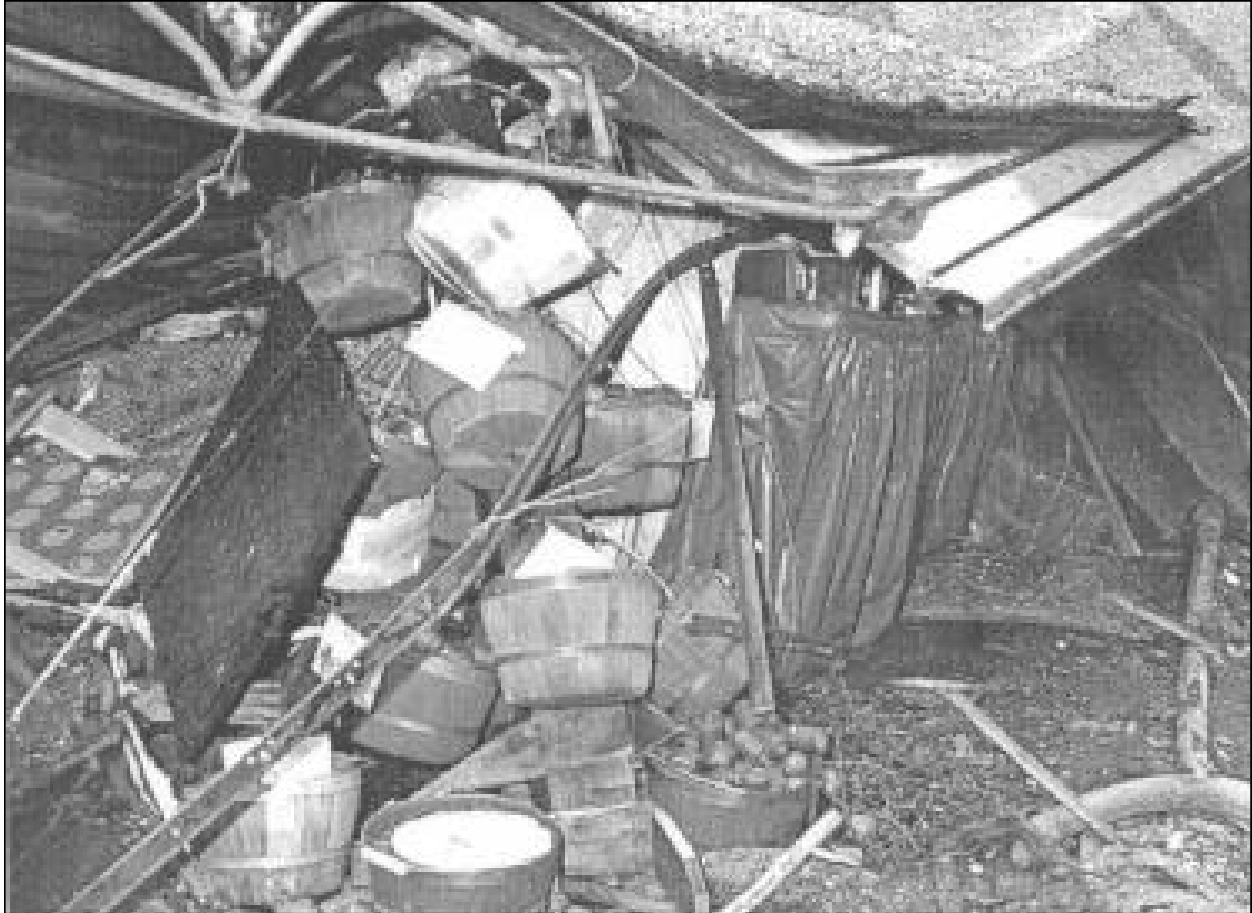
The fire and heat spread for a considerable distance in the covered mall area from in front of the G. C. Murphy store east to the food court. The covered mall's roof collapsed for about 60 feet to the east of the G. C. Murphy store. Further to the east, a roof section approximately 80 feet long was left standing but showed signs of burning on the underside of the deck. A kiosk below this section suffered only smoke and water damage. East of the standing section, another part of the roof collapsed in a lean-to fashion for a distance of approximately 60 feet. This collapse was due to the roof support beam on the south side rolling over. A candle kiosk under this collapse was not burned and the visible candles were not melted. One basket of candles was covered with melted tar, likely from the roof. (See Appendix F)

Photo 7. A candle kiosk under the roof collapse area shown in Photograph 6. Note that the candles, wicker baskets and table skirting are not melted or burned. Yet, the metal bar joist is severely deformed.

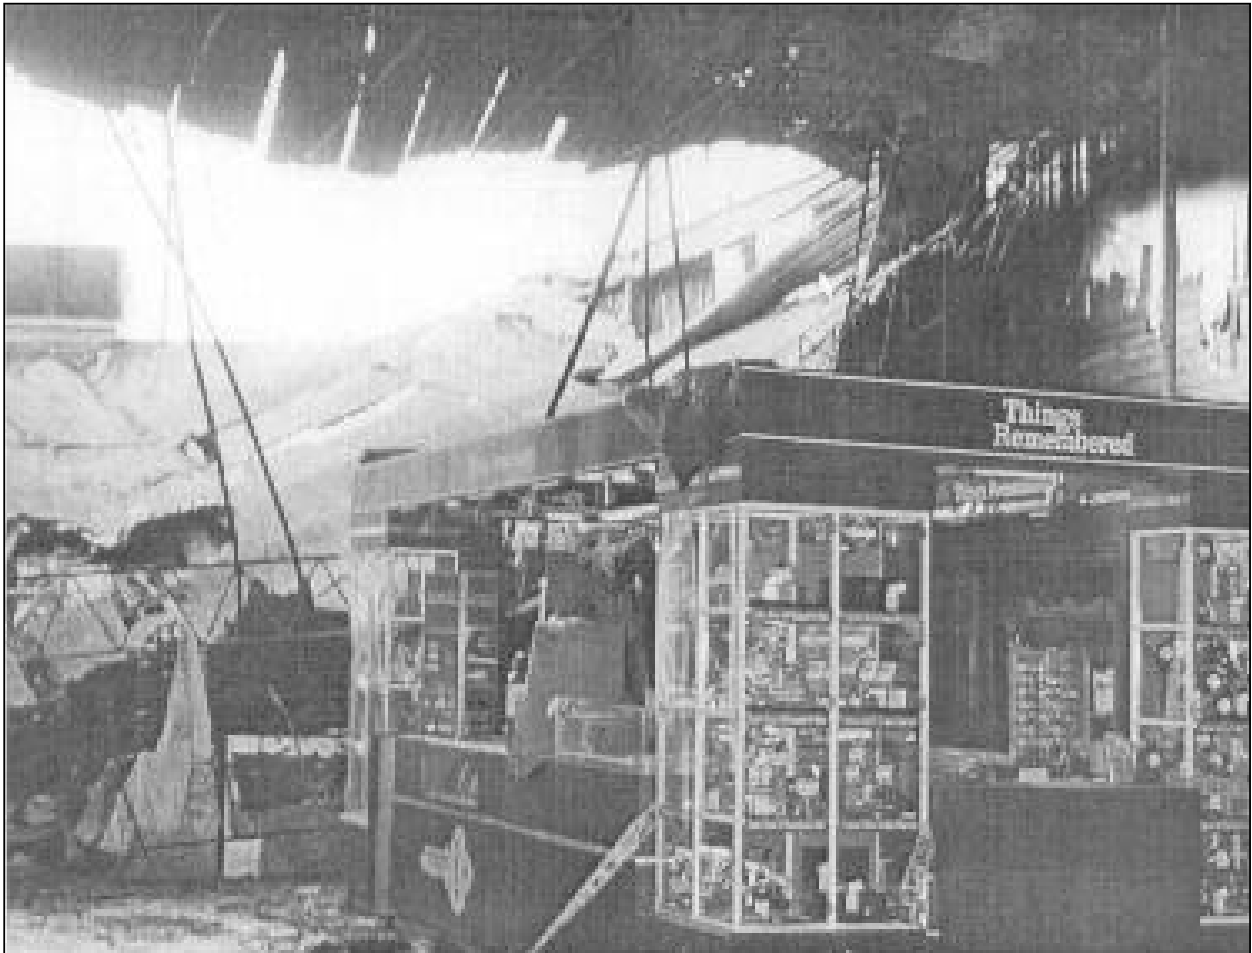
Photo 8. A front view of the partial roof collapse over the Things Remembered kiosk.

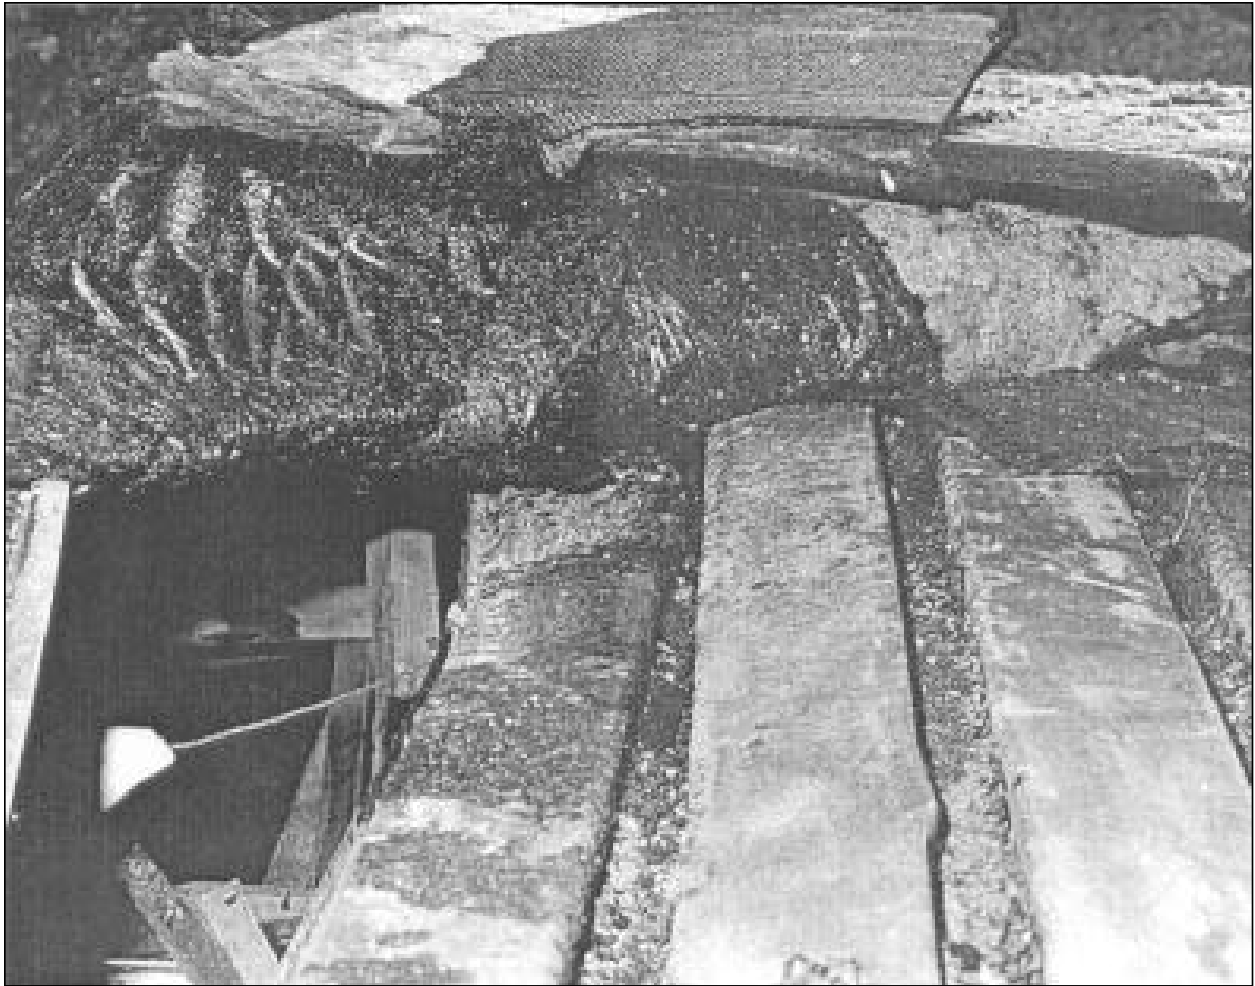
Photo 9. The top of the metal deck roof illustrating the insulation board, the vapor barrier under the board, the seam in the deck and the deformed condition of the metal. This section is in the partial roof collapse area shown in previous photographs.

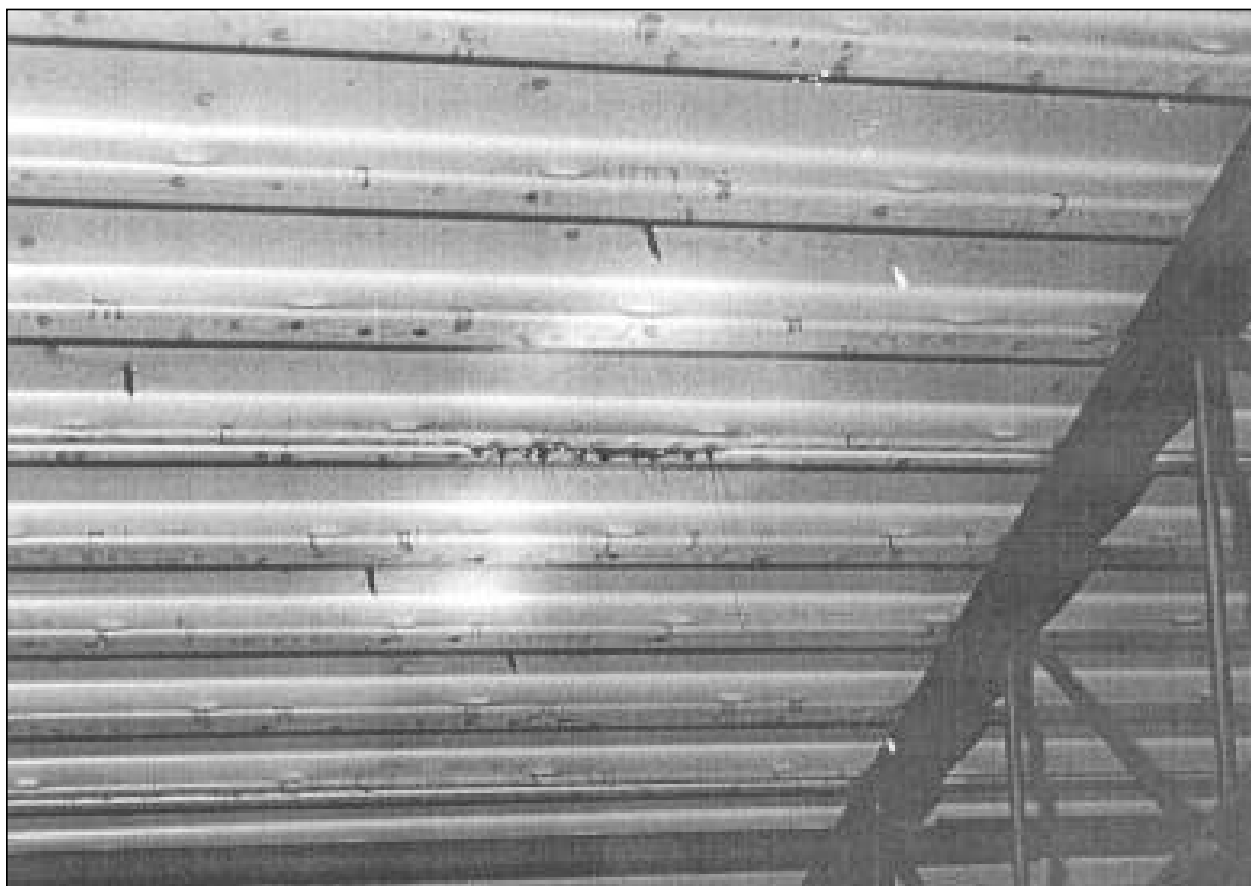
Recent re-roofings involved tearing off the combustible roof materials and replacing them with a Class I roofing system¹ with mechanical fasteners for the insulation board. However, the complete removal of the combustible asphalt from the metal deck is difficult to accomplish.

Therefore, even where a Class I roofing system had been installed, fuel supplies for a fire immediately under the metal deck remained. (See Lessons Learned for more on this type of fire.)

Photo 10. The underside of the metal deck roof above one of the stores adjacent to the covered mall. Note the tar dripping through the seam in the valley between metal deck sections. You can also see three mechanical fasteners poking through ridges in the deck. Such fasteners are usually found when less combustible roofing methods are employed.
