U.S. Fire Administration/Technical Report Series

Major Ship Fire Extinguished by CO₂

Seattle, Washington

USFA-TR-058/September 1991

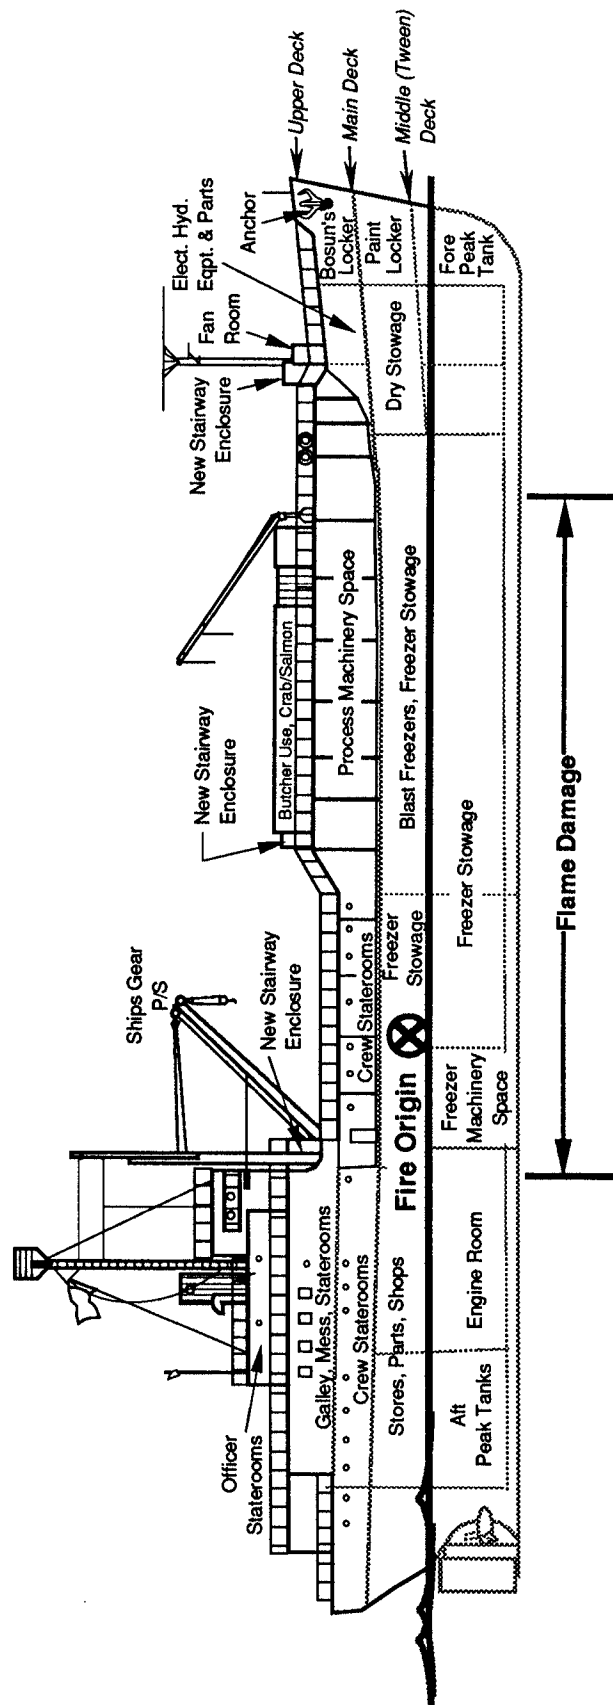
The Omnisea

Rather than fight the fire as a structure fire using water, the Seattle Fire Department's Marine Unit made the strategic decision to use carbon dioxide as the prime extinguishing agent. Handlines and monitors were used to cool hazardous materials stored on the deck, to cool the ship deck and hulls and to keep the fire from spreading to the pier. An interior defense was made of the aft third of the ship while the CO₂ was being set up. (See Appendix B for diagram of the *Omnisea*.)

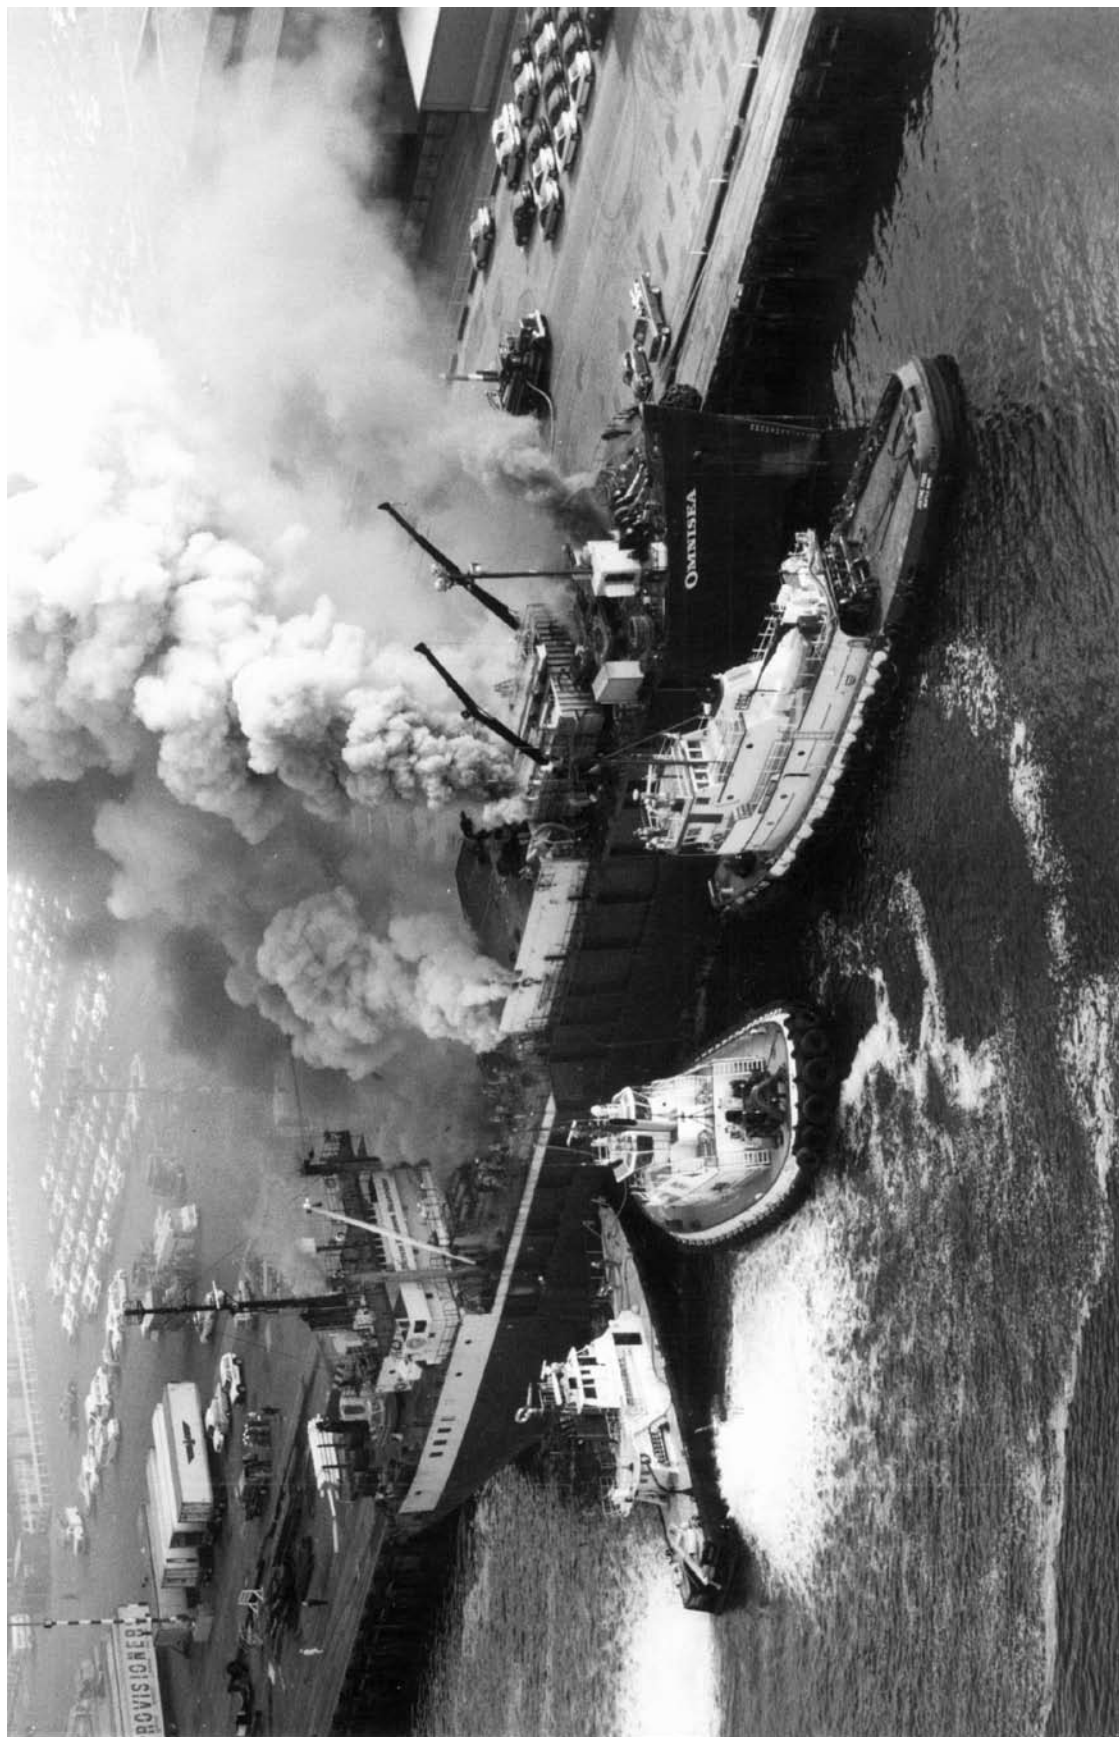
A tug and two fireboats alongside the Omnisera during the fire.
Note at least nine firefighters visible on board on the starboard side amidships.

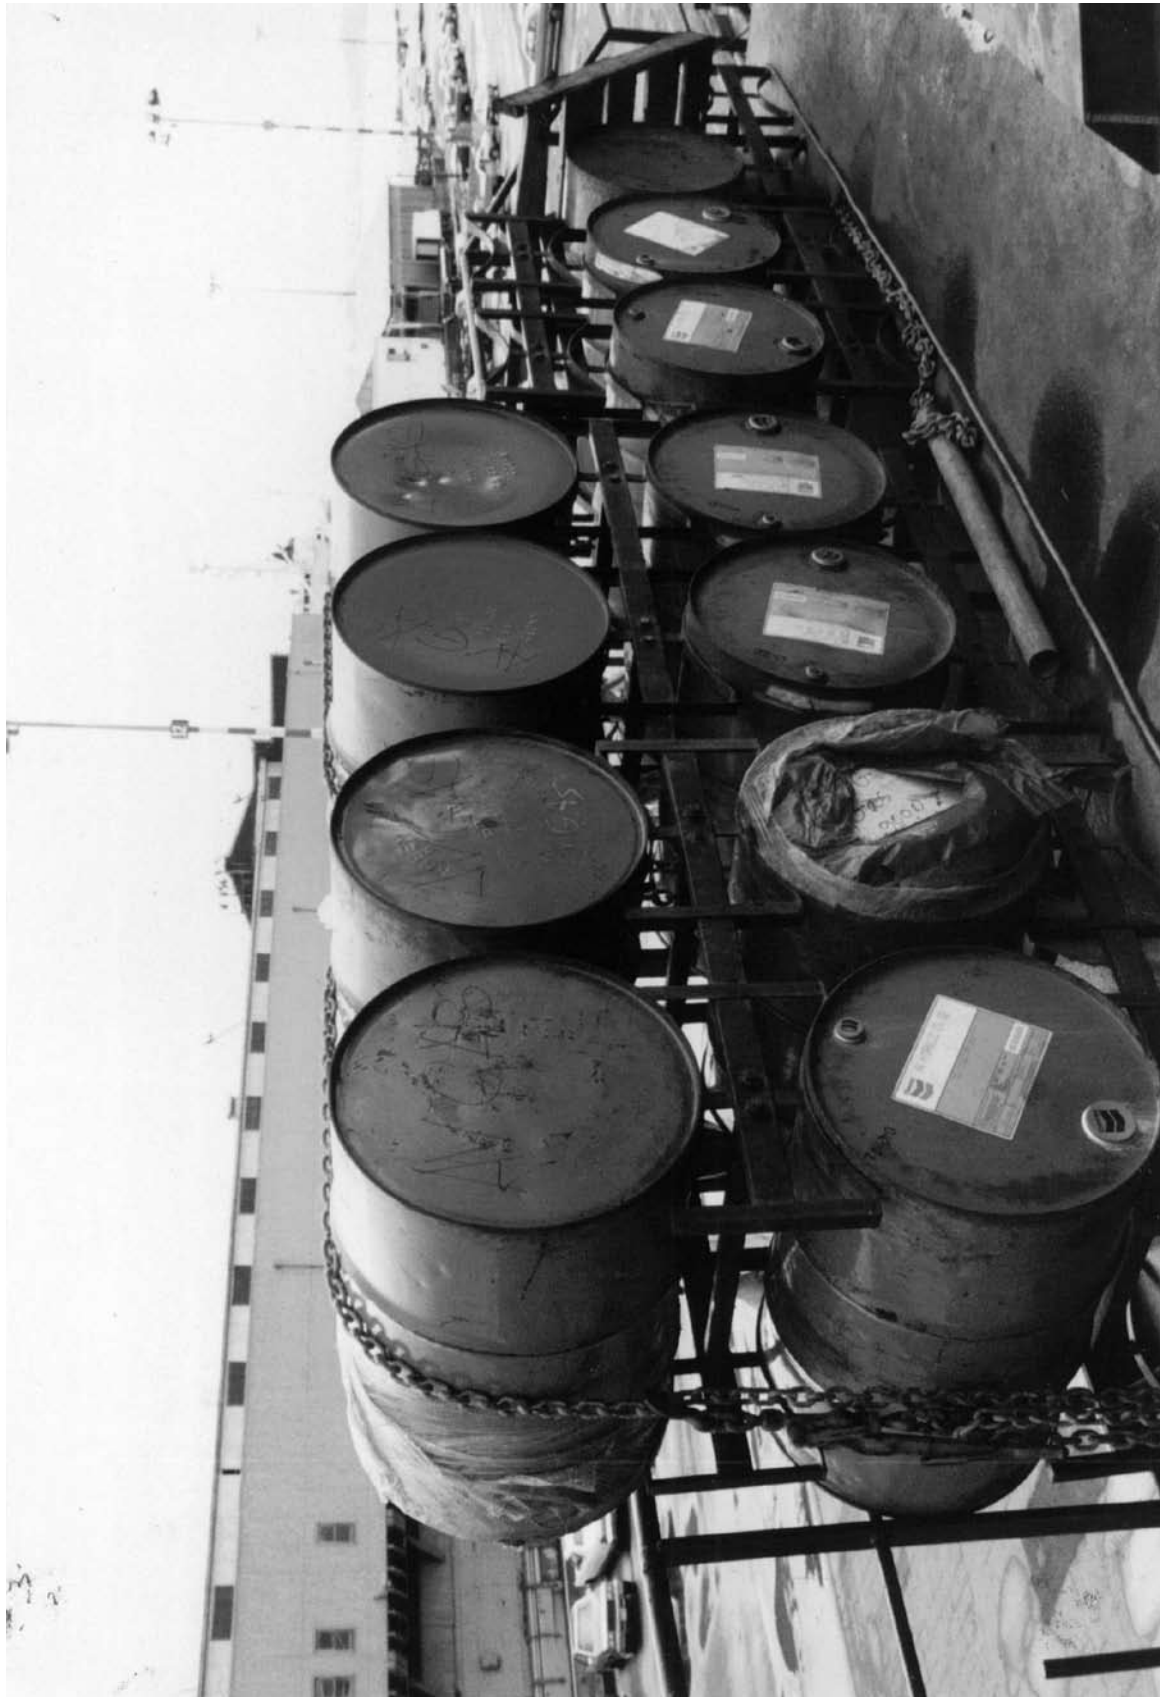
| Issues | Comments |
|---|---|
| Hazardous Materials | Large quantity of ammonia in tanks and refrigeration piping posed an air Hazmat threat; ship fuel oil posed a water pollution threat. Acetylene and aviation gasoline also present in drums. |

Drums of aviation gasoline and other petroleum products.

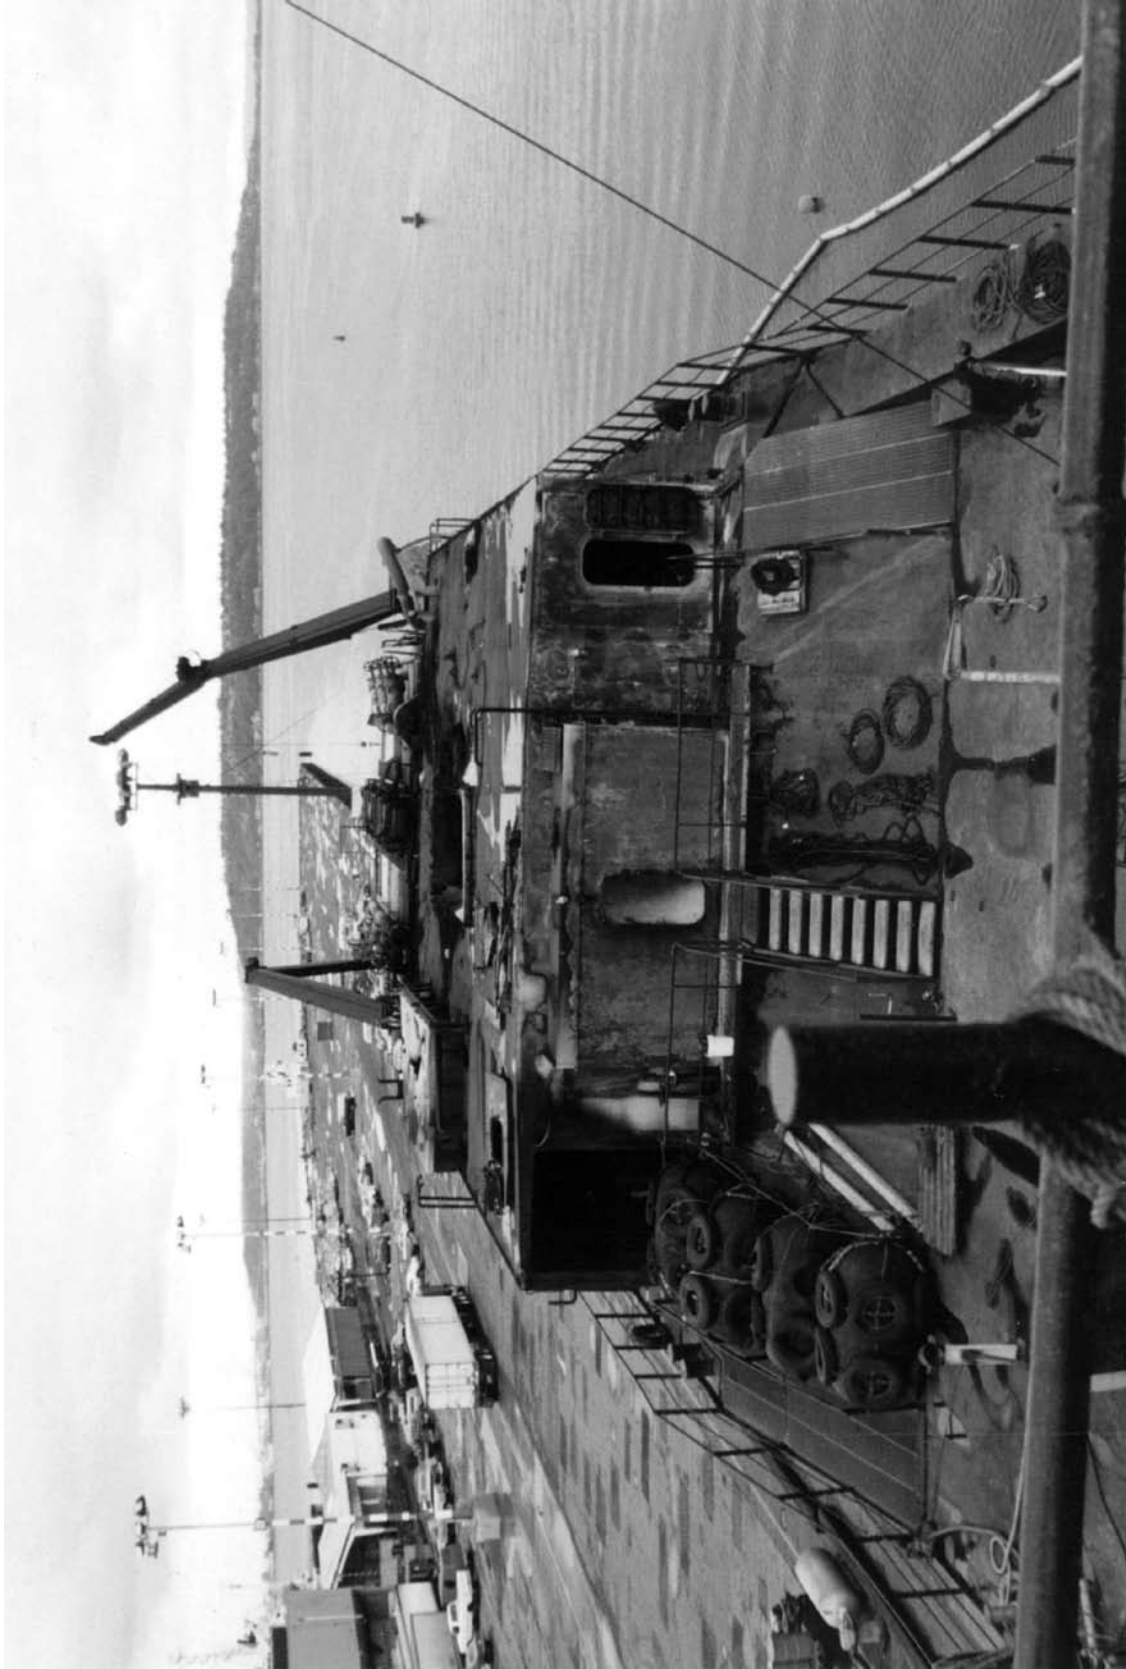
View from superstructure looking aft. Fish receiving house on deck. Major columns of fire and smoke came up from tween deck through square hole in the center of the "house." Another hatch and that hold had to be sealed.

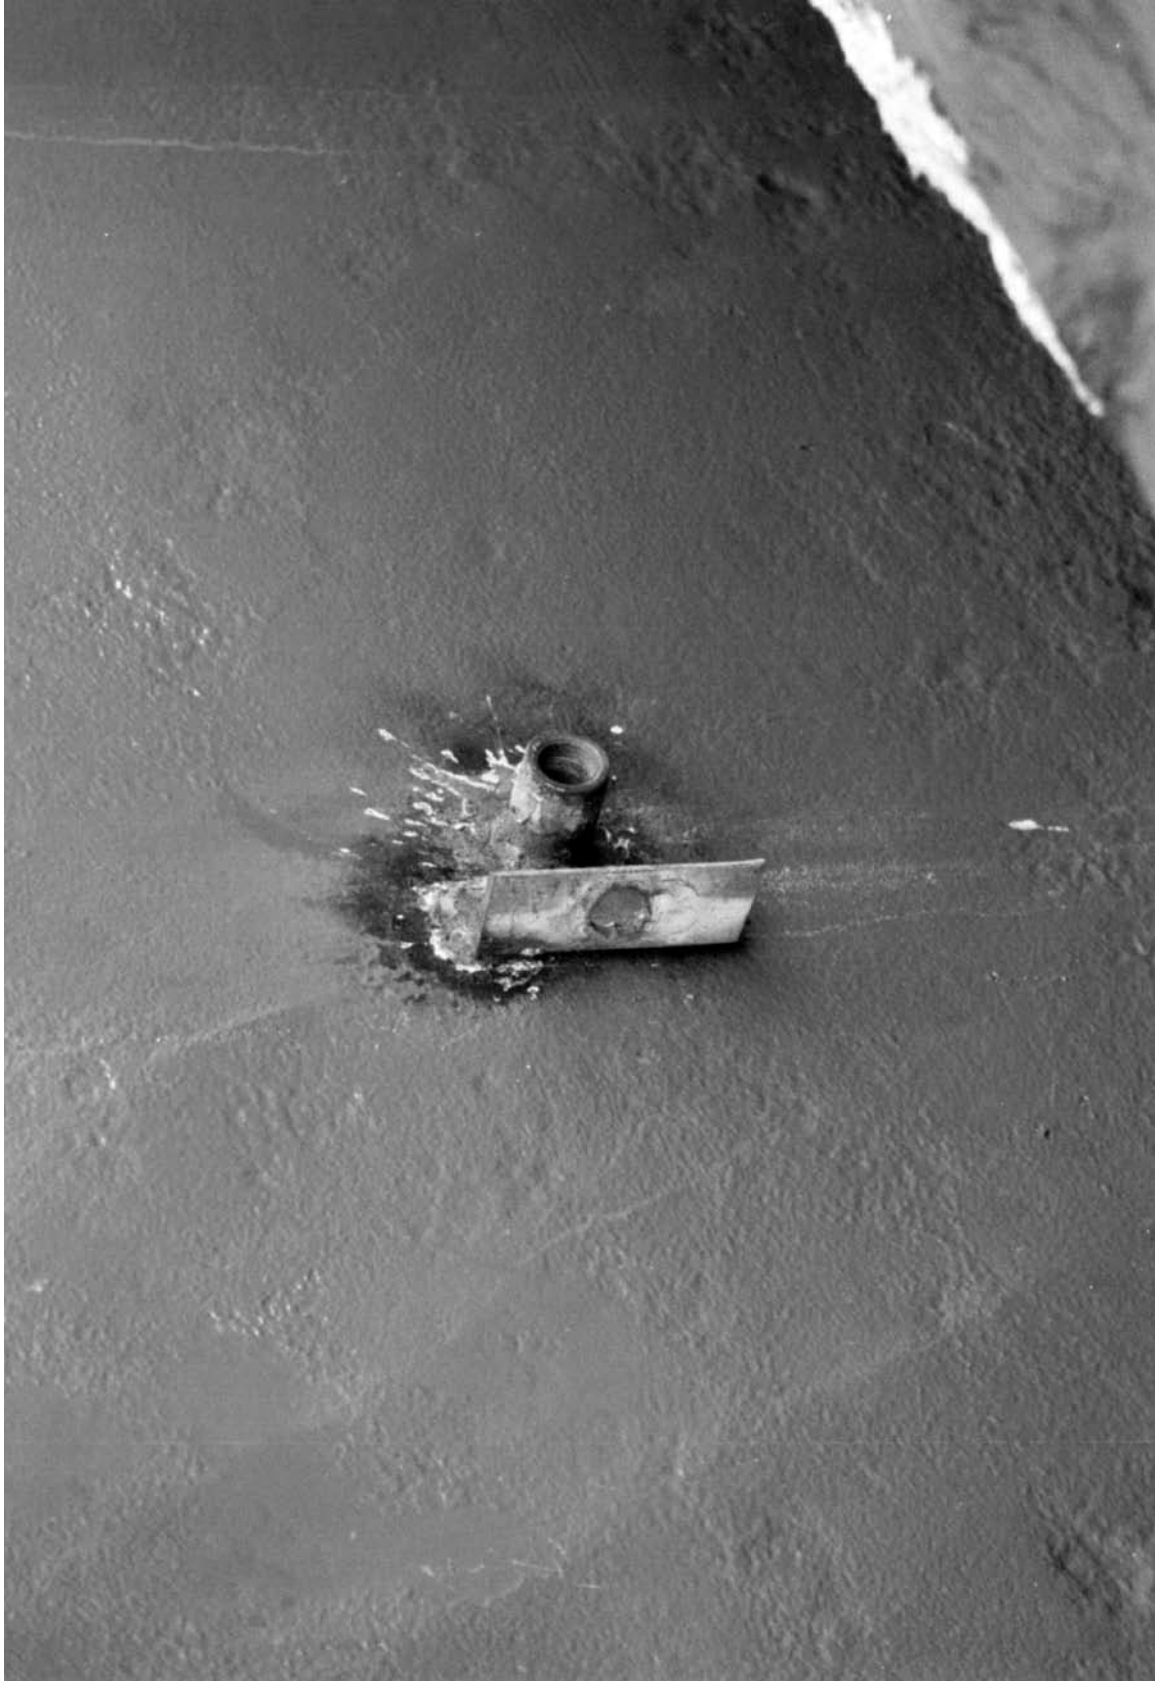
And as previously noted, the city's **Water Department** helped drill holes in the side of the ship for the CO₂.

Closeup of hole used to insert CO₂ with coupling welded into place.

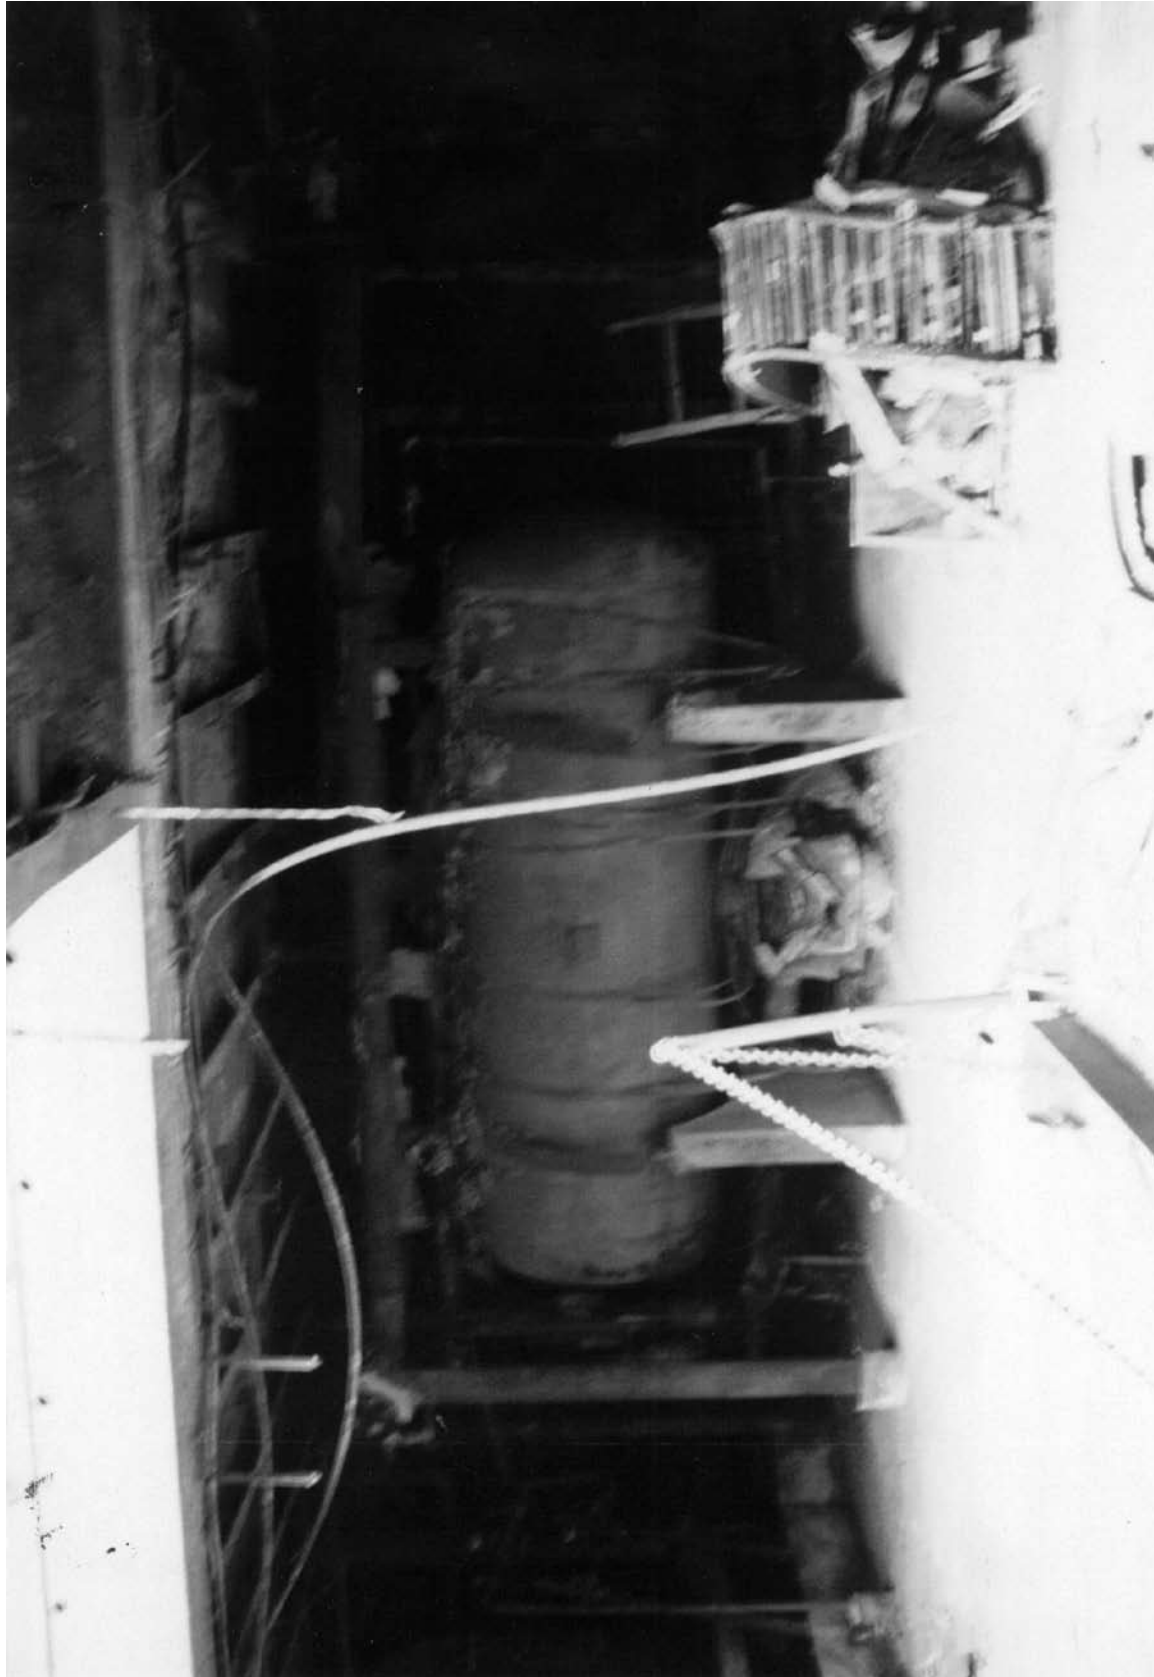
A concern during the fire was whether the CO₂ might accidentally be injected directly on the ammonia tank in the tween deck Number 3 hold and whether that would cause the tank to crack or lose strength and fail catastrophically. It turned out that they missed it by about five feet. The tank survived with its structure intact and was not deformed. The pressure relief valve apparently proved

adequate for this size tank, though there also may have been ammonia leakage from piping damage during the fire; there was considerable fire damage to the piping, gaskets and valve.

Ammonia tank in hold near fire origin.

Understanding whether flame impingement will cause ammonia (or similar) tanks to blow or whether the venting is sufficient for different size tanks would be useful. Also, would CO₂ impingement on the heated tanks of hazardous materials cause them to crack while being heated?

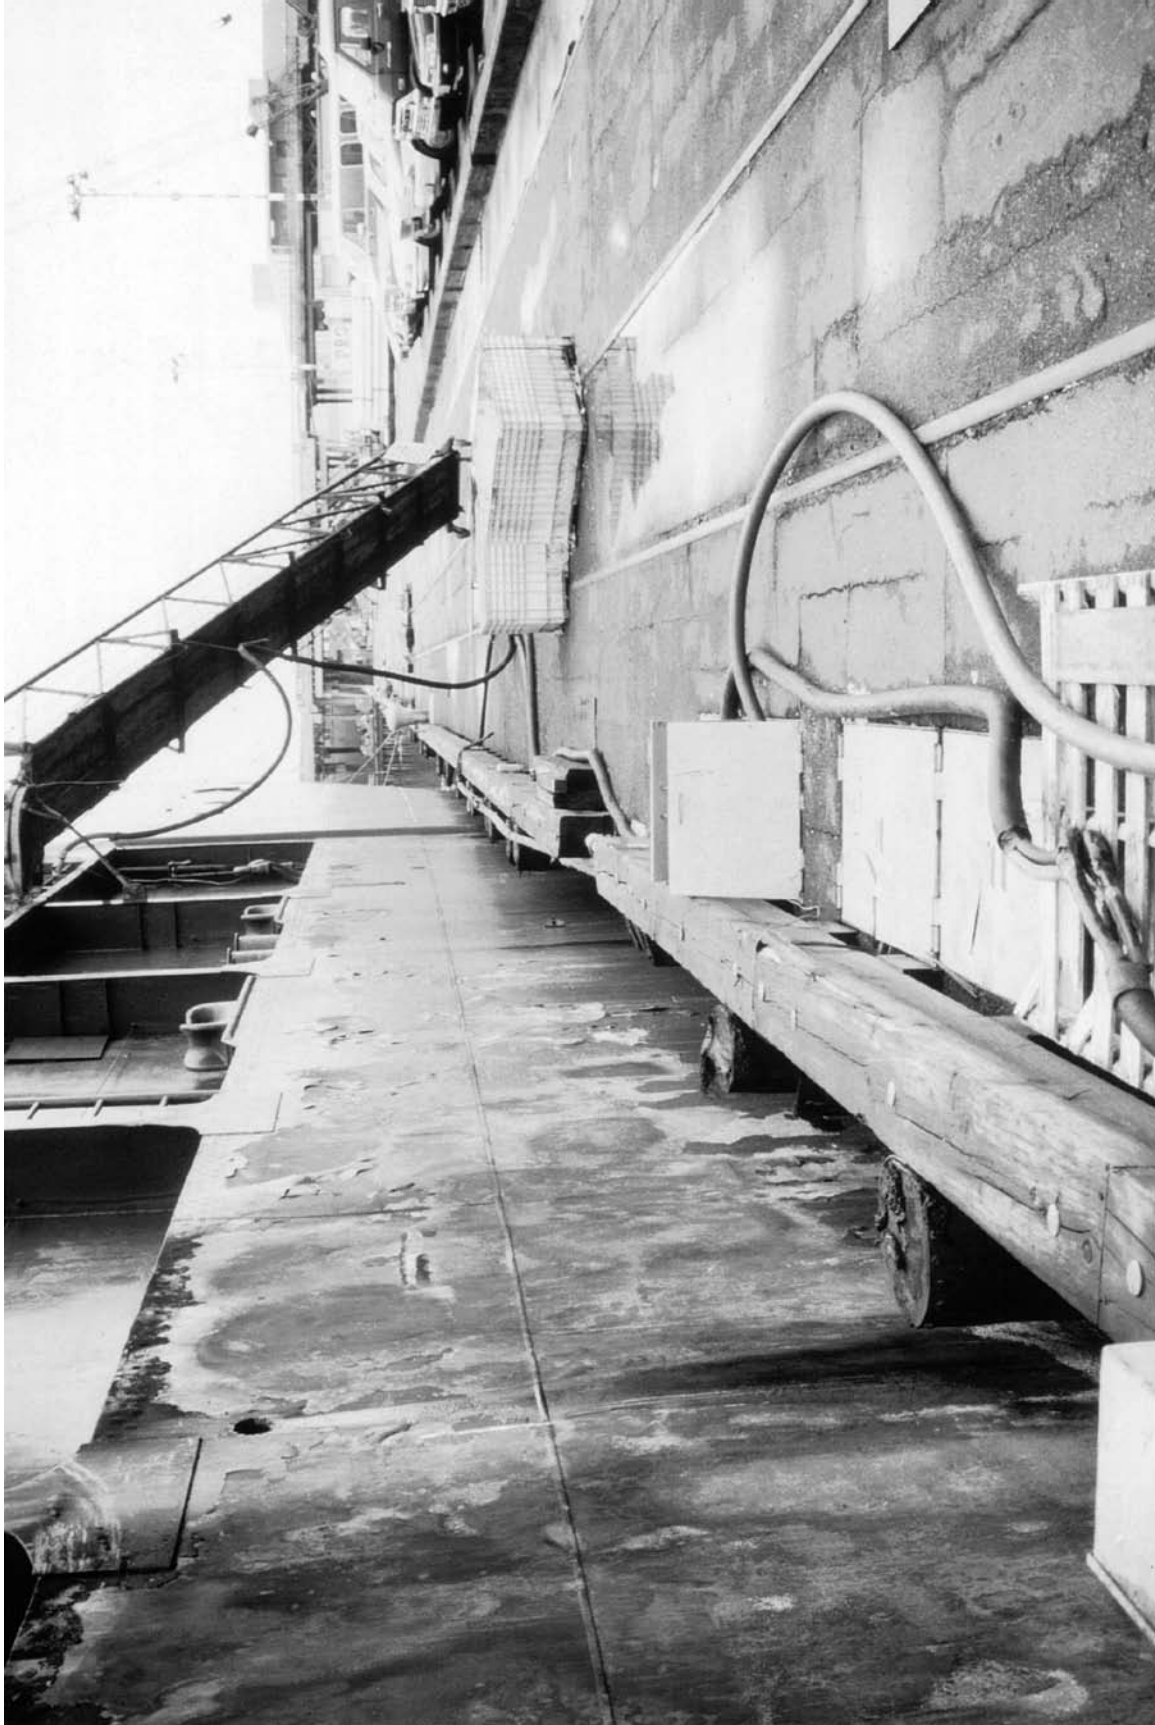
From the Pier, fire damage is noticeable on the hull of the ship in the midships area on both port and starboard sides. This damage is in the form of blistered paint, warped and deformed hull sections and metal discoloration from heat. The aft 1/3 of the vessel appears to be undamaged externally while the forward 2/3 shows the described hull damage. On the deck surfaces, the same type of damage is reflected with the rear 1/3 undamaged. All water tight doors and portholes on the forward exterior 2/3 of the ship showed smoke and heat damage. Heavy black smoke staining is seen coming from all openings and all deck areas have a mild to severe degree of warping and heaving due to heat.

A line of demarkation on the hull is clearly seen at the 19' draft mark with the fire damage above. This is noted on the port side with the greatest amount of exterior hull damage at a point approx 210' from the bow. Starboard side damage mimics the port side but to a lesser intensity. Viewed from the port side, the greatest degree of damage to the hull is located amidships at a point approx 2 decks below the main deck.

Port side – maximum discoloration near Hold #3; paint in good condition toward bow; note that the hull did not buckle.

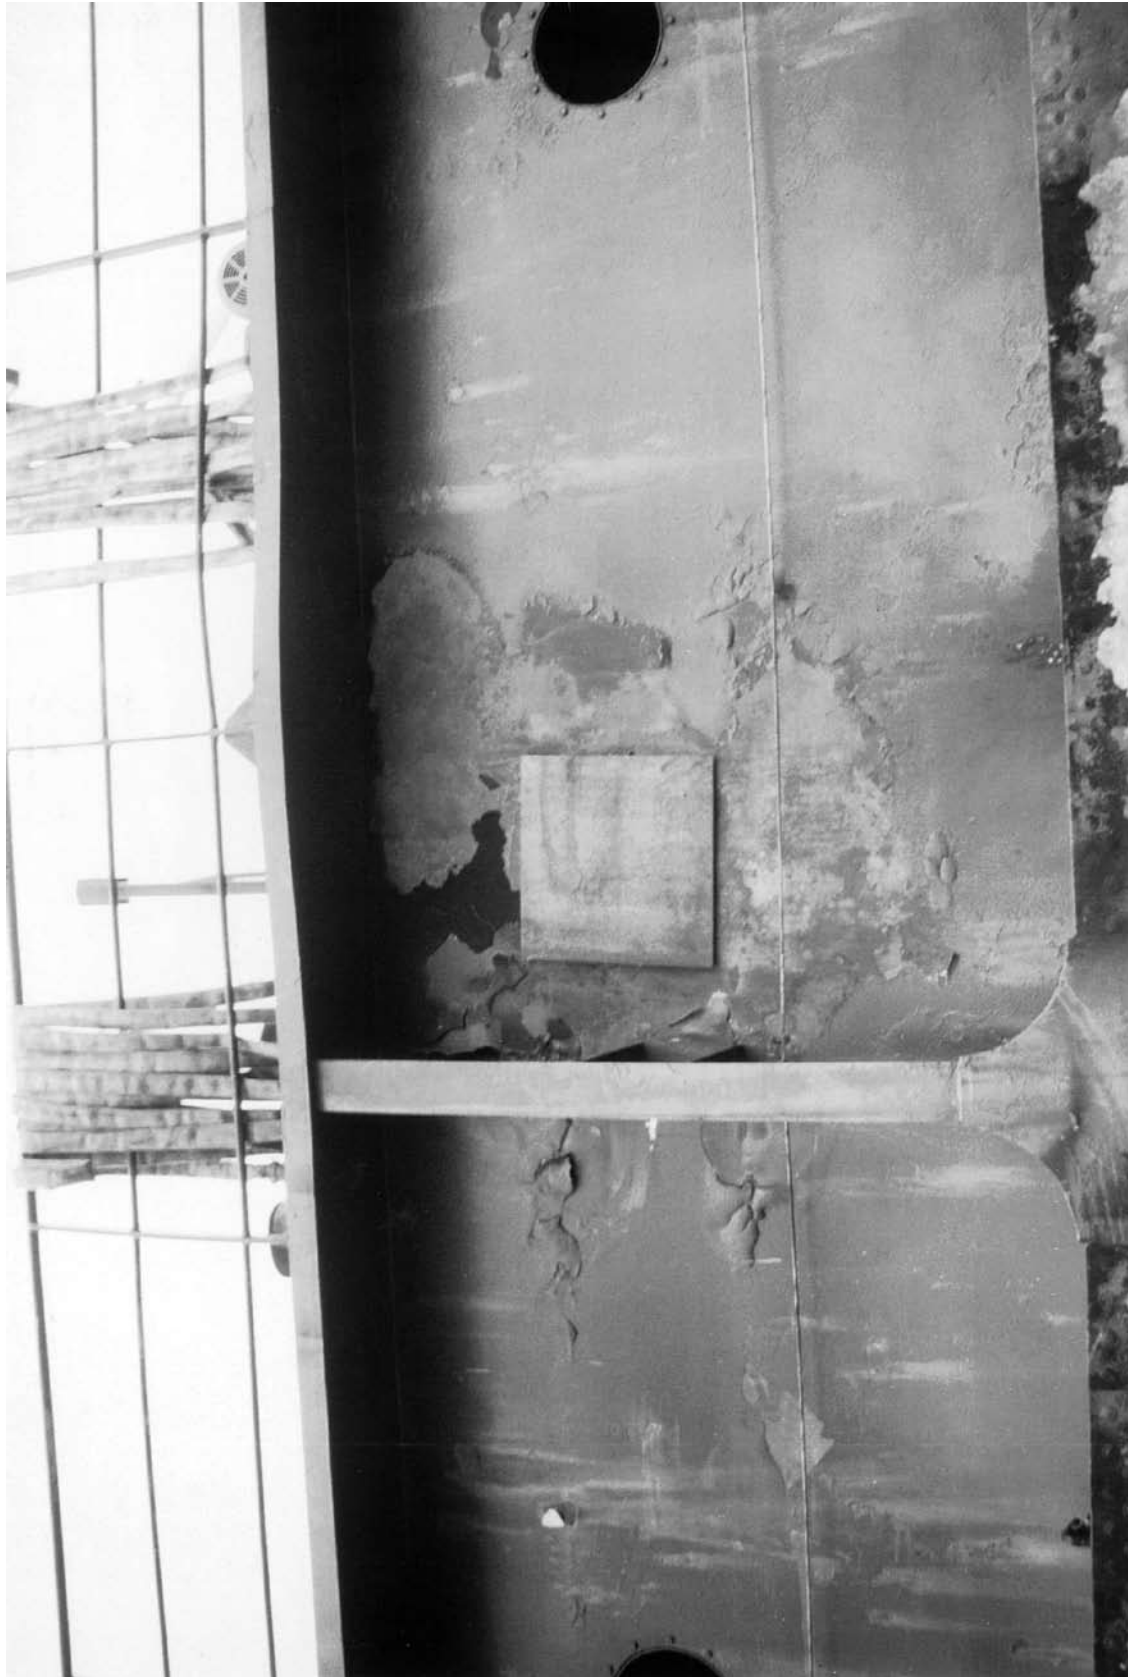
Small steel plates also were cut and welded in place over broken portholes. Other portholes and small vents were covered or stuffed with tarpaulins and other handy materials.

Steel plate welded over porthole as part of buttoning up the ship prior to CO₂ insertion. Adjacent portholes were stuffed with materials to seal them. Note buckling of deck and railing from heat.

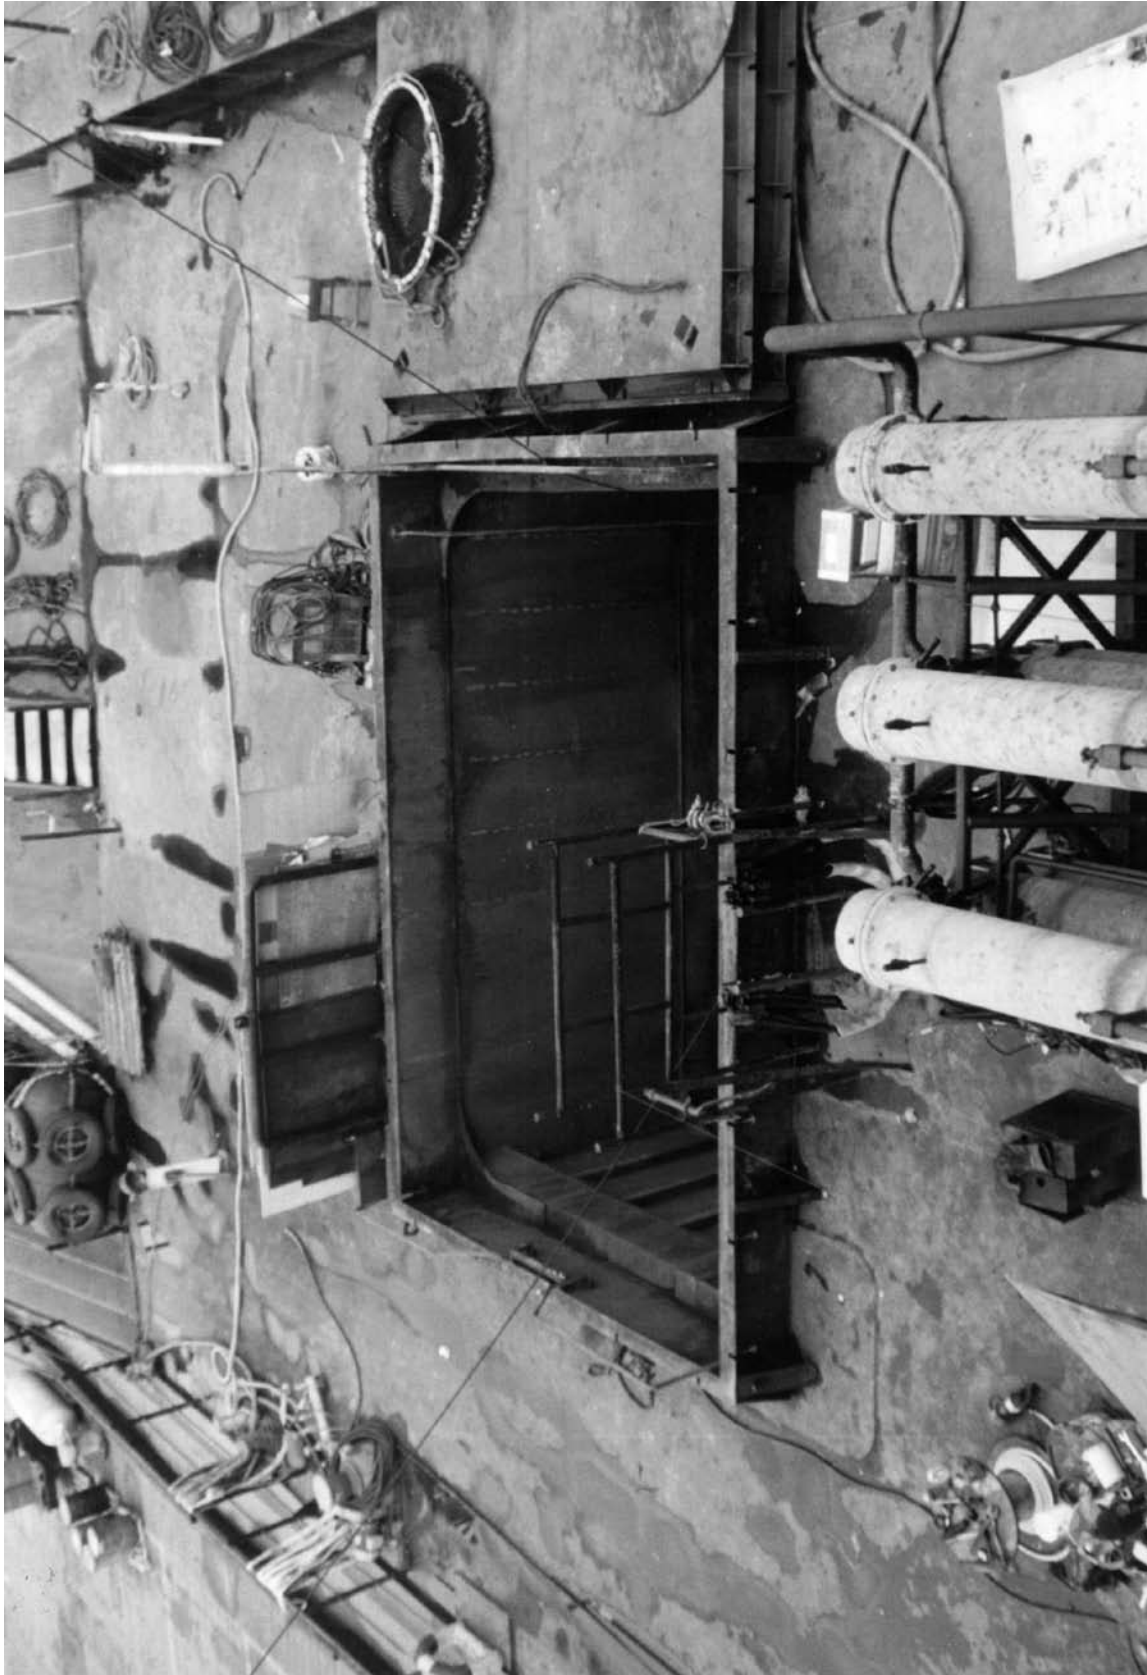
Some steel hatch covers on the ship were missing because the ship was undergoing repairs, and some aluminum hatches had burned through. Some portholes had been broken by the initial firefighting and others were blown out by the fire. All of these openings plus many others had to be sealed.

Hatch opening to holds; it, too, had to be sealed.

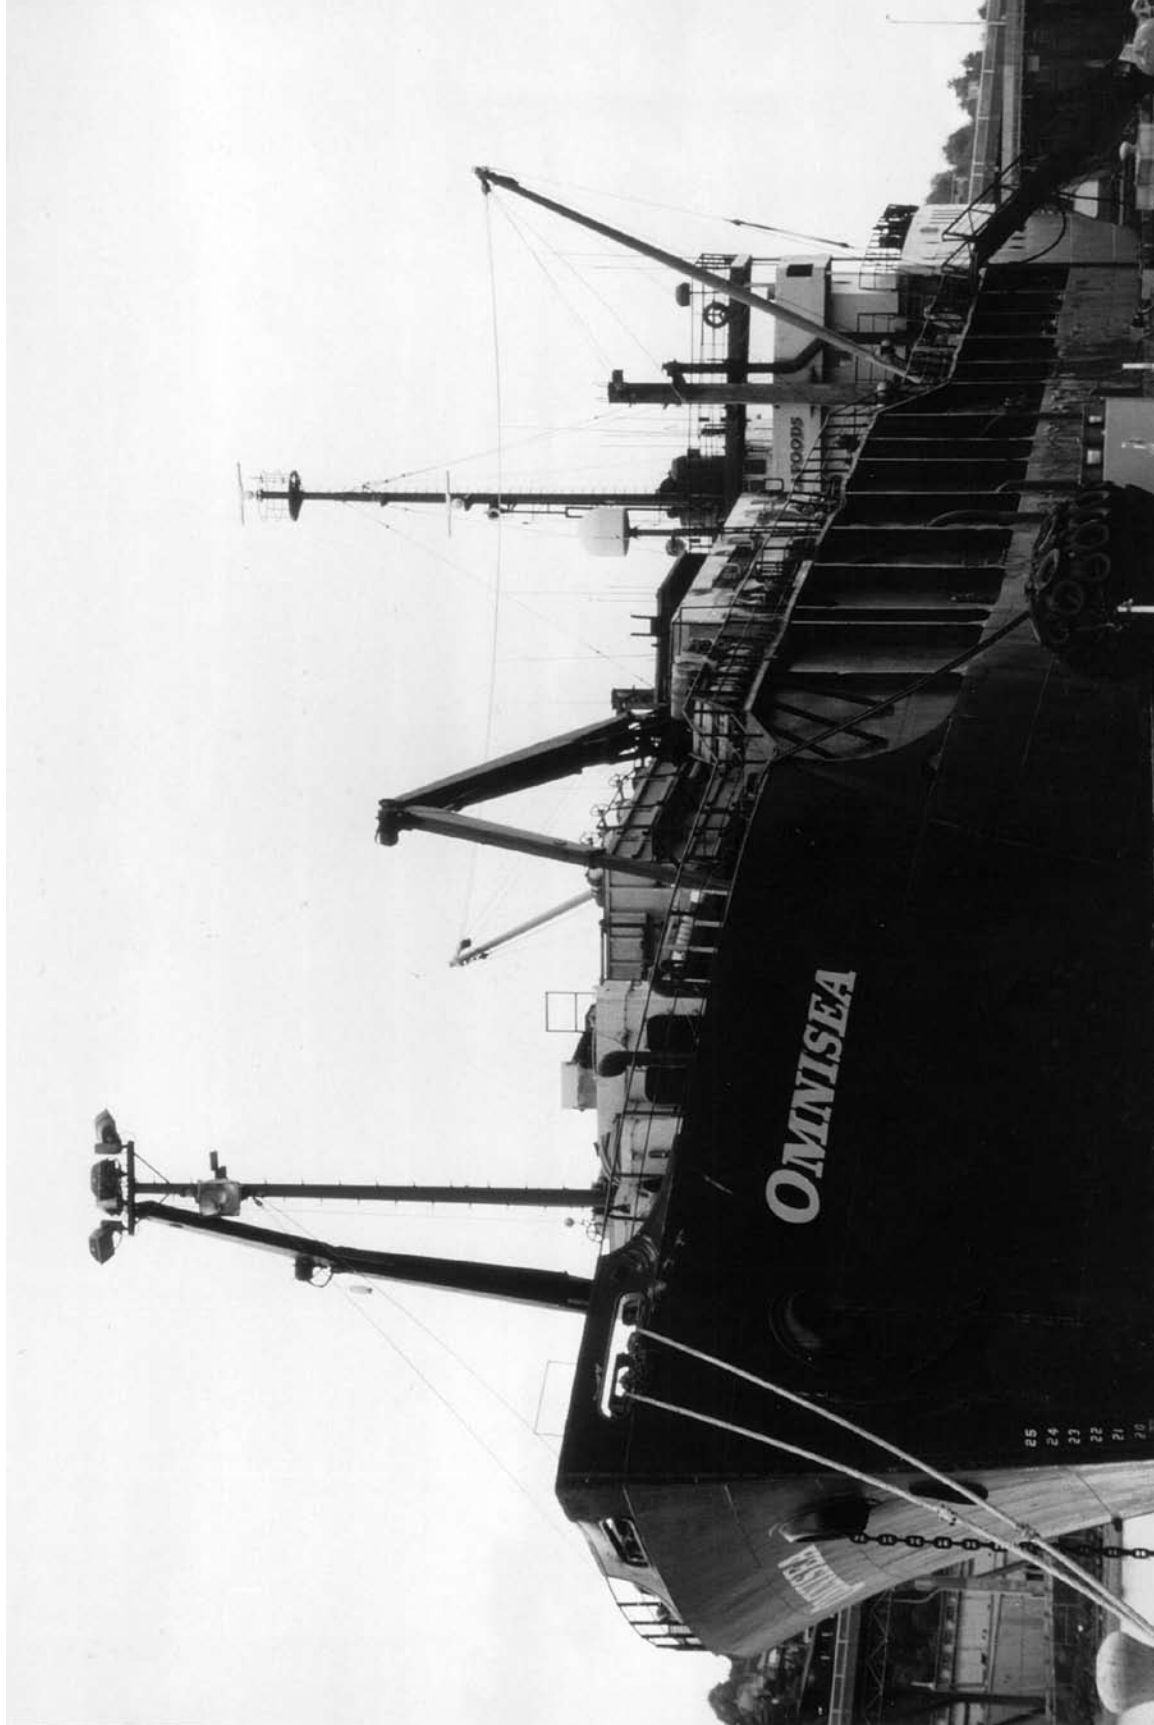
Bow of Omnisea. Note amount of compartments and equipment on deck – a complex area for firefighting.

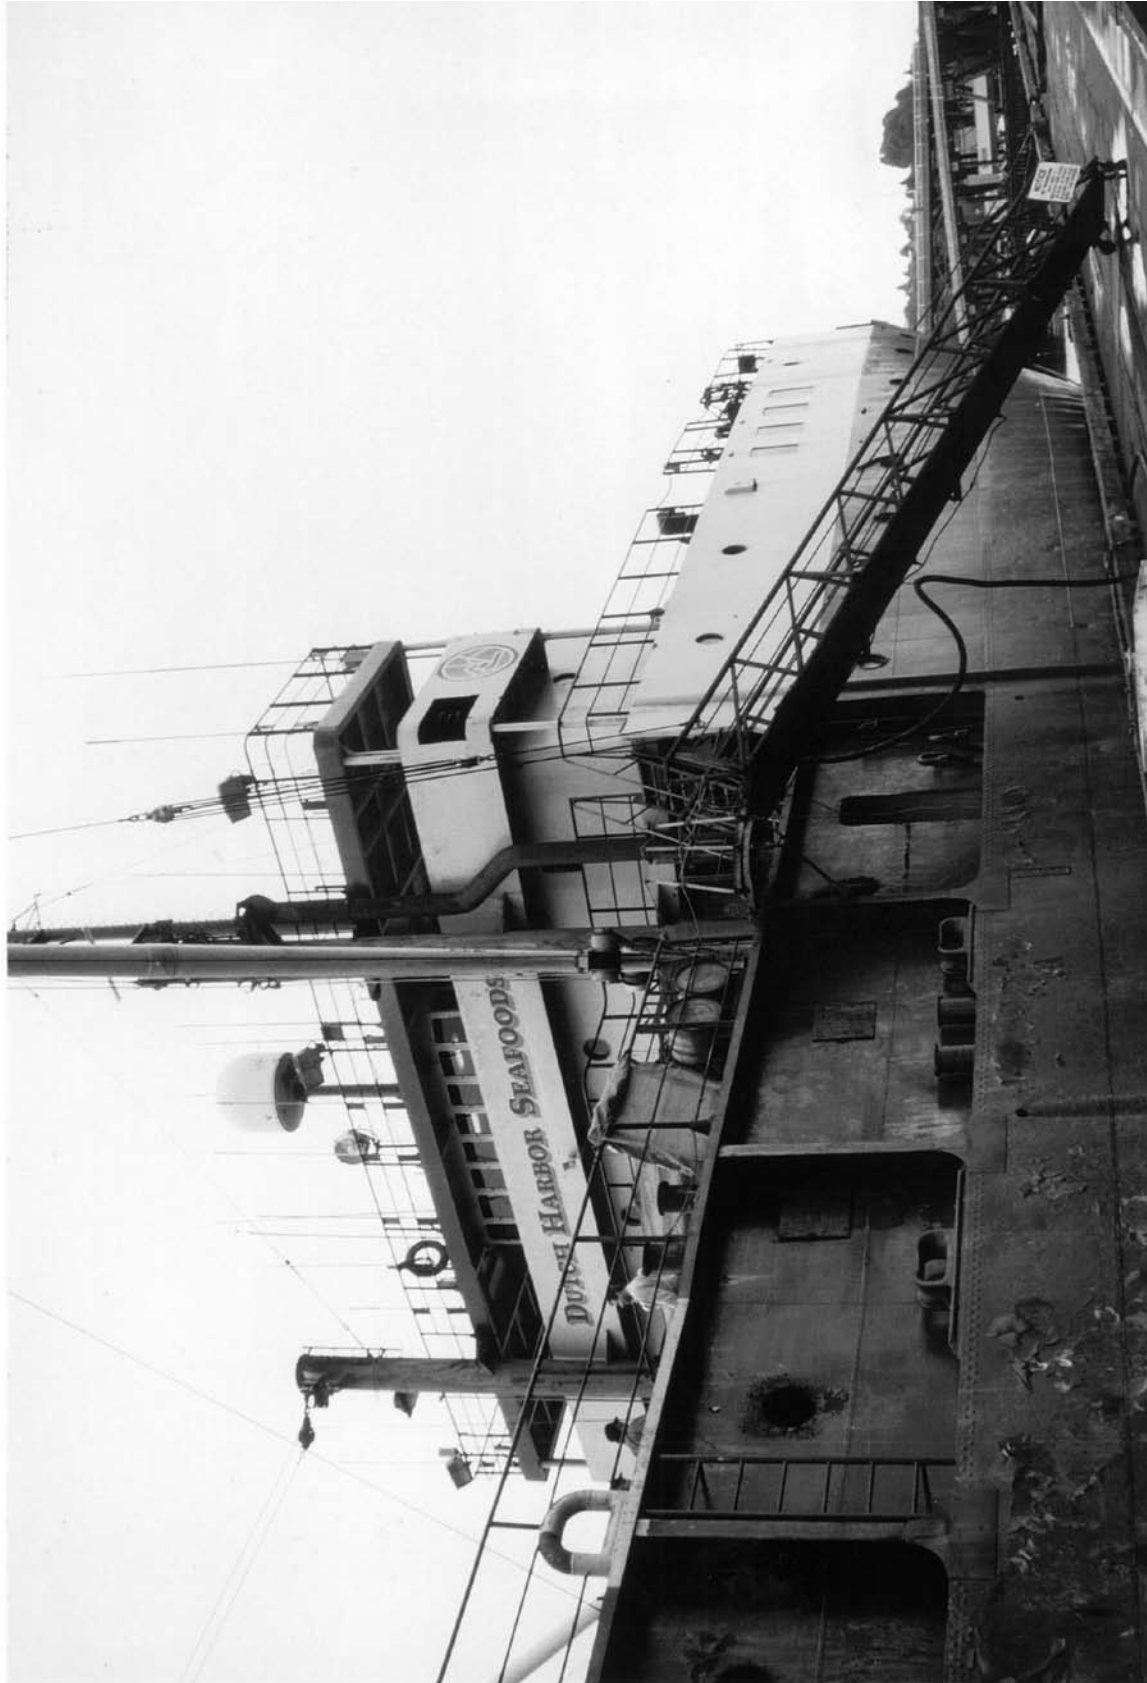
The fire department extinguished the fire with the CO₂ and saved the entire superstructure and engine compartment in the aft third of the ship. Damage was assessed at \$7-10 million. There were no serious injuries.

Aft third of the ship was saved, including ship controls, electronics, and engine room.
