# Manufacturing Mill Fire

Methuen, Massachusetts

USFA-TR-110/December 1995

Investigated by: Scott M. Howell  
Edited by: J. Gordon Routley

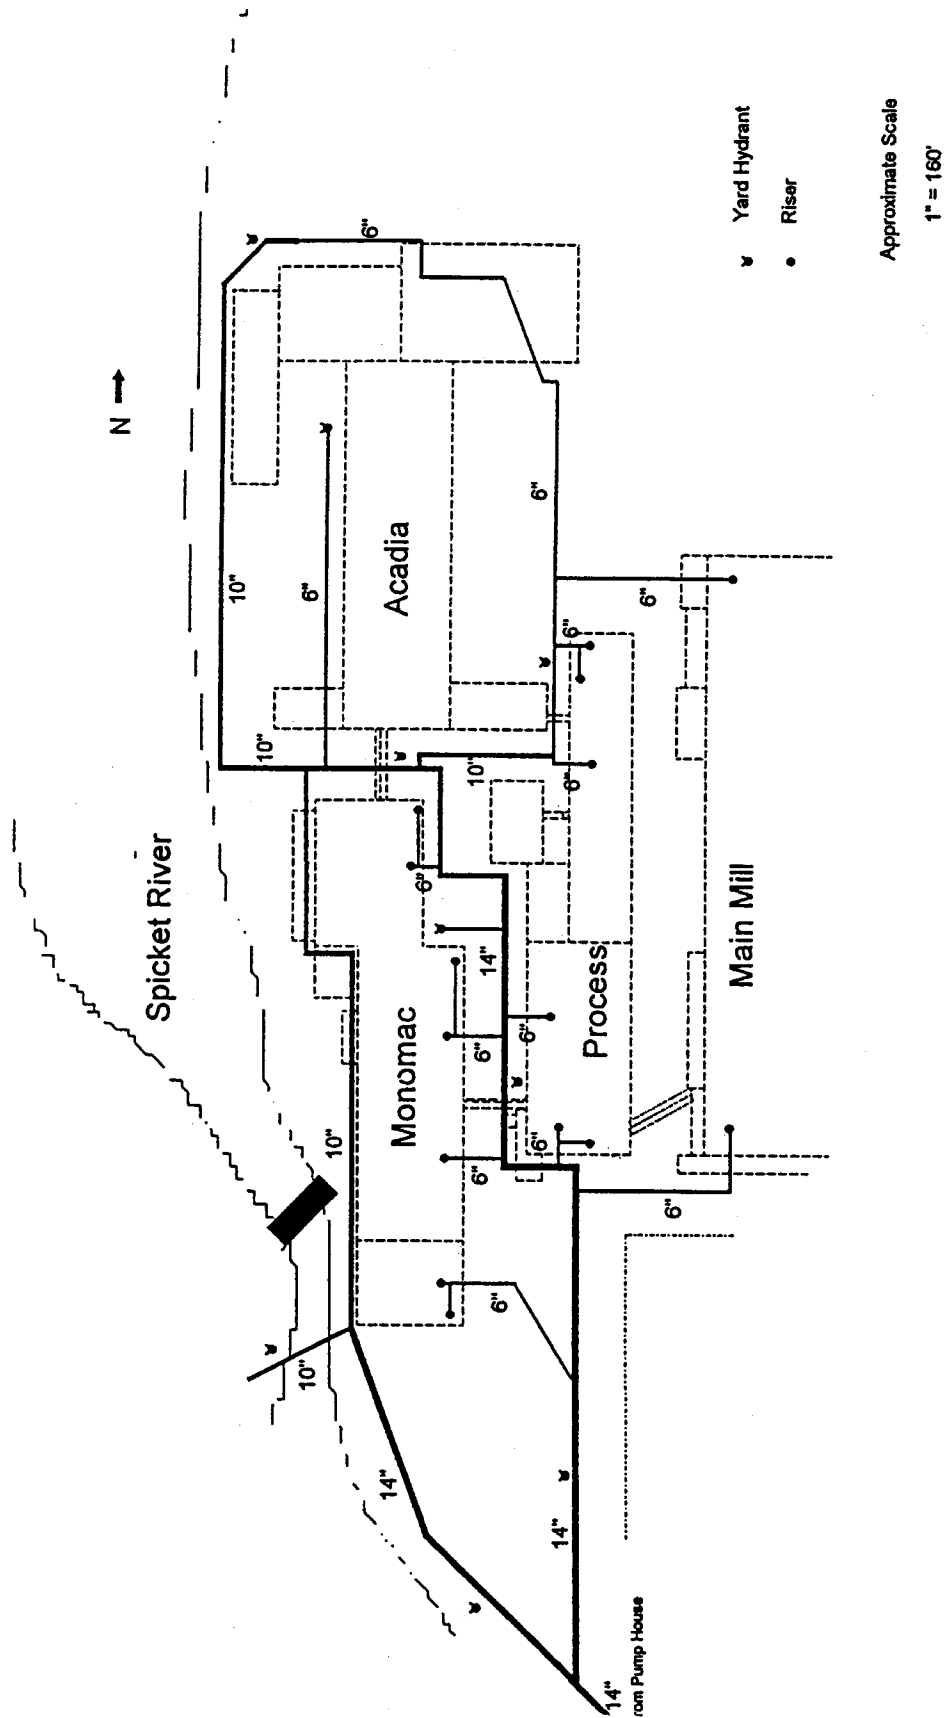
Figure 3. Private Water System

The on-site fire protection system was supplied by a 2000 gpm electric fire pump and a 2000 gpm diesel powered backup pump which both drew water from the river. Both pumps could operate simultaneously to supply a rated capacity of 4000 gallons per minute to the fire protection systems. A 750 gpm jockey pump was set to maintain a static pressure of 120 psi in this system. A 14 inch main delivered water from the pump house to the alley between the Monomac and Process Buildings. A 10 inch main was buried to the west of the Monomac and Acadia Buildings, parallel to the river, and the loop was completed by a 6 inch main. (Figure 3).

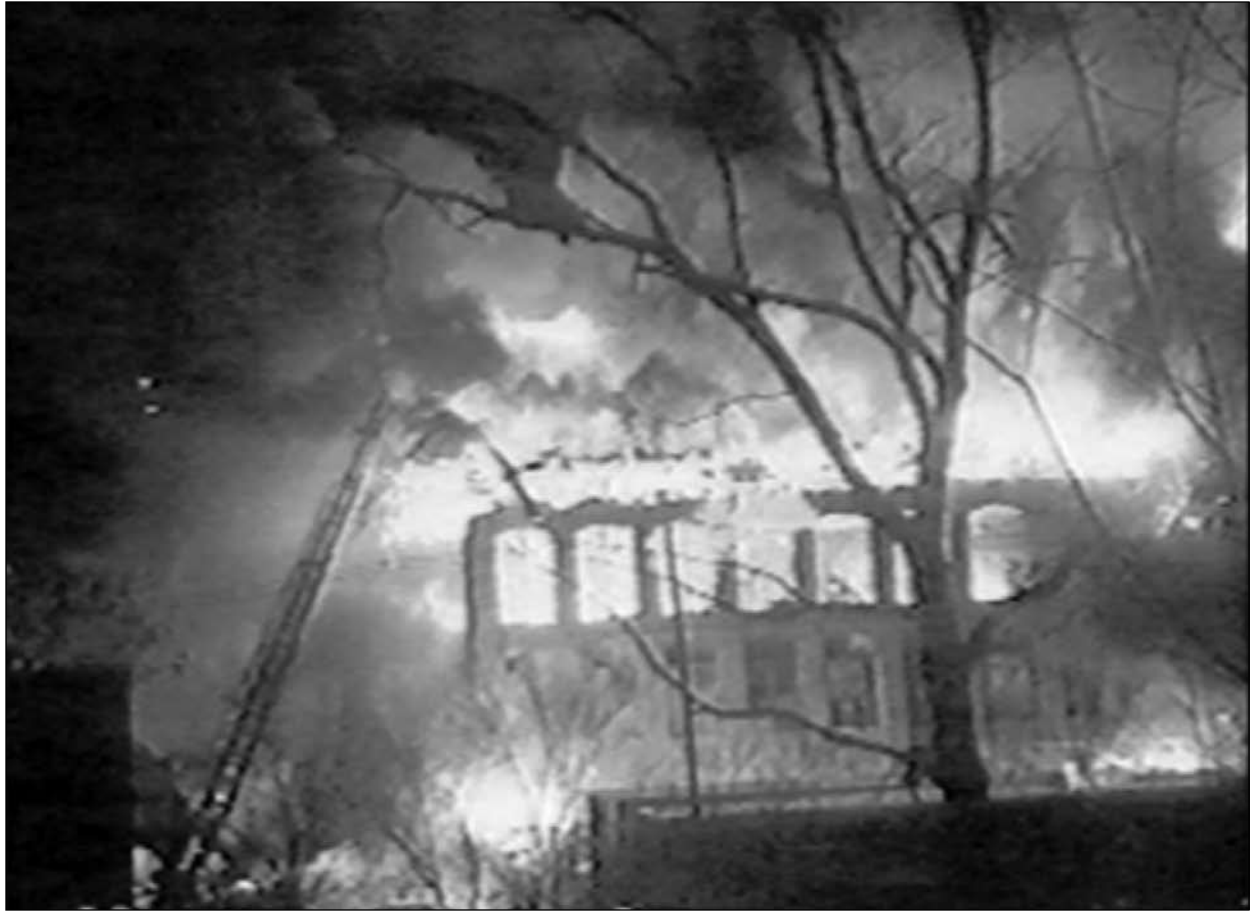
1. Ladder pipe operations near the northwest corner of the Monomac Building early in the fire. Vantage point was across the Spickett River.

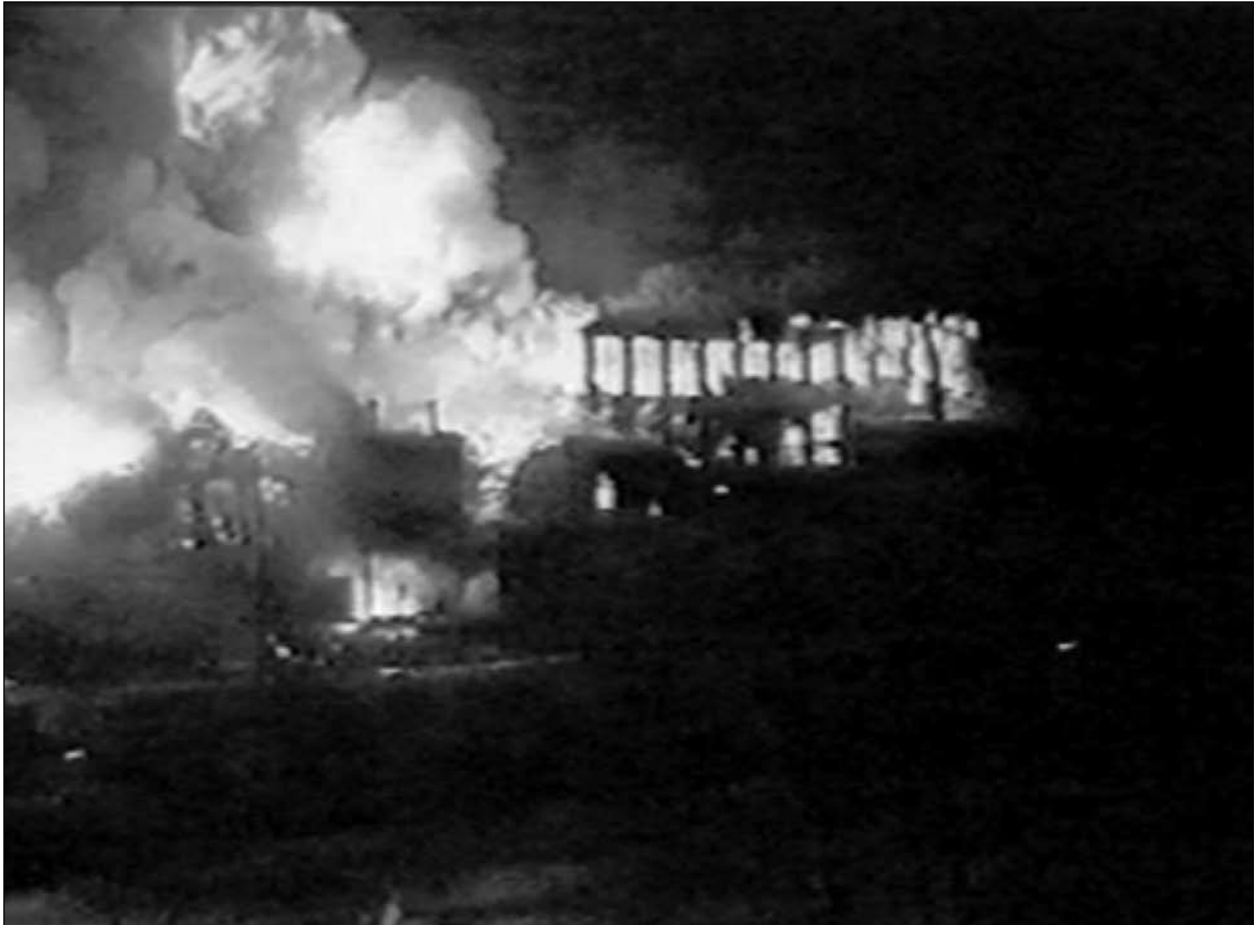
2. The fully involved west side of the Monomac Building; floors have collapsed as have some walls. Vantage point was across the Spickett River.

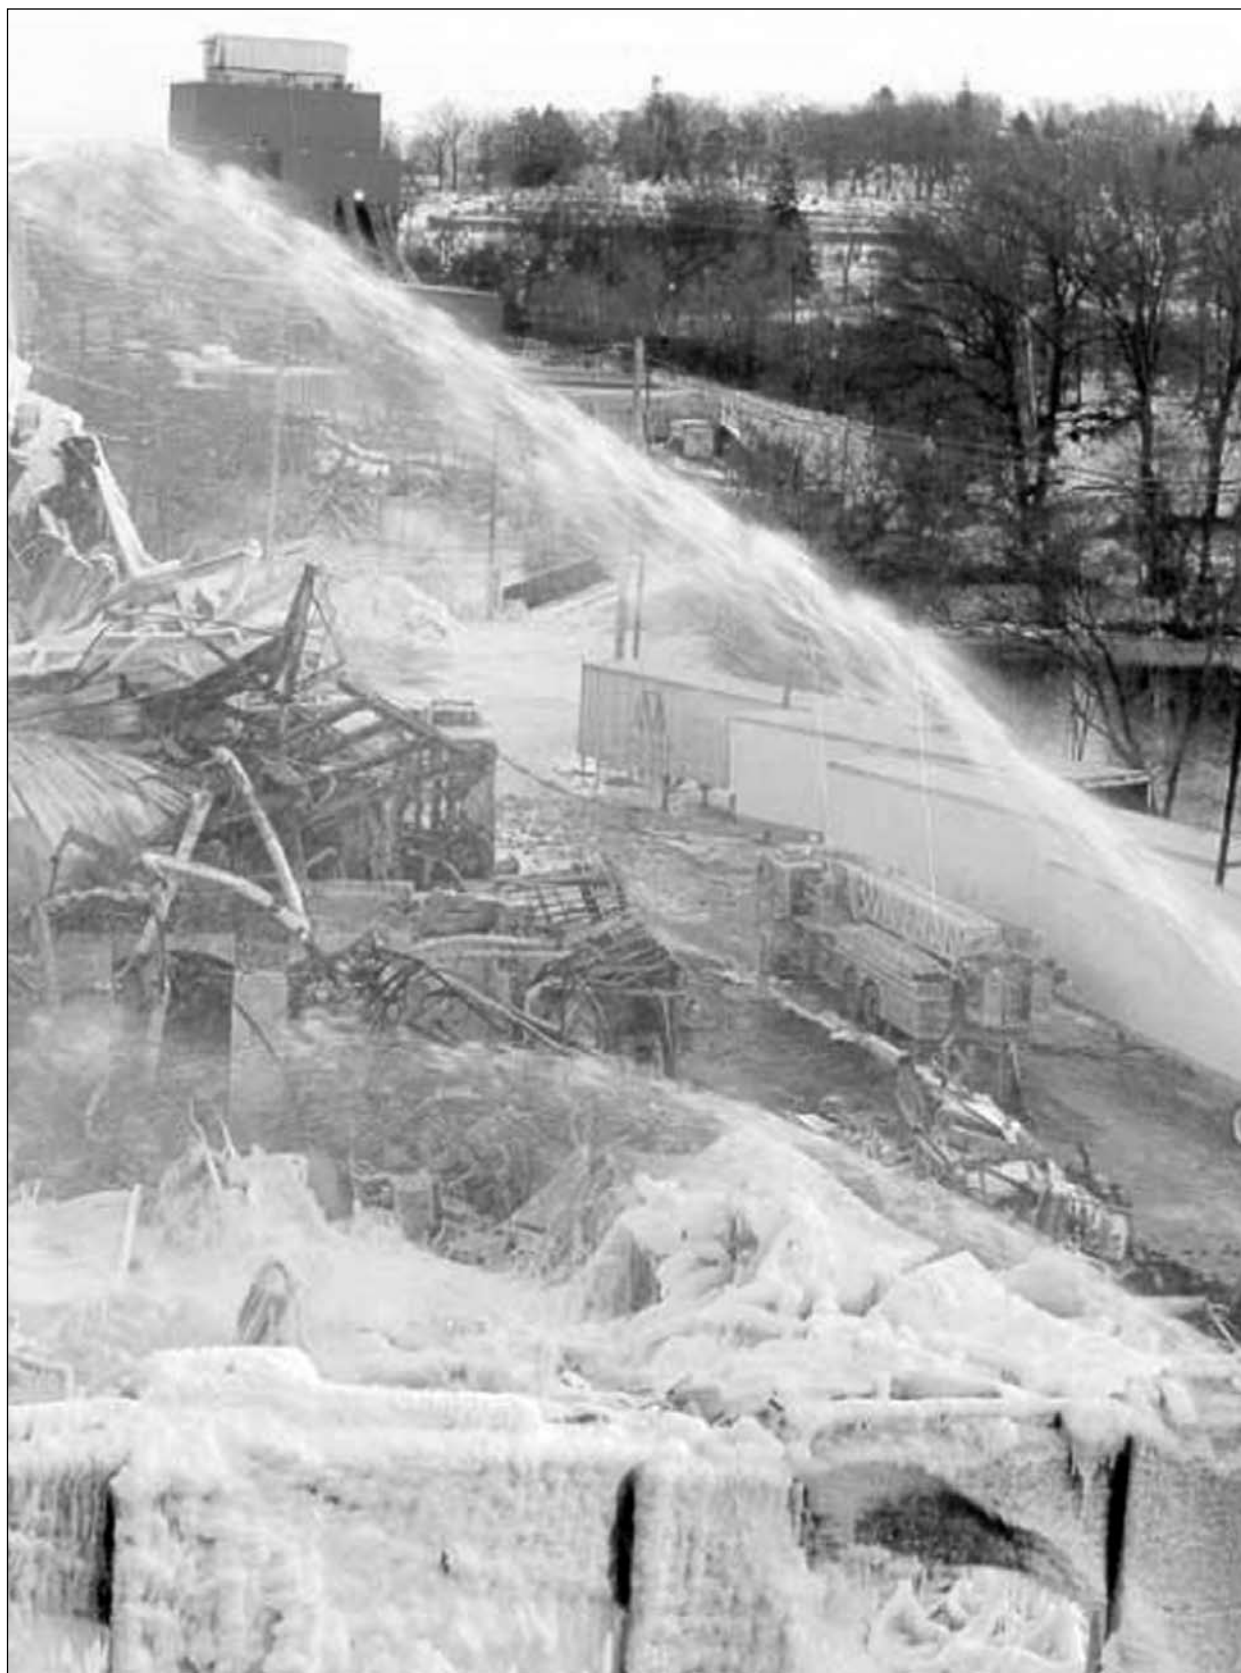
4. Mop-up operations on the west side of the site. The bridge over the Spickett River is in the background. Note the tight conditions and truck trailer parking.

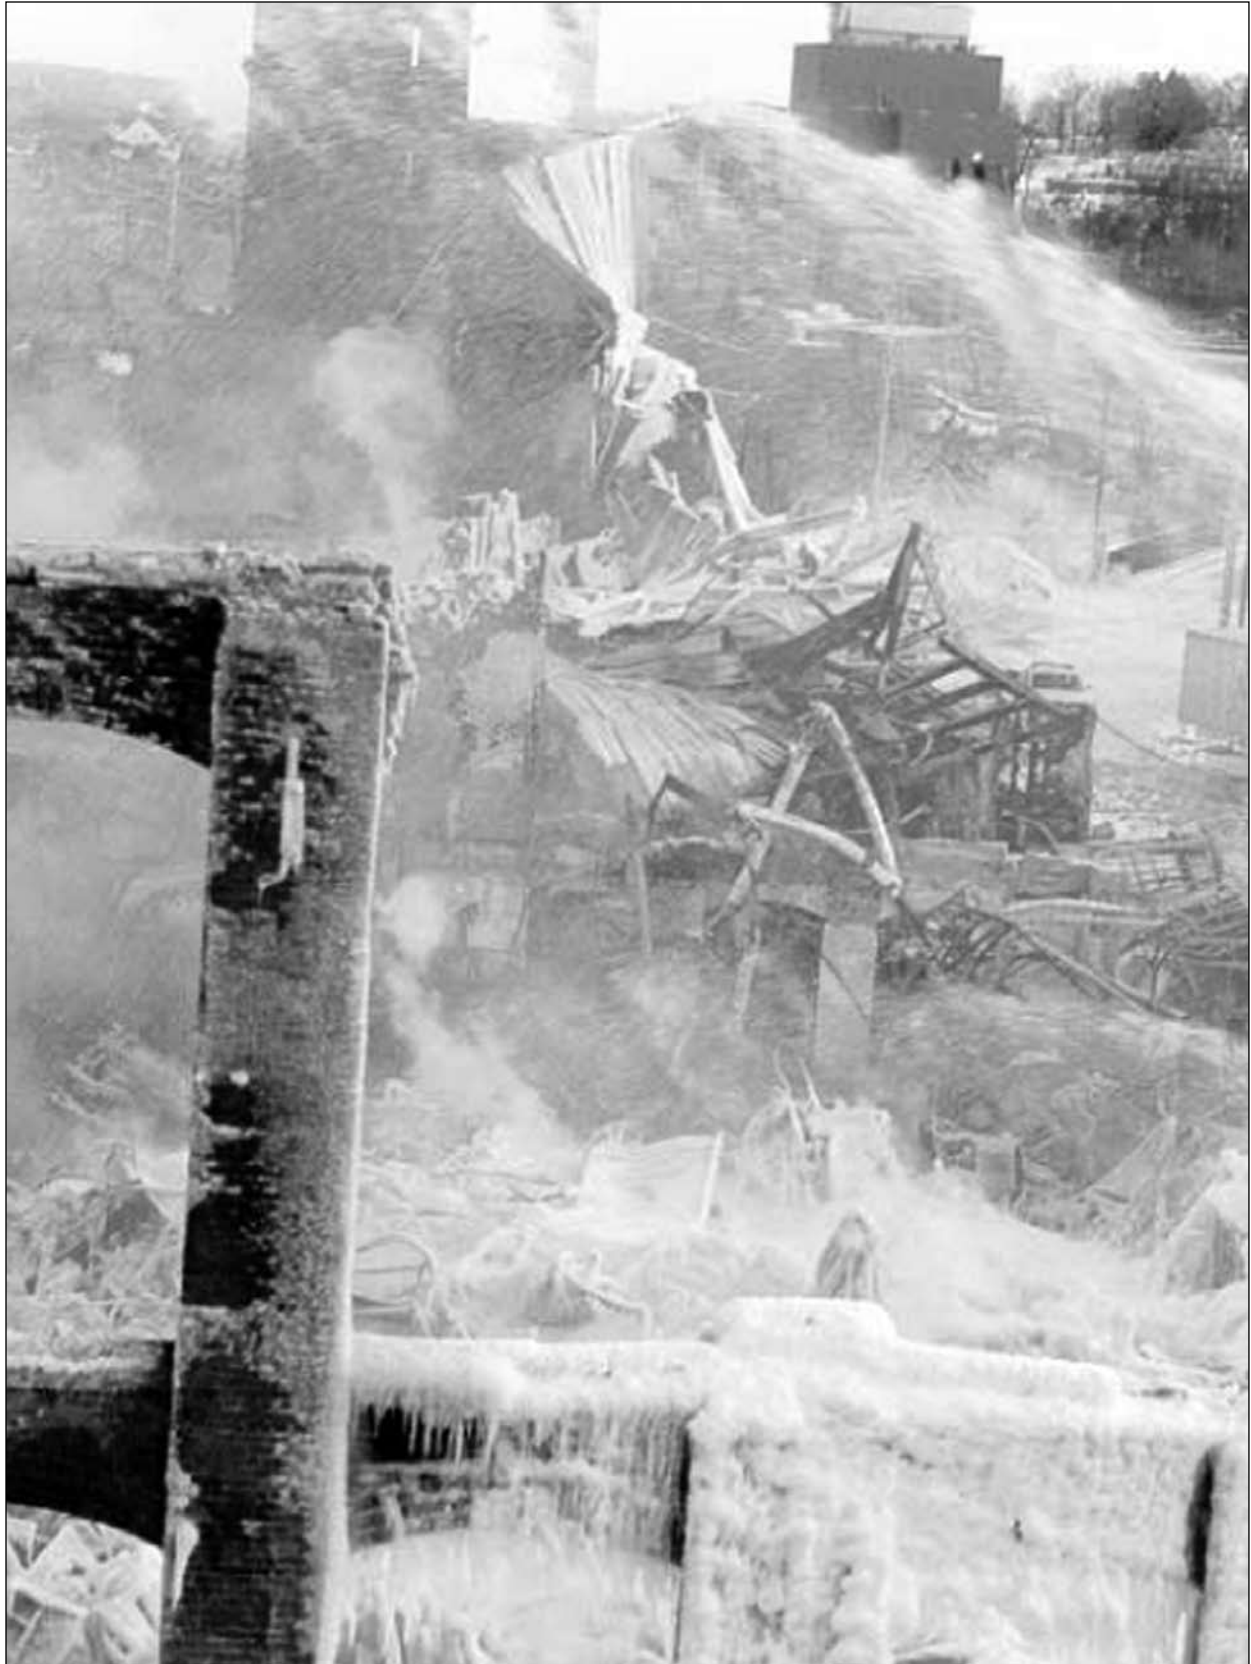
5. Remains of the Monomac Building looking to the south.

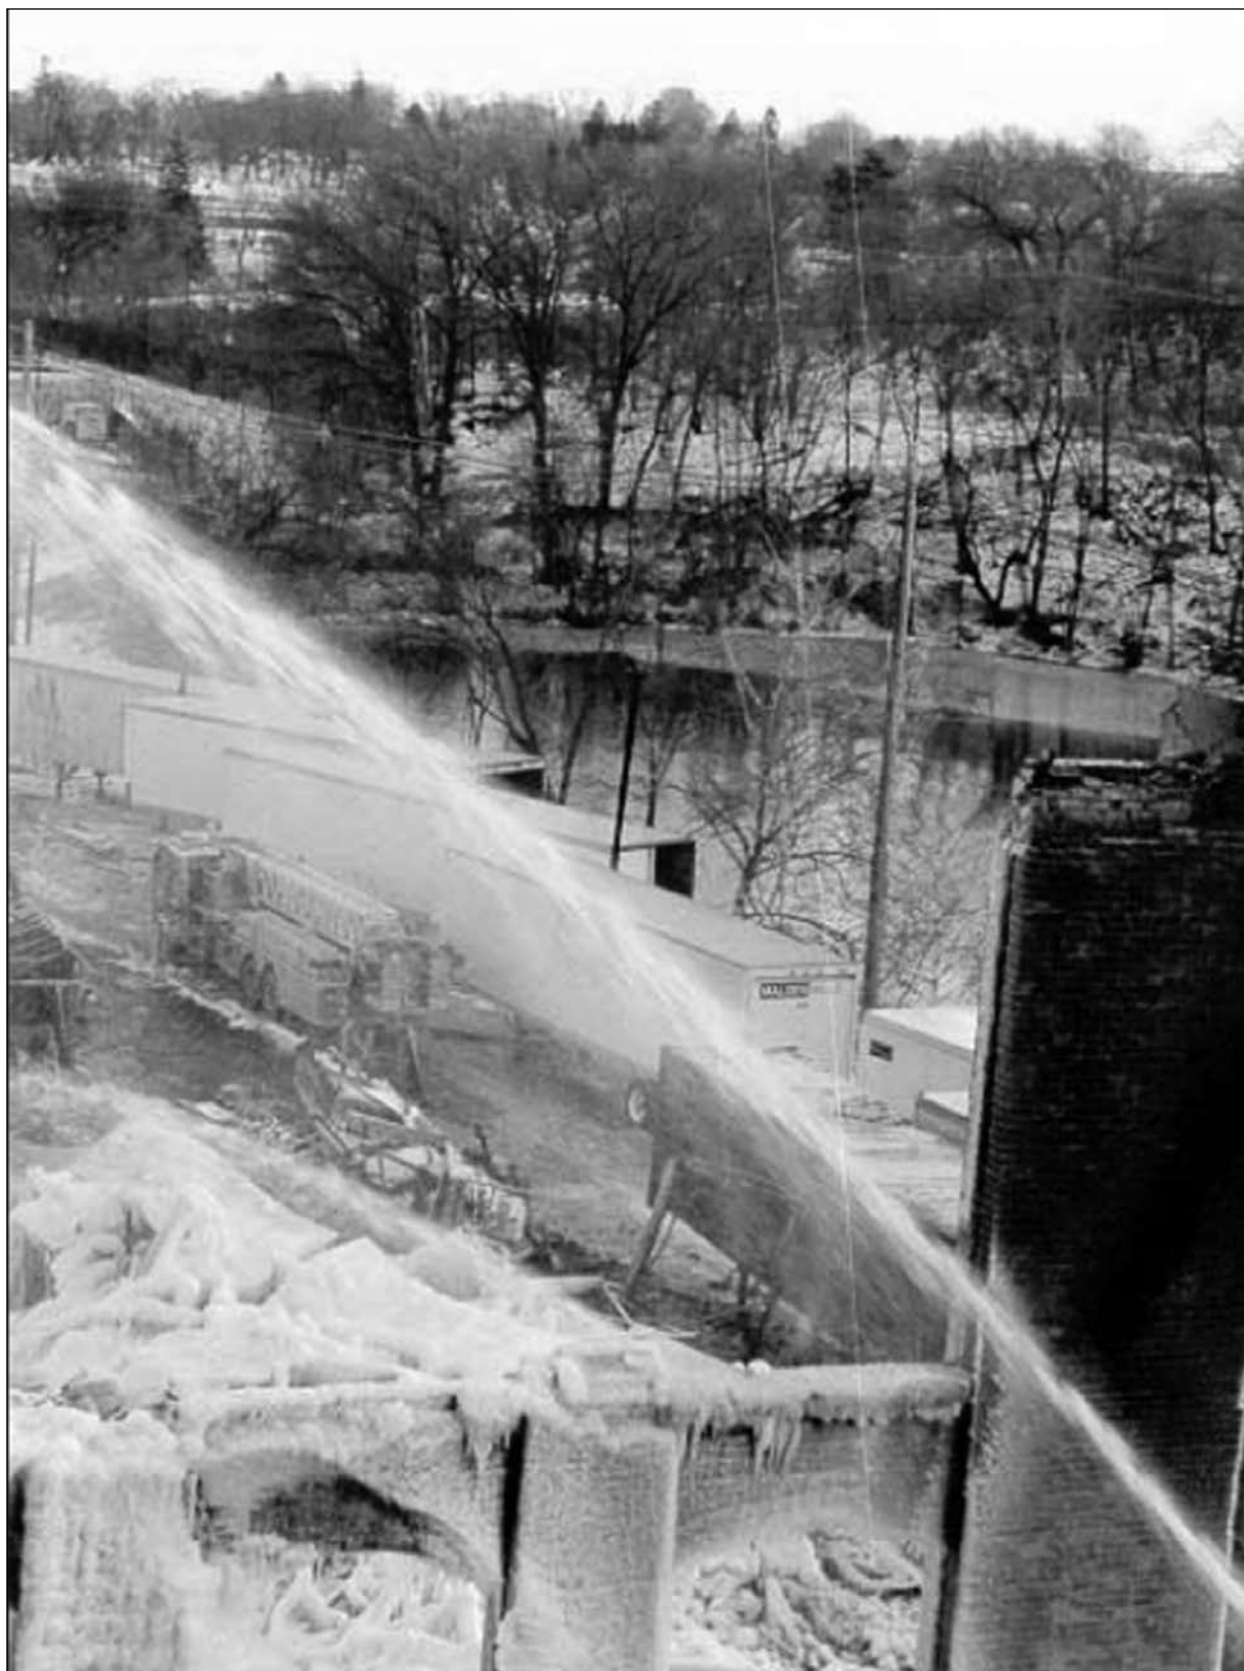
6. Conditions on the west side of the site with the truck trailers and the Spickett River.

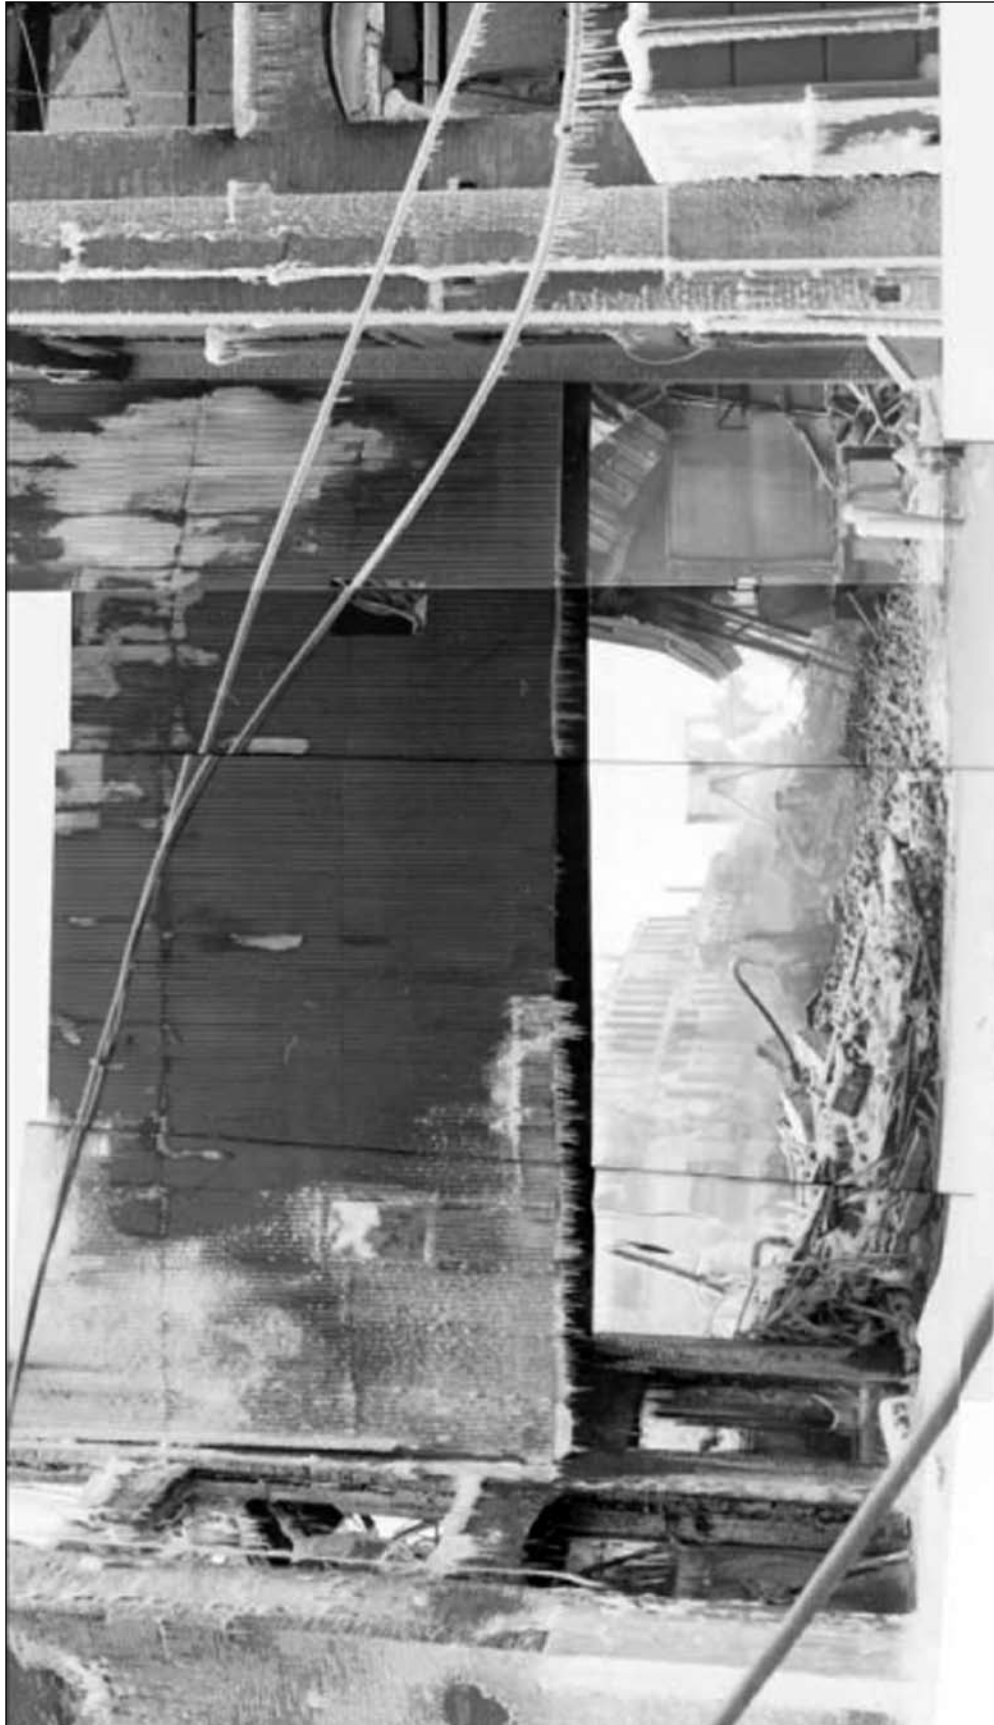
7. Composite of the overhead connecting bridge between the Monomac and Process buildings.

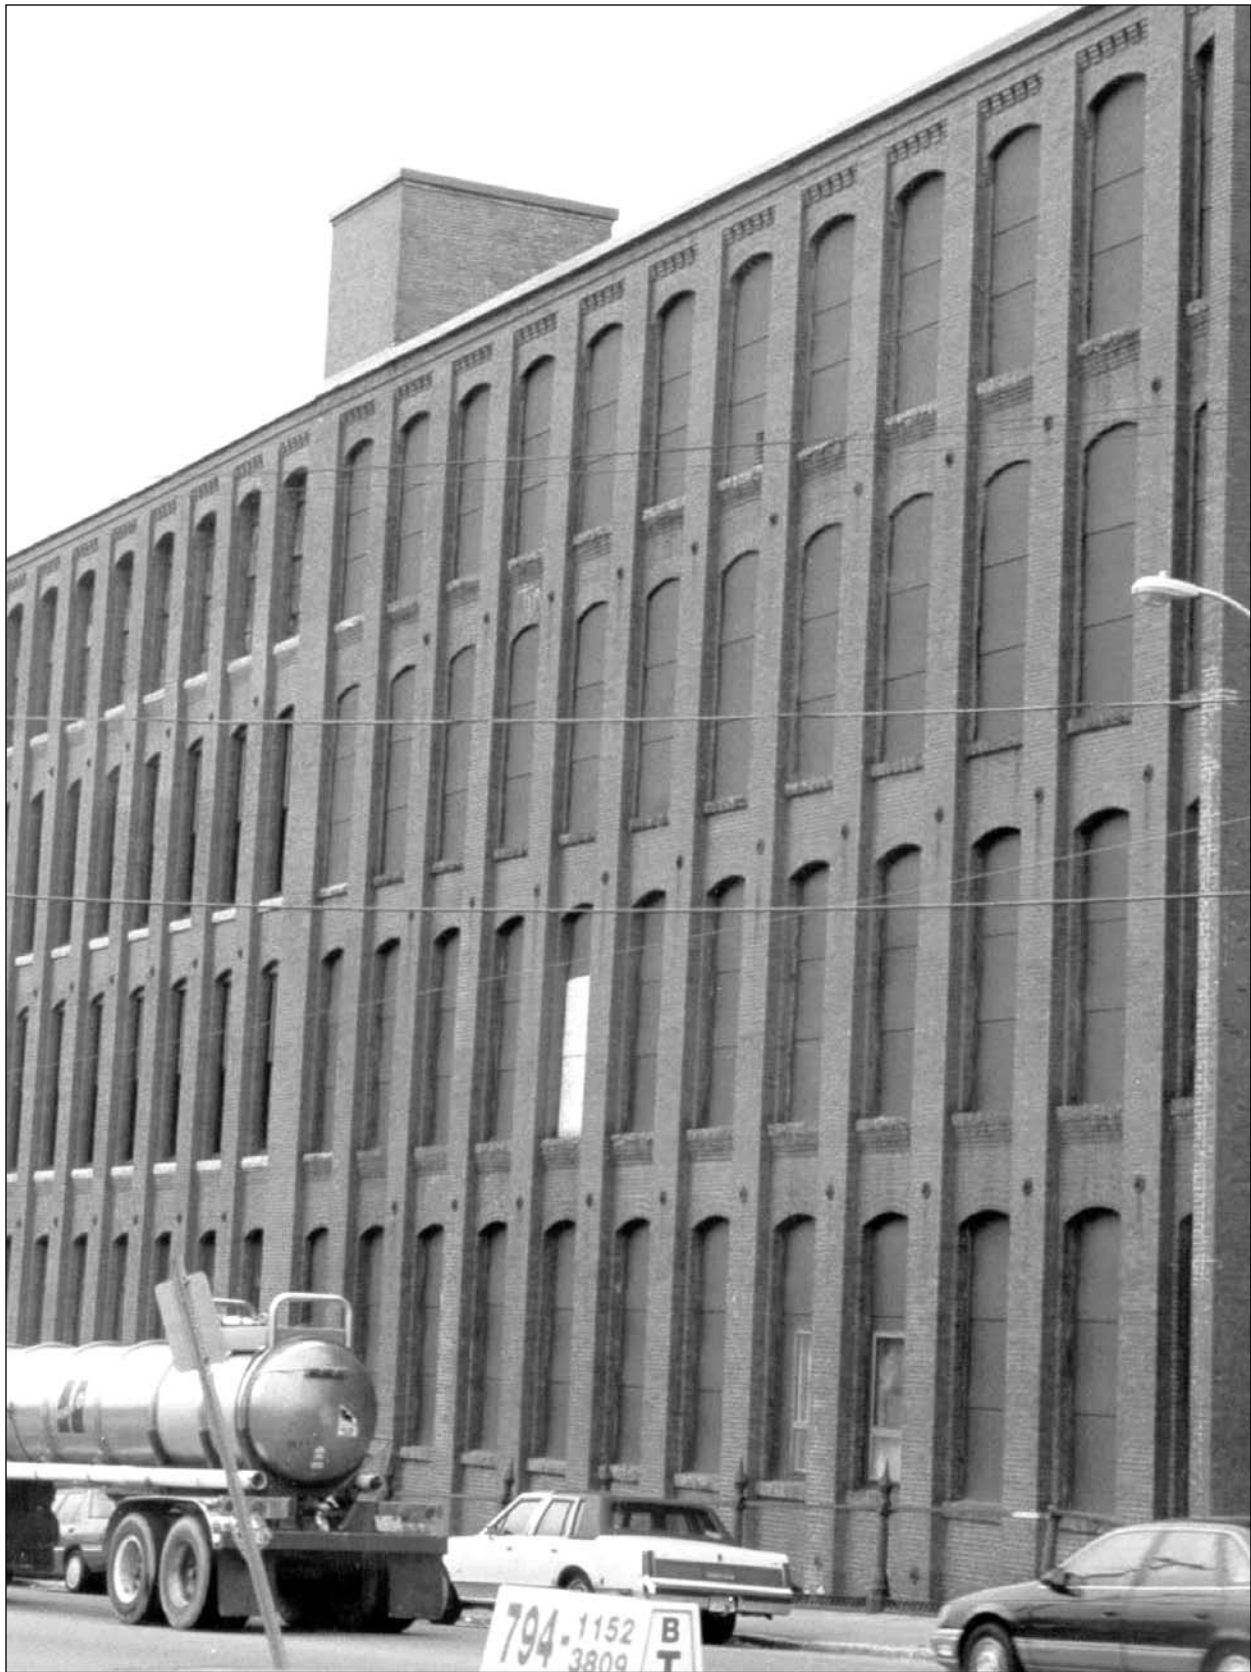
11. Windows once needed for natural light have been covered over, making visible fire location difficult. In addition, depending on the materials used, ventilation may be difficult.
