U.S. Fire Administration/Technical Report Series

Nine Elderly Fire Victims in Residential Hotel

Miami Beach, Florida

USFA-TR-041/April 1990

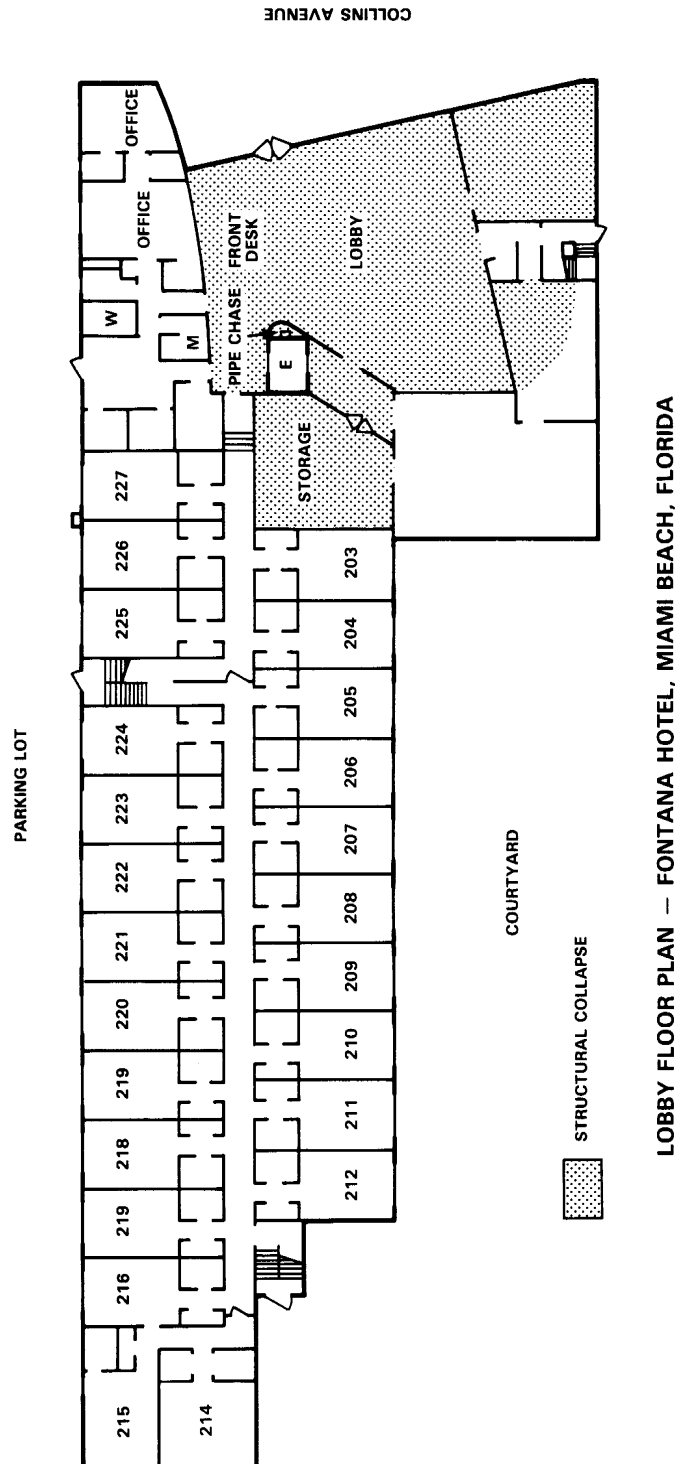
LOBBY FLOOR PLAN — FONTANA HOTEL, MIAMI BEACH, FLORIDA

Attack on the fire was finally changed to a defense mode due to deteriorating conditions within the structure. The fire had made significant headway in concealed spaces and the attic before it was discovered. The second floor had collapsed into the lobby about an hour into the blaze. The fire extended into the attic and burned the length of the building over the next several hours. Fire dropped from the attic into the third floor as it consumed the roof. The fire burned about four and one-half hours before being brought under control. Ultimately, much of the roof was destroyed as fire spread through the attic space. The front section of the building was basically gutted, with the fire burning through the room and causing collapse of the upper floors into the lobby area. (See Appendix A.)

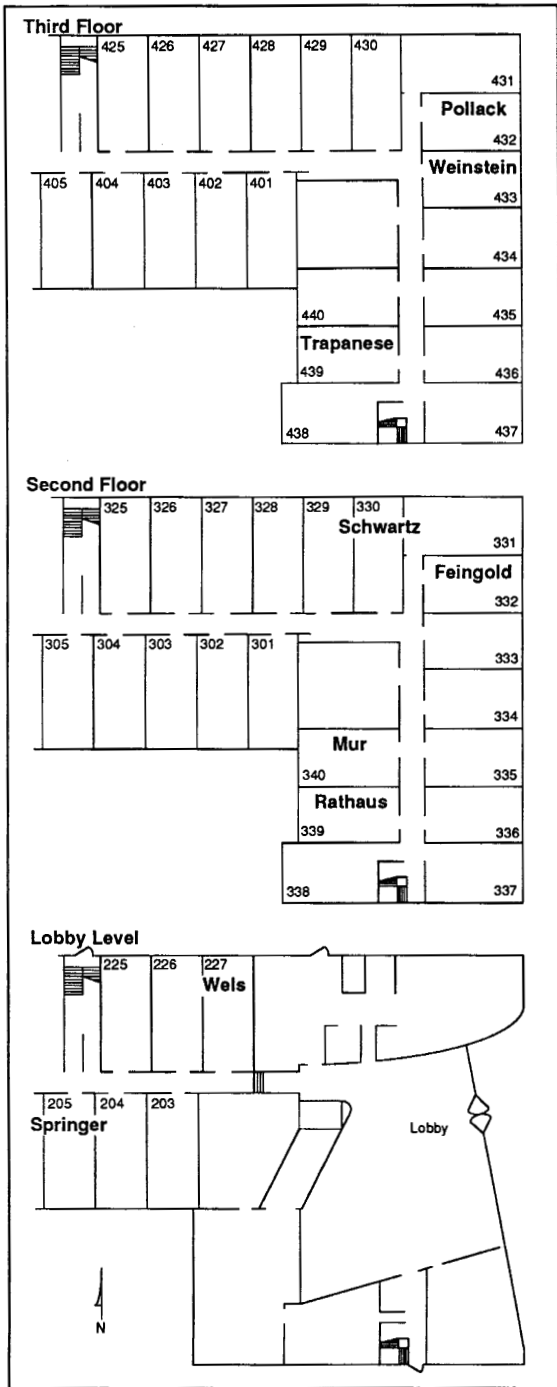
Room Registered to Victim

The Miami Beach Fire Department estimates that there were about 140 people in the Fontana Hotel on the morning of the fire. Most occupants were asleep when the fire was discovered. Of the nine fatalities, several were overcome while attempting to exit the structure. A complete listing of victims with ages and room of residence is included in Appendix B. A floor plan showing the room of residence and position of fatalities when recovered is included in Appendix C.

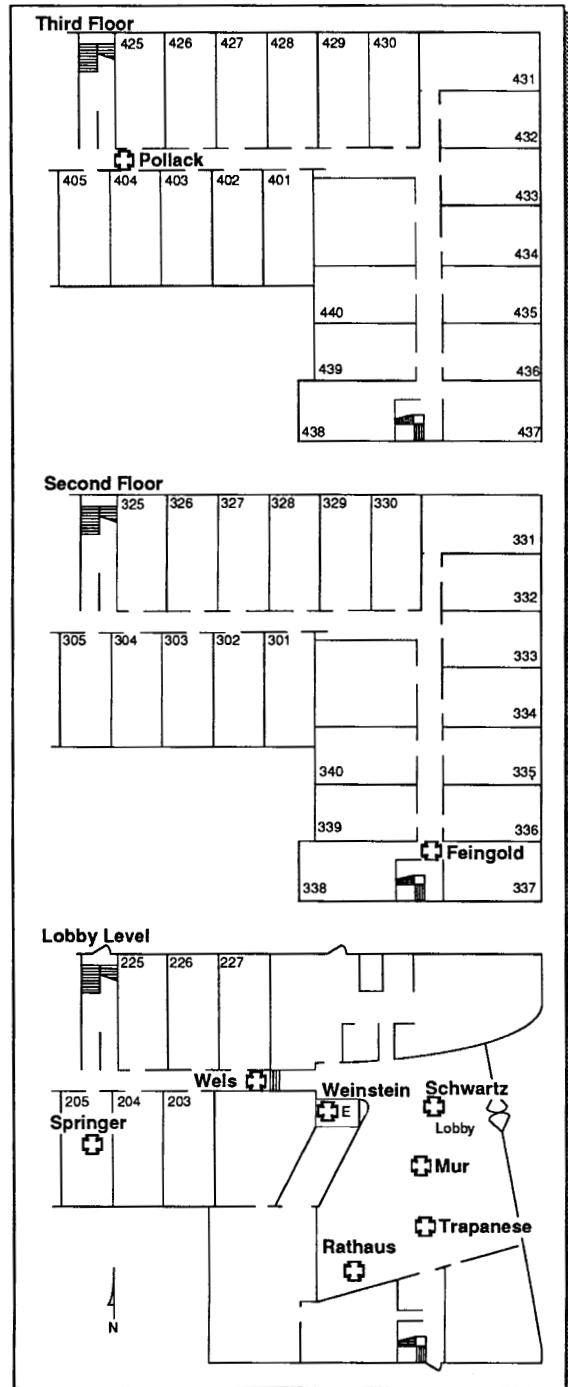
Location of Bodies

It is believed that most of the victims found in the lobby were originally on upper floors. Their bodies were recovered amid the burned debris from the collapse of the second and third floors in the lobby area. It is not clear whether they had attempted to evacuate before they were overcome.

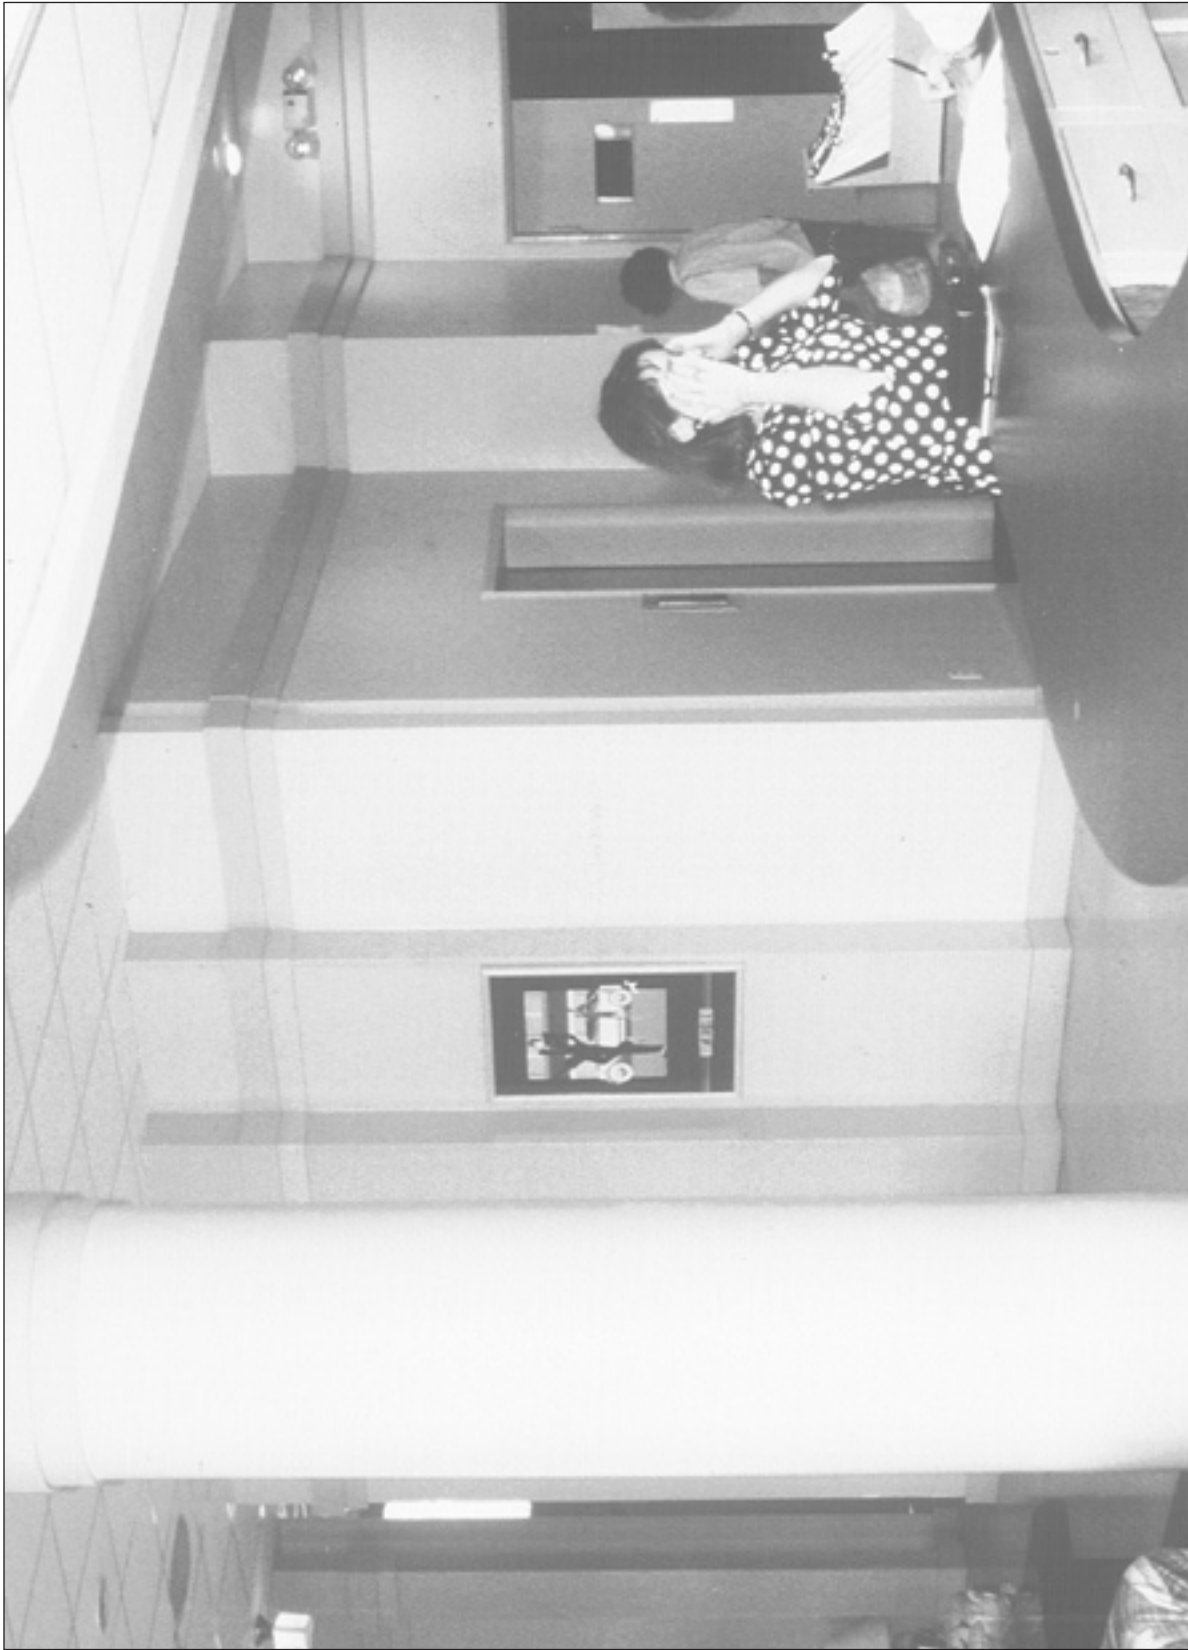
(MBFD Photo)

Lobby of the Prince Michael Hotel, interior finish and construction is similar to that of the Fontana.

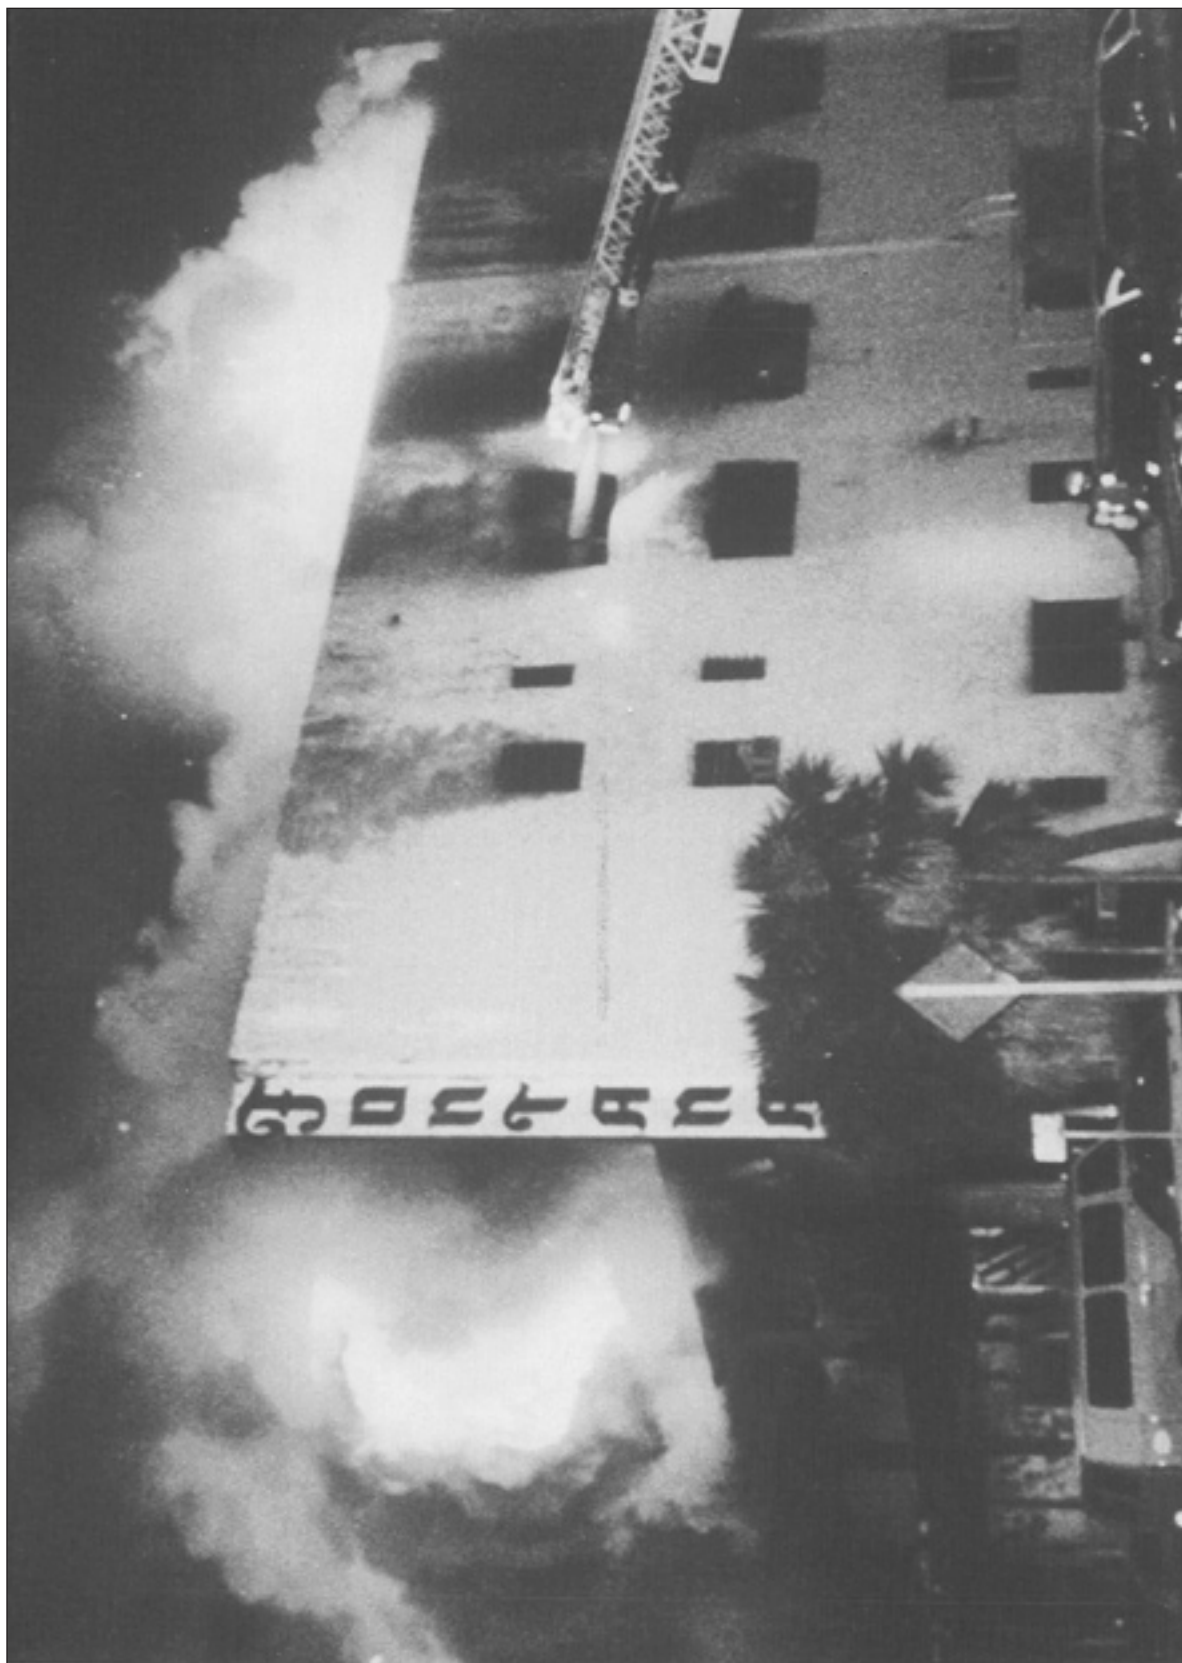
(MBFD Photo)

Exterior attack in progress, note fire involvement in attic.

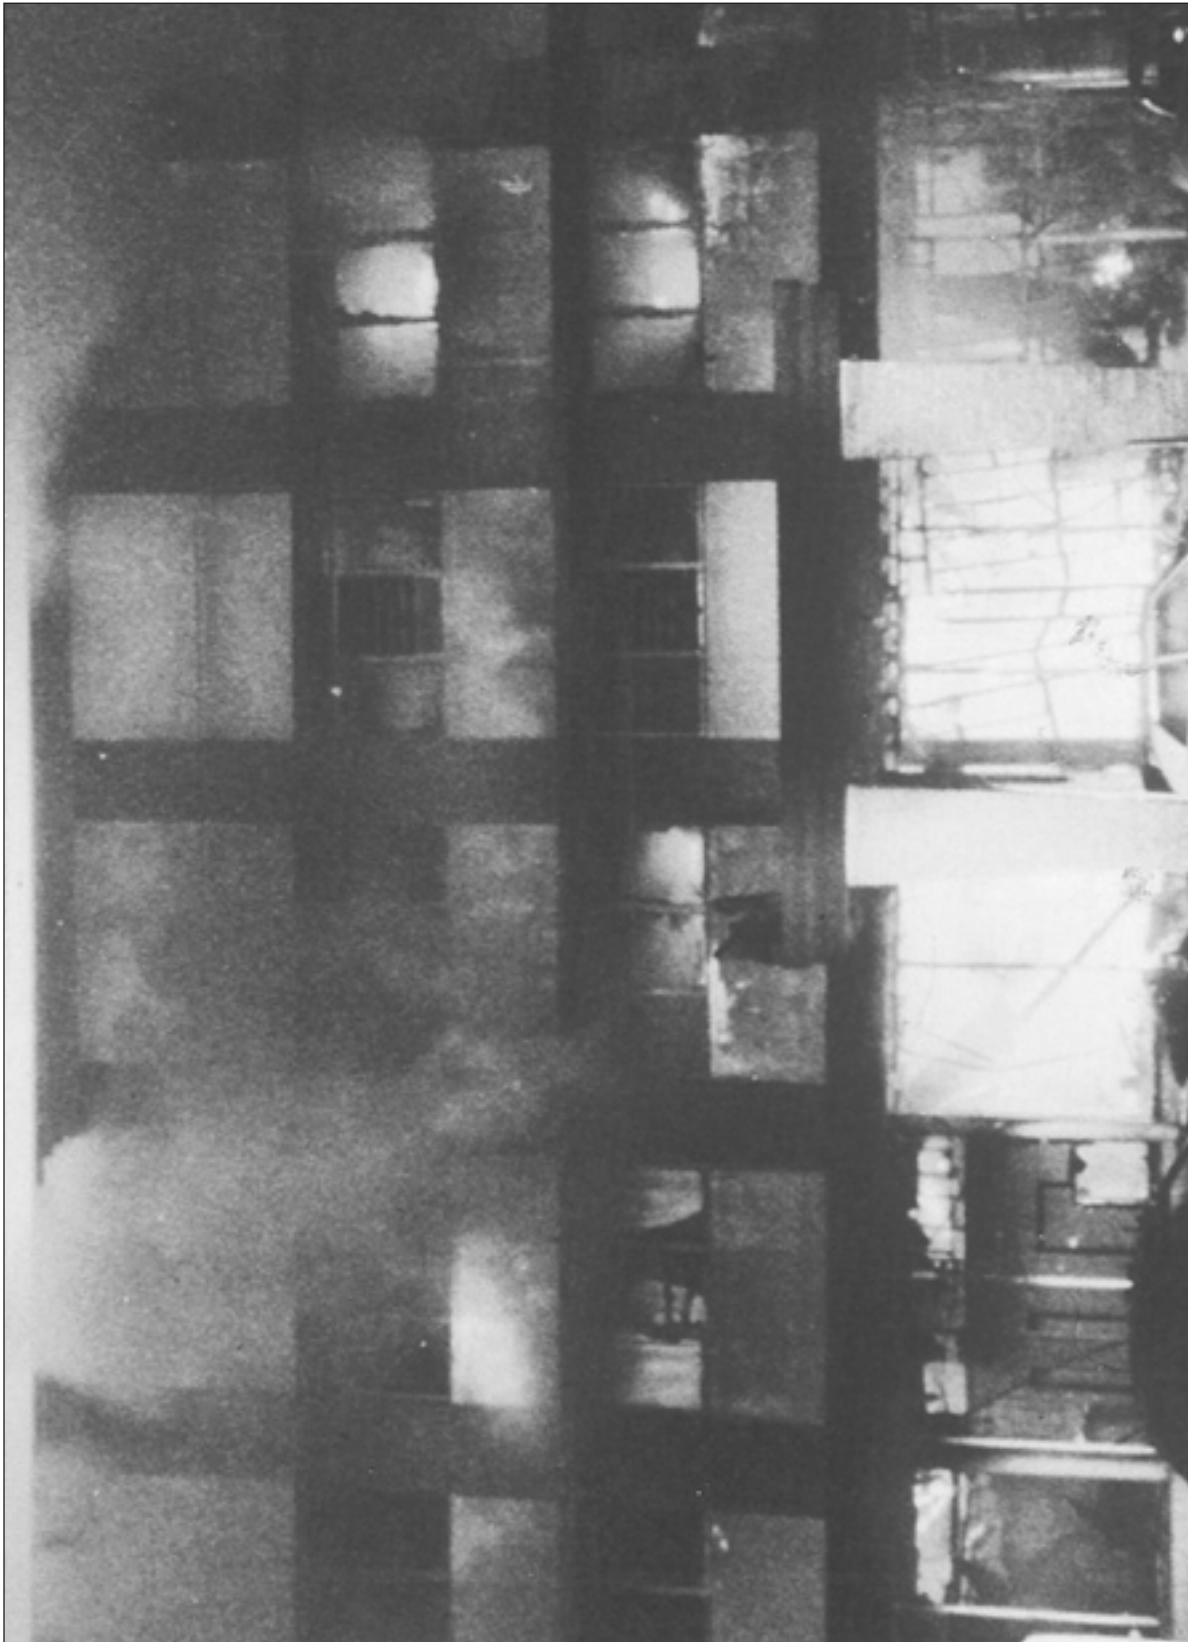
(MBFD Photo)

Front of hotel.

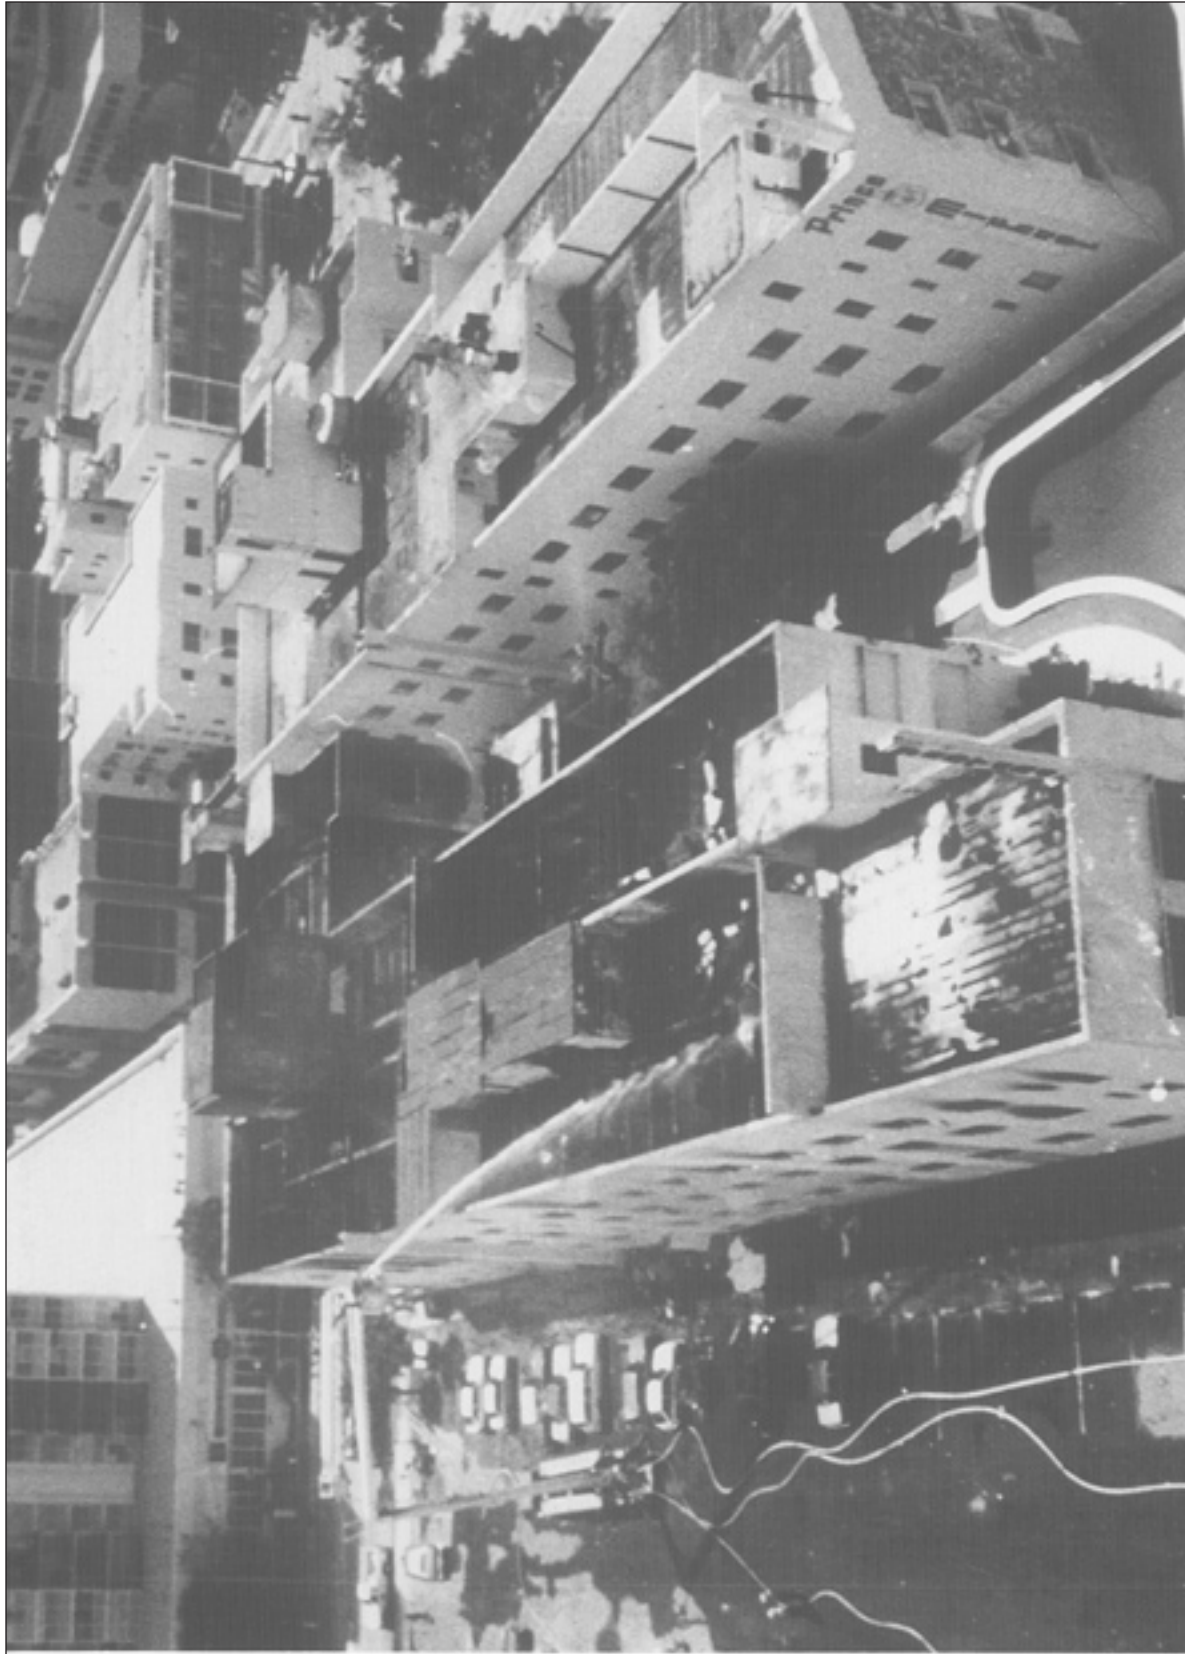
(MBFD Photo)

The fire destroyed the front portion of the structure, burning through the roof. The remainder of the hotel received smoke and heat damage, although many of the rooms were spared from fire damage.

Aerial view of hotel after the fire. Note destruction of the roof and proximity of the Prince Michael Hotel.

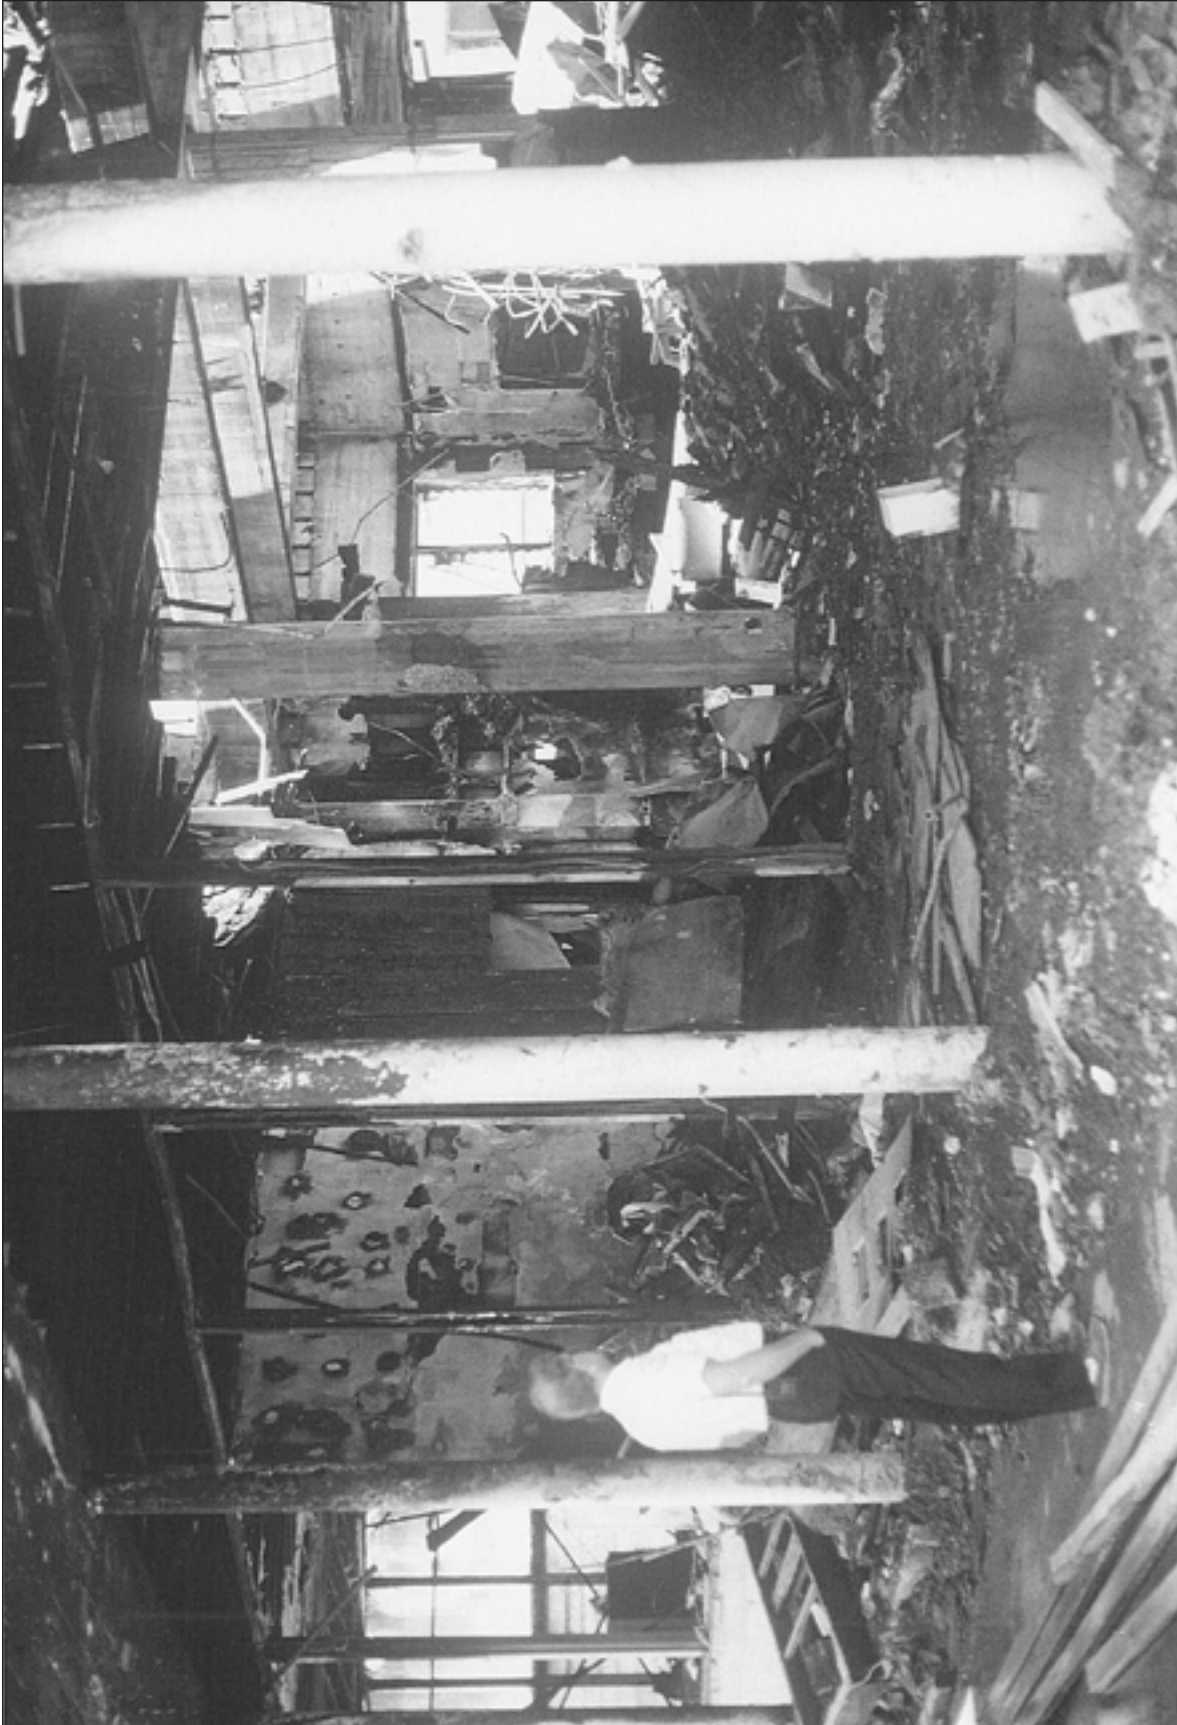
Front of hotel, lobby desk is located to far right along wall.

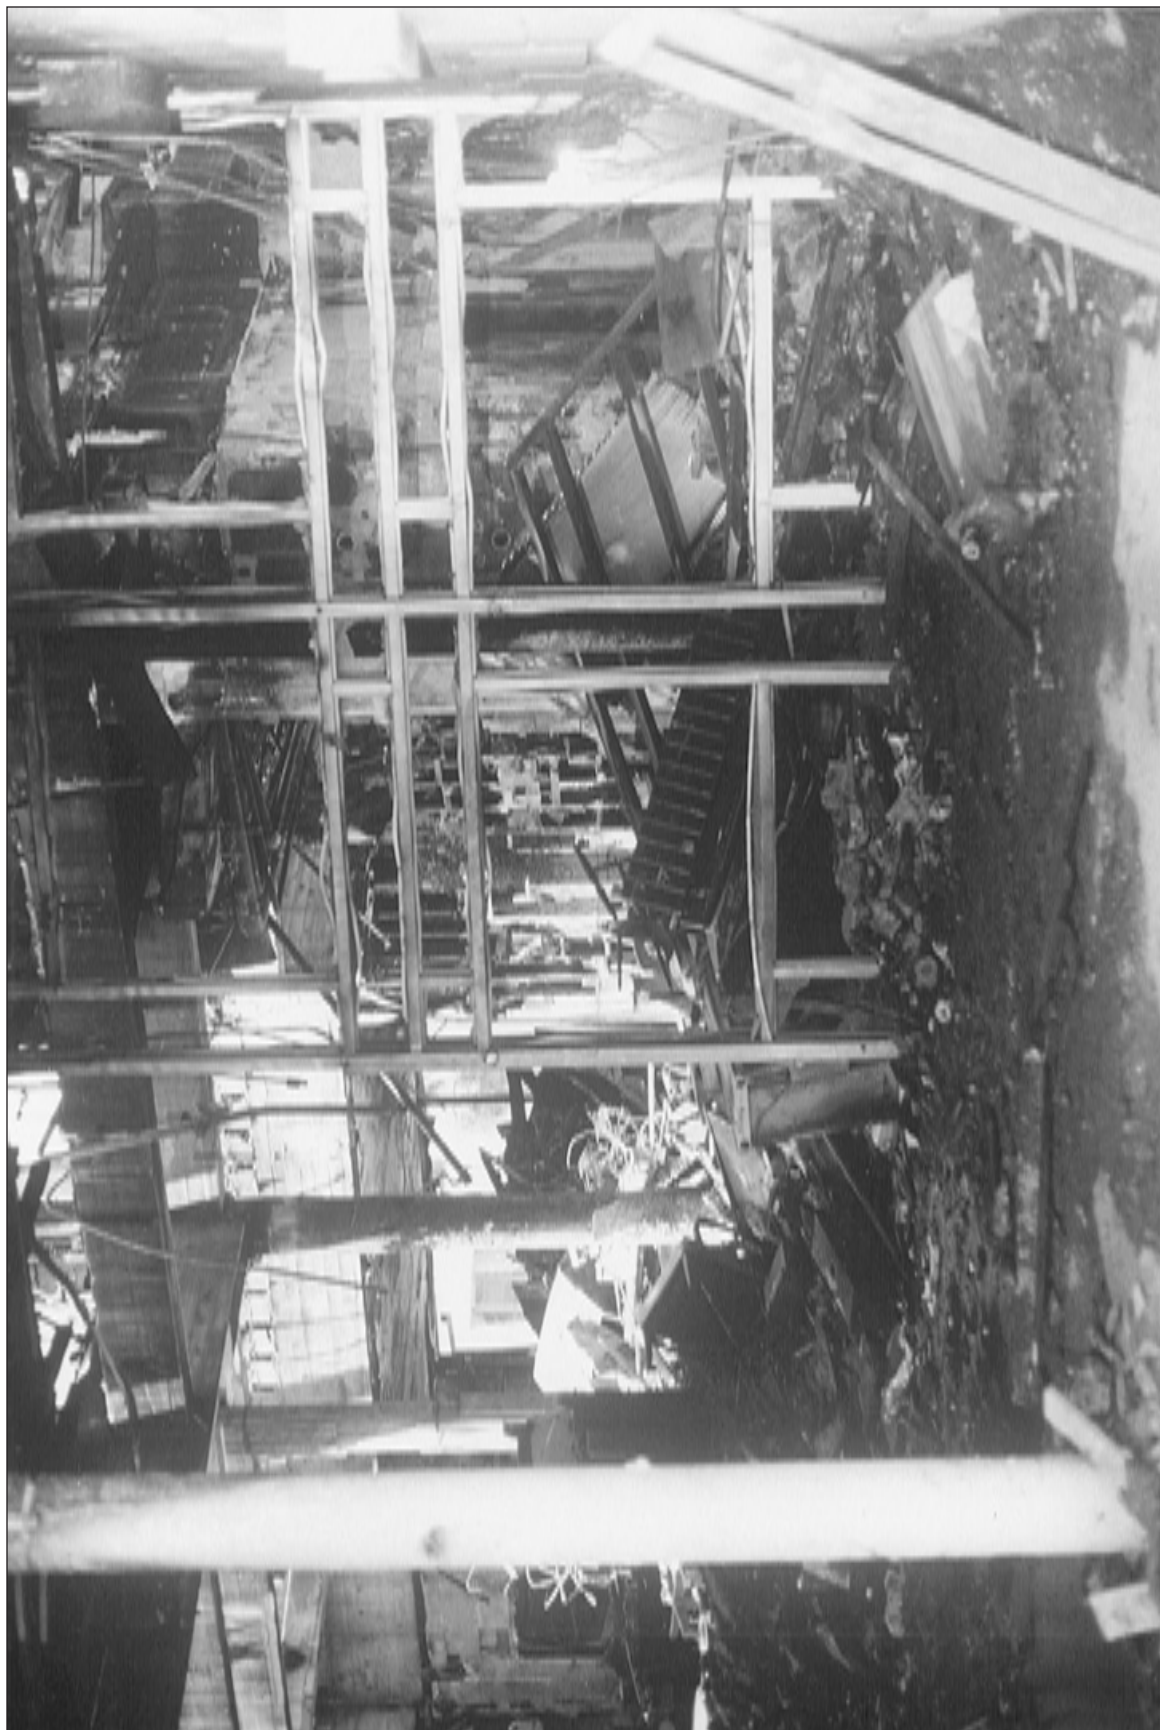
Front of hotel, looking toward the Prince Michael Hotel.

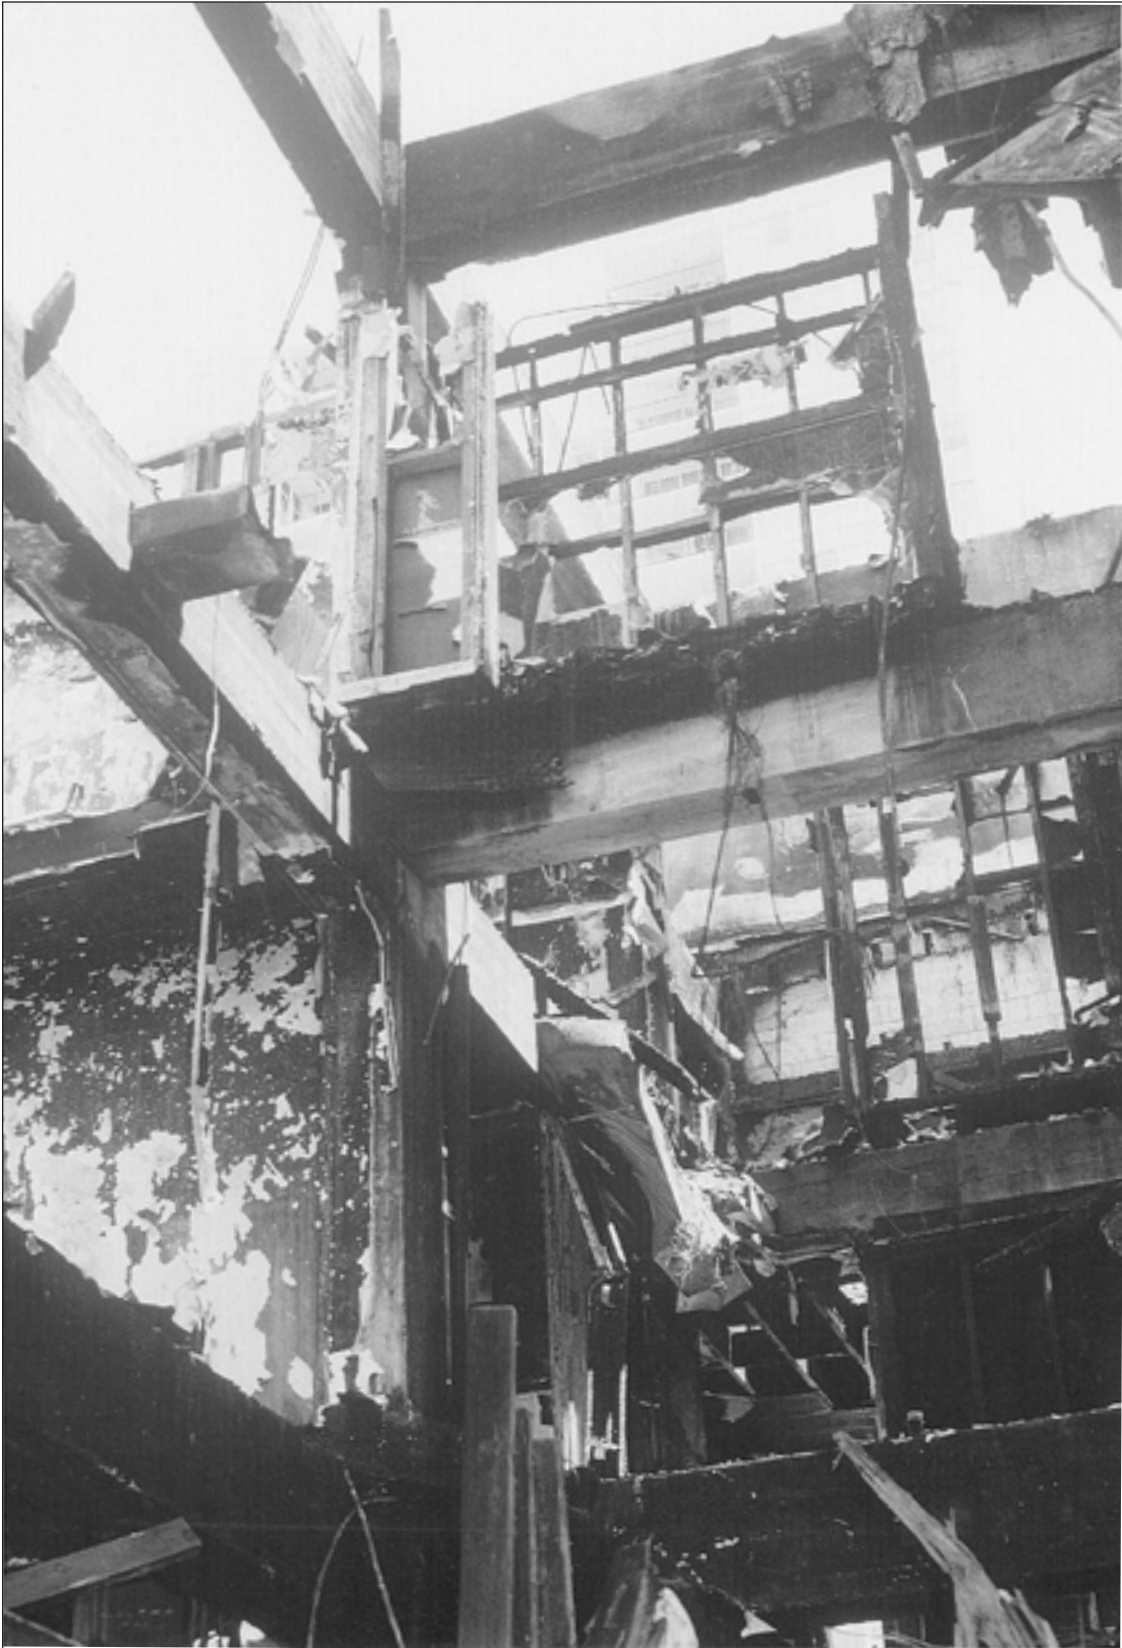
Lobby, looking up through roof facing Collins Street.

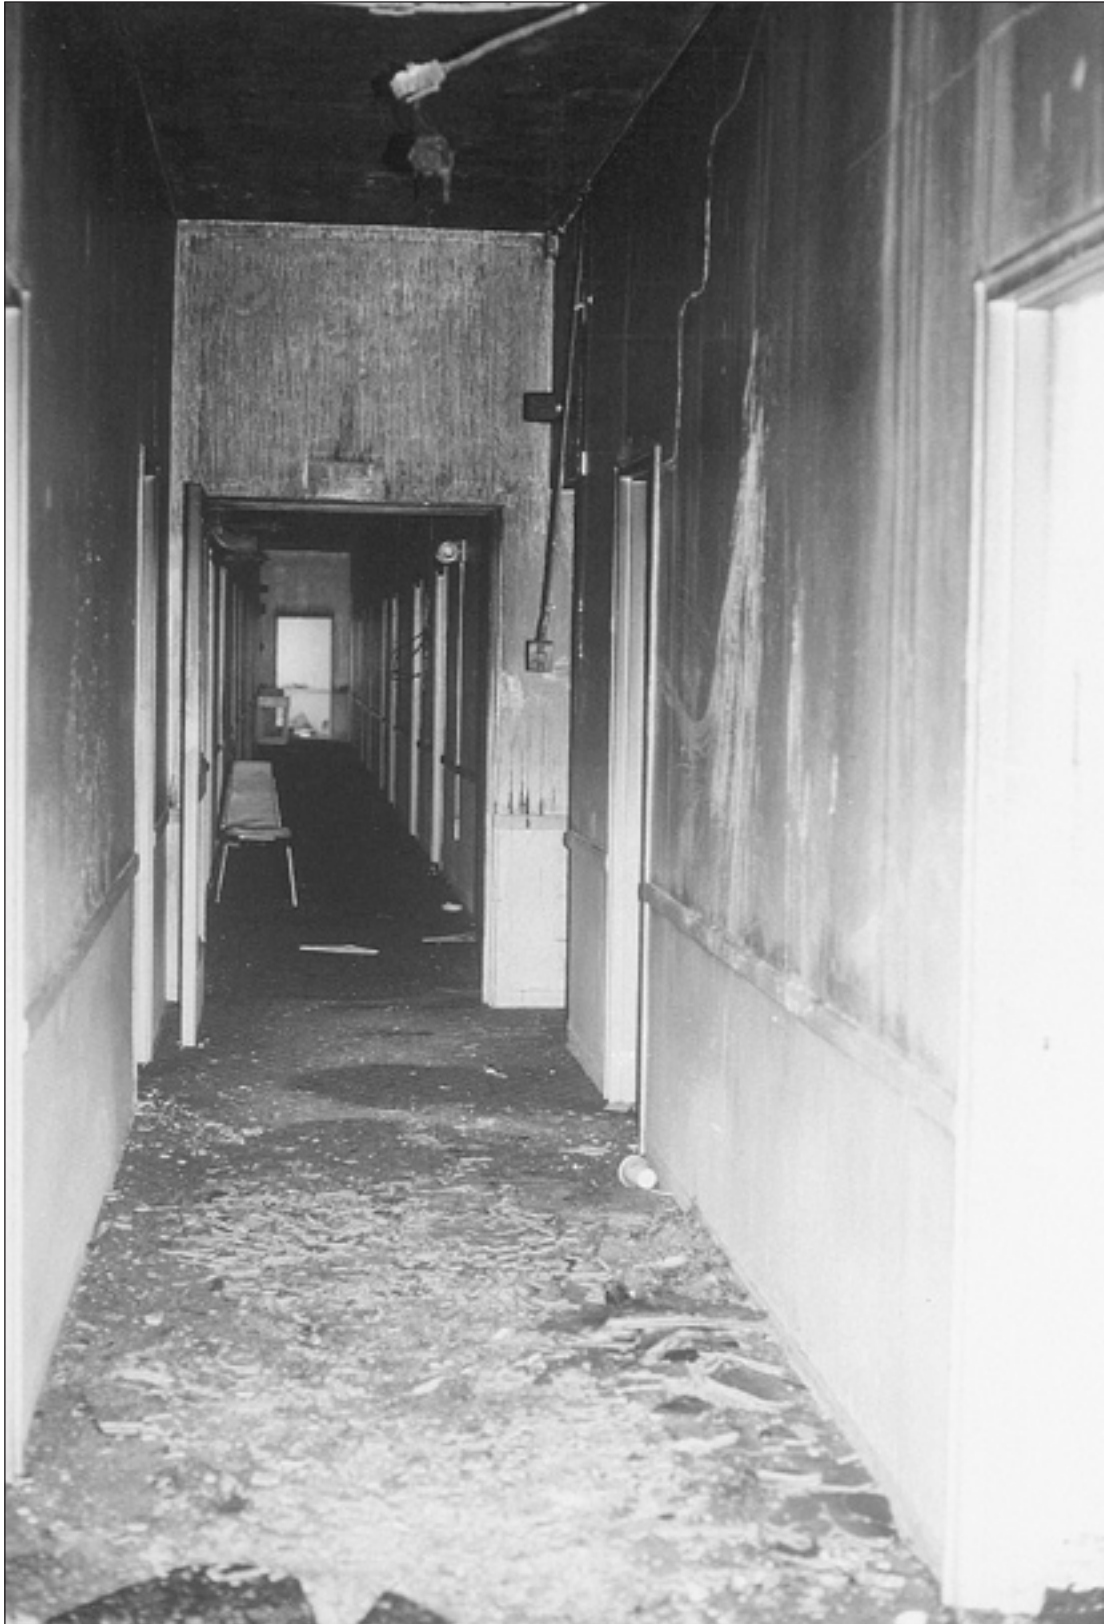
First floor corridor, looking to rear of building from lobby. Fire door in foreground was closed throughout much of the fire.

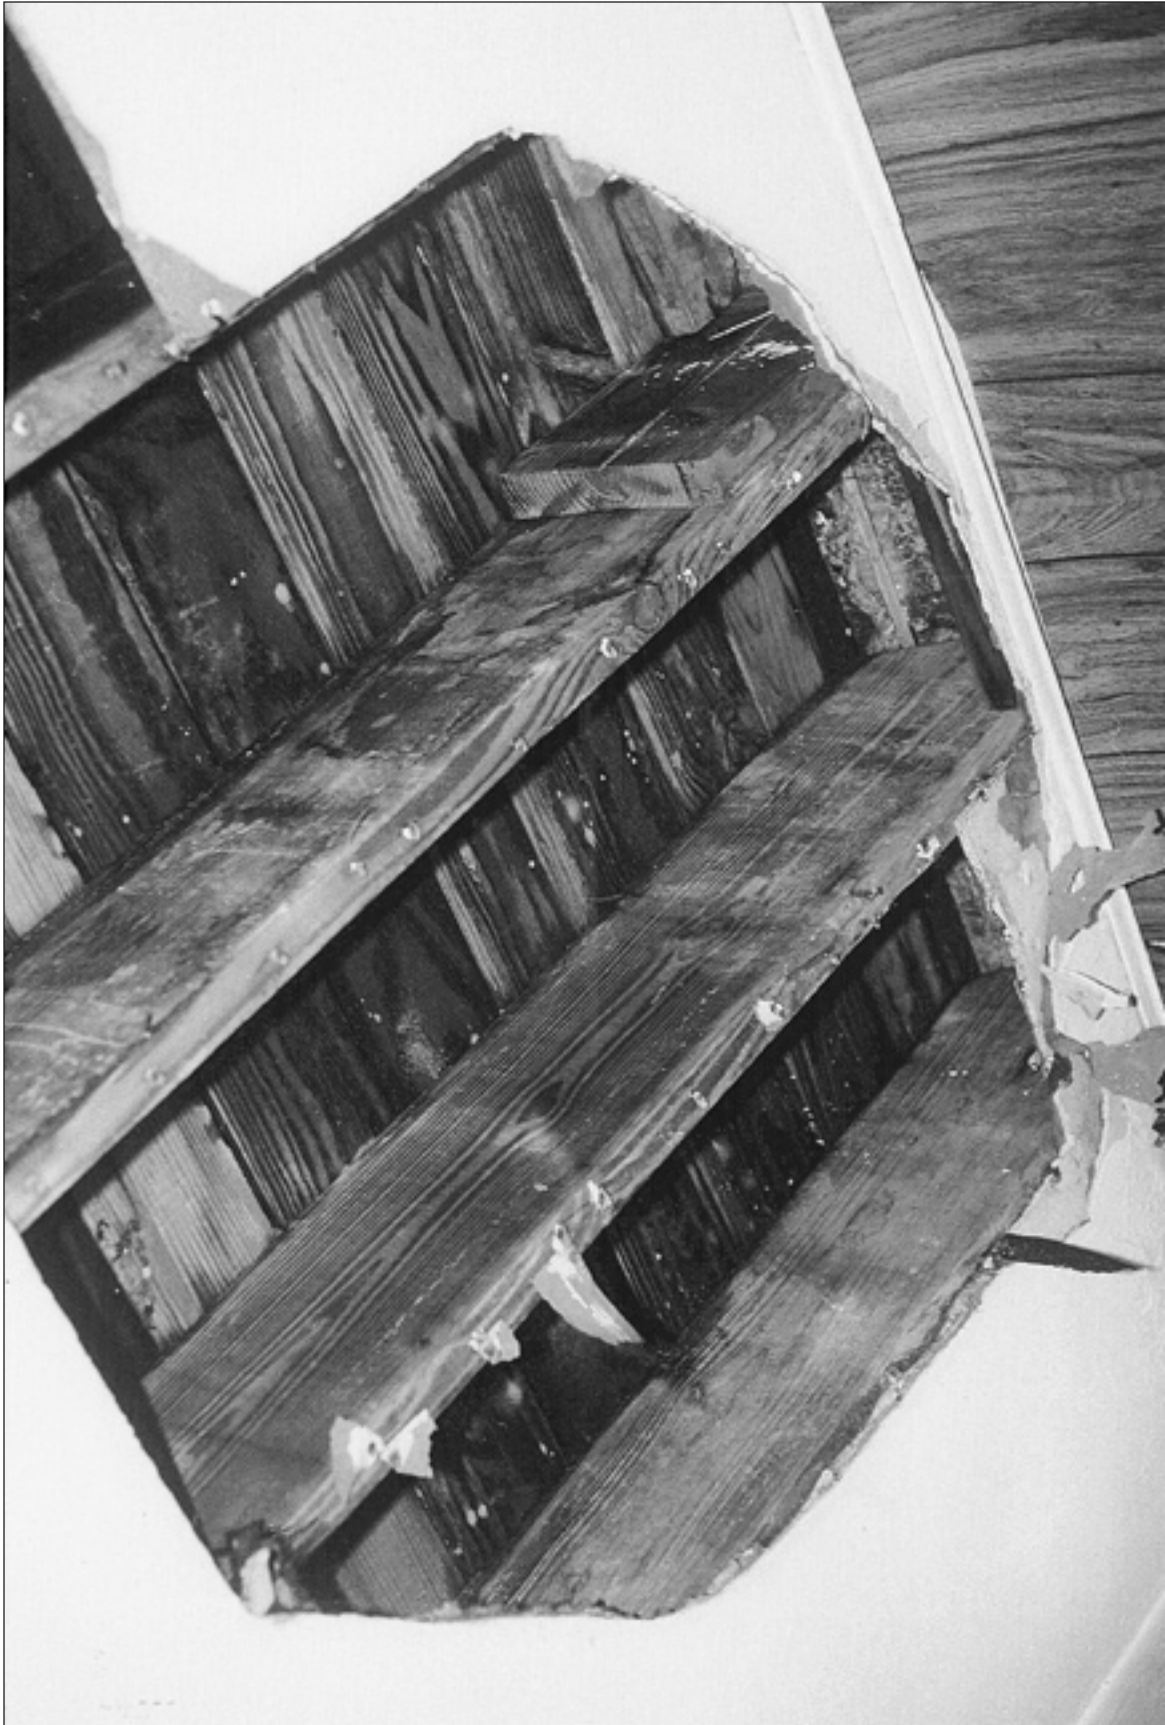
The construction of the building created concealed spaces which ran the length of each floor in the space between the floor and ceiling. In addition, there was a major pipe chase which ran from the first floor ceiling to the attic. This pipe chase, which was adjacent to the elevator shaft, was approximately five by ten feet and carried plumbing and other building services (see floor plan, Appendix A). The interior framing of this pipe shaft was exposed wood. The openings on to each floor were not fire stopped.

This pipe chase and the construction of the floors effectively created a single concealed space that ran the length of the building from the first floor to the attic. A photograph of typical floor construction is included in Appendix E.

Typical floor construction, shown from ceiling of first floor room.

Providing combustible concealed spaces with detection or suppression systems can prevent these types of fires from spreading before being detected.

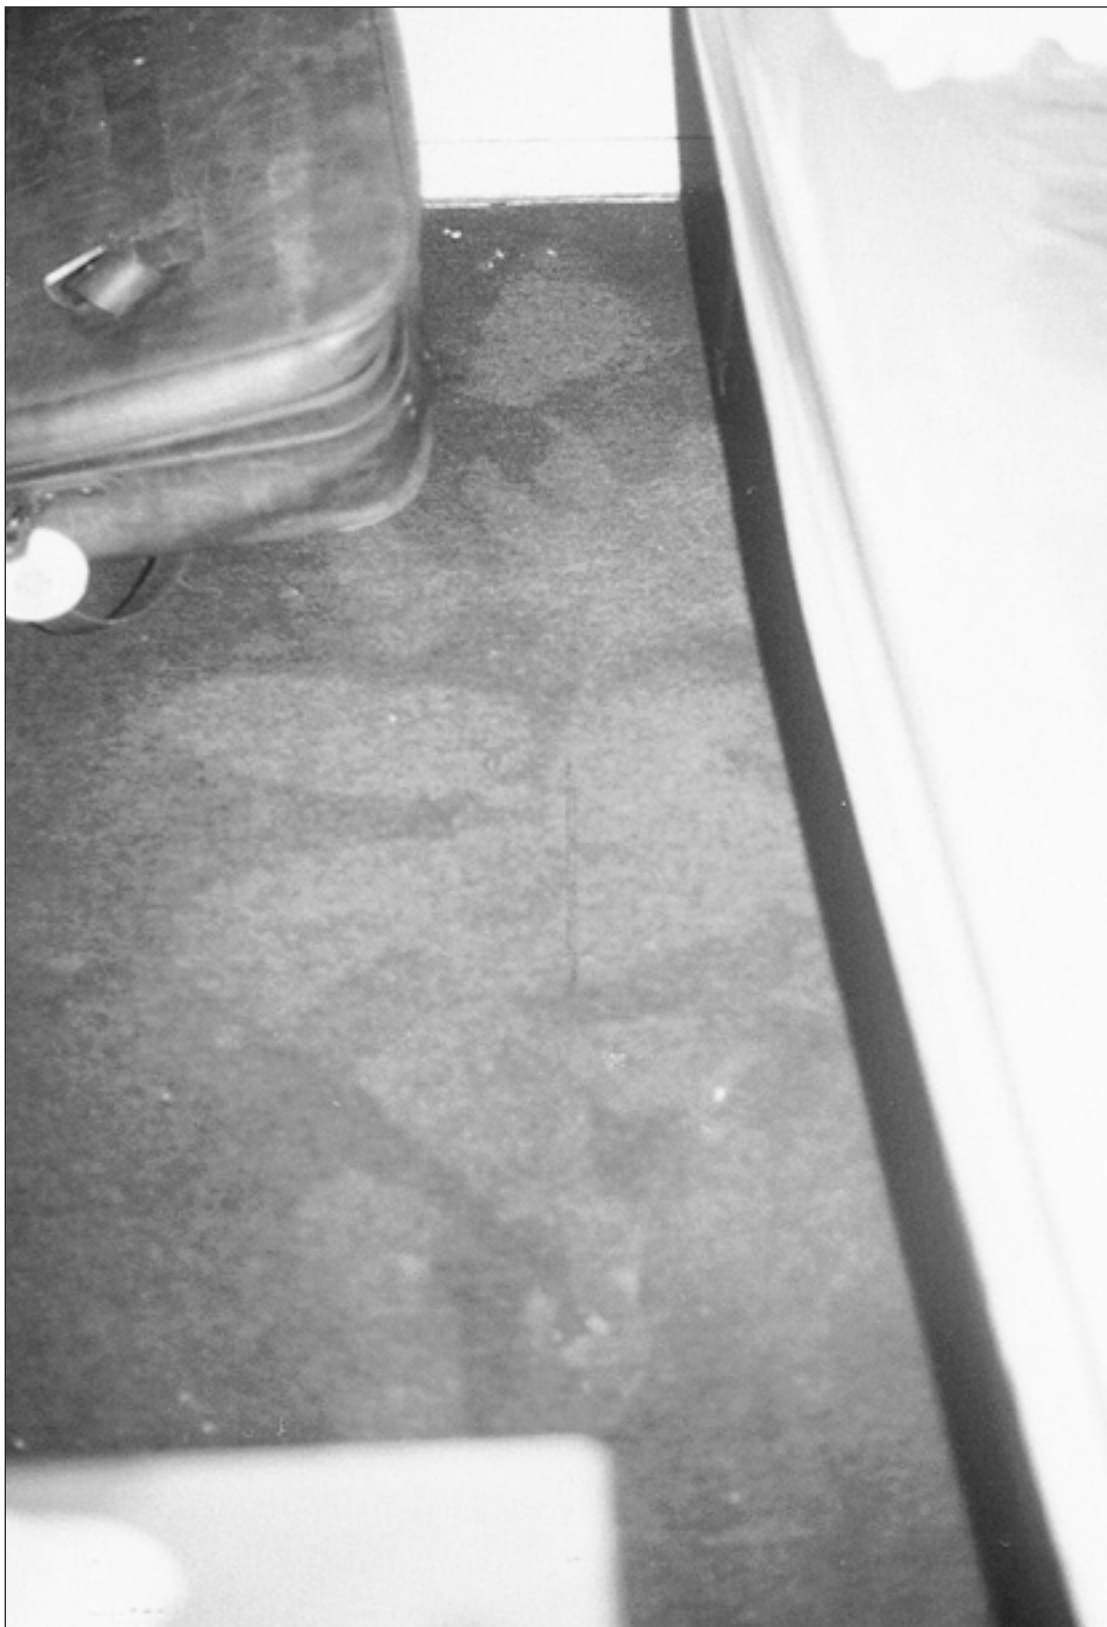
One fatality, whose room was located across the hall from an exit, was discovered fully dressed, with coat and shoes, and had a purse containing valuables. Apparently, she took time to get dressed and collect valuables before leaving. She was found on the floor of her room carrying a flashlight, which was still on when she was removed. Her delay to gather belongings cost her life. A photograph of her room (205) showing its closeness to the exit is included in Appendix E.

Outline of victim in smoke stain, Room 205. Victim was reportedly found carrying a flashlight (still on) and personal belongings in a purse.
