U.S. Fire Administration/Technical Report Series

Nine Elderly Fire Victims in Residential Hotel

Miami Beach, Florida

USFA-TR-041/April 1990

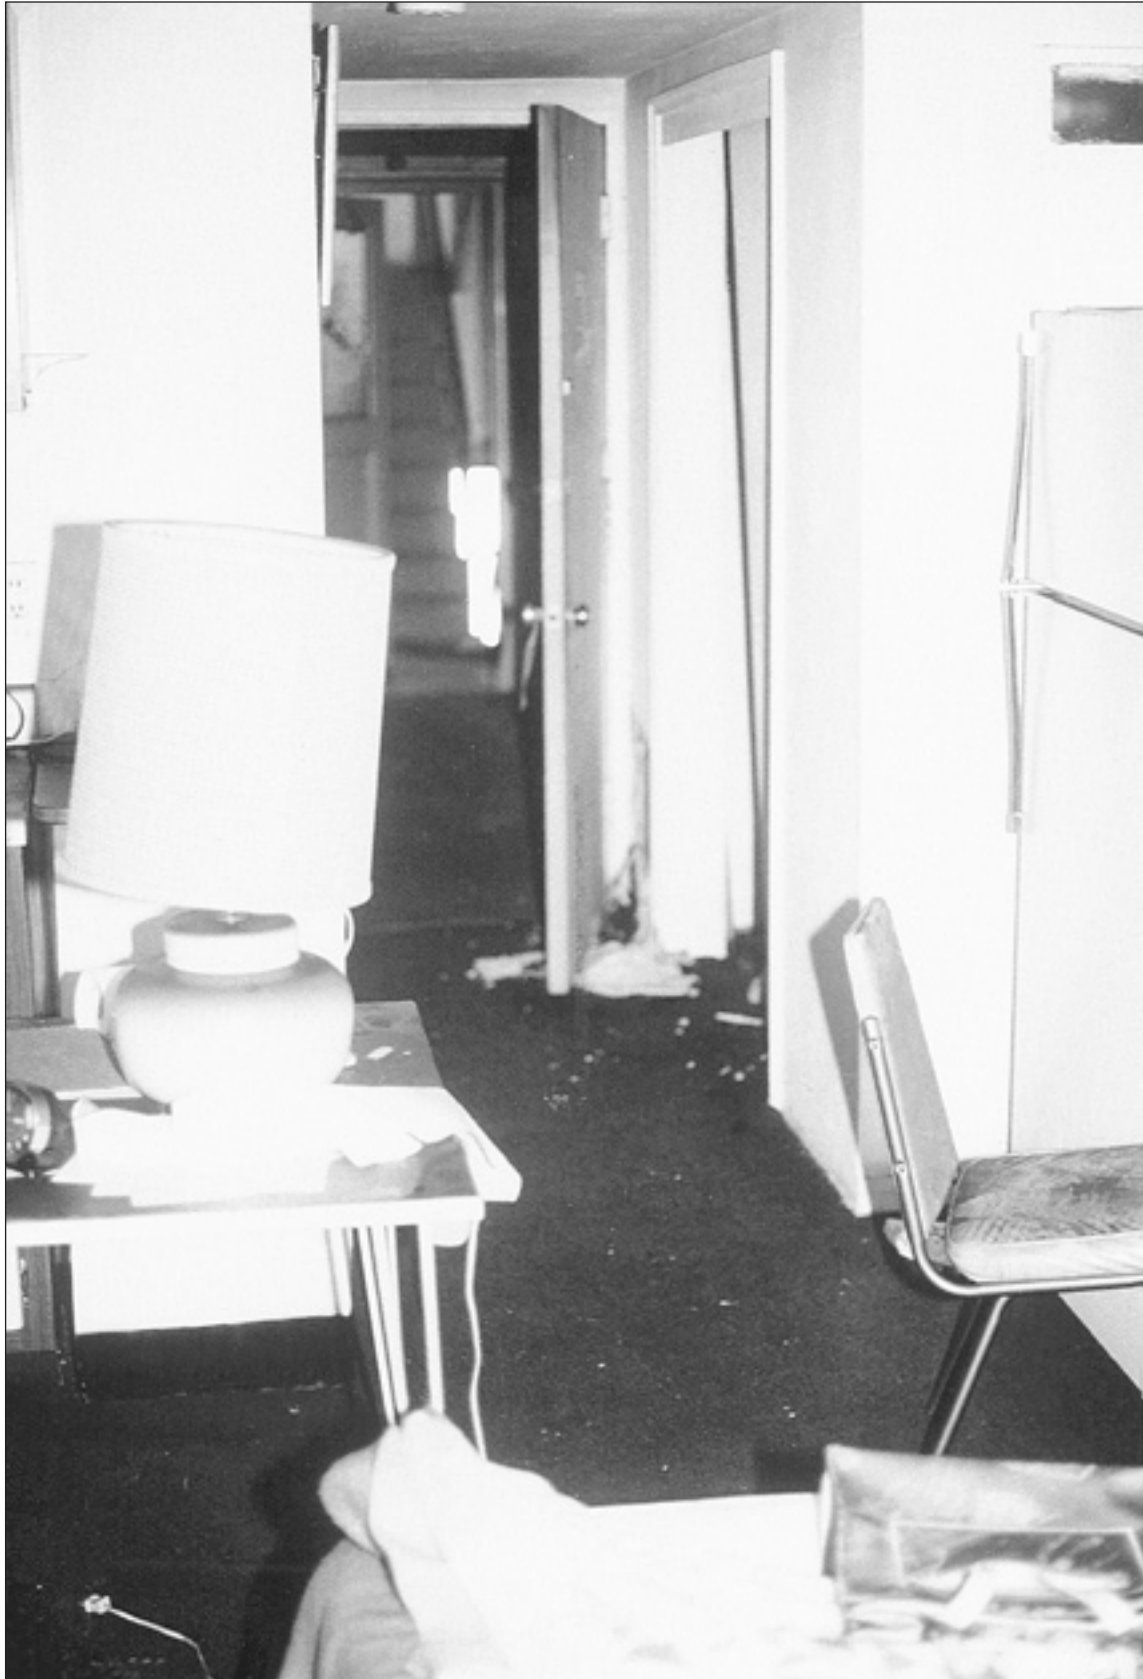
View of Room 205, fire exit is visible across corridor.

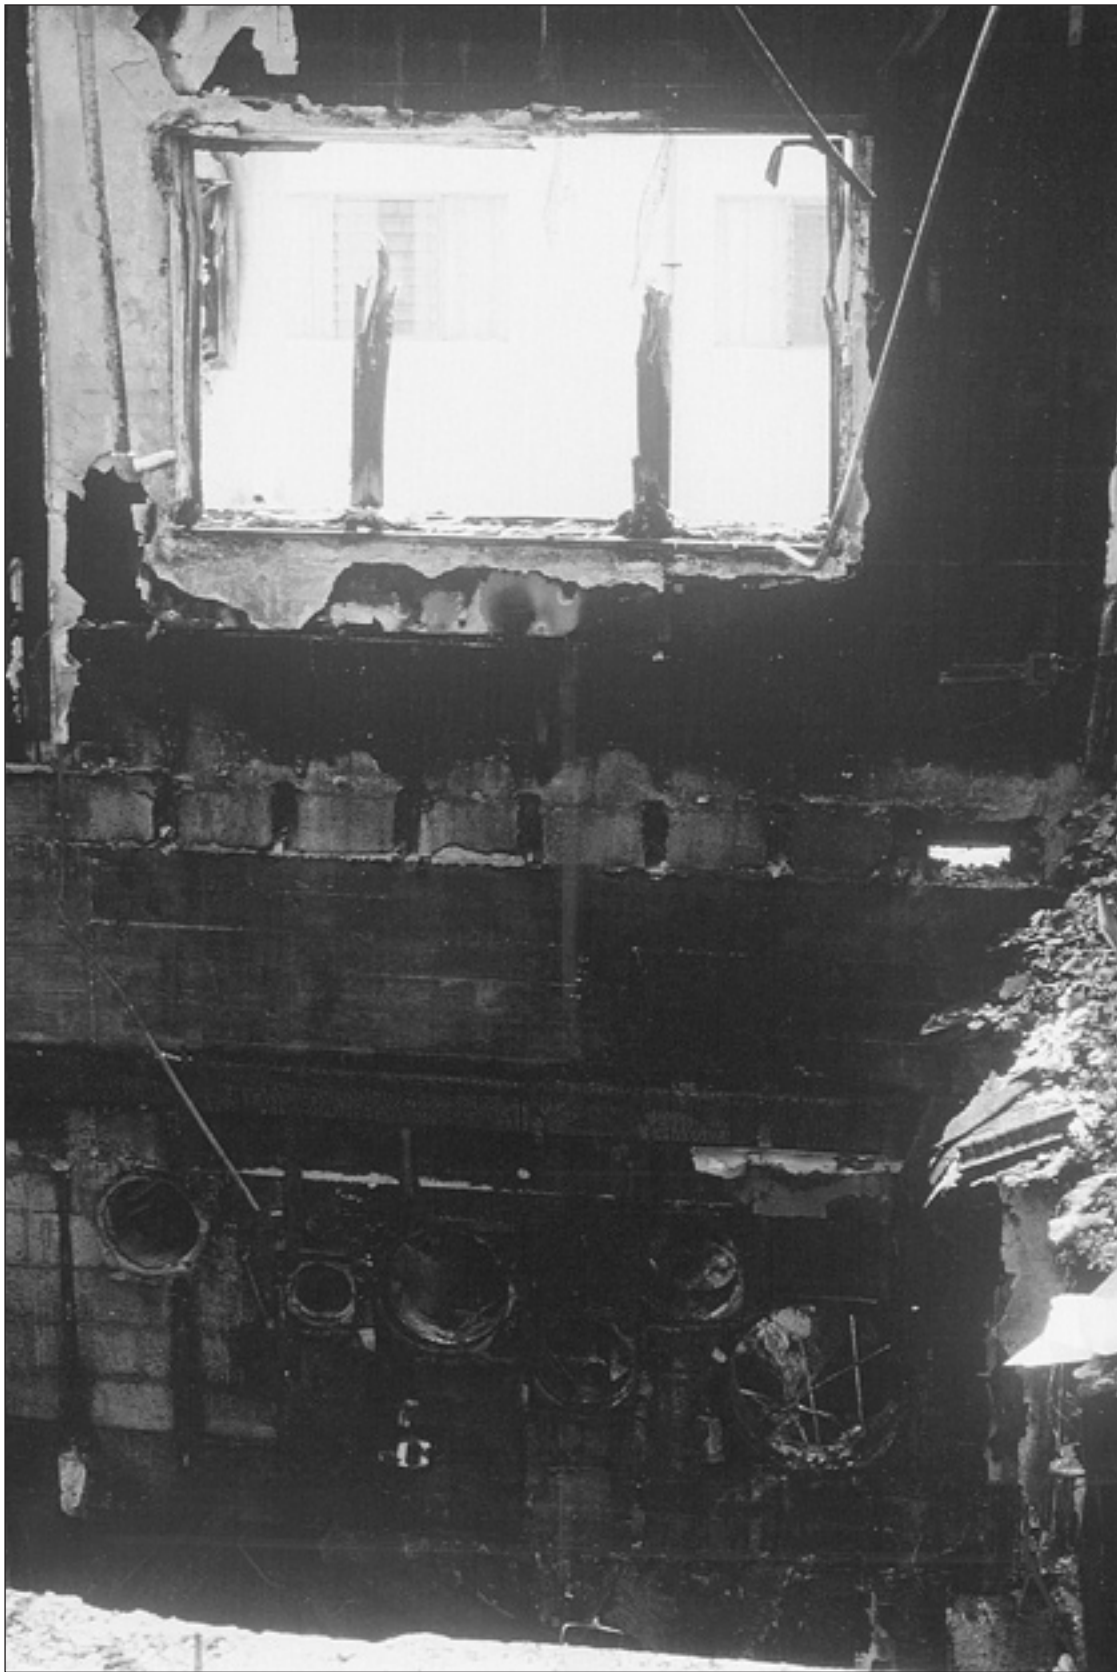
Second floor, looking across to Room 301 from front stairway, area of origin is at base of photo.

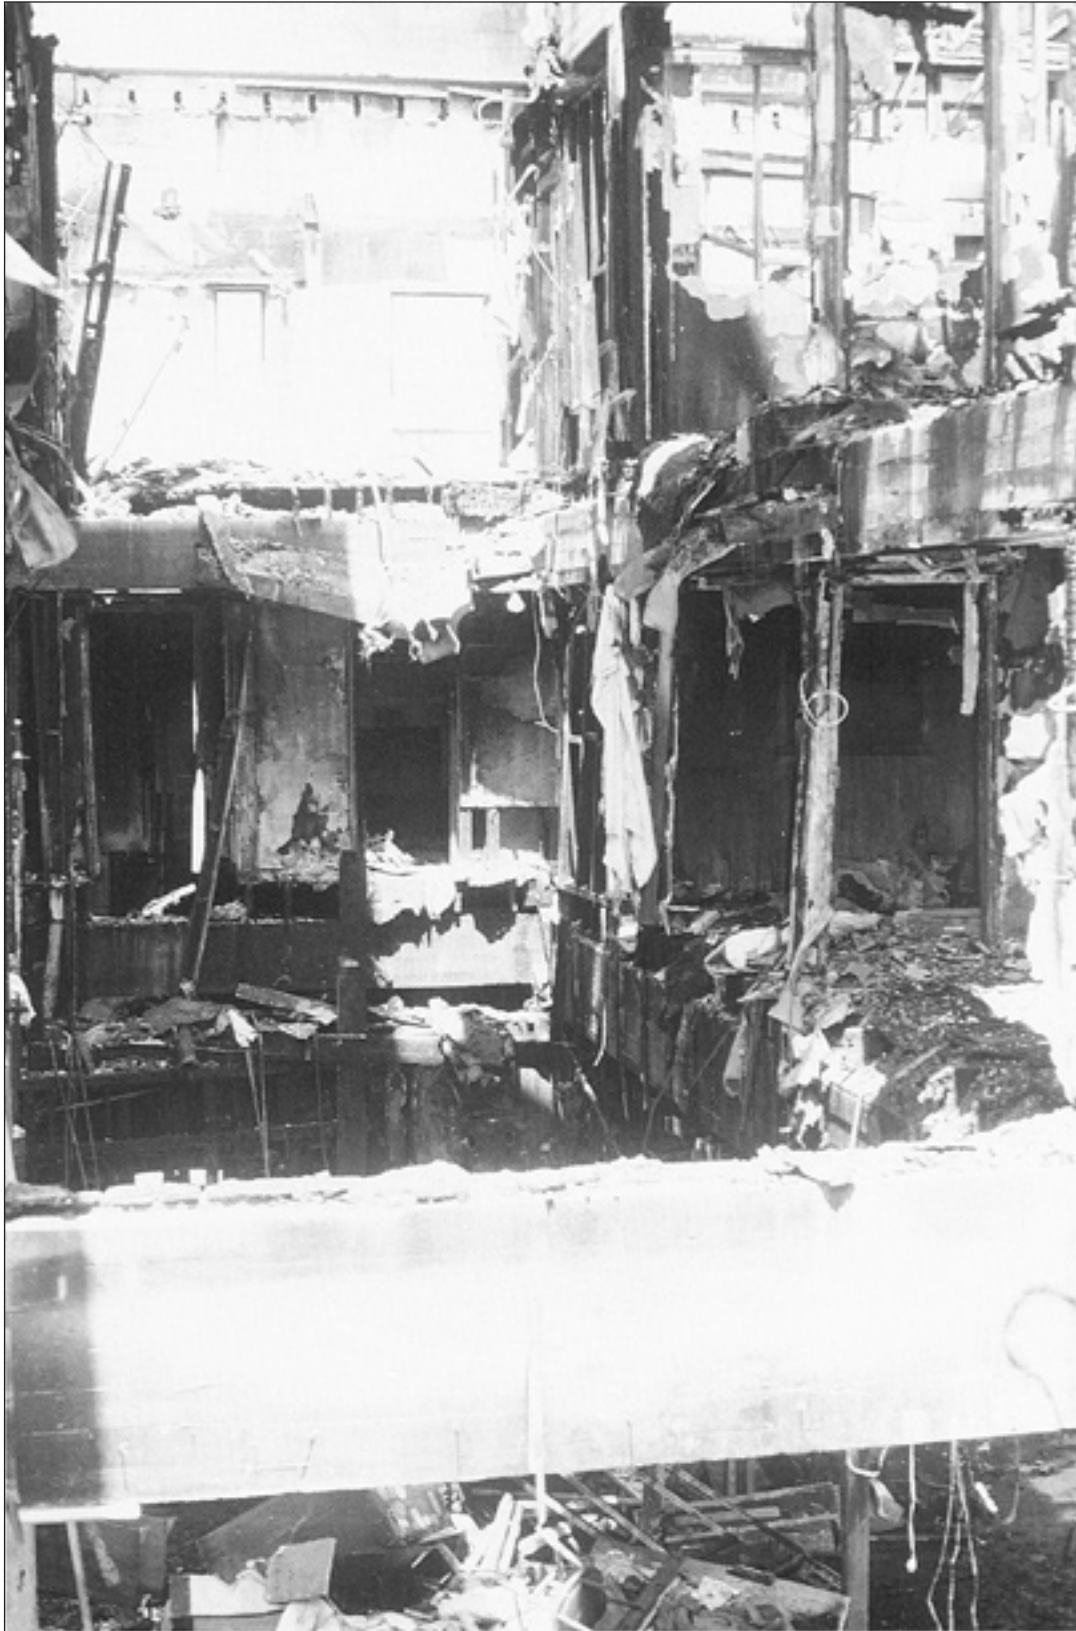
View from second floor, front stairway looking straight across building.
Lobby is at bottom of photo.

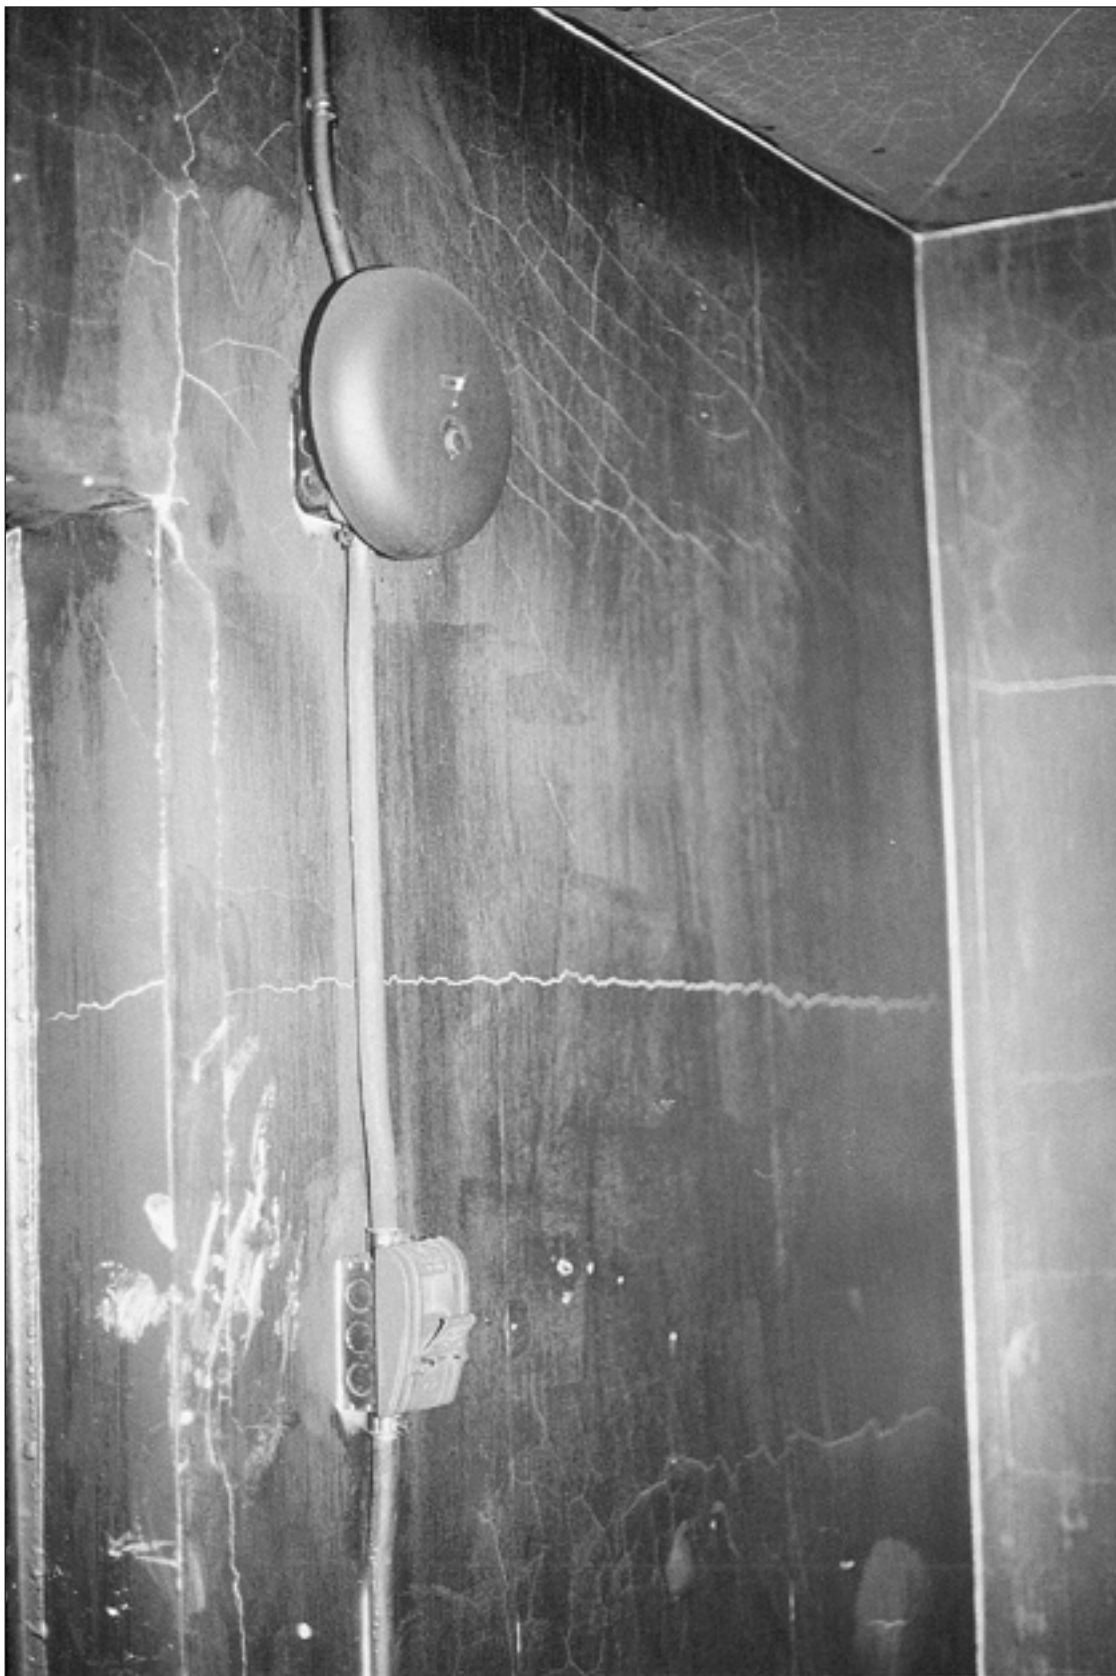
Manual fire alarm station and bell, third floor, at rear stair. Note extensive darkening soot.

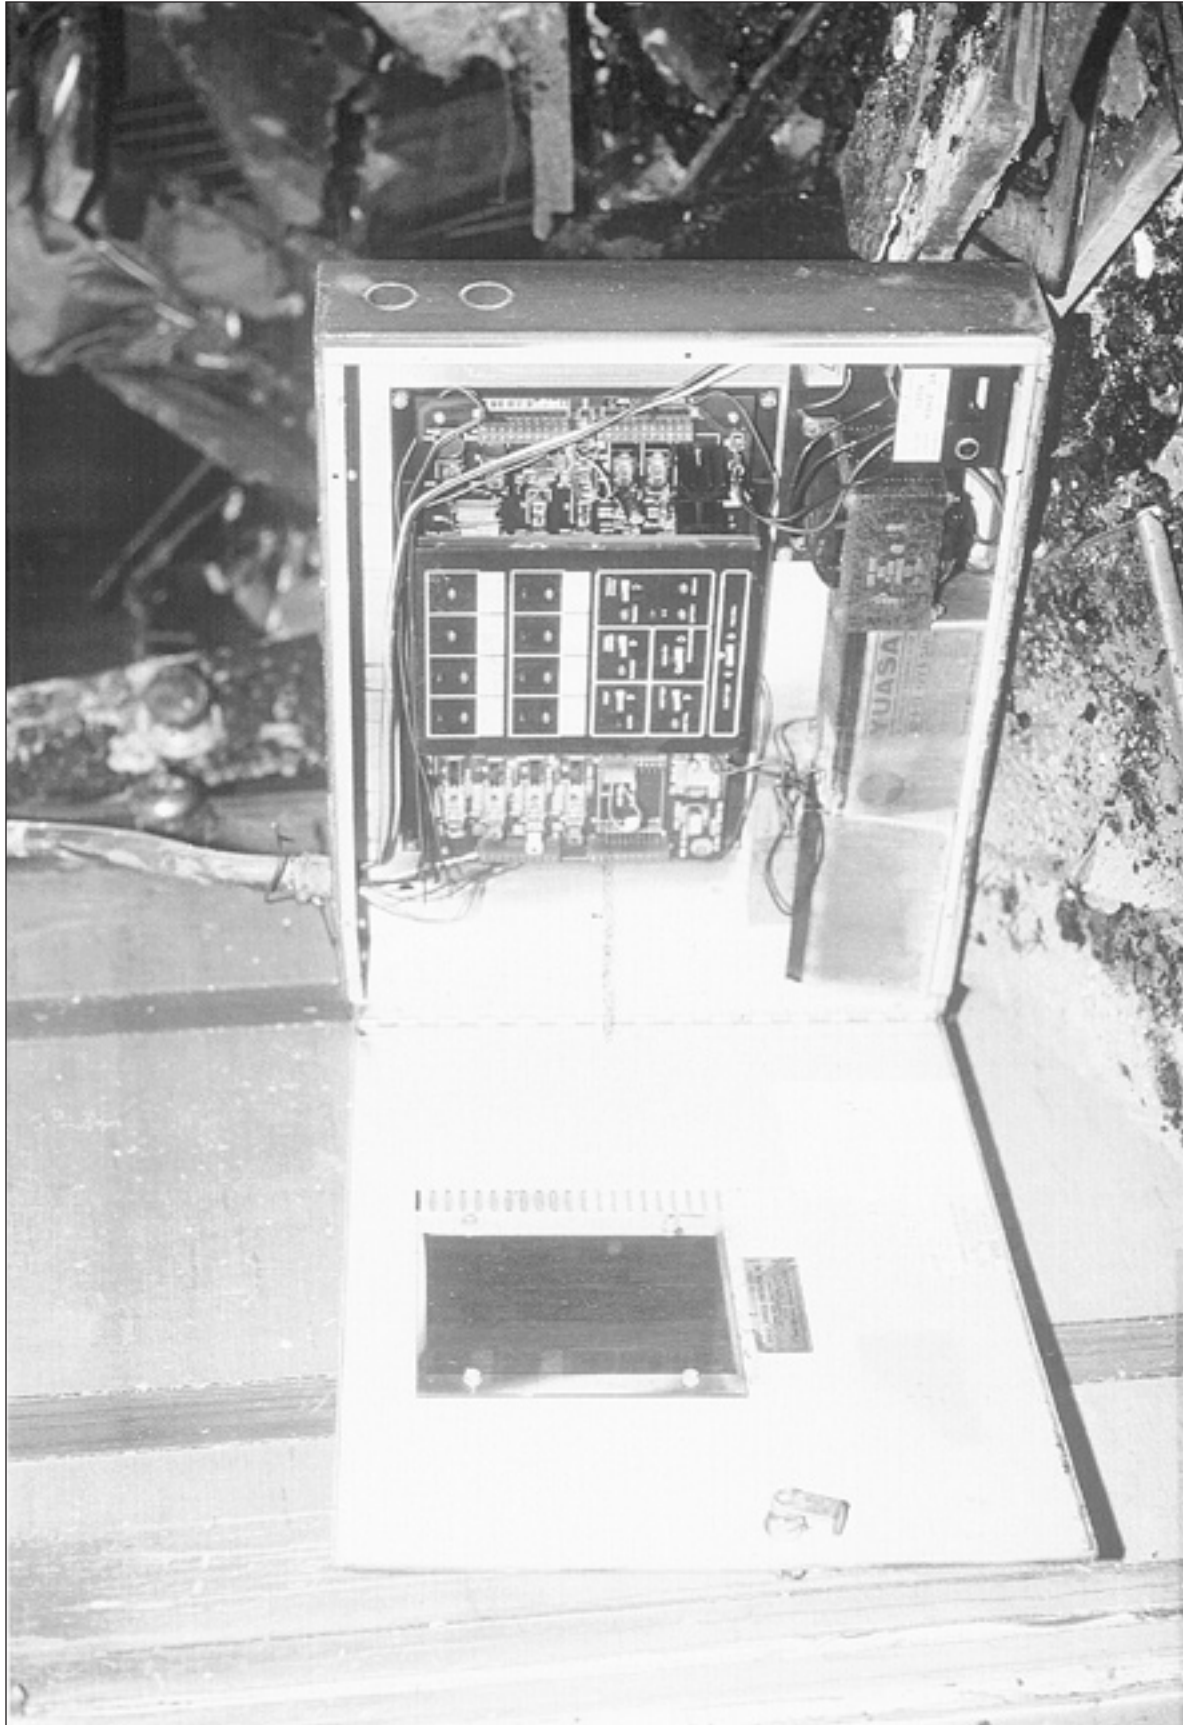
Single station hard-wired smoke detectors in guest rooms did activate. There were conflicting statements as to whether the building fire alarm was activated. The control wiring for the alarm ran through the concealed space where the fire originated, leading some to believe that by the time a manual station was pulled, the fire alarm wiring was destroyed. The fire alarm control panel was located in an office behind the front desk and remained basically intact throughout the fire. (See photograph, Appendix E.) The fact that corridor smoke detectors did not activate was consistent with the development of fire.

Remains of fire alarm control panel.
