# Nine Fatality Apartment House Fire

Ludington, Michigan

USFA-TR-072/February 1993

Investigated by: Randolph E. Kirby

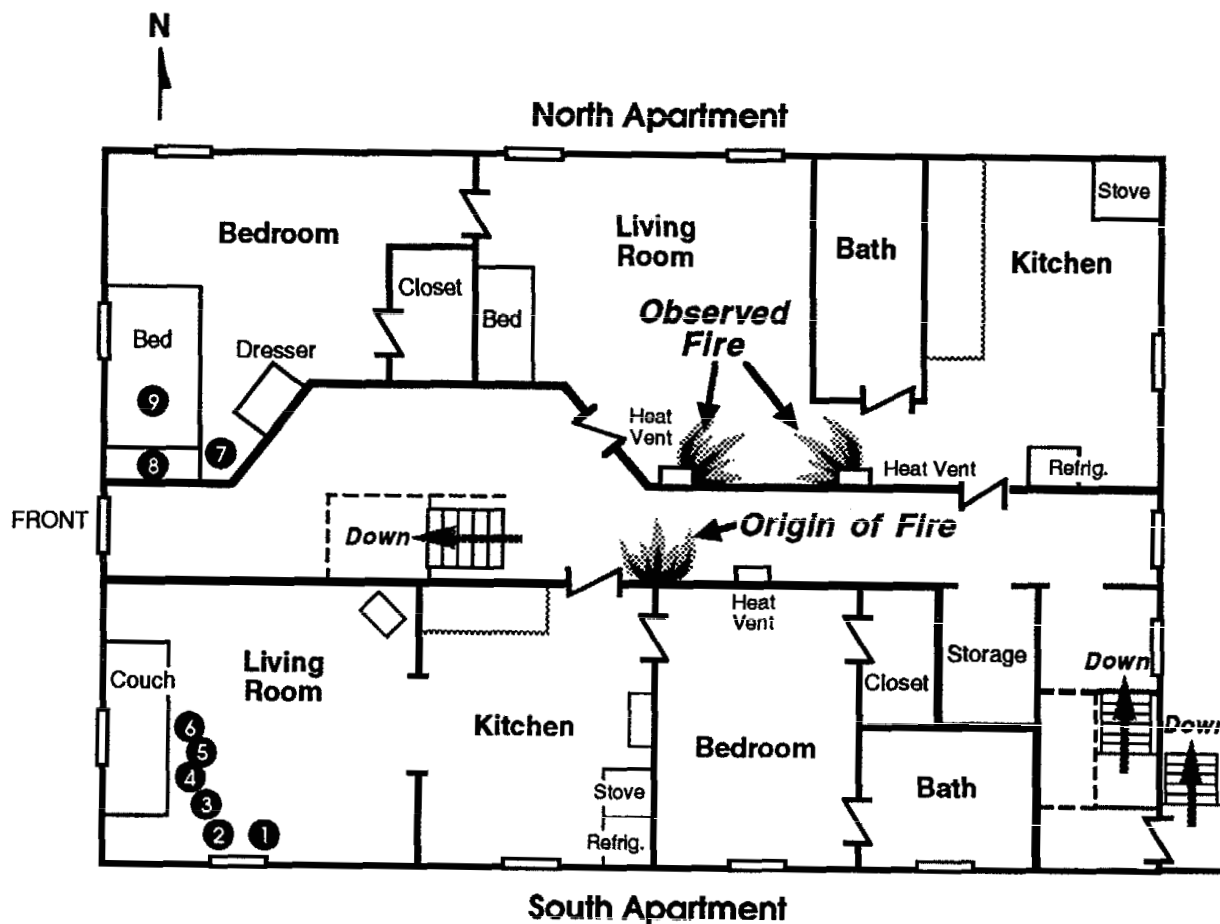
### SECOND FLOOR PLAN

FATALITIES	
①	3-year-old girl
②	2-year-old boy
③	3-year-old boy
④	1-year-old boy
⑤	6-year-old boy
⑥	13-year-old girl (babysitter)
⑦	1-year-old
⑧	18-year-old woman
⑨	2-year-old boy

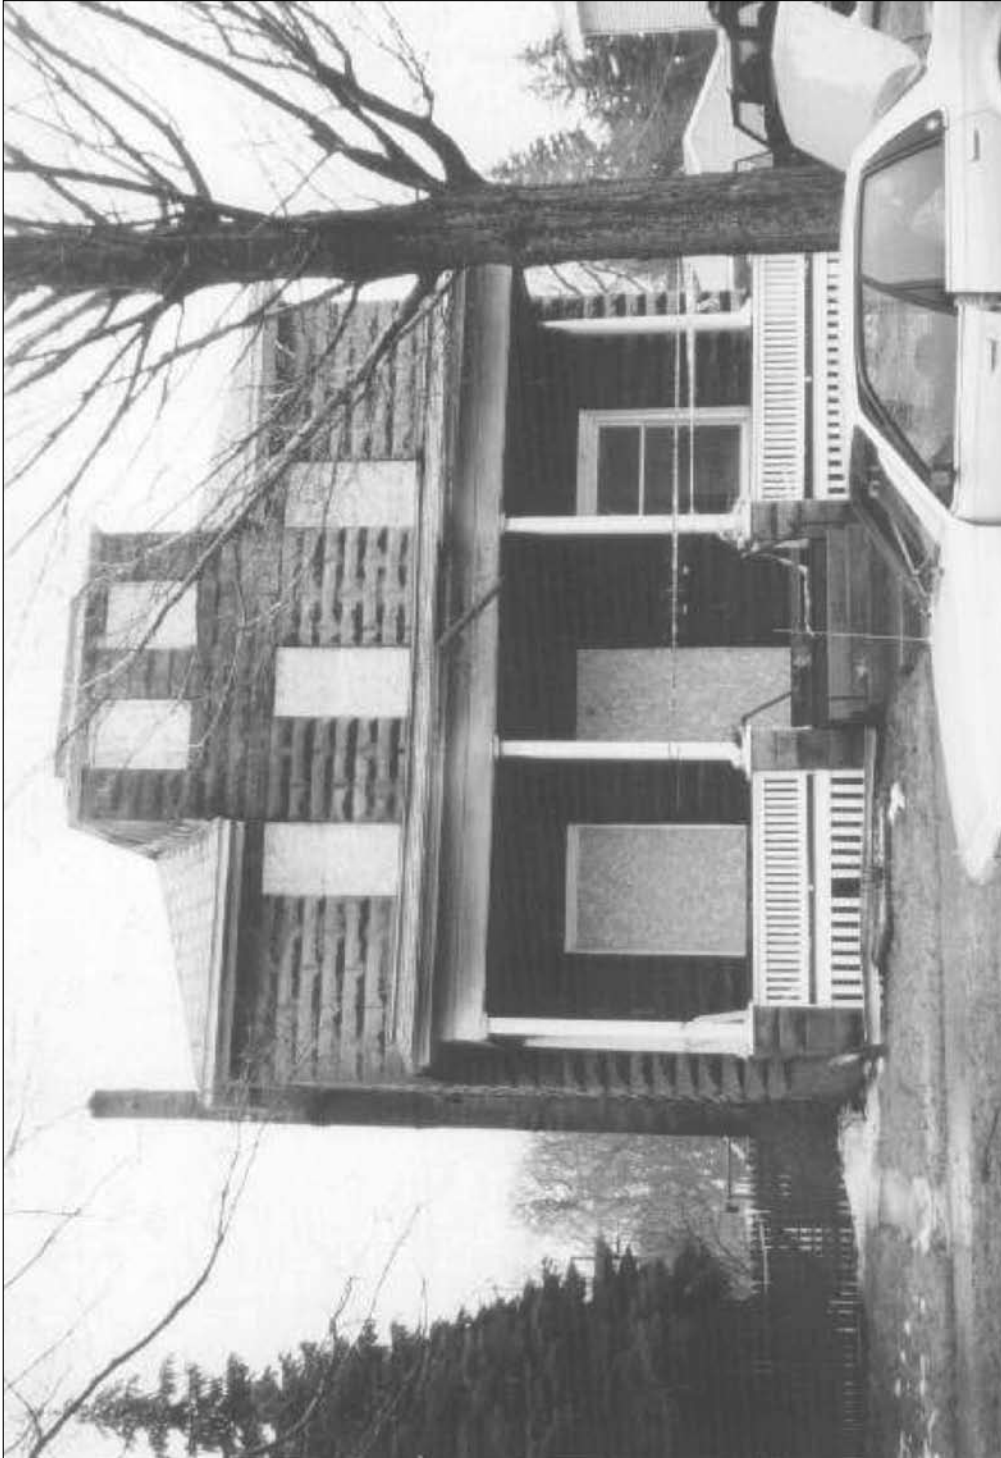
**Front of building facing James Street.**

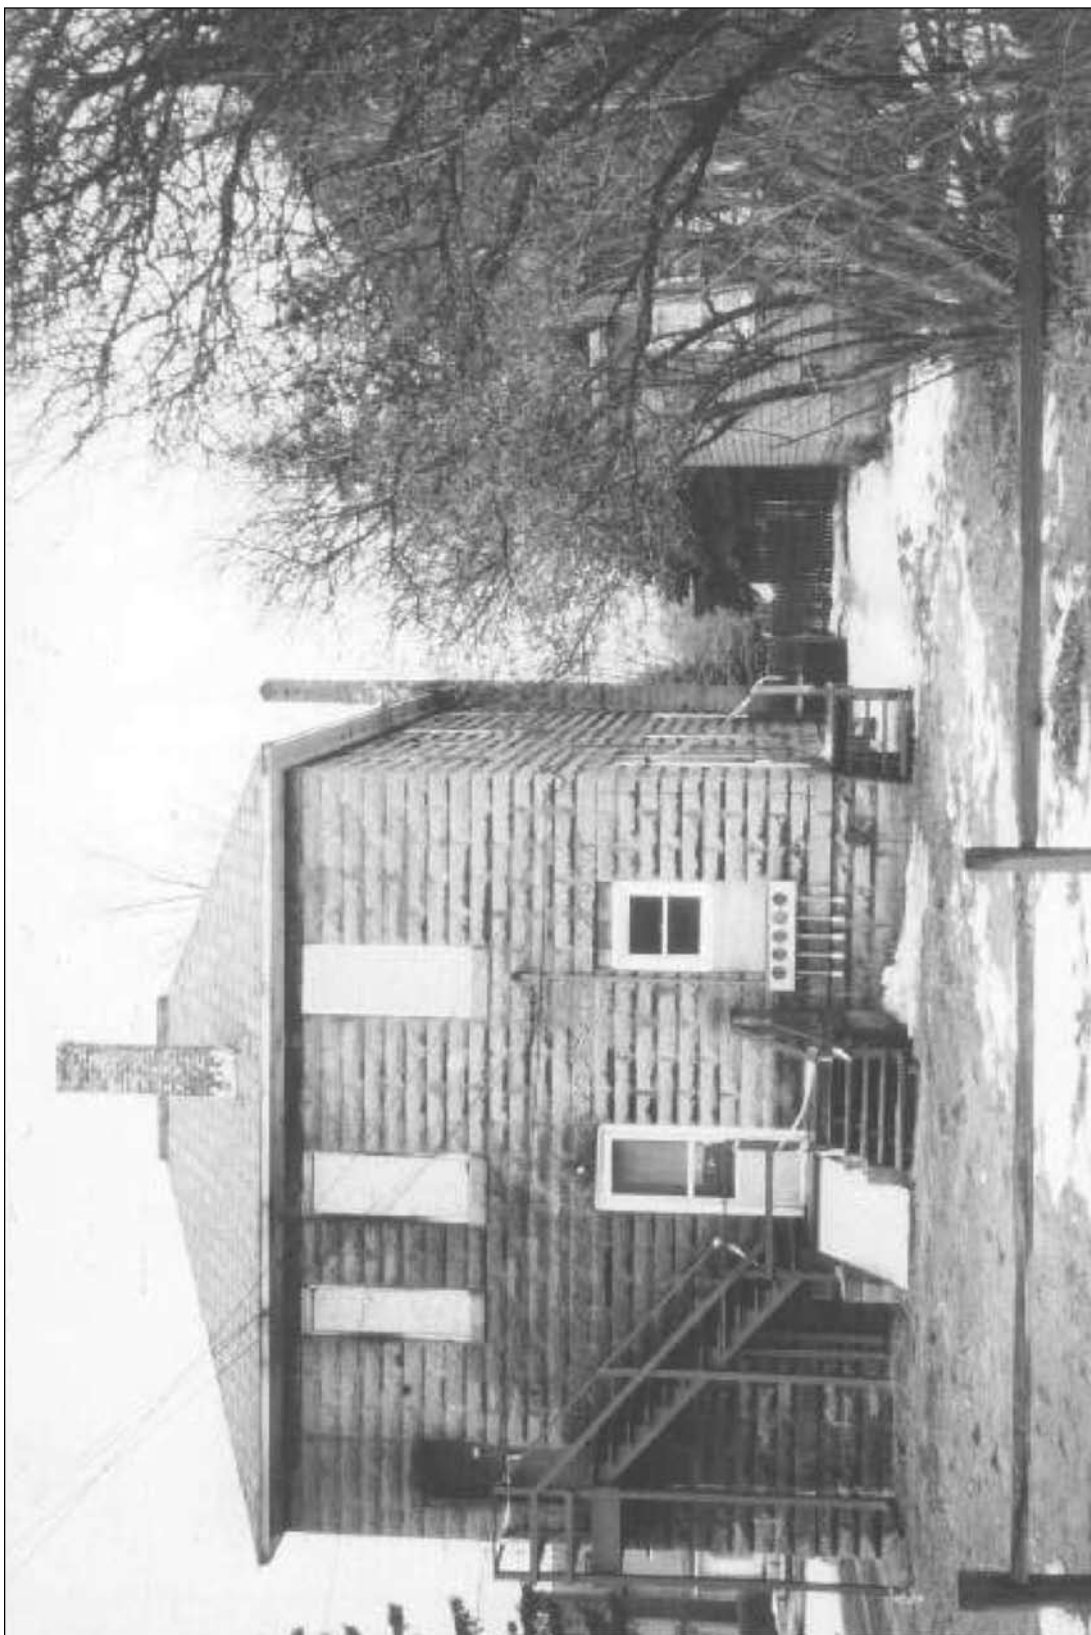
Separate entrance to first floor rear apartment and wooden fire escape to second floor.

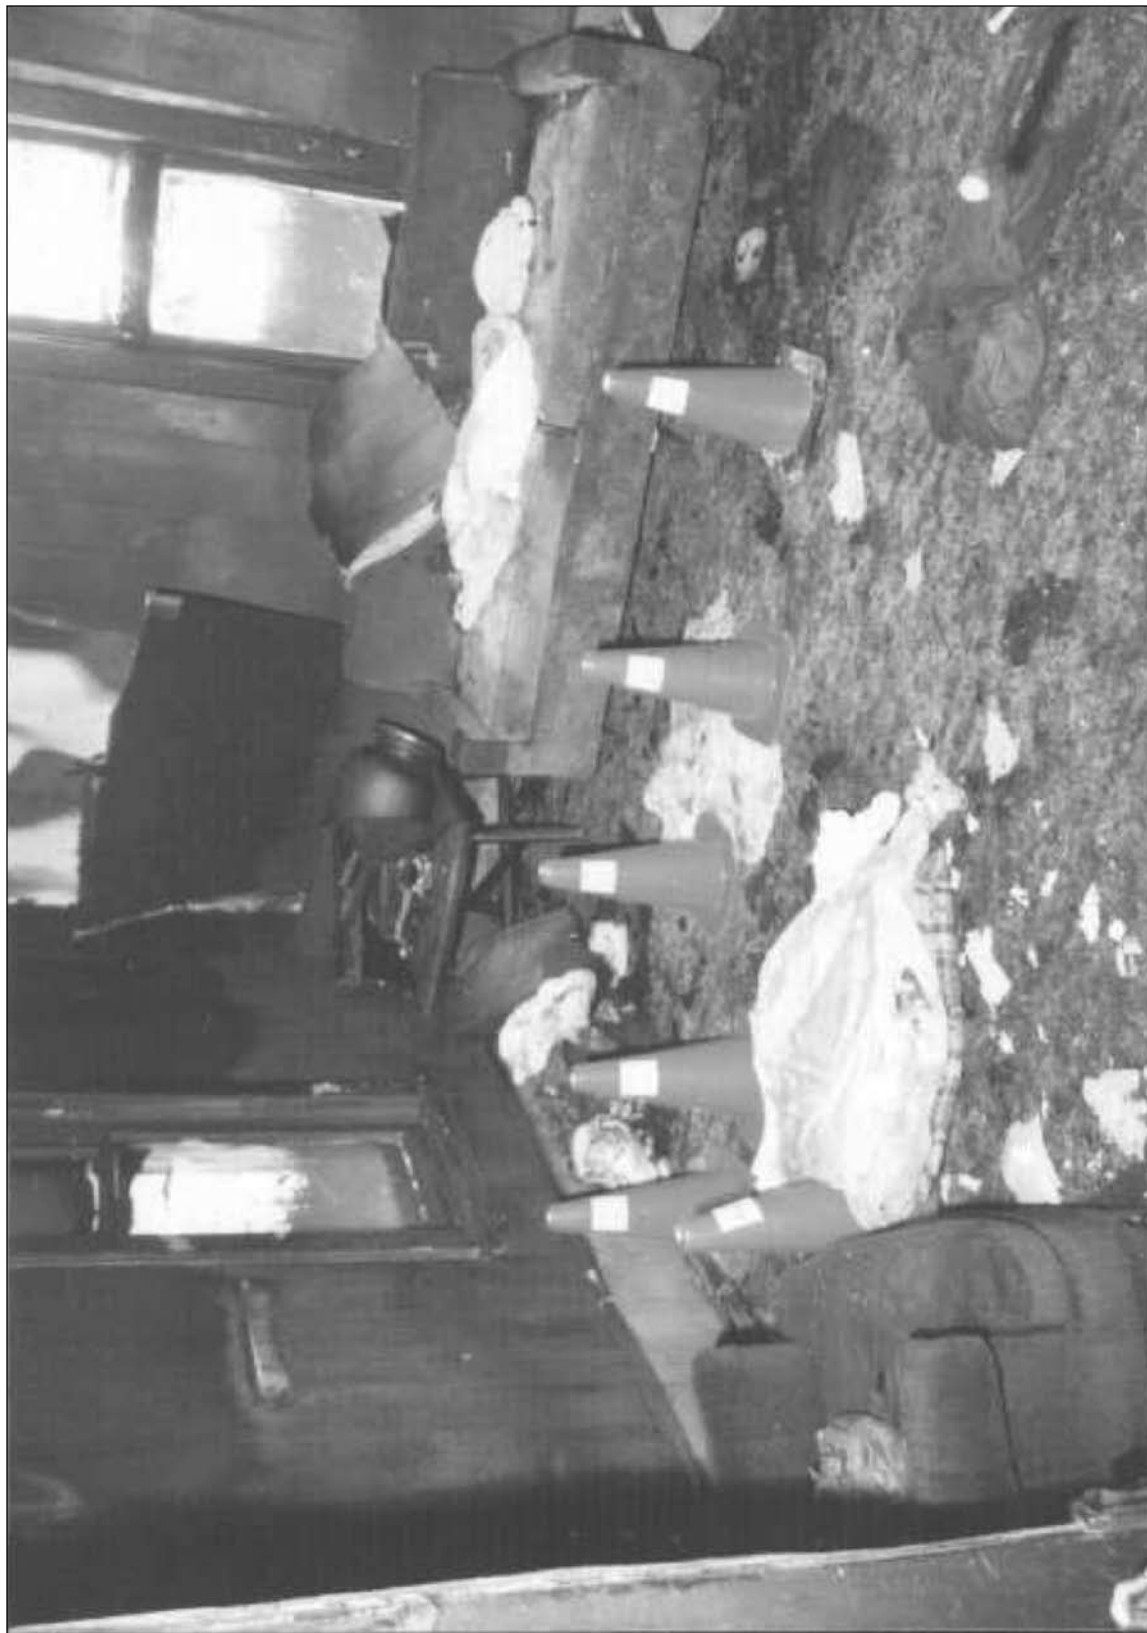
The positions of the victims located in the south apartment indicate, with one exception, that all were asleep on the living room floor and never woke up. Some were still clutching stuffed animals or other objects children normally sleep with.

Area on second floor south apartment living room where six fatalities were found. Notice little or no actual fire damage.

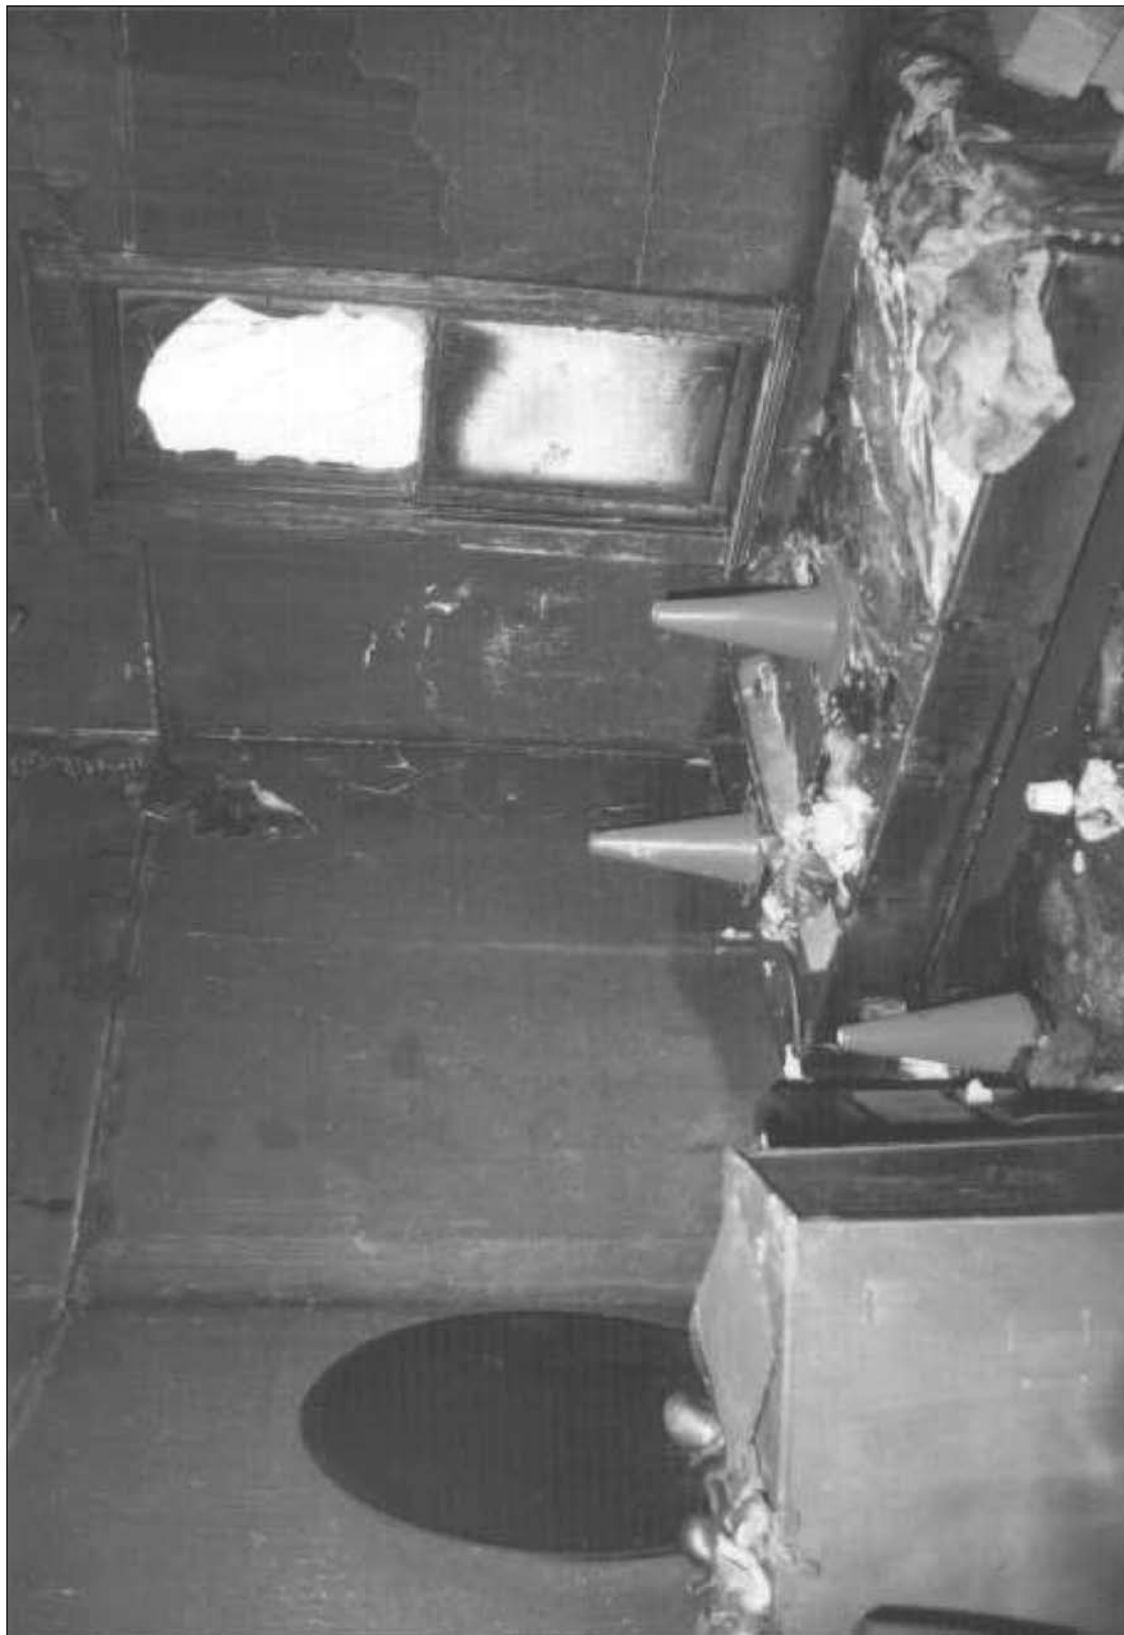
**Bed in living room of second floor north apartment; area where three fatalities were discovered.**

**Notice heat and smoke damage only.**

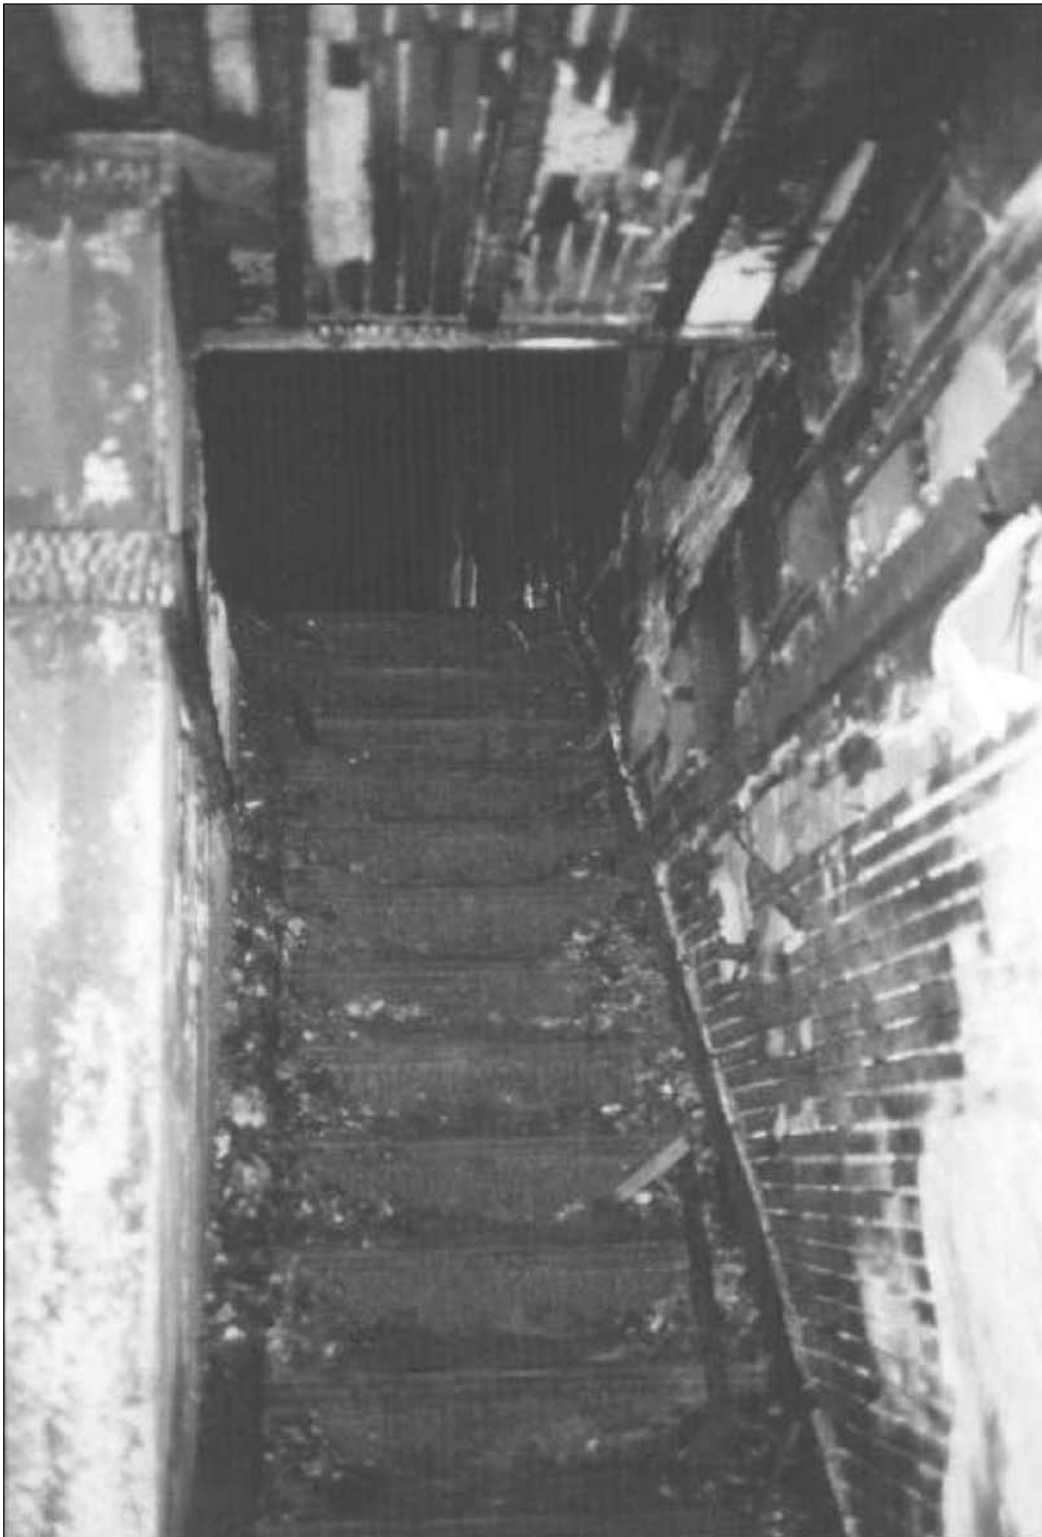
**Stairway from first to second floor showing burn damage to staircase, wall, and ceiling.**

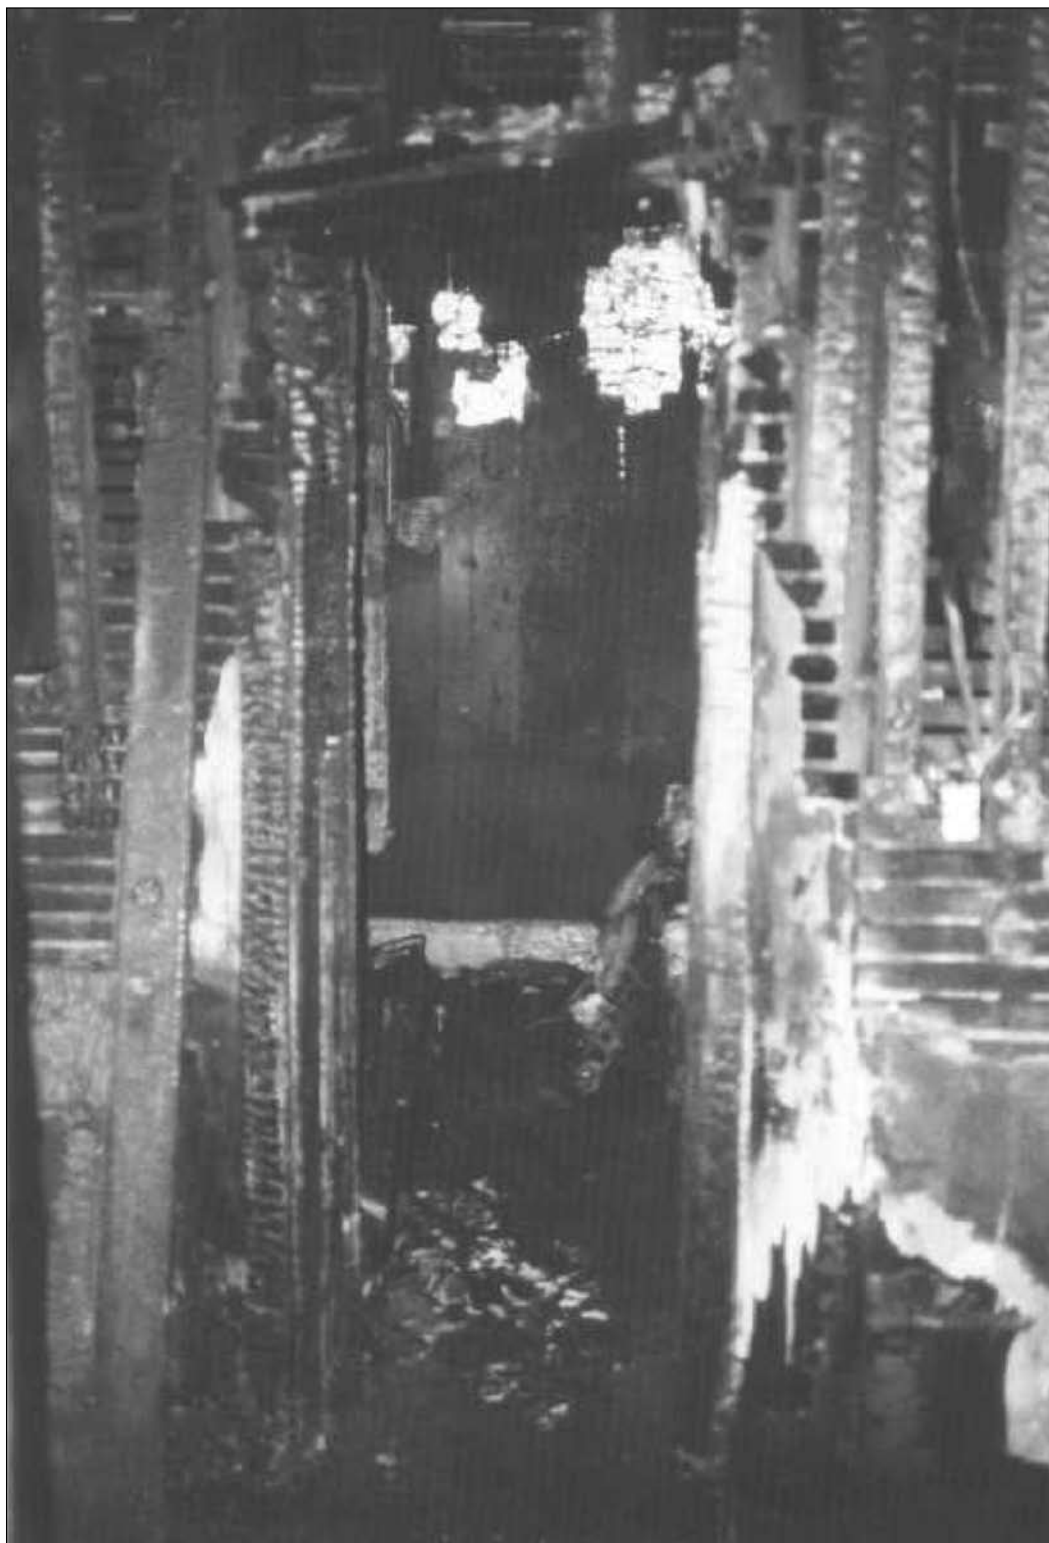
The fire is believed to have been of accidental nature, originating in or around a second floor corridor wall light fixture located in the vicinity of the entrance door to the south apartment. Burn patterns reveal the source of the fire originating at this location and moving east down the corridor, igniting plywood paneling on the walls and combustible ceiling tiles. Fire developed very rapidly due to the presence of sufficient fuel and the lack of early detection. It quickly penetrated the upper ceiling joist area and gained entrance into the two second floor apartments by way of the wood panel doors and in and around air-transfer vents that were exposed once the paneling had burned away.

**Fire damage to entrance doorway and walls of the second floor north apartment living room. Notice height of burn patterns and suspected area of origin.**

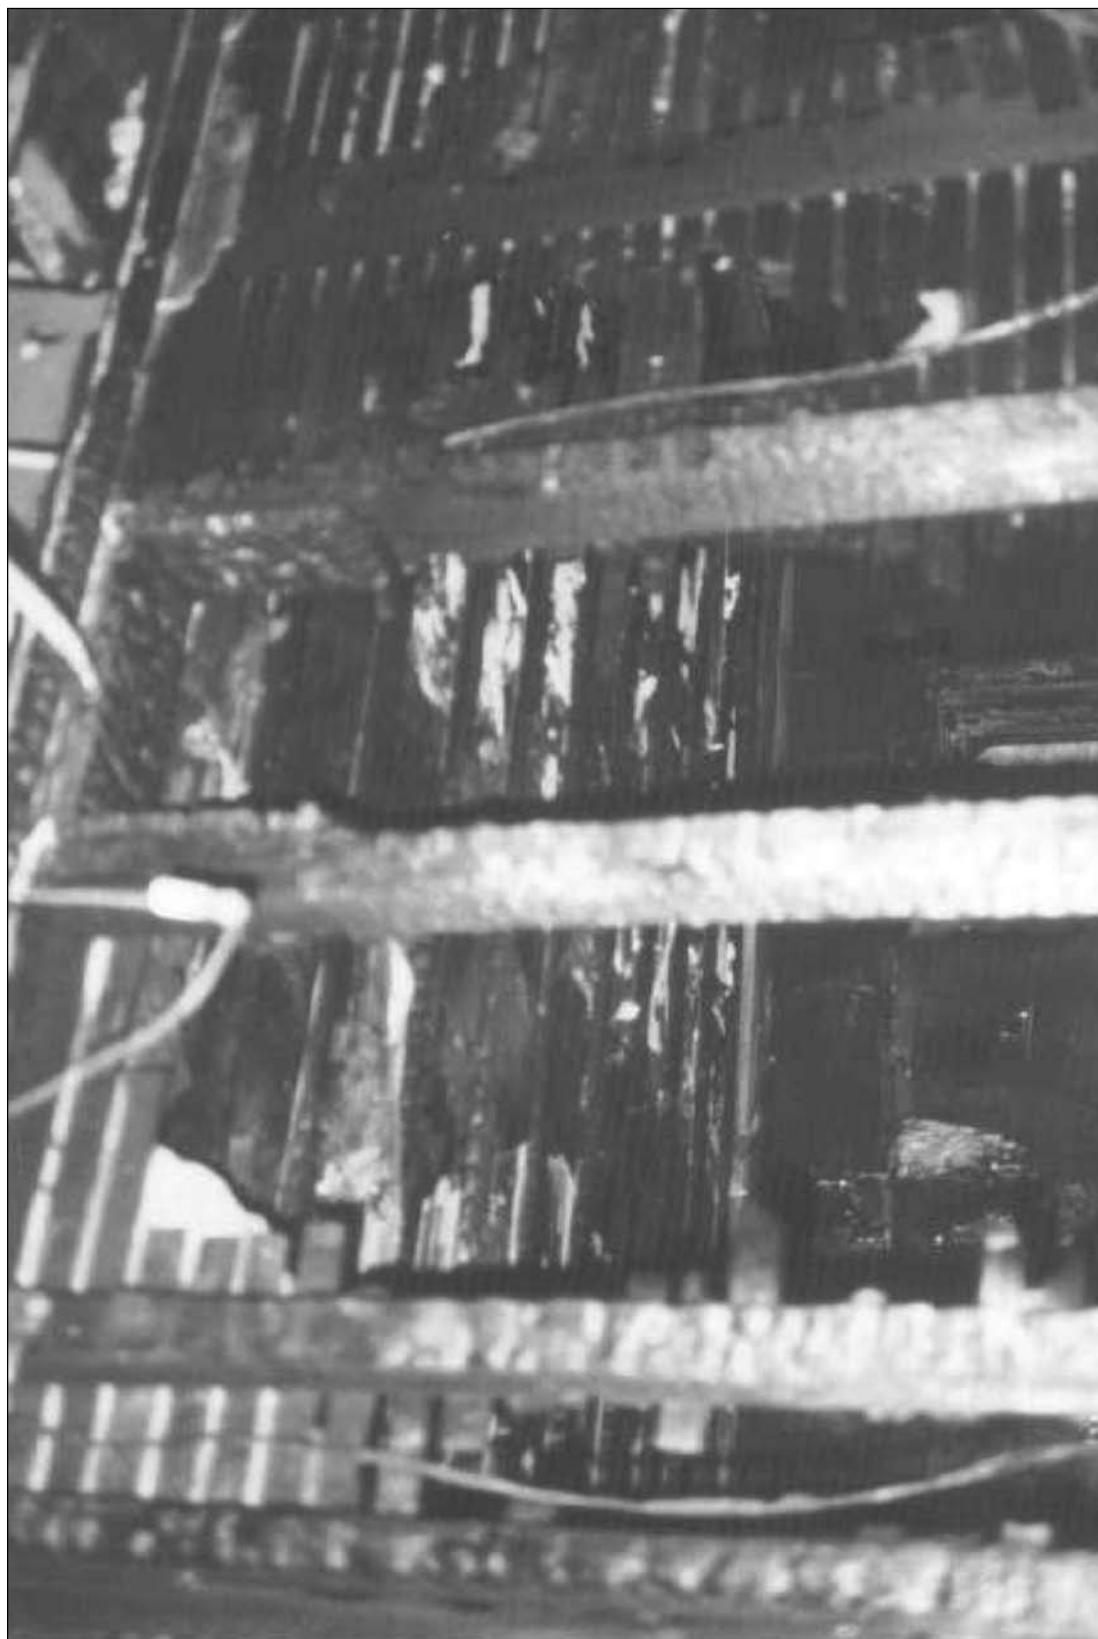
Fire traveled through air vent from suspected area of origin into second floor north apartment living room.

Again, notice high burn pattern.

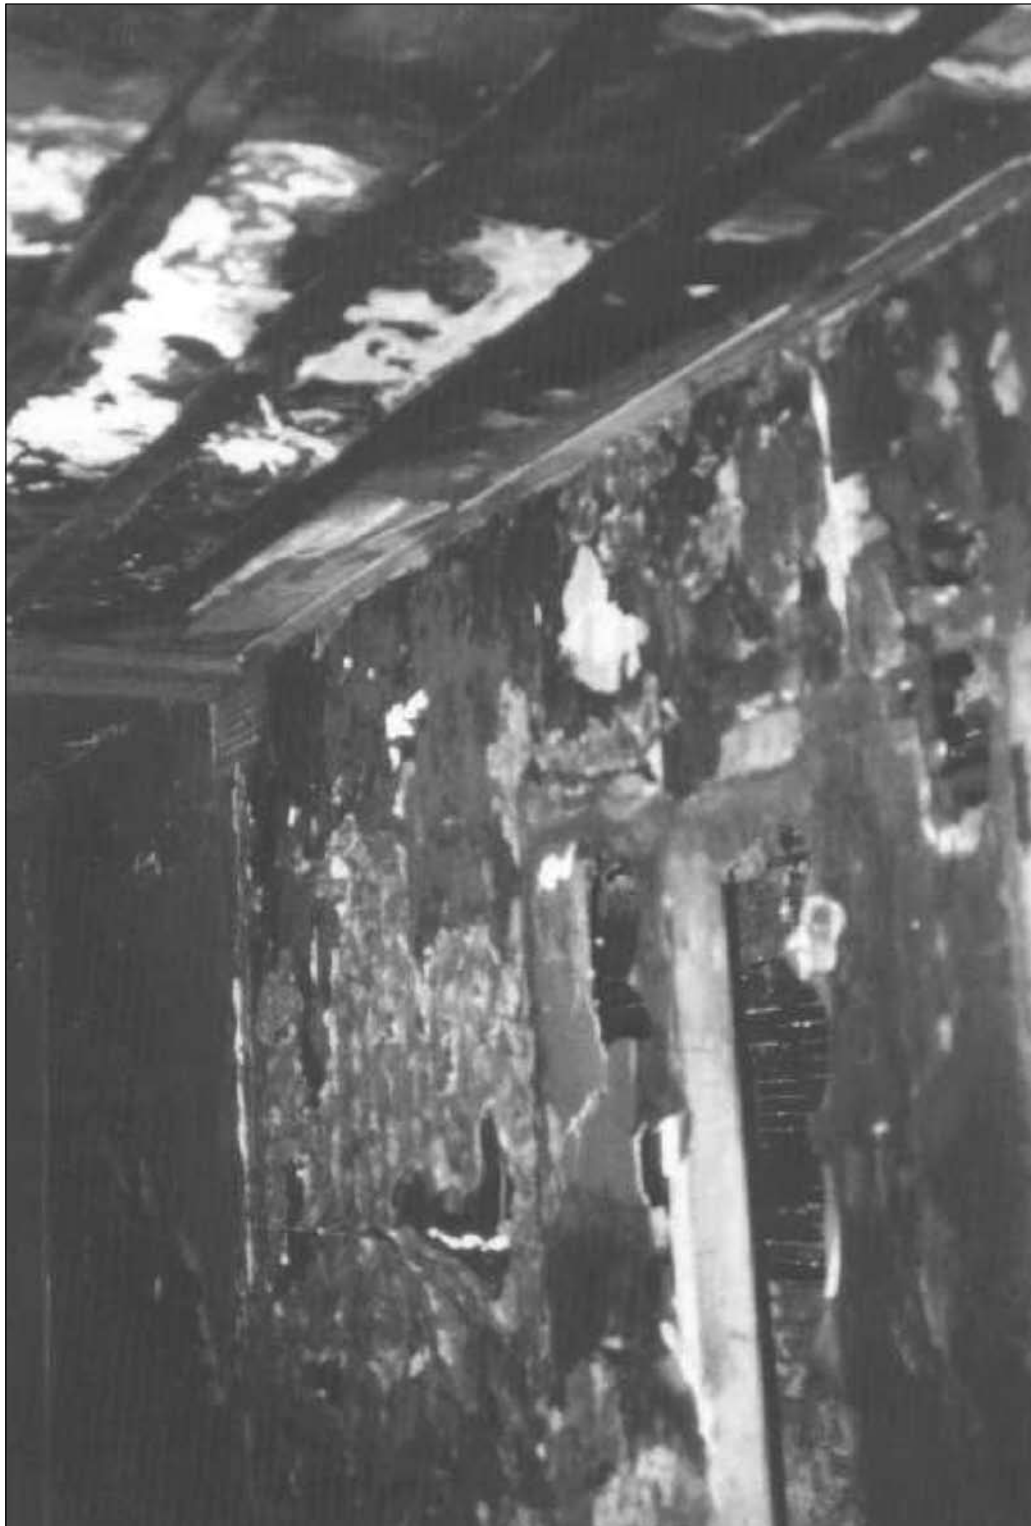
Fire damage revealed that the fire originated in the corridor at or below the ceiling level in the vicinity of a light fixture on the south wall. Fire progressed rapidly because of the highly combustible wood paneling and wood fiber ceiling tiles. It was aided by an additional supply of oxygen as a result of the occupant leaving both his apartment door and the front door open when exiting the building. It was allowed to penetrate the north and south apartments at an early stage, burning through wooden doors and through air-transfer grills that were installed in the corridor walls that separated the living units.

**Fire damage to second floor corridor walls and ceiling. Notice fire penetration through wall into north apartment.**
