# Schomburg Plaza Fire

New York City (Harlem)

USFA-TR-004/March 1987

**BOARD OF INQUIRY  
INTO THE MARCH 22, 1987  
SCHOMBURG PLAZA FIRE  
PRELIMINARY REPORT  
June 11, 1987**

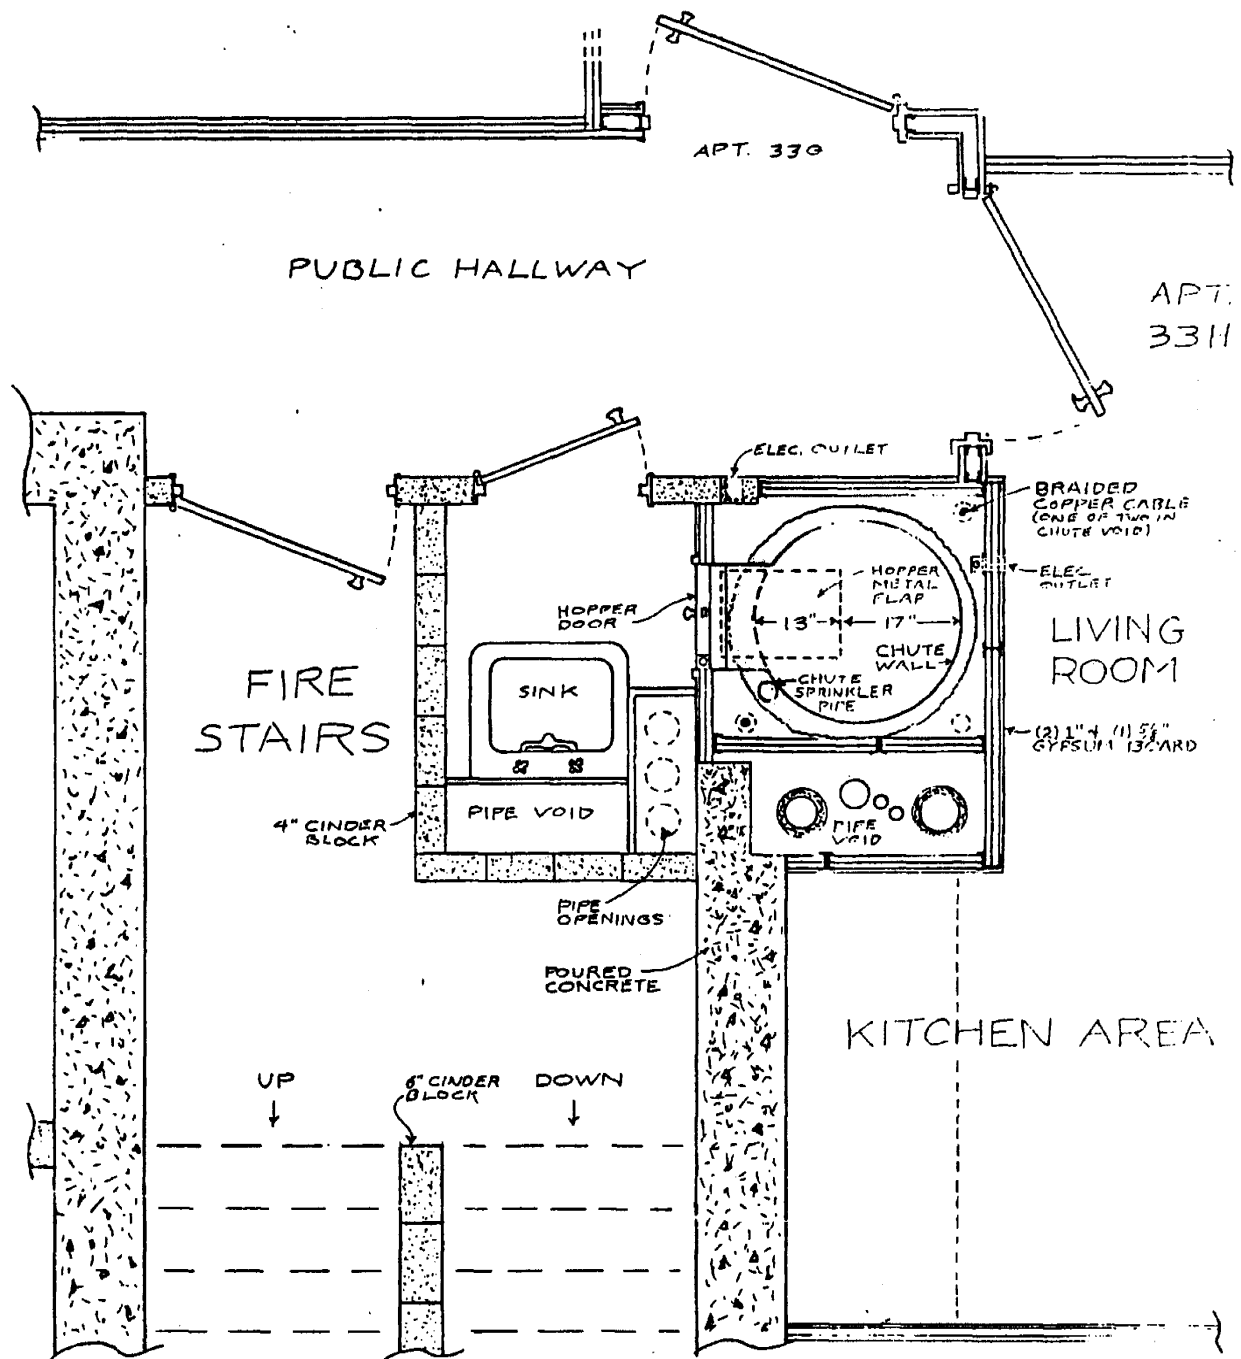
# 1295 5<sup>TH</sup> AVE MAN. 33<sup>RD</sup> FLOOR COMPACTOR CHUTE AREA\*

However, examination of the shaft discloses that it was not built according to plan. The wall assembly was two and five-eighths inches (2 5/8 inch) thick, not the three inches (3 inch) called for in the "as built" plans. The Board has been unable to find any test which indicates that a two and five eighths inch (2 5/8 inch) assembly has a two-hour fire-resistance rating. The Board is continuing its analysis of code requirements and approved assemblies as they relate to shaft enclosures and compactors and will make further comments in its final report.

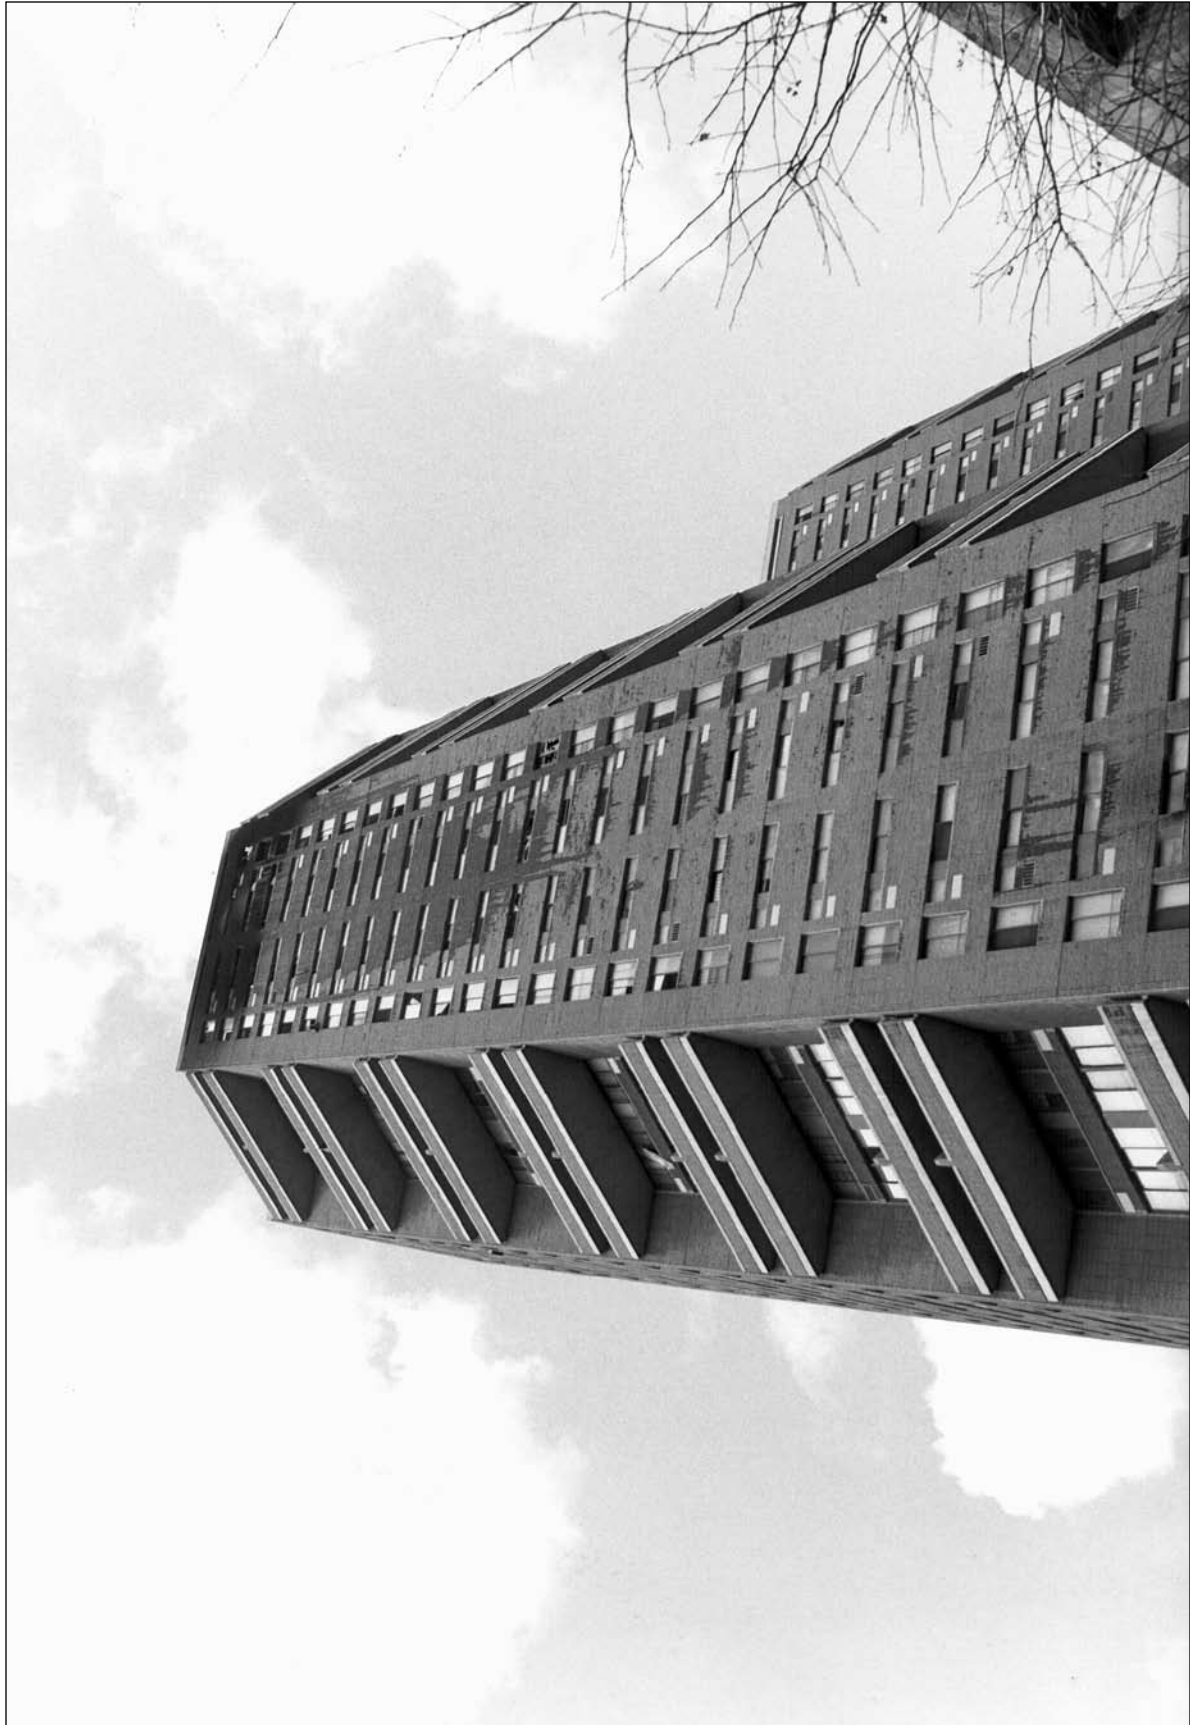
Photo 1

1. Exterior of fire building with water and burn patterns.
2. Compactor unit in the fire building (morning of fire).
3. Kitchen area, Apartment 23, adjoining compactor and pipe chase.

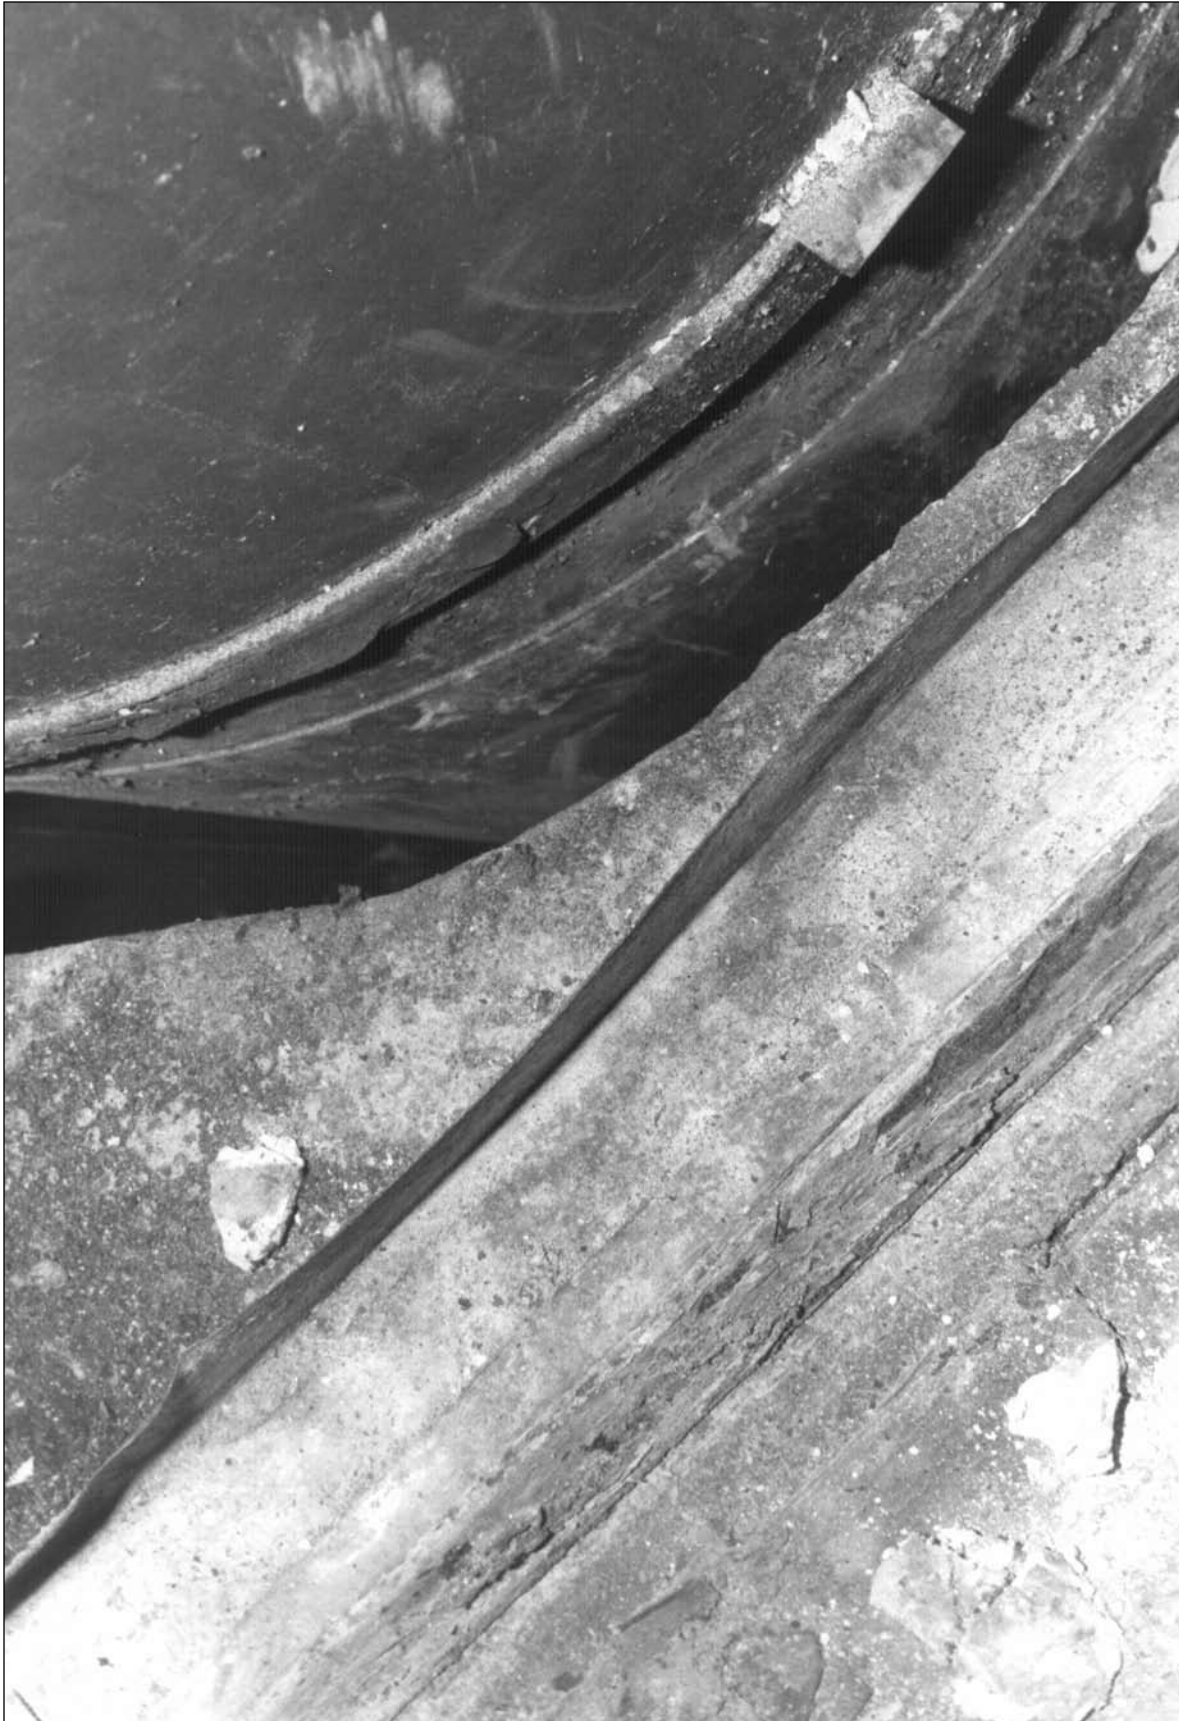
Photo 12

12. Void between chute and structure floor allowing for passage of heat from floor to floor.
13. Interior of chute with opening at seam.
14. Clogged sprinkler head.

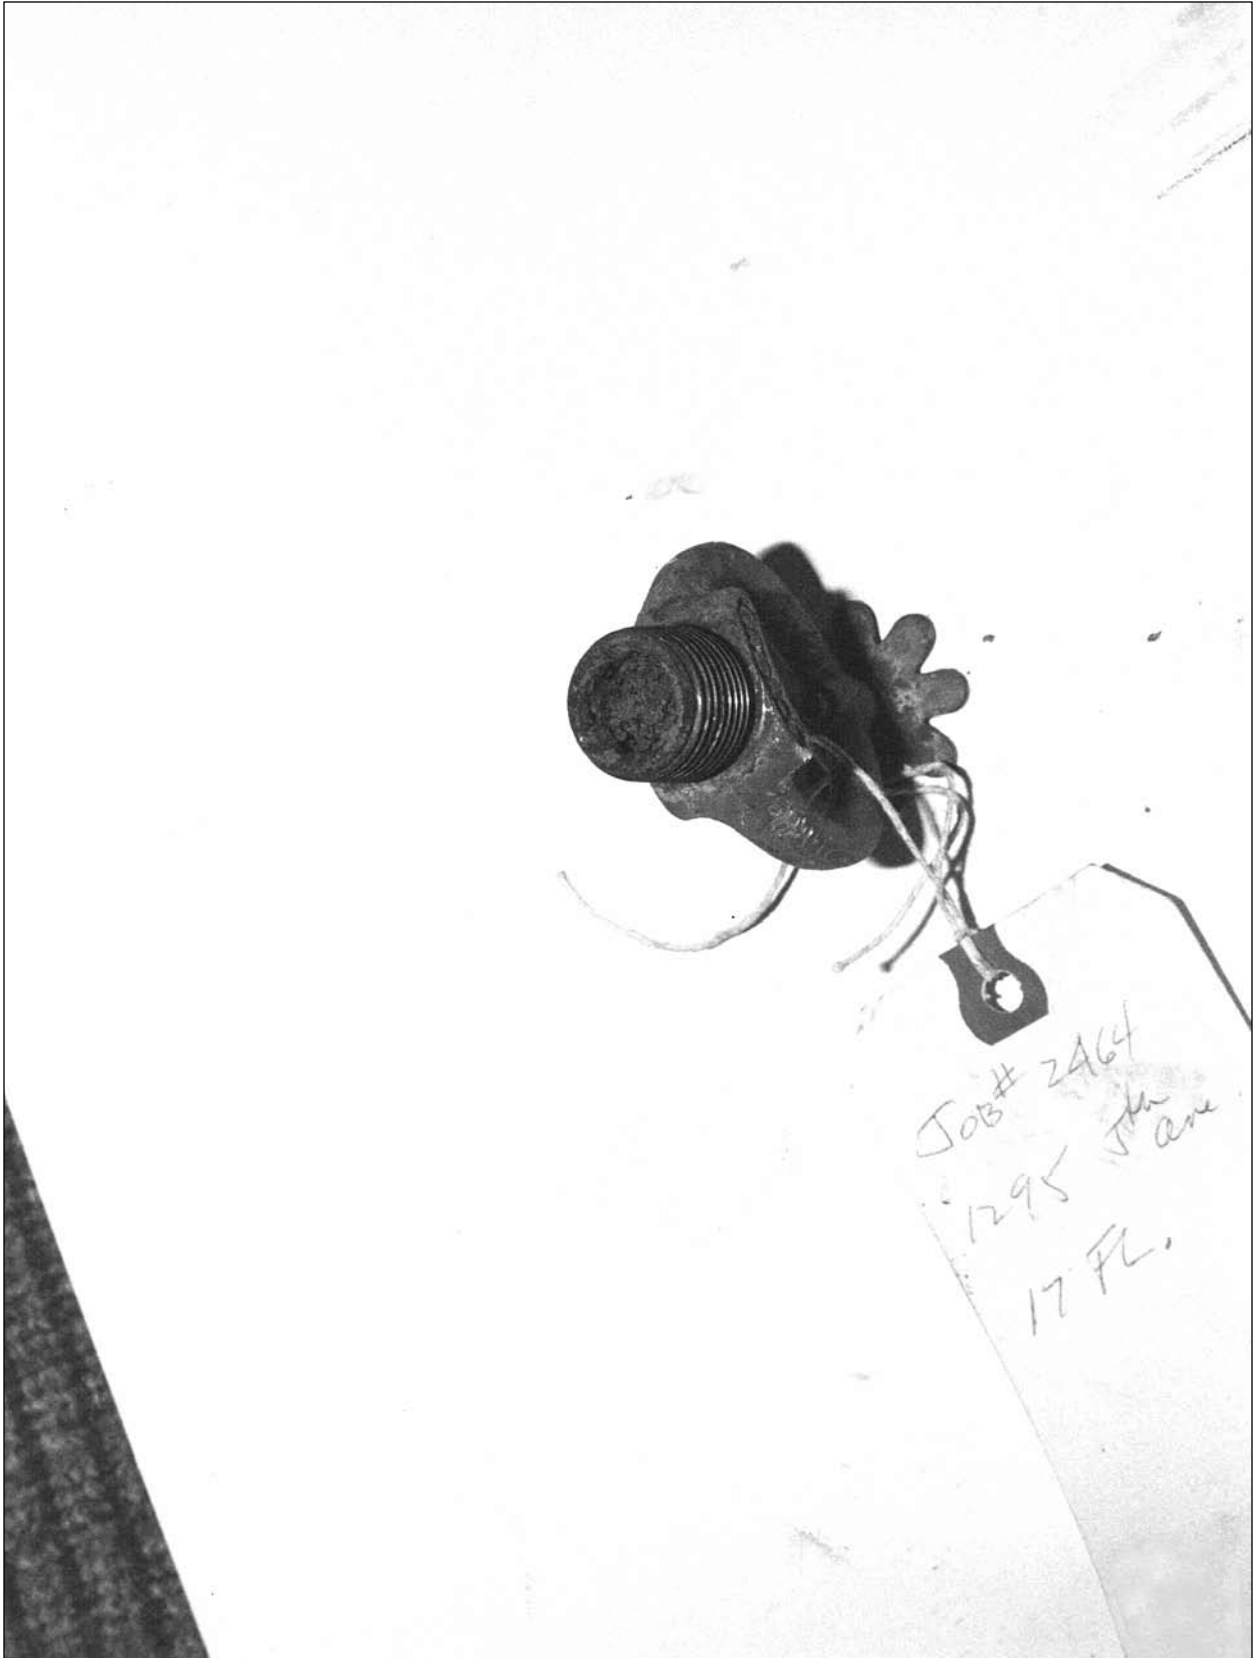
Photo 14

Investigation of the upper sprinkler system during the initial fire investigation revealed that sprinkler heads were clogged with rust and silt at various floors. Additionally, the evaluation of the extensive fire damage on the upper floors indicated that the upper sprinkler system failed to operate at the time of the fire.

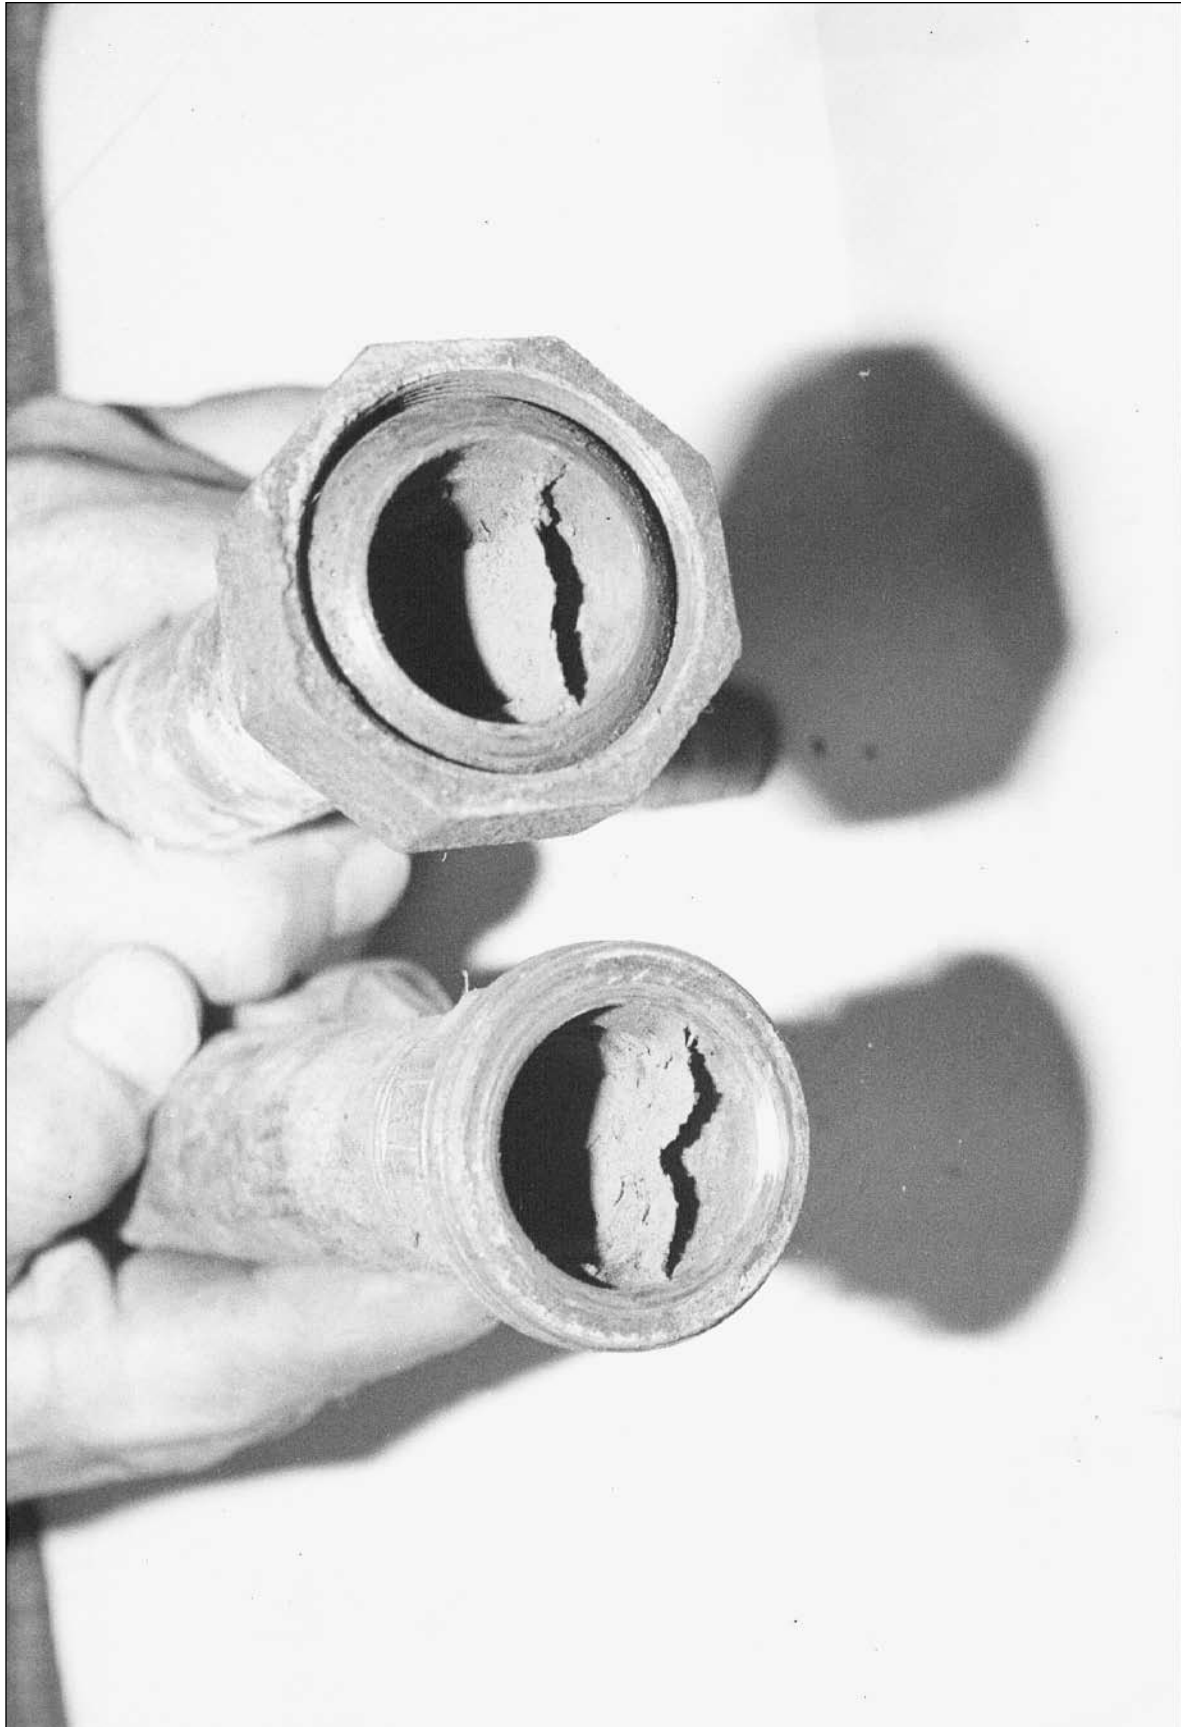
Photo 15

15. Horizontal piping with solidified silt and rust.
16. Evidence voucher. (Sample)
17. Sprinkler shut off valve in dayroom, first floor.
18. Sprinkler shut off valve in closet (compactor) on 35th floor at ceiling.
