U.S. Fire Administration/Technical Report Series

Sprinklers Control Arson Fires in Rack-Storage Warehouse

Mt. Prospect, Illinois

USFA-TR-030/October 1988

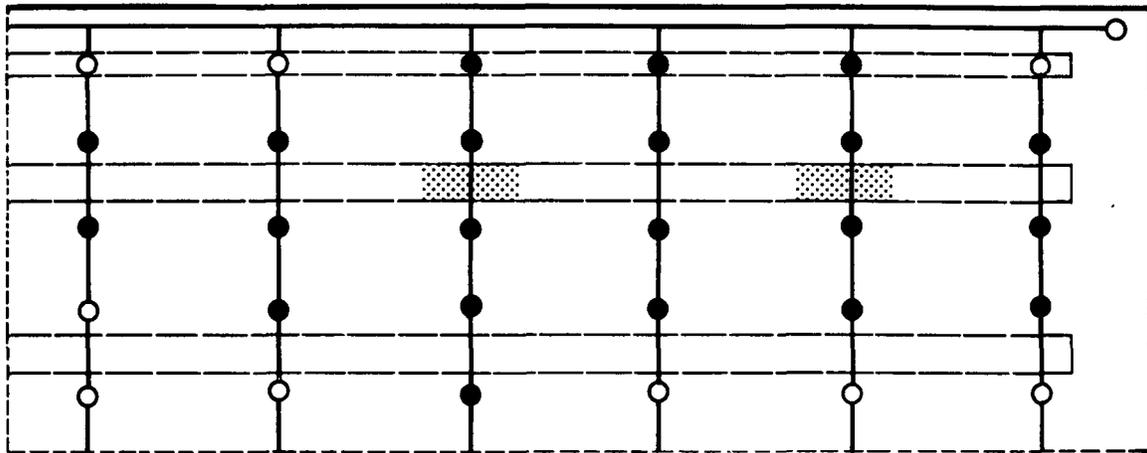
Blow-up diagram of fire area

The fires had been intentionally set in paper goods stored on wooden pallets lying in the second aisle between the first row of double racks from the southern end of the building. The fire then spread to packed goods on the lower level of the nearest double rack. In all, approximately five bays of the southern-most double rack, and about three bays of the single width rack system on the southern wall of the building were affected. These bays were damaged due to the heat developed by the fire.

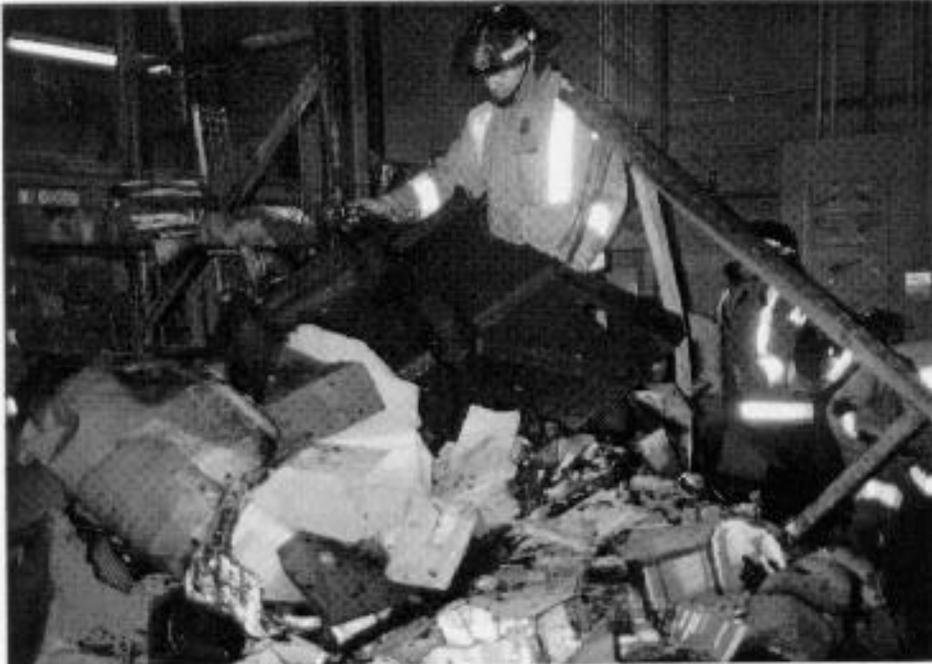
2

- *2. Looking due southwest from the second aisle. The main sprinkler riser is visible just above the firefighter's right hand.
3. Shows damage to goods stored.

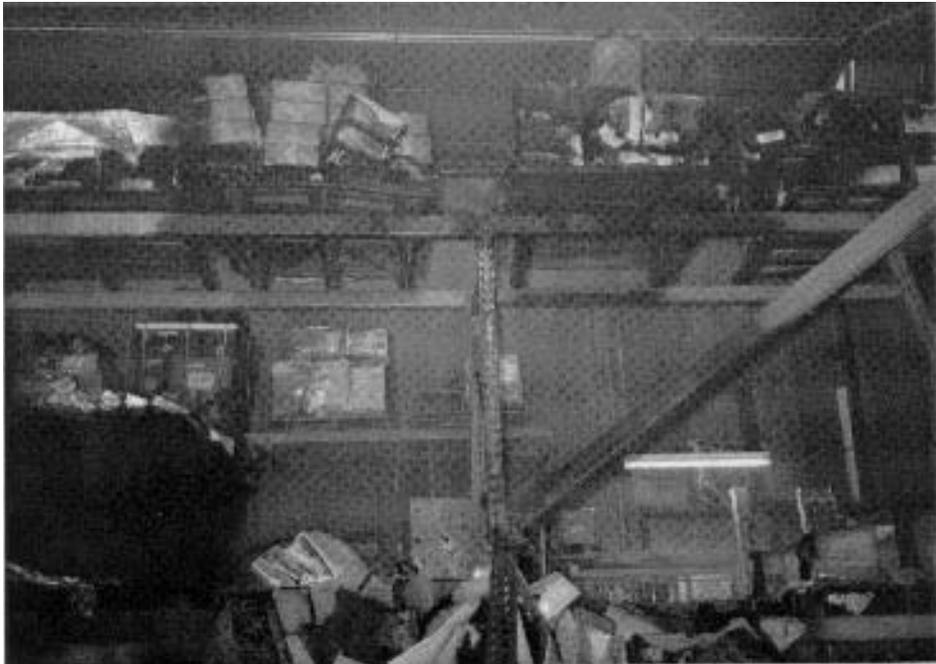
7

- *7. Typical damage to goods on upper level of racks
8. Looking due south at door leading to warehouse section. Shows extent of water penetration due to fire

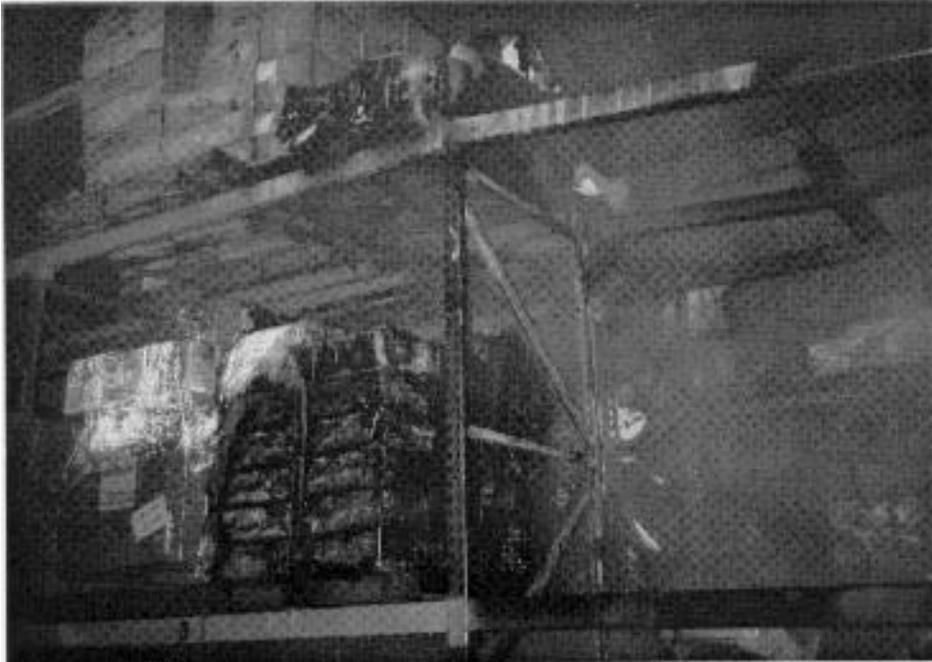
18

17. From aisle two showing fire damage to storage racks
- *18. Typical fire damage to goods on rack in aisle two
19. From aisle two, showing fire damage to storage racks

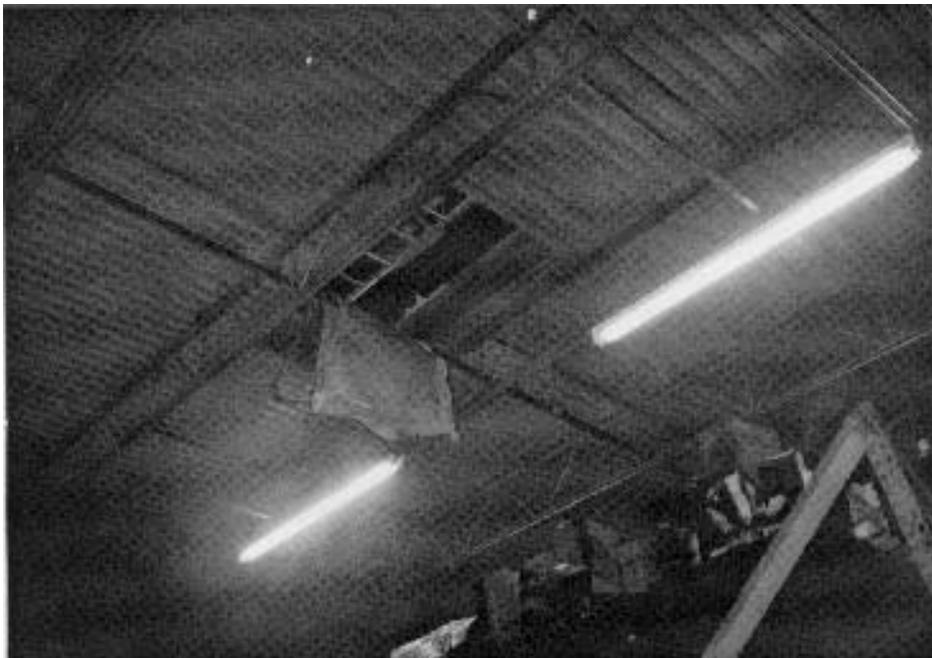
20

Although the building did not suffer any structural damage, a skylight located above the fire area failed prior to extinguishment. This failure is thought to have occurred soon after the time the first responding units arrived on the scene. This is based on the fact that no outward signs of fire were observed upon arrival, but once the fire department completed its walk around the building, smoke was simultaneously observed from the loading dock area and the roof at the southwestern end of the structure.

- *20. Failed skylight above aisle one. Note sprinkler piping
- 21-30. Shots taken west and due east from aisle two showing extent of fire damage to goods and rack
