U.S. Fire Administration/Technical Report Series

Three Firefighters Die in Pittsburgh House Fire

Pittsburgh, Pennsylvania

USFA-TR-078/February 1995

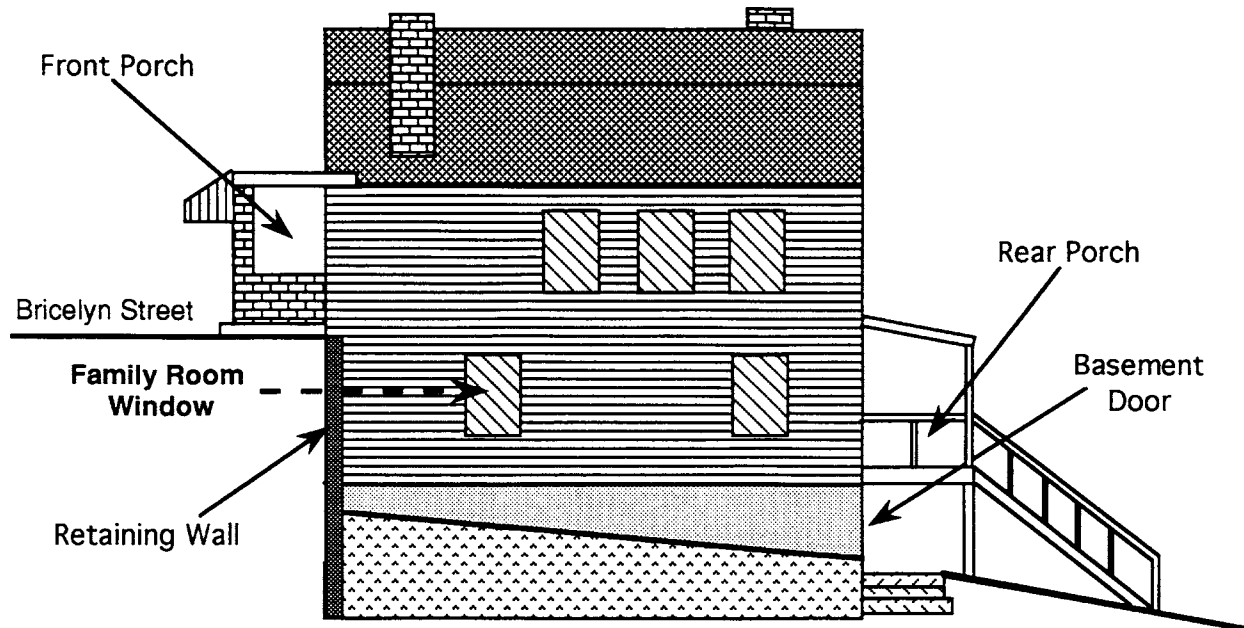
EAST SIDE OF DWELLING - 8361 Bricelyn Street

frame wood construction. The separation to the neighboring house on the left side was only 27 inches wide, which created a significant exposure problem. On the right side there was a 12 foot wide side yard between houses.

Because the house was built on a slope, the front entrance at 8361 Bricelyn Street was actually at the second floor level. When viewed from the front, the house appeared to have only two stores; however, from the rear most of the basement was exposed above grade level and the house appeared to be the equivalent of four stories. The first floor was one level up from the back yard and one level down from the front door. (Refer to the building diagram and floor plans on the following pages for details of the arrangement.)

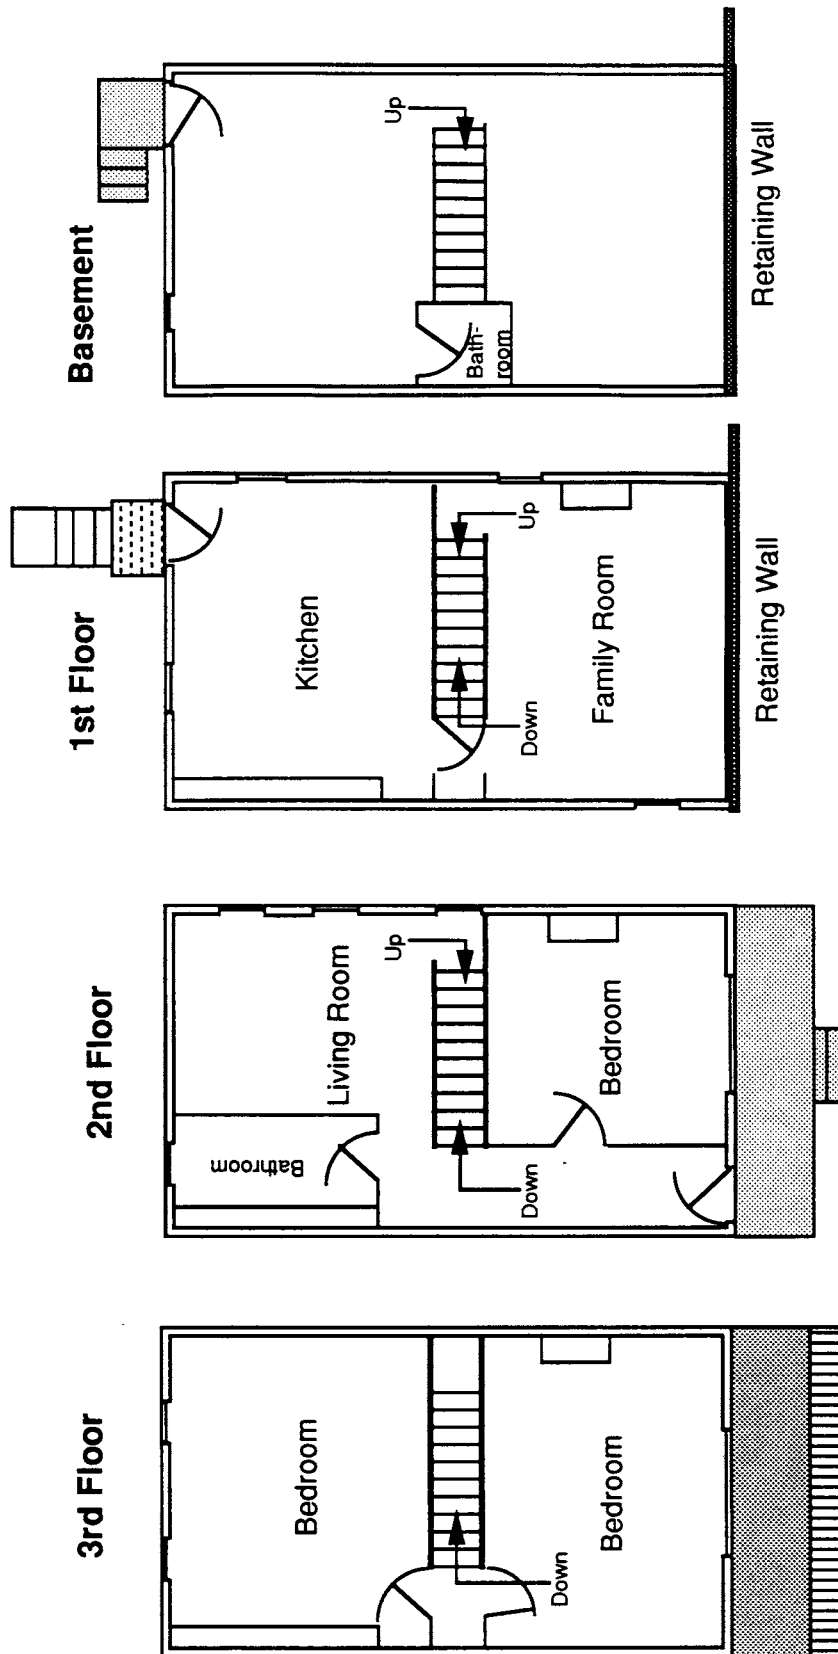
FLOOR PLANS 8361 Bricelyn Street

The fire occurred in a single family dwelling that was approximately 20 feet wide and 33 feet deep and had three occupied floor levels above a partially finished basement. The interior walls were lath and plaster, and the exterior walls were aluminum siding over asphalt shingles attached to balloon

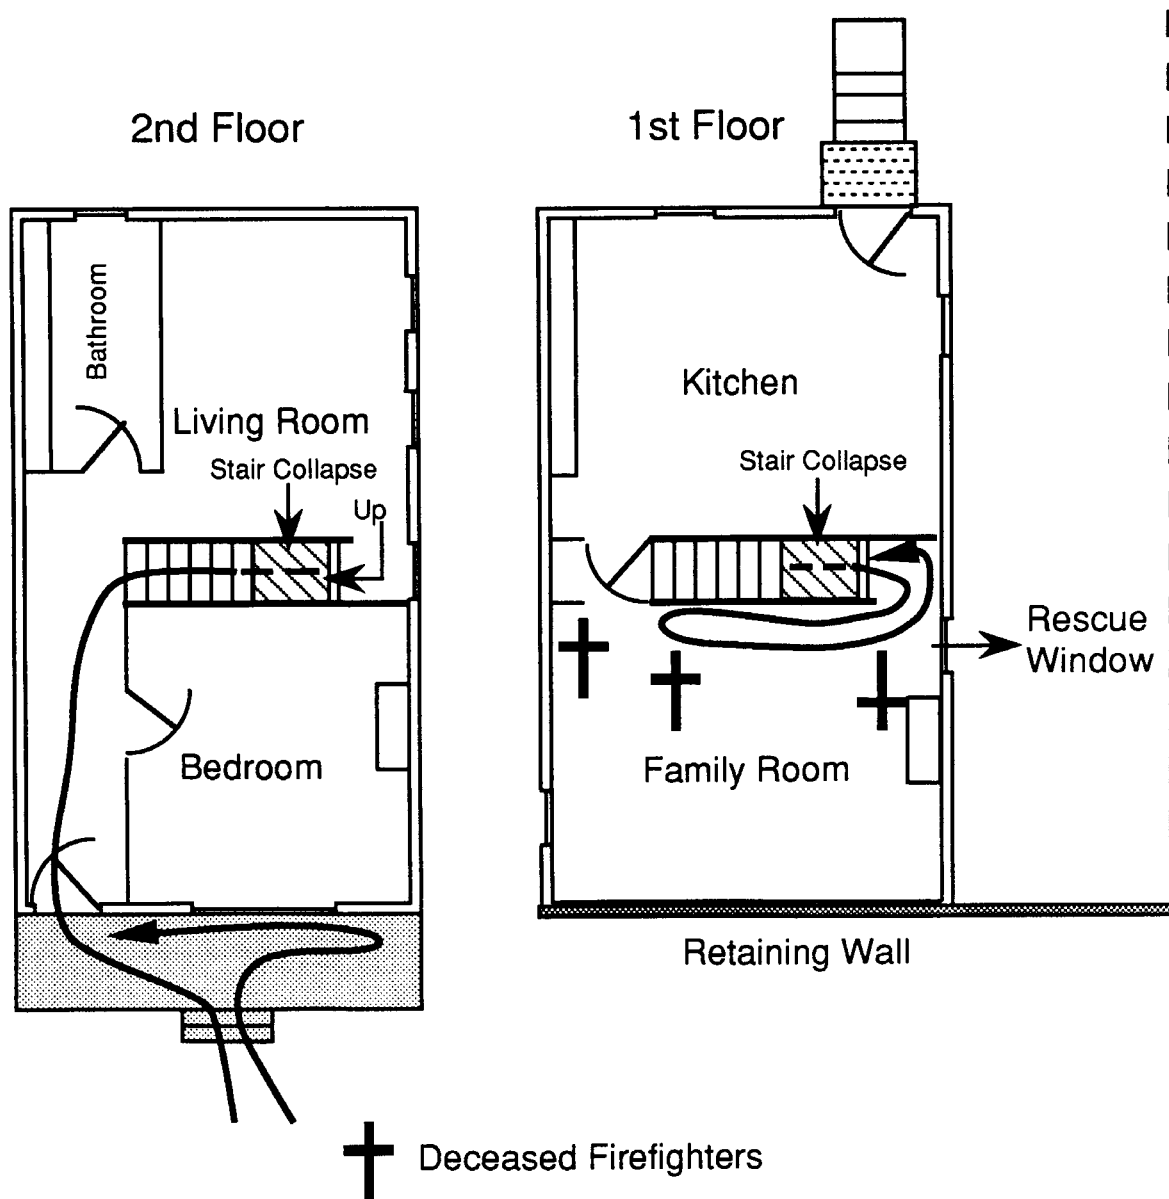
INTERIOR DETAILS - 8361 Bricelyn Street

Advancing into the family room, the crew from Engine 7 found the three unconscious personnel from Engine 17. (See diagram on the following page.) At 0139 hours the Incident Commander was informed that three additional firefighters had been found and were being removed from the building. Additional personnel responded to the urgent requests for assistance and the three firefighters were removed to the rear yard.

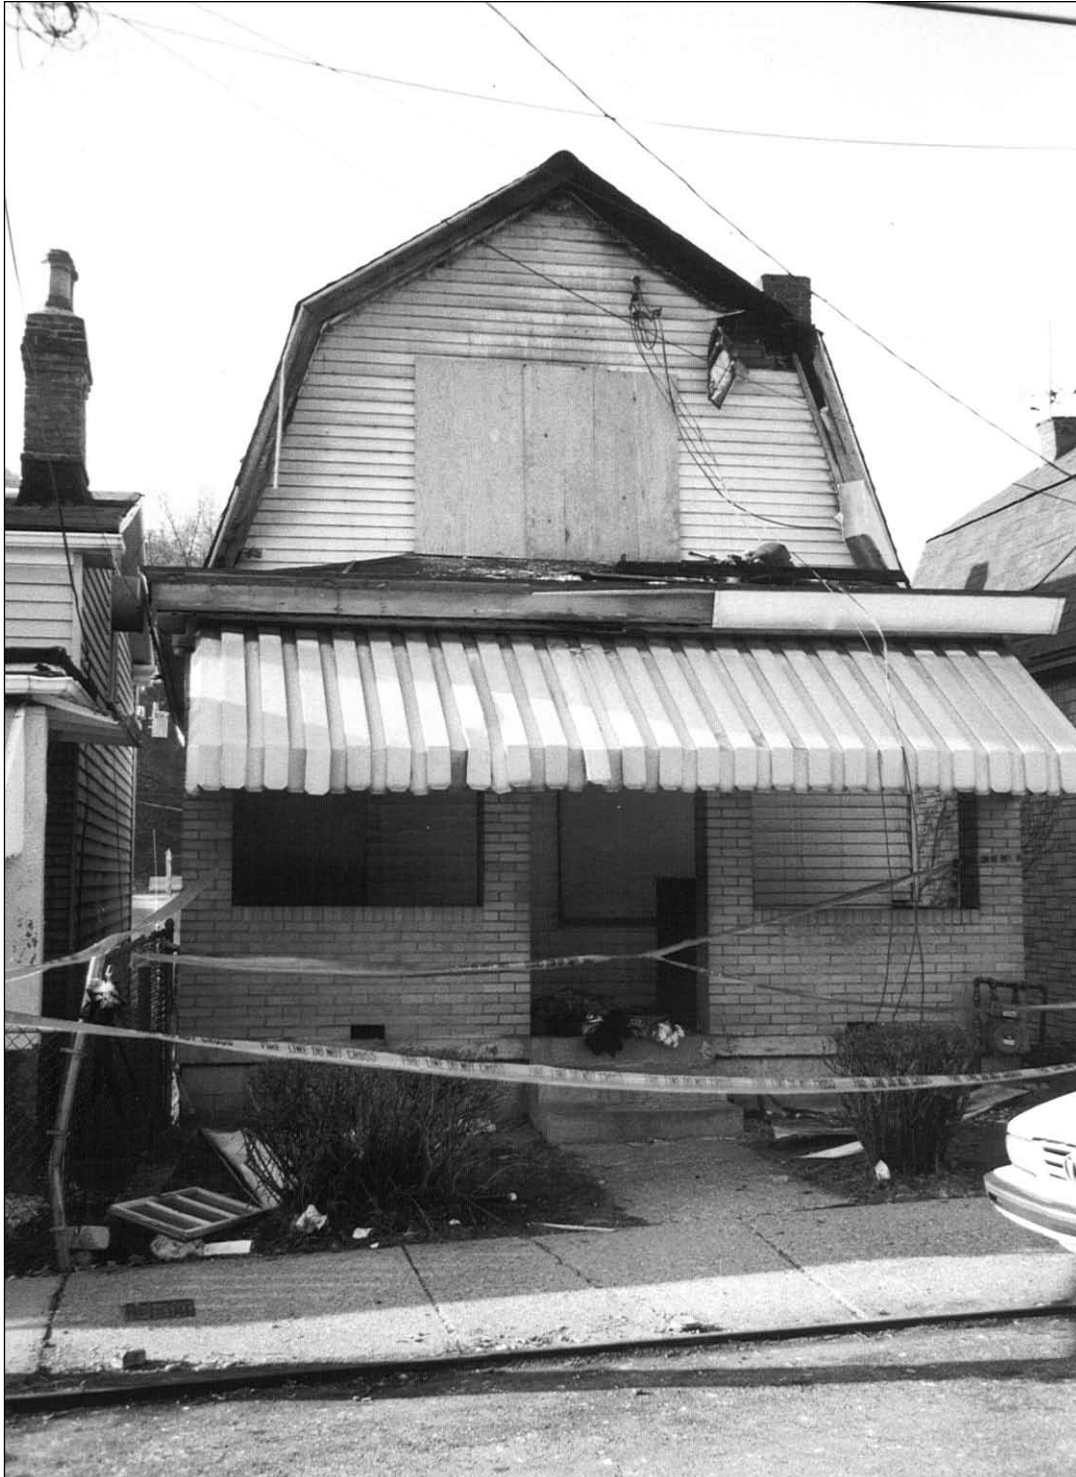
1. Front view of 8361 Bricelyn Street.

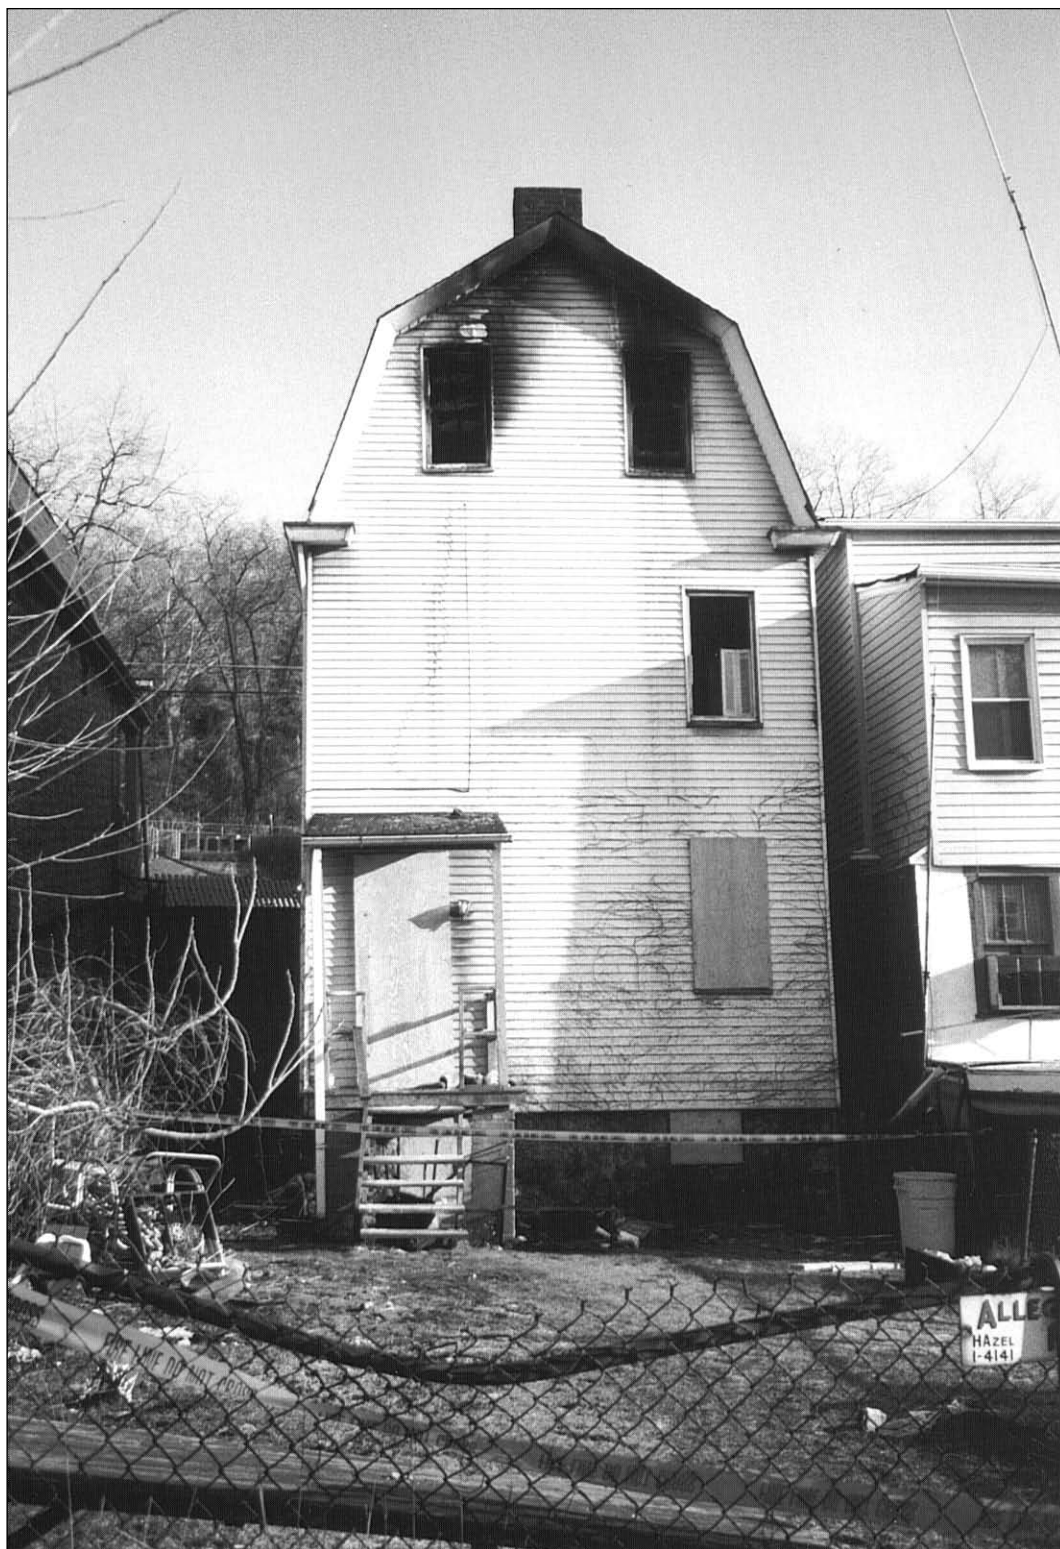
2. Rear view of 8361 Bricelyn Street.

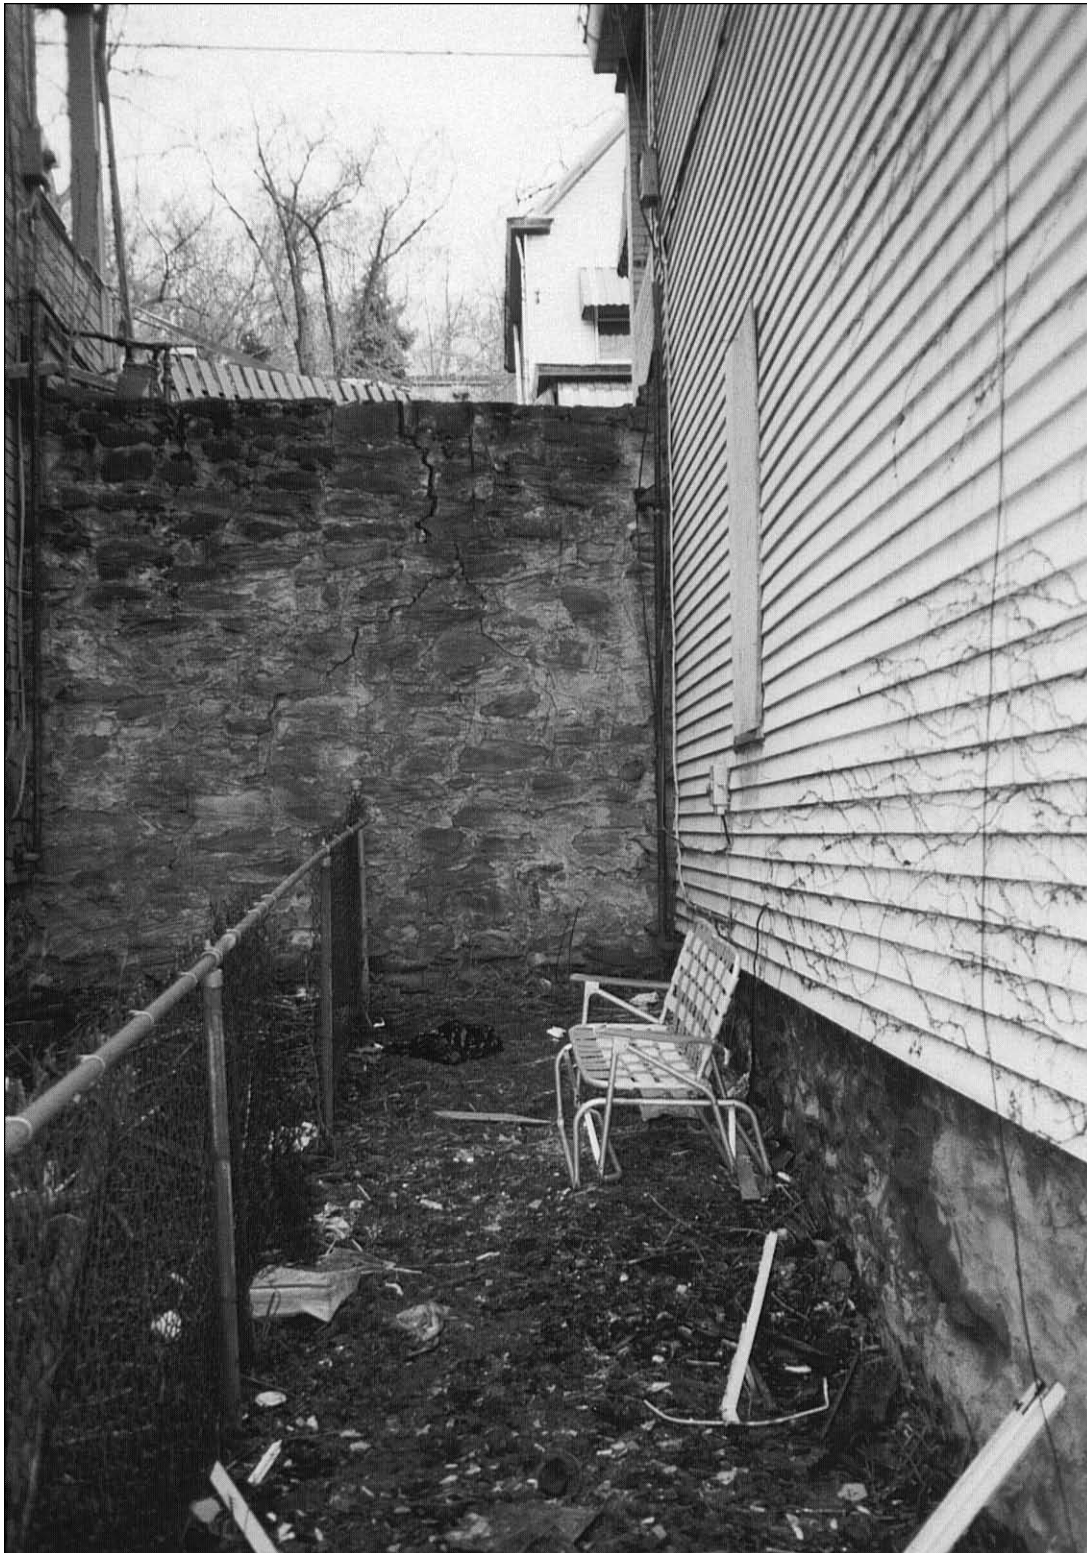
3. Side yard showing retaining wall and window where firefighters were rescued (above lawn chair).

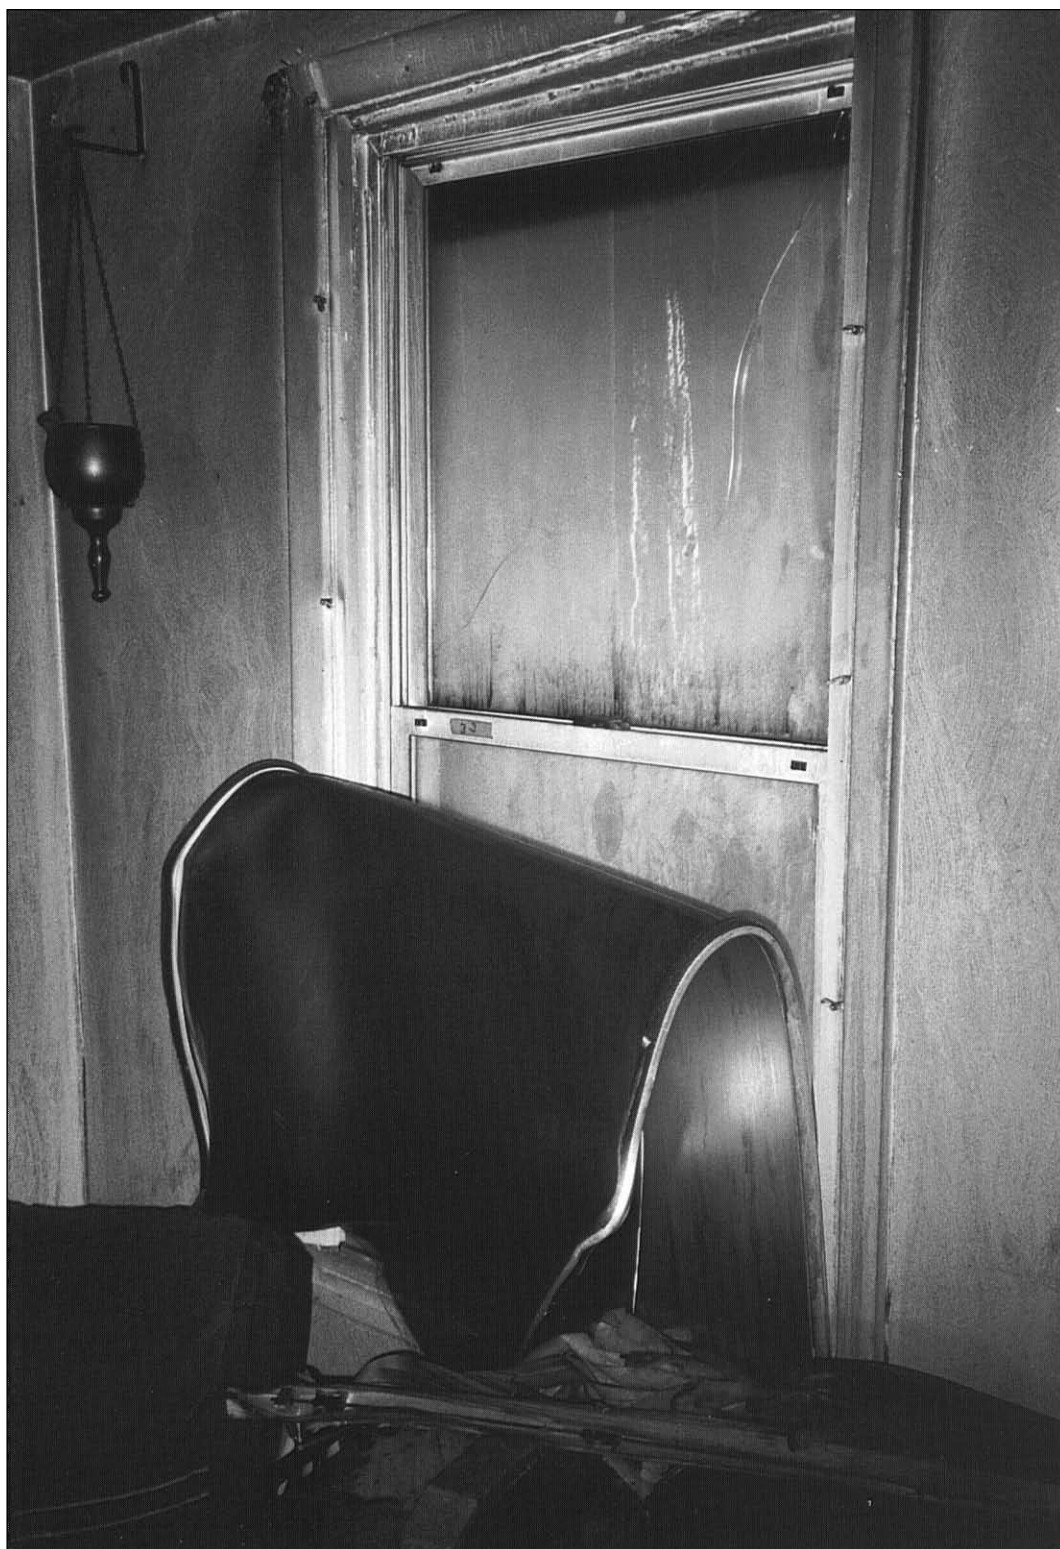
4. Window in corner of family room showing plastic panel which has partially melted and bent-over due to heat.

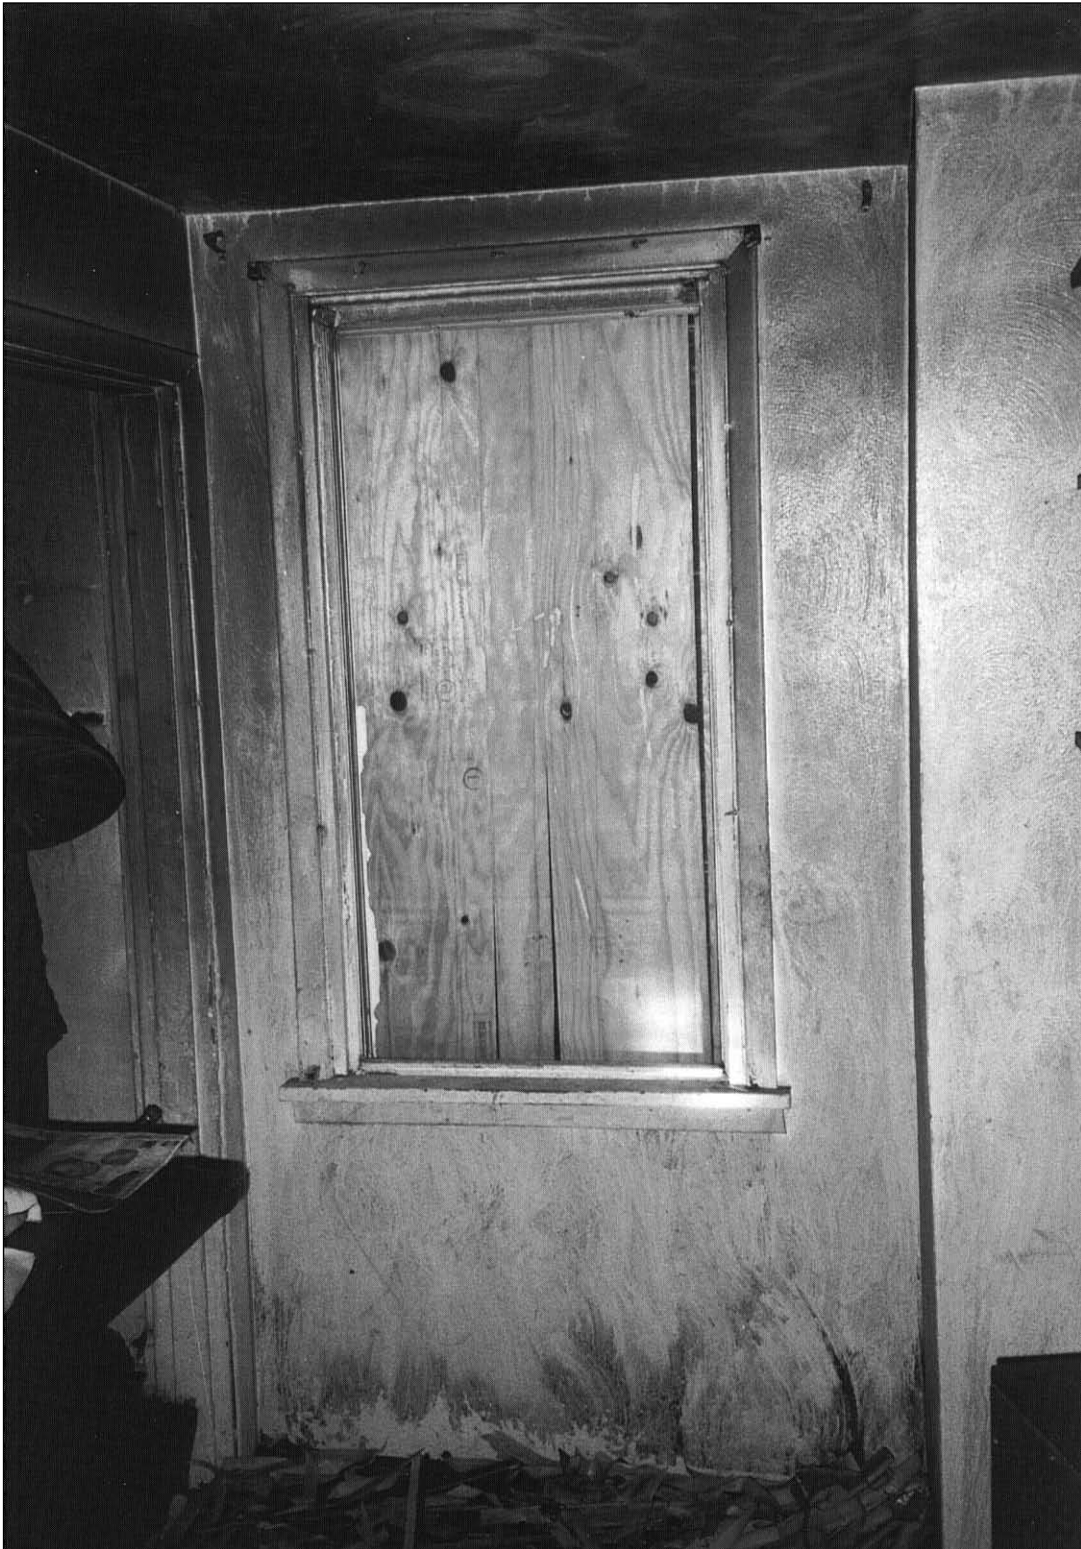
5. Inside view of window where firefighters were rescued.

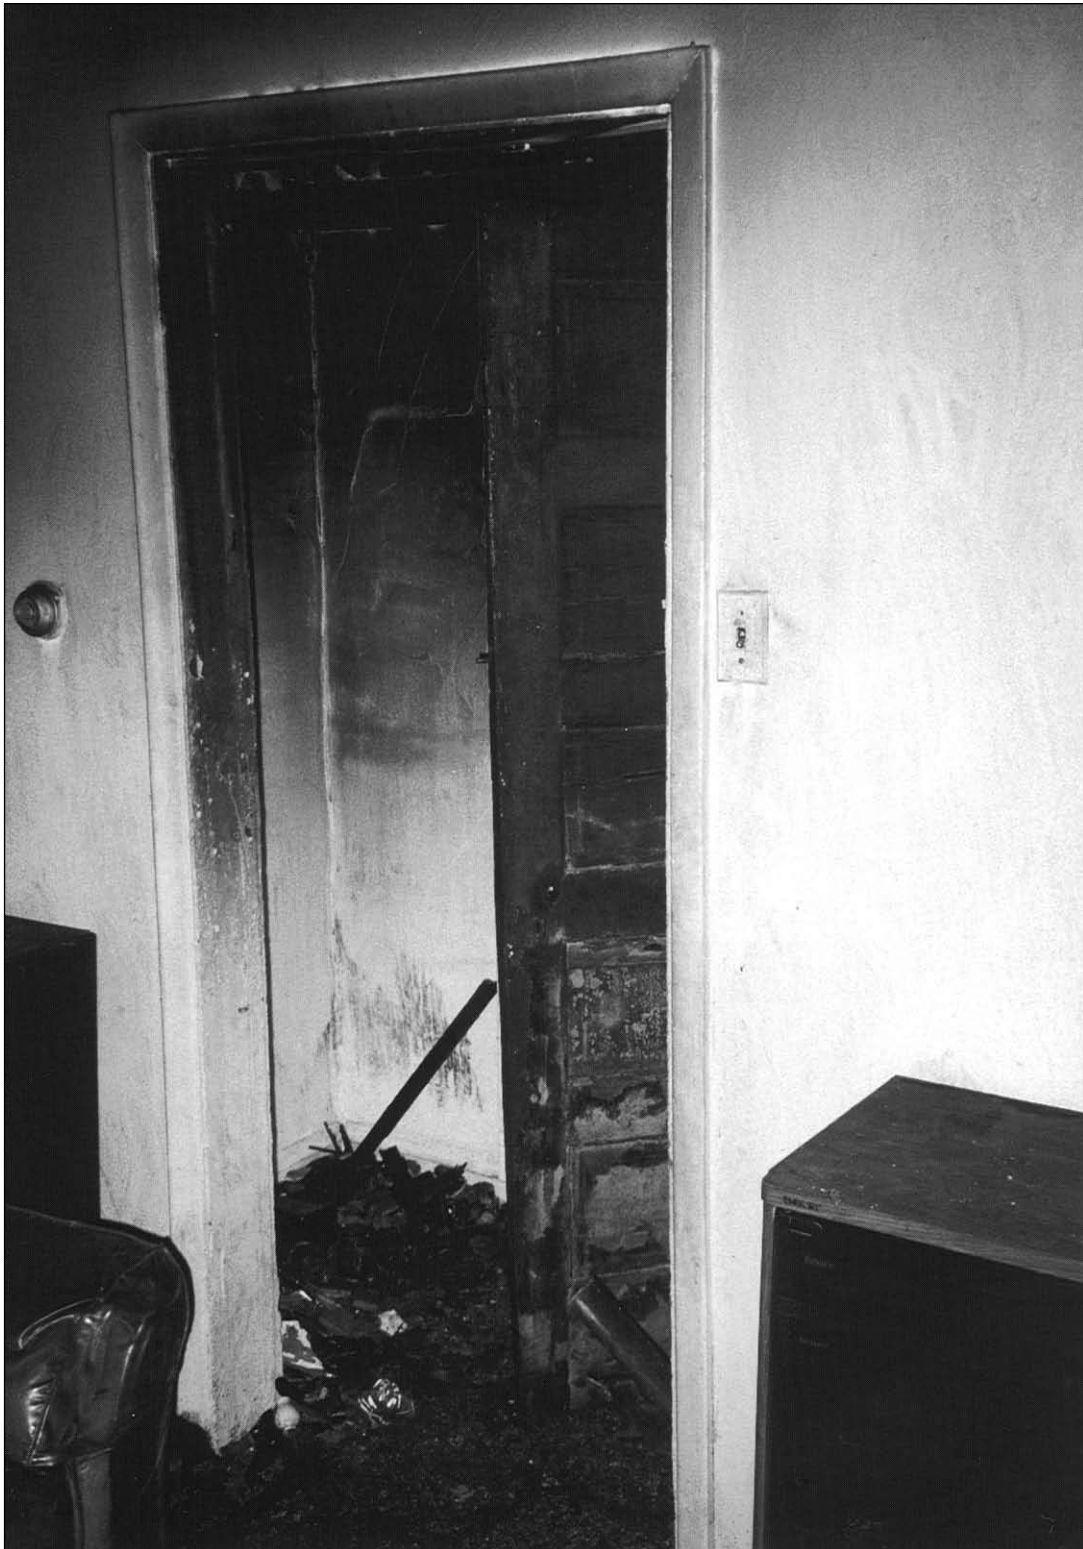
6. View from family room looking toward kitchen. Partially open door is at the top of the basement stairs.

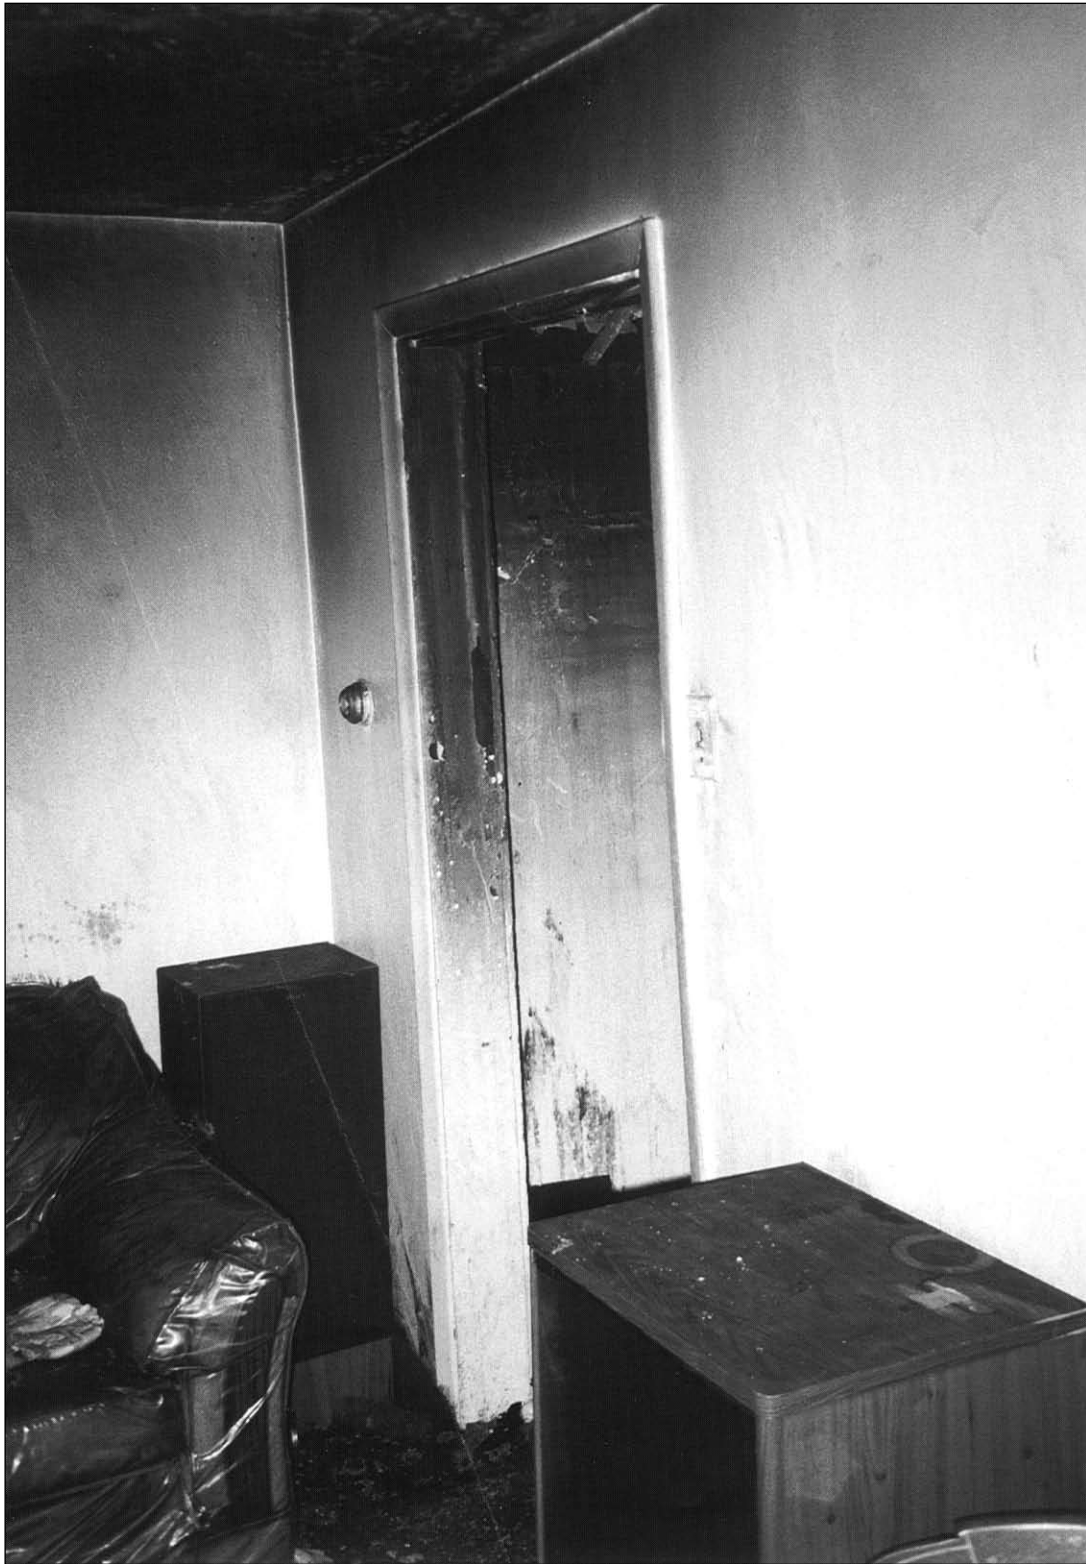
7. View of corner of the family room at top of basement stairs.
