# Two Fatality Board and Care Facility Fire

Miami, Florida

USFA-TR-090/November 1995

# **Two Fatality Board and Care Facility Fire Salvation Army Rehabilitation Center**

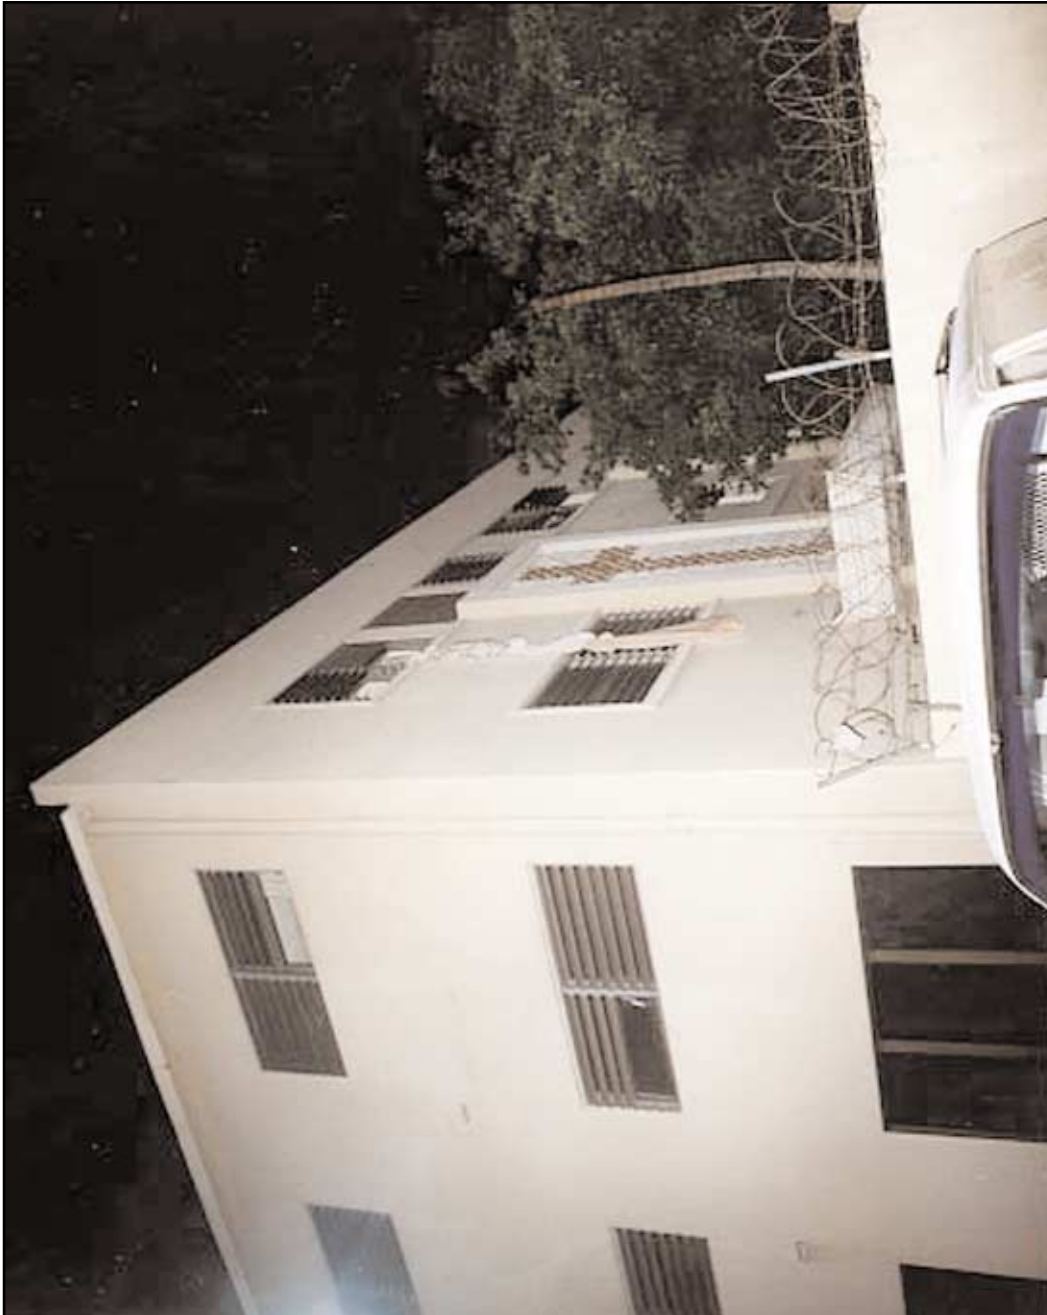
The building was equipped with hurricane shutters which were installed on the outside of the building over the glass windows. The shutters hampered the residents attempting to exit through the windows, when the corridors became impassable because of heavy smoke conditions. Some residents used furniture to break out the shutters. There were instances of persons becoming stuck in windows from which the shutters had only been partially removed.

Each of the windows in the building was equipped with a permanent hurricane shutter. Installed on the outside of the operable glass windows, the shutters consisted of several interlocking metal louvers mounted on two vertical tracks. They could be opened and closed from the inside with a crank and lever mechanism, similar to awning windows. The shutters effectively precluded egress from the windows without their forcible removal. (See Appendix B, photograph 1.)

1. Southeast corner of the Rehabilitation Center. Front entrance is just north of the razor wire topped wall. Note permanent hurricane shutters installed on the outside of the windows. Some residents tied sheets together and climbed from the windows after breaking out the shutters.

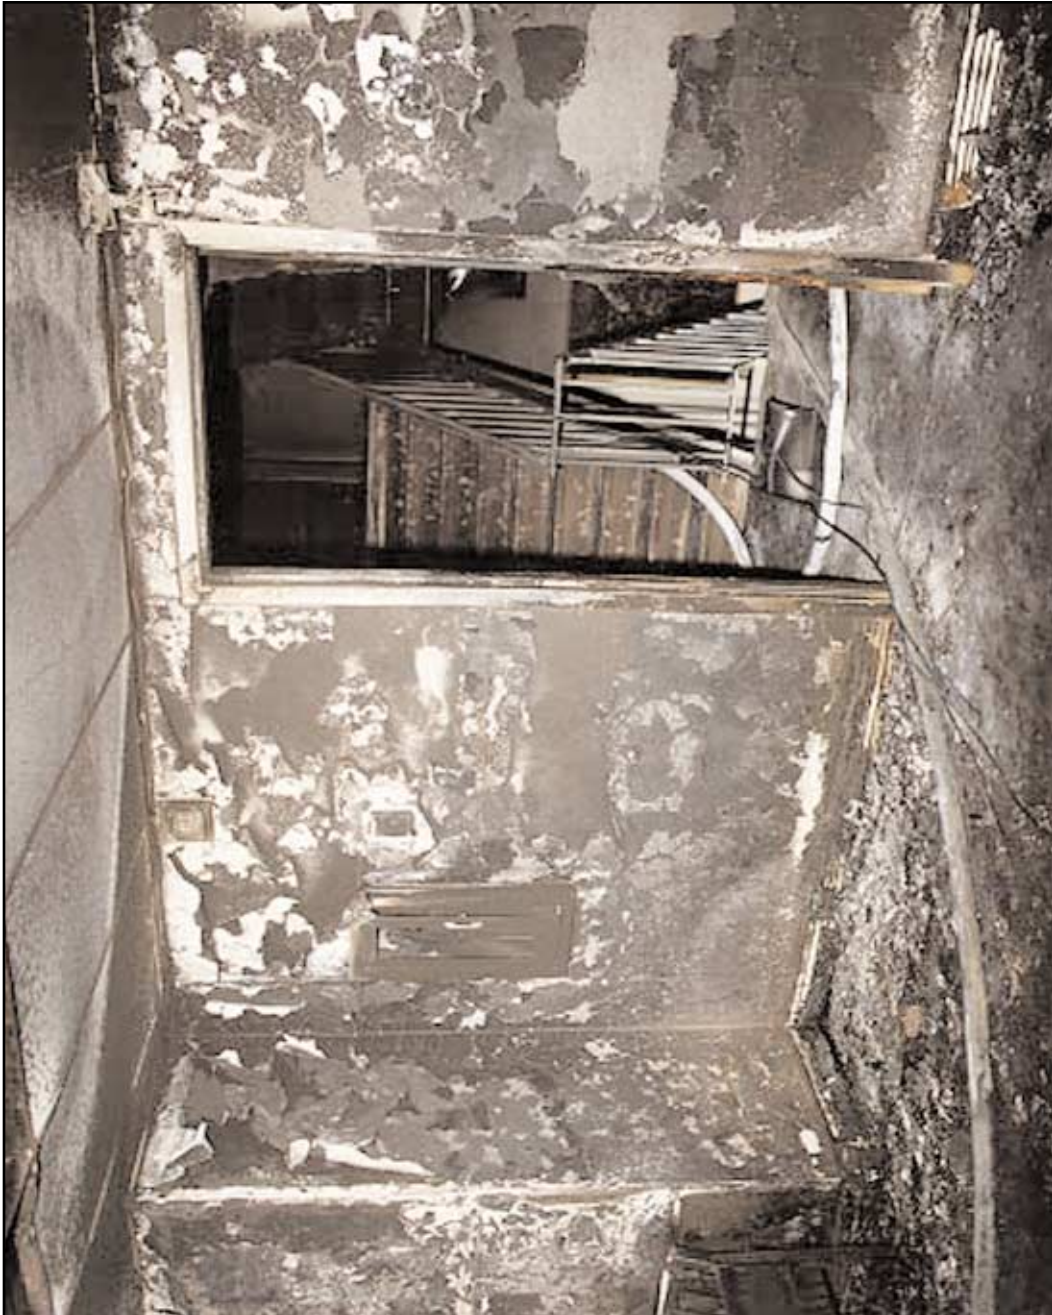
2. Doorway opening from SE stairway into office waiting area on second floor, adjacent to where investigators determined the fire originated.

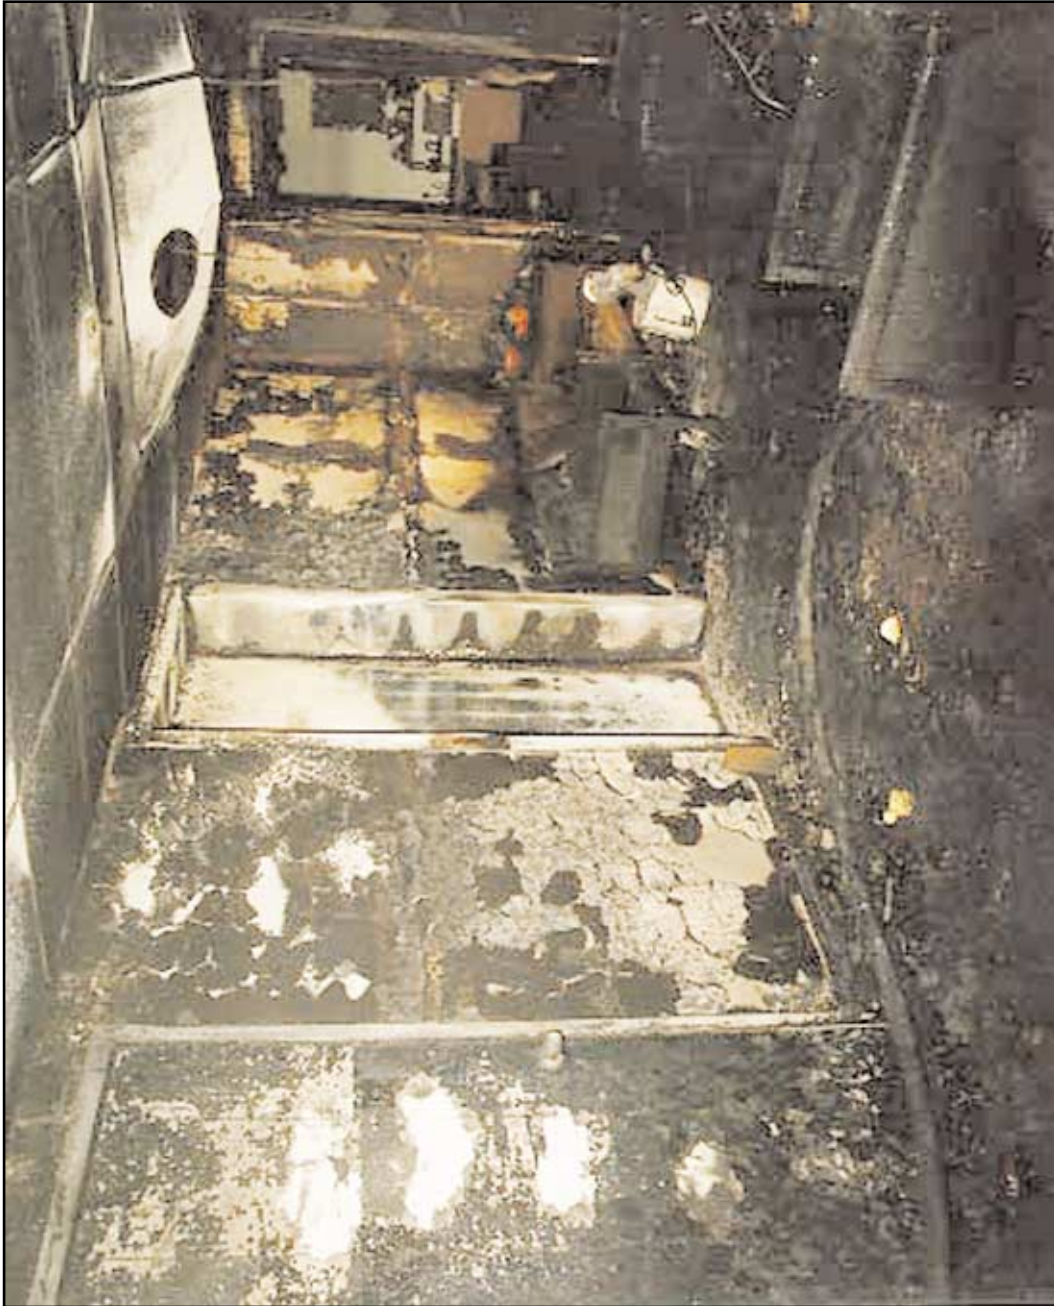
The office waiting area on the second floor where the fire originated was furnished with upholstered chairs, end tables and racks of magazines and promotional literature. Chair cushions were shown to be highly flammable in tests conducted by the fire department after the fire and shown to produce large quantities of thick black smoke.

3. View of office waiting area on second floor from the SE stairway door.

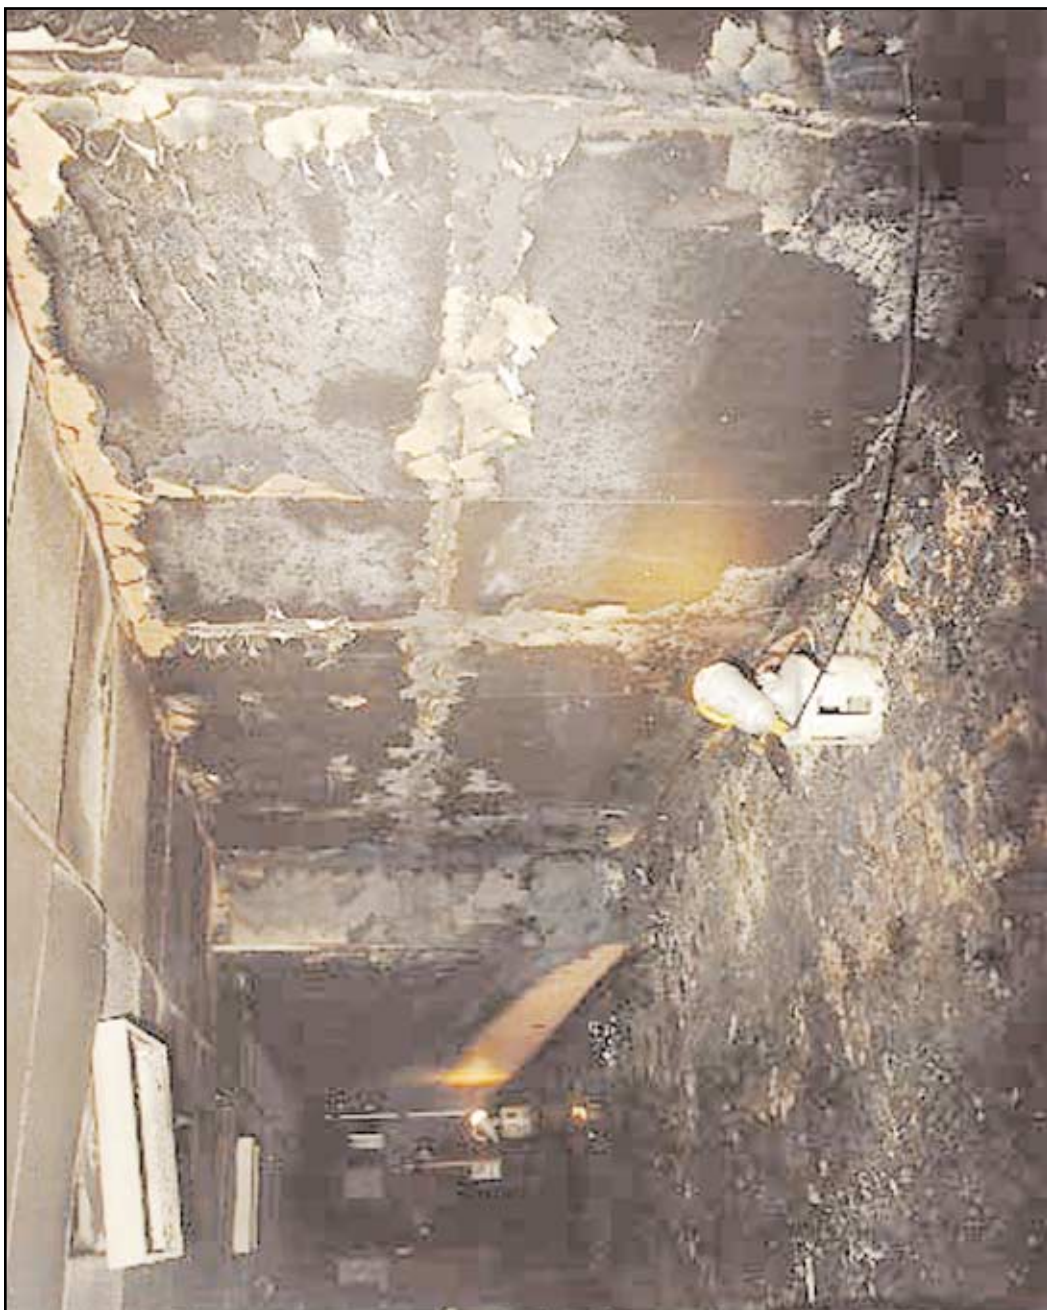
Wallcoverings in the Center varied from plywood paneling and painted gypsum wallboard to vinyl wallcoverings. Investigators observed that the vinyl wallcovering in the area of origin, and leading down the second floor hallway from the area of origin, was completely burned away.

4. First view of hallway leading from office waiting area to residential areas of the second floor.

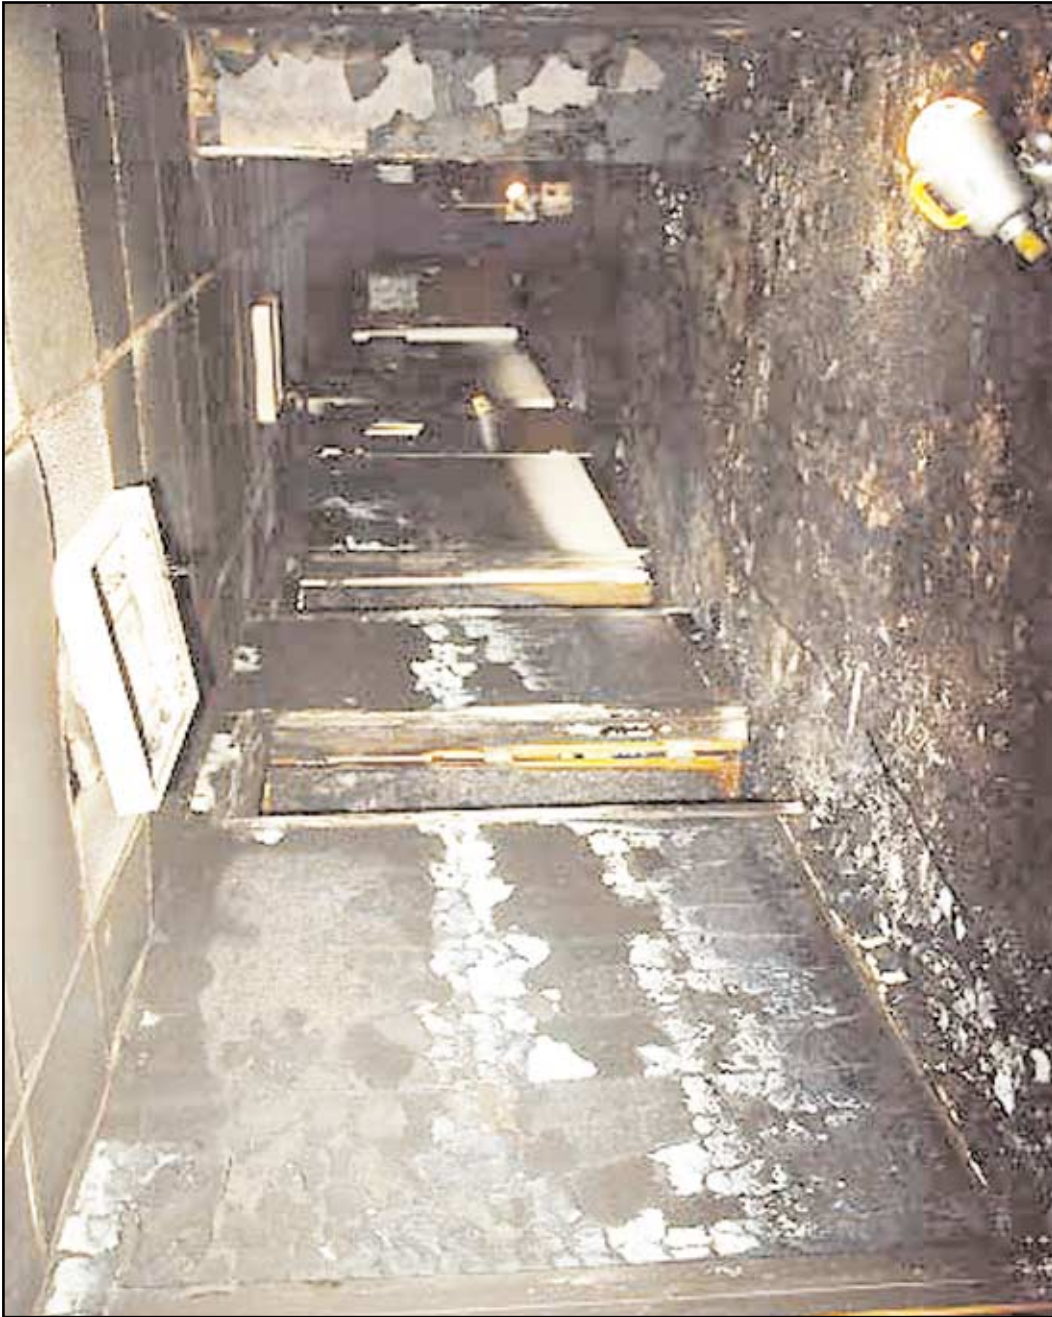
5. Second view of hallway leading from office waiting area to residential areas of the second floor.

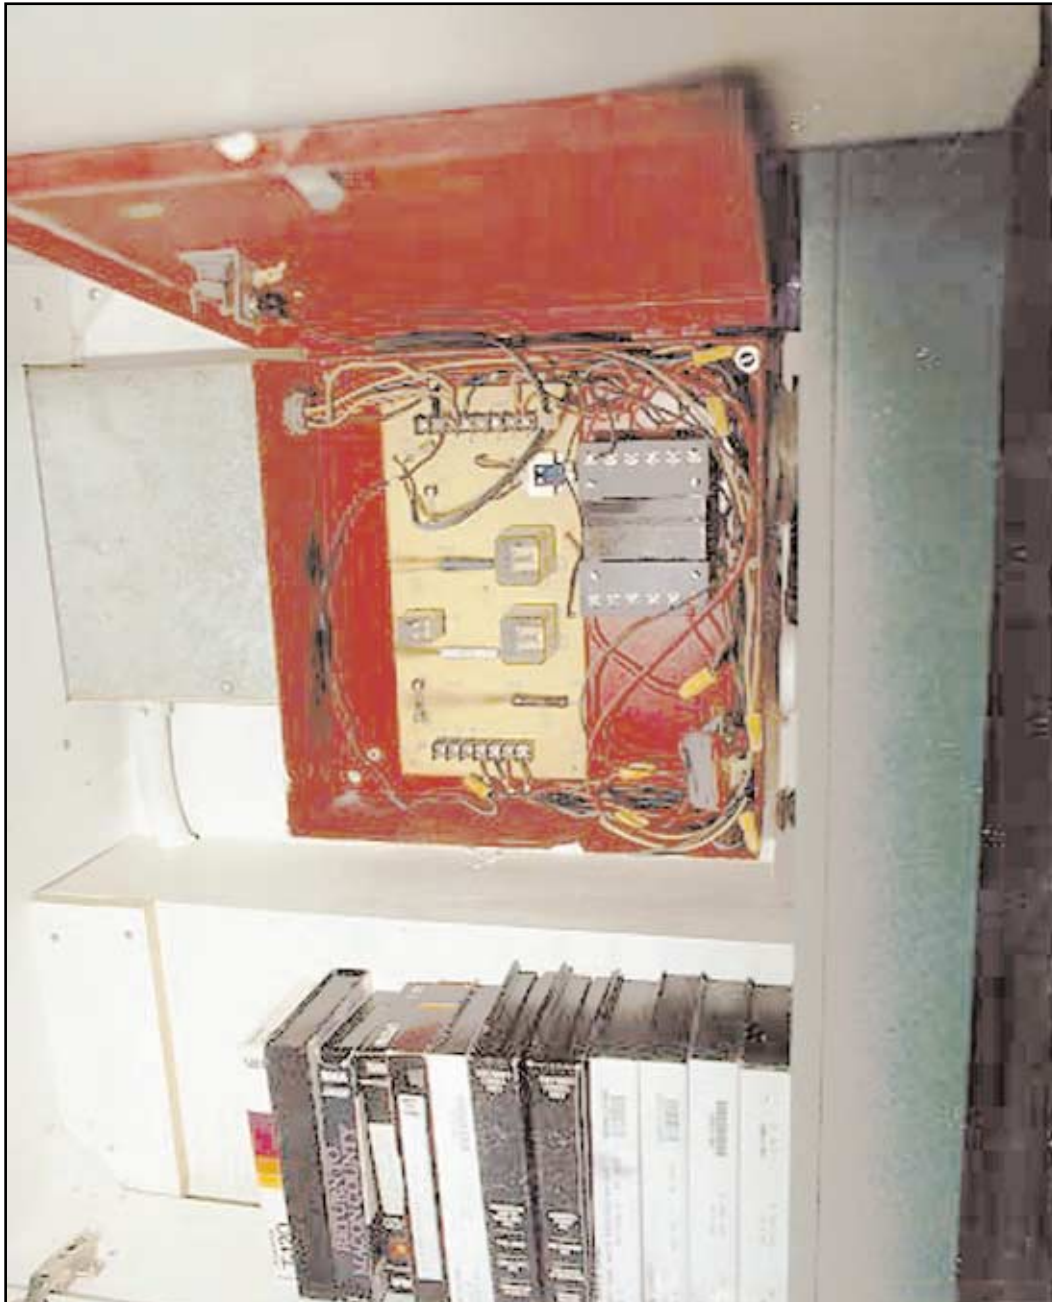
The fire alarm system control panel was mounted on a wall in a storage cabinet in the first floor watch room. The control panel was completely out of sight, hidden behind closed cabinet doors with cleaning supplies stacked in front of it. The Center staff, when questioned, was unaware of its existence. A switch of the type normally used as a wall switch had been installed in the control panel, providing an on/off switch for the system. When located after the fire, the switch was found in the “off” position.

There were no records or staff recollection to indicate when the fire alarm system had last been tested or inspected. The system was not connected to a central station or alarm monitoring service. There was no public announcement system in the building.

6. Fire alarm control panel. The panel was located inside a cabinet in the first floor front office. Note the on/off switch in the bottom left hand corner of the box.
