1968 CESSNA 150

ACCIDENT INVESTIGATED BY:
GALE BRADEN AND DON ROWLAN
CAMI

1946 TEMCO SWIFT

1961 PIPER COLT

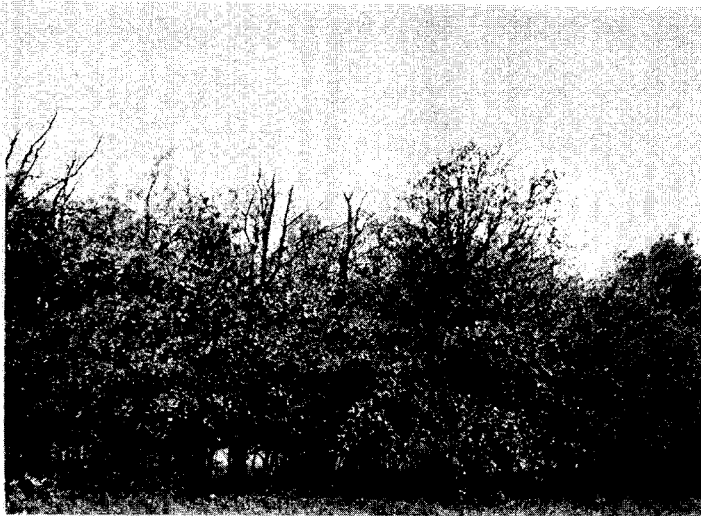
A. Tree tops clipped by inverted aircraft just before it crashed.

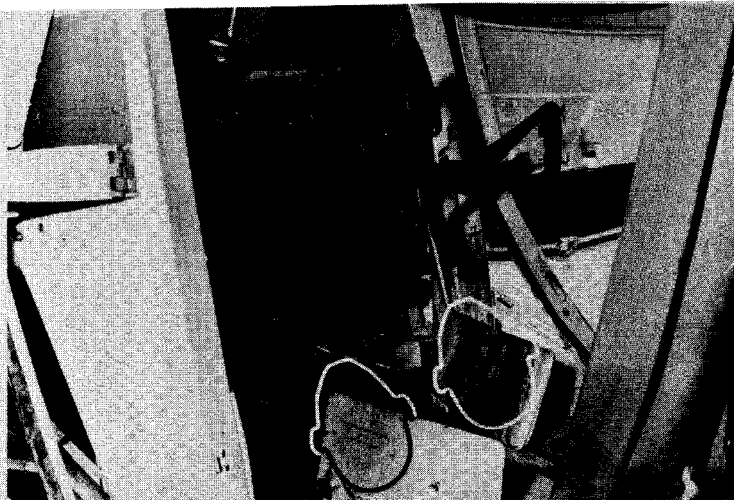
F. Head outlines of head positions in inverted aircraft.

E & G Artist sketches of lacerations & abrasions of 2 occupants heads from dragging along the ground & contact with torn metal from top of cabin.

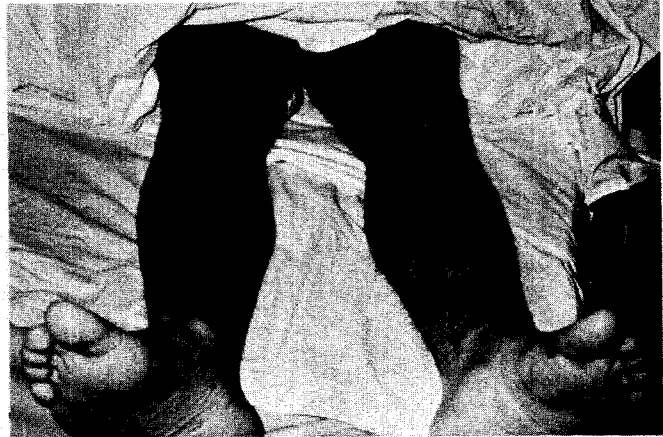
H & I Matching photographs of knee abrasions of copilot
& lower instrument panel push buttons.

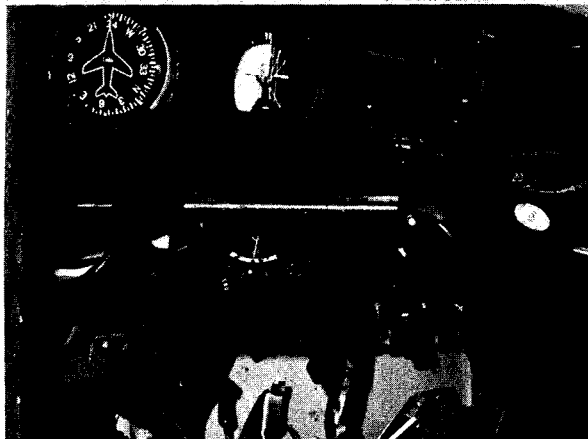
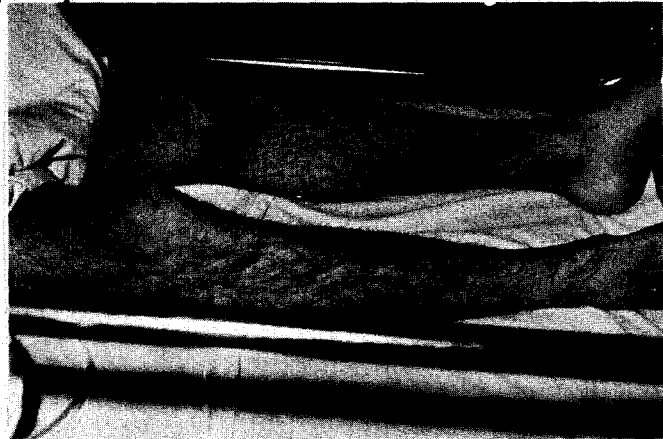
J & K Matching photographs of pilot's knees & lower left
instrument panel.

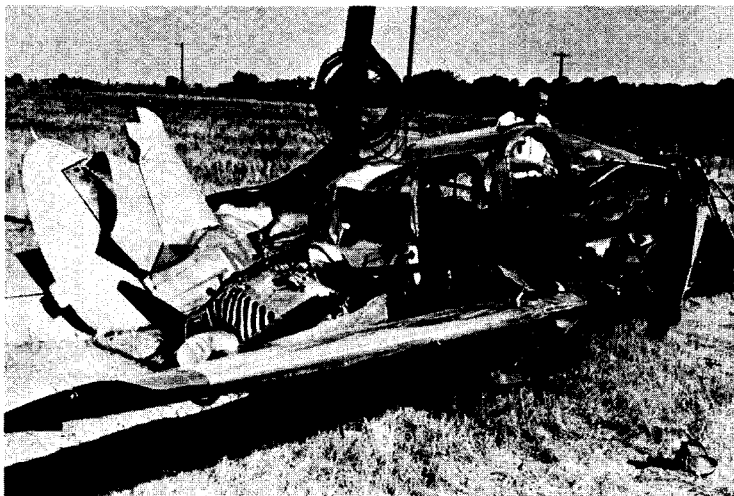
A. Telephone pole is completely buried in fuselage after side impact by aircraft.

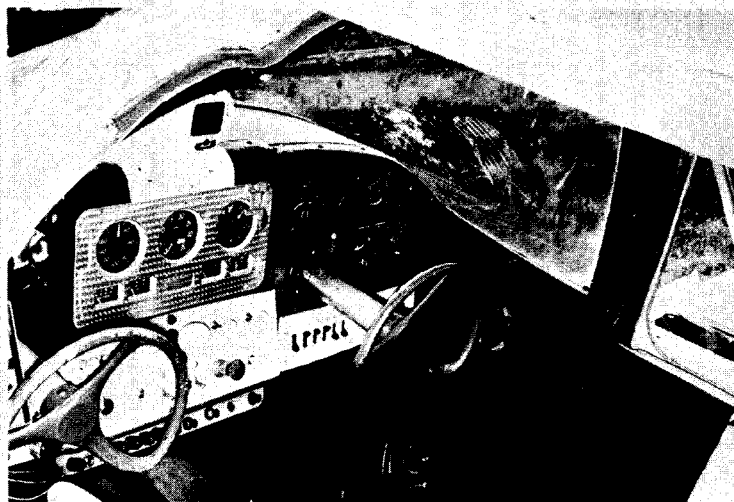
B. Since both occupants were thrown to the side, the instrument panel is unmarked.

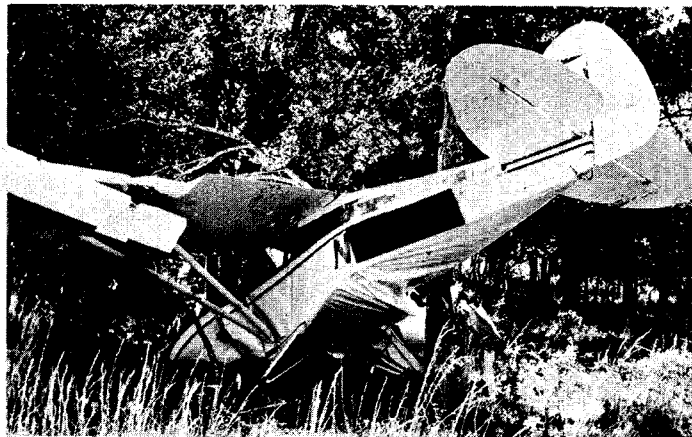
B. Rear view of aircraft after tree impact & 90° change of direction.

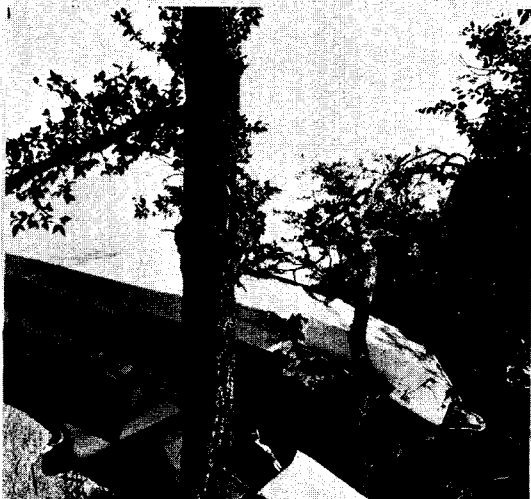
C. Right side of aircraft. Note bark missing from tree & snagged control cable about 5 feet above the ground.

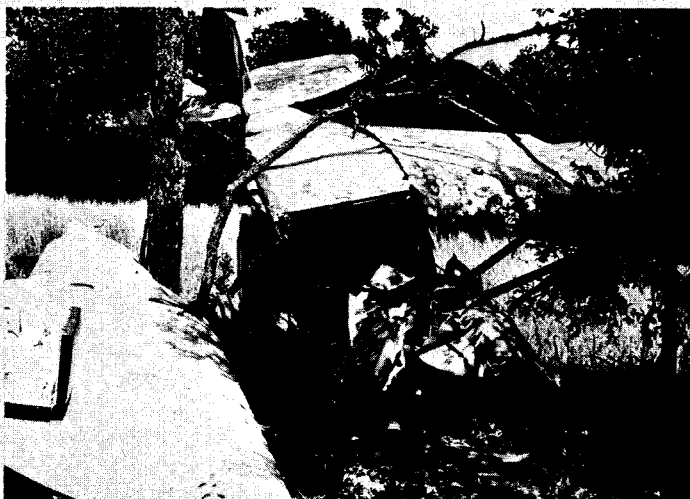
D. Front of aircraft showing complete separation of motor & instrument panel.

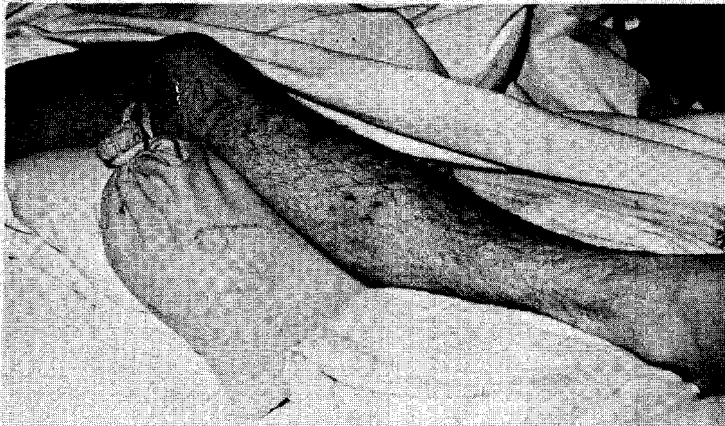
G. Copilot fractured tibia & fibula of right leg.

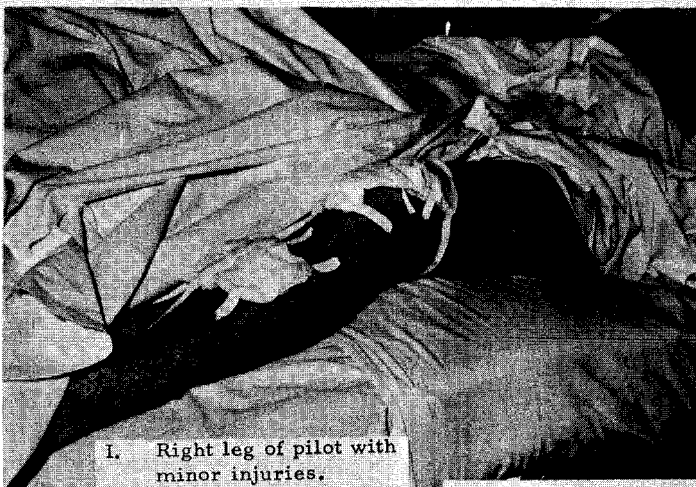
I. Right leg of pilot with minor injuries.

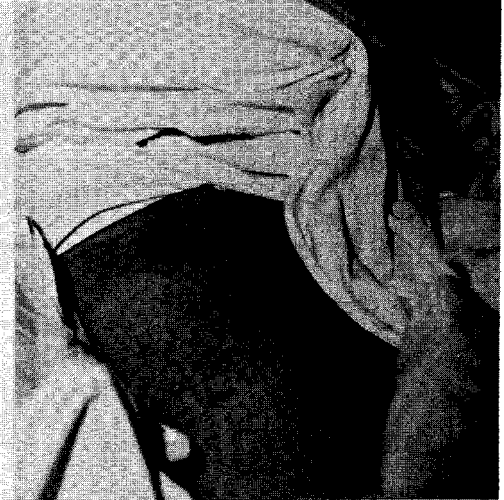
F. Seat belt abrasion on copilot.

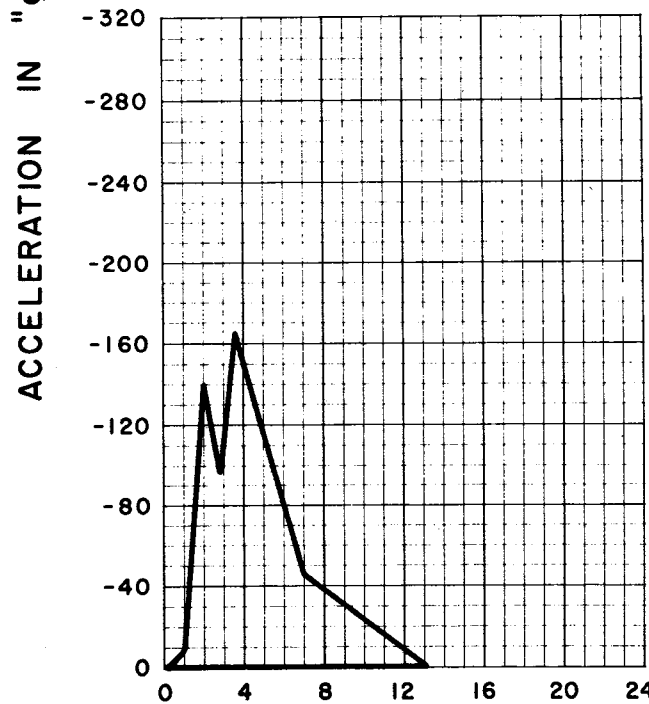
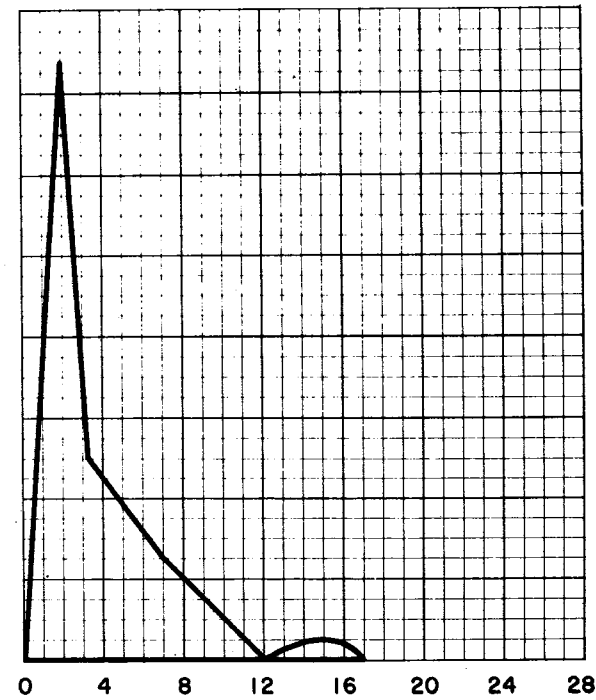
FIGURE 36. Comparison of test results of head impact tests against the Piper Pawnee aluminum $\frac{1}{2}$ cylinder (Case 1), and one of the common rigid instrument panels in general aviation aircraft (Case 2).

similar data for impacts against a rigid instrument panel in common use in general aviation aircraft, are presented in Figure 36. Note that not only does the aluminum roll reduce the peak "g" force at 15 ft./sec. from 160 to 30 "g", but also extends the time for deceleration from 12 milliseconds to nearly 24, while at 30 ft./sec. im-

pact velocity it reduces the force of head impact from 300 "g" to 110 "g" with a doubling of the deceleration time. Decreased impact forces and extended duration times are most important for preventing head injuries, but of even more significance was the distribution of the load over a greater surface area. As the light aluminum

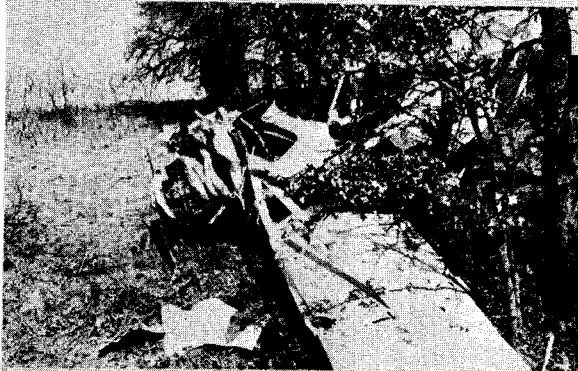
C. Crash design causes motor to fold under the aircraft.

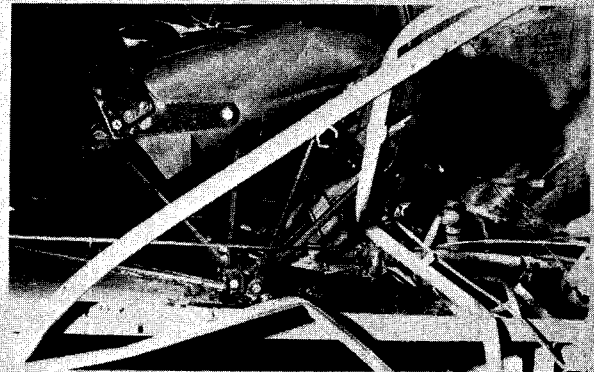
D. Seat attachments held since belts & harness were attached to fuselage.

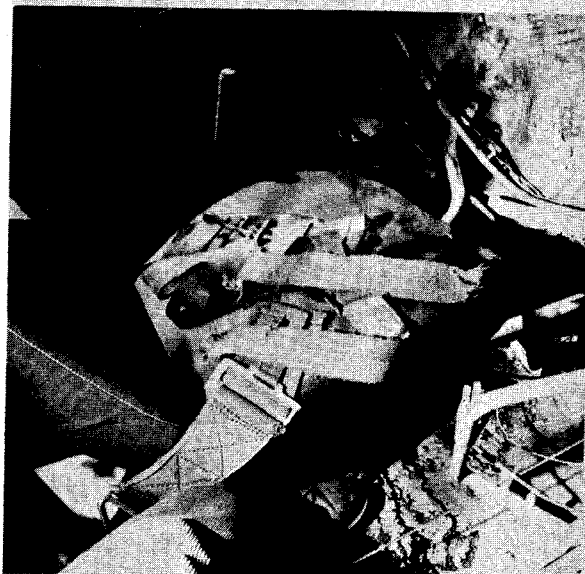
E. Shoulder harness & 3" seat belt broke.

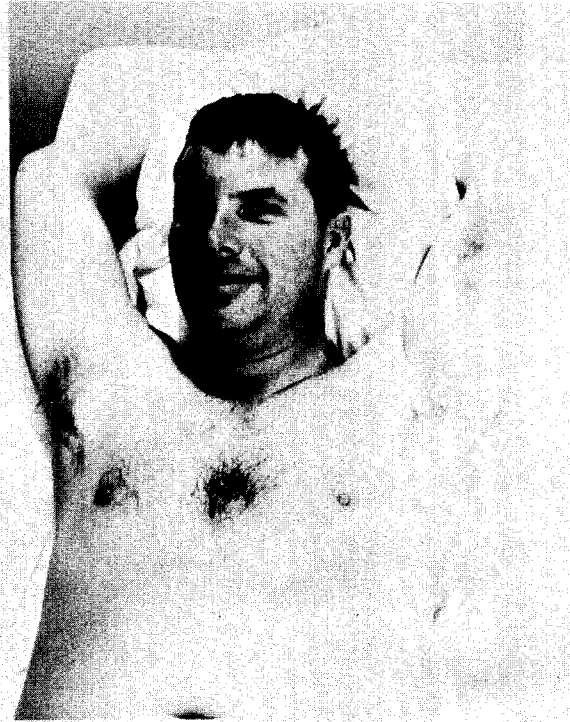
G. Pilot with minor bruises & facial lacerations 4 days after crash.

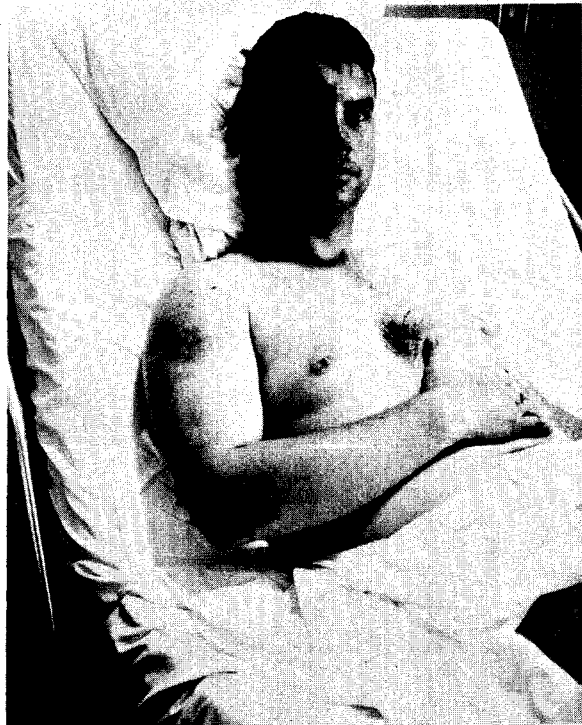
H. Bruise on right shoulder from contact with microphone.

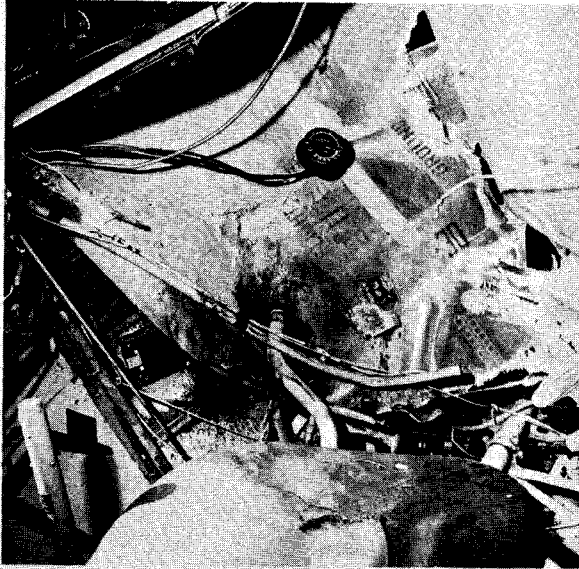
I. Knees penetrated fiberglass hopper without serious injury. Left ankle was fractured in pedal area.

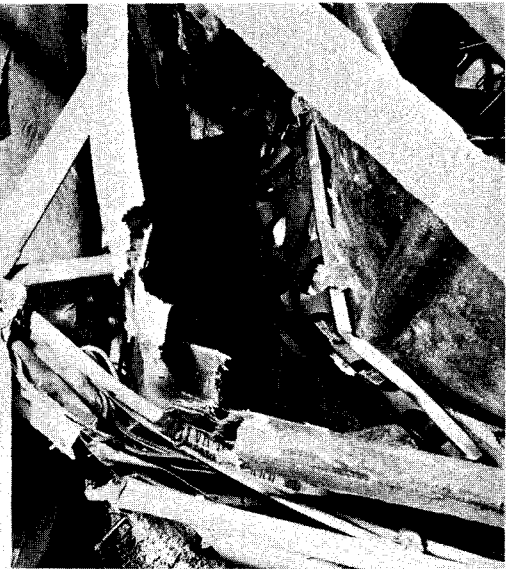
J. Perforated aluminum hopper liner served as good decelerator for knees.

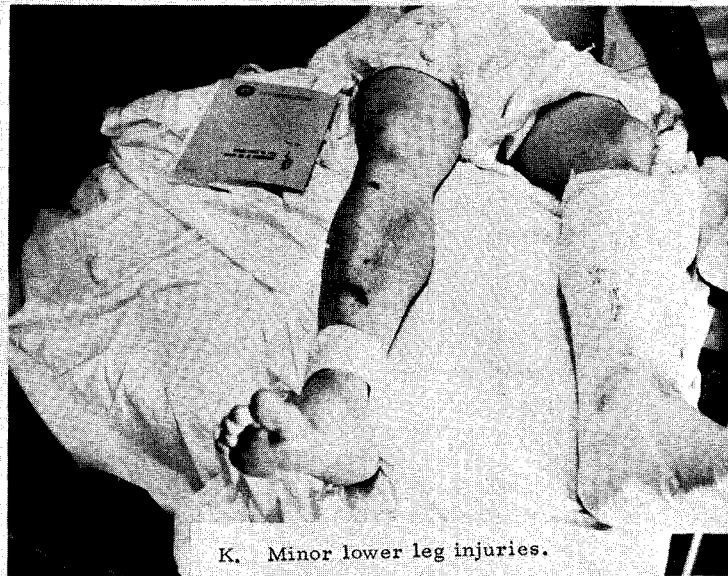
K. Minor lower leg injuries.

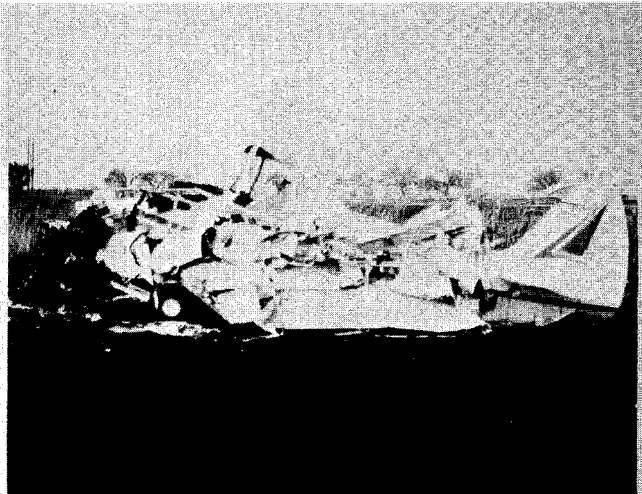
A, B & C Various views of aircraft showing how tubular construction around the cabin prevents its collapse on the pilot even in severe crash impacts.

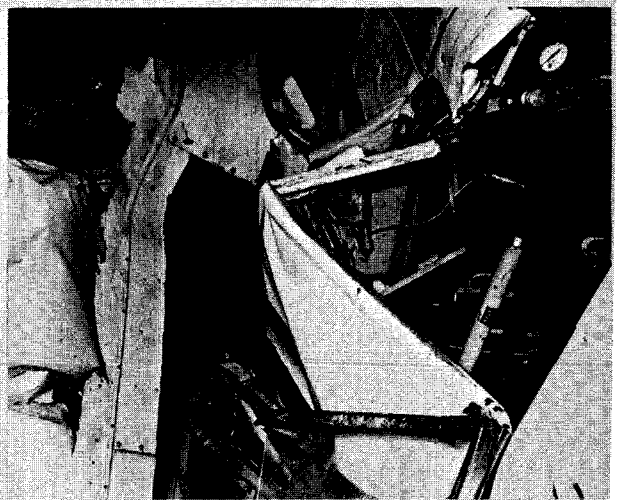
D. Sides of Pawnee cockpit are designed to buckle outward away from the pilot.

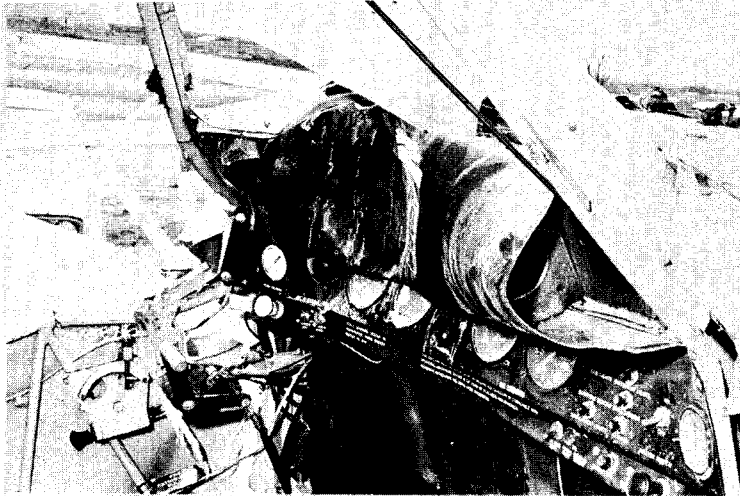
E. Side view of light aluminum cylinder at the top of the instrument panel designed to reduce head injuries.

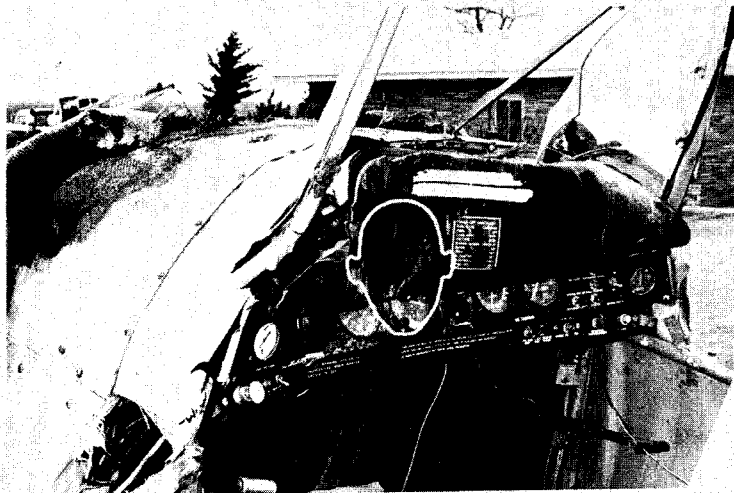
F. Outline showing area of pilot's head impact on aluminum cylinder. Note chin slipped down & contacted reset knob on altimeter.

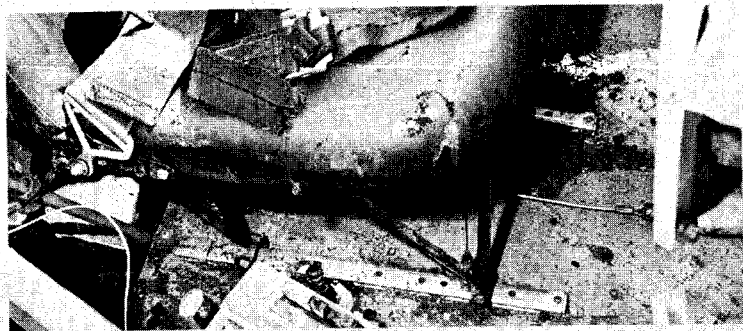
G. Shoulder harness failed in webbing but seat & seat belt held.

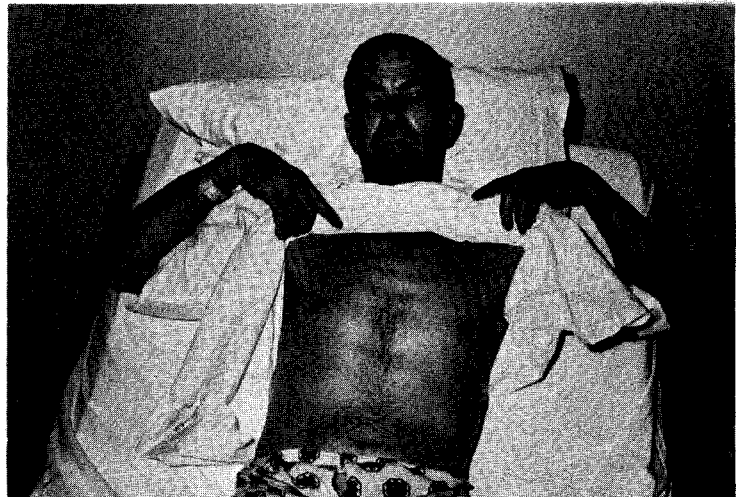
I. No chest injuries.

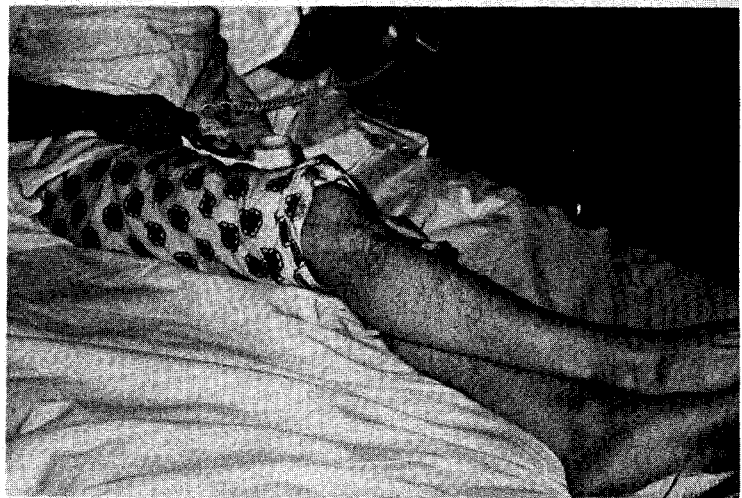
K. Practically no leg injuries.

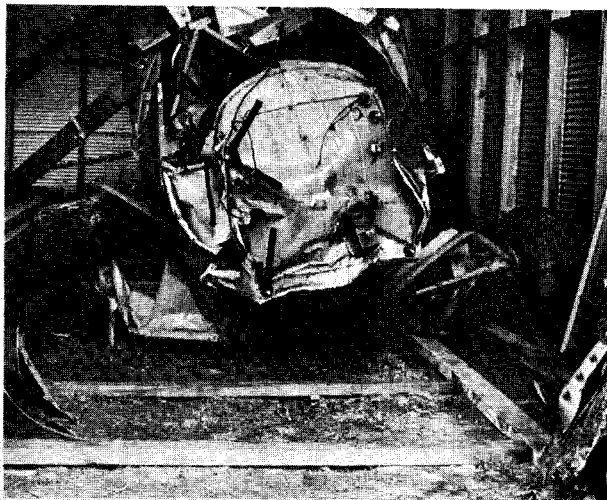
A. Upward bending of landing gear indicates heavy vertical crash forces.

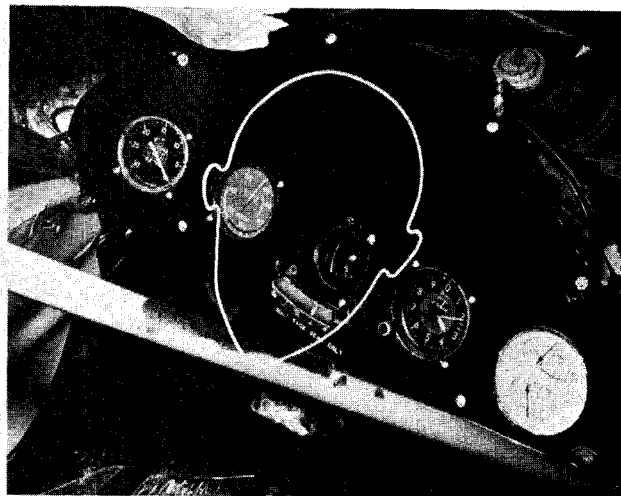
B. Outline indicating area of head impact.

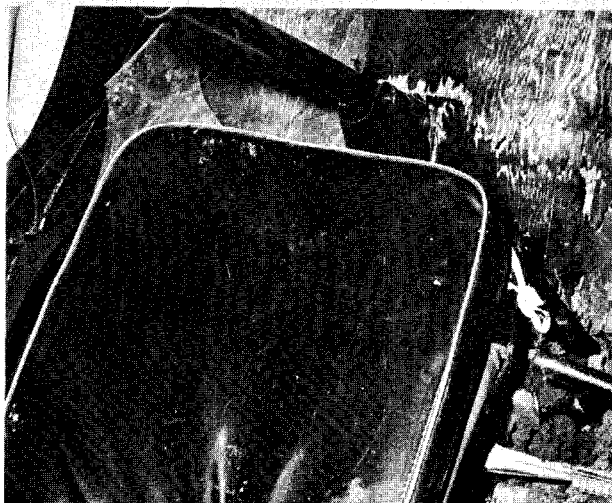
C. Upward buckling of floor structure further indicates vertical forces.

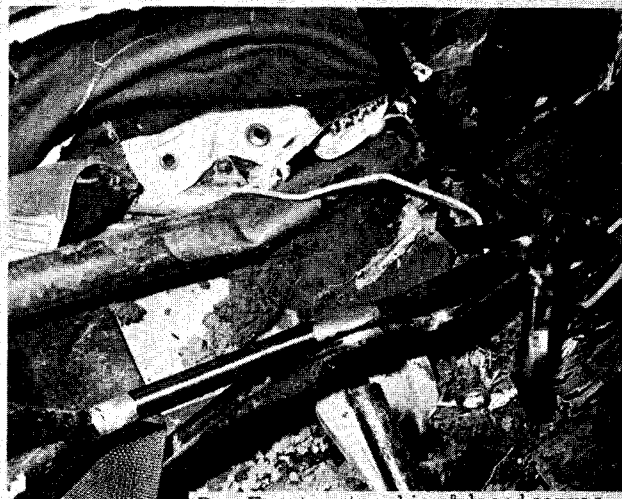
In Case 25 (a 1940 Piper Cub J-3C-65) numerous serious vertebral fractures resulted from vertical impact forces on a seat constructed of a cushion placed on top of a sheet of canvas laced to the sides of the seat structure. This flimsy structure gave way readily, allowing the buttocks of the front seat occupant to impact the heavy tubular structure under the center of the seat (Case 25 D). The forces involved in the crash of the 1964 Beech Musketeer A-23 presented as Case 26 were not all vertical as indicated by the pilot's receiving a brain concussion when his head hit the unpadded "A" post (Case 26 E) and the copilot's receiving a similar head injury from impact with the compass (Case 26 F) mounted on top of the instrument panel. However, the vertical component was significant as attested by the engine breaking straight down (Case 26 B and C) and the buckling of the legs of the front seats (Case 26 H and I). The fact

D. Front seat cushion & laced canvas removed to show tubular structure under seat that was responsible for vertebral fractures.

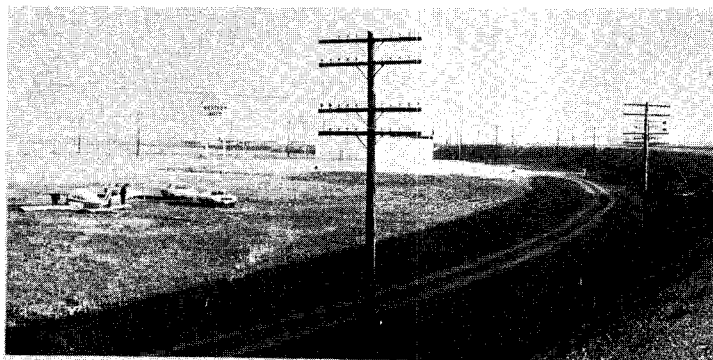
A. General view of crash site.

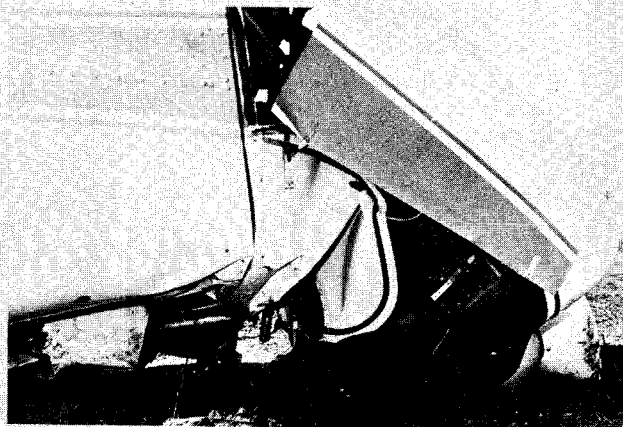
B & C Short 6-foot gouge mark under the aircraft, upward bending of the landing gear, & downward bending of motor all indicate that the aircraft crashed nearly flat with heavy vertical loads.

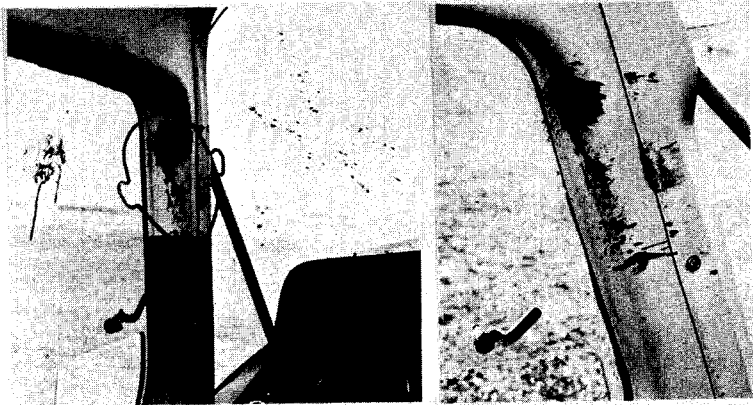
E. Pilot was thrown slightly to the left & his head hit the rigid "A" post.

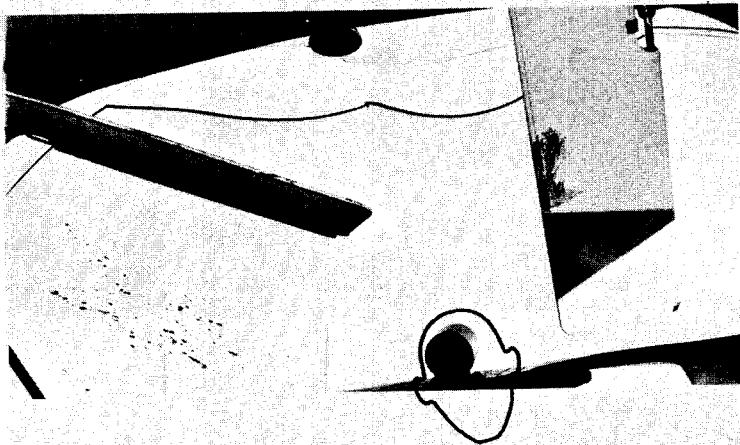
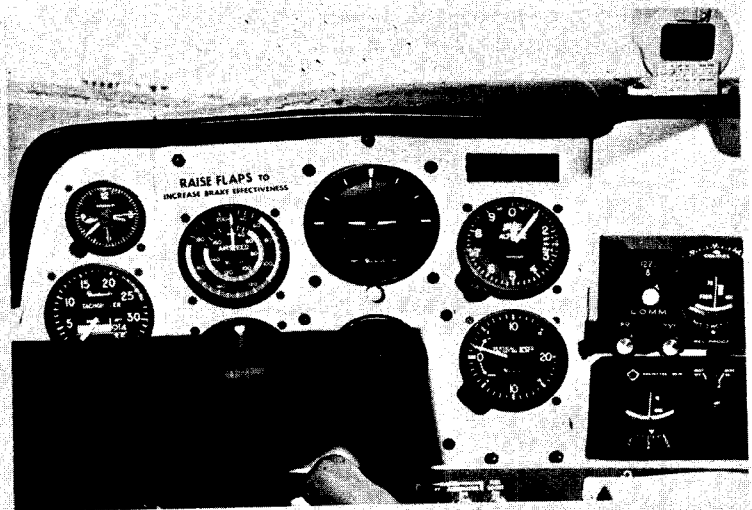
F & G Copilot's head struck compass & top center edge of instrument panel.

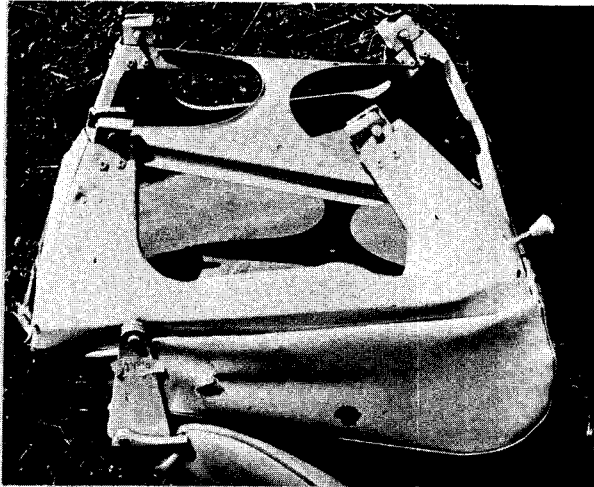
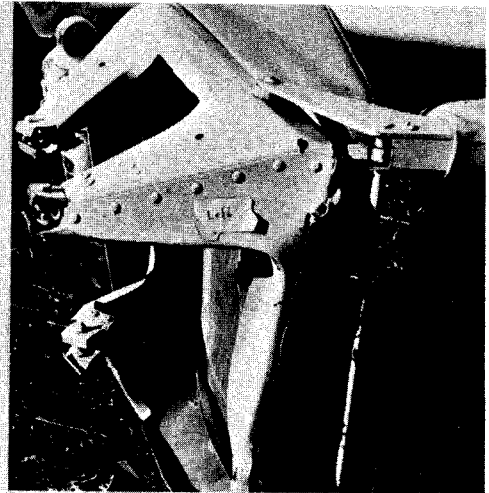
that the legs did buckle to a degree probably prevented more serious back injuries of these two occupants. Fractures of L1 for both front seat occupants would have been avoided in this case if only one or two additional inches of vertical attenuation had been provided. It is interesting that the single occupant of the rear seat escaped without vertebral injury or even a back sprain. The rear seat cushion (3-inch-thick foam) is not mounted on a rigid seat pan and rigid legs as is the case with the front seats, but instead lies on top of lightweight aluminum stringers perforated with 5½-inch diameter holes. The attenuation offered by this type of construction, offering up to 9 inches of crush distance, was sufficient in this case to prevent vertebral fractures.

H & I Heavy seat legs buckled from vertical forces. Vertebral fractures could have been prevented by attenuation in seats.

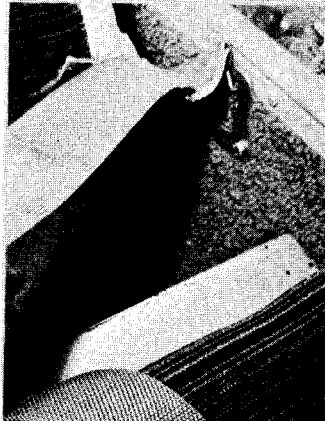
J. Outboard belts fuselage-attached.

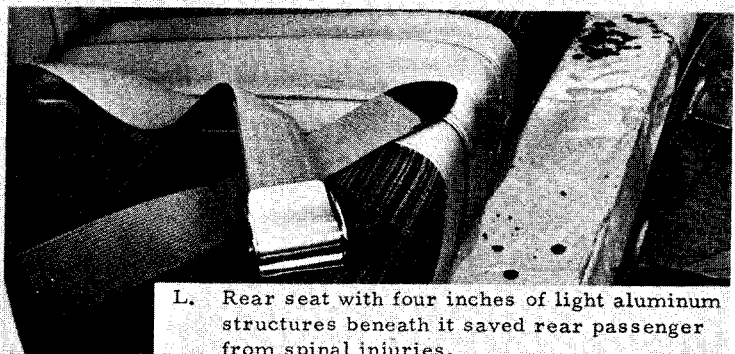
L. Rear seat with four inches of light aluminum structures beneath it saved rear passenger from spinal injuries.

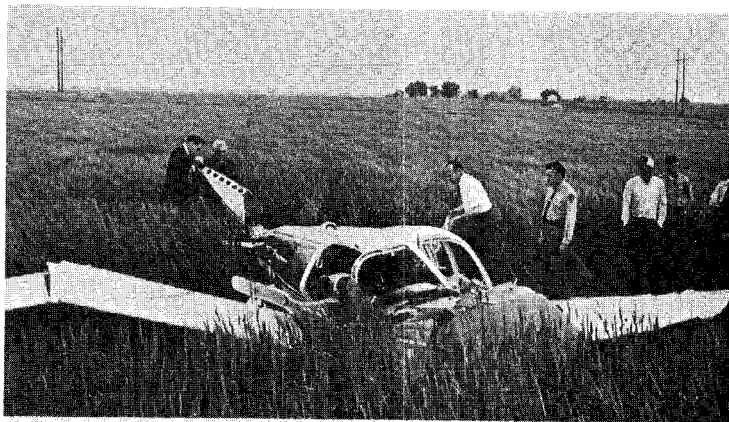
A. Aircraft crashed flat in a tall wheat field. Note wheat all around aircraft is undisturbed.

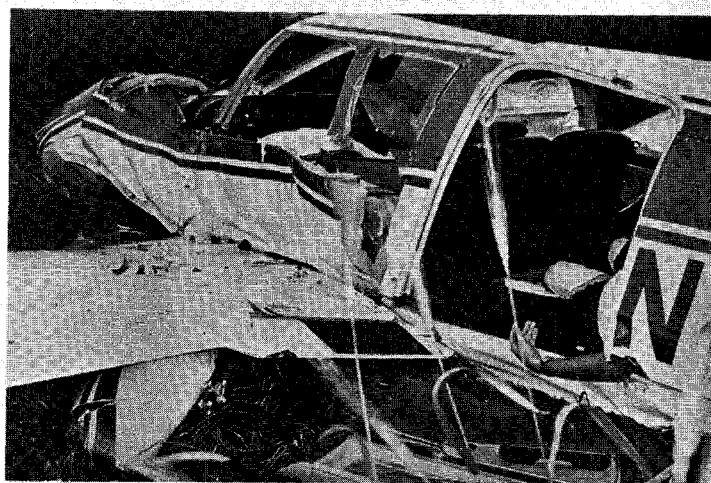
B. Motor is bent downward, landing gear pushed up into wings, instrument panel completely undamaged & rear passenger appears to be sitting flat on the ground.

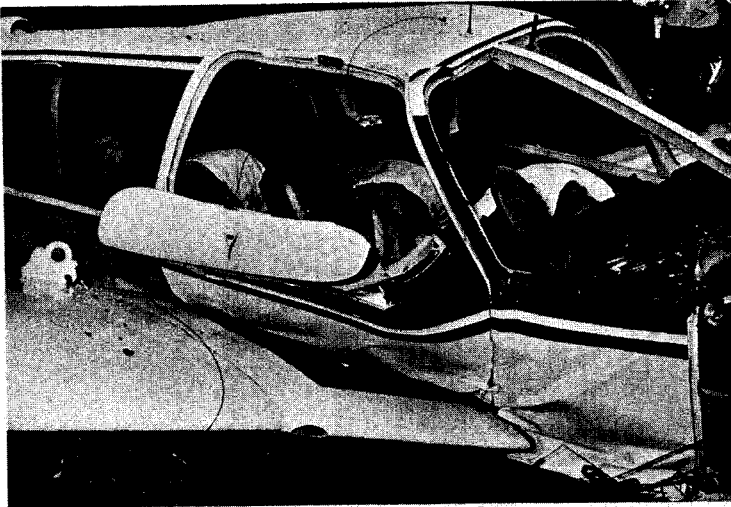
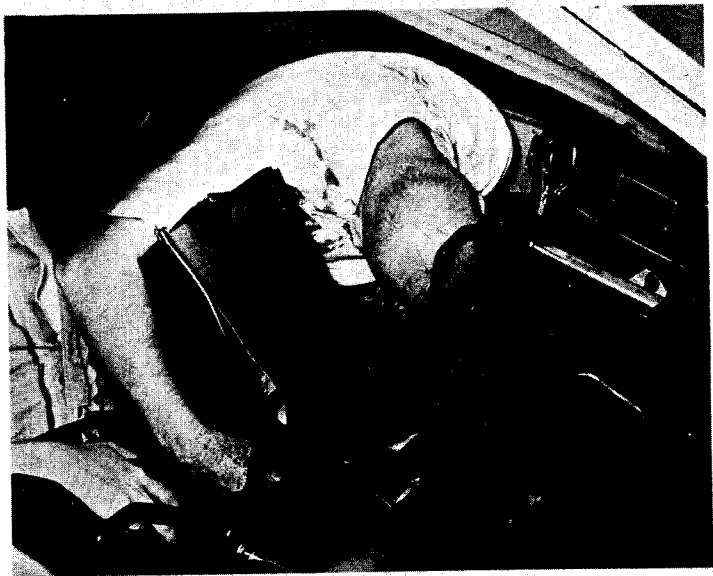
C & D Front seat occupants appear to be uninjured & asleep.

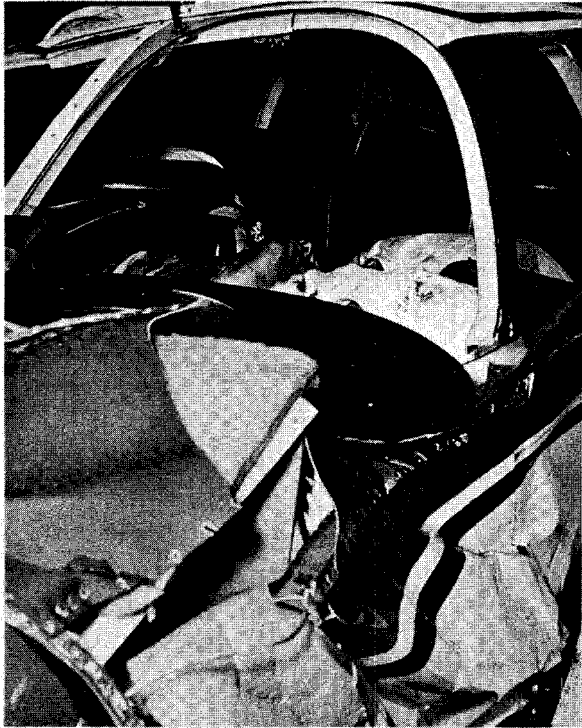
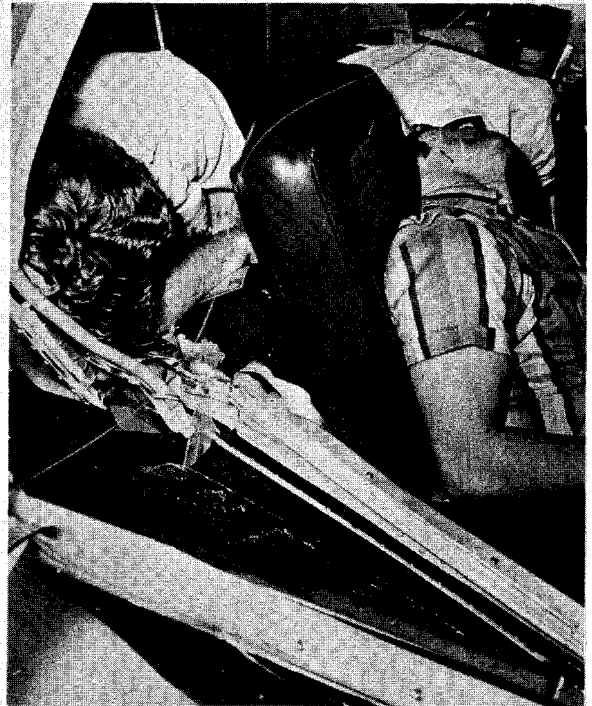
E & F Views of right front & center seat occupants.

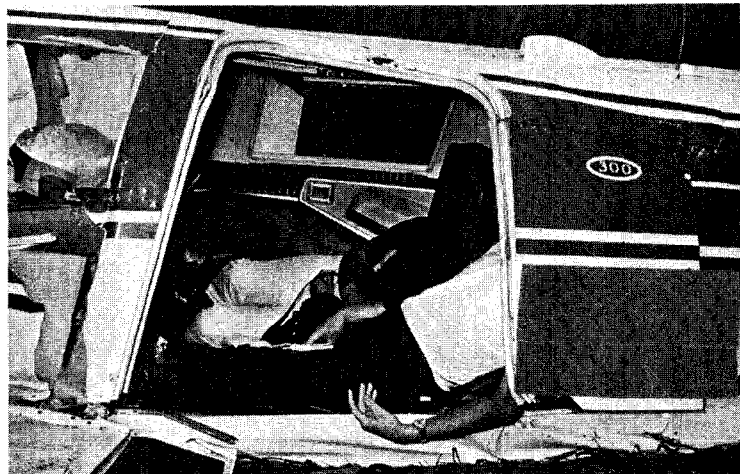
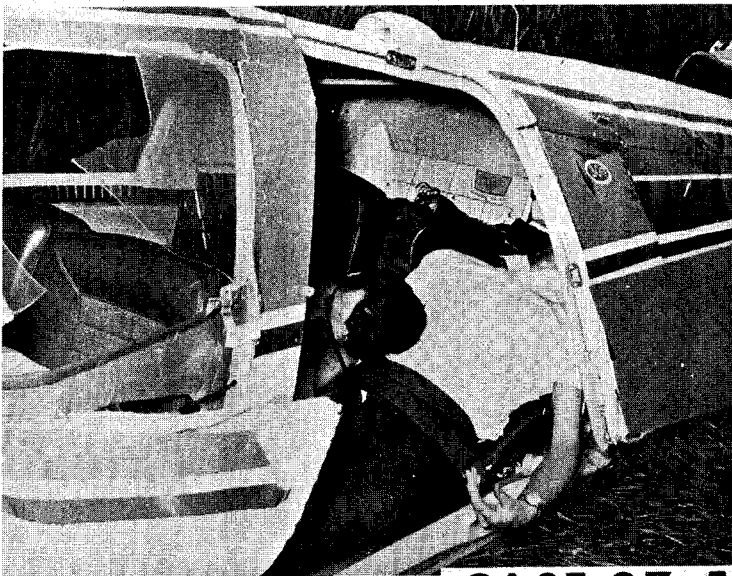
G, H & I All occupants have seat belts fastened, appear to be sitting on the ground, & died from severe internal injuries produced by vertical forces.
