# **Morphological Analyses and Simulated Flood Elevations in a Watershed with Dredged and Leveed Stream Channels, Wheeling Creek, Eastern Ohio**

Scientific Investigations Report 2008–5133

By James M. Sherwood, Carrie A. Huitger, Andrew D. Ebner, and G.F. Koltun

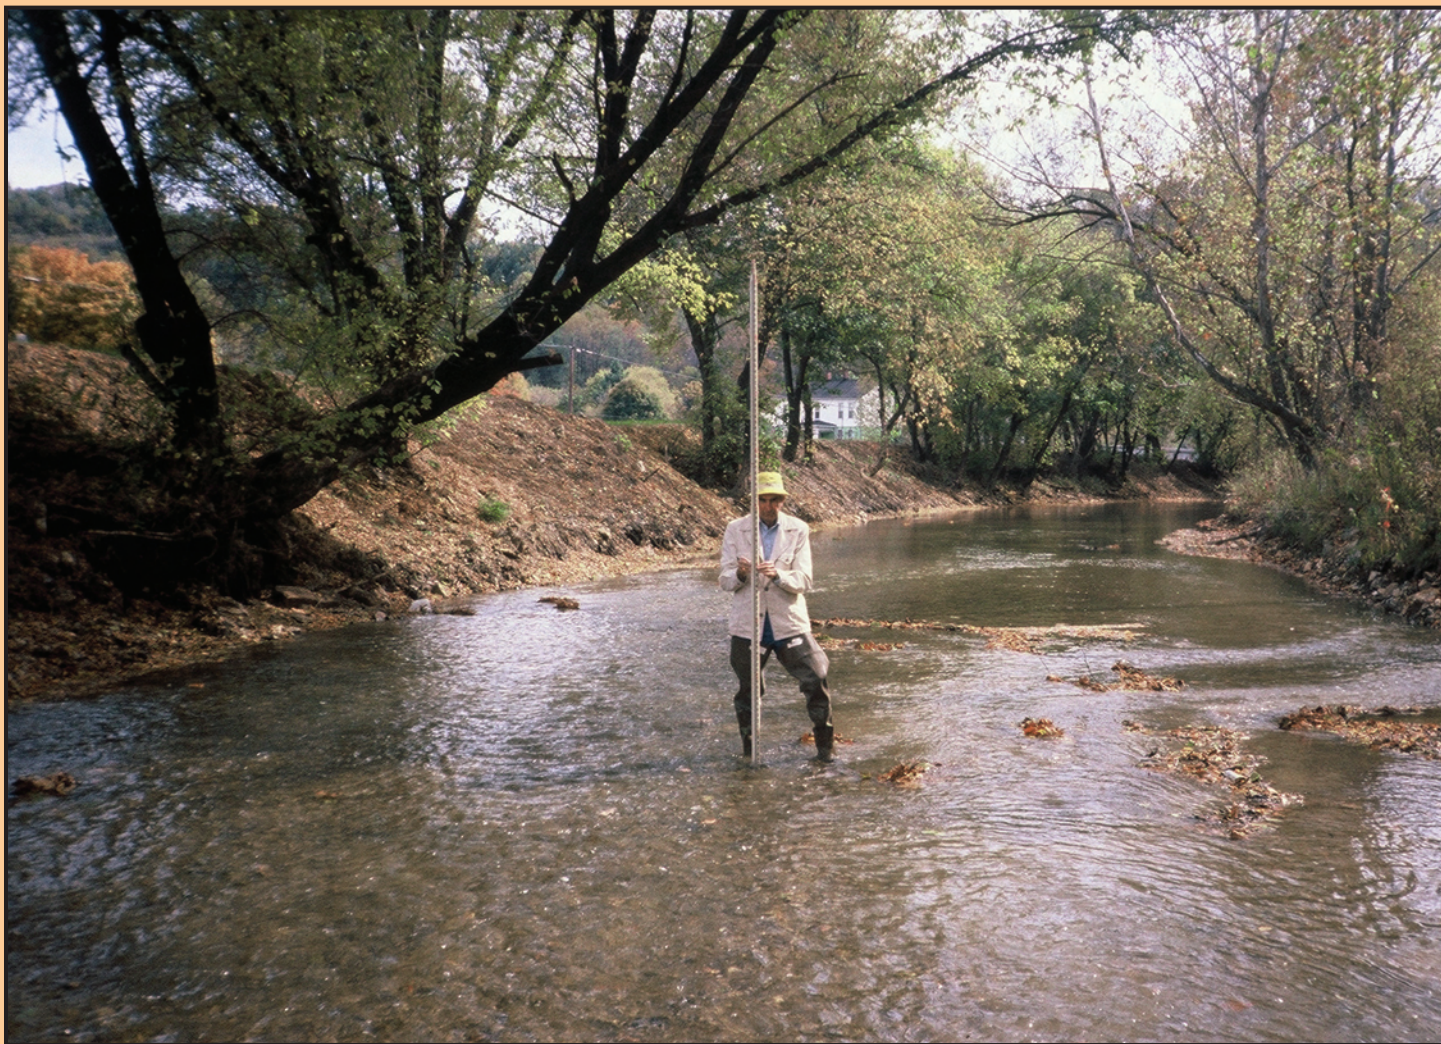
**Cover.** Looking downstream at cross-section C-5 on Wheeling Creek in Maynard, Ohio, after dredging was completed in 1985. (Photograph by G.F. Koltun, U.S. Geological Survey)

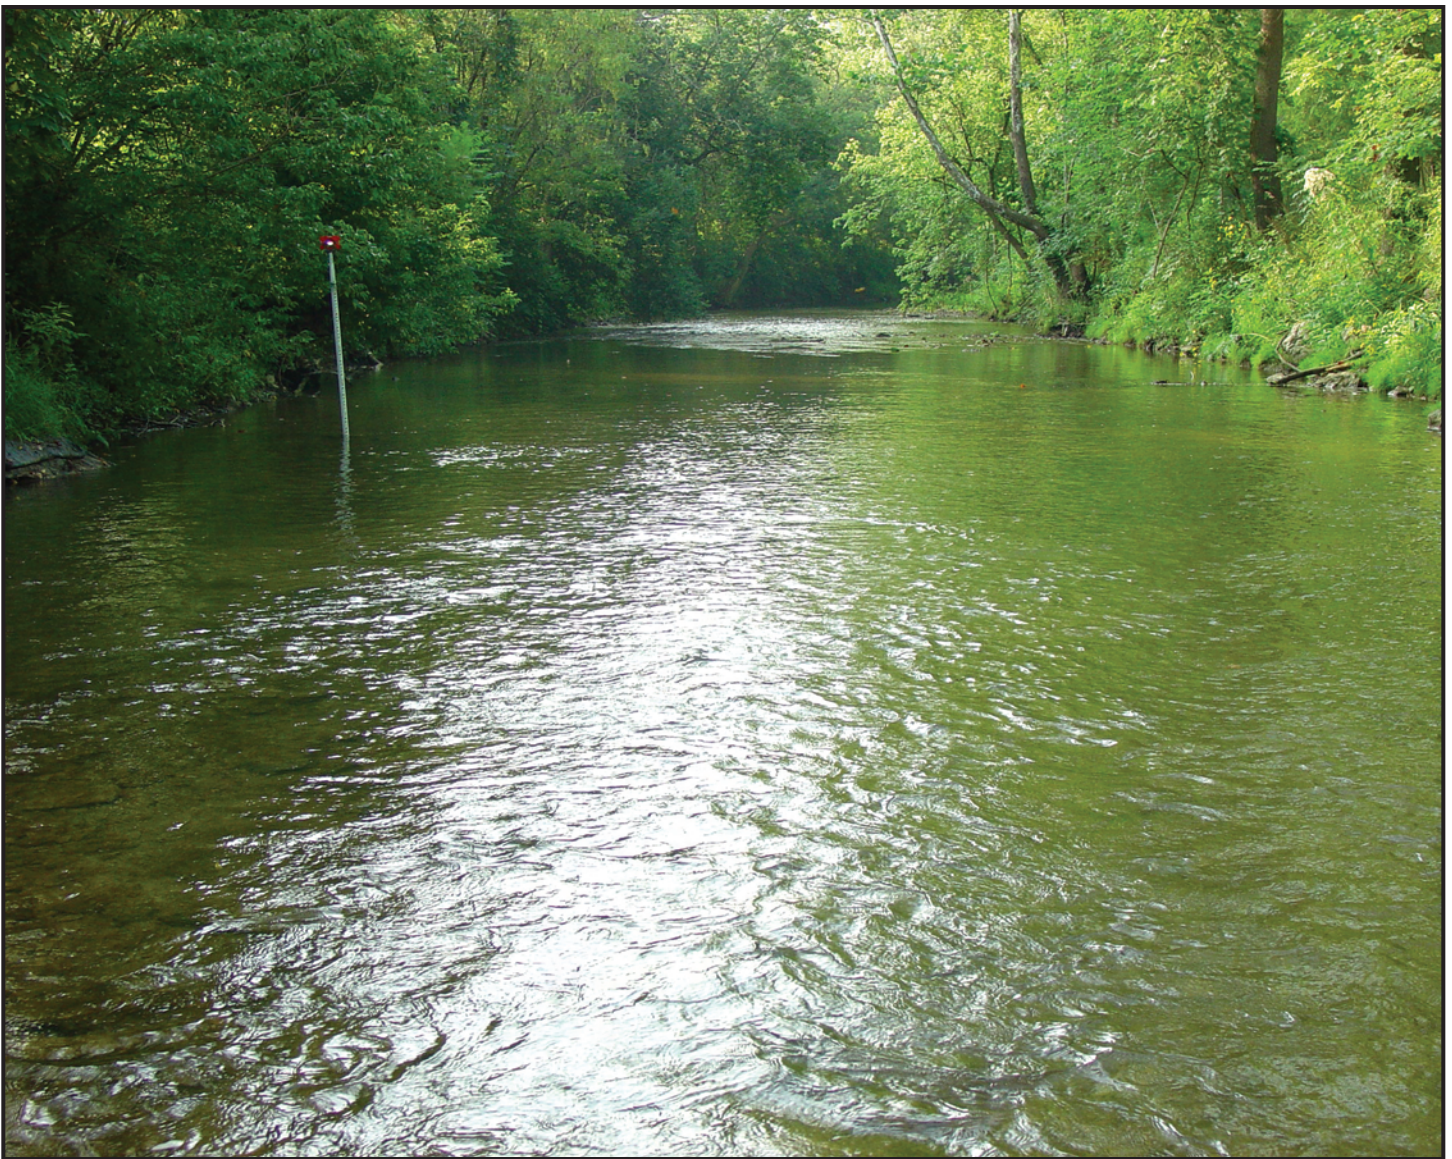
**Above.** Looking downstream at cross-section C-5 (photograph taken from same location as cover photograph) on Wheeling Creek in Maynard, Ohio, summer 2006. (Photograph by James M. Sherwood, U.S. Geological Survey)
