Regional Curves for Bankfull Channel Characteristics in the Appalachian Plateaus, West Virginia

Scientific Investigations Report 2009–5242

U.S. Geological Survey

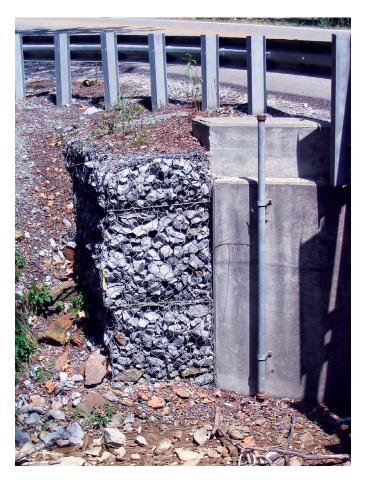
Figure 7. Crest-stage streamgage at Marsh Fork at Maben, West Virginia.
