Wind Turbine Generator System Duration Test Report for the ARE 442 Wind Turbine

Technical Report

NREL/TP-500-47203

May 2010

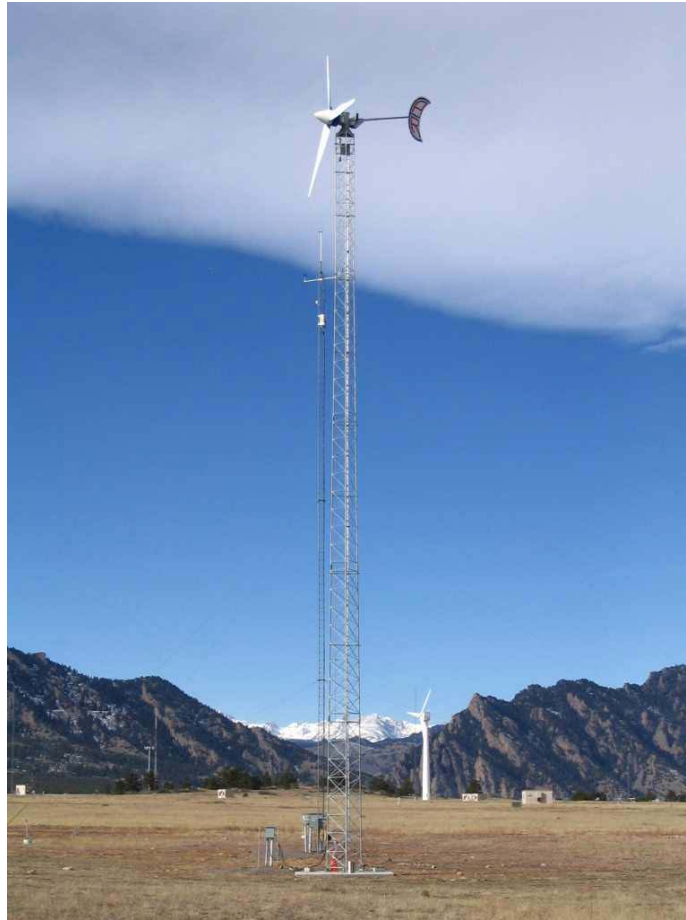
Figure 1. The ARE 442 wind turbine

The test turbine (Figure 1) is a three bladed, upwind, furling turbine with a rated power of 10kW. Table 1 lists basic turbine configuration and operational data. Figure 2 shows the one-line diagram for the test turbine installation.

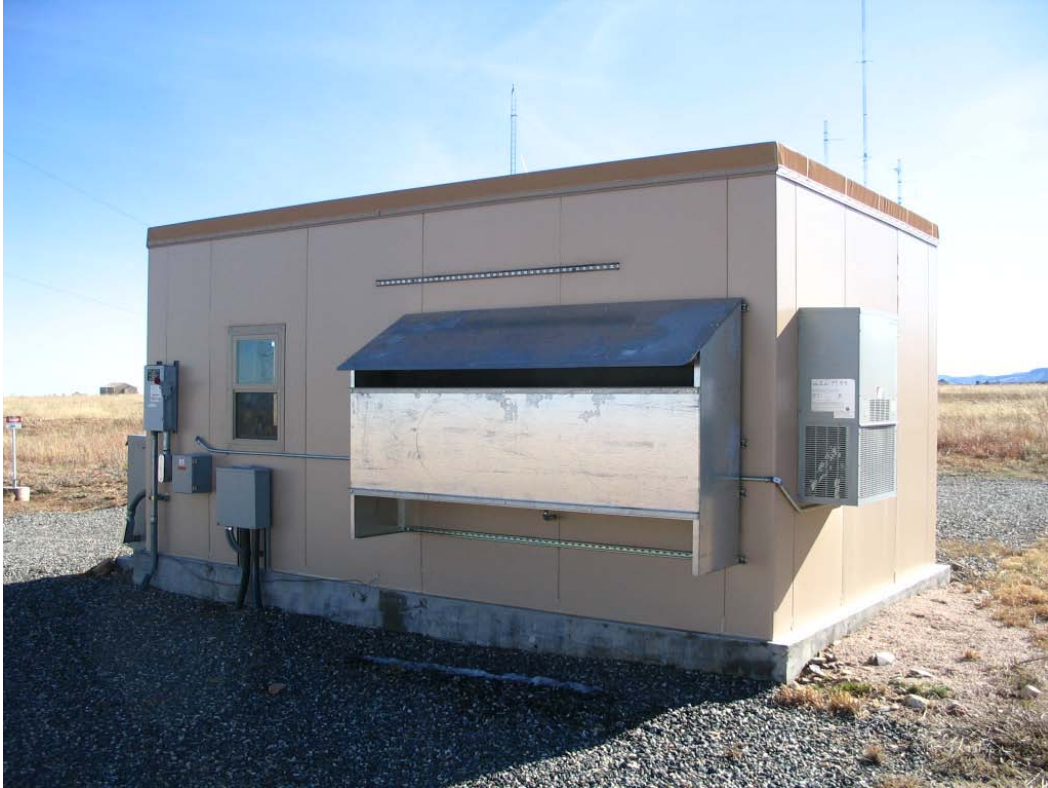
Figure 5. Diversion loads on exterior of data shed

At the start of the test, the diversion loads were installed inside the data shed per the manufacturers installation instructions. The data shed was unable to disperse the heat which caused the turbine to experience over temperature faults in high winds. The ten minute periods in which the turbine was faulted for more than 300 seconds were counted at T_N . On 10 and 11 February 2009, the diversion loads were moved to the exterior of the data shed (Figure 5) to avoid further over temperature faults.

After the diversion loads were moved to the exterior of the building no more over-temperature faults were observed. Instead, in high winds, the turbine would fault to over-voltage faults. The ten minute periods in which the turbine was faulted for more than 300 seconds were counted as T_N .

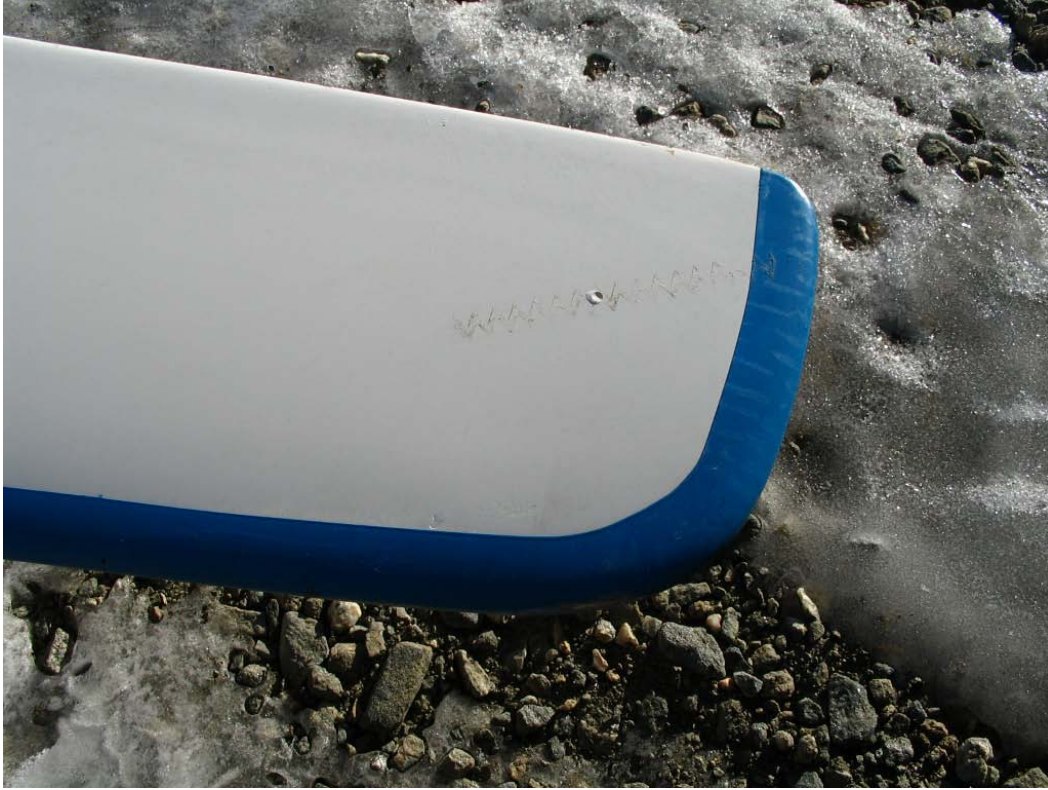
Figure C-9. Remnants of trip strip on one of the blade tips

All the blades had the trip strip missing on the high pressure side (Figure C-9). All three blades also had some cracking in the trailing edge bond line in the root area (Figure C-10). Blade 2 also had some more severe cracking in the leading edge near the root (Figure C-11 and Figure C-12). All blade roots showed signs of light rubbing on the clamping plates and alternator.

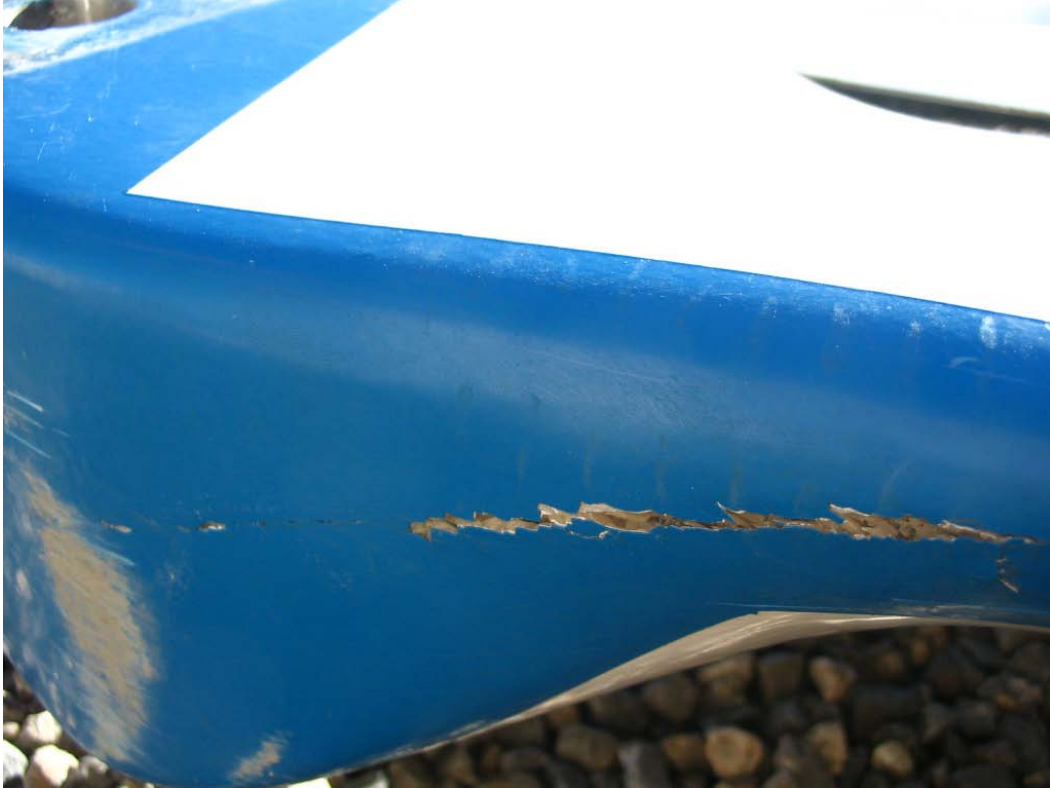
Figure C-11. Crack in leading edge near blade root of blade #2.

The tear down inspection was performed on 15 December 2009. The results are documented in Appendix C. The main finding was a leading edge crack in one of the blades.

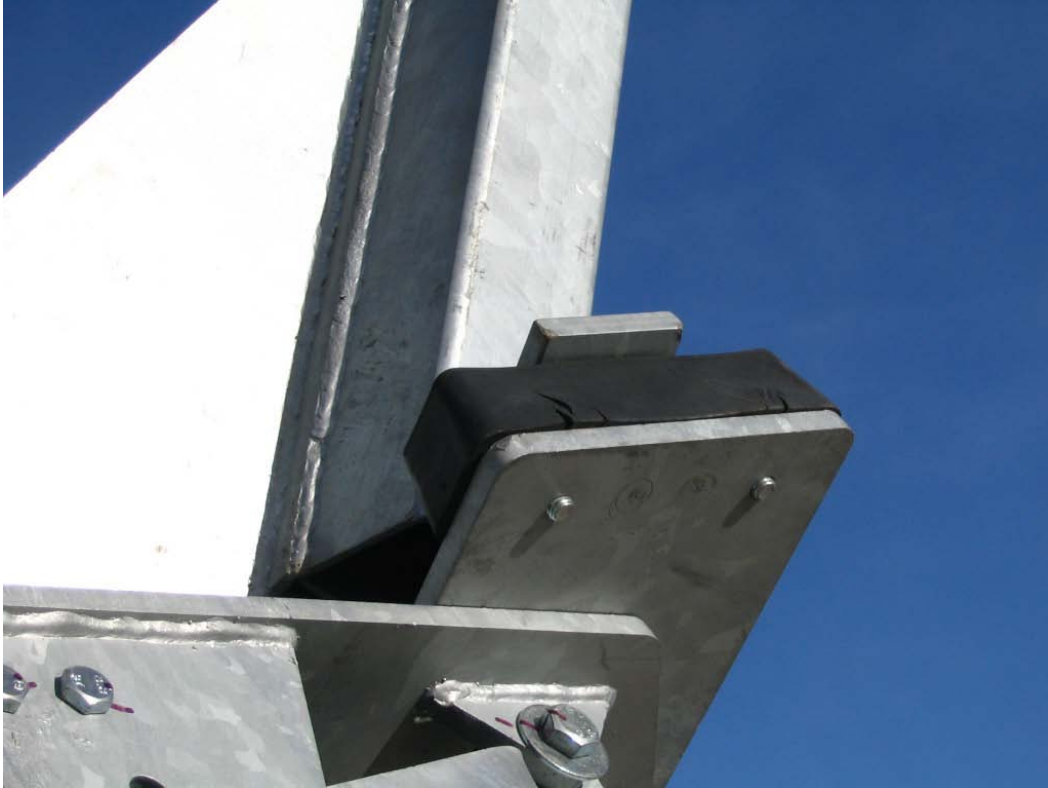
Figure C-13. Cracked tail stop bumper

The tail vane was inspected visually, no cracks were found. The tail boom did not have any cracks or signs of wear. The tail stop bumper was found to be cracked (Figure C-13). This bumper gets hit by the tail when the turbine comes out of furl. This may have been caused by over-torquing of the mounting bolts by ARE during the turbine production. The plate that contacts the tail stop bumper when the turbine comes out of furl was found to be bent (Figure C-14).

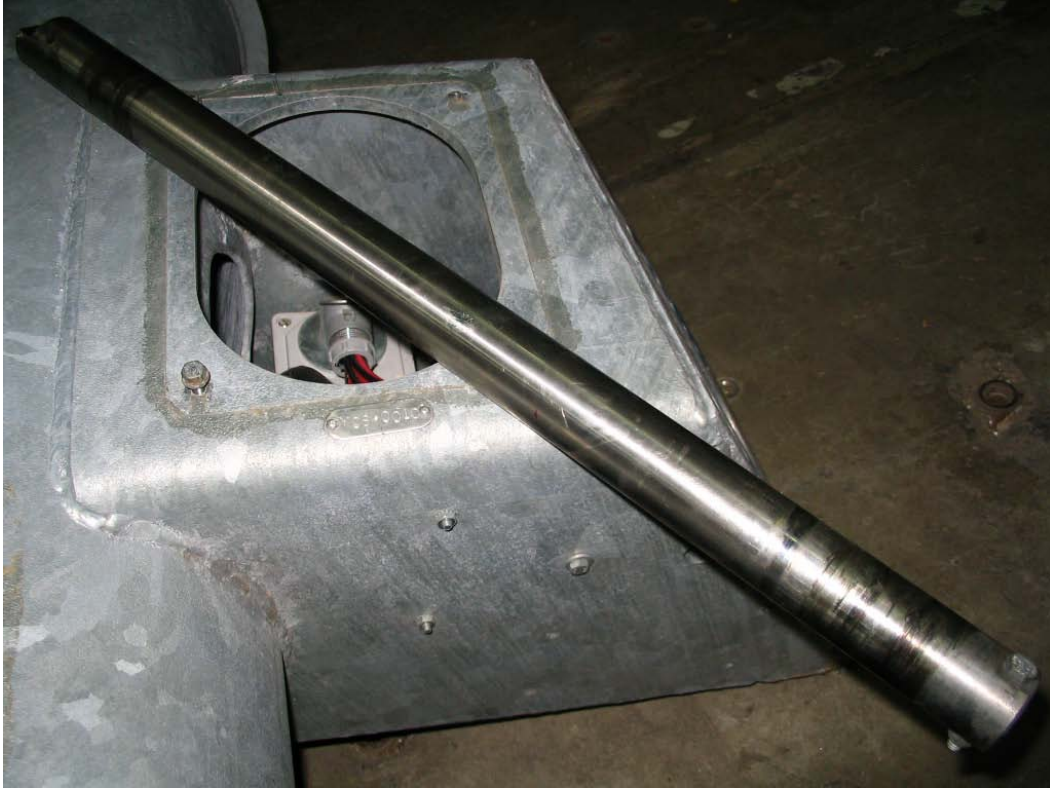
Figure C-15. Tail hinge pin

The tail hinge pin and bronze sleeve bearings showed very little wear. Most wear was likely caused by the disassembly process. See Figure C-15.

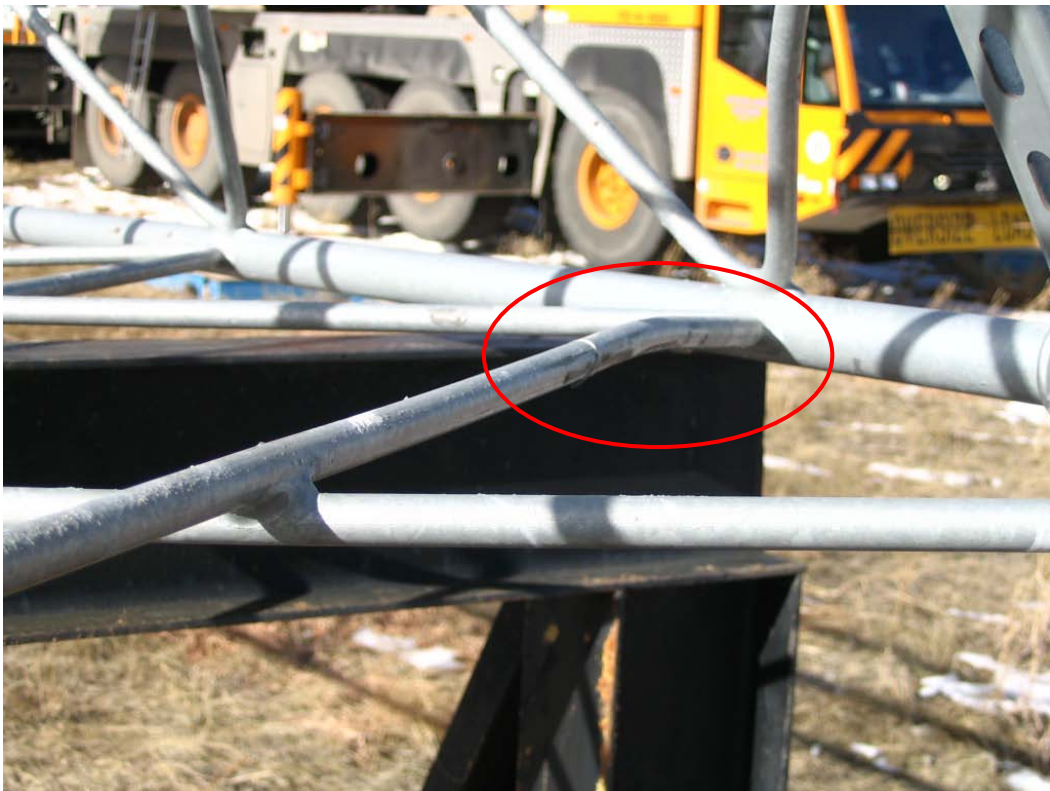
Figure C-16. Bent tower diagonal

The tower was visually inspected. No cracked welds were found. All fasteners were present. A couple of diagonal supports were found to be bent (Figure C-16). Although no clear evidence is present, this was most likely caused by shipping and did not occur during the test.
