During March 14-15, 2007, the U.S. Geological Survey (USGS), Caribbean Water Science Center (CWSC), in cooperation with the PREPA conducted a bathymetric survey of Lago Patillas to update the reservoir storage capacity and update the reservoir sedimentation rate by comparing the 2007 bathymetric survey data with previous 1997 data. The purpose of this report is to update the reservoir storage capacity, sedimentation rates, and areas of substantial sediment accumulation since April 1997.

## SEDIMENTATION SURVEY OF LAGO PATILLAS, PUERTO RICO, MARCH 2007

By Luis R. Soler-López.  
2010

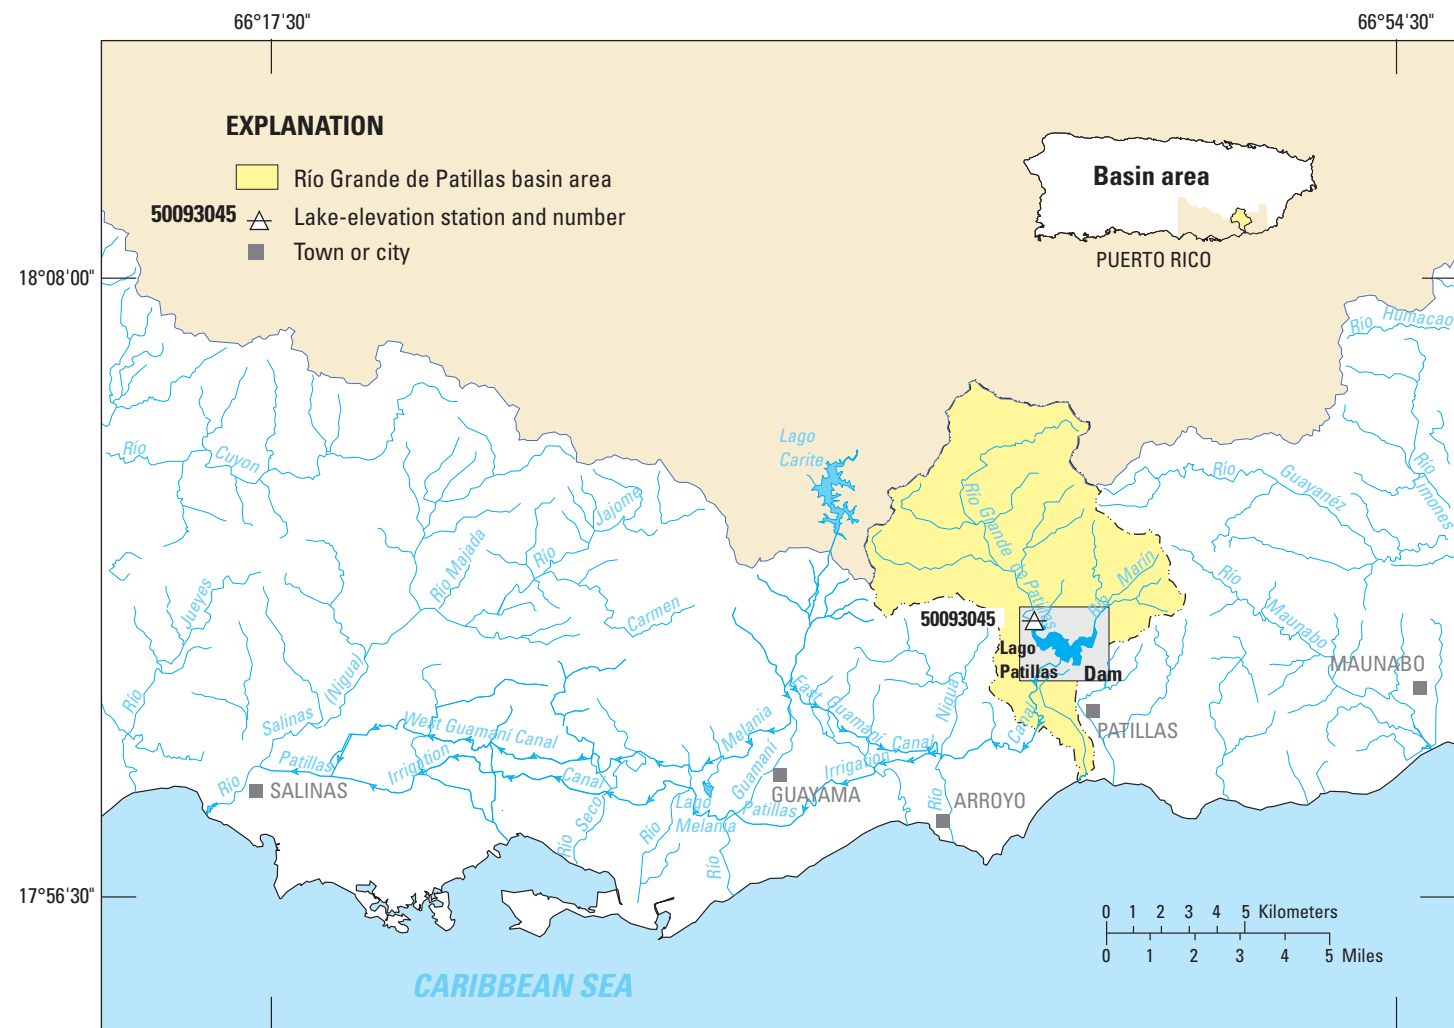
Figure 1. Location of Lago Patillas in the Río Grande de Patillas basin, Puerto Rico.

Lago Patillas is a reservoir located on the confluence of Río Grande de Patillas and Río Marín, in the municipality of Patillas in southern Puerto Rico, about 3 kilometers north of the town of Patillas and about 8 kilometers northeast of the town of Arroyo (fig. 1). The dam is owned and operated by the Puerto Rico Electric Power Authority (PREPA) and was constructed in 1914 for the irrigation of croplands in the southern coastal plains of Puerto Rico along the towns of Arroyo, Guayama, Patillas, and Salinas. Irrigation releases are made through the outlet works into the Patillas Irrigation Canal that extends 32.2 kilometers from the Patillas dam to Río Salinas. The dam is a semi-hydraulic earthfill with a structural height of 44.80 meters, a top width of 4.57 meters, a base width of 190.49 meters, and a crest length of 325.21 meters. The spillway structure is physically separated from the earthfill dam, has an elevation of 58.21 meters above mean sea level, and has three radial arm gates (Puerto Rico Electric Power Authority, 1979). The reservoir impounds the waters of the Río Grande de Patillas and Río Marín. The reservoir has a drainage area of 66.3 square kilometers. Additional information and operational procedures are listed in Soler-López and others (1999).

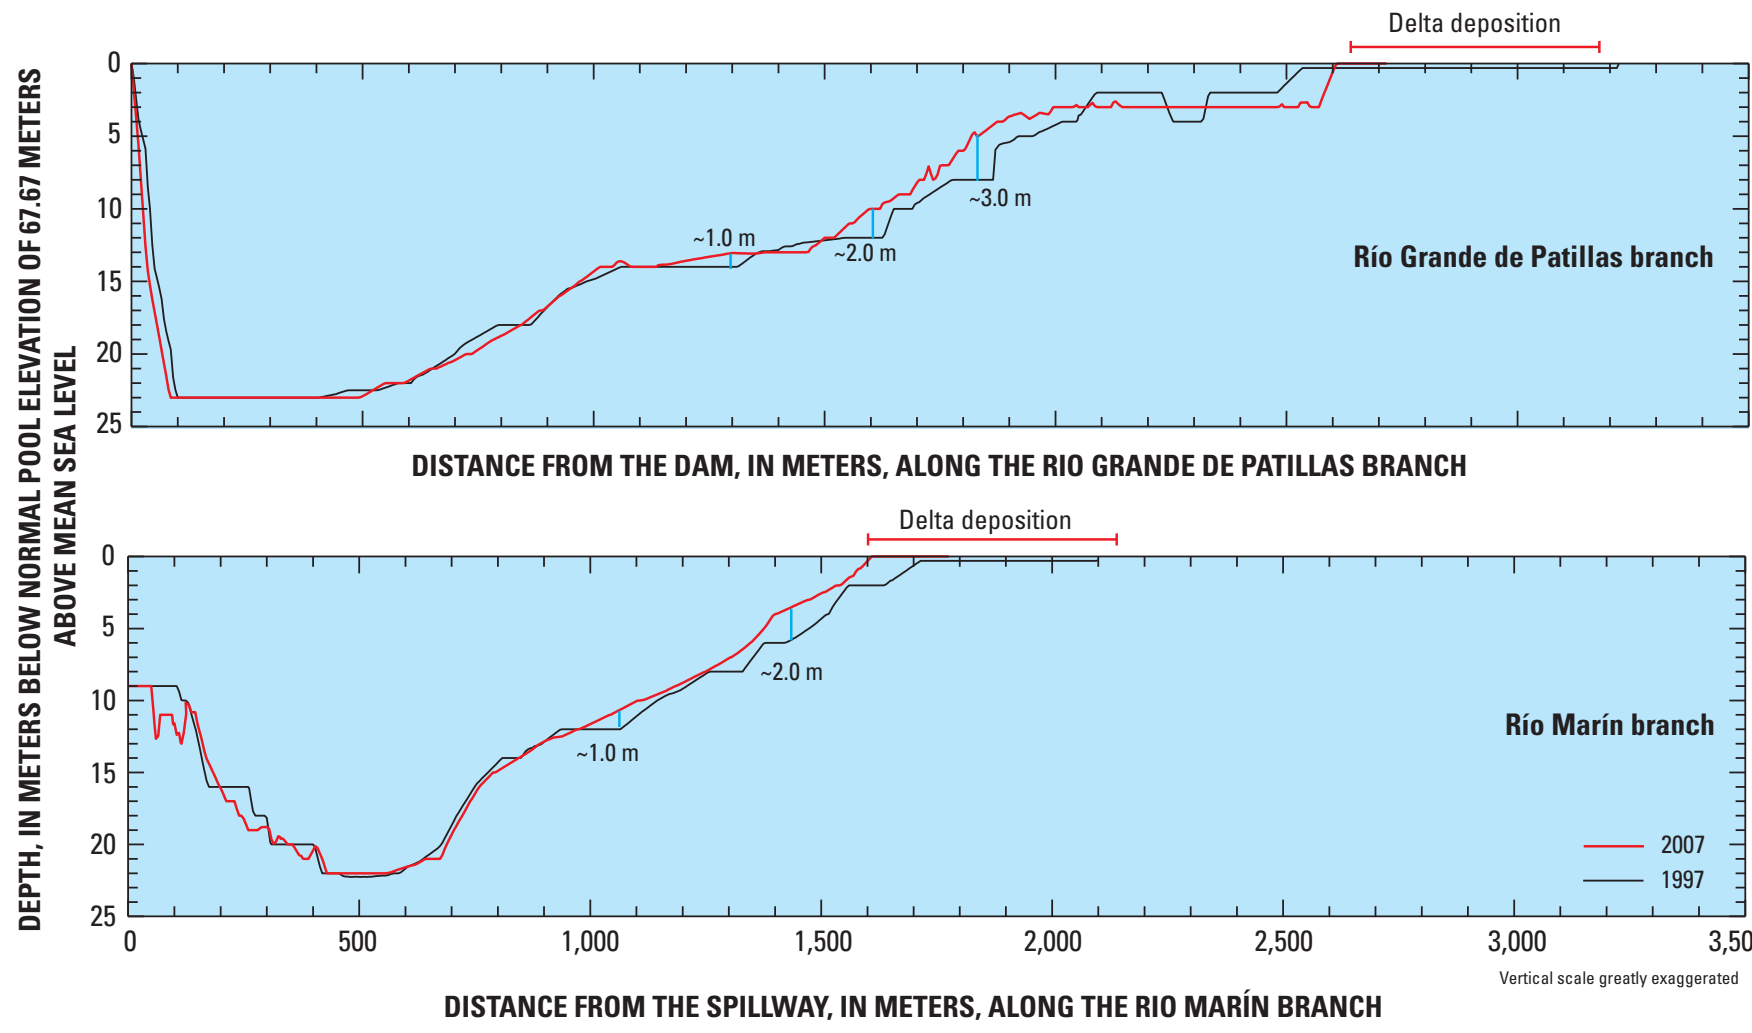
Figure 5. Longitudinal bottom profiles for 1997 and 2007 along the Río Grande de Patillas and Río Marín branches of Lago Patillas.

Sediment accumulation in Lago Patillas between 1997 and 2007 has been minimal, as indicated by a comparison of 1997 and 2007 longitudinal bottom profiles of Lago Patillas along the thalweg of the Río Grande de Patillas and Río Marín branches of the reservoir (fig. 5). Although these profiles are slightly different from those presented in Soler-López and others (1999), the profiles shown in figure 5 were generated from both surface models (1997 and 2007) in a simpler, more descriptive way to depict the reservoir bottom along the different river branches upstream from the dam and spillway. Near the confluence of the Río Marín and Río Grande de Patillas, the reservoir bottom

for 2007 is flat with no change since 1997; therefore, the comparison generated shows one flat line overlapping the other with no discernable difference between profiles. The comparison indicates that the greatest sediment accumulation has occurred along the riverine zones of Lago Patillas. Along the Río Grande de Patillas tributary branch, sediment accumulation is greatest in a section that extends from about 1,500 to 2,100 meters upstream from the dam, averaging about 2.5 meters in thickness. Within the Río Marín tributary branch, the average sediment accumulation along a reach extending from about 900 to 1,700 meters upstream from the confluence with the Río Grande de Patillas is about 1.5 meters. Sediment accumulation near the dam and the spillway structure is minimal. The sediment deposition rates from 1997 to 2007 were about 25 and 15 centimeters per year, respectively, along the Río Grande de Patillas Río Marín branches. The more noticeable effect of material accumulation is that the reservoir surface area has been reduced on the Río Grande de Patillas and Río Marín riverine zones (fig. 5). Figure 6 shows an aerial photograph of the Lago Patillas earthfill dam and the spillway section.

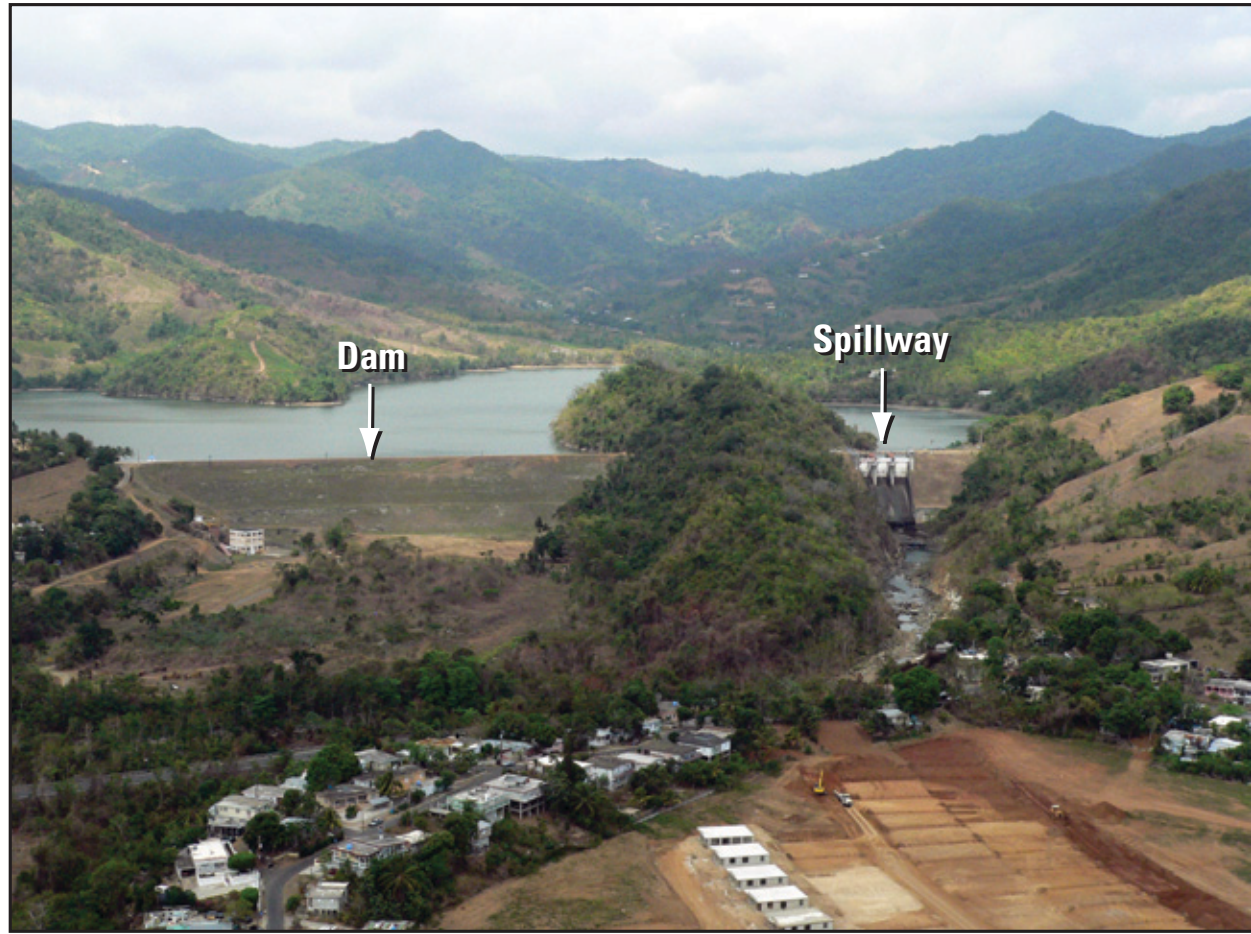
Figure 6. Aerial photograph of the Lago Patillas earthfill dam and spillway section. Photograph courtesy of the Puerto Rico Electric Power Authority.

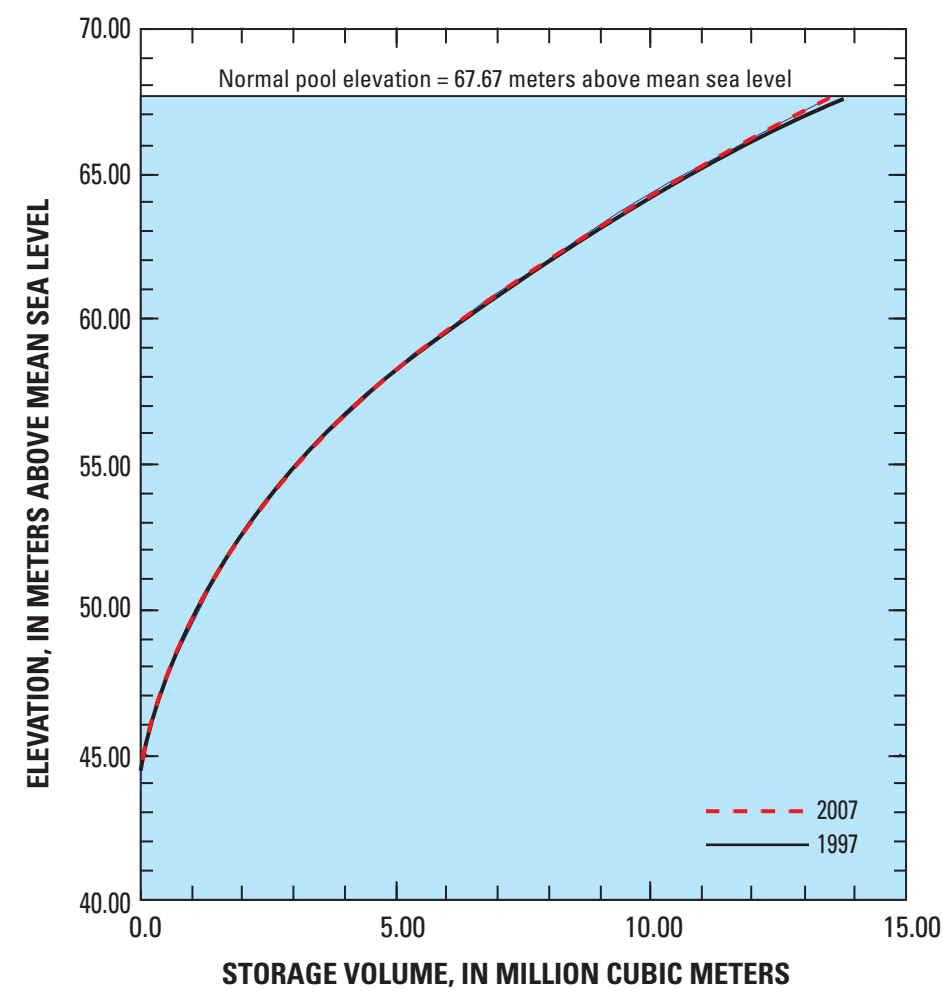
Figure 4. Relation between water-storage capacity and pool elevation of Lago Patillas, for 1997 and 2007.

The survey navigation lines were established at a spacing of about 50 meters, beginning at the dam and spillway face of the reservoir and continuing upstream to the reservoir tail along the different river branches. Geographic position and water depths were acquired simultaneously using the DGPS interfaced to the depth sounder. The pool elevation of the reservoir was measured at USGS lake-level station 50093045, Lago Patillas at Damsite near Patillas. The soundings were subsequently adjusted to represent water depths below normal pool elevation. The 2007 data were stored and transferred into the USGS geographic information system (GIS) where final analysis and volume calculations were made following similar procedures used to develop the 1997 bathymetric map of Lago Patillas reservoir (Soler-López and others, 1999). Field data were used to generate a bathymetric map representing the reservoir bottom in March 2007 (fig. 2). A triangulated irregular network (TIN) surface model of Lago Patillas was then created from the bathymetric map, and the reservoir volume was calculated using the GIS. The TIN surface model was used with the digital data for 1997 and 2007 to generate a stage-storage curve and longitudinal profiles along the different tributary branches of Lago Patillas. An actualized storage capacity table and curve were generated by calculating the TIN volume at 1-meter elevation intervals (table 2, fig. 4).

Bathymetric data indicate storage capacity of the reservoir decreased slightly from 13.84 million cubic meters in April 1997 (Soler-López and others, 1999) to 13.57 million cubic meters by March 2007 (table 1). This decrease represents a reduction between 1997 and 2007 of 270,000 cubic meters (or 2 percent over 10 years) for an annual storage capacity loss rate of about 27,000 cubic meters. The nearly 75 percent reduction in sedimentation rate from 1997 to 2007 (table 1) may be a result of the nearly undisturbed Lago Patillas drainage area (fig. 3). An actualized storage capacity table and curve were generated by calculating the TIN volume at 1-meter elevation intervals (table 2, fig. 4).
