# Wind Turbine Safety and Function Test Report for the Mariah Windspire Wind Turbine

**Technical Report**

**NREL/TP-500-47496**

**July 2010**

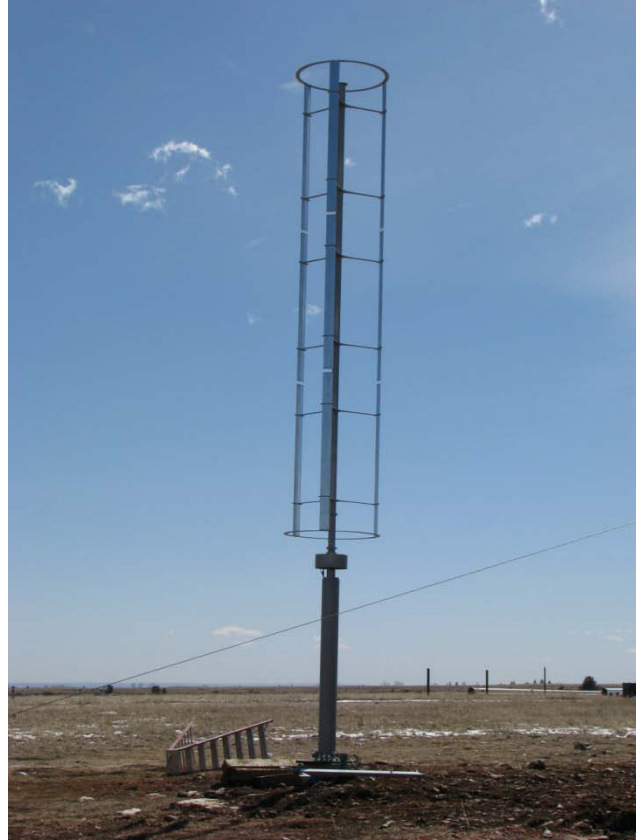
**Figure 1. Windspire wind turbine at the NWTC test site**

The test turbine was a Mariah Power Windspire wind turbine. This turbine is a vertical axis, three-bladed, variable-speed, turbine with a rated power of 1-kW. Figure 1 shows the test

turbine installed at the NWTC. Table 1 provides the key descriptive information of the test turbine.

The Windspire wind turbine was installed at site 3.3C at the NWTC, which is located 8 miles south of Boulder, Colorado. The site's terrain primarily is flat with short vegetation. The test site has prevailing wind bearing 292 degrees relative to true north. For measurements requiring highly accurate wind-speed data, NREL used data obtained when the wind direction was between 132 degrees true to 323 degrees true. In this measurement sector—which was established in accordance with IEC 61400-12-1—the influence of terrain and obstructions on the anemometer and turbine is slight.
