Investigation of Tapered Roller Bearing Damage Detection Using Oil Debris Analysis

Prepared for the
2006 Aerospace Conference
sponsored by the Institute of Electrical and Electronics Engineers
Big Sky, Montana, March 4–11, 2006

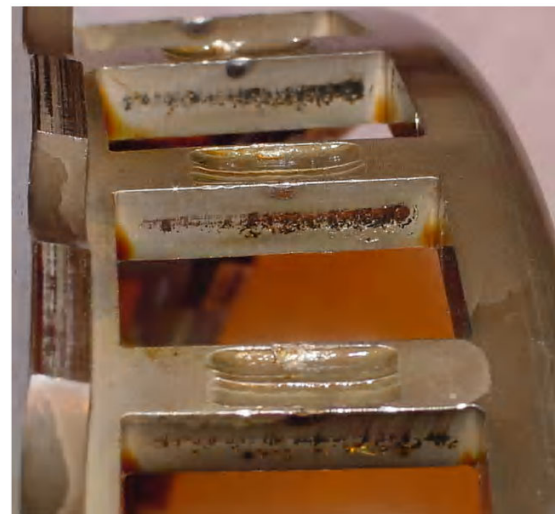
Figure 12.—Test 2 cage damage at test completion.

on the rollers. At inspection interval 4, the cone spall increased in size. At test completion the cone spall doubled in size, the small pits observed on the cup at inspection 2 remained the same, and cage damage was observed.

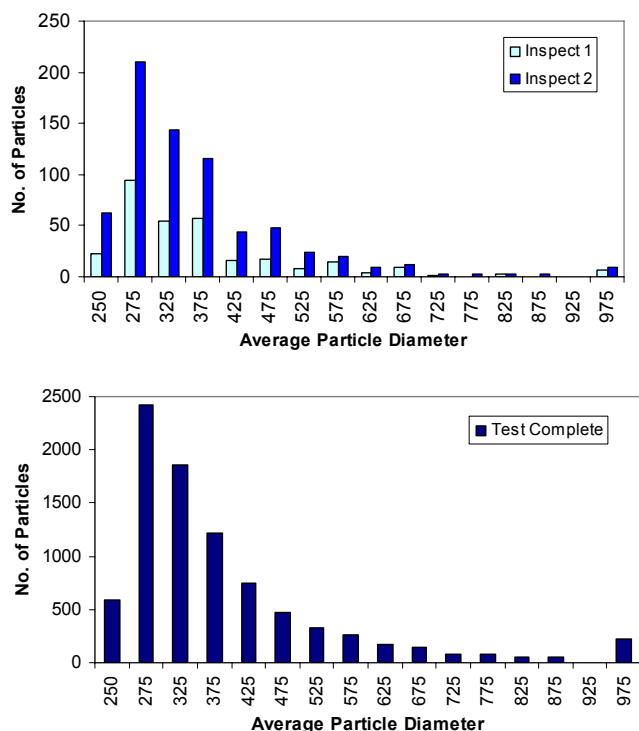
Figure 16.—Test 1 particle distributions after inspections 1 and 2 and at test completion.

Due to the fact that different bearing components experienced different levels of damage during each test, particle size distributions were plotted to determine if particles distributions vary when different components in the bearing are damaged. Figures 16 through 19 are histograms of the three bearing tests and the baseline tests. The histograms show the frequency particles were measured within each size distribution. The histograms indicate inspection intervals and test completion particle distributions. It should be noted that when performing a particle distribution analysis on the oil debris data, the bin size ranges are critical to the results. A brief review of the figures show particle distributions are very similar at test completion and during the inspection intervals when spalling occurred on the cage and the rollers. During the inspection intervals when spalling damage was observed, the maximum particles were observed in the 275 to 325 μ bin range. During the baseline test, when no damage occurred, the maximum particles were observed in the 325 to 375 μ particle size range.

The following equations were used to calculate relative kurtosis and relative skewness from the particle distributions shown in figures 16 through 19 (ref. 13), where d_j is equal to average bin size, j is equal to the number of bins and $P[d_j]$ is equal to the particles per average bin size divided by total number of particles:

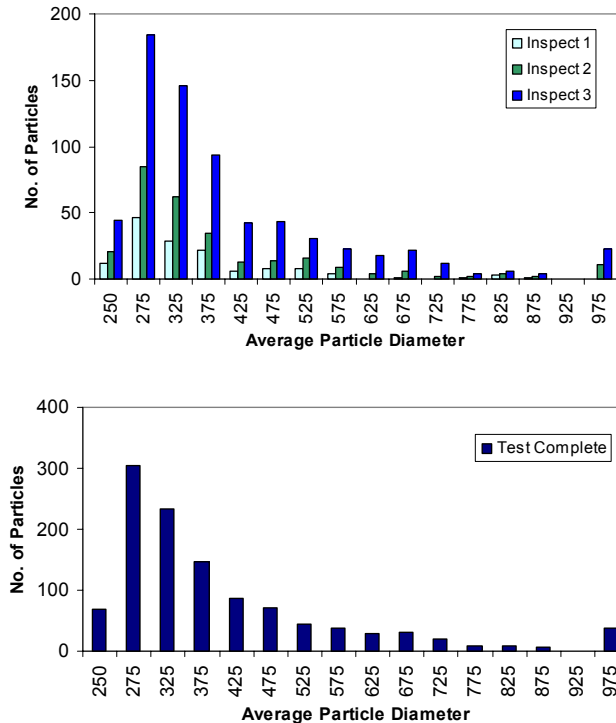
Figure 18.—Test 3 Particle distributions after inspections and at test completion.

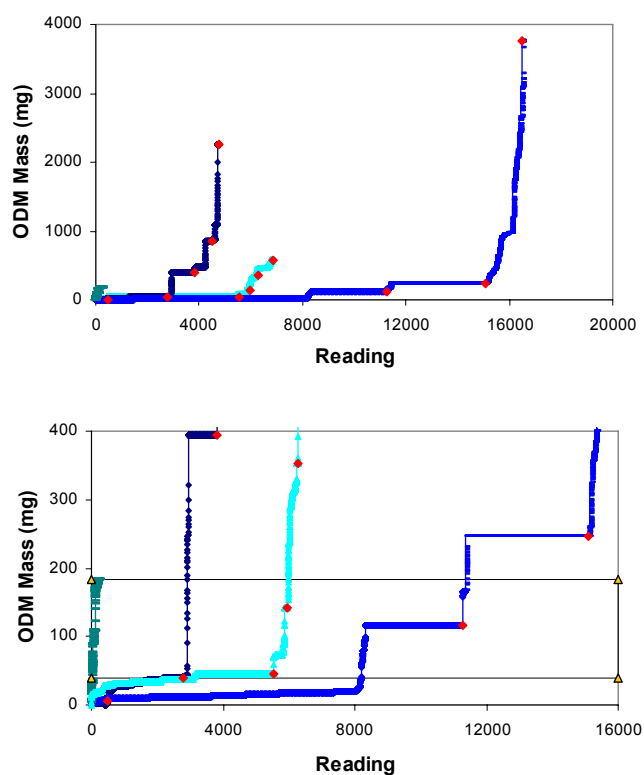
Figure 20.—Oil Debris mass during each experiment.

In order to develop an oil debris feature that best predicts damage levels to the tapered roller bearings, the bearing damage levels or state of the bearing must be defined. Three primary states of the bearing health will focus on spalling damage: O.K. (no damage); Inspect (initial spalling); Damage (severe spalling). Next, initial limits for these damage levels must be defined. The oil debris mass data from the 3 experiments with damage were plotted on figure 20. The red diamonds identify the inspection intervals during tests. Next, the plot is expanded, with the gear state transition regions expanded: O.K. (green); Inspect (yellow); Damage (red). Since spalling damage was not observed during test 2, inspection intervals 1 and 2, this mass (38.7 mg) will be used as the lower limit on the inspect region. The upper inspect band will be at 183.5 mg, the maximum mass measured at the baseline test completion. One interesting observation when reviewing figure 20 is that the mass alarm value (M_{alarm}) of 2058 mg and the mass warning value 205.8 mg, calculated using the manufacturers equation (1), both fall within the damage region.

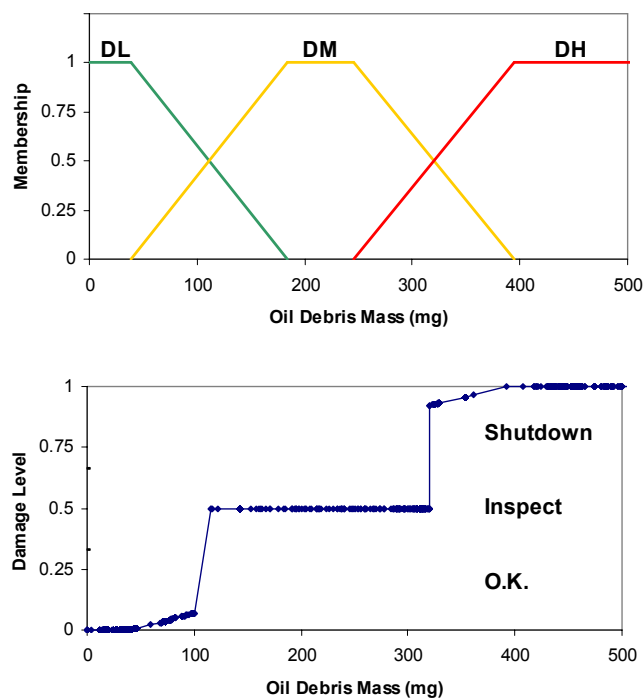
Figure 21.—Fuzzy logic membership values for oil debris feature and output of model.

The data measured from the oil debris sensor during experiments with damage and with no damage was used to identify membership functions to build a simple fuzzy logic model. Defining the fuzzy logic model requires inputs (damage detection features), outputs (state of bearings), and rules. Inputs are the levels of damage, and outputs are the states of the bearings as discussed in the preceding paragraph. Membership values were based on the accumulated mass and the amount of damage observed during inspection. Membership values are defined for the three levels of damage: damage low, damage medium, and damage high. Using the Mean of the Maximum (MOM) fuzzy logic defuzzification method, the oil debris mass measured was input into a simple fuzzy logic model created using commercially available software (ref. 15). The membership function and the output of this model are shown on figure 21. Threshold limits for the accumulated mass are identified. Results from the four experiments indicate accumulated mass is a good predictor of pitting damage on tapered roller bearings and fuzzy logic is a good technique for setting threshold limits that discriminates between states of pitting wear.
