# Physical Processes and Natural Attenuation Alternatives for Remediation of White Phosphorus Contamination, Eagle River Flats, Fort Richardson, Alaska

Daniel E. Lawson, Lewis E. Hunter and Susan R. Bigl

December 1996

CRREL Report 96-13

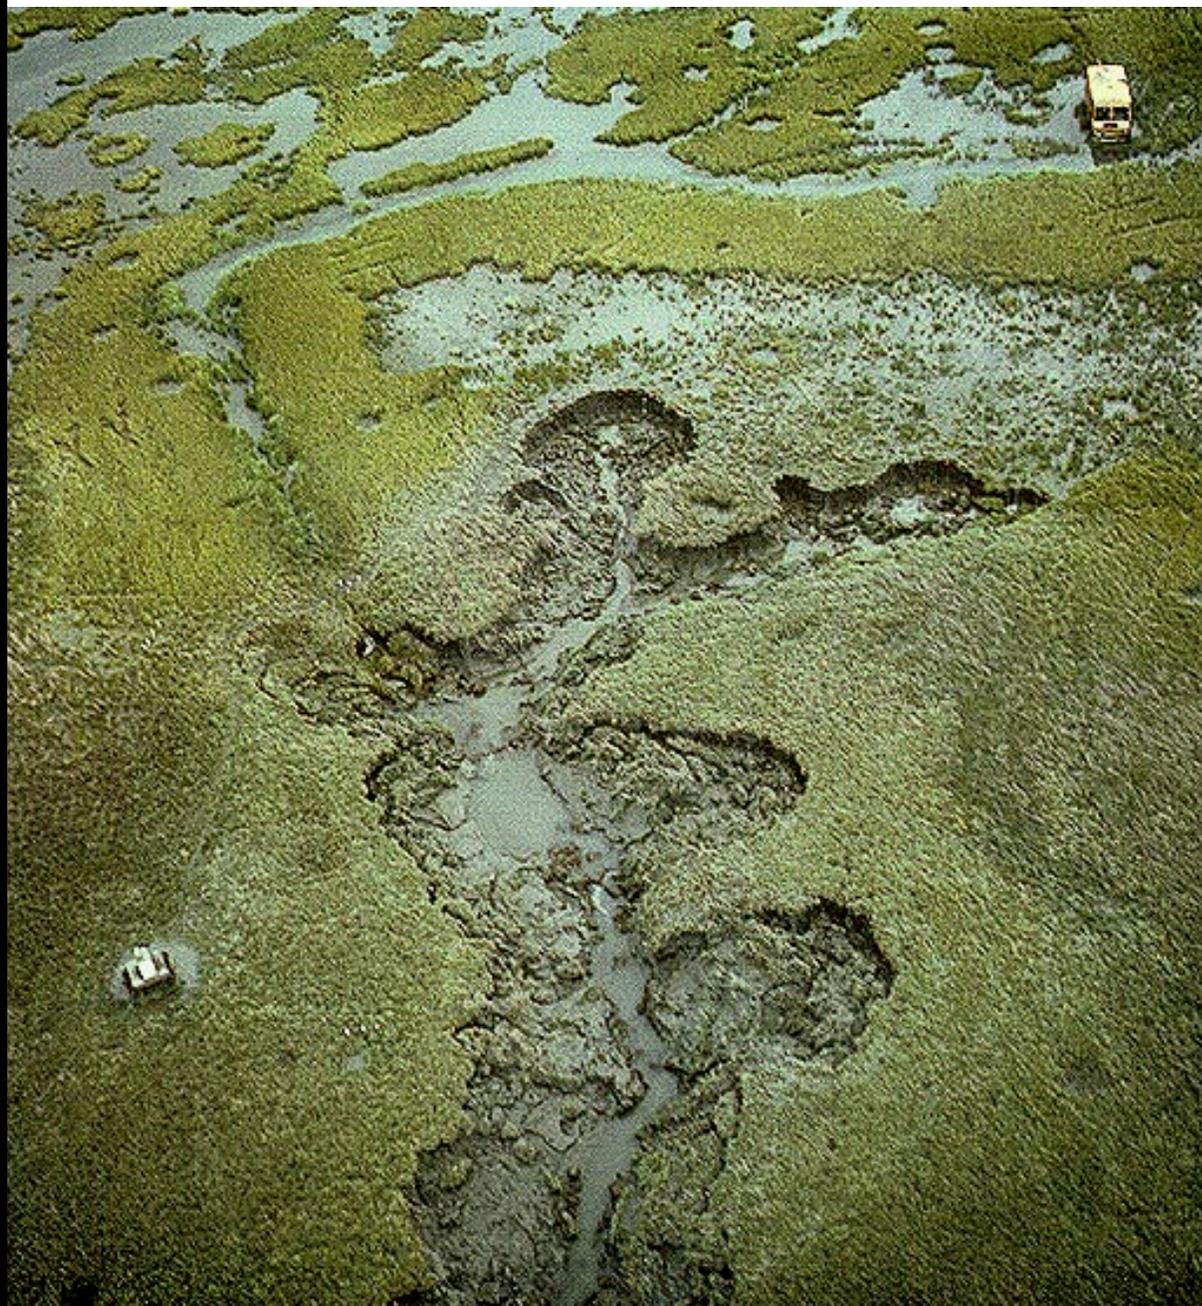
**Cover:** Oblique aerial photograph of the head of Bread Truck Gully. This gully is eroding headward at an average rate of 21.6 m annually, and will probably drain Bread Truck Pond (top of photo) within 1 to 2 years. A hydrostation platform (1.3 × 1.3 m) is located to the lower left.

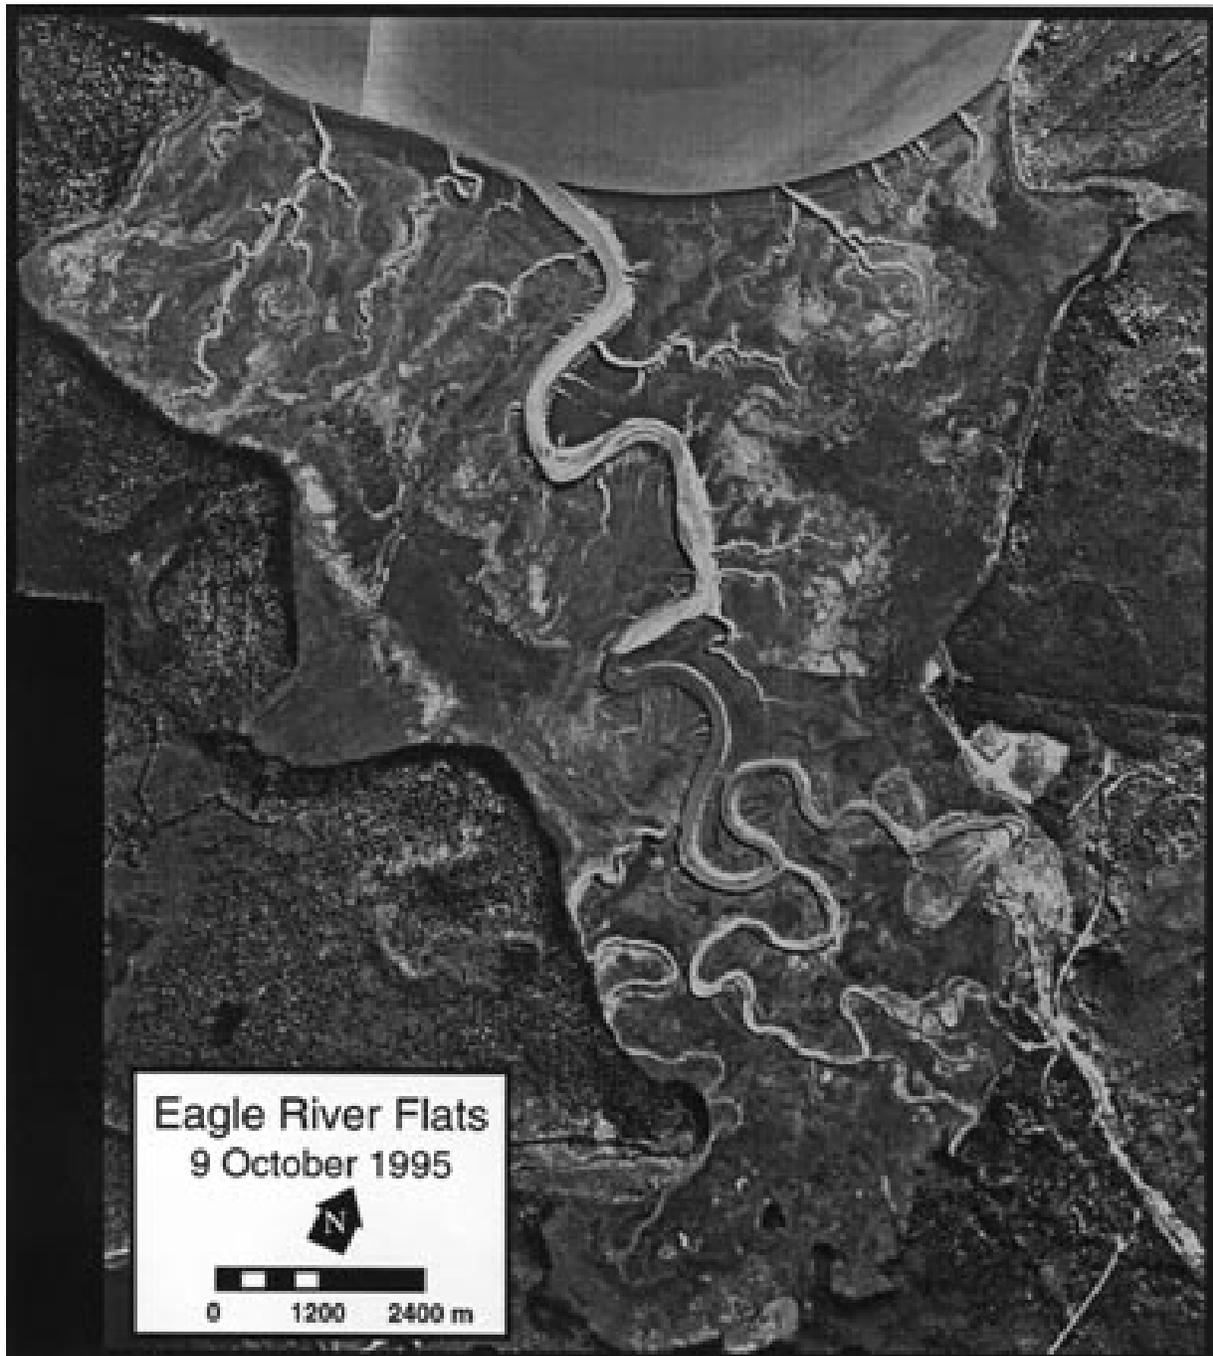
*Figure 2. 1995 aerial photograph of ERF showing the dendritic drainage network.*

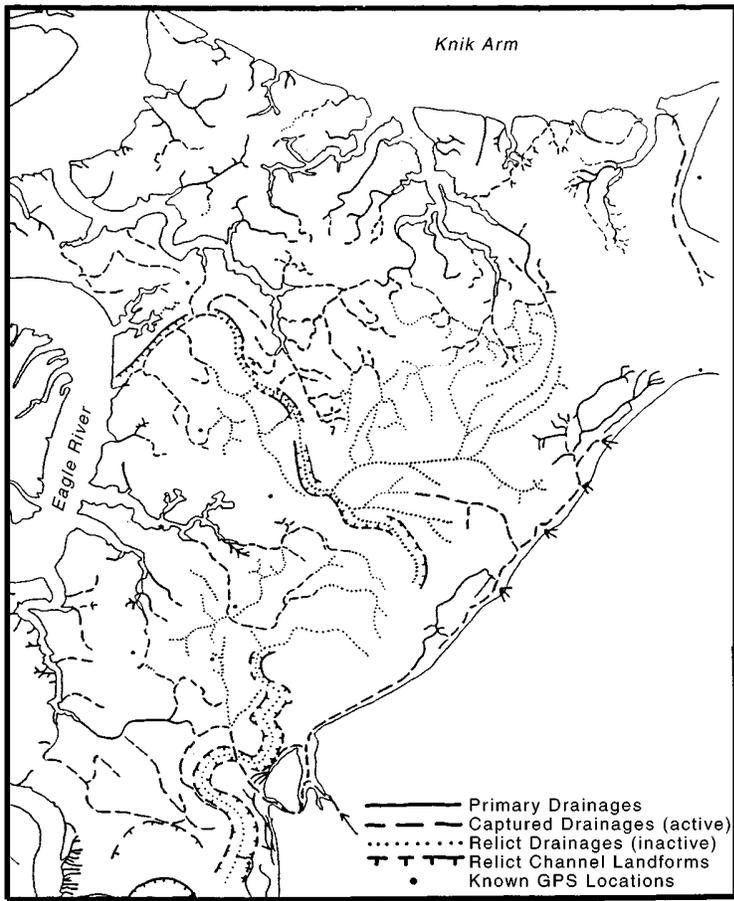
Figure 3. Drainage network in the C and D areas of ERF.

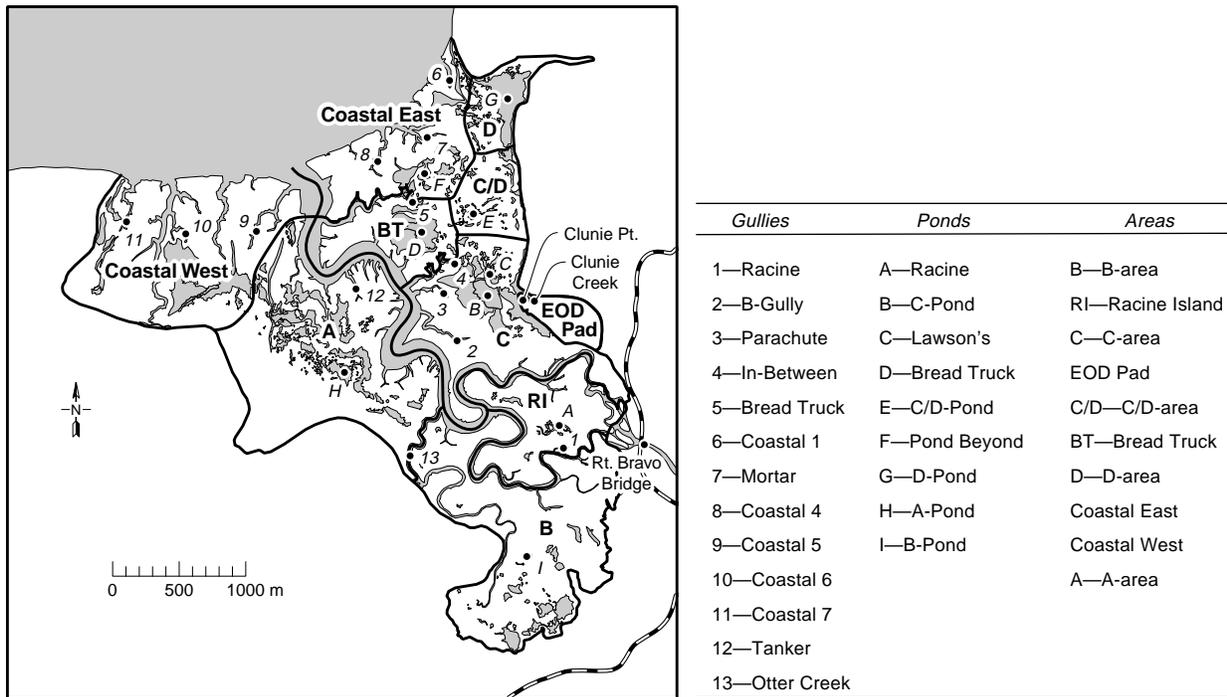
Figure 5. Locations of gullies, ponds and areas.

areas (Fig 5). Headwalls and adjacent lateral walls receded at variable rates: 0.1 to 4.9 m during summer 1992, 0.4 to 6.3 m during winter 1992–93, 0.0 to 9.8 m during summer 1993, 0.0 to 2.3 m in winter 1993–94, and 0.0 to 2.6 m in summer 1994. Large tidal floods in 1993 and 1994 caused the highest headwall recession rates. Two gully headwalls, one on the western side of Bread Truck Pond and the other near the pond complex be-

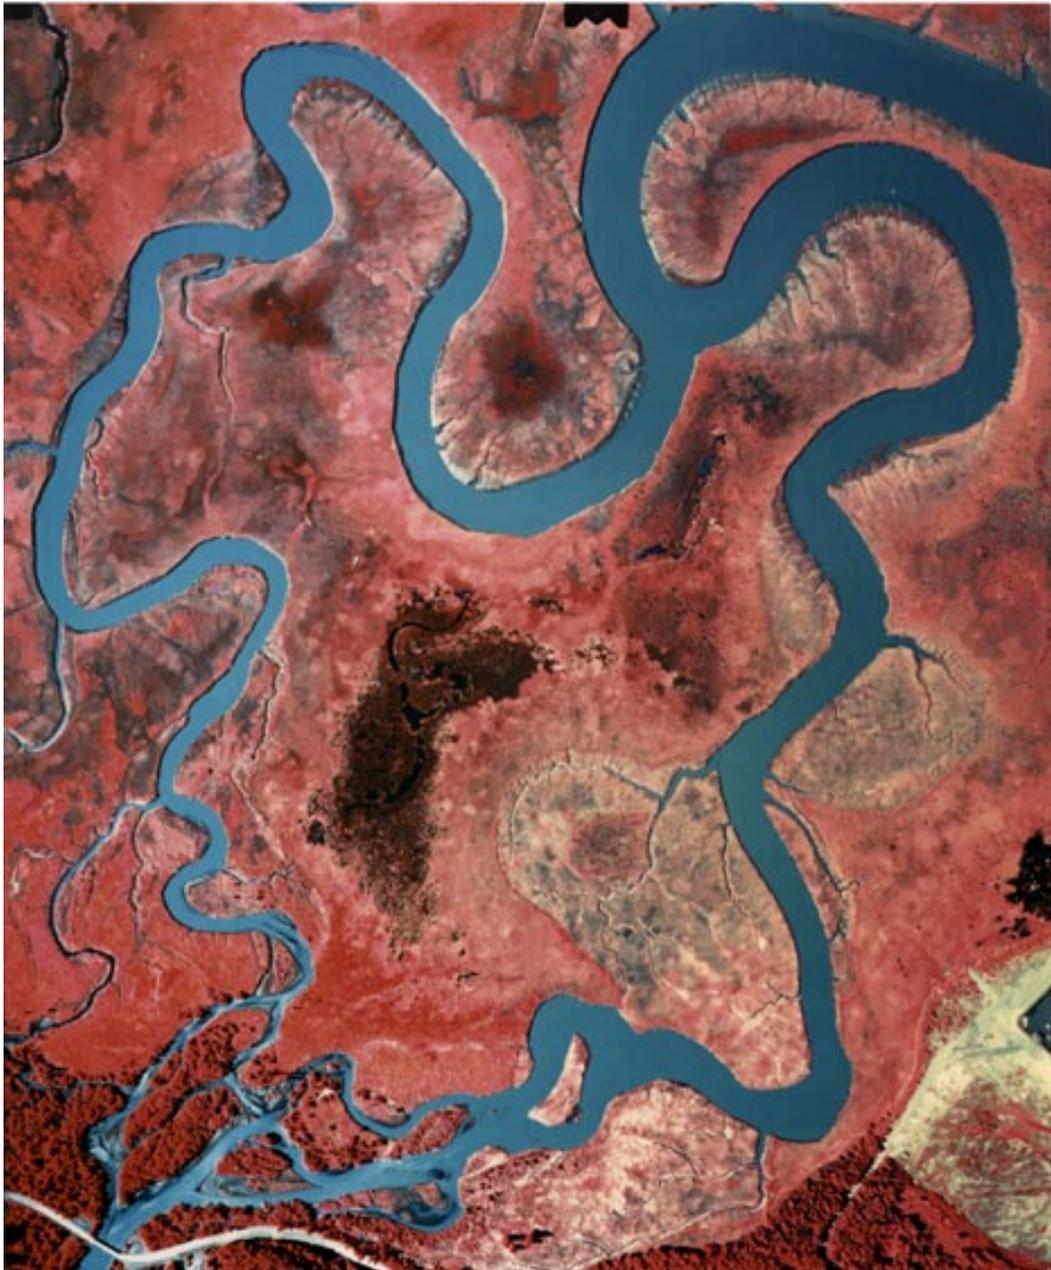
Figure 6. Aerial photograph of Racine Island taken 16 August 1995 showing remnant channel surrounded by overbank deposits.

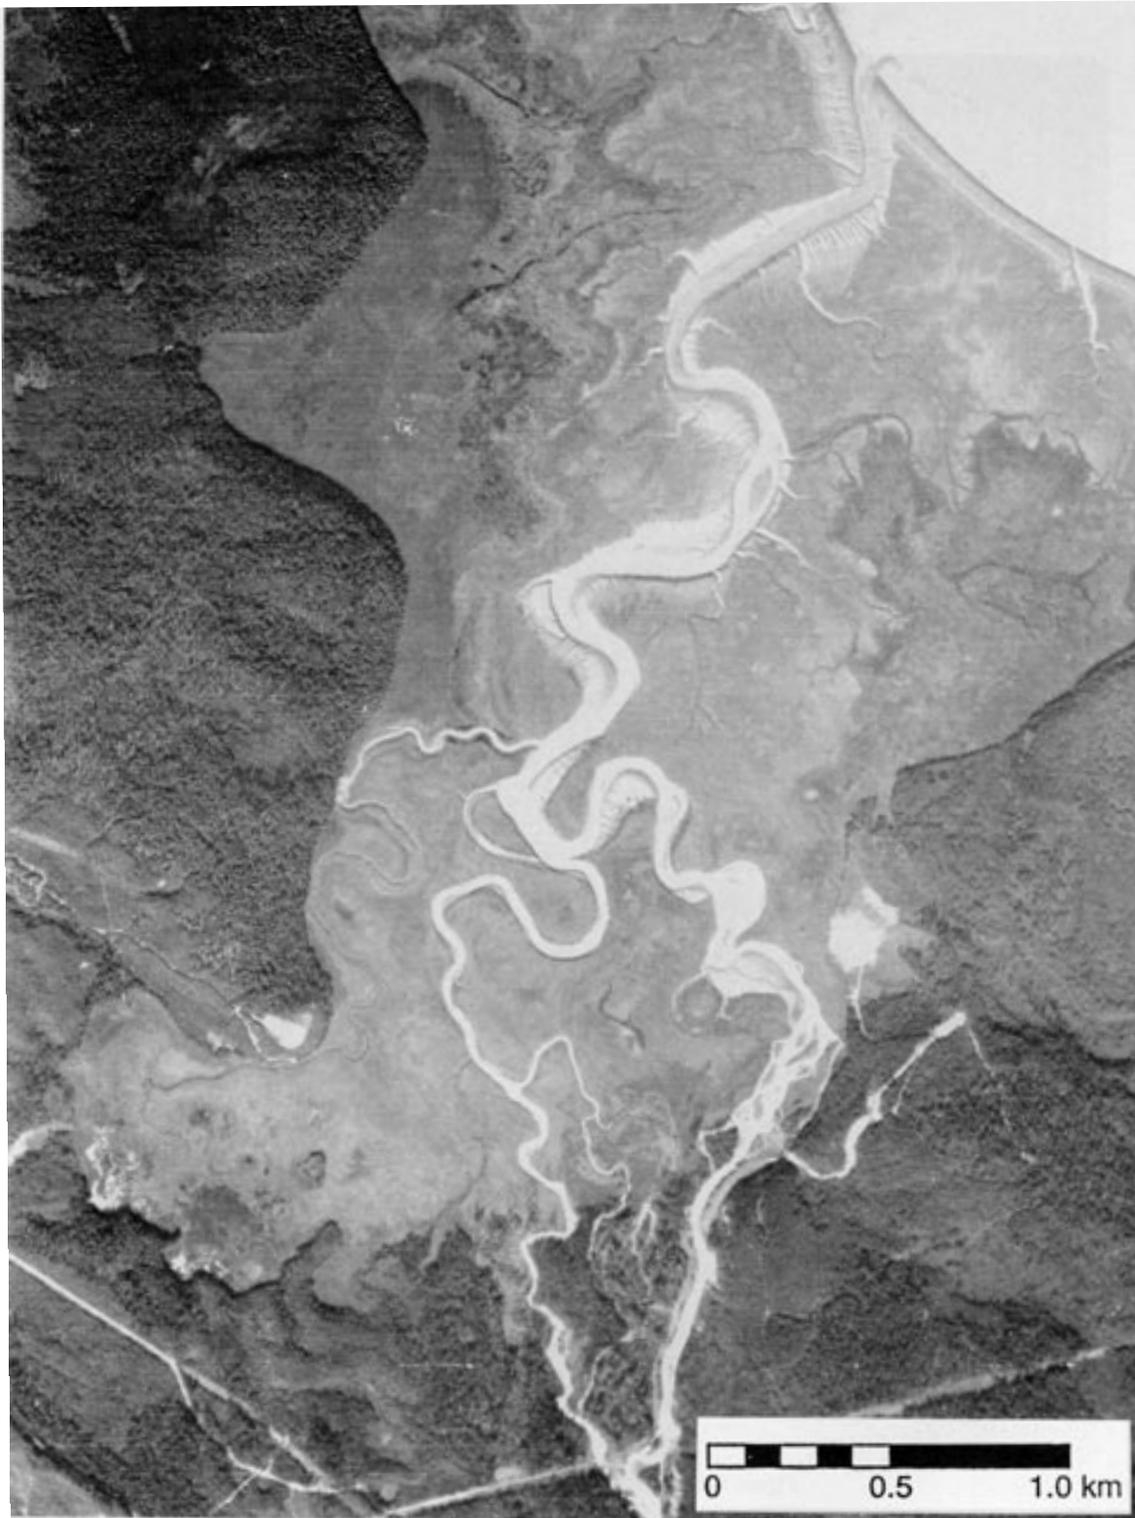
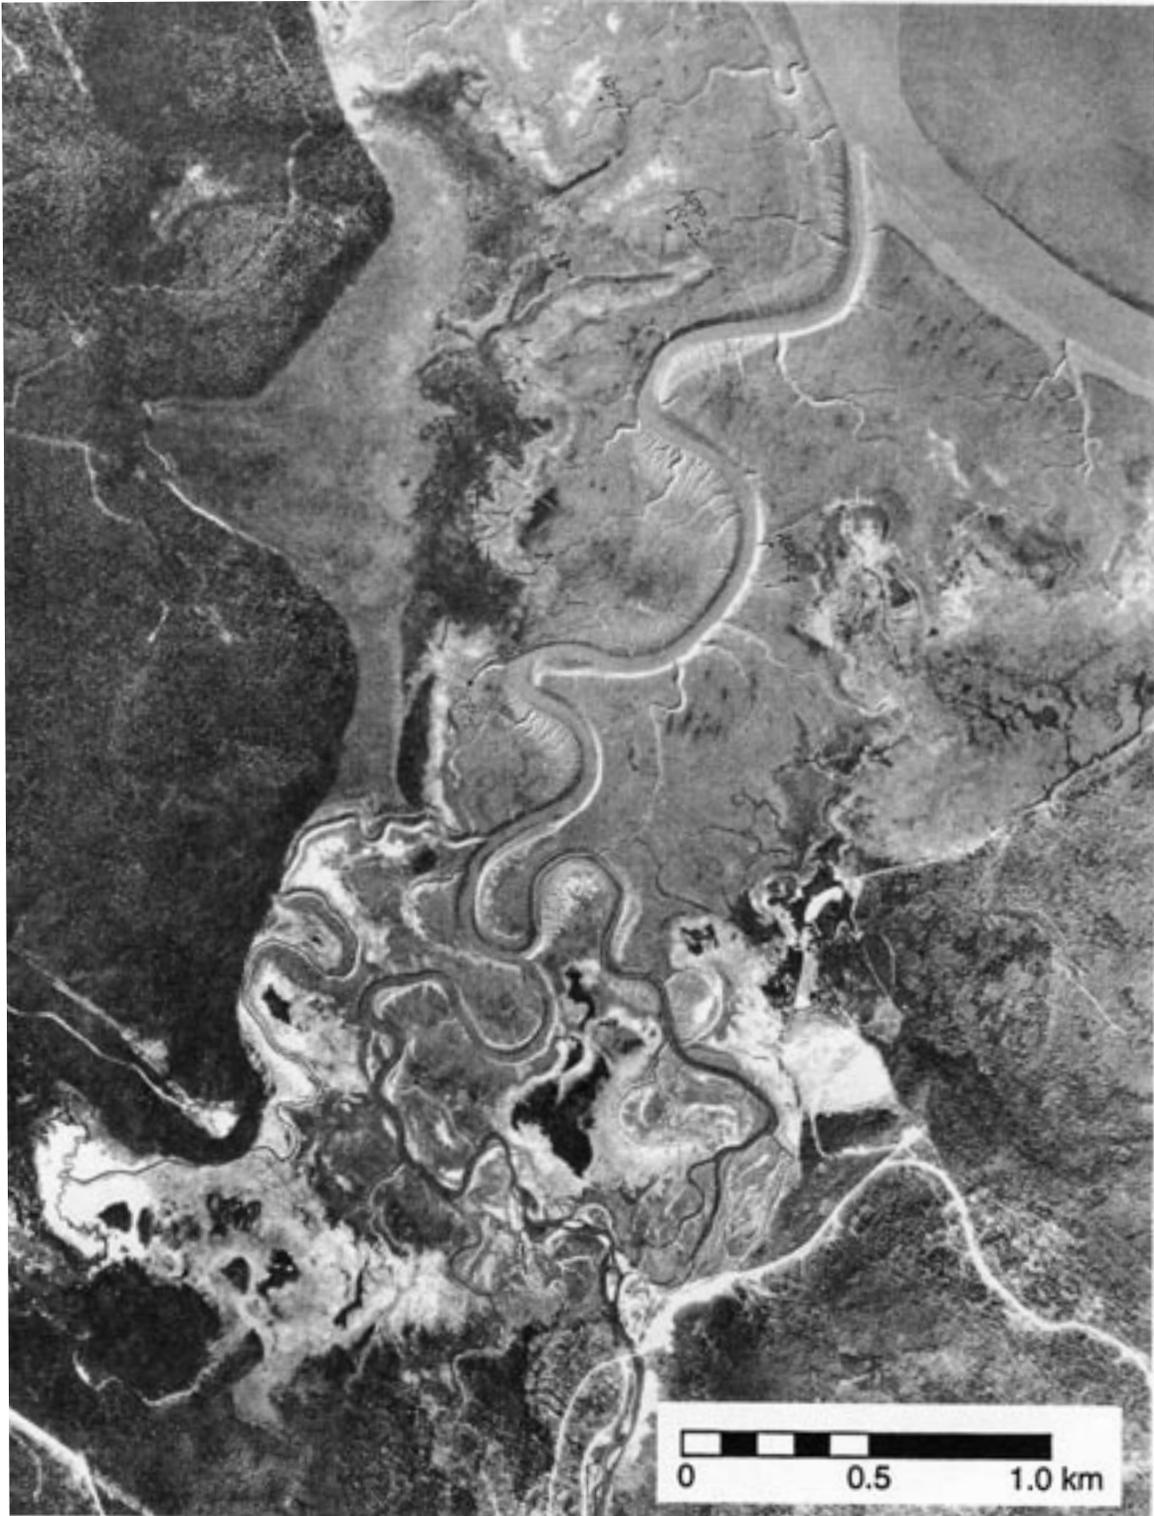
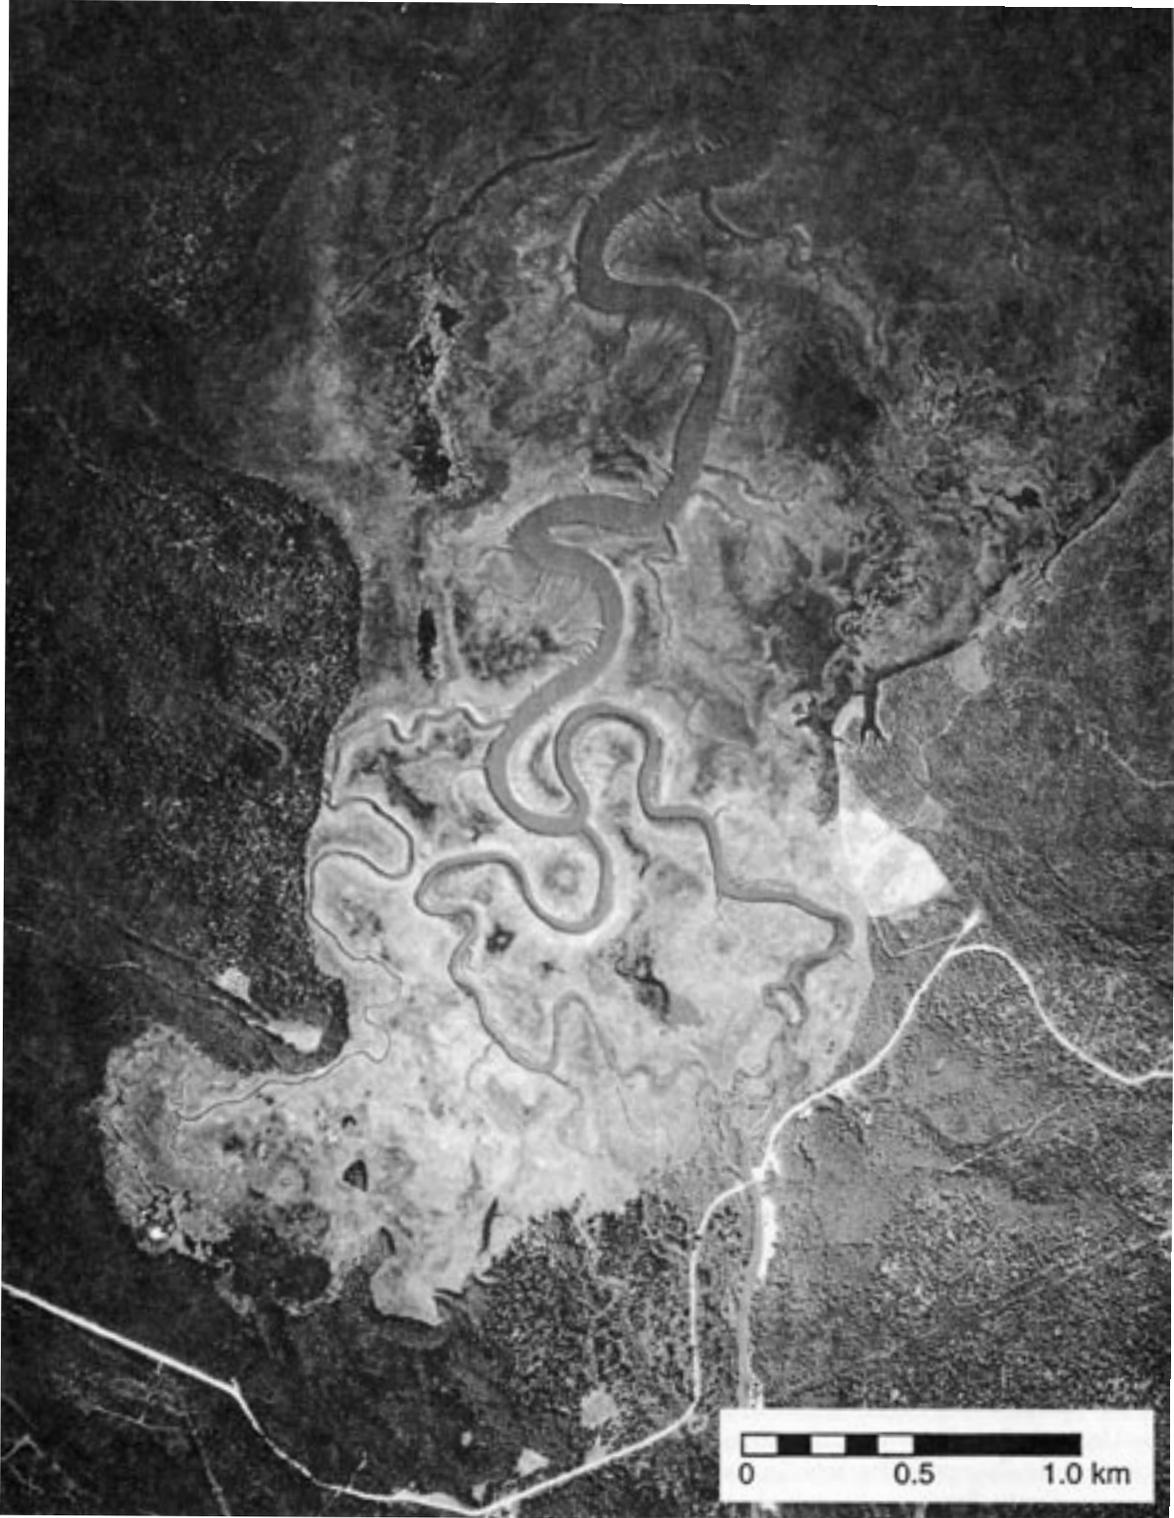
*Figure 7. Aerial photographs of ERF.*

*a. 1950.*

*b. 1967.*

*c. 1993.*

*Figure 7 (cont'd). Aerial photographs of ERF.*

Aerial photographs from 1950, 1967 and 1993 reveal changes in the distributary channel pattern entering ERF (Fig. 7). Three main channels entered the Flats in 1950, but by 1967 the westernmost channel was abandoned and the eastern and middle channels diverged just northeast of the Route Bravo bridge. These two primary channels were characterized in 1967 by partial braiding and a divergent pattern characteristic of an alluvial fan (Fig. 7b). Sediments in the fan area are relatively featureless overbank materials deposited by Eagle River flooding. Only the center of the Racine Island area (Fig. 6) is characterized by intertidal ponds and an abandoned gully. The westerly channel was abandoned in September 1995, during flooding of the Eagle River as channel scour shifted the easterly channel to the northeast.

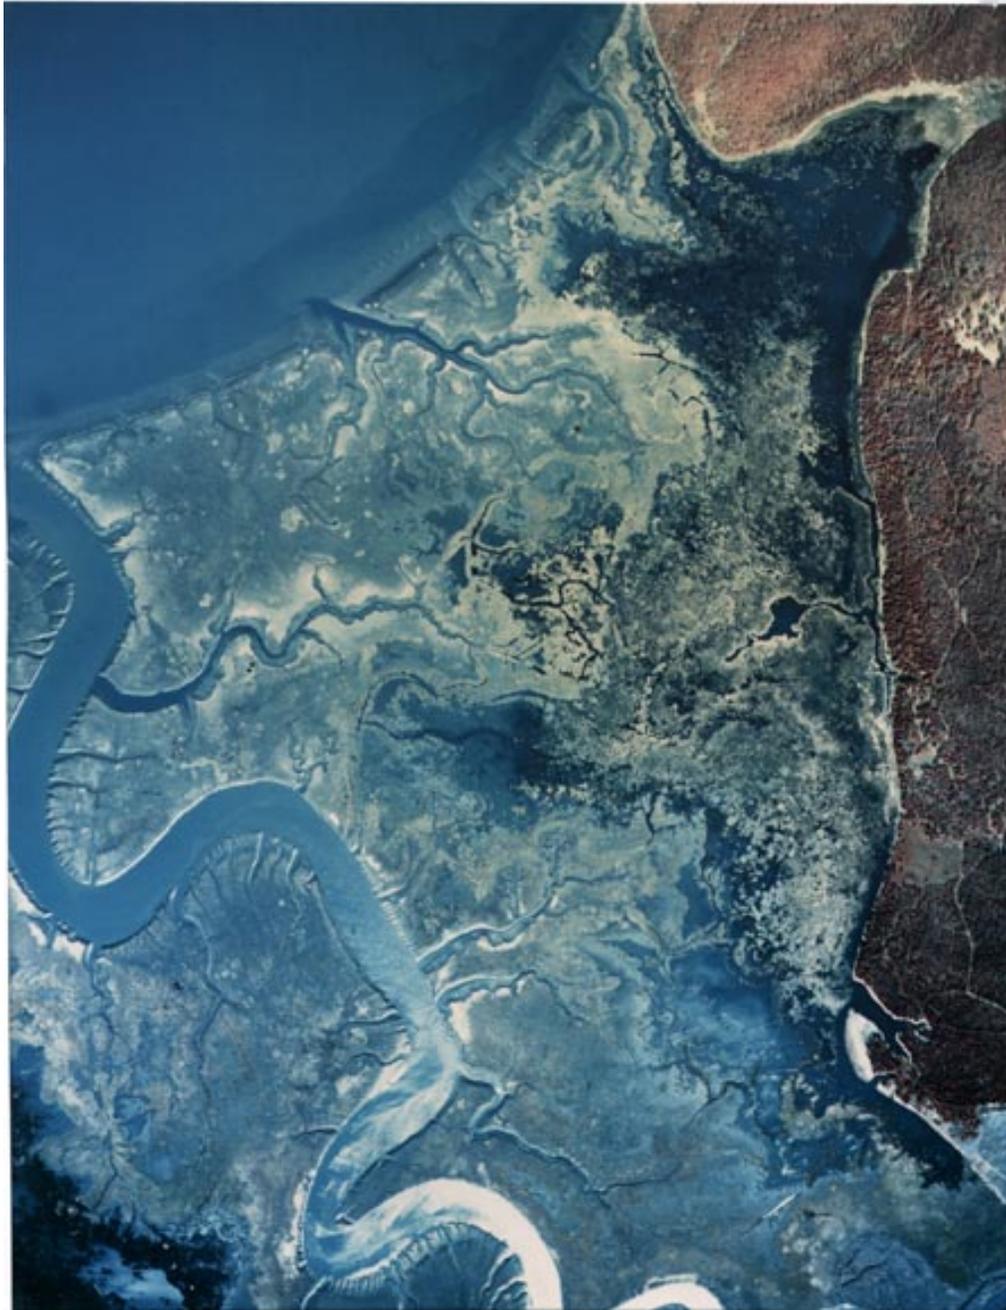
*Figure 8. 1992 aerial photograph of northeastern ERF.*

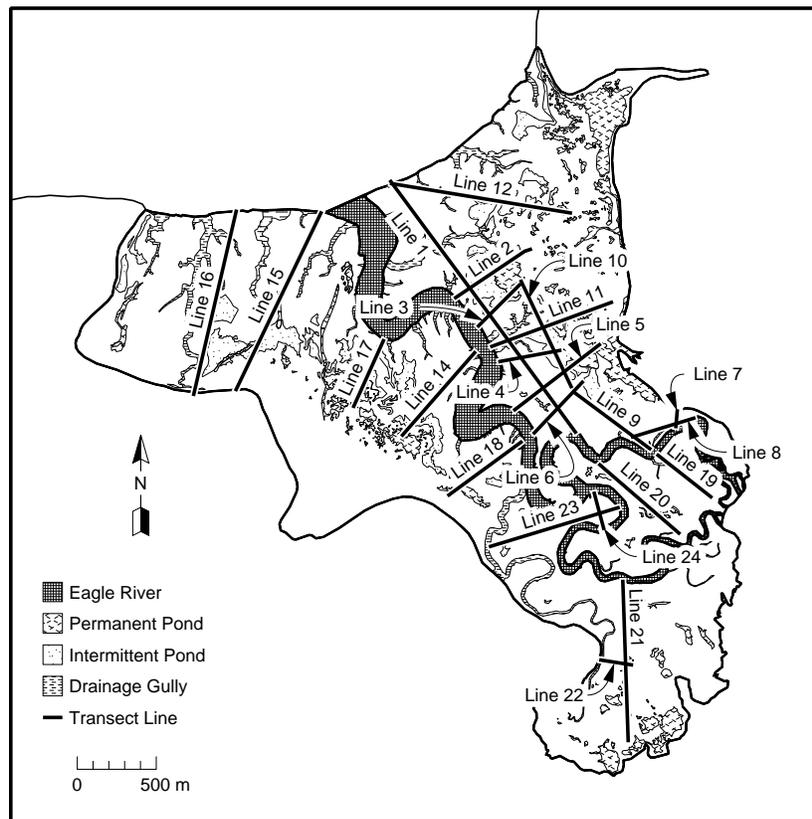
Figure 9. Mudflat sedimentation transect locations.

Sedimentation rates were measured along transects across representative landforms of ERF, with 11 transects being set out in May 1992 (Lawson and Brockett 1993), 1 in June 1993 and 11 in 1994 (Fig. 9). Their locations and elevations were

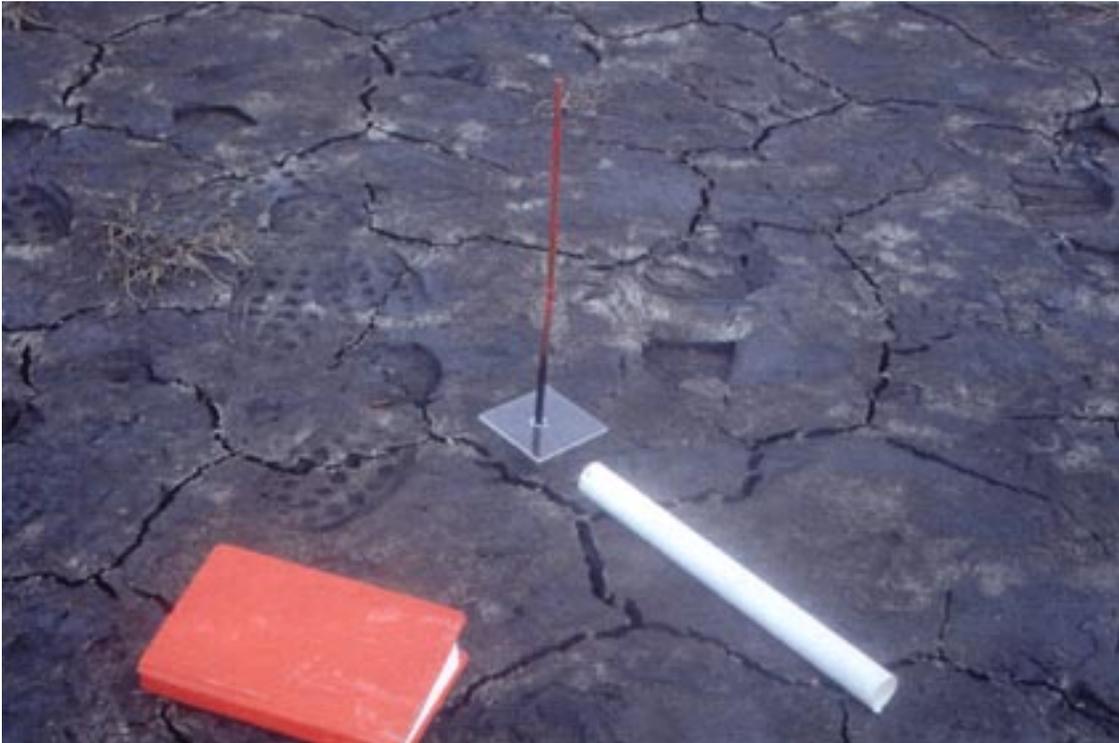
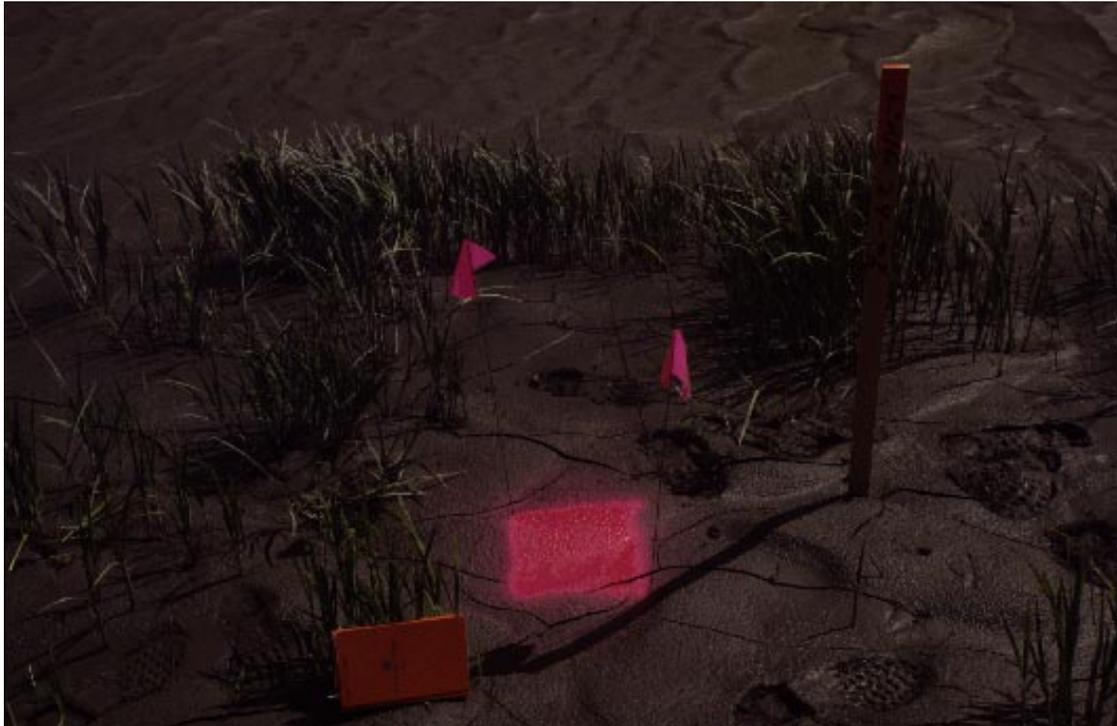
*a. Sedimentation stake with plate.*

*b. Wire flags mark an area of painted ground.*

*Figure 10. Sedimentation measurement techniques.*

Sedimentation on levee and mudflat surfaces was monitored by spraying an area (~30 × 30 cm) on the ground surface with pavement-marking paint and locating the corners of this area with wire survey flags (see also Vince and Snow 1984). Paint was applied at certain sites in June and August 1992, August 1993, and May–June 1994. Net accumulation was measured by cutting and removing a block of sediment with a putty knife or spatula (Fig. 11). The thickness of sediment above the paint layer was then measured to the nearest 0.5 mm. In contrast to the sedimentation stakes that were commonly broken or removed by ice during winter, the wire flags and buried paint horizons enabled us to acquire a continuous record of net sedimentation rates.

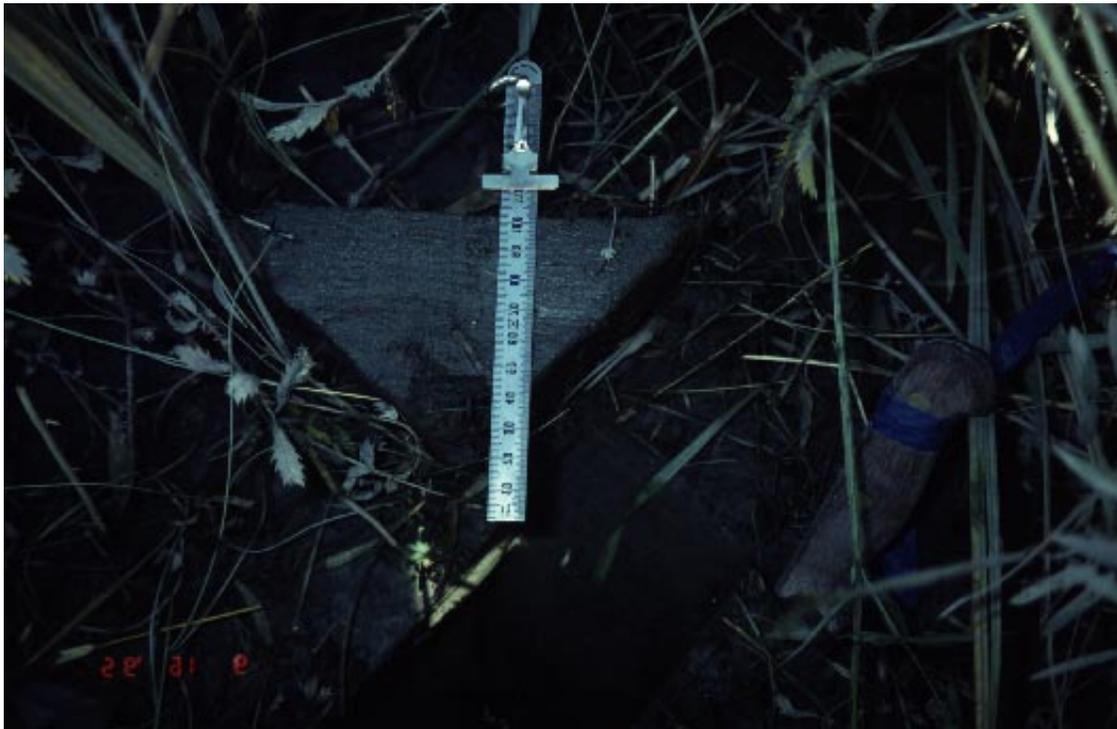
Figure 11. Wedge-shaped sediment block used to measure vertical accretion. Note subhorizontal laminations.

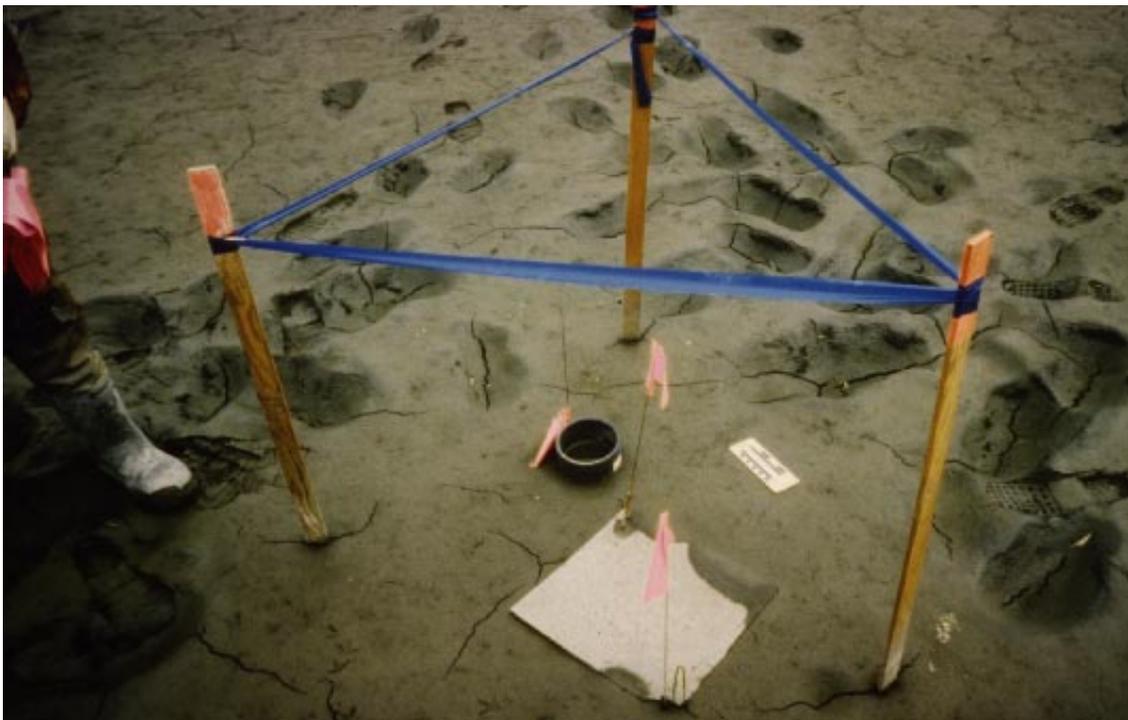
Figure 14. Example of sedimentation station at an intermittent pond location showing layout of cup and plate sampler.

Net sedimentation rates at isolated sites and transect sites were measured using a thin, rigid plastic plate of about 30 cm square that was pushed gently into the pond bottom until its surface was flush with the bottom surface. The corners of the plate were secured by aluminum tent pegs (Fig. 14). Sediment in suspension settled onto

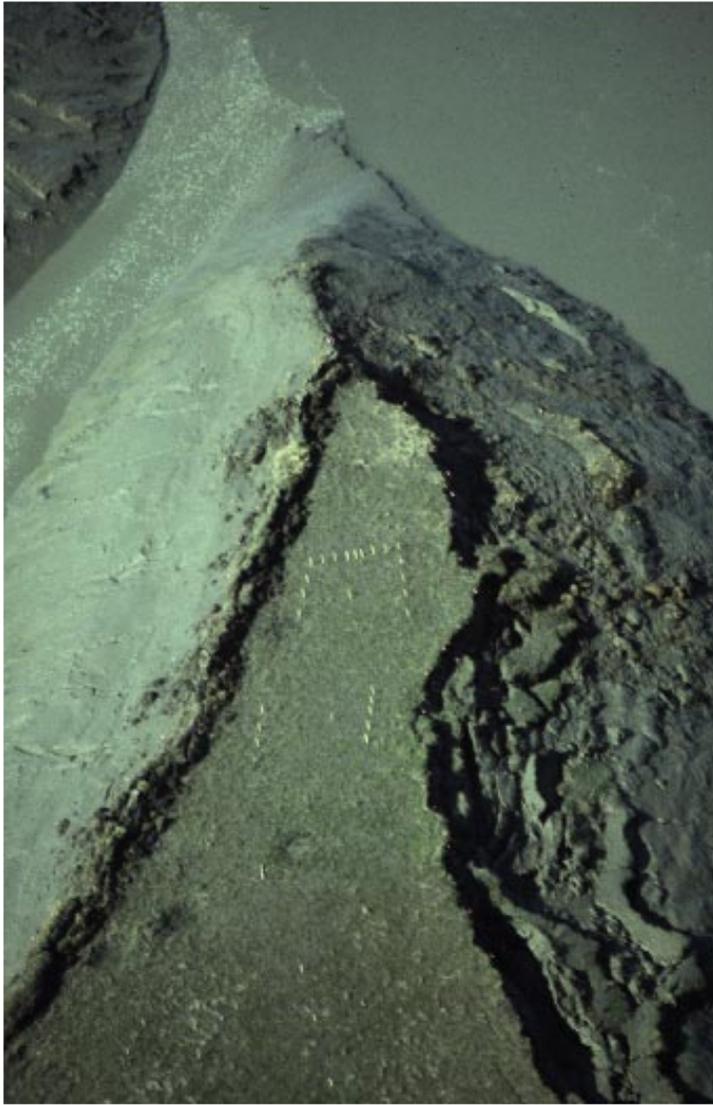
Figure 15. Example of layout of hub and line stakes at River-North erosion site.

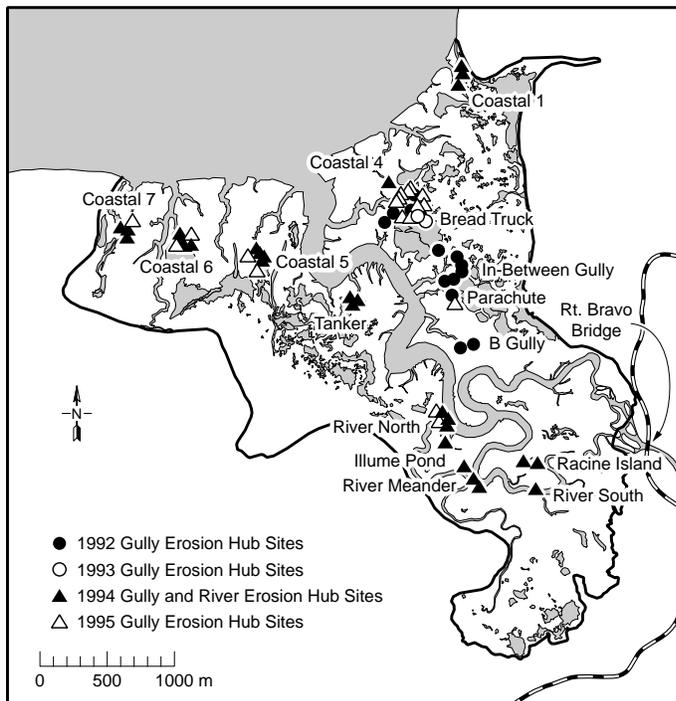
Figure 16. Location of gully headwall and lateral wall erosion sites.

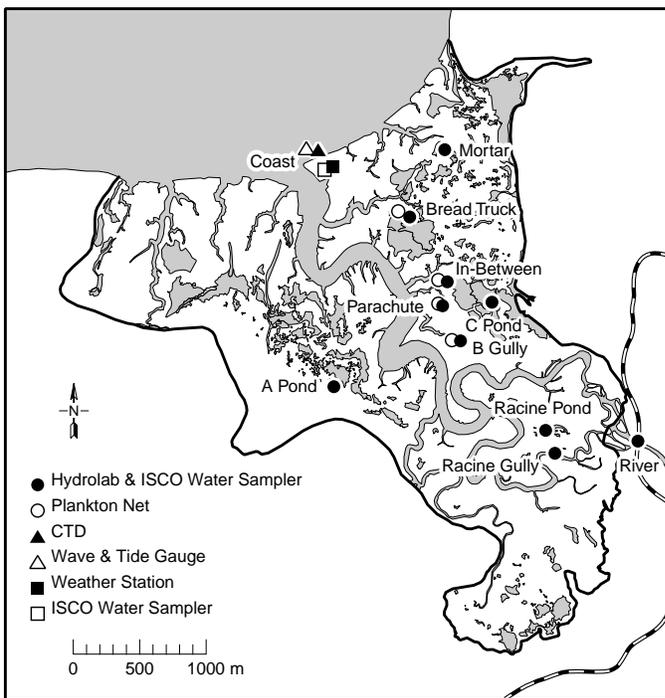
Figure 17. 1995 locations of instrumentation recording water quality parameters and water depths. Locations of weather station and plankton net sampling sites are also shown.

The same suite of water quality parameters was collected at the Knik Arm coastal site using a Seabird SBE 16 Profiler. In addition, a Seabird SBE 26 wave and tide gauge was located here to record water depth and temperature in Knik Arm (Table 6). The same location was used in 1993 and 1994 (Fig. 17).

Plankton nets of 3-m length with an opening of 1 m and a mesh size of 80 μm were placed at four gully sites, three of which were previously monitored in 1994 (Fig. 17). The plankton net was tied

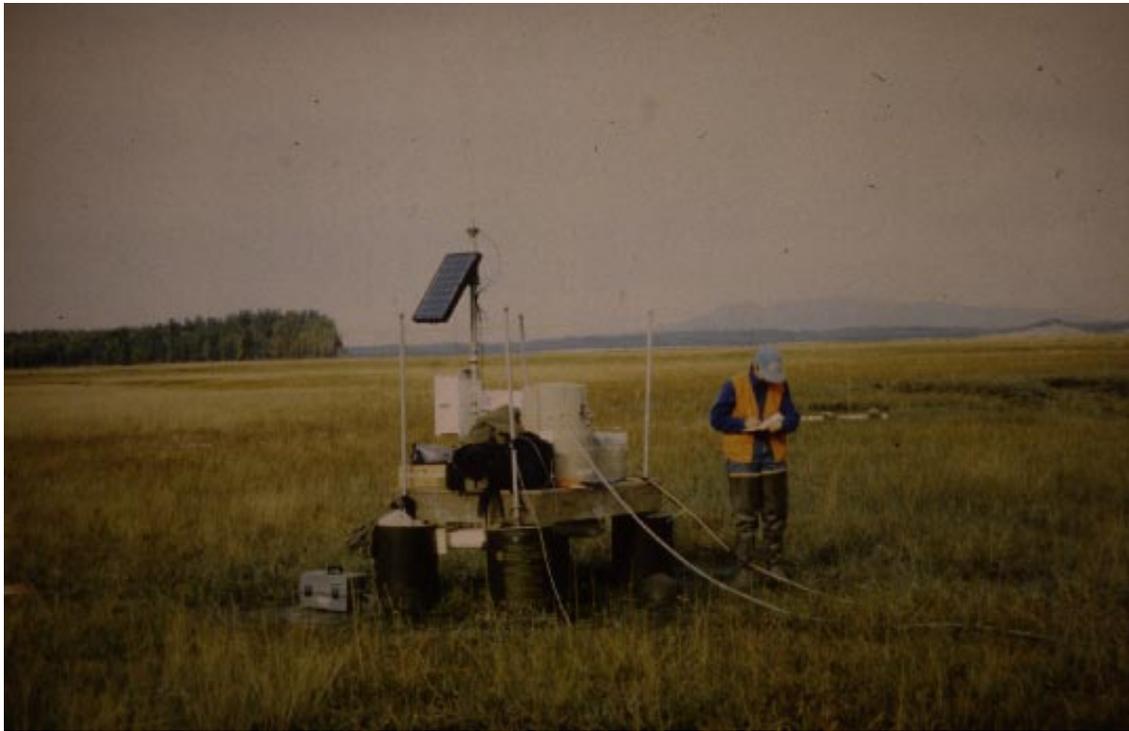
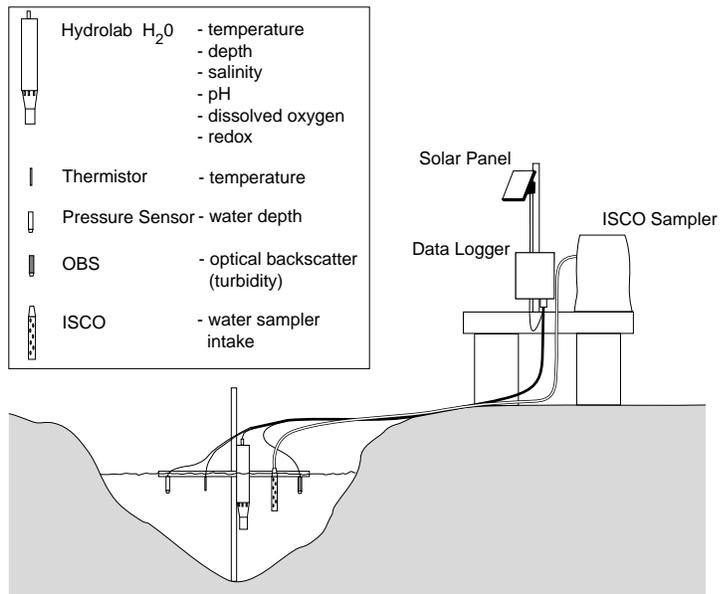
a. Platform and instrumentation at Bread Truck Gully.

b. Schematic showing layout of instrumentation in water and collection devices on a floatation platform.

Figure 19. Hydrostation layout at a gully location.

The instrumentation and samplers for water quality analyses were identically set up at each gully and pond site (hydrostations). Sensors and the suction sampler intake screen were mounted on a stake driven into the bottom of the pond or gully under investigation. Mounting hardware was identical at each hydrostation to permit us to precisely position them in the water column. Sensors in gully sites were placed in plunge pools to keep them wet at all times, usually about 15 to 45 cm above the bed. Current probes were mounted about 1 m above the bed on separate stakes located downstream of the plunge pool within a reasonably symmetrical gully cross section. Ultrasonic sensors were mounted on an arm attached to a metal stake located about 10 m from the platform. Each was aimed downward towards the mudflat surface, upon which a plate was pinned to provide a stable, reflective surface.

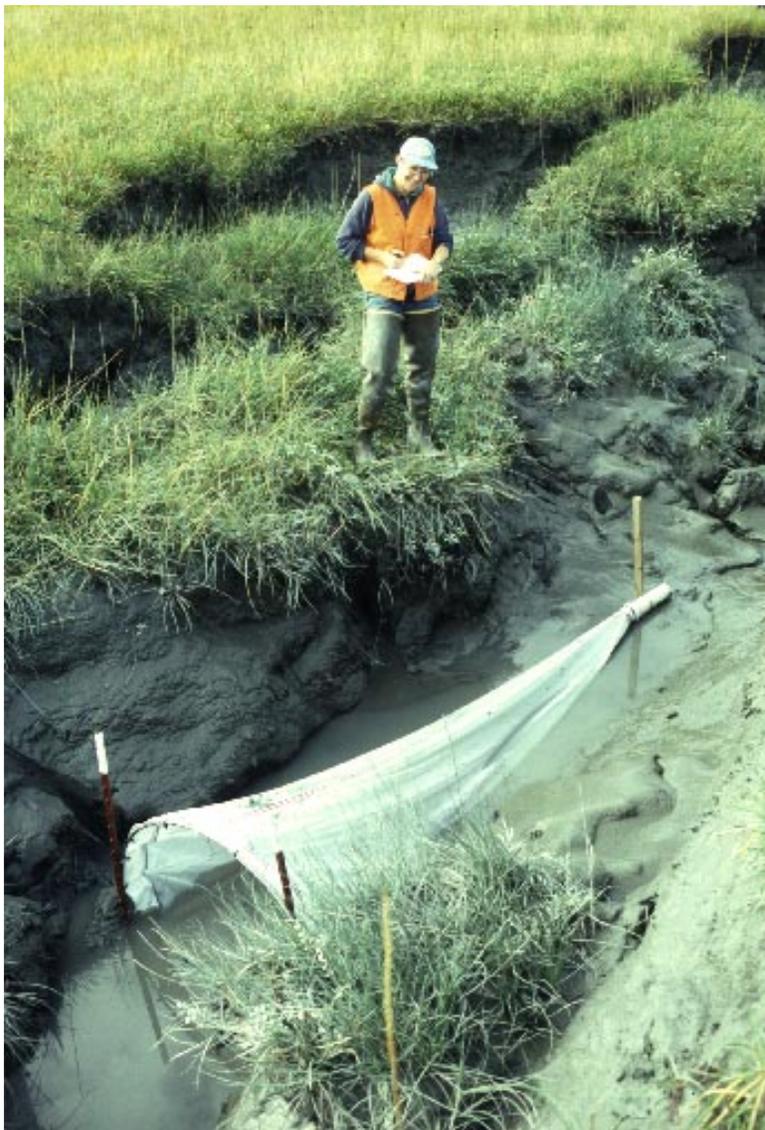
Figure 20. Plankton net used for collecting WP in water transport.
