# Physical Processes and Natural Attenuation Alternatives for Remediation of White Phosphorus Contamination, Eagle River Flats, Fort Richardson, Alaska

Daniel E. Lawson, Lewis E. Hunter and Susan R. Bigl

December 1996

CRREL Report 96-13

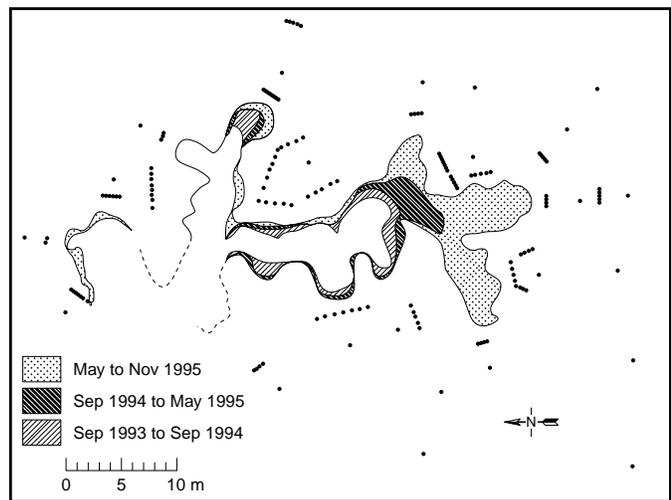
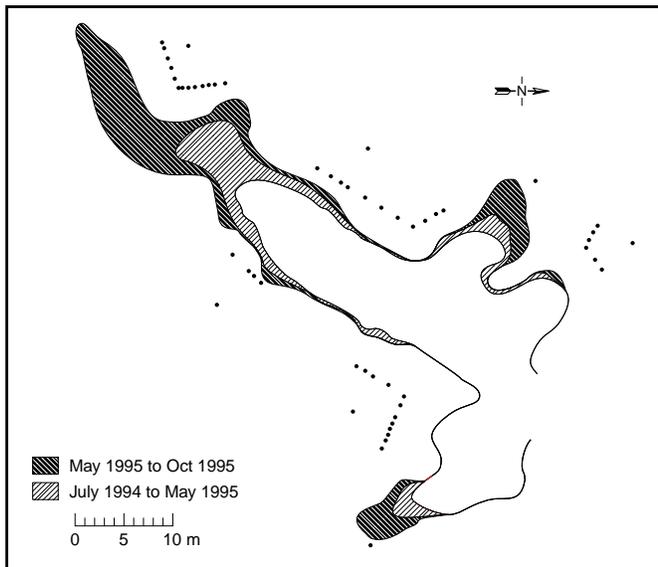
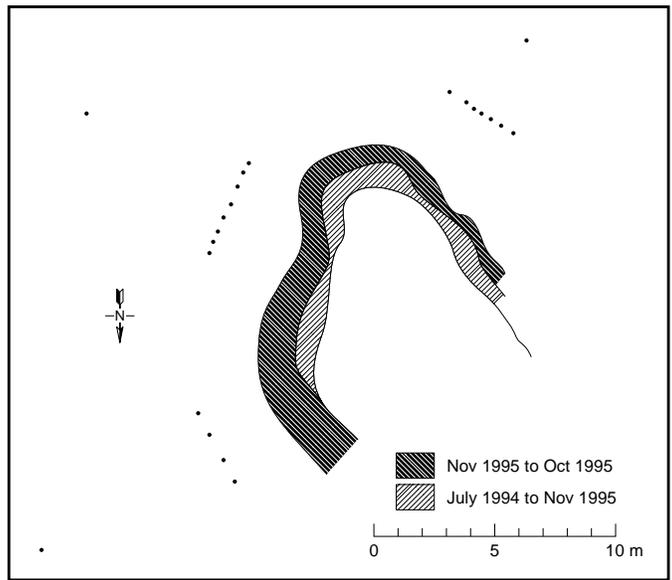
a. Bread Truck Gully.

Figure 23. Summary of gully scarp recession.

c. Coastal 5 Gully.

*g. Coastal 7 Gully.*

The spatial variability in recessional rates is evident in the plots showing the sequential recession of scarp crest location through time (Fig. 23). One of the first gullies monitored at ERF was

at Parachute Gully (Tables 8) is almost identical to the 3.9-m/year average since 1986; the 1.6-m rate observed at Mortar is lower than the 11-year average of 3.9 m/year (Fig. 23d, 32b; Table 8b). Since our hub and line stakes at B-Gully record only lateral erosion, the current rates are not comparable to the 11-year average of 3.9 m/year of headward recession.

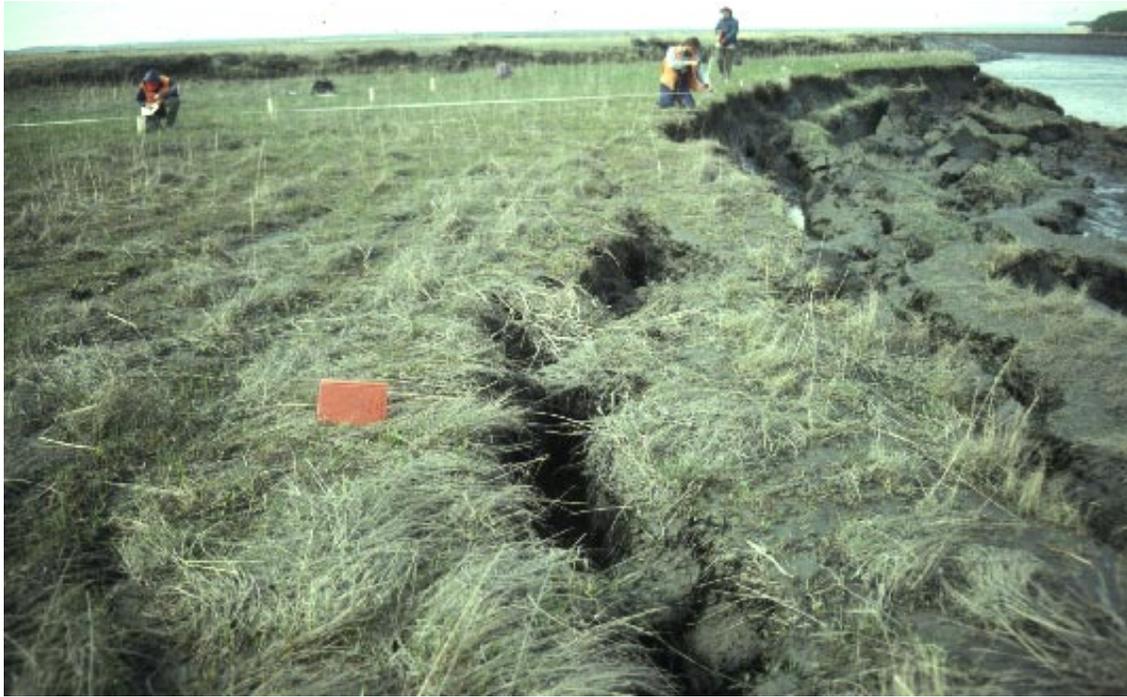
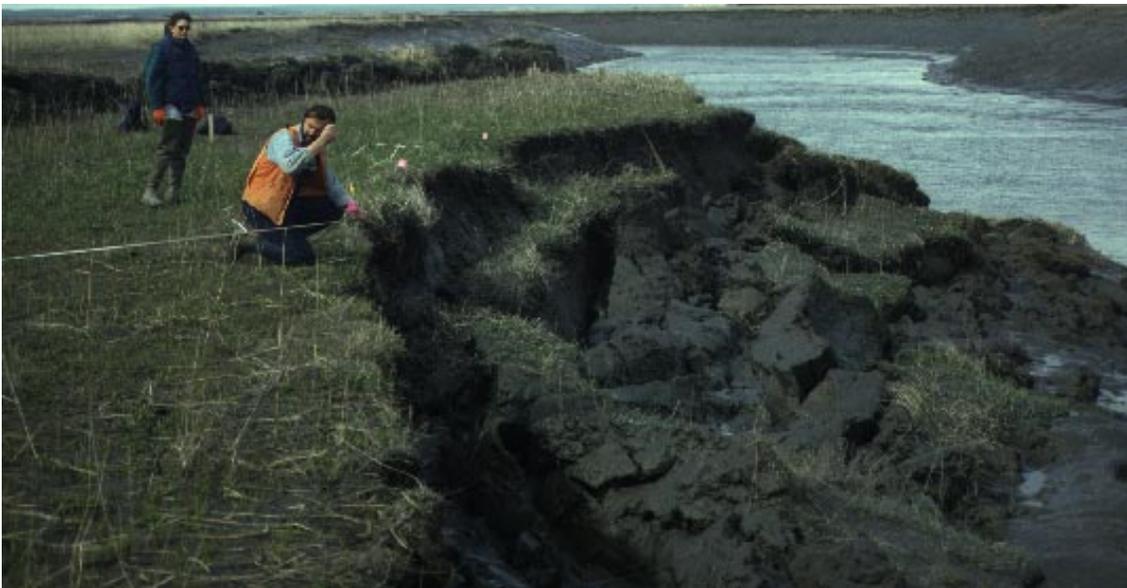
*a. North view showing extension crack in foreground.*

*b. Rotational slump blocks visible to right of scarp.*

early stage of collapse (Fig. 24). This extension was particularly evident in May of 1995 following the first tidal flooding cycle (15–17 May 1995) after thawing of the ground began. A shallow snow cover in the winter allowed frost to penetrate deeply. Intermittent flooding and subsequent pond drainage are favorable to ice growth (Fig. 25). The subsequent freezing of interstitial

Figure 23h shows one section of the monitoring network at the River-North site, where slope processes are consuming mudflat sediments and introducing material directly into the Eagle River (Fig. 24). Rapid lateral erosion on the order of 3.2 m was recorded at this site between July and November of 1994, and there was up to 7.4 m of recession by late October 1995. Erosion occurs along large rotational slumps that fail because of river undercutting and removal of sediment supporting the toe of the slope (Fig. 24b). Prior to failure, large extension cracks develop parallel to the scarp, gradually leading to catastrophic failure (Fig. 24a). The location of the crack becomes the new scarp of the riverbank.

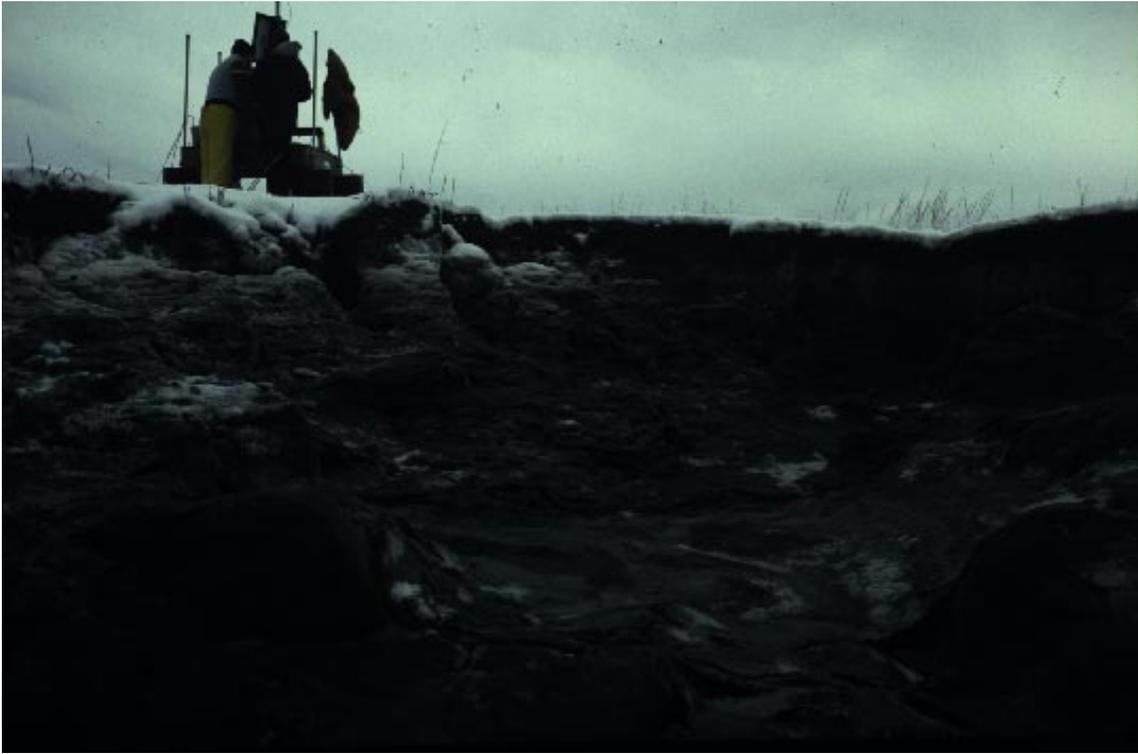
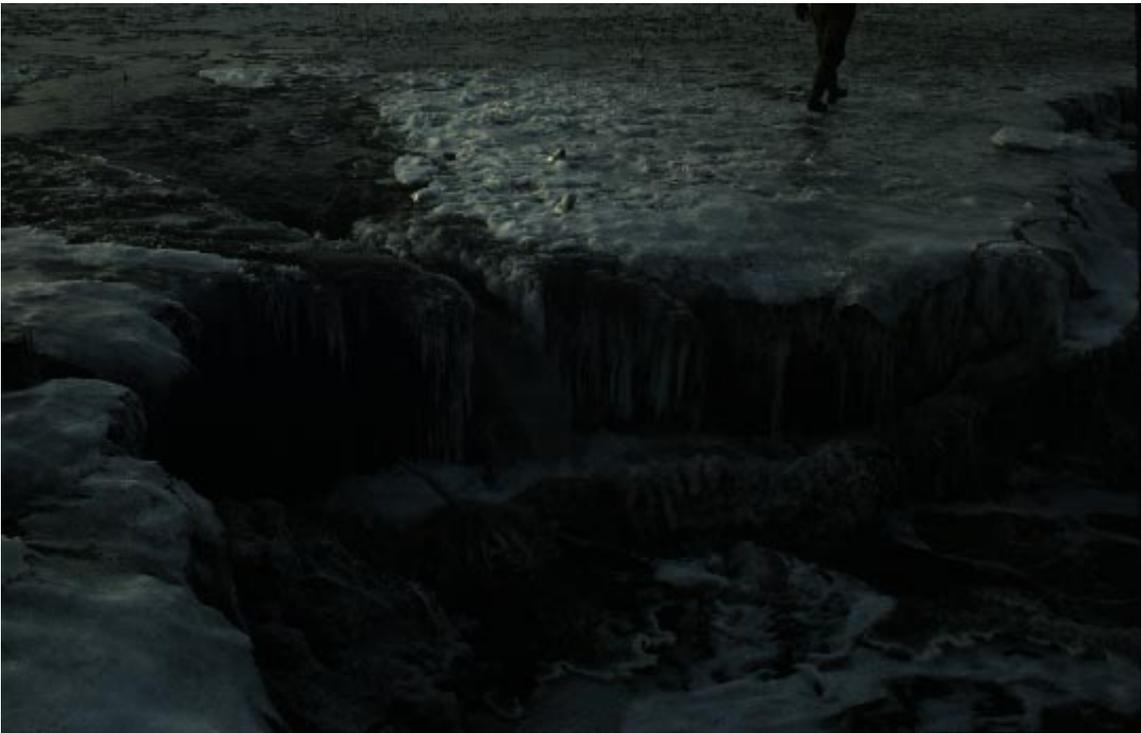
*a. Lateral wall view. Ice armor is caused by repeated flooding and subsequent freezing in gully.*

*b. Headwall view showing ice coating formed by freezeup of waters flowing into gully.*

*Figure 25. Bank of Bread Truck Gully showing ice growth formation.*

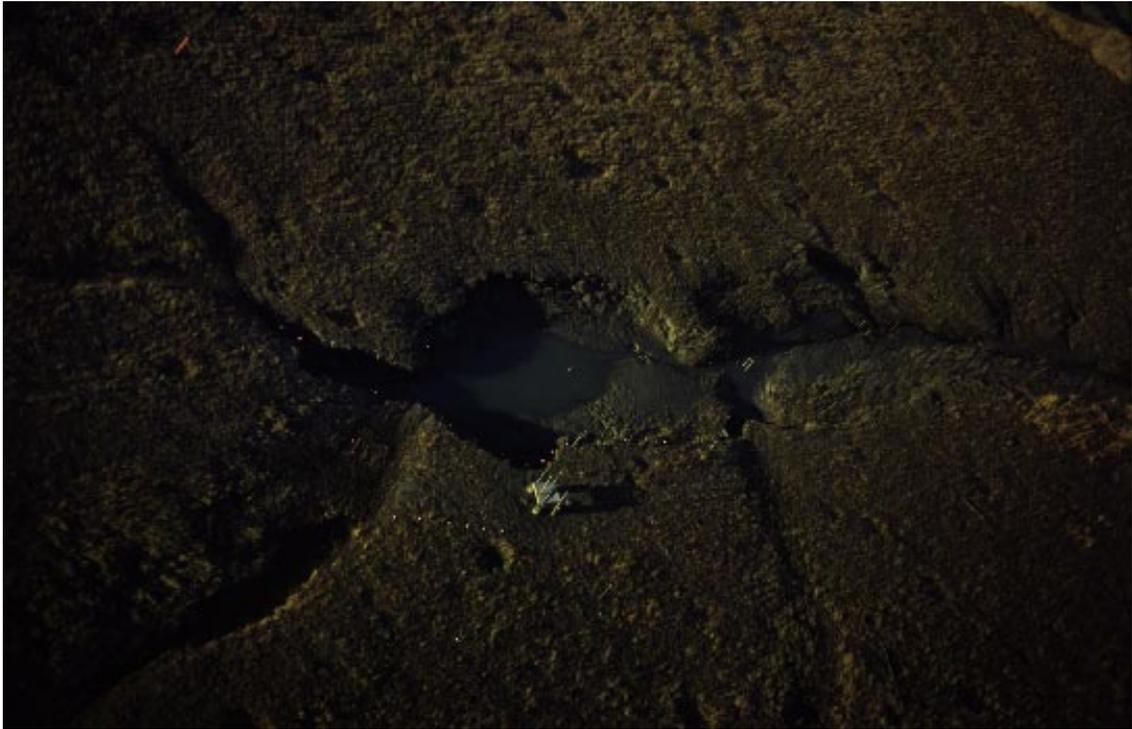
*Figure 26. Aerial view of Parachute Gully in October 1995 showing accelerated headward recession that has accompanied capture of flow through craters.*

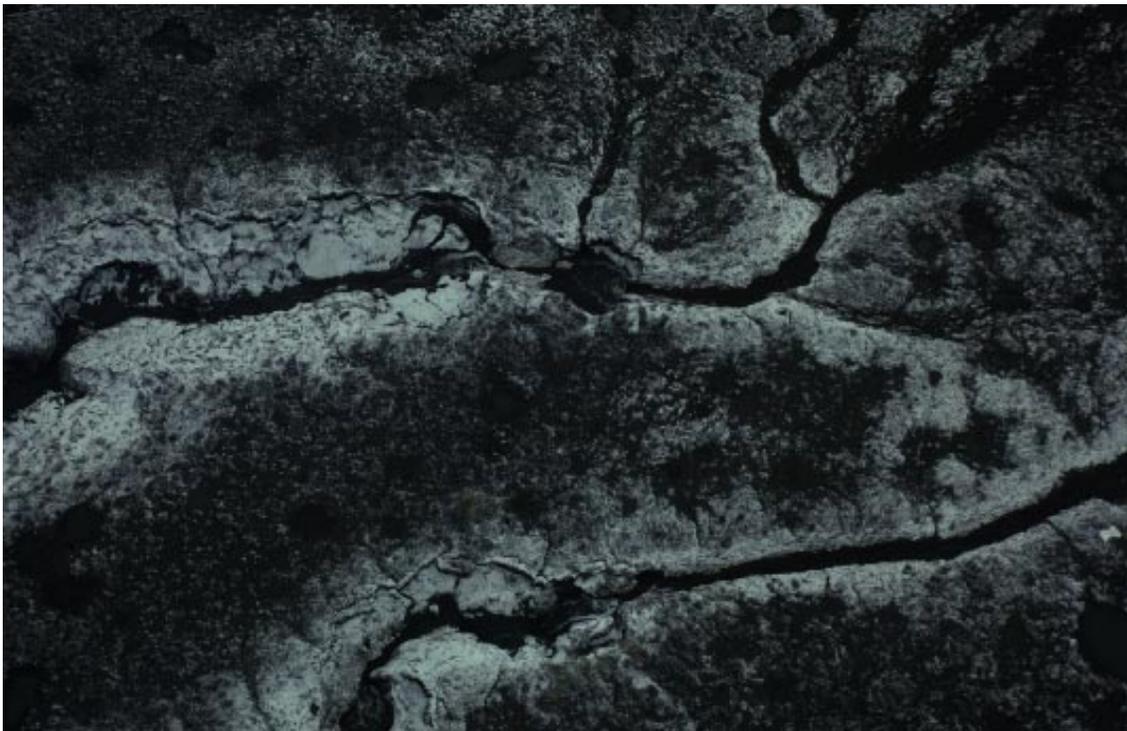
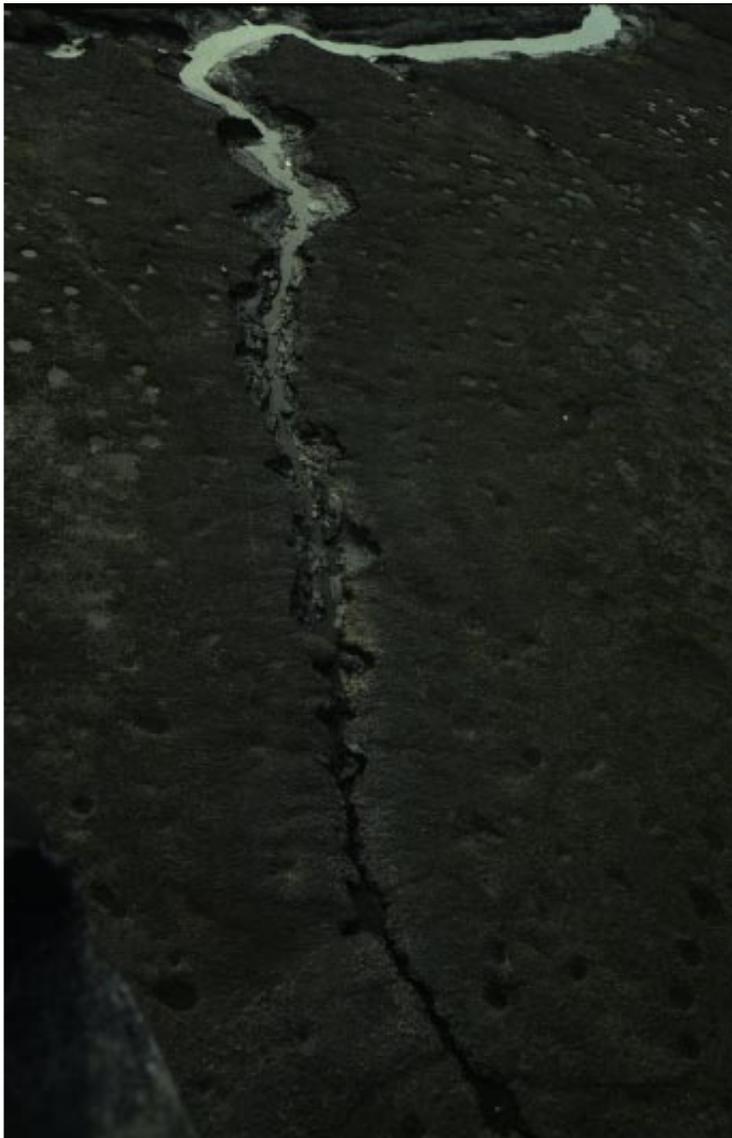
*a. Area A.*

*Figure 27. Aerial view of gullies where recession and ebb flow have been modified by surface craters.*

*b. B-Gully.*

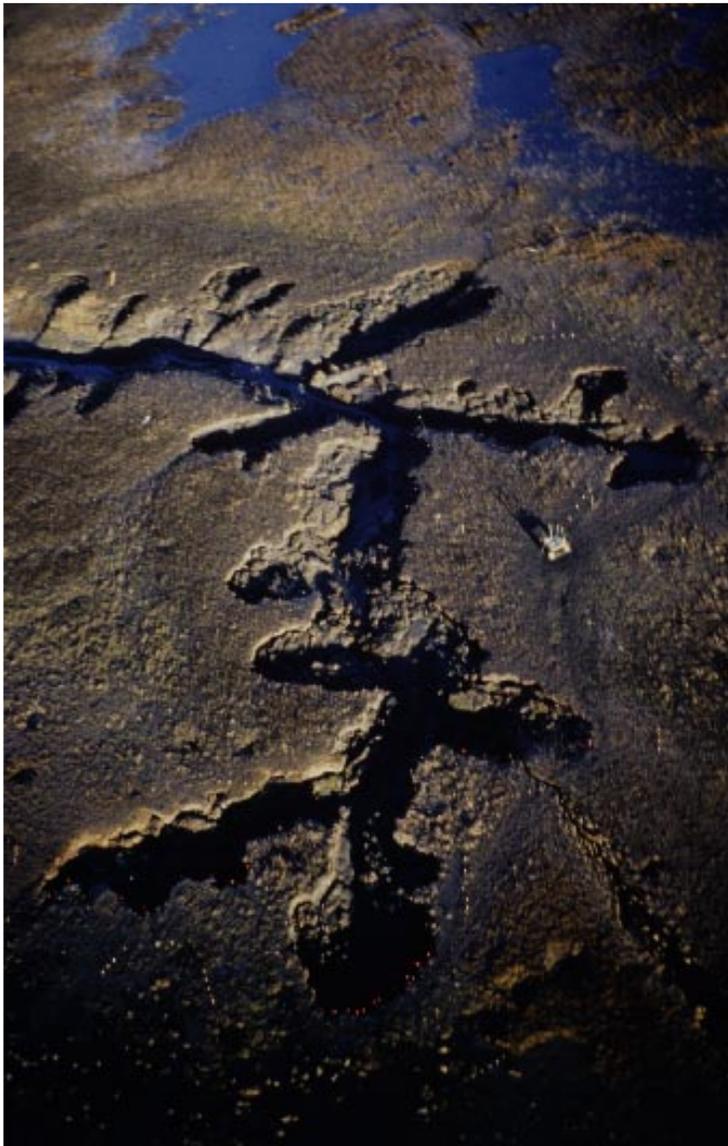
Figure 28. Aerial view of Bread Truck Gully in October 1995.

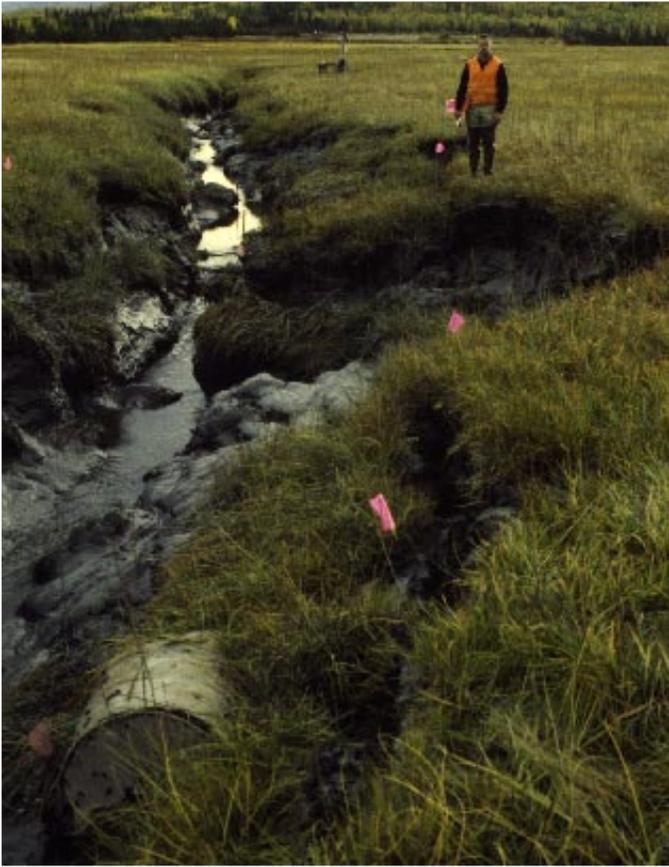
*Figure 29. Eastward view of eroding cusped embayments at B-Gully.*

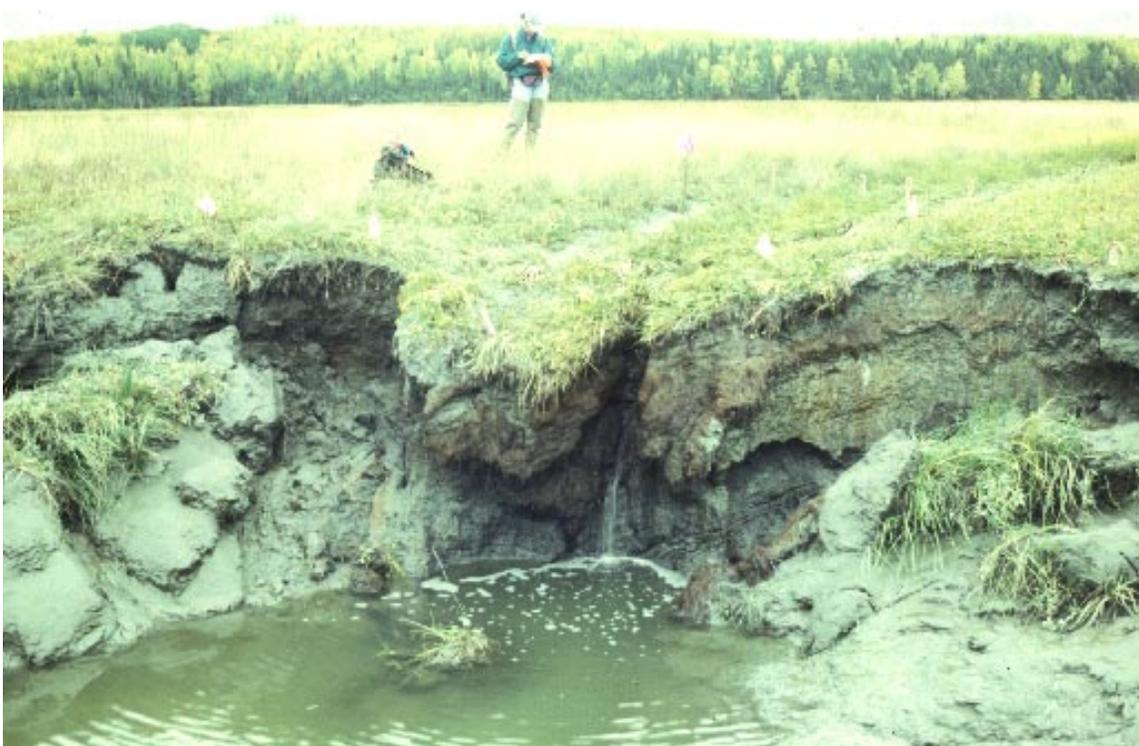
*Figure 30. Thick laminated peat layer at Coastal 6 forms the threshold to channel downcutting and headward recession.*

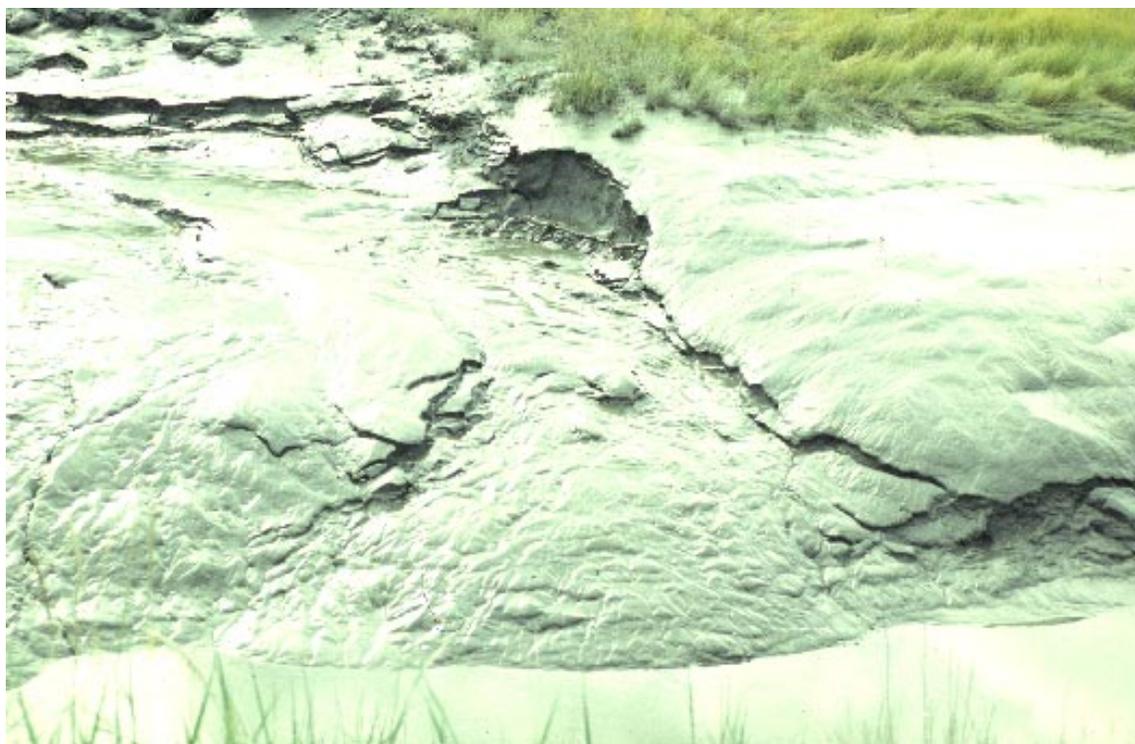
*Figure 31. Sediment flow at Bread Truck Gully. Saturated sediment fails when erosion during ebb tide removes material from the slope toe.*

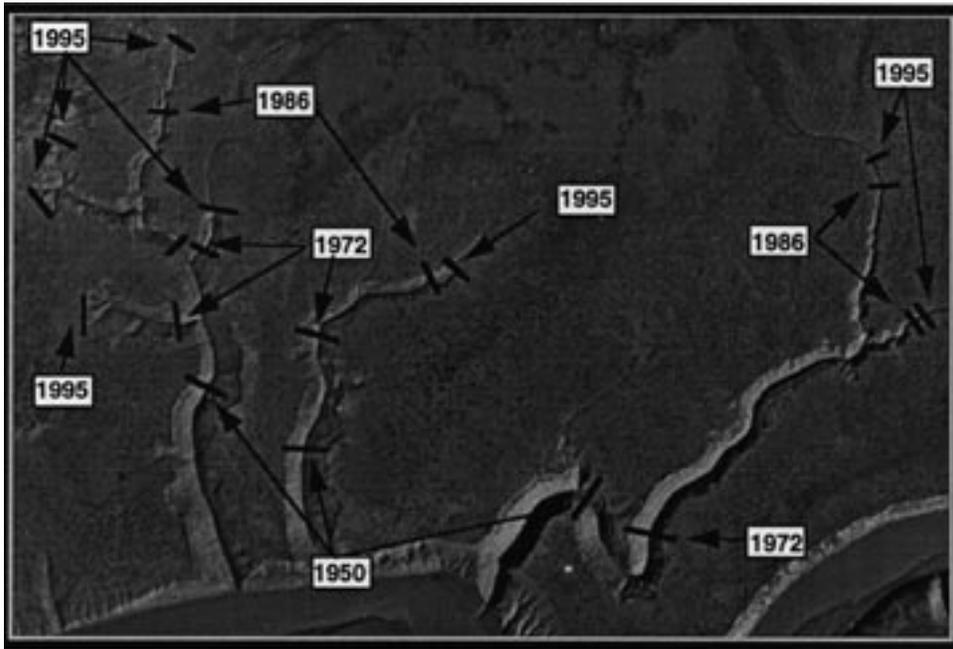
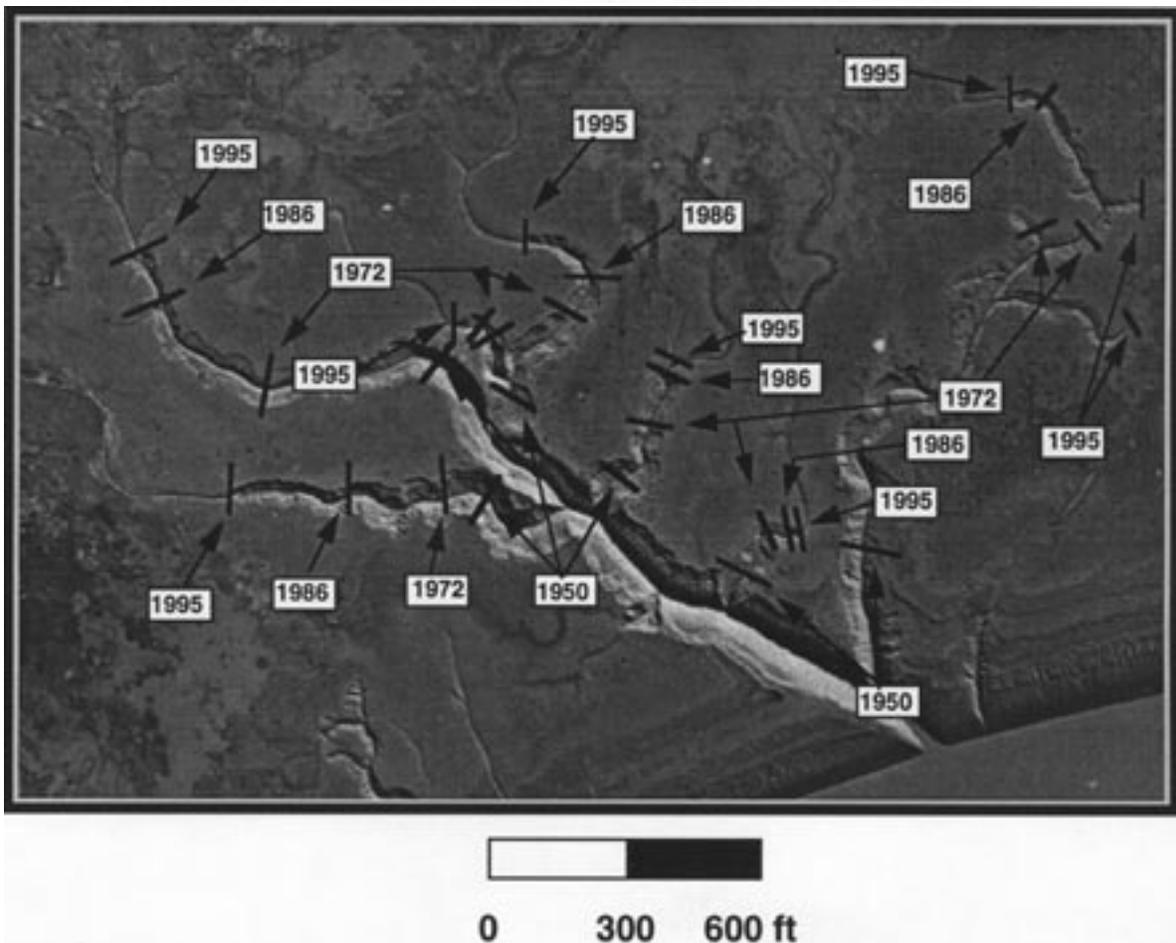
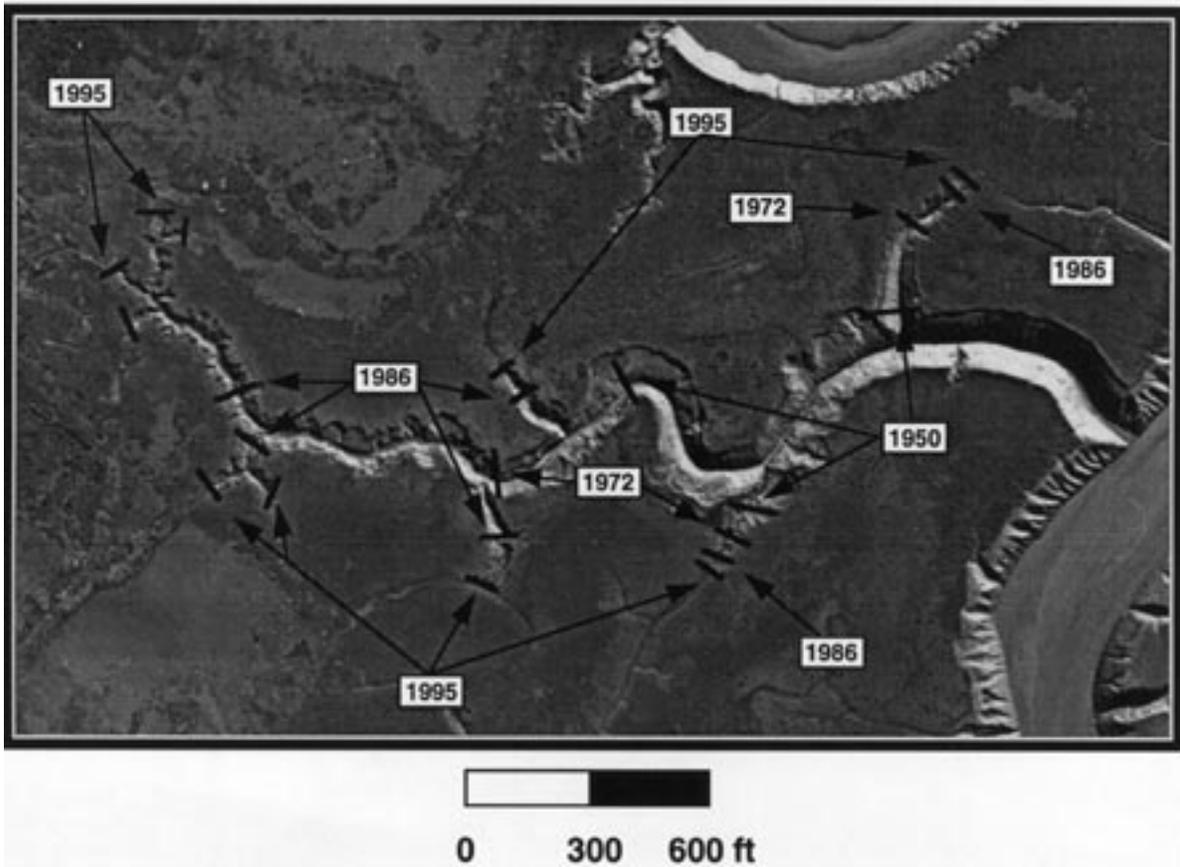
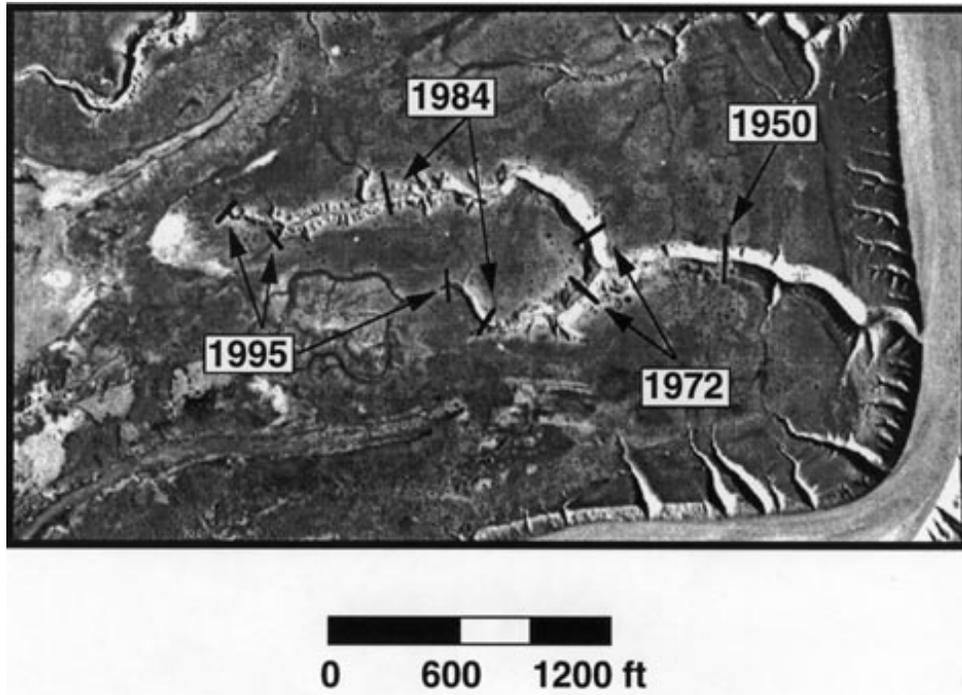
a. B-, Parachute and In-Between gullies.

b. Mortar Gully.

Figure 32. Historical gully recession (see Table 9 for corresponding recession rates).

*c. Bread Truck Gully.*

*d. Coastal 5 Gully.*

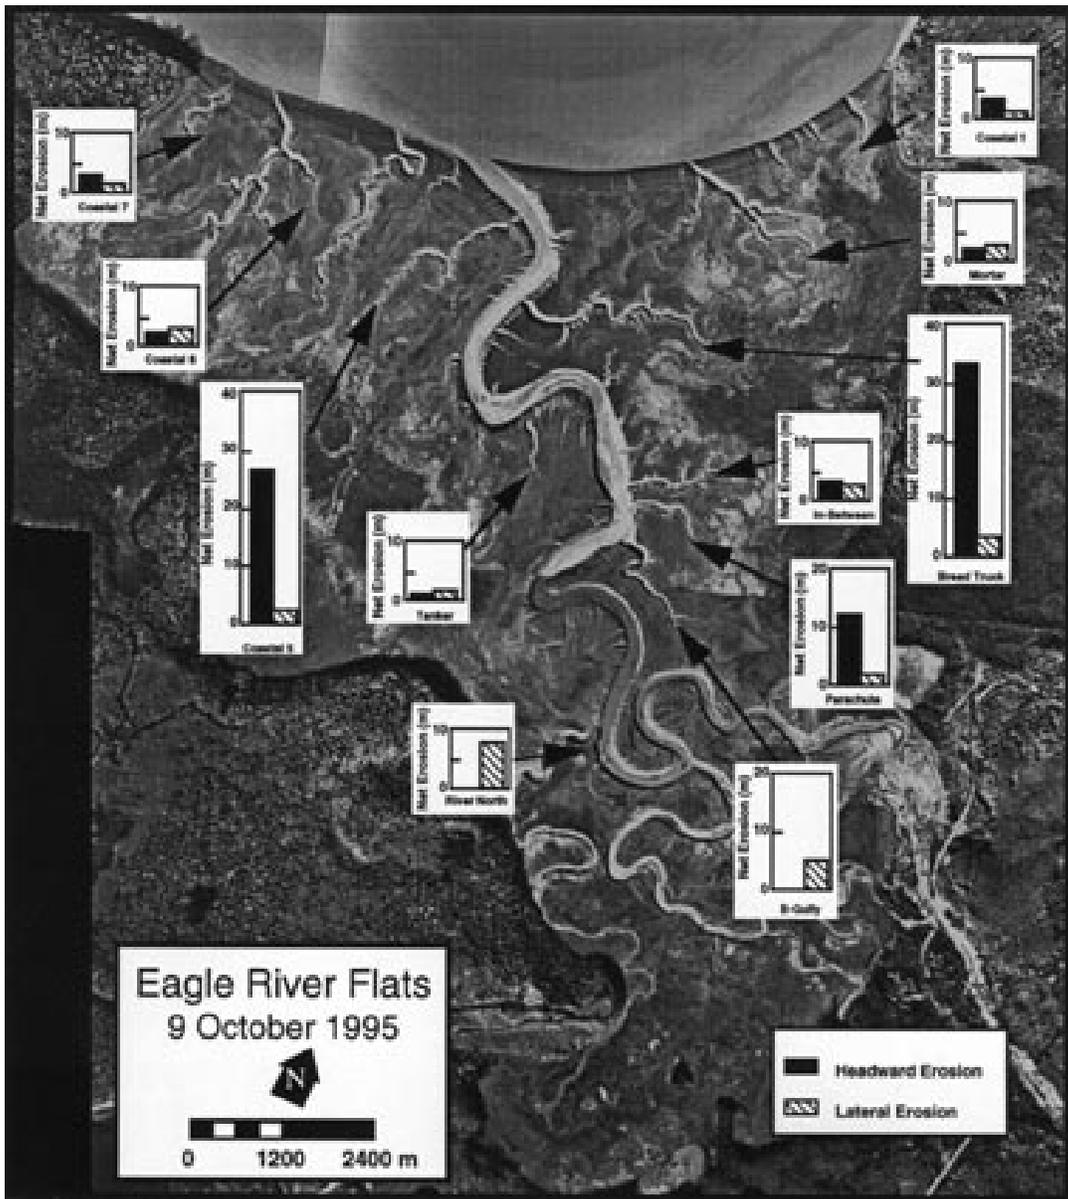
Figure 33. Spatial comparison of headward and lateral recession monitored at selected hub-line stake erosion sites.

The modern rates of net headward and lateral recession measured using the hub and line stake technique are depicted in Figure 33 to show the spatial patterns in gully erosion along a transect from the mouth of the Eagle River inland to the head of the Flats. Nearest the coast, sites Coastal 1 and Coastal 7 have experienced more headward than lateral recession. In the mid-coastal regions, Mortar and Coastal 6 have experienced similar rates of lateral and headward recession, with lateral erosion dominating slightly as these gullies have been widening by bank collapse and slumping. Slightly inland from the mouth of the river, Bread Truck and Coastal 5 gullies have been experiencing drastic, yet rather

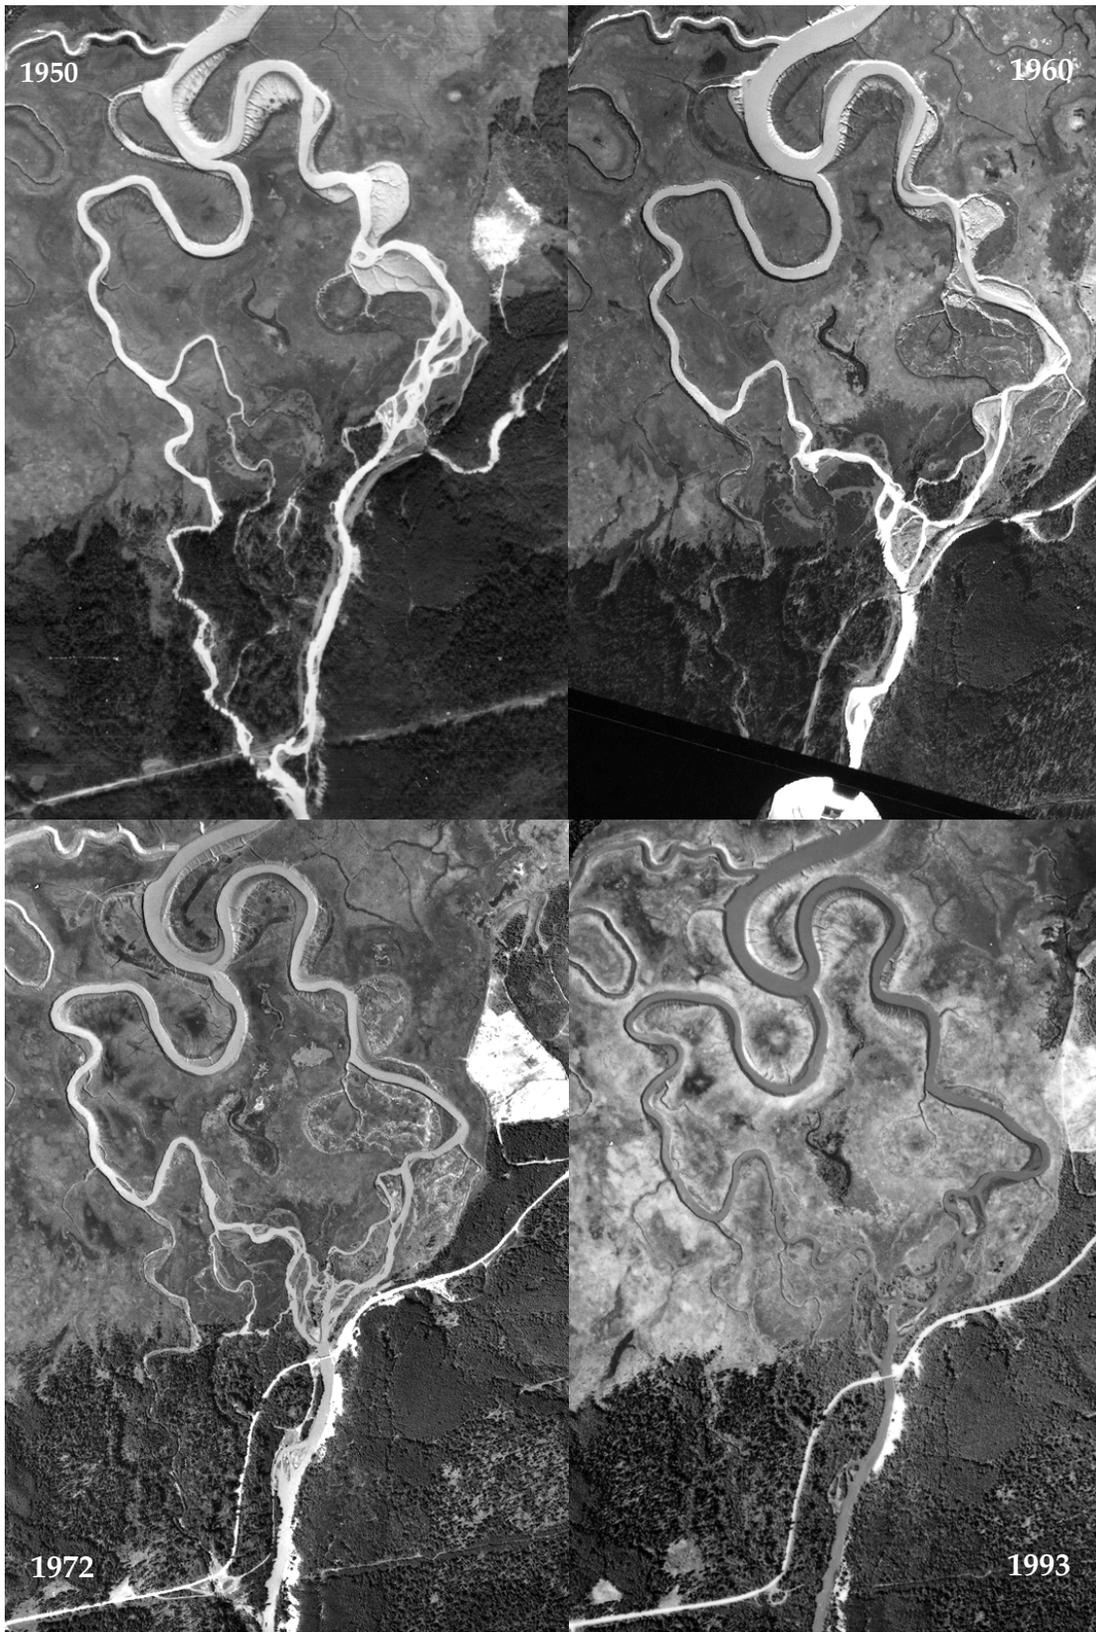
Figure 34. Aerial photographs depicting the morphologic changes in the Eagle River where it enters the ERF.

The Eagle River exhibited major changes only where it enters ERF; these changes are probably related to floods of the river, rather than tidal inundation. In 1950, two well-developed channels, which bifurcated about 850 m southeast of the Route Bravo Bridge, entered ERF (Fig. 34a). The northern channel was straight and confined by the uplands, while the south channel appears slightly subordinate in discharge volume and had a meandering pattern. Between 1957 and 1960, the south channel had eroded and captured

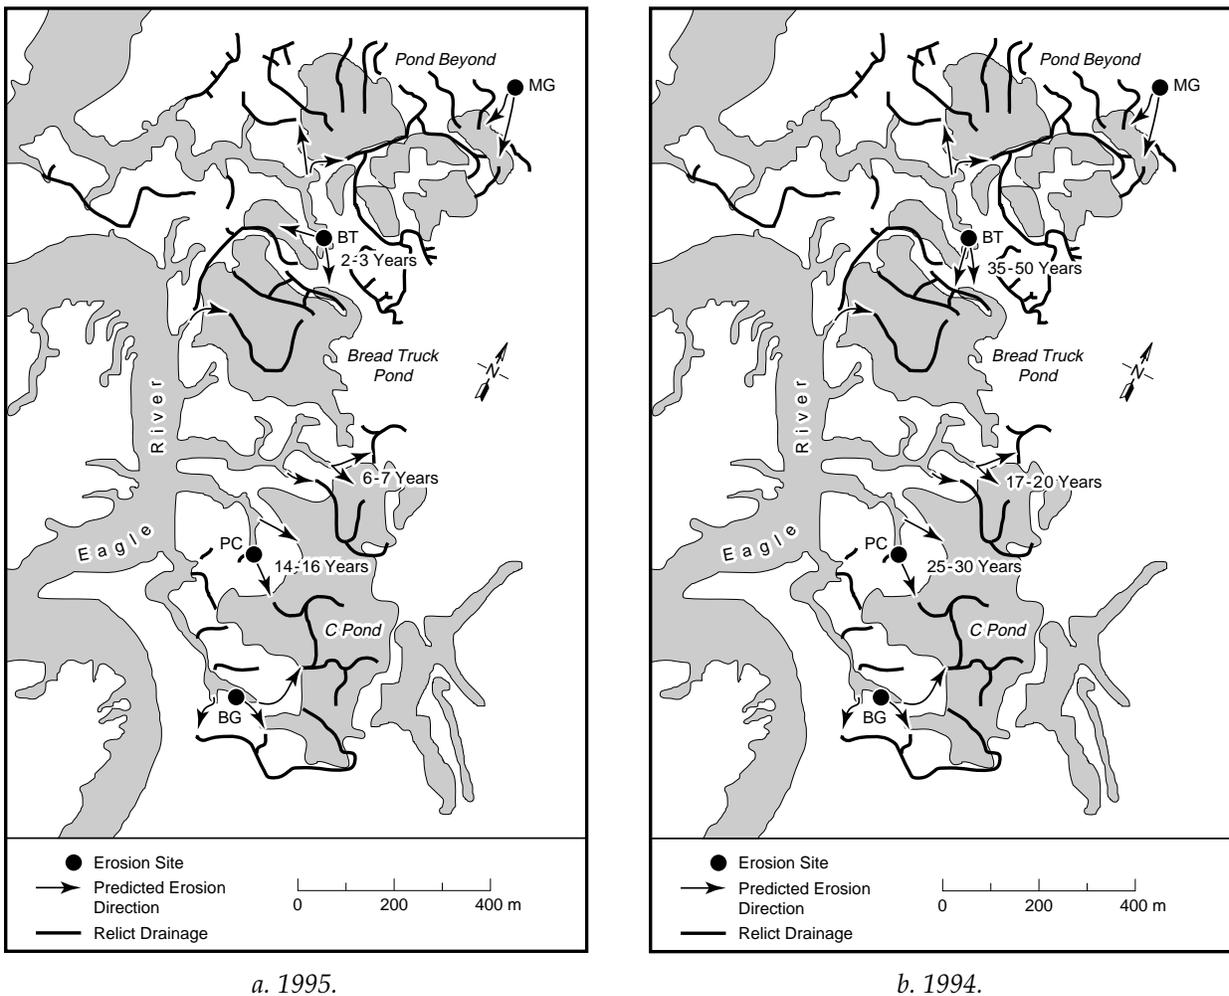
Figure 35. Predictions for pond drainage by selected gullies in Areas C, Bread Truck and C/D.

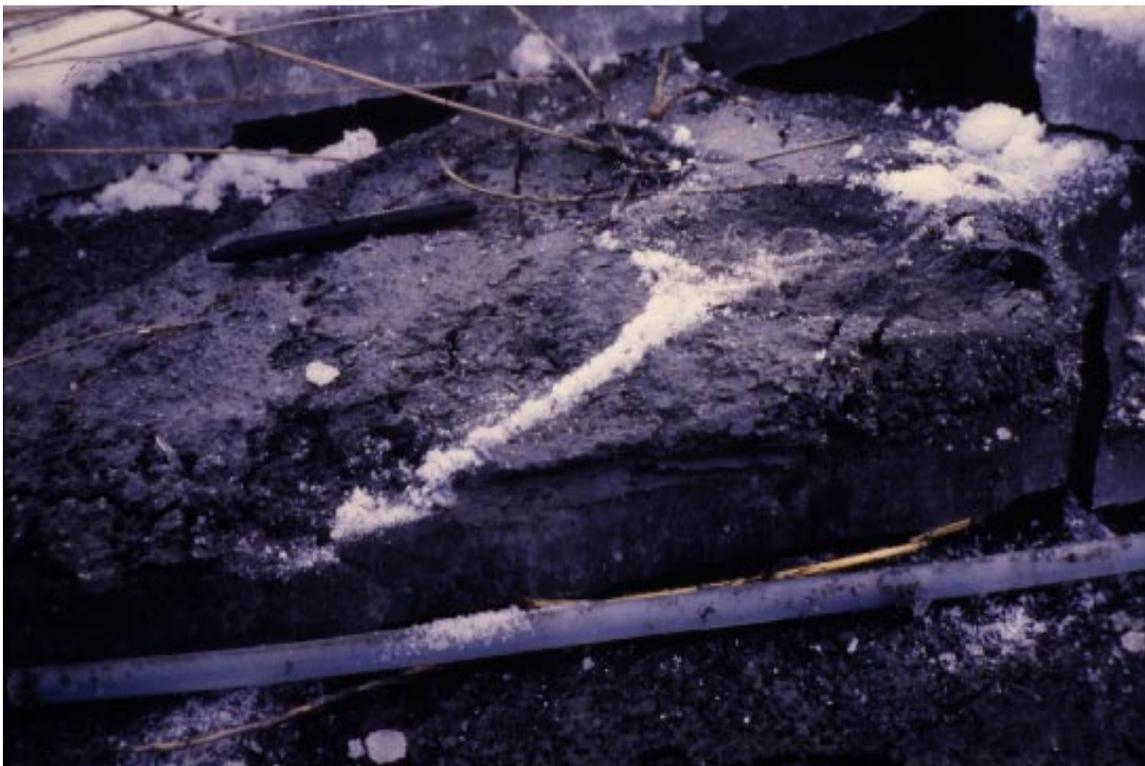
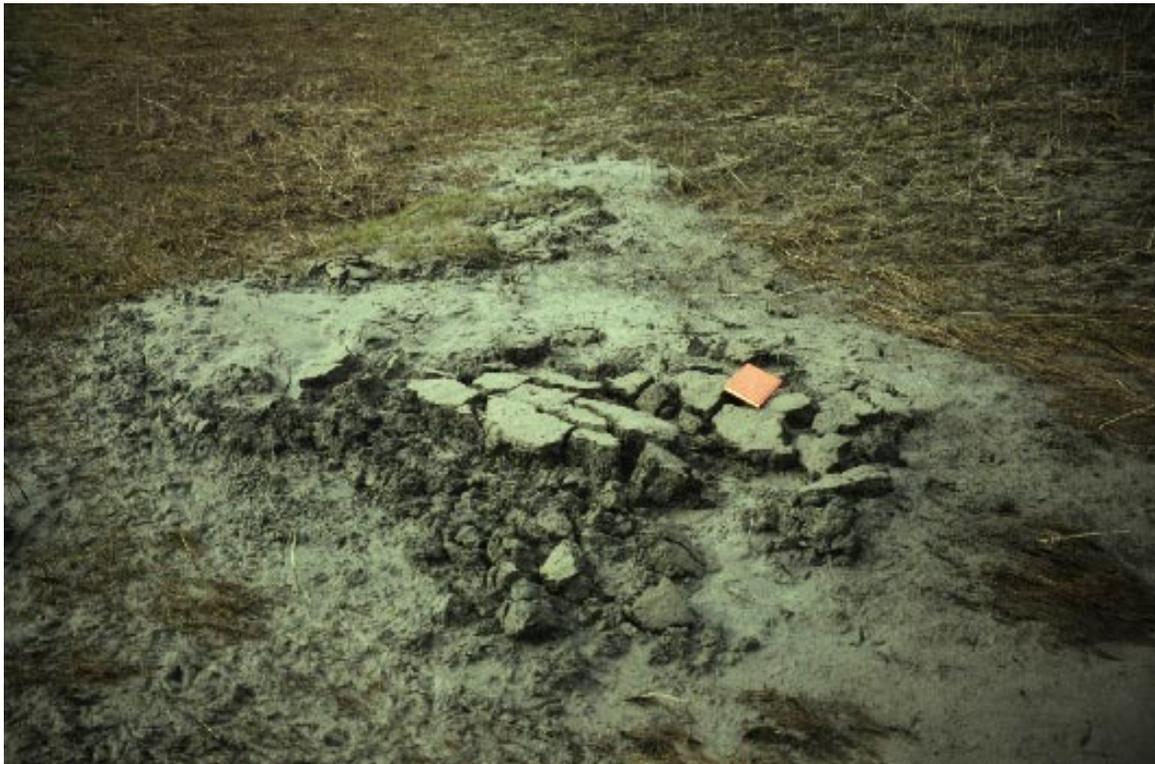
*a. Sediment layer frozen onto an ice block transported during the November 1994 flooding tides.*

*Figure 36. Ice rafting at ERF.*

*b. Ice-rafted sediment deposited at the head of Mortar Gully.*

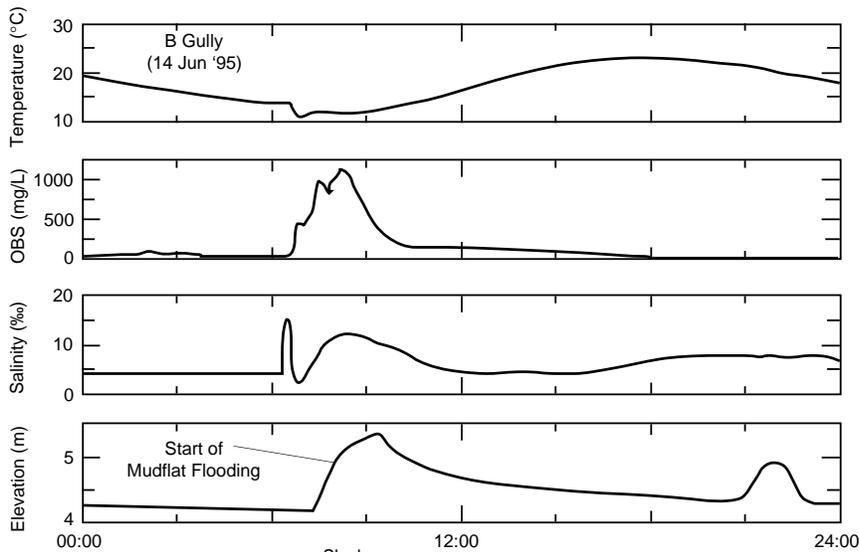
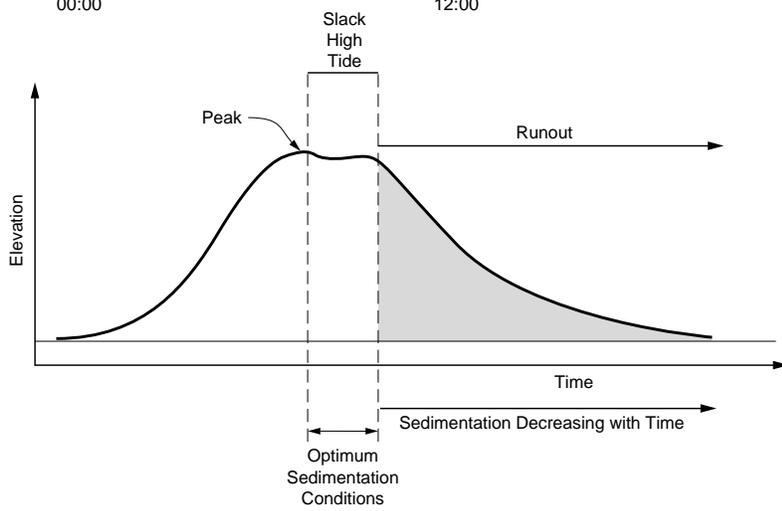
a. B-Gully on 14 June 1995.

b. Schematic showing a typical tidal cycle and period of sedimentation during the ebb tide event.

Figure 37. Example of a flooding tide cycle. Note that rate of tidal rise decreases following bankfull stage when water begins to flood adjacent mudflats.

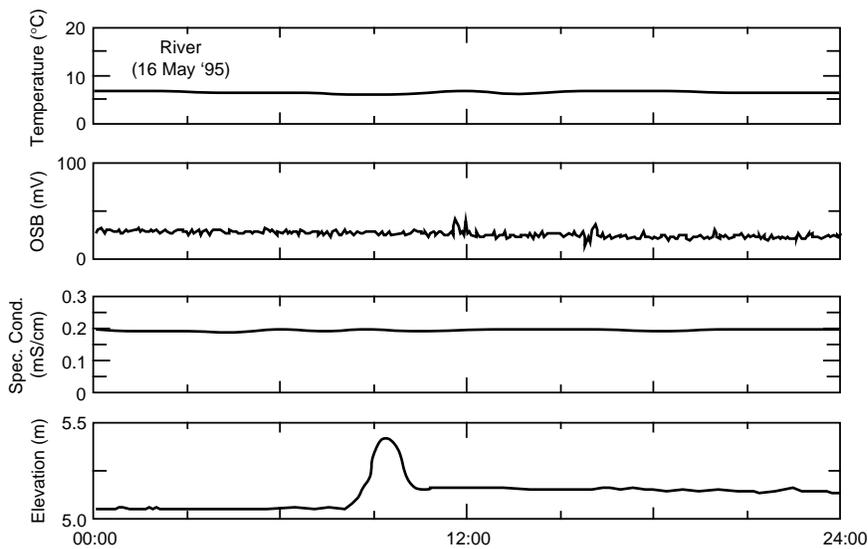
Figure 38. Water quality data from the Eagle River site showing the effect of water damming caused by a flooding tide.

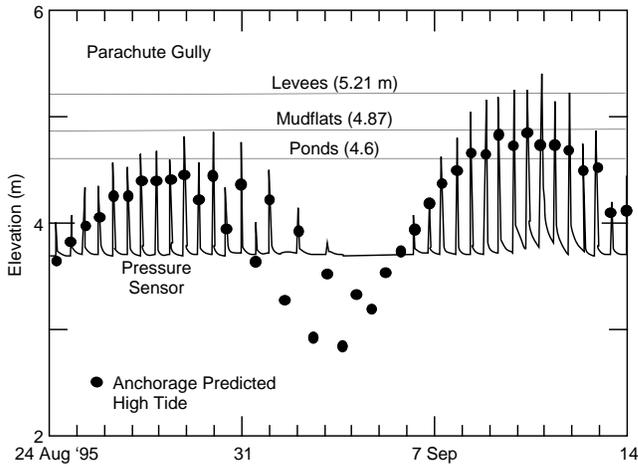
Figure 39. Water elevation record showing elevations required to flood selected landforms and tidal amplification at Parachute Gully above predicted high tide at Anchorage.

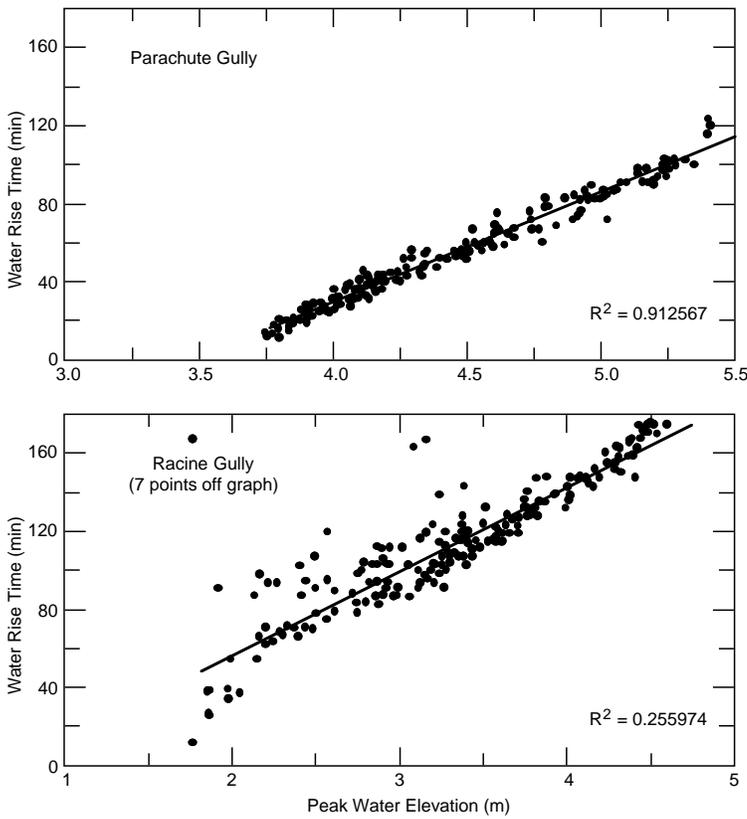
Figure 40 (cont'd).

Figure 40. Relationship between water rise time and peak water elevation at several gully sites. Note that x-axis for Racine Gully differs from other graphs.
