# Physical Processes and Natural Attenuation Alternatives for Remediation of White Phosphorus Contamination, Eagle River Flats, Fort Richardson, Alaska

Daniel E. Lawson, Lewis E. Hunter and Susan R. Bigl

December 1996

CRREL Report 96-13

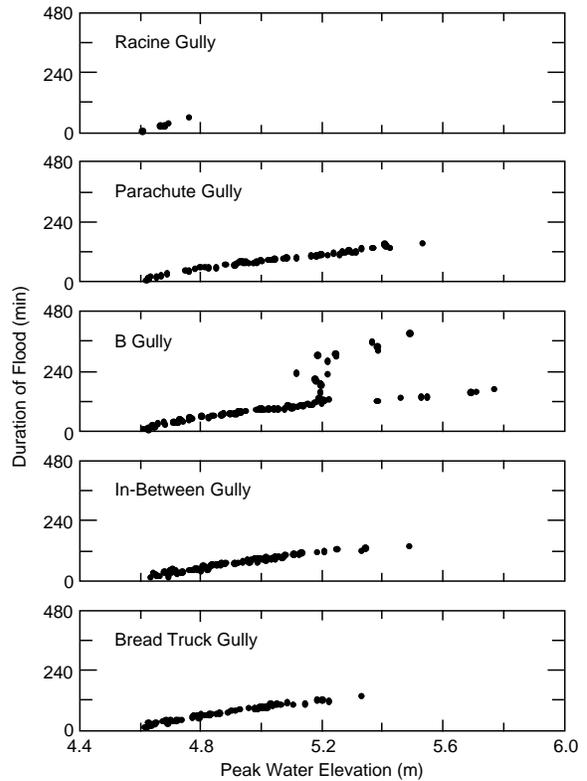
Figure 41. Tidal flooding time as a function of peak flood elevation at selected gullies.

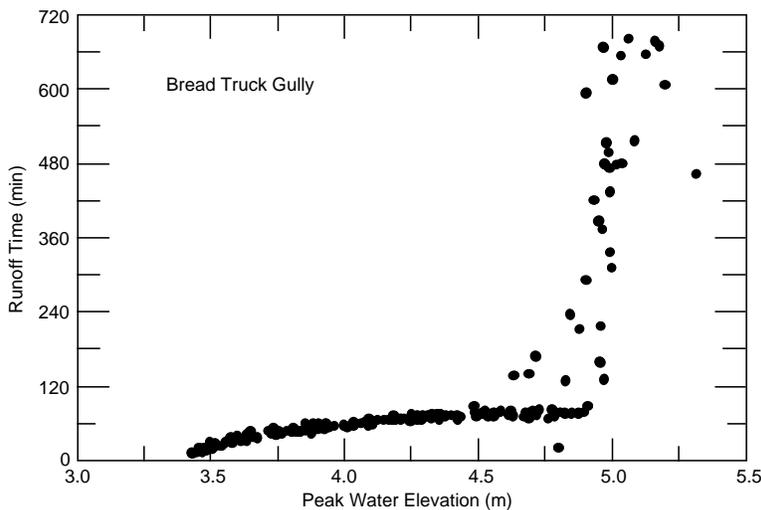
Figure 42. Runoff time vs. peak water elevation at Bread Truck Gully. The change in slope reflects the effect of pond drainage where runoff is extended once ponds are flooded.

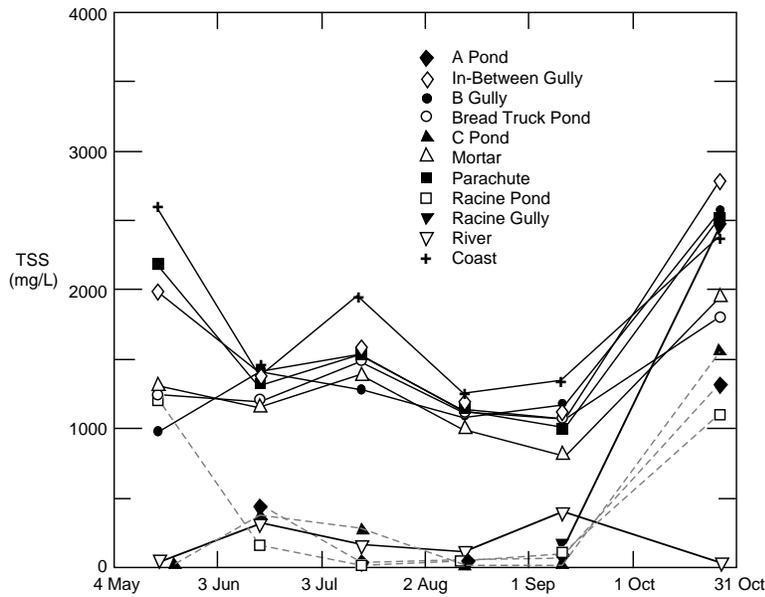
Figure 44. Maximum monthly TSS comparison at all sites. Dashed lines connect data from pond sites.

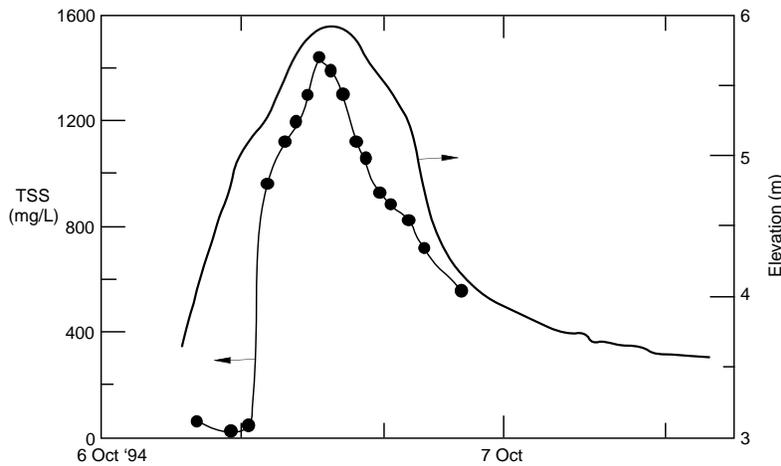
Figure 45. Typical TSS variation through a flooding tide.

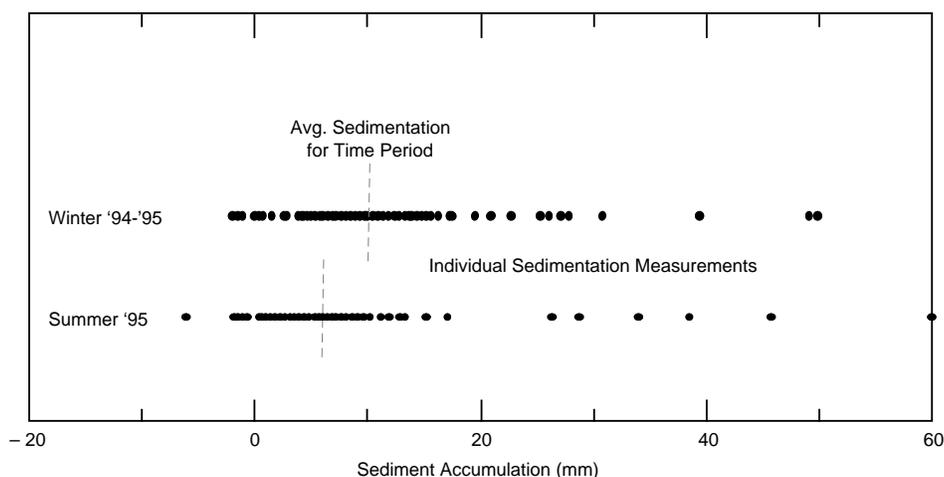
Figure 46. Net seasonal accumulation rates at sites spray-painted in the C and D areas.

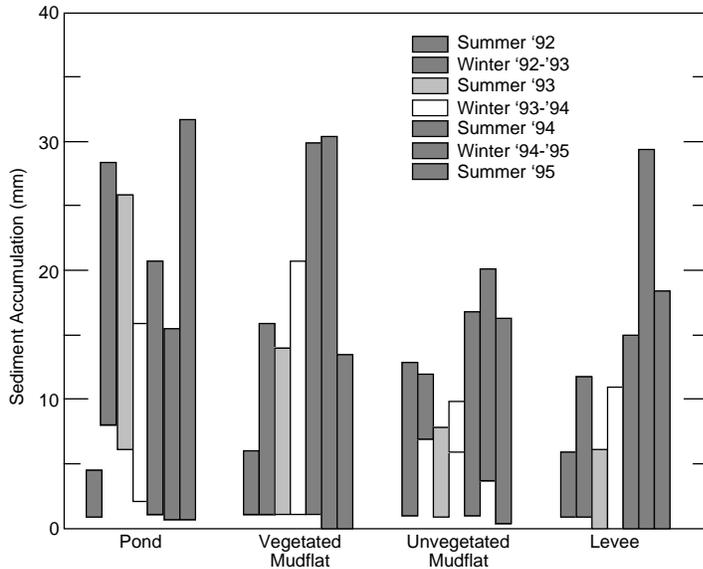
Figure 47. Variations in sedimentation rate as a function of landform type.

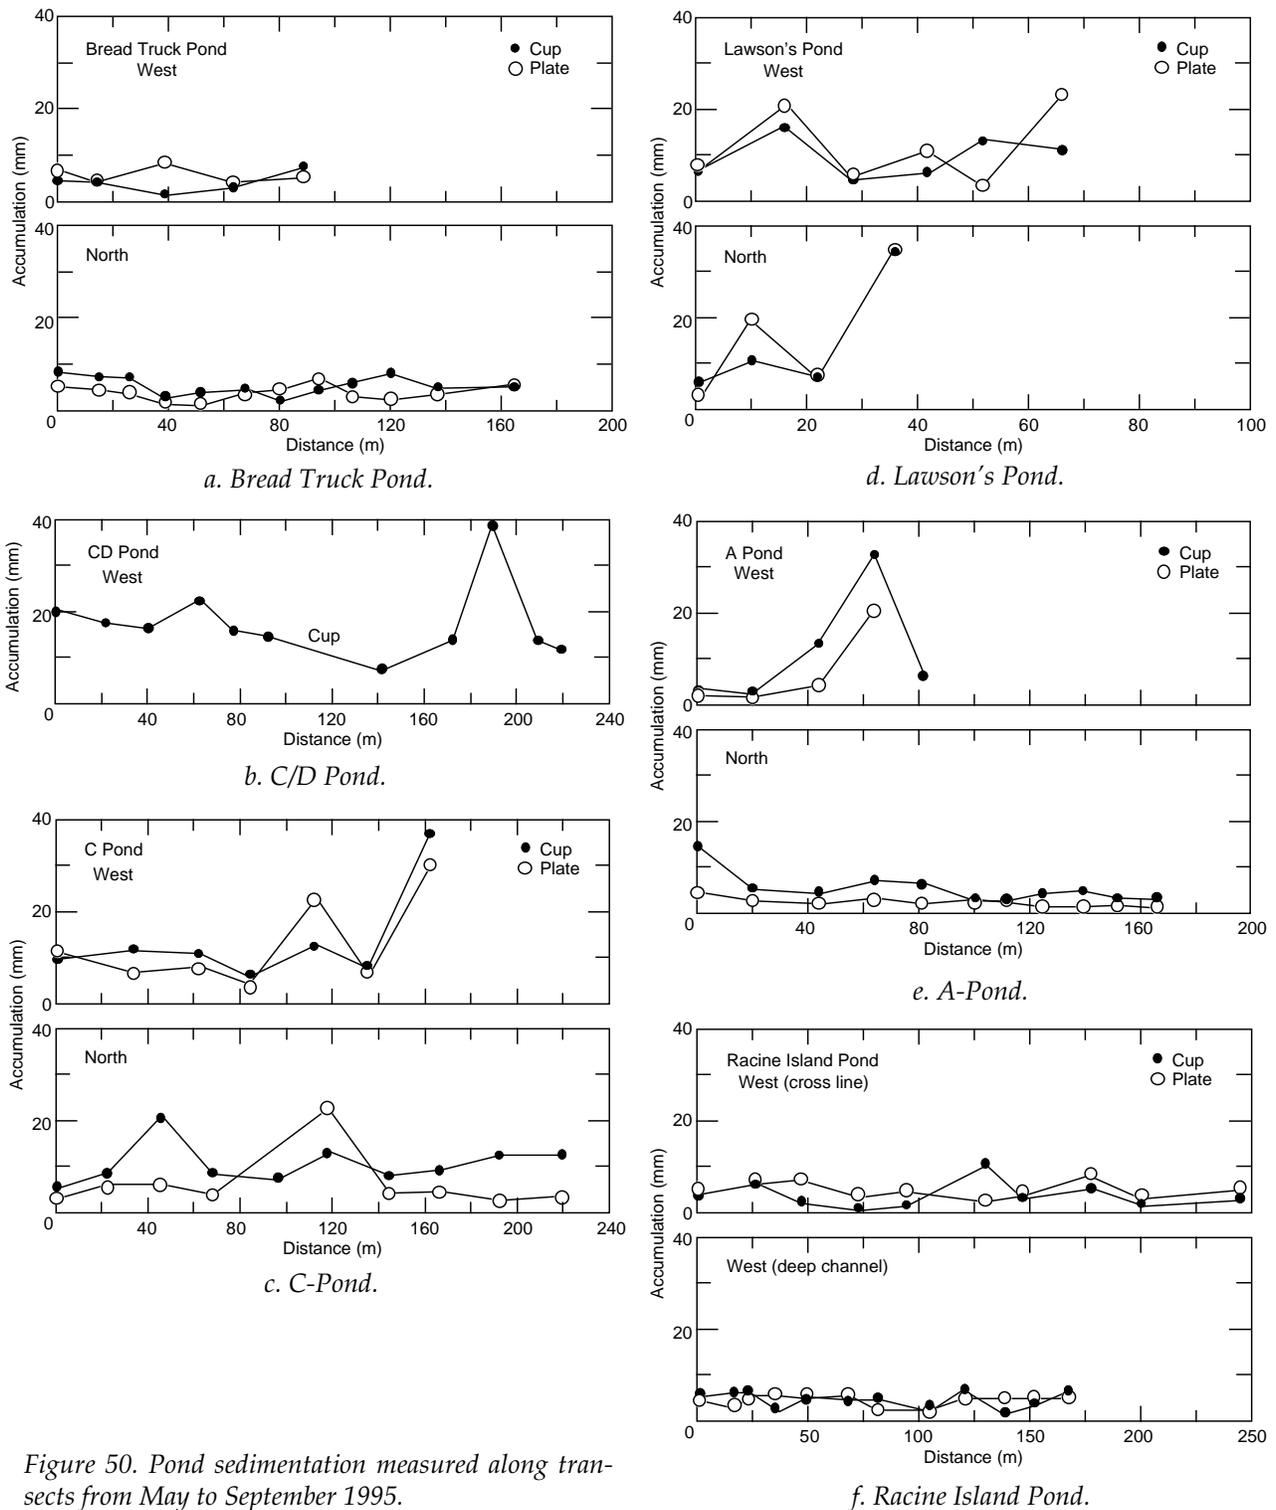
Figure 50. Pond sedimentation measured along transects from May to September 1995.

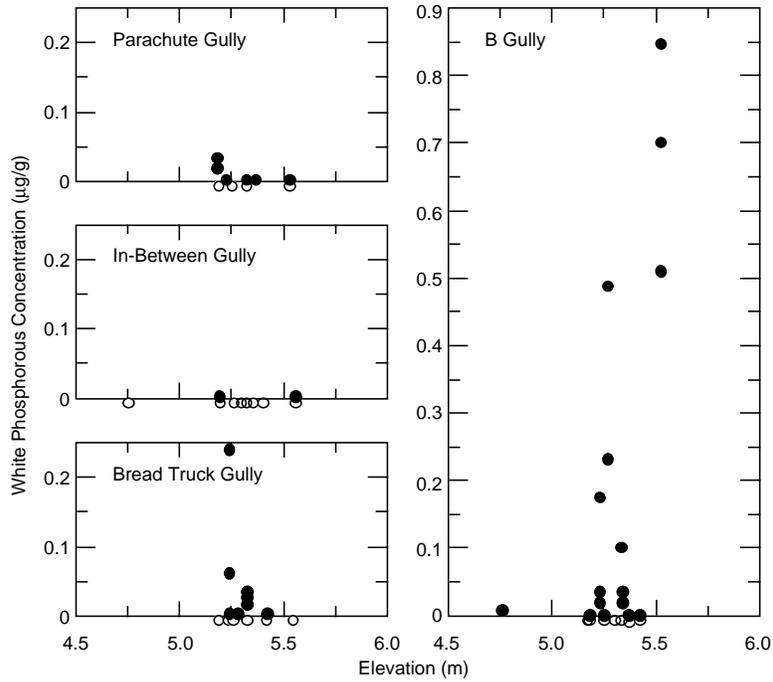
Figure 53. Relationship between WP detected in plankton net samples and peak elevation of flooding event sampled. Open circles are samples in which no WP was detected.

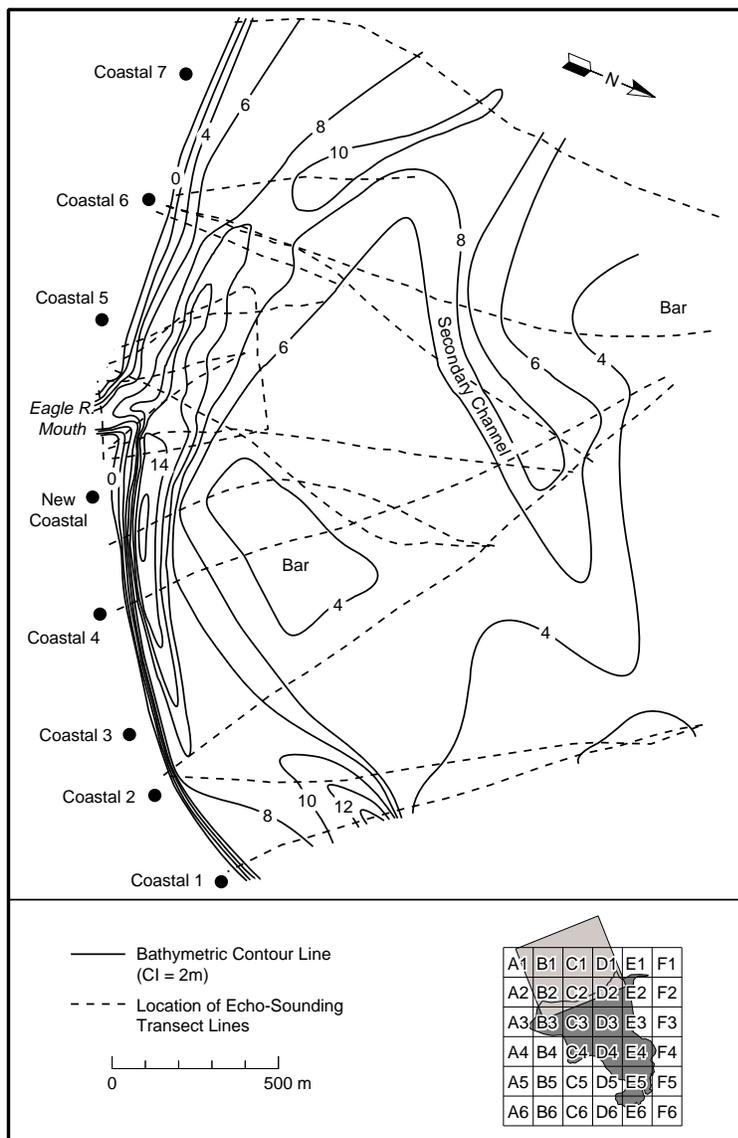
Figure 54. Bathymetry of Knik Arm near the mouth of the Eagle River and adjacent to the coast of ERF.

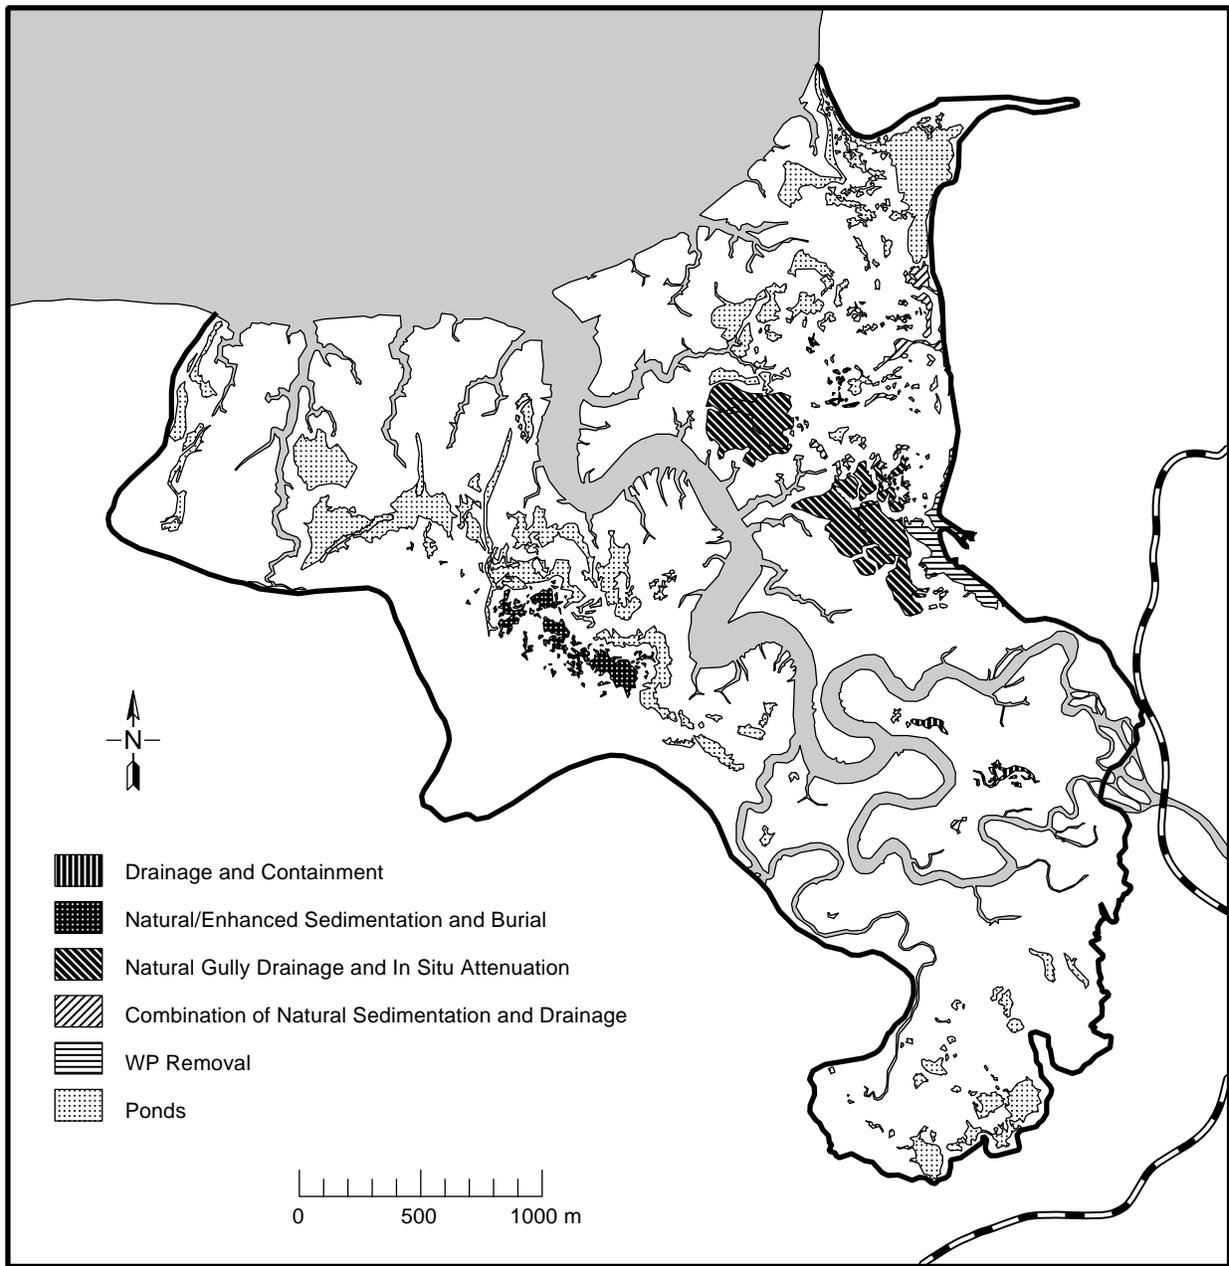
Figure 55. Recommendations for site remediation.
