# **Preliminary Hydraulic Analysis and Implications for Restoration of Noyes Slough, Fairbanks, Alaska**

**Water-Resources Investigations Report 00–4227**

*By* Robert L. Burrows, Dustin E. Langley, and David M. Evetts

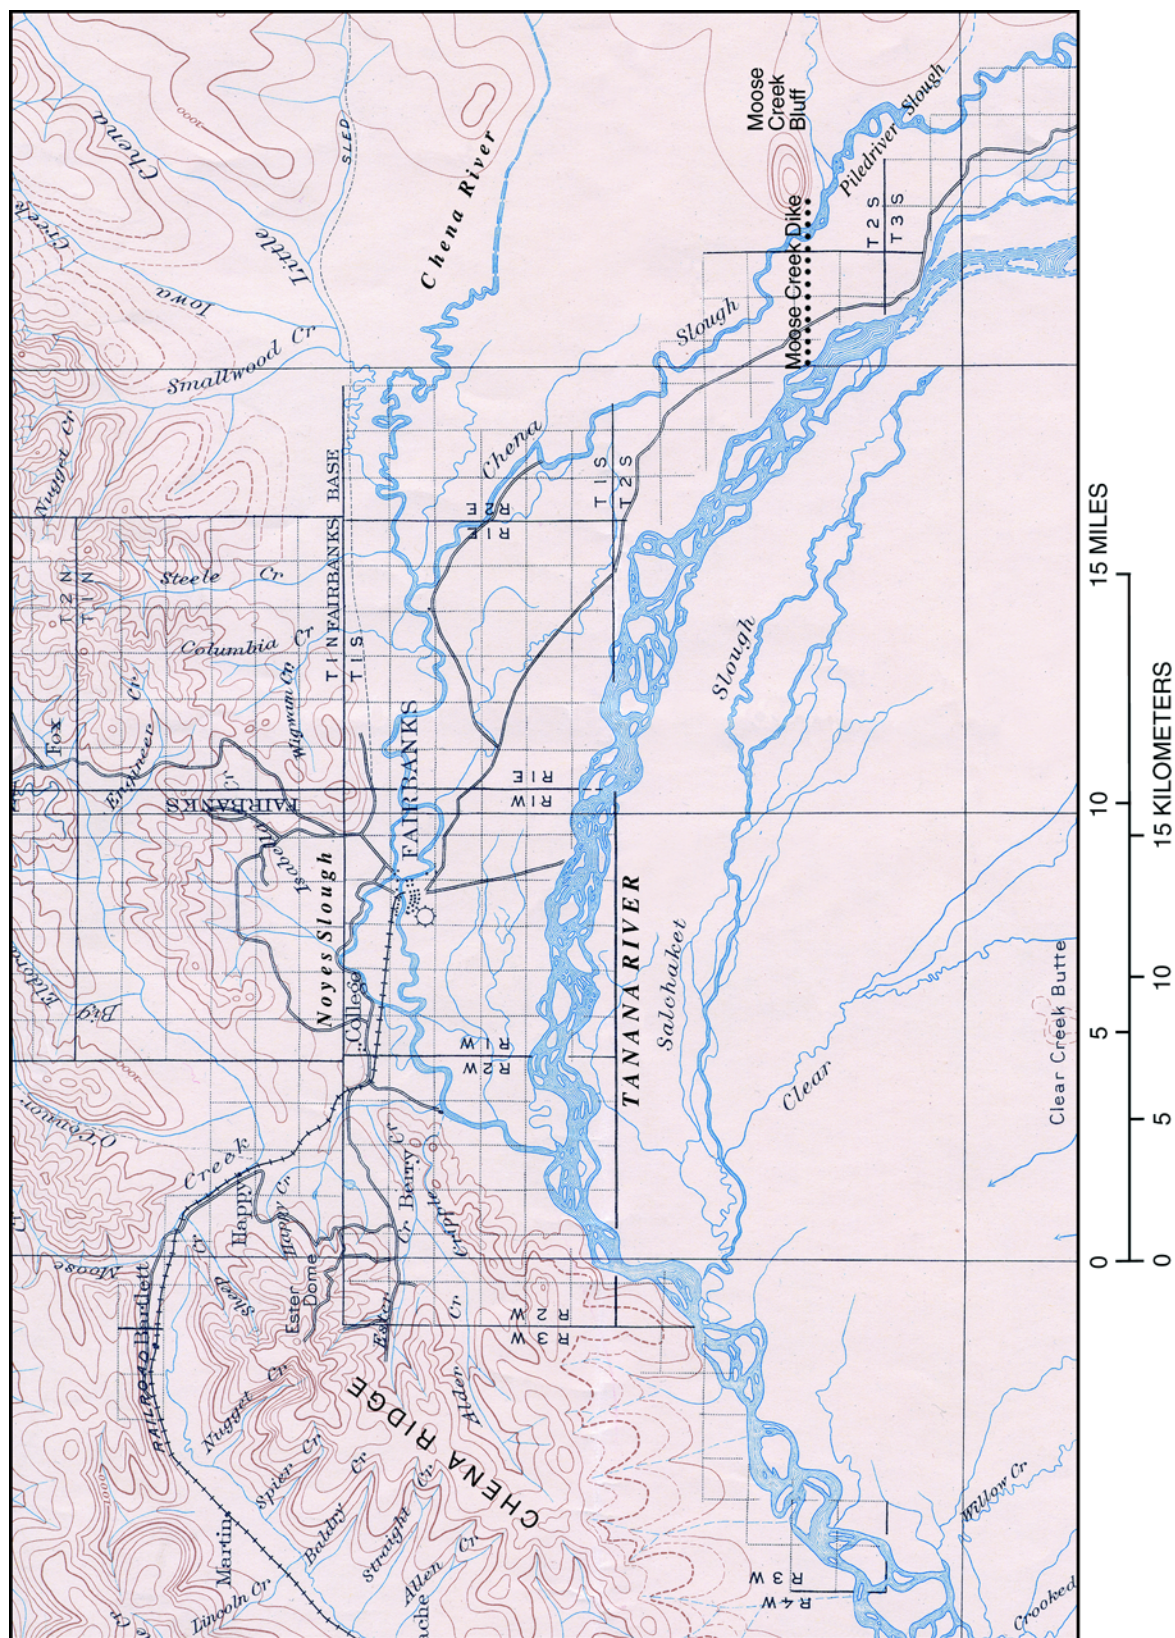
**Figure 2.** Fairbanks in 1940, showing Tanana and Chena Rivers; Piledriver, Chena, and Noyes Sloughs; and location of Moose Creek Dike, built across Chena Slough during 1940–45. Original topographic surveys (U.S. Geological Survey, 1940) were done in 1902 and 1916.

The proposed solution to reducing the flow contributed to Chena Slough by the Tanana River was to construct an earth-and-rock dike across the slough extending from Moose Creek Bluff westward to the Tanana River (fig. 2). This dike was constructed during the period 1940–45, although additional work on it may have been done as late as 1947. This construction cut off the flow from the Tanana River into the Chena Slough. Considerable seepage through the dike occurred during the years after the dike was constructed. Records from a gaging station that operated during 1948–52 on the upper part of Chena Slough above the old mouth of the Chena River indicate that flows ranged from about 50 to 100 ft<sup>3</sup>/s throughout the year. Some seepage still occurs through the dike, and some subsurface flow enters the channel known locally as Badger Slough, which is the reach of the old Chena Slough from the dike downstream to the confluence of the Chena River. (Upstream from the dike, the channel still is called the Piledriver Slough.) Various discharge measurements made by the U.S. Geological Survey (USGS) in the early 1970's indicate an average flow in the slough of about 50 ft<sup>3</sup>/s during the open-water season, although it is greater at times of high flow on the Tanana River. Flow was reduced further in Piledriver Slough from some blockages placed in the upper end during the flood-control construction period, 1977–82, and seepage into Badger Slough possibly is even less today. Seepage may have declined as the Tanana River deposited sediment against the upstream side of the dike and as Piledriver Slough shifted away from the dike.

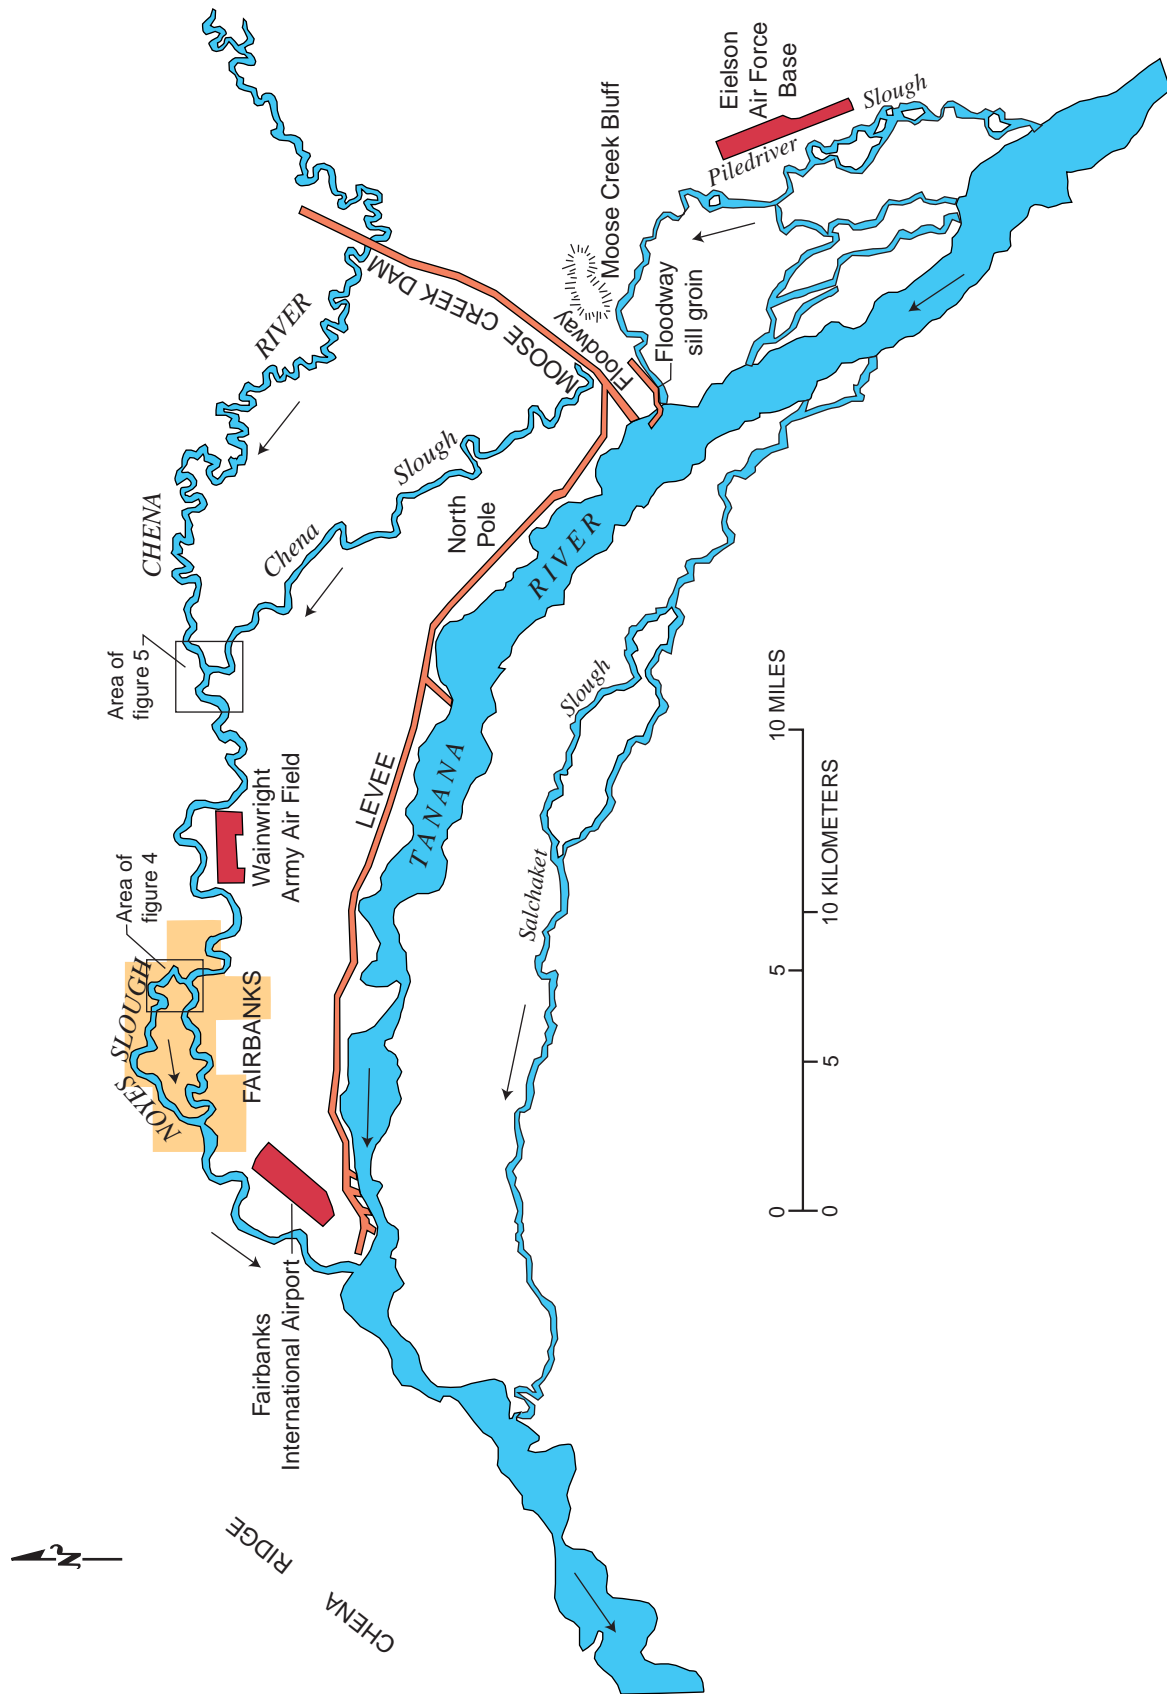
**Figure 3.** Present-day conditions affecting Chena River and Noyes Slough, showing Chena River Lakes Flood Control Project and other structures in vicinity. Chena Slough is also known locally as Badger Slough. Arrows indicate flow directions. Modified from Burrows and Harrold (1983).

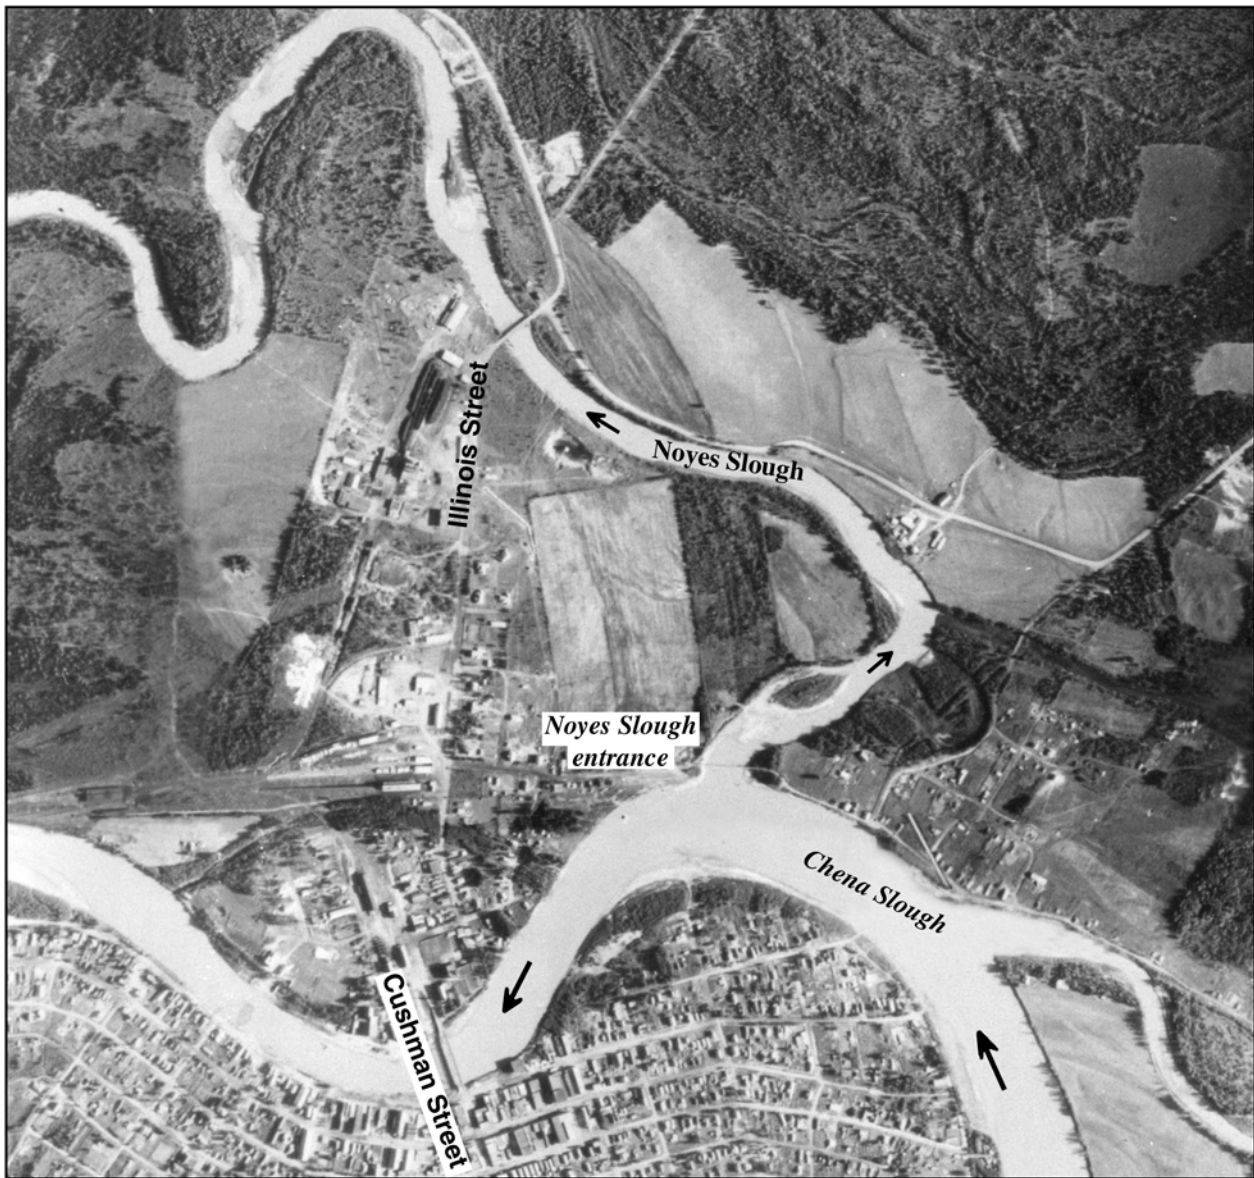
**Figure 4.** Noyes and Chena Sloughs near entrance to Noyes, also showing Illinois and Cushman Streets, Fairbanks, 1938. Light color of water indicates high suspended-sediment load from Tanana River's contribution to flow. Arrows indicate flow direction in sloughs. See figure 3 for location. Photograph courtesy of U.S. Army Corps of Engineers.

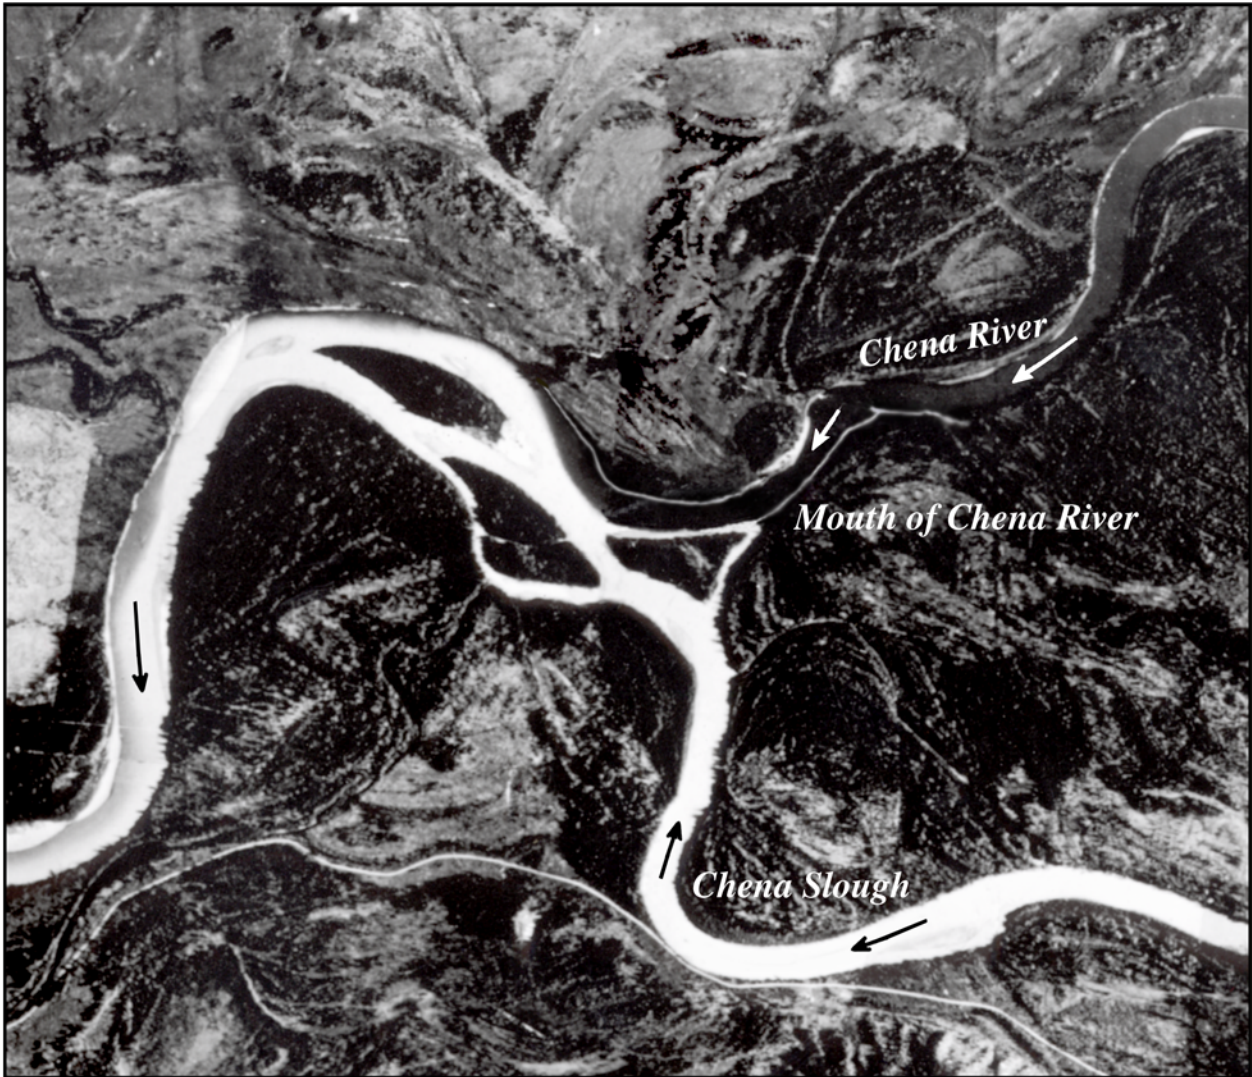
**Figure 5.** Mouth of Chena River on old Chena Slough about 7 miles east of Fairbanks, 1938. Silt-laden water of slough (light) contrasts notably with clear water of river (dark). Arrows indicate flow direction in slough and river. See figure 3 for location. Photograph courtesy of U.S. Army Corps of Engineers.

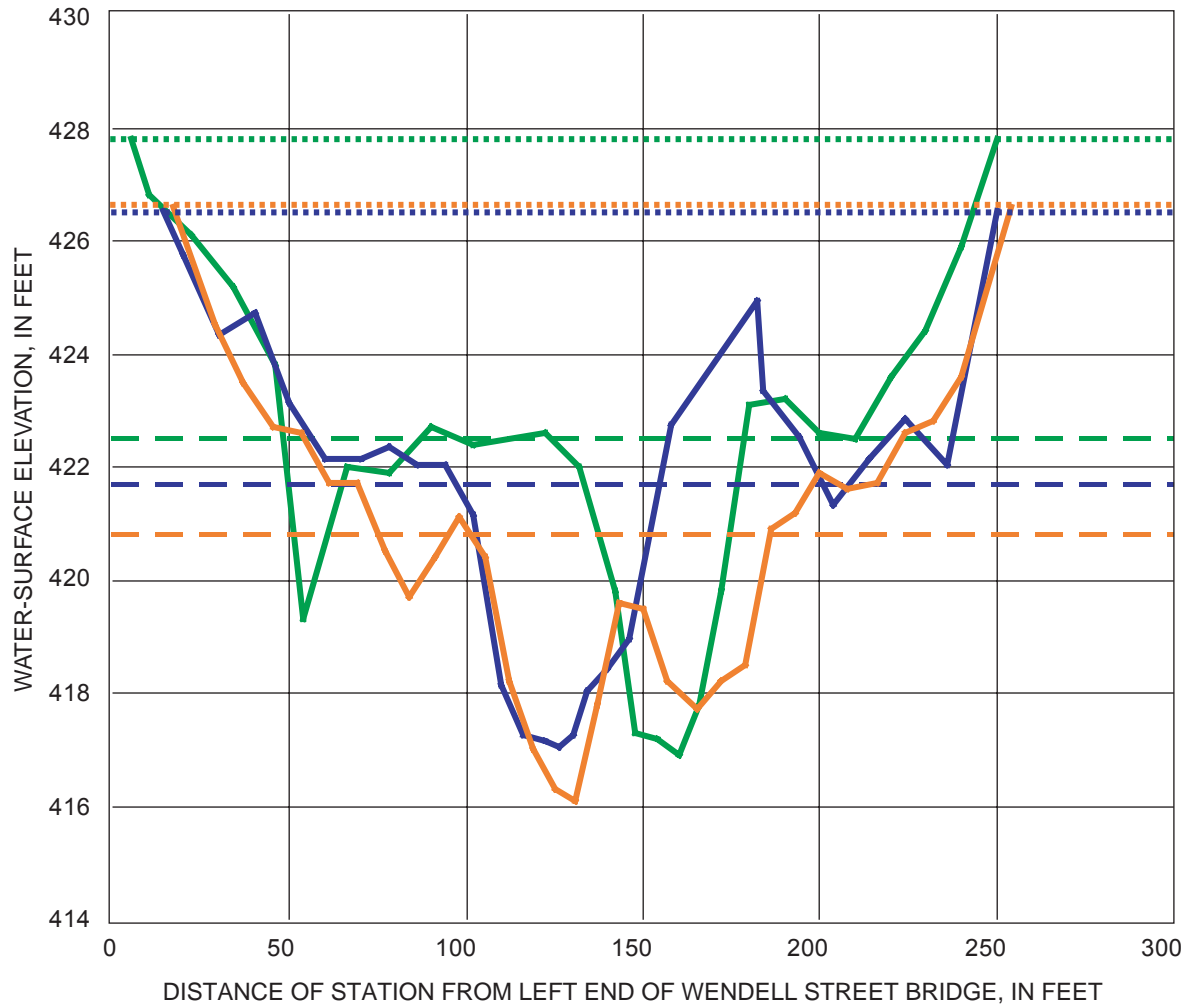
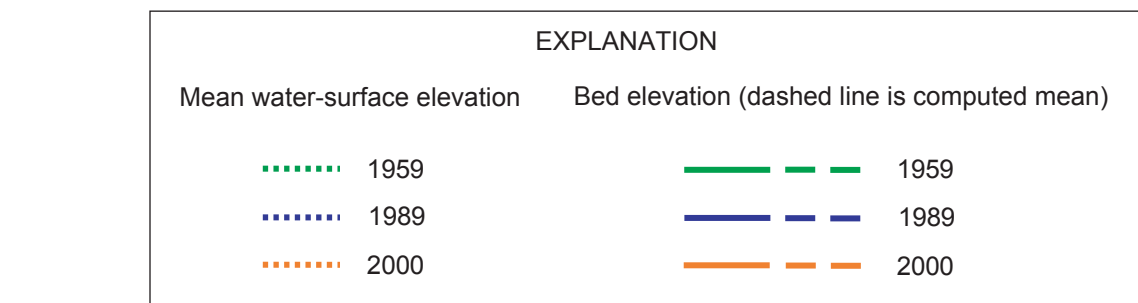
**Figure 6.** Cross sections for Chena River at Wendell Street bridge, showing mean water-surface and bed elevations on May 13, 1959, at discharge of 3,450 cubic feet per second; April 28, 1989, at discharge of 3,180 cubic feet per second; and May 3, 2000, at discharge of 3,270 cubic feet per second.

sible downstream effects is channel scour or degradation (Williams and Wolman, 1984). Channel cross sections measured at the Wendell Street bridge on the Chena River (immediately upstream from Noyes Slough) in 1959, 1989, and 2000 are shown in figure 6. Although the flows are about the same for the three years (3,450 ft<sup>3</sup>/s, 3,180 ft<sup>3</sup>/s, and 3,270 ft<sup>3</sup>/s, respectively), the main deep part of the channel broadened

and shifted to the left from 1959 to 1989. Further enlargement of the main channel and scouring of the thalweg occurred by 2000. These changes caused a lowering of the mean bed elevation and consequently a decline in water-surface elevation of about 1.8 ft (fig. 6).

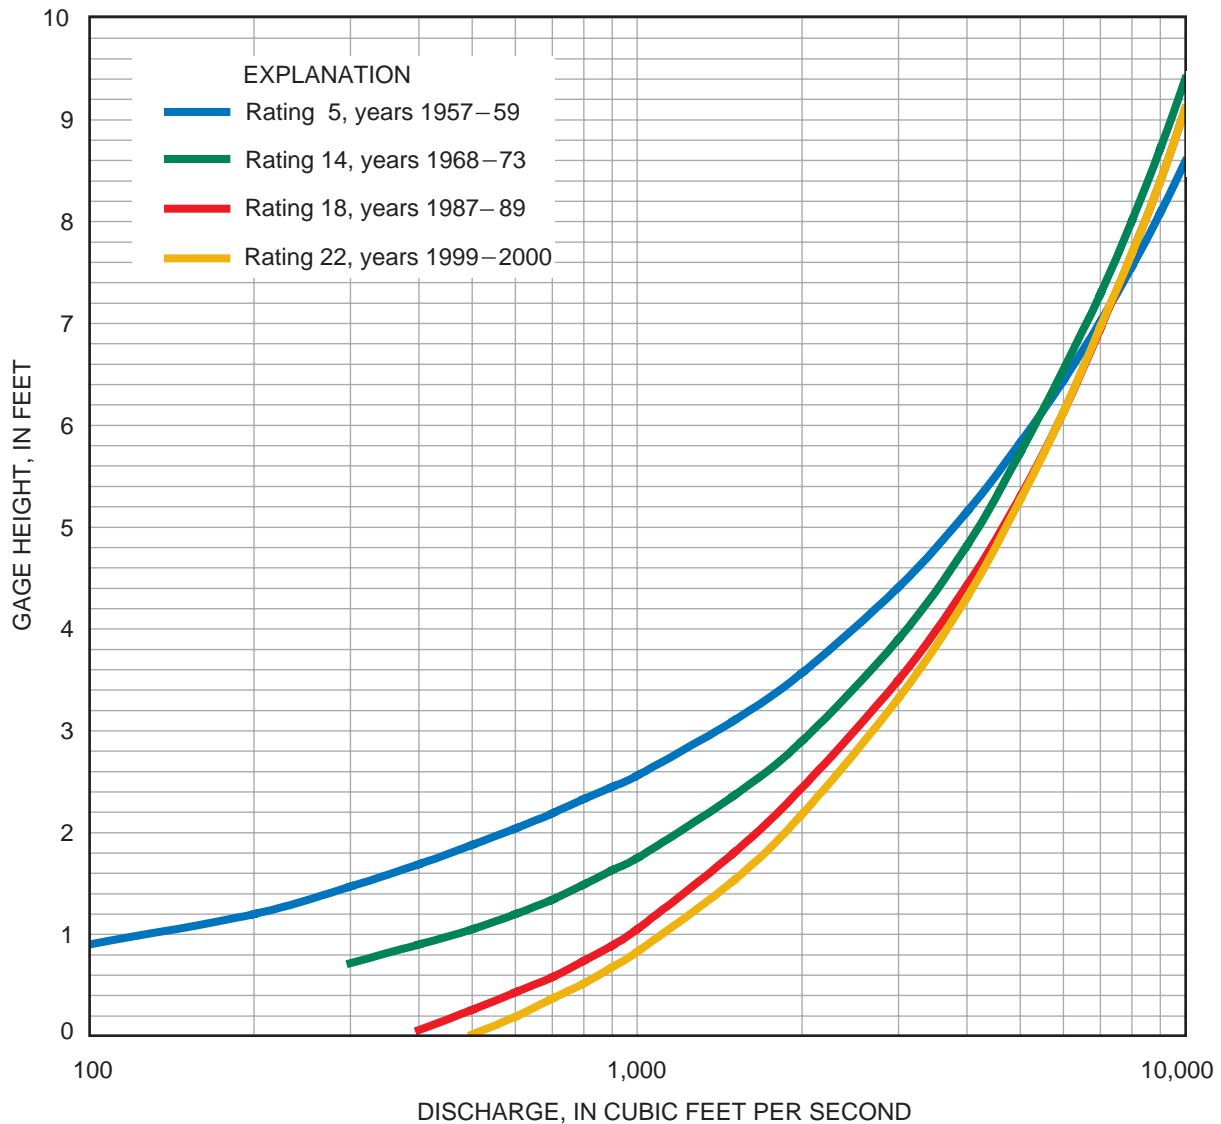
**Figure 7.** Rating curves for Chena River stream-gaging station, 1957–2000. (Gage datum, 422.92 feet above sea level.)

numbers 5, 14, 18, and 22) are shown in figure 7. No measured flow data are available for the Chena Slough prior to the construction of Moose Creek Dike. By 1957, the dike had been in place for about 10 years. Rating 5 was in effect during 1957–59. In 1967, the river flooded, and then rating 14 was in effect during 1968–73. Rating 18, in use 1987–89, reflected conditions after the Moose Creek Dam had been in effective operation. Rating 22 is the present-day stage–discharge relation.

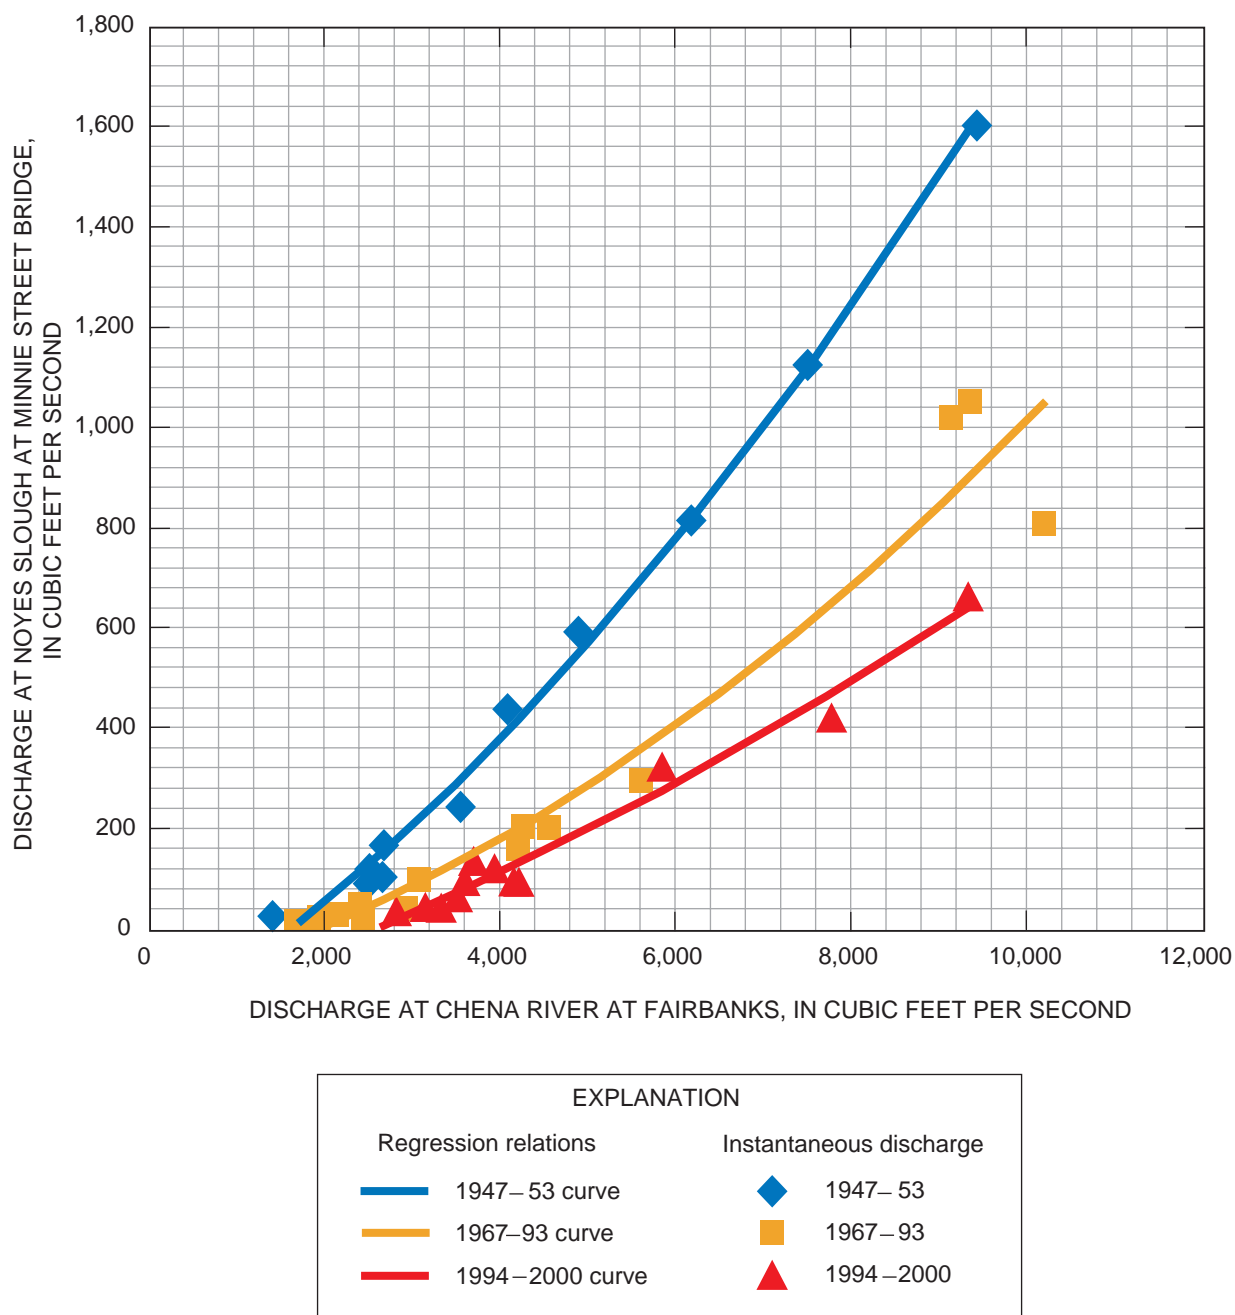
**Figure 8.** Relations between flows in Noyes Slough and Chena River for three periods during 1947–2000.

sponding regression relations are shown in figure 8. During 1947–53, when flow was about 2,400 ft<sup>3</sup>/s in the Chena River, flow in Noyes Slough was about 100 ft<sup>3</sup>/s, and when the flow in the river was about 1,600 ft<sup>3</sup>/s, the slough had almost no flow. During 1967–93, the same flow of about 2,400 ft<sup>3</sup>/s in the Chena River corresponded to a flow in Noyes Slough of only about 40 ft<sup>3</sup>/s, and when the flow in the river was about 2,000 ft<sup>3</sup>/s, the slough had almost no flow. To reach 100 ft<sup>3</sup>/s in Noyes Slough under present conditions, the Chena River must be flowing at about 3,800 ft<sup>3</sup>/s; when flow in the river drops below about 3,000 ft<sup>3</sup>/s, the slough has no flow. Because of regu-

In years when the slough receives little flow, trash and brush may accumulate and entrance conditions change. Conversely, as in the spring of 2000, when the slough receives significant flow, the obstructions are washed out and flow conditions in the channel improve. As flow in the Chena River recedes, the slough entrance again becomes an area of deposition, affecting the threshold at which flow begins to enter the slough; subsequently the entrance is scoured out again during another rise. This alternating pattern and the ground-water inflow and outflow likely account for the variation in the discharge measurements at lower flows (fig. 8).

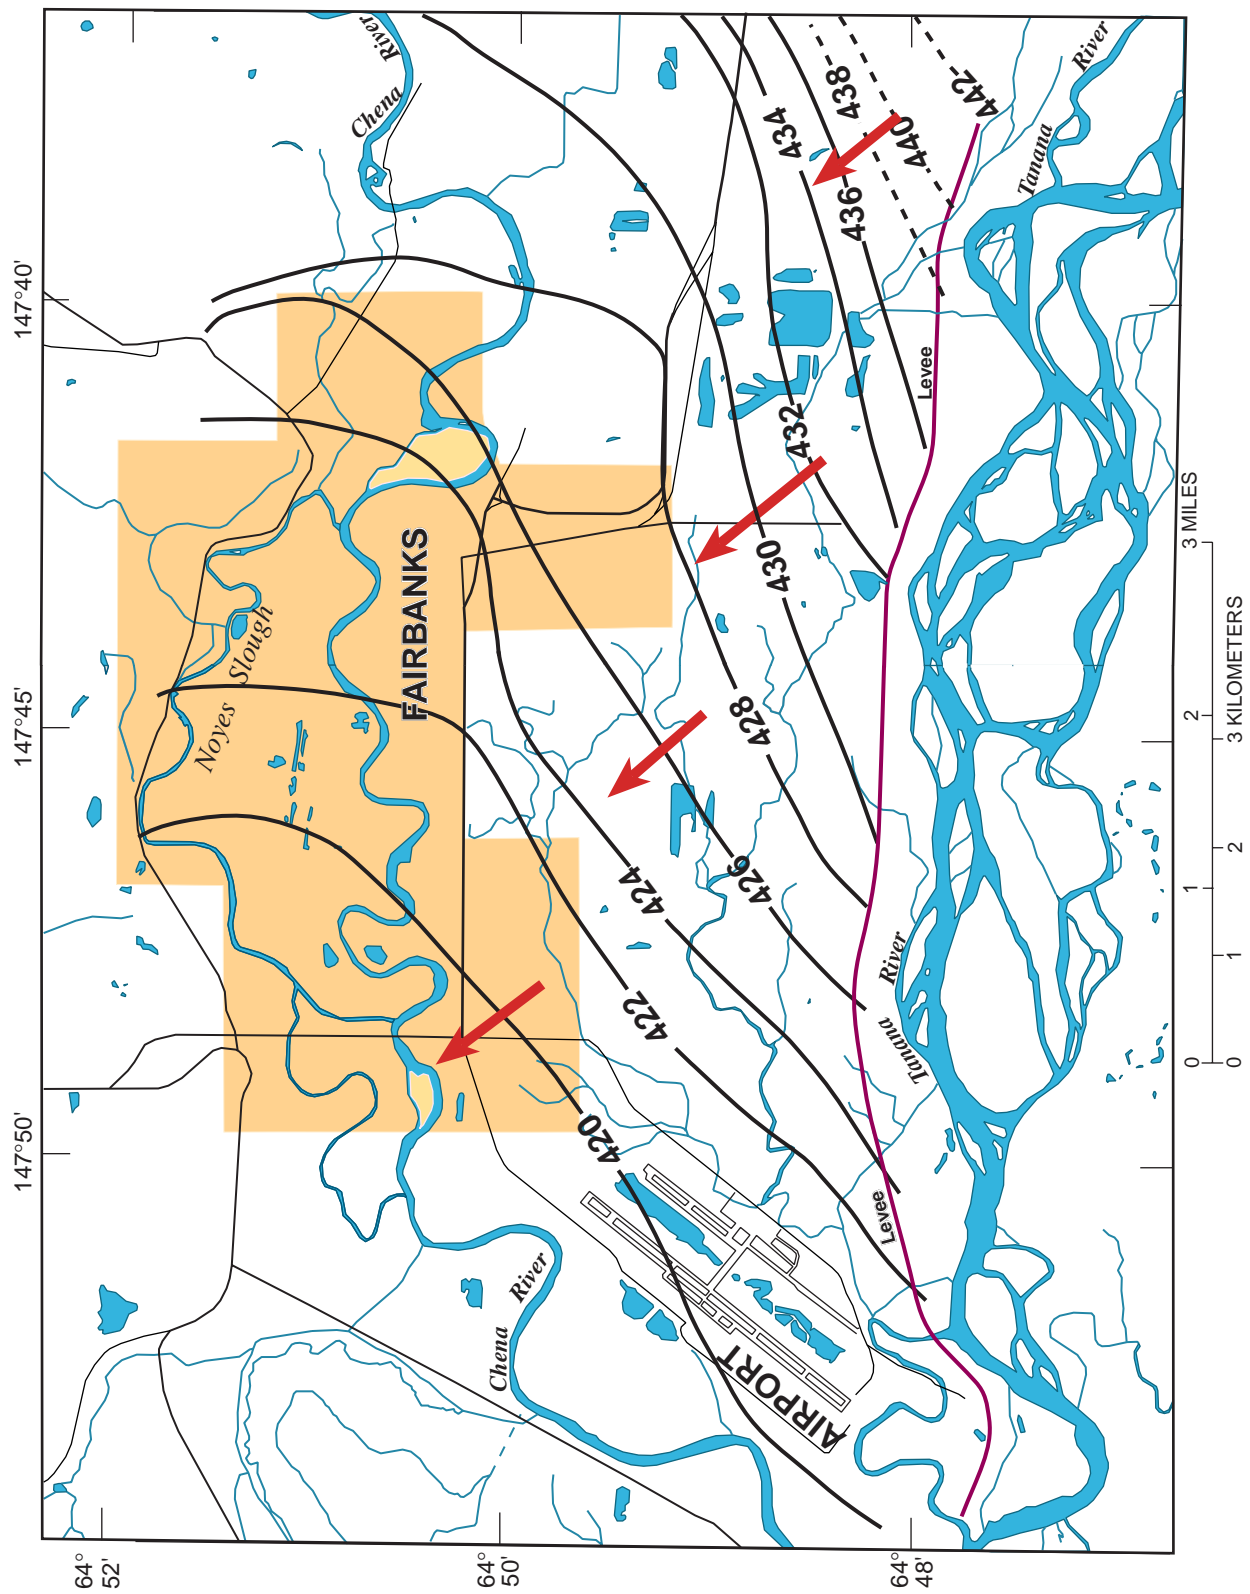
**Figure 9.** Water-table map of Fairbanks, showing ground-water elevations, in feet above sea level (contour interval, 2 feet), and flow directions (red arrows). Dashed contours indicate uncertainty. Modified after Glass and others (1996).

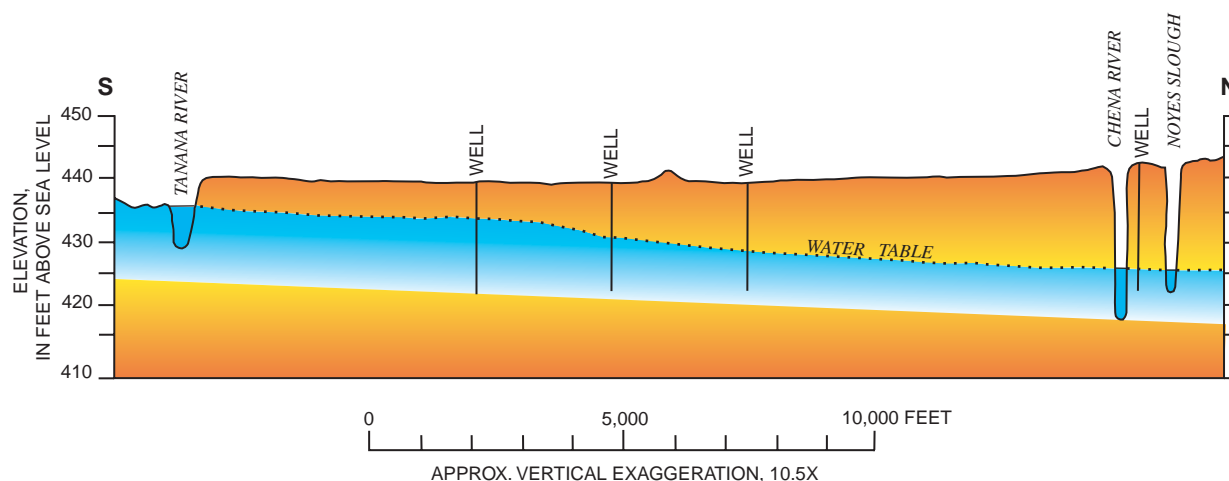
**Figure 10.** Geohydrologic cross section of Tanana–Chena alluvial plain, showing surface-water–ground-water interaction in vicinity of Tanana River, Chena River, and Noyes Slough. Modified after Nelson (1978).

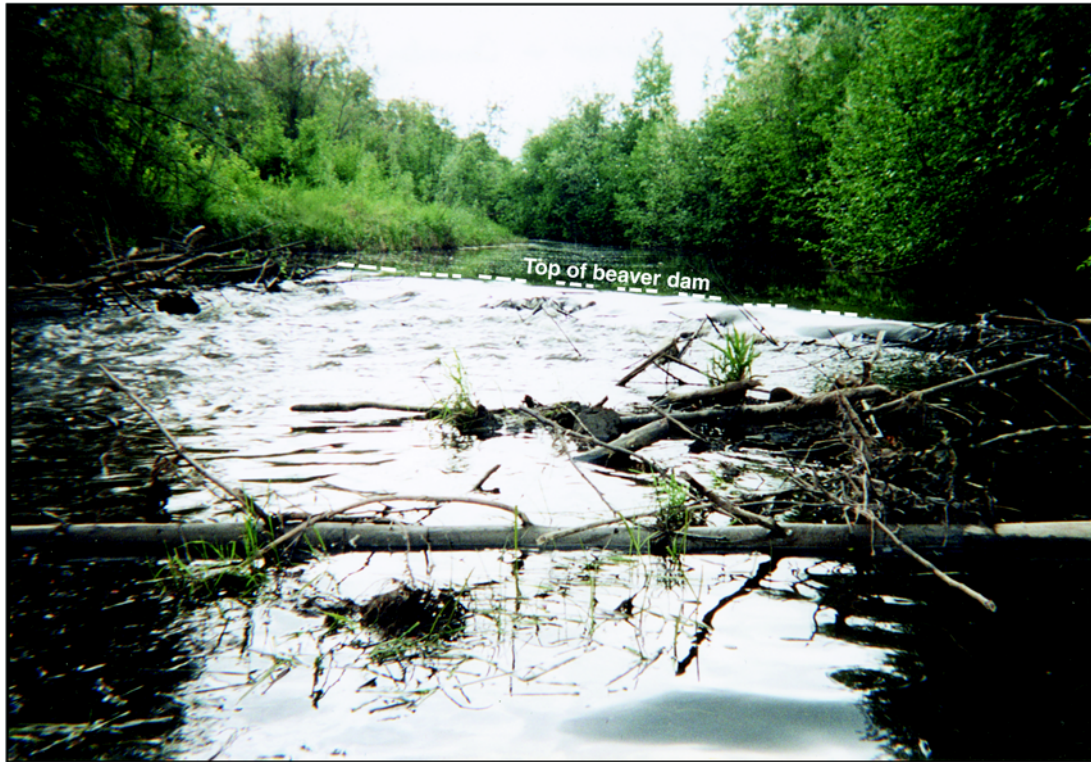
**Figure 11.** Noyes Slough looking upstream during period of flow in spring 2000, showing beaver dam (station 20209, fig. 14)

Photographs of the slough under different flow conditions are shown in figures 11 through 13. Also, the locations and dimensions of the 10 beaver dams along the length of the slough were determined and included in the model because they significantly affect water-surface elevations along the slough.

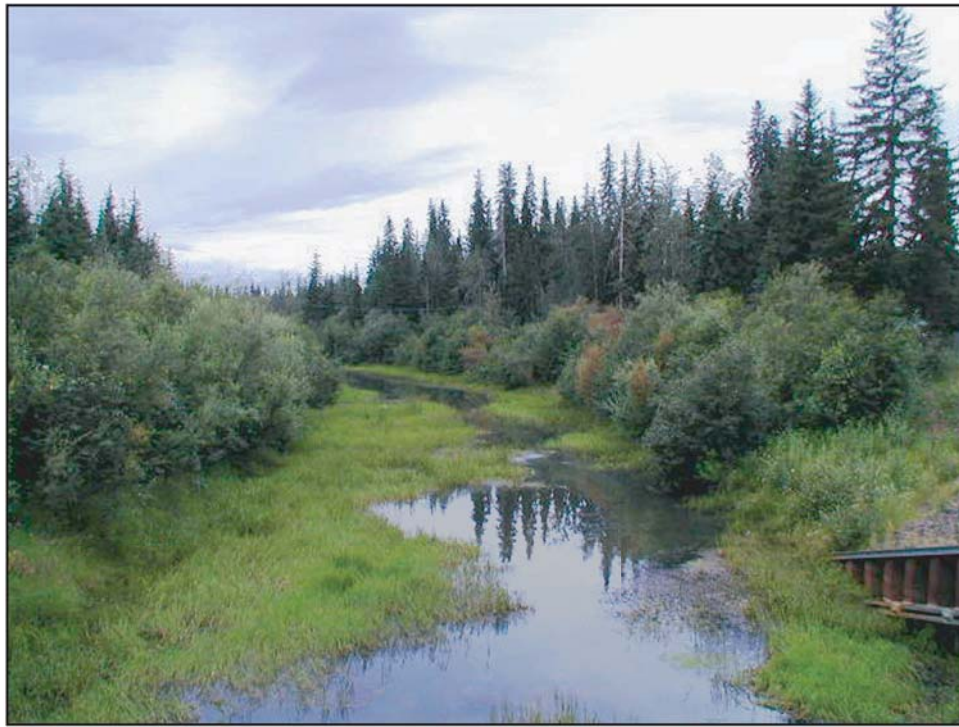
**Figure 12.** Noyes Slough looking downstream after flow ceased in midsummer 2000, at West Johansen Expressway bridge (station 2917, fig. 14).

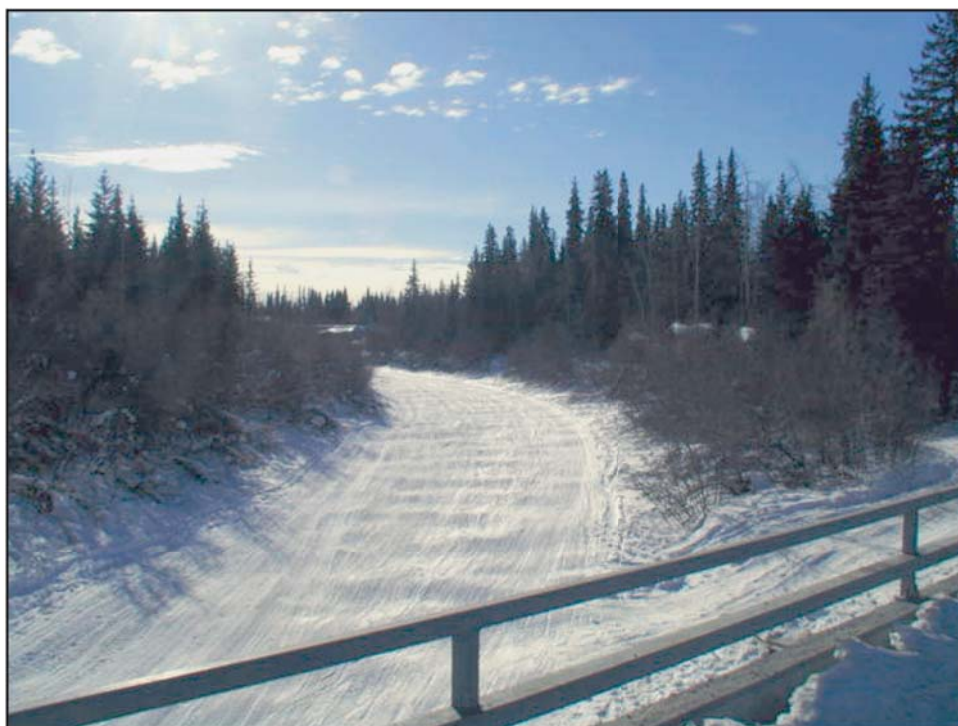
**Figure 13.** Noyes Slough looking downstream showing channel filled with snow and ice in late winter, at West Johansen Expressway bridge (station 2917, fig. 14).

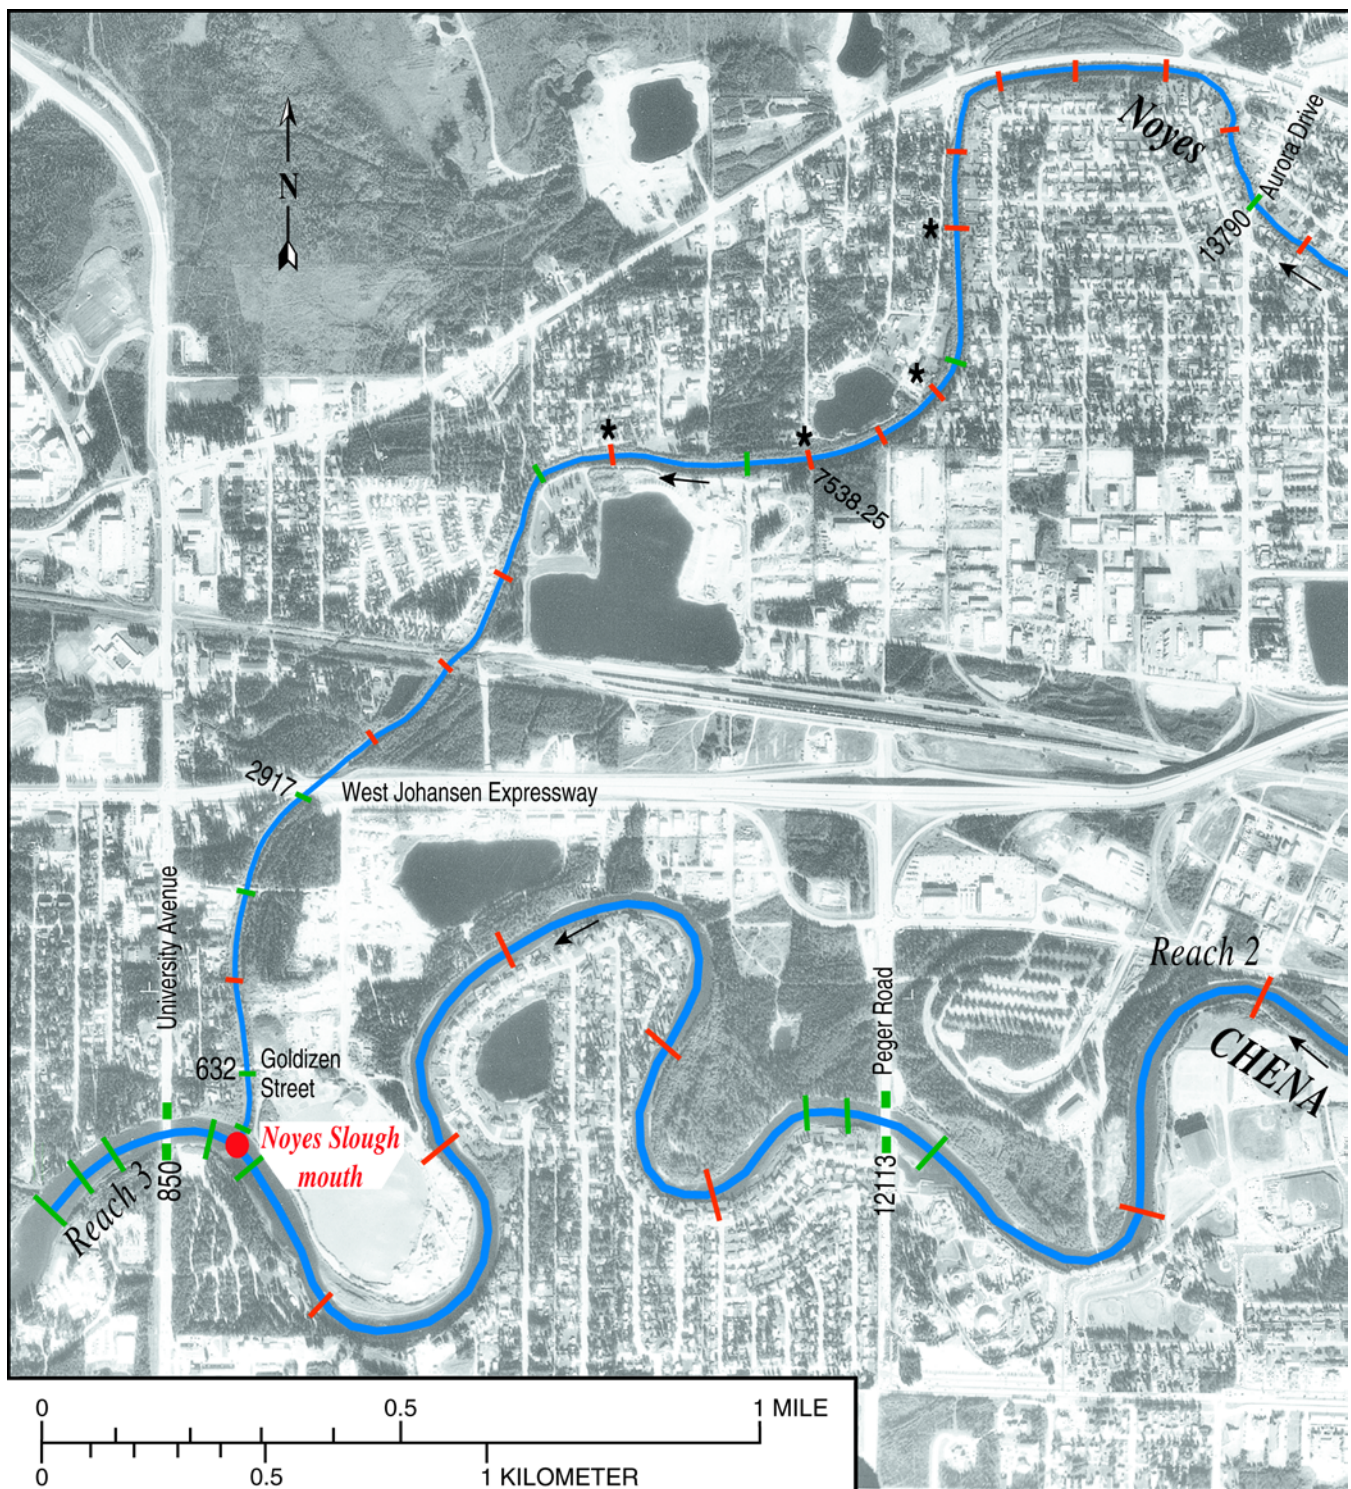
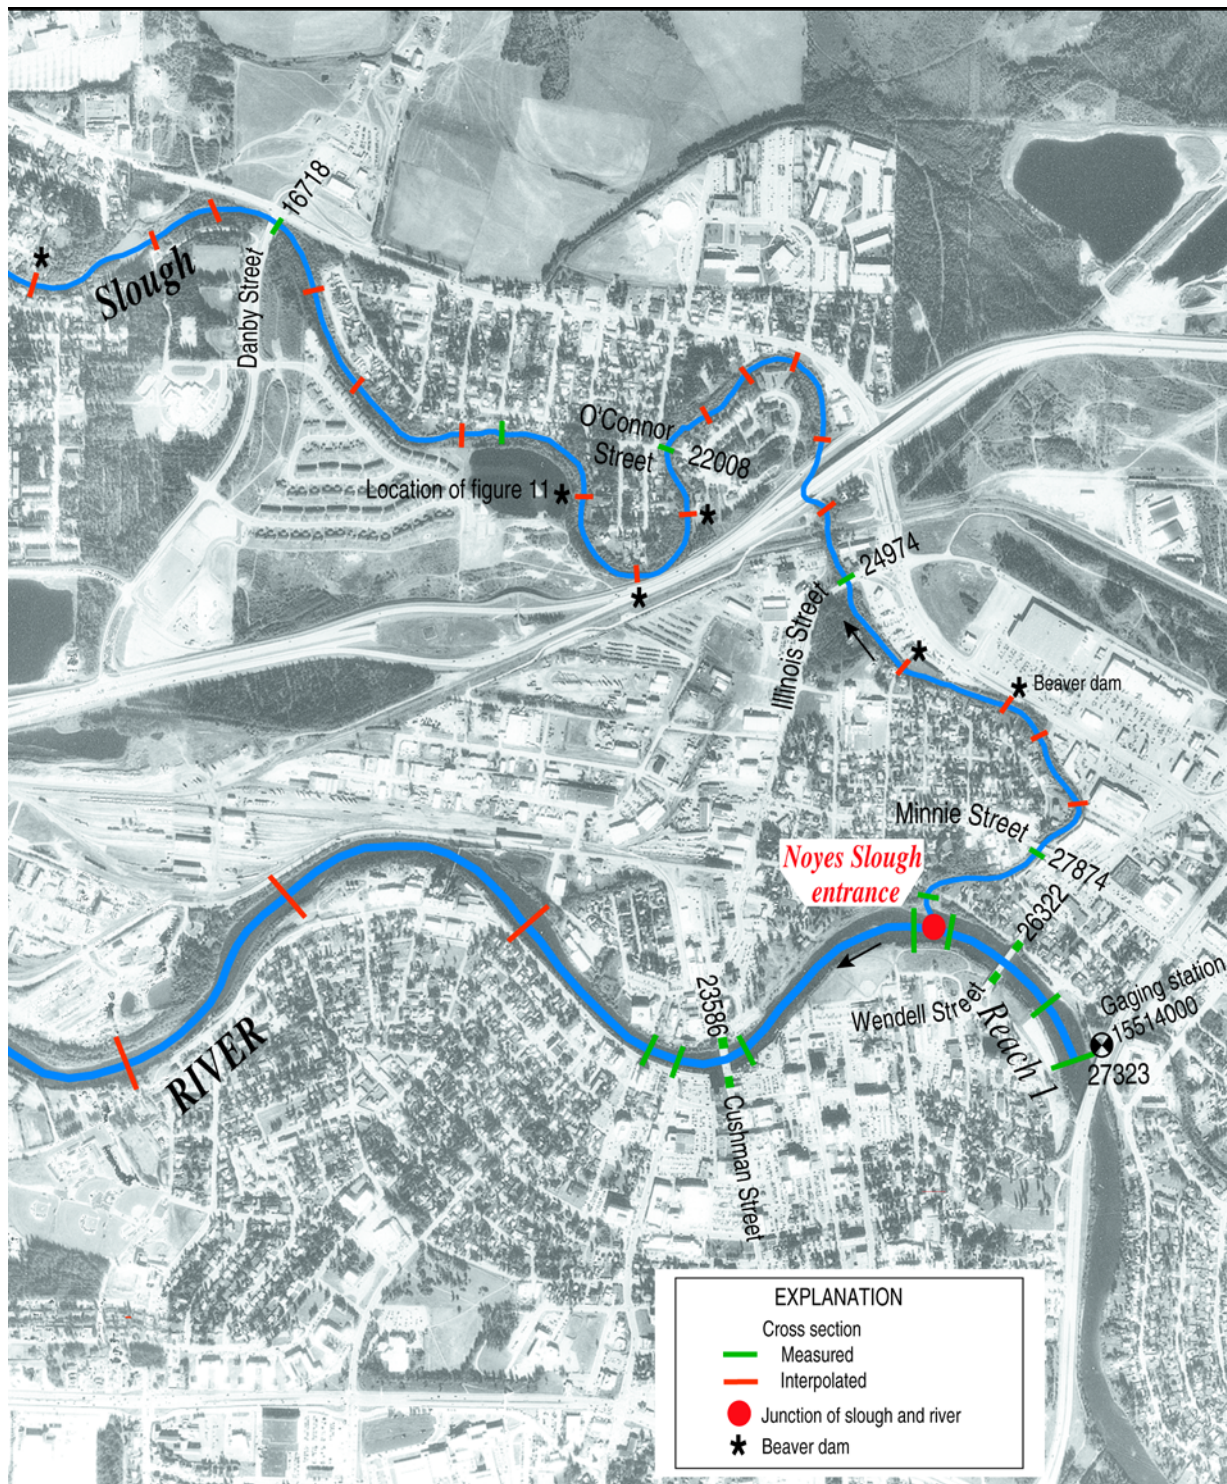
**Figure 14.** Study reach (fig. 1), showing locations of cross sections used in model, 10 beaver dams, and flow  
Aerial photograph courtesy of Natural Resources

directions (arrows). Scale is approximate. Numbers labeling some cross sections refer to stationing, in feet. Conservation Service; flown in 1996.

The slough was floated by canoe and the location of the beaver dams marked on a field copy of the photo image. The relative geometry of each beaver dam was measured by using a tagline and measuring depths and dam height relative to the channel bottom. The locations were established in the local-grid coordinate

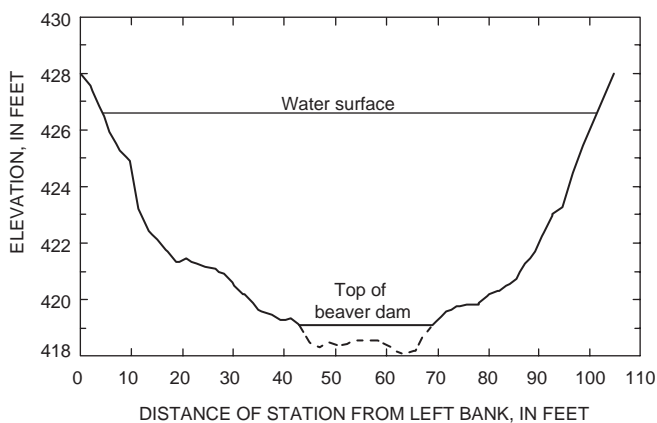
**Figure 15.** Example of cross section used in HECRAS model, showing channel and beaver dam on Noyes Slough (station 7538.25, fig. 14).

system used to construct the HECRAS model. The average height of the beaver dams then was used to modify the cross-sectional area at these sections and hence the channel geometry (fig. 15).
