# **Preliminary Hydraulic Analysis and Implications for Restoration of Noyes Slough, Fairbanks, Alaska**

**Water-Resources Investigations Report 00–4227**

*By* Robert L. Burrows, Dustin E. Langley, and David M. Evetts

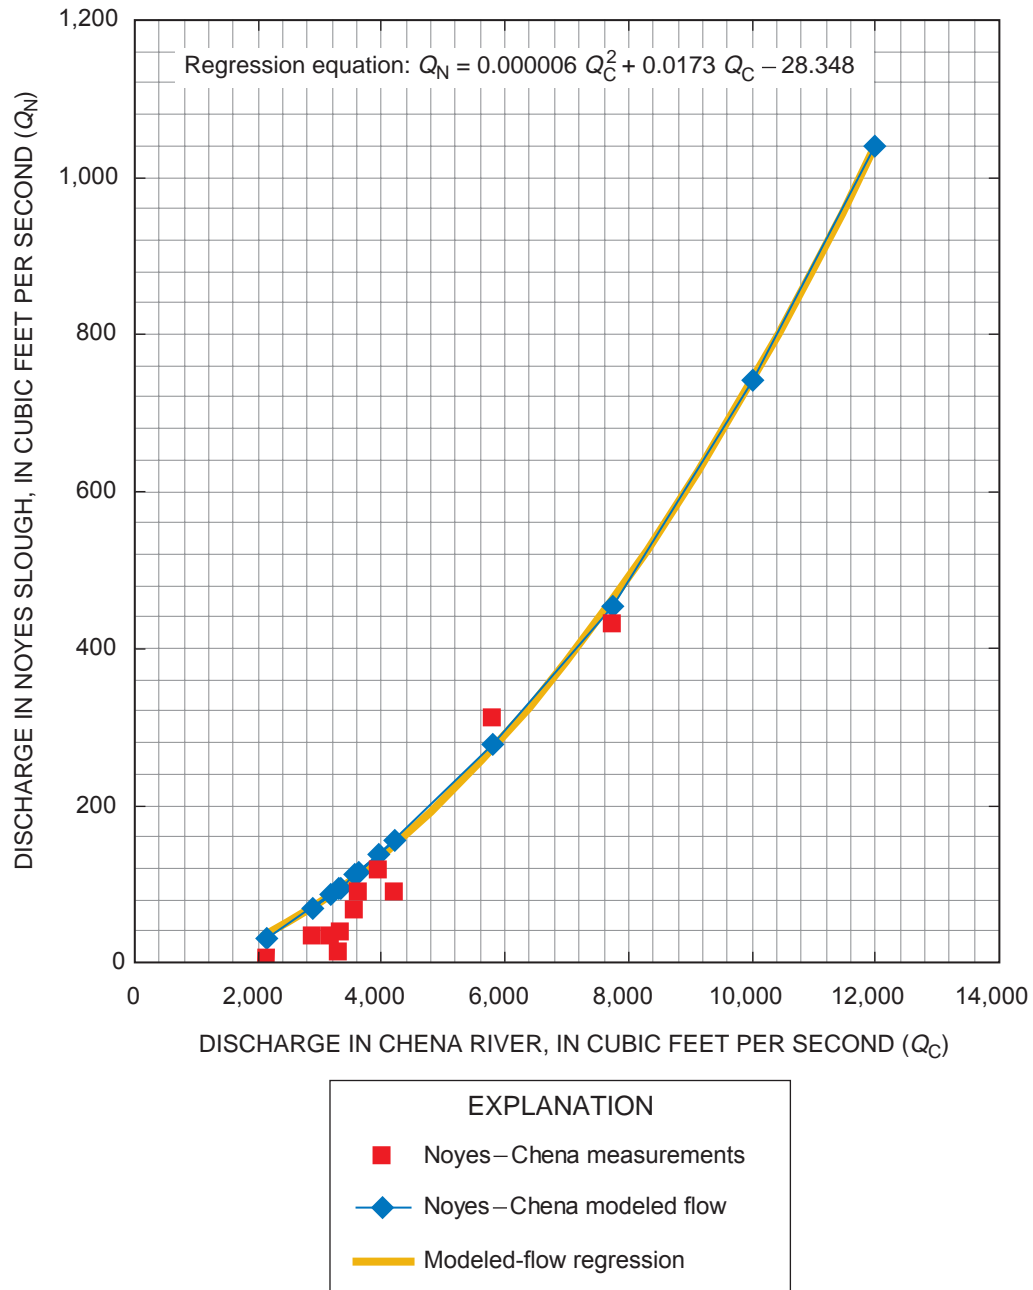
**Figure 16.** Regression relation between Noyes Slough and Chena River flows for present-day conditions as modeled by HECRAS and measured flows in slough (instantaneous) and river (mean daily).

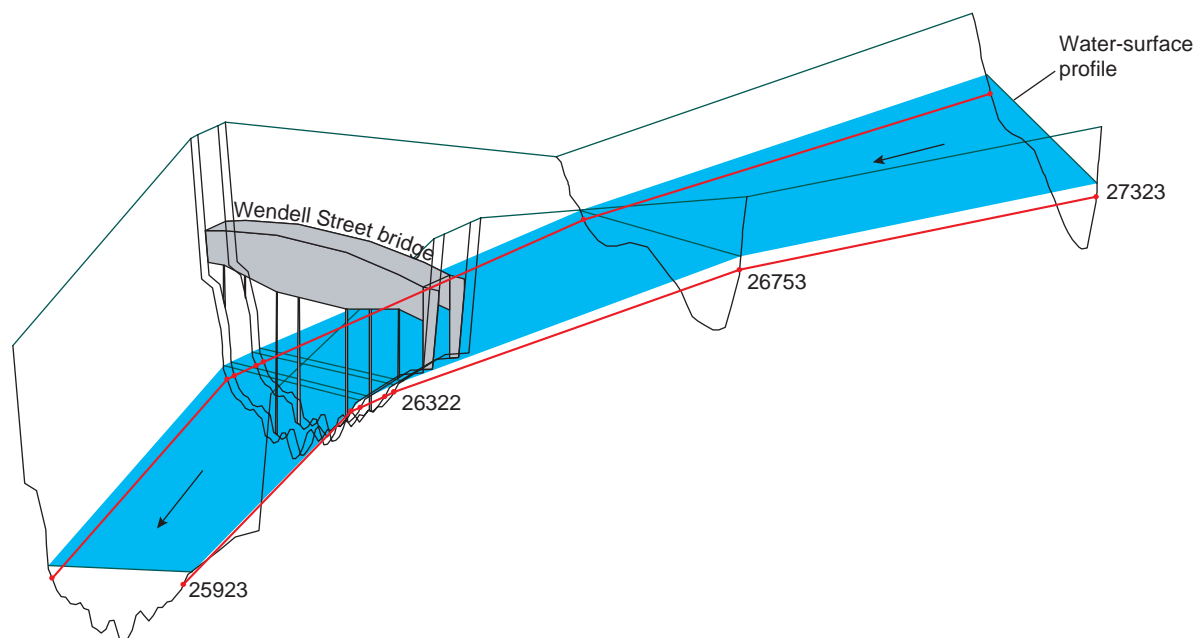
**Figure 17.** Example of HECRAS model output, showing water-surface profile (at flow of 2,000 cubic feet per second) for reach 1, Chena River through Wendell Street bridge, just upstream from entrance to Noyes Slough. Note differences in cross-section geometry of channel through reach. At points where red lines intersect channel, it was subdivided for different roughness (Manning's  $n$ ) values. Number labels refer to stationing, in feet.

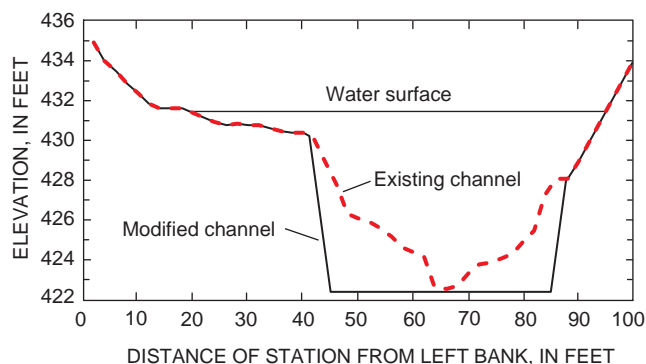
**Figure 18.** Cross-section geometry at entrance to Noyes Slough and modified channel configuration.

A channel 40 ft wide at the bottom, 2 ft deeper than at present, and having sides that rise 2 ft for every 1 ft of width would yield the additional area needed. Although such steep sides likely would be unstable, the actual width of Noyes Slough at the channel bottom is constrained to about 40 ft in some parts and thus would require steeper banks to gain the necessary increase in cross-sectional area. Assuming this geometry and a

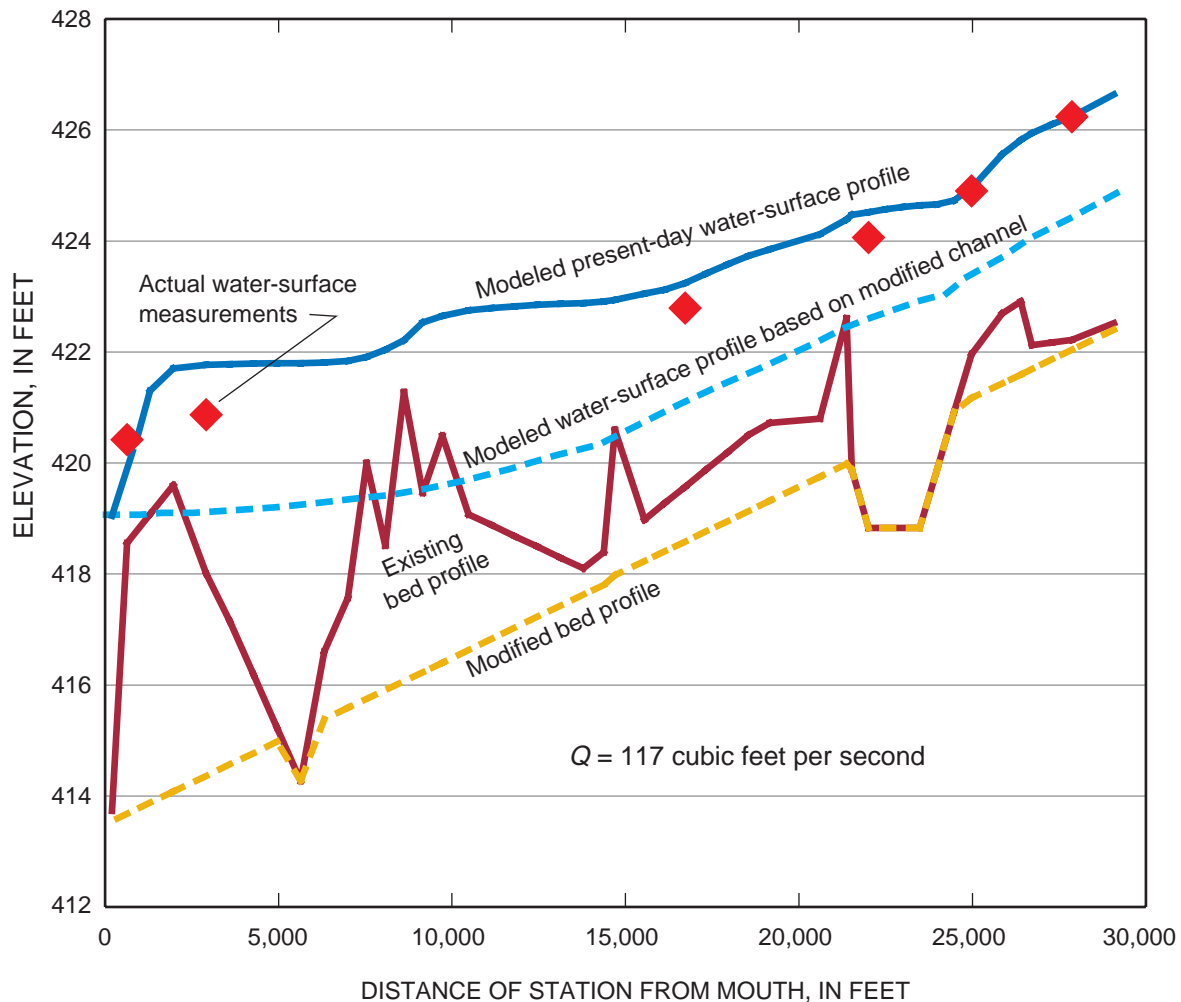
**Figure 19.** Measured and modeled water-surface and bed profiles at flow of 117 cubic feet per second in Noyes Slough, for present-day conditions and after channel modification.

Rerunning the model using the same modified-channel geometry, flows, and boundary conditions and optimizing the flow split produced a lower water-surface profile throughout the reach. Actual Noyes Slough channel-bed and water-surface profiles compared to modified-channel profiles, assuming a flow of 117 ft<sup>3</sup>/s, are shown in figure 19.

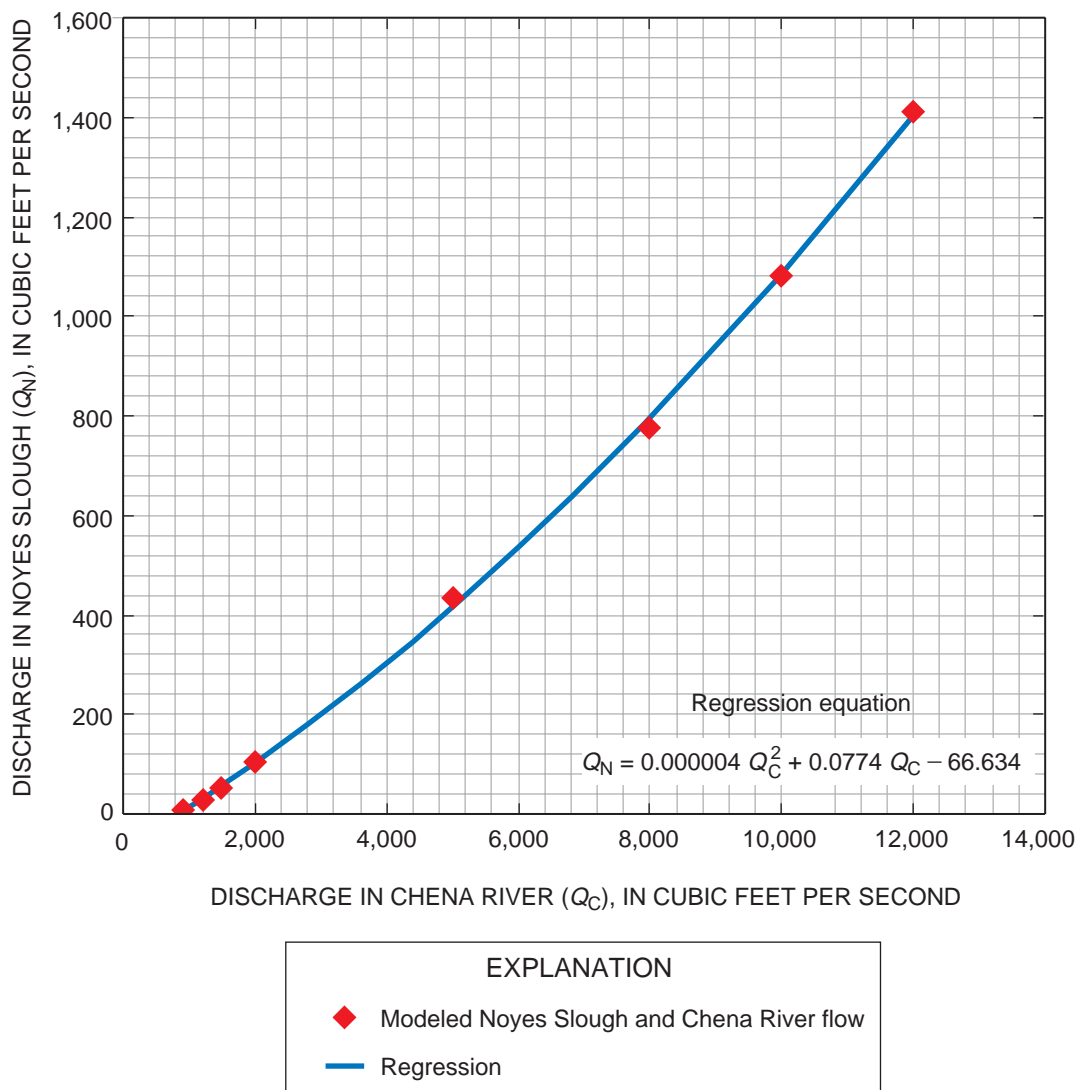
**Figure 20.** Regression relation between Noyes Slough and Chena River flows for modified channel conditions in Noyes Slough as modeled by HECRAS.

The regression relation between modeled flows in Noyes Slough and Chena River for the modified conditions in the slough are shown in figure 20. Flow in the slough begins at a flow of  $1,200 \text{ ft}^3/\text{s}$  in the Chena River (stage 1.08 ft, elevation 423.30 ft above sea level, rating 22; fig. 7). Hydrographs for the river (based on discharge data) and the slough (based on regression equations; see figs. 16 and 20) for water year 2000 are shown in figure 21. Hydrographs for Noyes

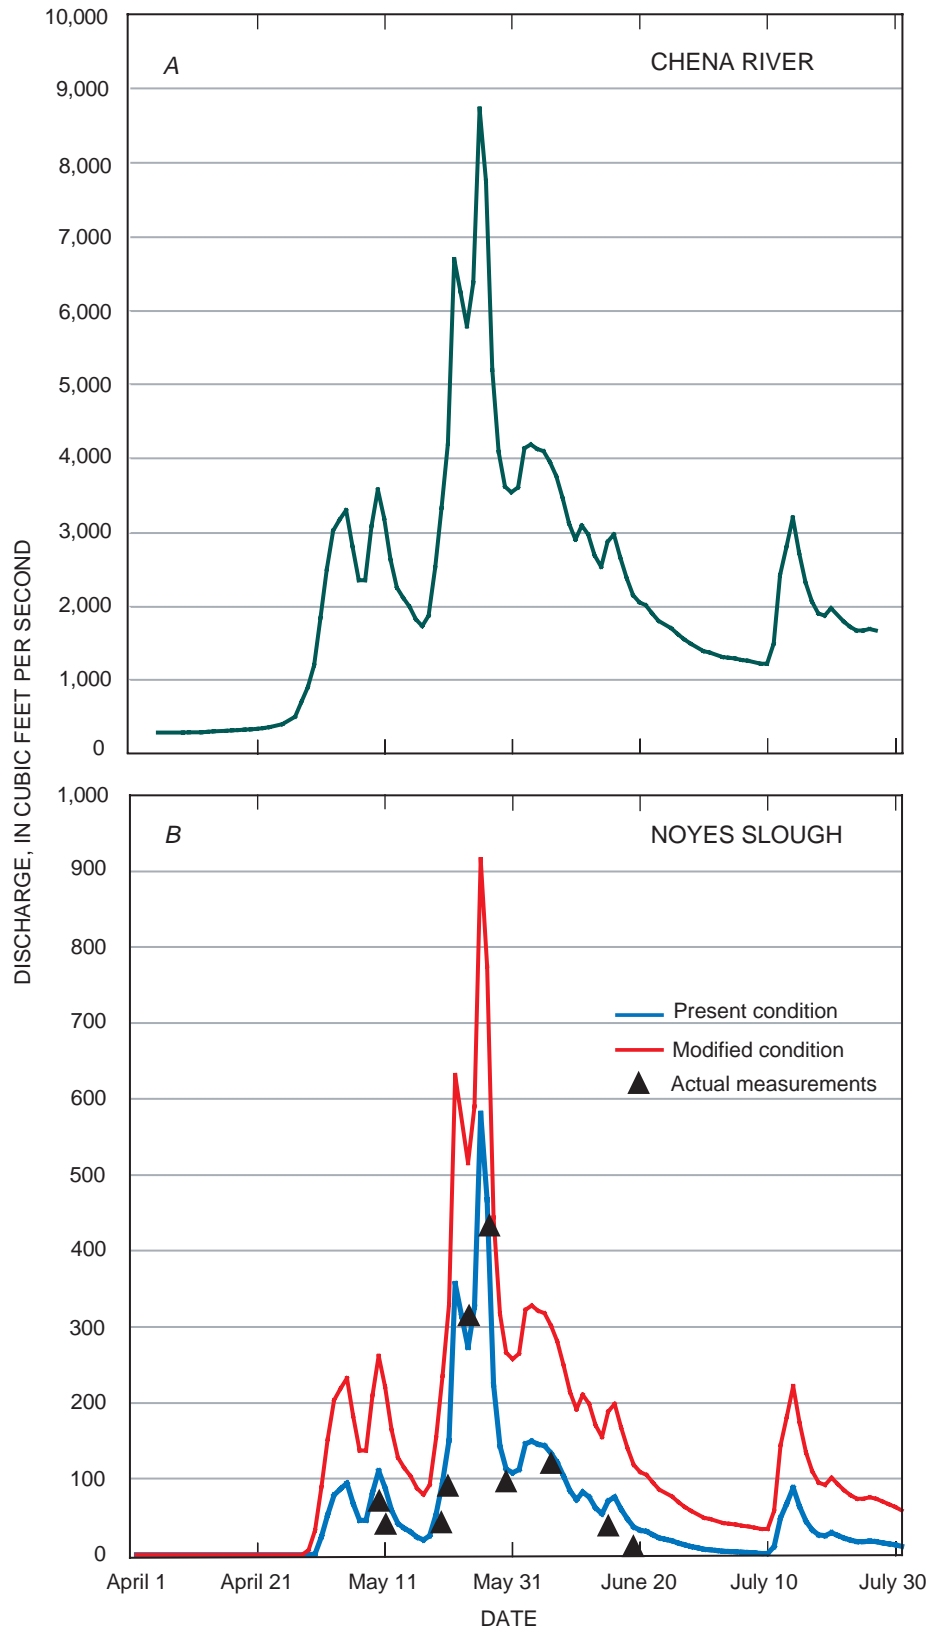
**Figure 21.** Hydrographs for period April 1–July 31, 2000. *A*, Chena River, from gaging-station records. *B*, Noyes Slough, computed from regression equations for existing and modified channel and also showing discharge measurements made in May and June.

Slough under existing and modified conditions show flow of increased magnitude and duration in the modified channel.

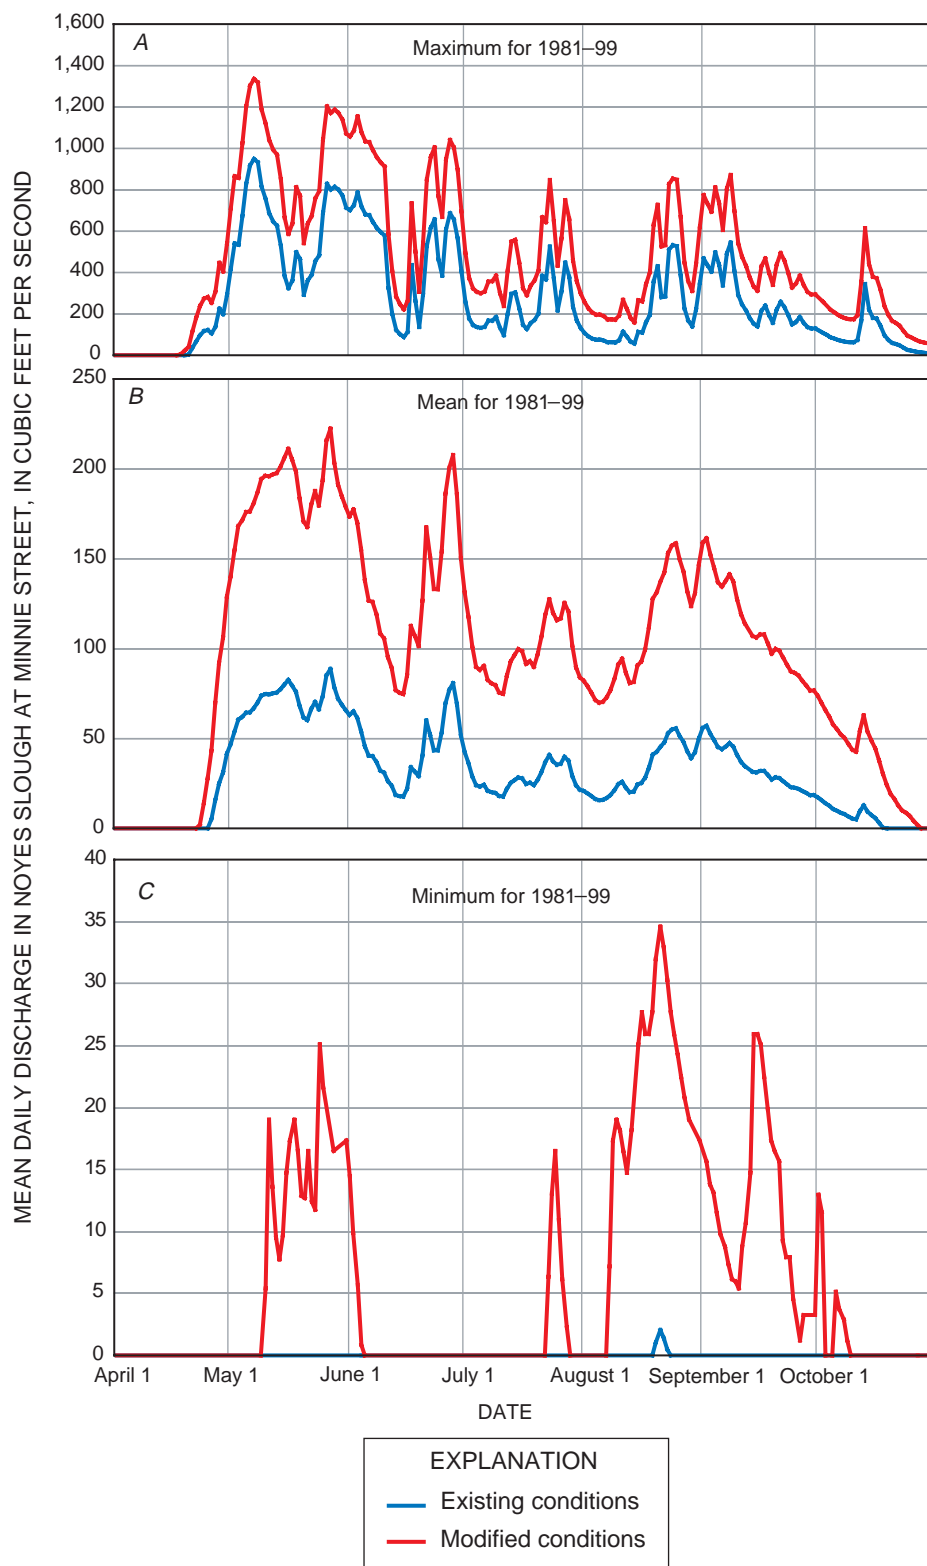
**Figure 22.** Estimated hydrographs for Noyes Slough for existing and modified channel conditions at maximum (A), mean (B), and minimum (C) mean daily flows in Chena River for period April 1–October 31, 1981–99.

For the period April 1–October 31 of water years 1981–99, the maximum, mean, and minimum of the mean daily flows for the Chena River (table 3) were used to construct three theoretical periods of flow. In turn, these Chena River conditions were used to compute theoretical maximum, mean, and minimum hydrographs for modified Noyes Slough (fig. 22) from regression equations.

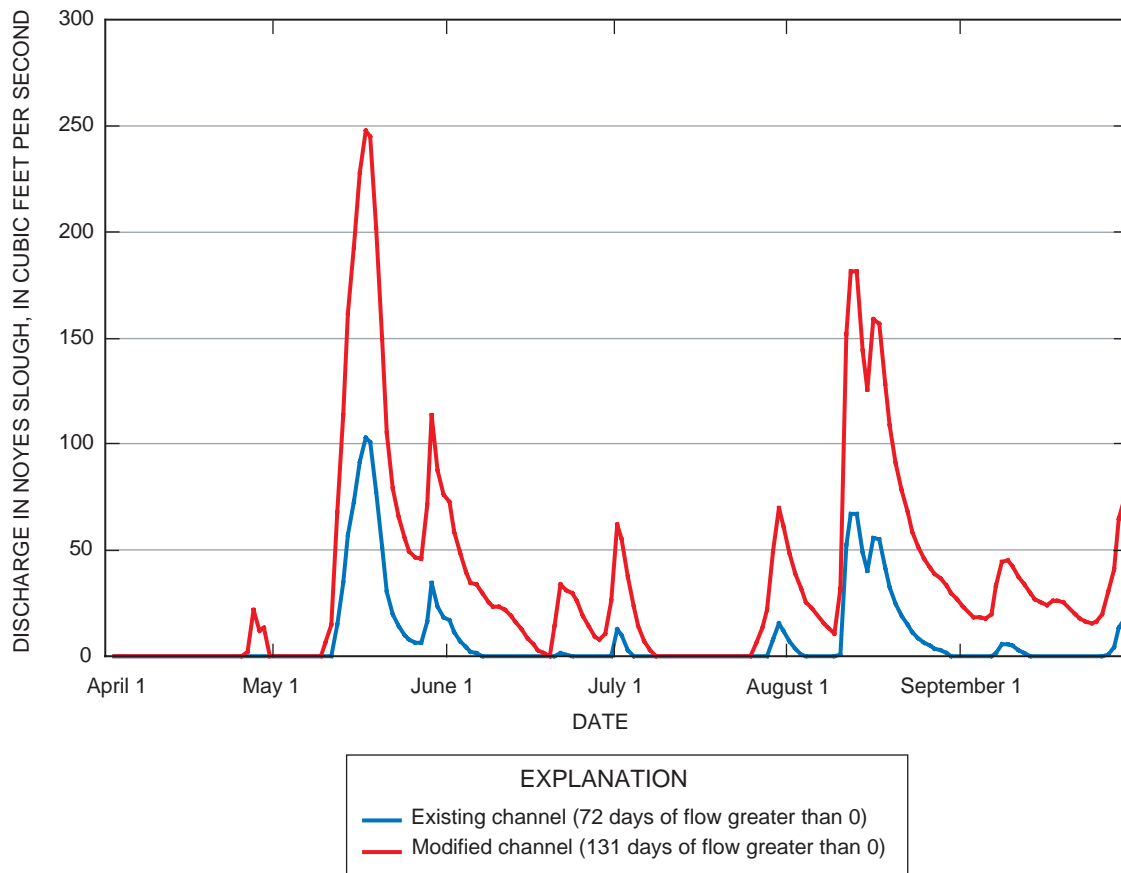
**Figure 23.** Estimated hydrographs for Noyes Slough for period April 1–September 30, 1999, for existing and modified channel conditions.

River at Fairbanks during water year 1999, a relatively low runoff year, was 809 ft<sup>3</sup>/s, or only about 60 percent of the mean for the period of record. The computed hydrographs for Noyes Slough for water year 1999 are shown in figure 23. Increasing the channel capacity and lowering of the bed would have increased flow duration from 72 to 131 days.
