# Advanced High Temperature Structural Seals

Charles W. Newquist, Juris Verzemnieks, Peter C. Keller, Michael Rorabaugh,  
and Mark W. Shorey  
The Boeing Company, Seattle, Washington

Prepared under Contract Number F33615-95-D-3203,  
Delivery Order No. 0014

This program addresses the development of high temperature structural seals for control surfaces for a new generation of small reusable launch vehicles. Successful development will contribute significantly to the mission goal of reducing launch cost for small, 200 to 300 pound payloads. Development of high temperature seals is mission enabling. For instance, ineffective control surface seals can result in high temperature (3100 °F) flows in the elevon area exceeding structural material limits. Longer sealing life will allow use for many missions before replacement, contributing to the reduction of hardware, operation and launch costs.

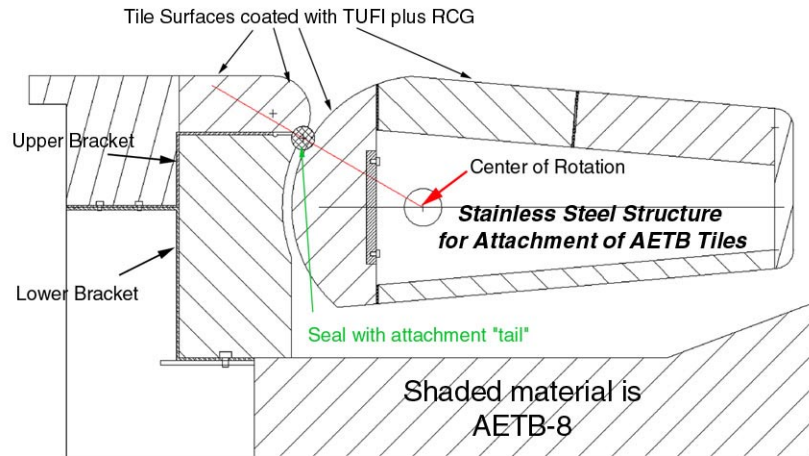
**Figure 1.—Cross Section of Arc-Jet Test Fixture Highlighting AETB Tile.**

The test fixture consists of a water-cooled copper box containing a stainless steel movable elevon section that is covered with AETB tiles. Figure 1 shows a cross-section drawing of the fixture indicating the tiles with shaded blocks. The two photographs of Figure 2 are of (a) the mock-up article that was made for fit-up trials and b) the mock-up article in the arc-jet facility.

*This Entire Assembly Fits Into A Water-Cooled Copper Box*

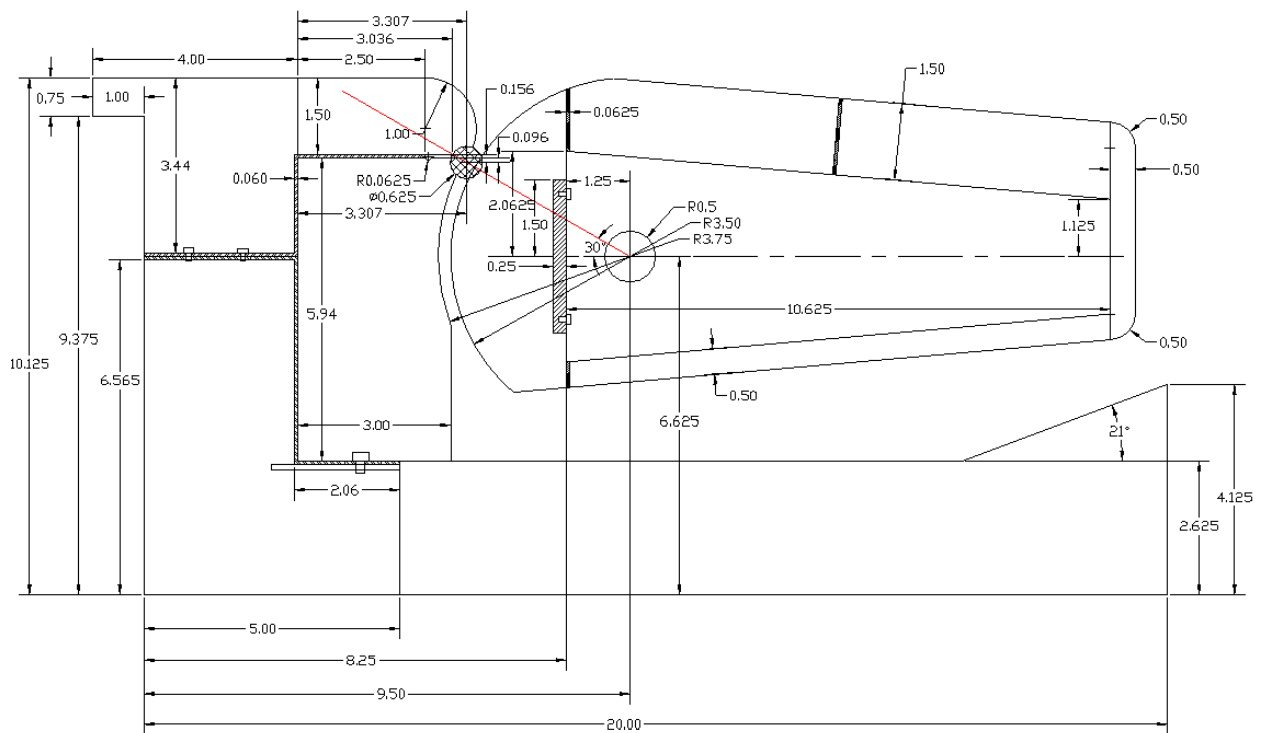
**Figure 3.—Arc-Jet Test Fixture Dimensional Drawing.**

Figure 3 is a dimensioned drawing of the fixture, and Figures 4 and 5 are the upper and lower brackets that were modified at NASA ARC after a late design change. This design change was needed to accommodate the adjustable seal gap as well as elongated holes for the stainless steel pressure tap tubes and thermocouple wires. Figure 6 is a more detailed view of the area in which the test seals are installed. The seal cross-section is actually compressed (*not circular as shown in the drawing*) into the gap against the curved nose of the movable elevon. The seal compression for all of the runs for the standard 0.25-inch gap was designed to be a nominal 20% diametrically. The compression for the 0.375-inch gap was to be slight contact.

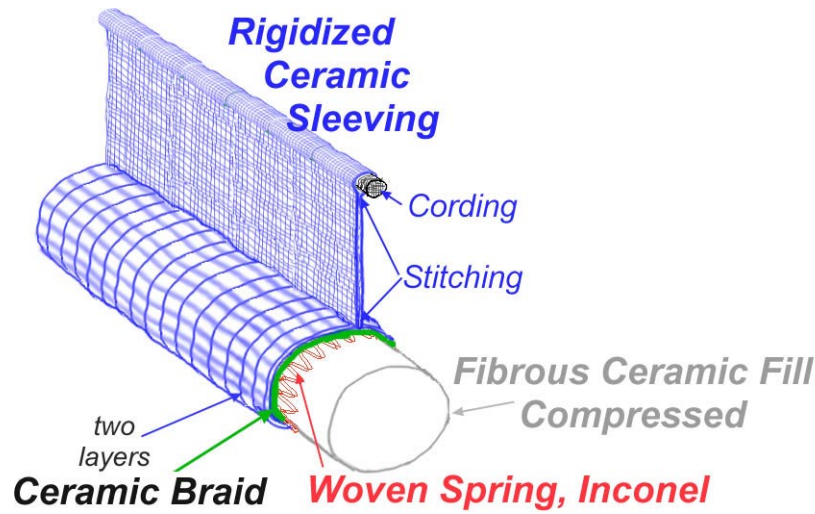
**Figure 14.—Single Bulb Seal Construction Details.**

Attachment of bulb seals to the thermal protection system structure is very important. A method of attachment that is 100% ceramic was selected. This method uses the basic bulb seal element combined with braided fiber products; then finished with a selective rigidization using a proprietary Boeing ceramic coating/matrix material. This construction is shown in the drawing of Figure 14.

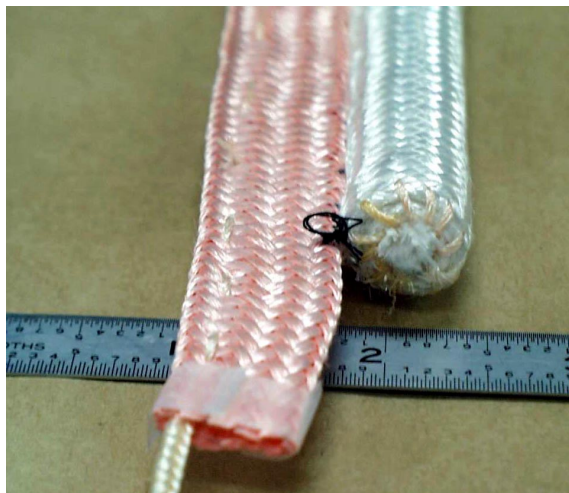
**Figure 15.—End View of Seal Assembly Showing End Closure and Attachment “Tail” Prior to Sizing Burnout.**

The stitching used to secure the attachment tail to the bulb seal can barely be seen in Figure 15. The ends of the attachment sleeving (the pink material) will be trimmed to the proper length after the rigidization process is complete. Figure 16 shows another end view of the seal assembly. The

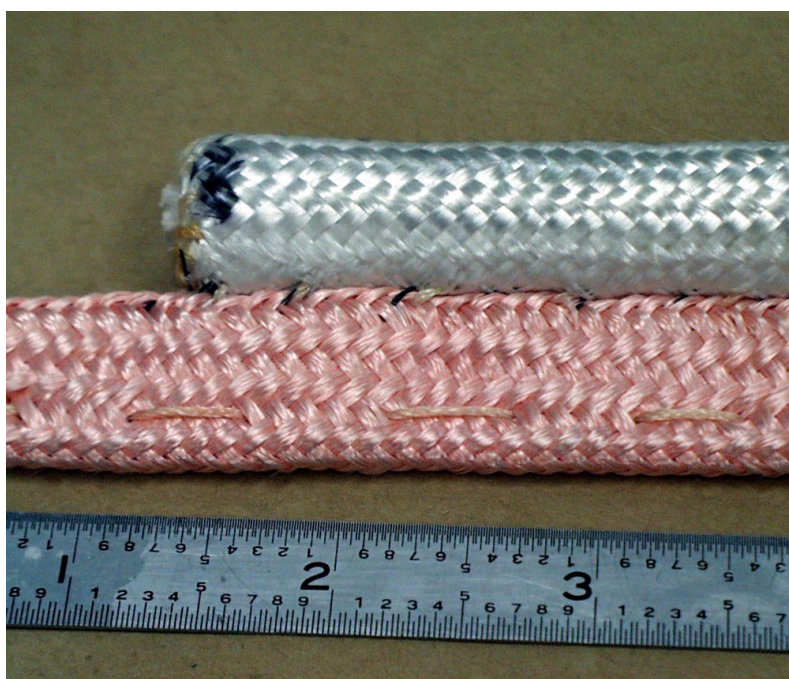
**Figure 16.—Another End View of Seal Assembly Showing End Closure and Attachment “Tail” Prior to Sizing Removal.**

black thread in the figure is cotton and was used as a temporary fabrication aid. It disappears during the sizing removal process. The photo in Figure 16 also shows a black marking of ink from the fabrication sequence.

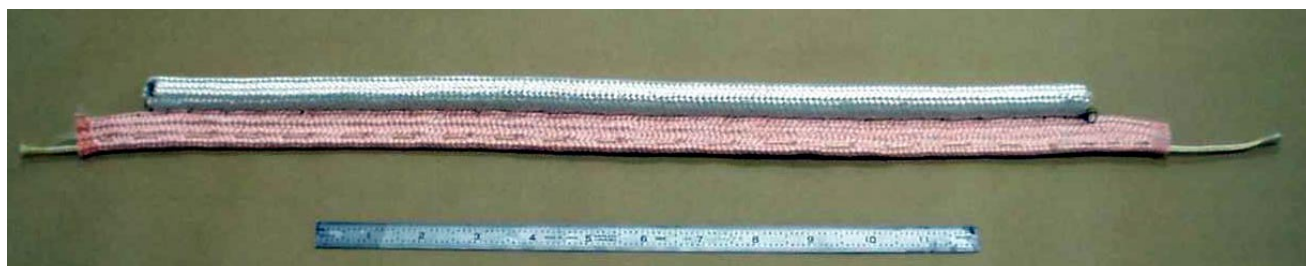
**Figure 17.—Typical Seal Assembly Ready for Sizing Removal.**

Figure 17 shows the entire seal assembly prior to being placed into a furnace for the removal of the sizing. The temporary cotton basting thread and Scotch™ cellophane tape fabrication-aids are also shown.

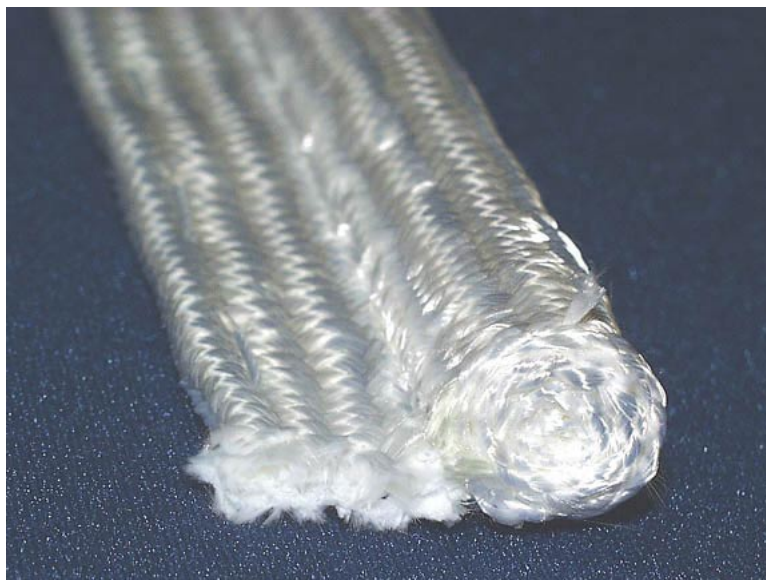
***Figure 18.—End View of a Typical Seal Assembly After Sizing Removal,  
But Prior to Rigidization of the “Tail.”***

Figure 18 shows the end of a typical seal and the trimmed attachment “tail.” Figure 19 is a collection of the seal assembly and the two tooling articles used for forming the tail and keeping the bulb and the “tail” properly aligned.

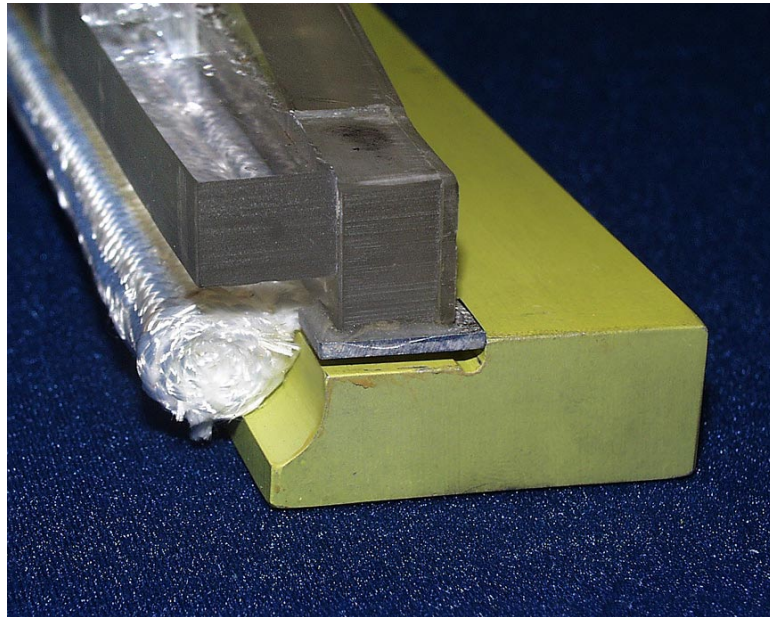
***Figure 20.—End View of a Seal Assembly Placed onto the Tooling for Rigidization.***

Figure 20 is a photograph of the end of the tooling article. The metal pad under the acrylic piece is a spacer that defines the thickness of the attachment “tail.” The ends of the acrylic section are clamped to the painted aluminum base to compress the tail as seen in Figure 21. The close-up photo of Figure 22 is a more detailed view of the slurry infiltration process. The acrylic was used so that we could see how far the slurry had wicked into the tail section. Slight wicking into the bulb exterior was allowed. However, on one seal the slurry wicked into the exterior braid of the bulb over approximately 1/3 of the seal length (test seal #3).

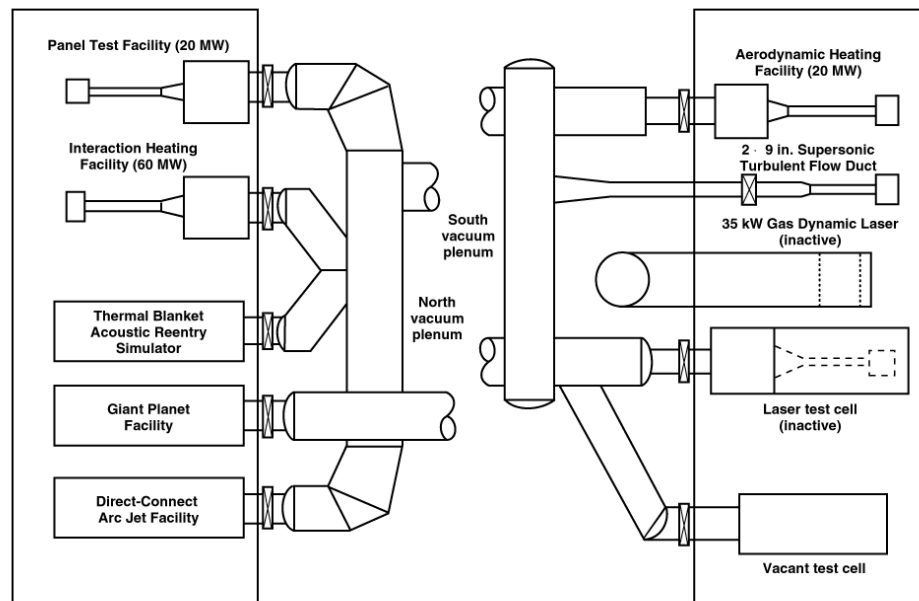
**Figure 23.—The Test Bays in the Arc-Jet Complex.**

The 20-MW Panel Test Facility (PTF, upper left in Figure 23) was the facility chosen for the Spaceliner 100 Control Surface Seal Evaluation test program. This arc jet test is part of a test program to evaluate control surface seals concepts for 3<sup>rd</sup> Generation reusable launch vehicles.

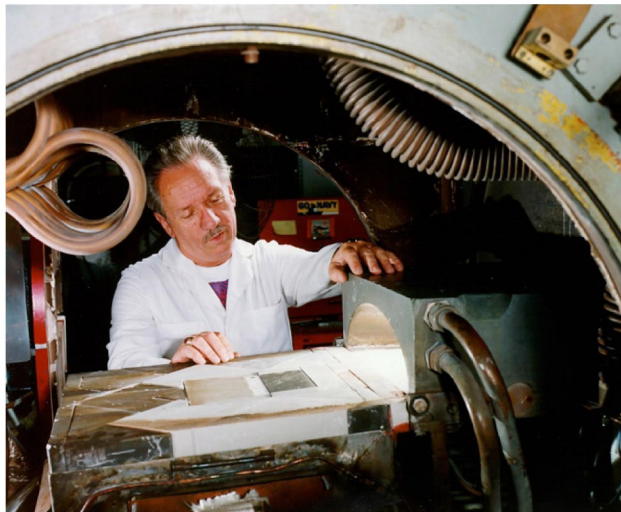
**Figure 24.—Installation, typical in the PTF.**

The PTF consists of a 20-MW segmented arc heater coupled to a semi-elliptical nozzle. The nozzle discharges in a semi-free jet within a  $4 \times 4 \times 4$ -foot test cabin where the panel test fixture attaches at the nozzle exit (Figure 24 shows a typical installation in the PTF). The test stream is suitable for the simulation of boundary layer heating environments on flat-panel samples of approximately 14 by 14 inches. The panels can be inclined to the flow direction at angles of  $-4^\circ$  to  $+15^\circ$ , although  $+6^\circ$  is the practical maximum.

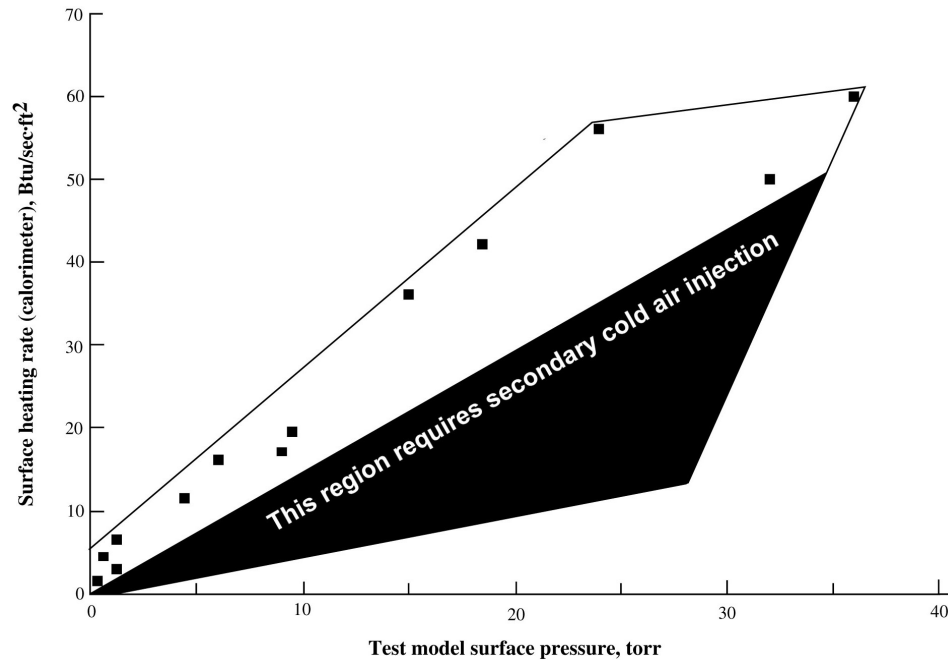
**Figure 25.—Operating Envelope of the PTF at NASA ARC.**

The heater operates at pressures from 1 to 10 atmospheres and enthalpy levels from 2000 to 14,000 Btu/lbm (air). The lower enthalpy range is achieved by mixing cold air with the test stream in the plenum or downstream electrode package. The PTF simulates some of the conditions experienced by the Space Shuttle heat shield tiles, such as heat flux, surface pressure, and gap flow, and has been used extensively in Space Shuttle heat shield development and certification.

Recent test programs in the PTF have focused on testing flexible thermal protection blankets for next-generation reusable launch vehicles. The envelope of surface conditions on the test article for the PTF is shown in Figure 25, and the physical parameters are listed in Table 3. Run durations as long as 30 minutes are possible with a 45-minute cool down between runs.

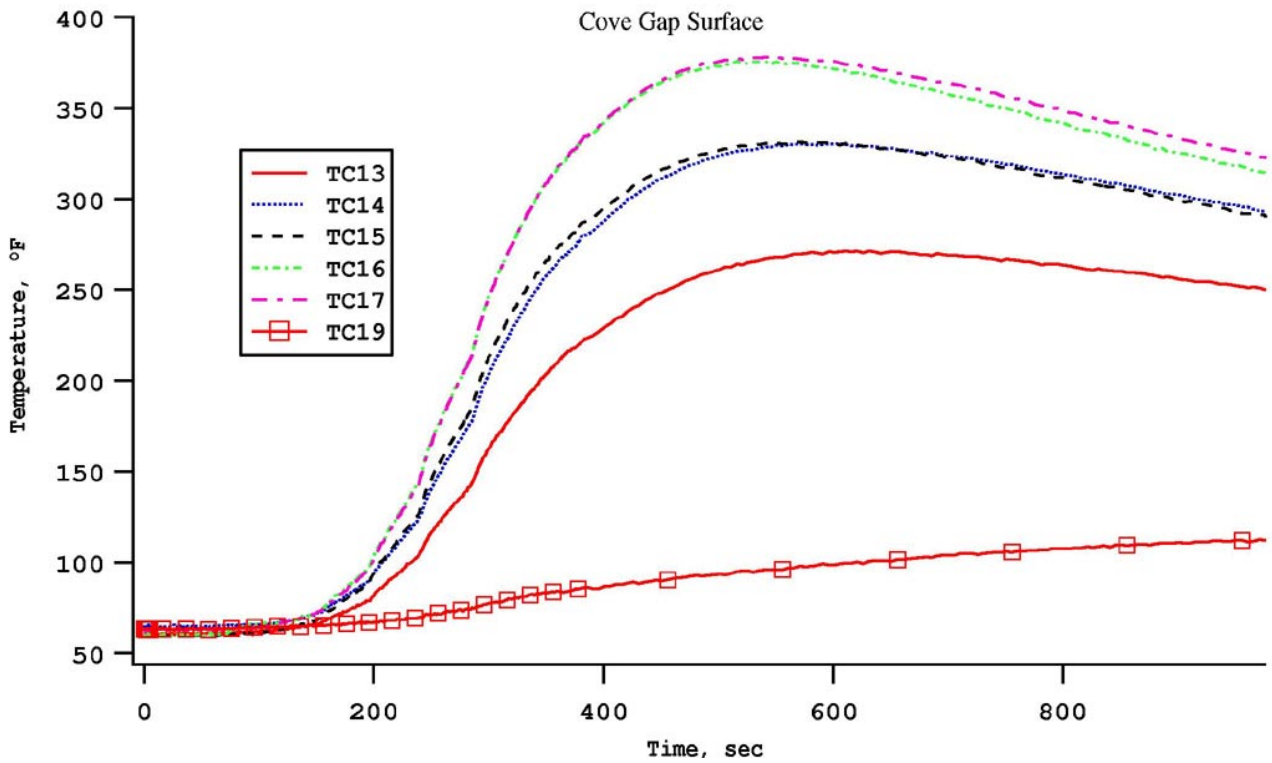
**Figure 26.—Temperature Plot from Run 98-07(Below the Seal).**

On figure 27 the time at arc-off is approximately 330 seconds; but figure 26 shows that heating below the seal continued for about 200 seconds after arc heating was stopped. This continued heating is due to thermal conduction through the AETB tile—and not from leakage through or around the seal.

Typical plots of the measured data from thermocouples and pressure transducers are shown in Figures 26 through 37. Temperature data and pressure data are provided for arc-jet runs 7, 9, 11, and 12. Plots for all of the arc-jet runs, including arc-jet parameters, are in Appendix B.

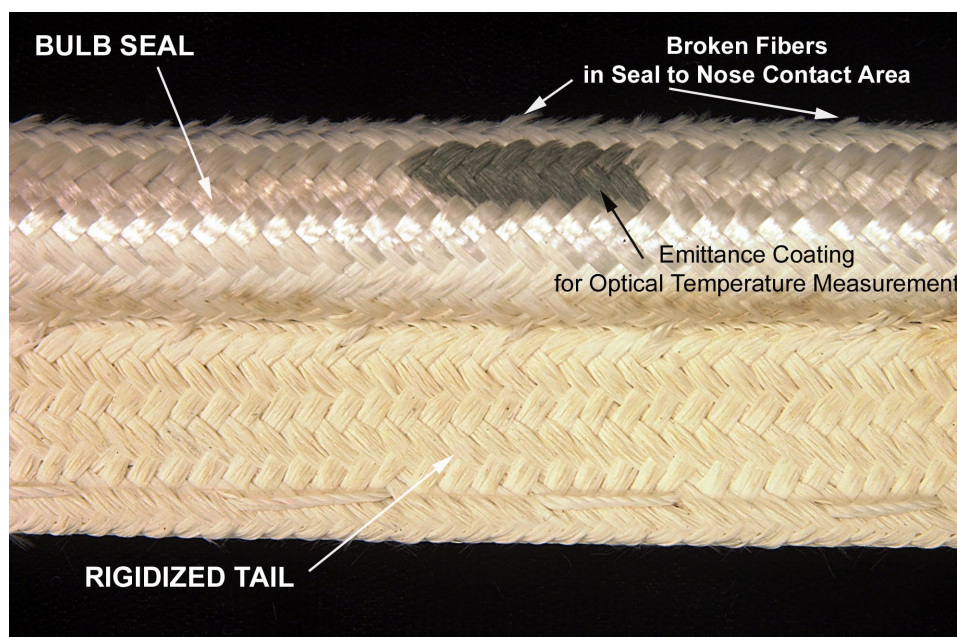
**Figure 38.—Post Test Seal #1 Showing Damaged Fibers in Contact Area.**

The issue of wear was not separately addressed, but was indirectly addressed from seal behavior. Test seal #1 was cycled 15 to 20 times before the test resulting in a white “mist” of Nextel filament fragments on the nose tile. Figure 38 is post-test and illustrates the damaged, frayed fibers in the contact area.

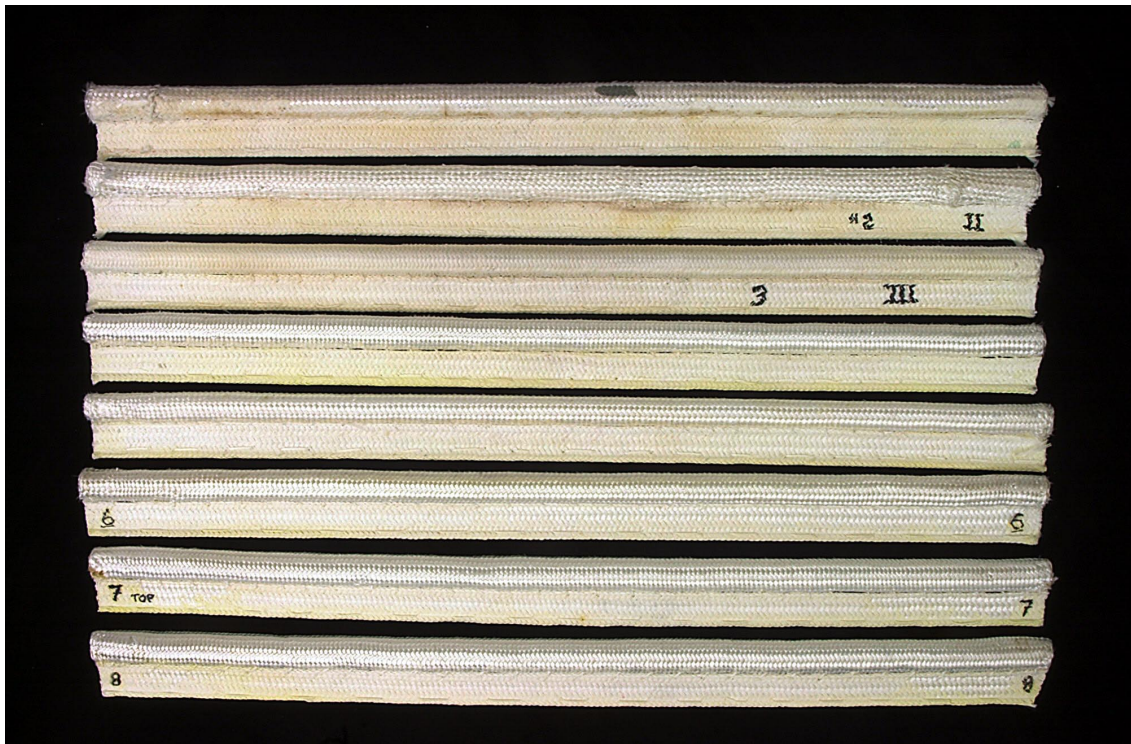
**Figure 39.—Backside view of Test Seals—Post-Test.**

Figures 39 and 40 are photographs of the two sides of the test seals after arc-jet exposure in the movable elevon fixture.

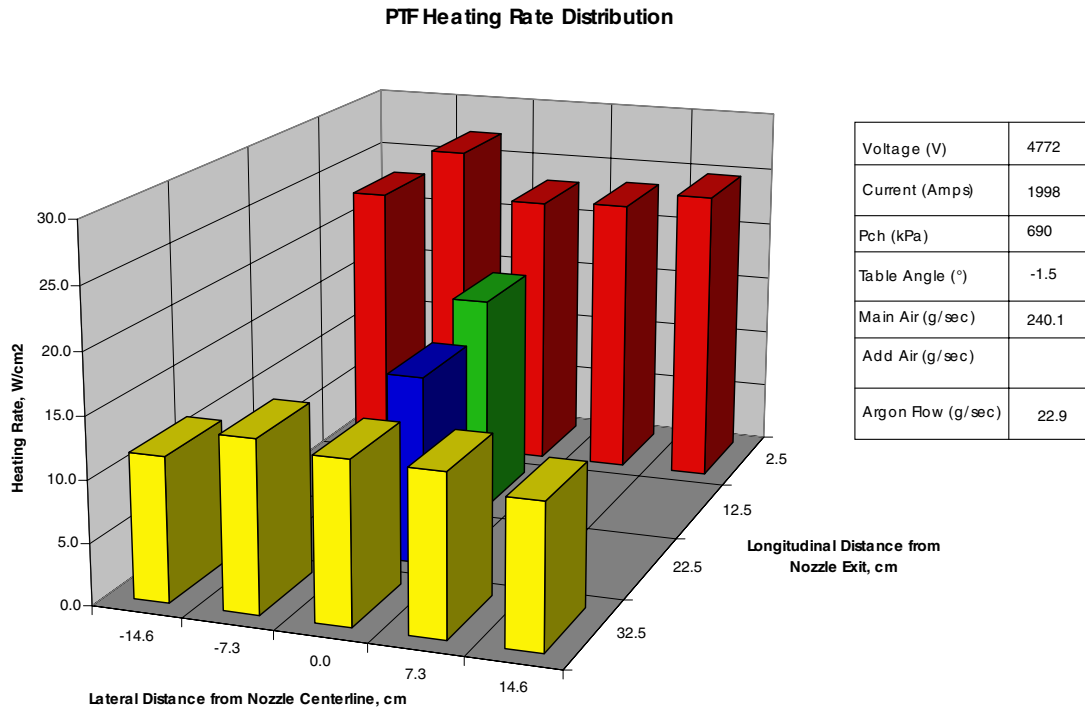
**Figure 42.—Post-Test Calibration of PTF Heating Rate Distribution.**

Figures 42 and 43 show the averaged data (averaged over roughly 30 seconds) from one run. During this one run, the test conditions were set and the table angle was varied, holding each angle for 30 seconds. Nine (9) degrees was the maximum table angle possible for the calibration plate.

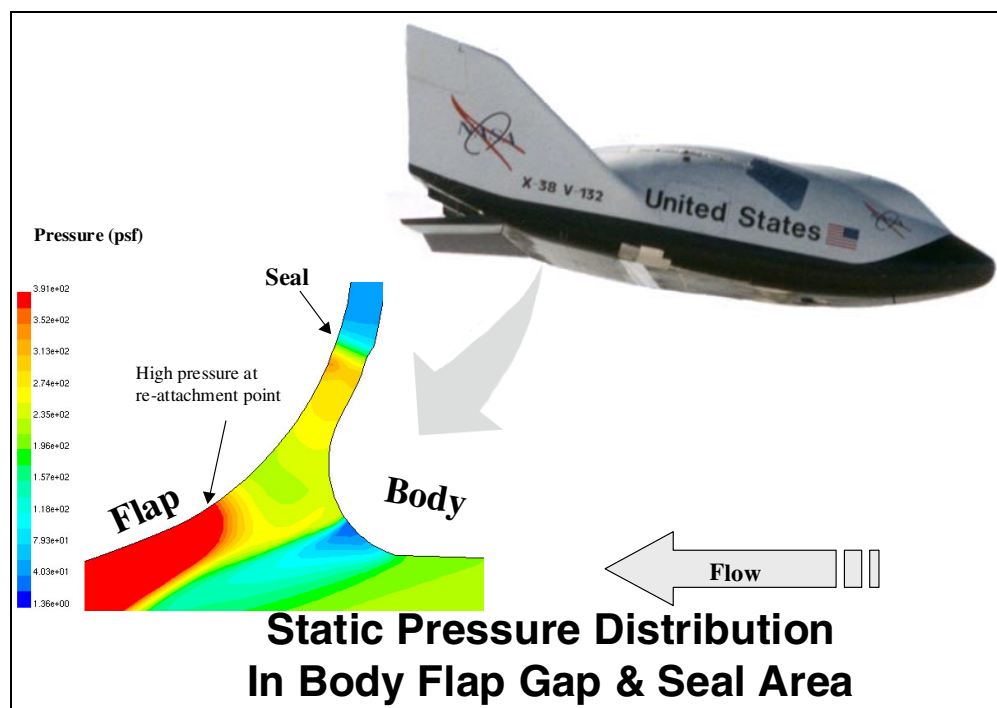
**Figure 44.—Static Pressure Distribution in Body Flap Gap and Seal Area.**

Figure 44 is a representation of the X-38 vehicle showing the location of the body-to-flap region along with the static pressure contour map for a 20-degree flap angle (with an impermeable seal). This plot is used for illustration purposes because static pressure correlates better than other CFD outputs with the heat transfer and ultimately with the temperatures of the structural components.

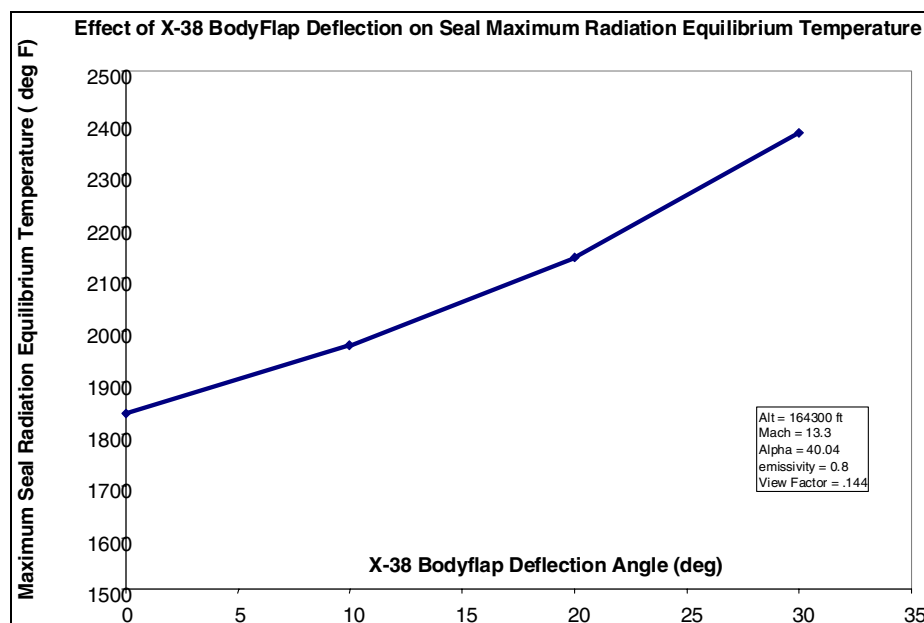
**Figure 50.—Flap Deflection vs. Seal Maximum Radiation Equilibrium Temperature.**

The previous five figures were based on a flap deflection angle of 20°. The maximum radiation equilibrium temperatures from CFD analyses of other flap deflection angles for the impermeable seal were also determined and are plotted as Figure 50. The conclusions of the preliminary aerothermal analysis are listed in Figure 51.

- Preliminary CFD analysis indicates that handbook cavity correlations slightly under-predict the aerothermal environment for deflected flaps.
- High seal permeability results in slightly increased aero-heating to the seal. Actual ceramic fiber seals are expected to be considerably less permeable than our initial analysis resulting in lower seal temperatures.
- Maximum seal surface temperatures are expected to be in the neighborhood of 2300 °F for a 20-degree flap deflection for an impermeable seal and higher for the high permeability seal.
- Seal temperatures increase as body flap deflection angle increases.
