Periodic Inspections of Kahului and Laupahoehoe Breakwaters, Hawaii

Armor Unit Monitoring for Period 1992/93-2001

Robert R. Bottin, Jr., and Daniel T. Meyers

August 2002

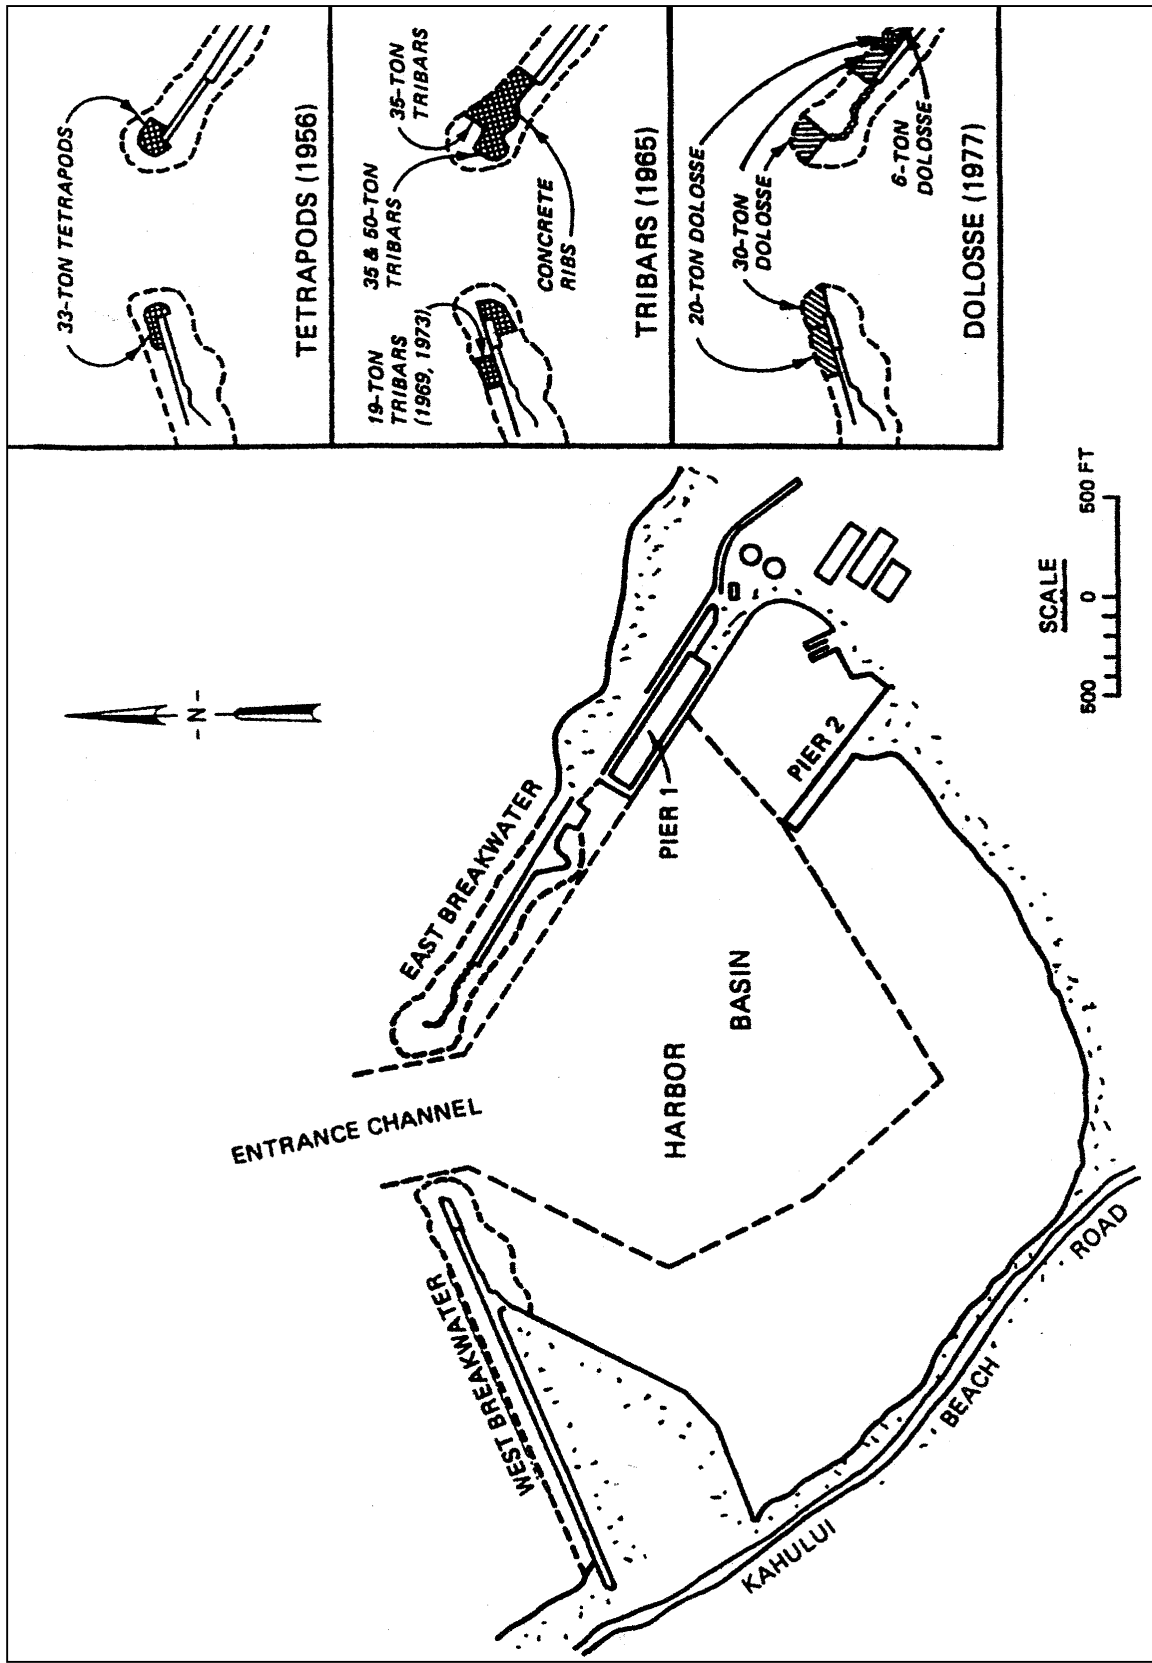
Figure 2. Layout of Kahului Harbor, Maui, HI

Kahului Harbor is rich in construction, repair, and rehabilitation history as noted in U.S. Army Engineer District, Honolulu (1981) and Sargent, Markle, and Grace (1988). The harbor complex was initiated when a berthing area, a dredged entrance channel, and a 122-m-long (400-ft-long) armor stone east breakwater were constructed by the Kahului Railroad Company in 1900. The Corps of Engineer’s first involvement with the project began in 1913 when the east breakwater was extended 122 m (400 ft). The west breakwater was constructed to a length of 594 m (1,950 ft) in 1919. In 1931, the east and west breakwaters were extended to their current lengths of 843 and 706 m (2,766 and 2,315 ft), respectively. A layout of the harbor is shown in Figure 2 and an aerial view is shown in Figure 3.

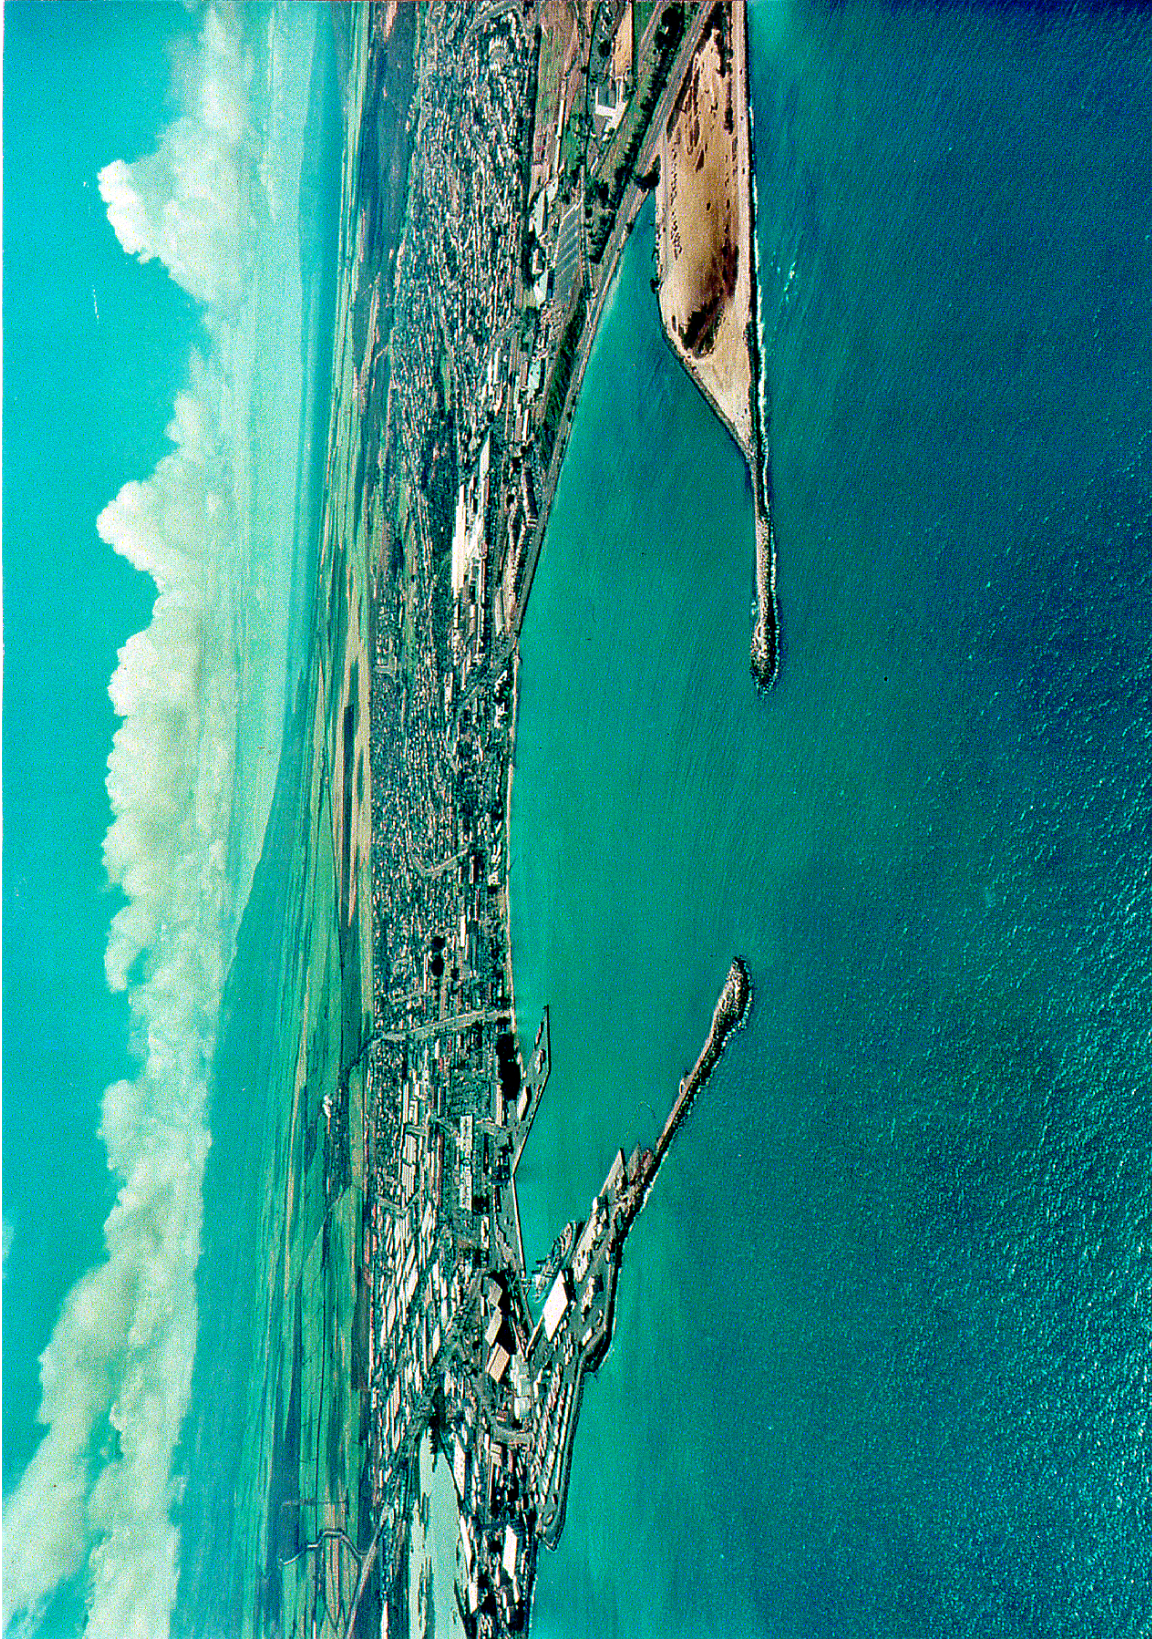
Figure 3. Aerial view of Kahului Harbor (2001)

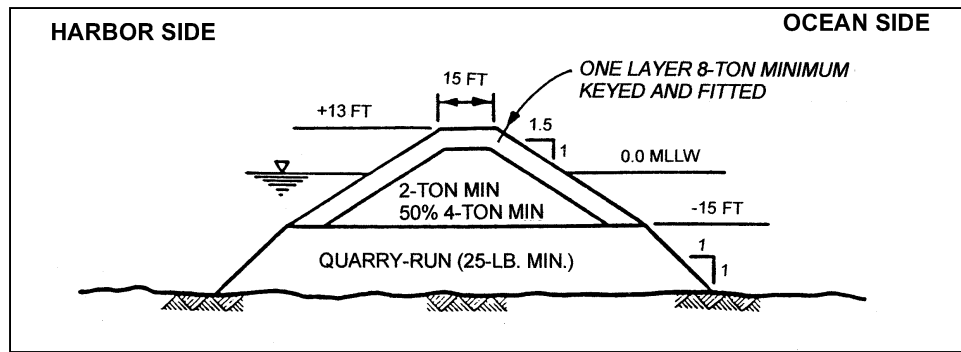
Figure 4. Typical cross section of 1931 Kahului breakwater trunk construction

Between 1931 and 1954, both breakwaters were severely damaged on numerous occasions and each repair, or rehabilitation, was completed by restoring the structure to its original condition with 7,257-kg (8-ton) keyed and fitted armor stone. In March of 1954, storm waves, with estimated 10.4-m (34-ft) breaker heights at the structure heads, attacked Kahului Harbor for a 3-day period. The outer 56.4 and 91.4 m (185 and 300 ft) of the east and west breakwaters, respectively, were severely damaged. This extensive damage initiated actions to base needed repairs on current design criteria rather than restoring the structure to its prestorm conditions. In 1956, repairs were completed on both breakwaters using 29,940-kg (33-ton) unreinforced tetrapods and a concrete cap (Figure 5). The new armor units were placed on the heads of both breakwaters and extended 76.2 m (250 ft) shoreward along the sea-side face on the west breakwater trunk.

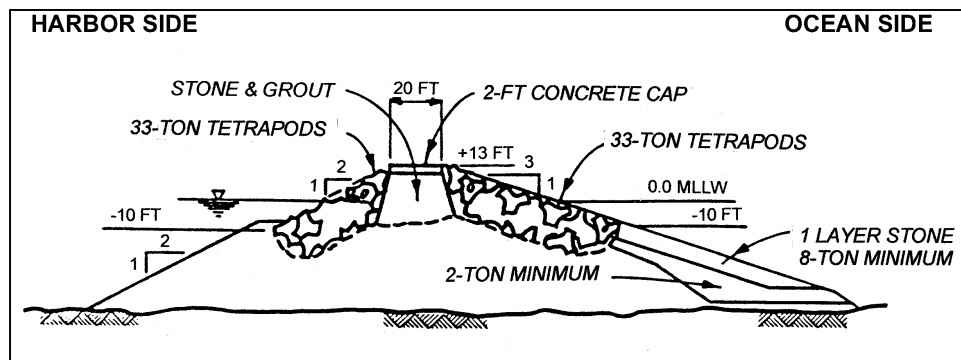
Figure 5. Typical cross section for 1956 Kahului breakwater repairs

A storm in 1958 with estimated wave heights of 7.6 m (25 ft) at the structures caused extensive damage to both breakwaters. A breach in excess of 45.7 m (150 ft) was opened up on the east breakwater at the transition between the armor stone and tetrapods. On the west breakwater, all of the tetrapods on the harbor-side quarter of the head were swept away. The 1V:2H slope used in this area was felt to be the major design deficiency. Temporary repairs of the east breakwater, consisting of a large monolithic concrete cap and placement of 10,885-kg (12-ton) or larger armor stone on the sea-side face, were completed in 1959.

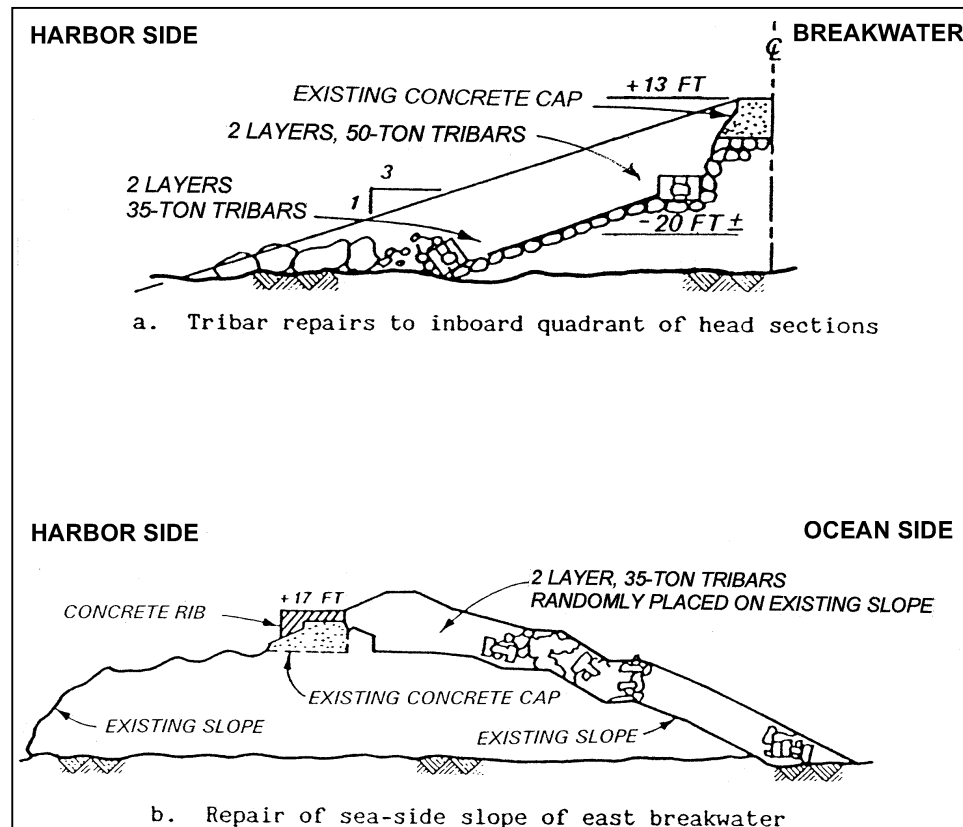
Figure 6. 1996 Kahului breakwater repairs

A major breakwater rehabilitation was completed in 1966. Both heads, and 108.2 m (355 ft) of sea-side slope of the structure immediately shoreward of the east head were included in the repair (Figure 6). The design was model-studied at ERDC (Jackson 1964). The inboard quarters of both heads were armored with two layers of 45,360-kg (50-ton) tribars on the upper one-third of the slope, while the lower two-thirds was protected by a double layer of 31,750-kg (35-ton) tribars. A two-layer system of 31,750-kg (35-ton) tribars was placed from the new concrete rib cap to the toe of the rehabilitated sea-side slope of the east breakwater trunk.

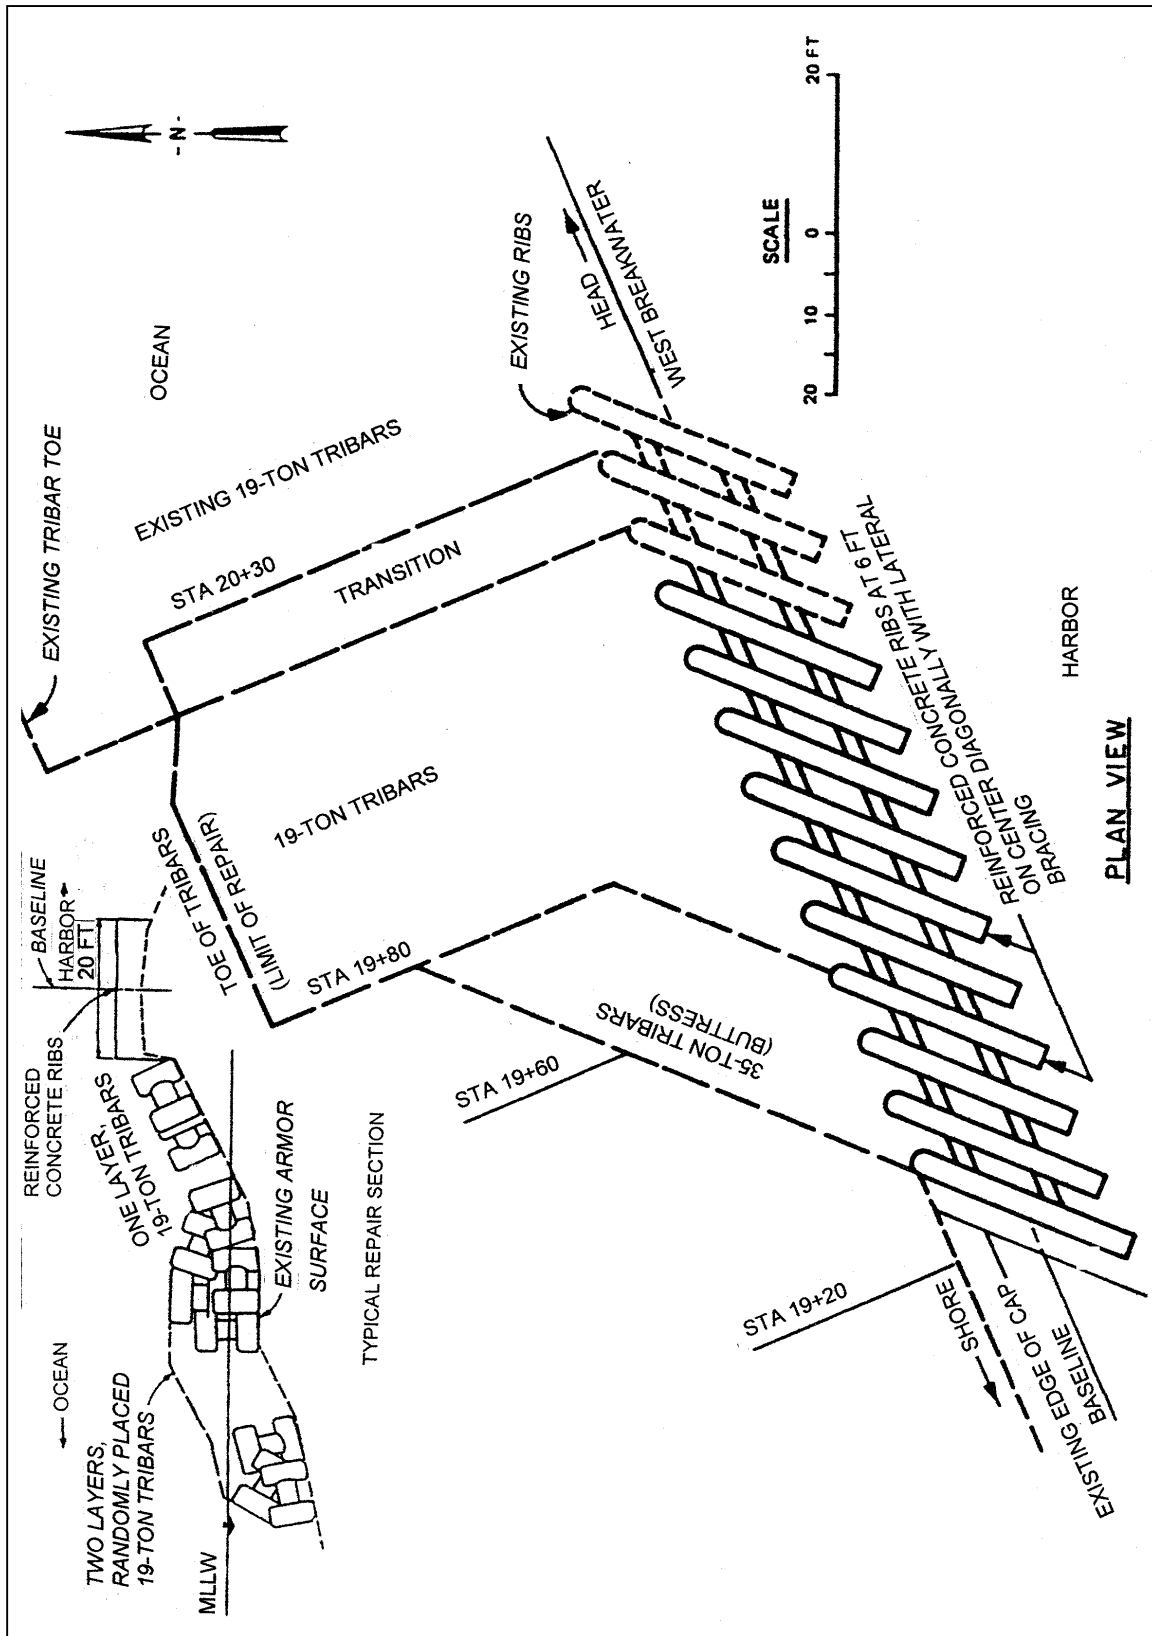
Figure 7. Kahului west breakwater repairs of 1973

A storm in 1967 severely damaged the west breakwater trunk. This area was repaired in 1969 by construction of a concrete rib cap and placement of 260 reinforced tribars, weighing 17,235 kg (19 tons) each, on the sea-side slope. In November of the same year, the area adjacent to the 17,235-kg (19-ton) tribars at the shore end was damaged by 4.6- to 6.1-m (15- to 20-ft) breaking waves. This area was repaired in 1973 by a 24.4-m (80-ft) shoreward extension of the concrete rib cap and 17,235-kg (19-ton) tribars. The shoreward extent of the tribars was buttressed with 25 tribars, weighing 31,750 kg (35 tons) each (Figure 7).

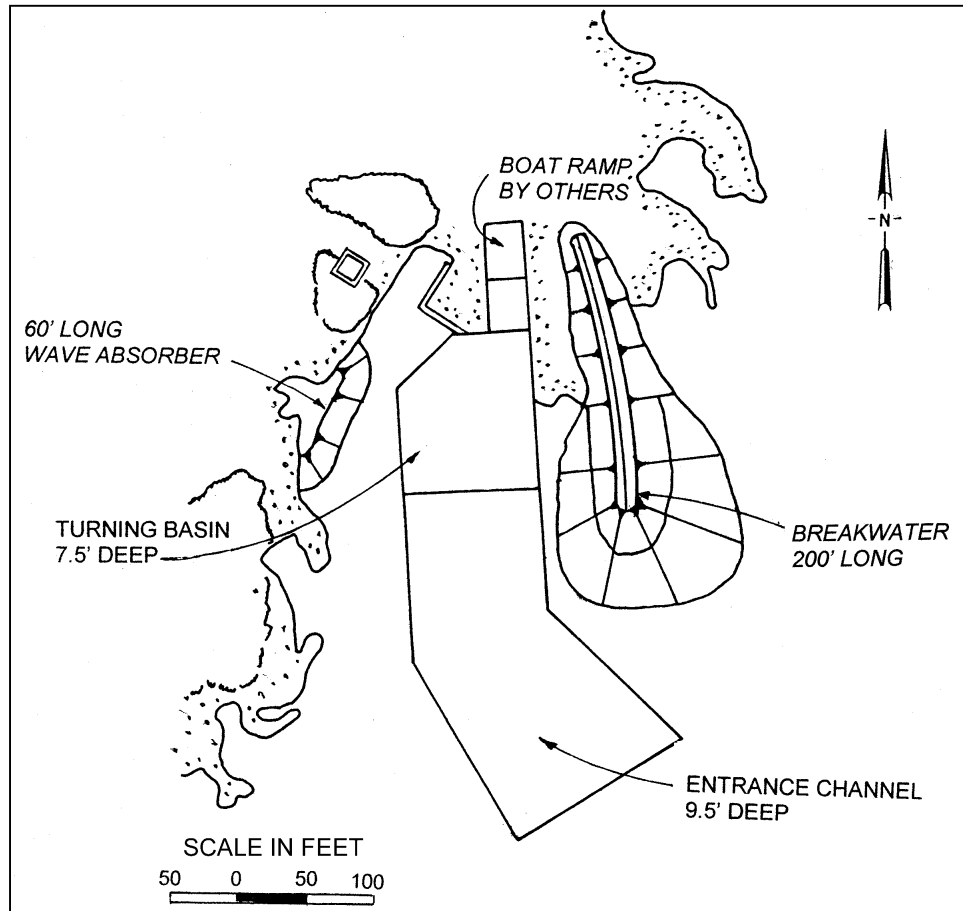
Figure 8. Layout of Laupahoehoe boat-launching facility

Plans were developed to improve conditions in the area (U.S. Army Engineer District, Honolulu, 1984). In 1988, a 60.1-m-long (200-ft-long) rubble-mound breakwater protecting a 2.9-m-deep (9.5-ft-deep) entrance channel, 2.3-m-deep (7.5-ft-deep) turning basin, and a boat-launching ramp was completed. The design layout for the facility and stability of the breakwater were optimized through physical model studies conducted at ERDC (Bottin, Markle, and Mize 1987). A layout of the boat-launching facility is shown in Figure 8.

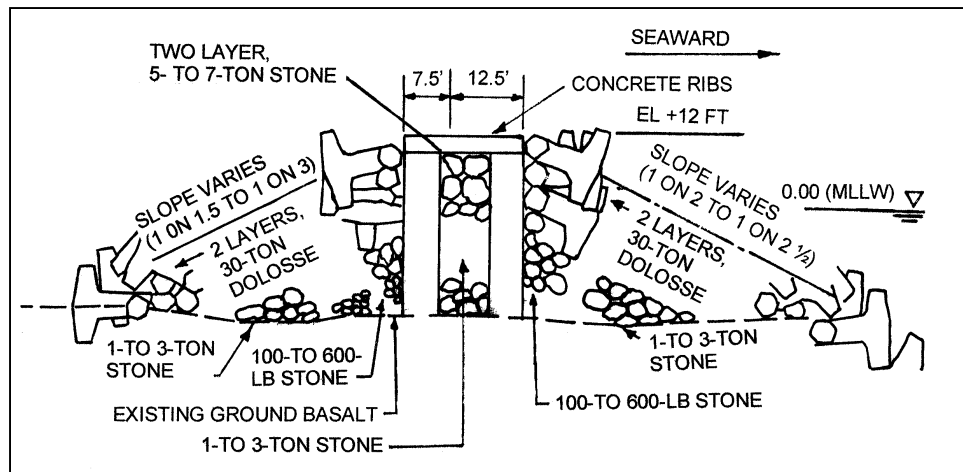
Figure 9. Cross section of Laupahoehoe breakwater

The breakwater is armored with 27,215-kg (30-ton) reinforced dolosse and the crest is stabilized with a concrete rib cap. The toe of the dolosse was keyed into the hard basalt bottom by means of a trench excavated around the perimeter of the breakwater. The rib cap is supported on concrete pipe columns. A stable breakwater core was achieved through the innovative design of a reinforced concrete pipe rib cage forming a containment area for core and capstone. A cross section of the breakwater is presented in Figure 9, and an aerial view of the area is shown in Figure 10.

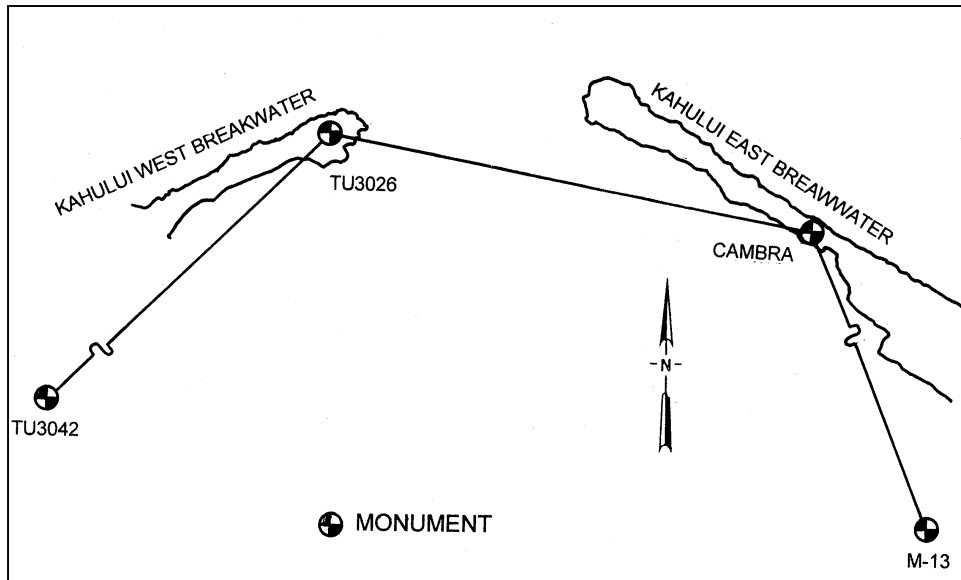
Figure 11. Monuments used to establish survey control at Kahului Harbor

To serve as control for the ground-based surveys as well as the photogrammetric work, existing monuments from previous surveys were located and resurveyed using Trimble real-time kinematic global positioning system equipment and electronic surveying techniques. Monuments at the sites used to establish vertical and horizontal control are shown in Figures 11 and 12 for the Kahului and Laupahoehoe projects, respectively.

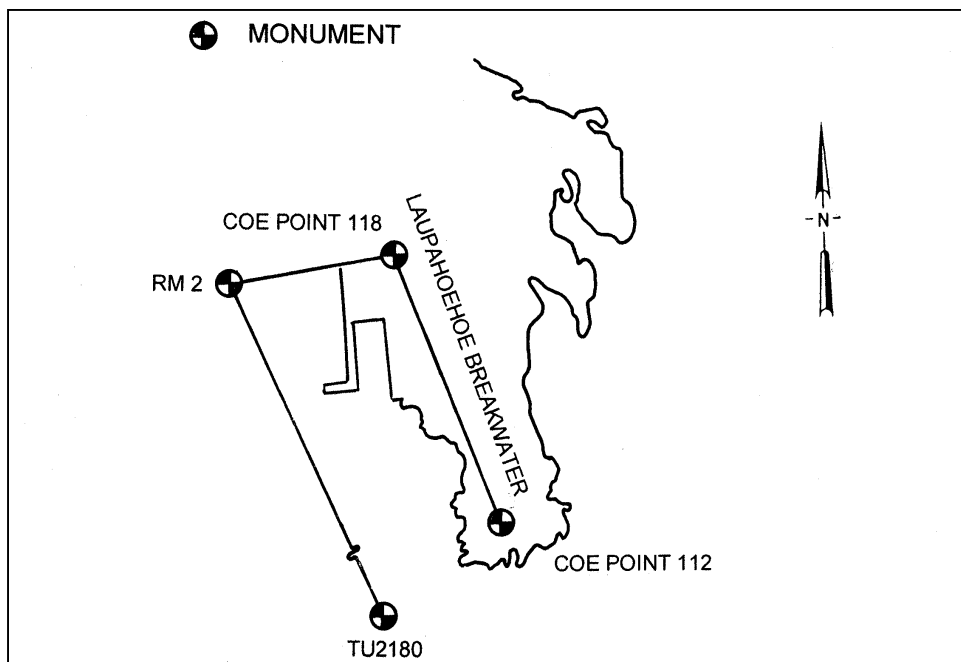
Figure 12. Monuments used to establish survey control at Laupahoehoe boat-launching facility

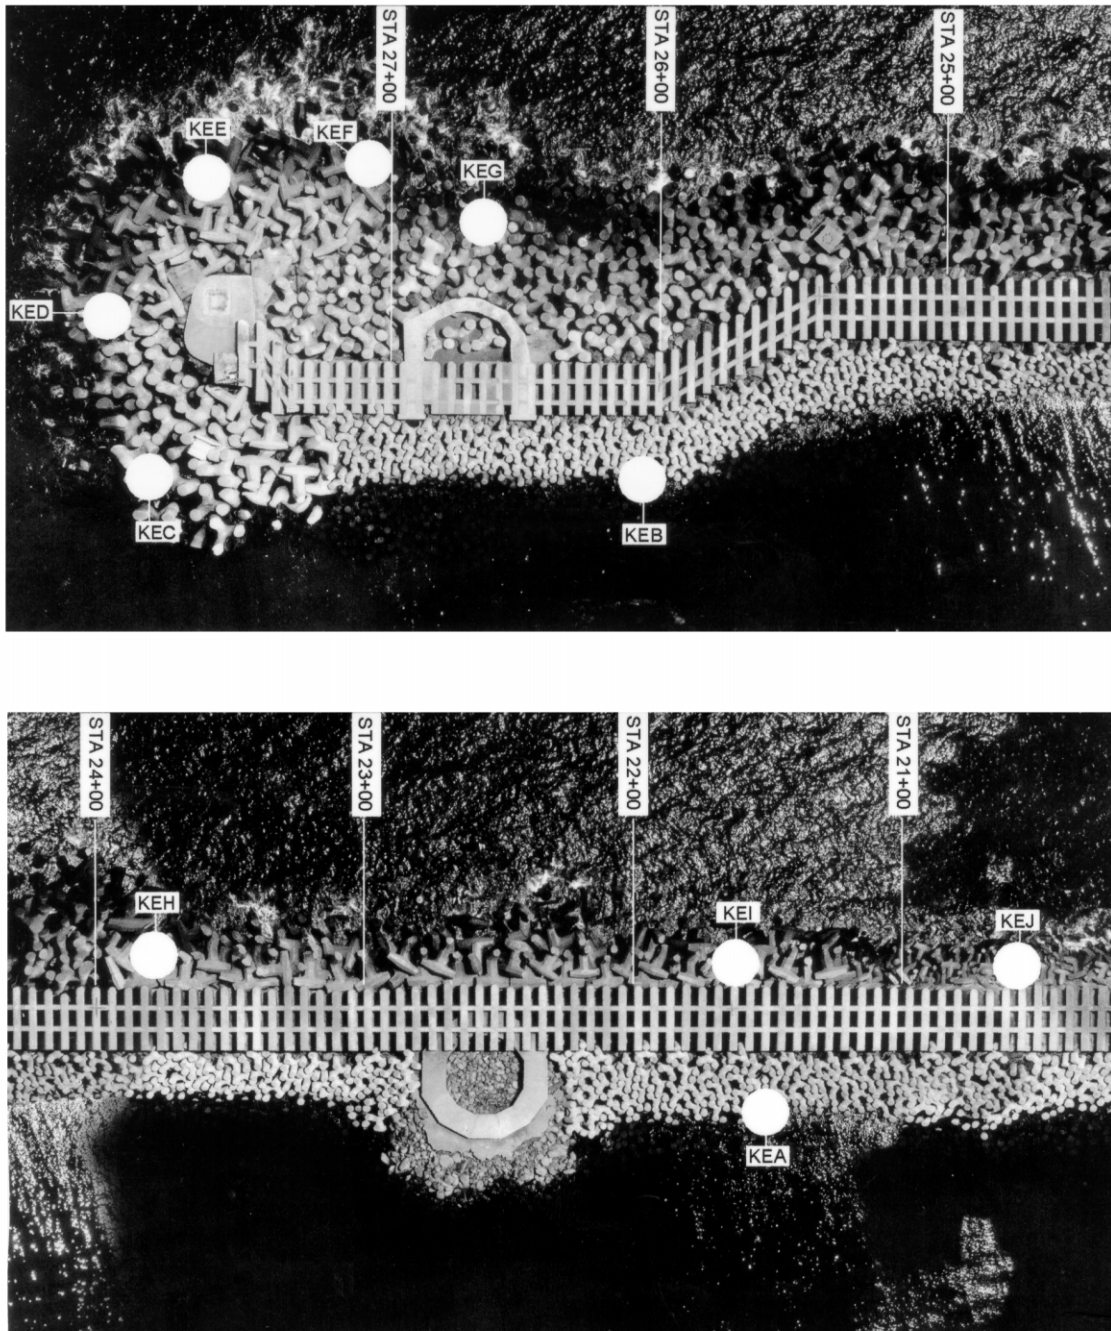
Figure 13. Locations of targeted armor units on Kahului east breakwater

In addition, targets were re-established on concrete armor units. As previously reported (Markle and Boc 1994), 10 targeted armor units were monitored on the Kahului east breakwater, 10 on the Kahului west breakwater, and five on the Laupahoehoe breakwater. A description of the targeted units is presented in Table 1. On the Kahului east breakwater, two of the targeted units were 8,165-kg (9-ton) tribars, five were 27,215-kg (30-ton) dolos, two were 31,750-kg (35-ton) tribars, and one was a 5,445-kg (6-ton) dolos. On the Kahului west breakwater, two of the targeted units were 5,900-kg (6.5-ton) tribars, one was a 9,980-kg (11-ton) tribar, five were 27,215-kg (30-ton) dolos, and two were 31,750-kg (35-ton) tribars. All five units targeted on the Laupahoehoe breakwater were 27,215-kg (30-ton) dolos. Units were distributed on the sea and harbor sides of the breakwaters as well as around their heads, and from the breakwater crest to the waterline. Figures 13–15 show the locations of targeted armor units on the Kahului east and west breakwaters and the Laupahoehoe breakwater, respectively.

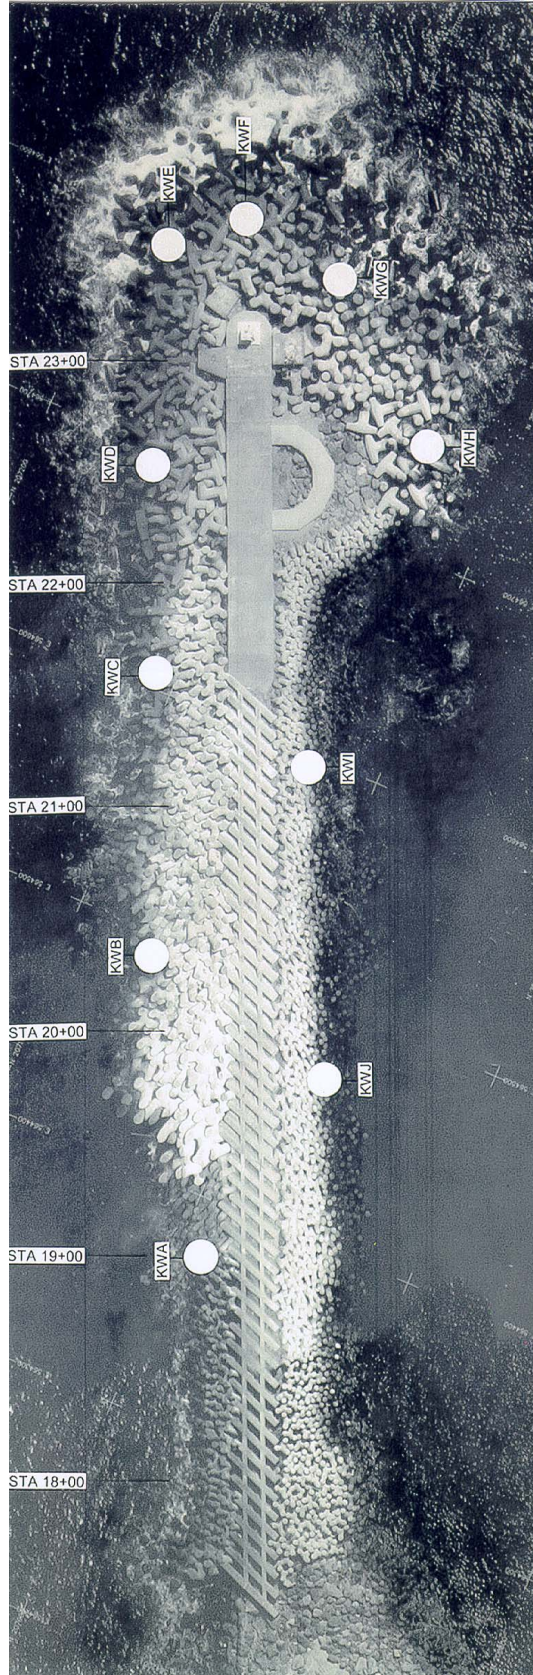
Figure 14. Locations of targeted armor units on Kahului west breakwater

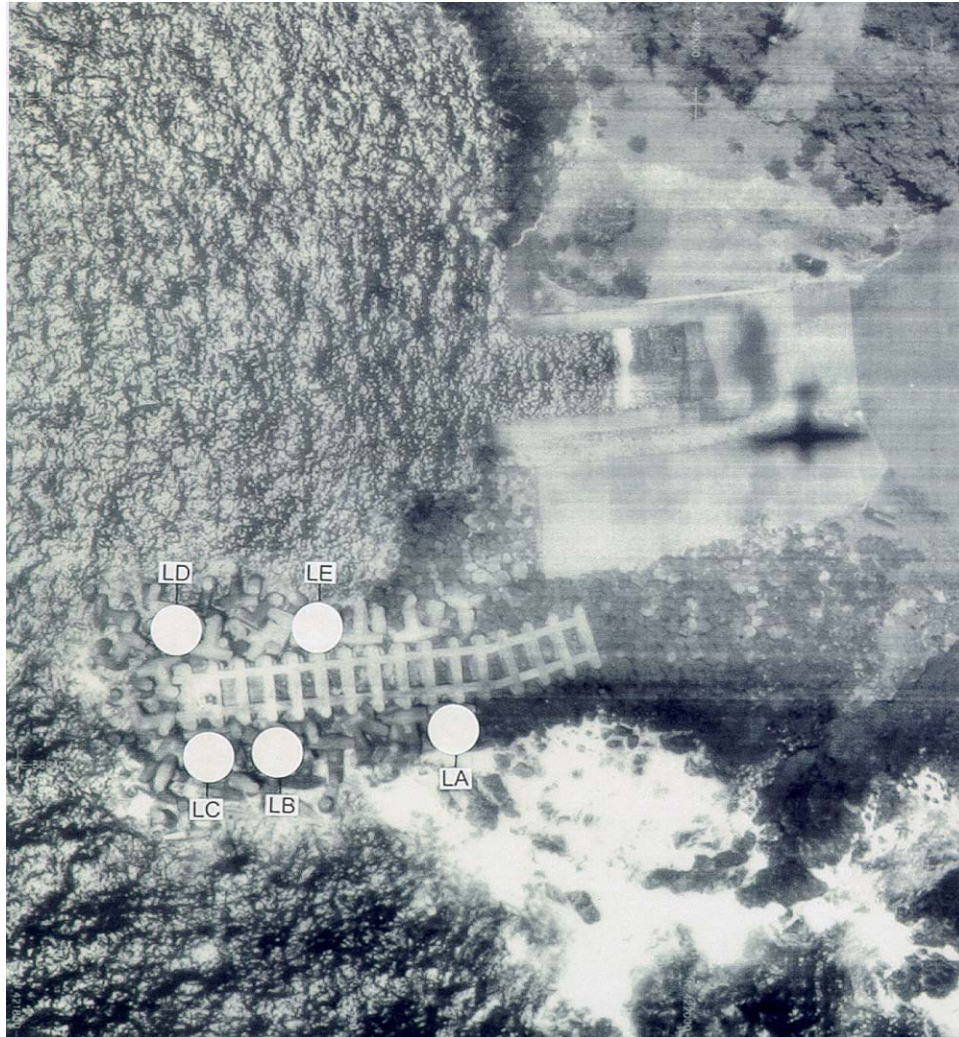
Figure 15. Locations of targeted armor units on Laupahoehoe breakwater

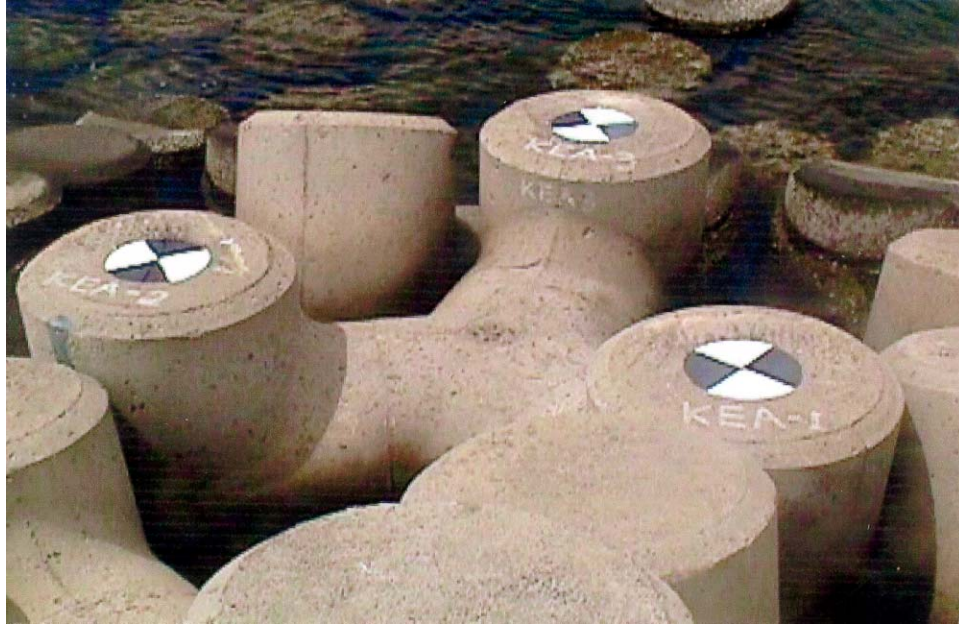
Figure 16. Example of targeted tribar

numeric characters identify the target on the armor unit. For example, armor unit “KEA” indicates a unit on the Kahului east breakwater that is unit A of 10 units (A through J) targeted on the breakwater. The unit has three targets labeled KEA-1, KEA-2, and KEA-3. An example of a targeted armor unit is shown in Figure 16.

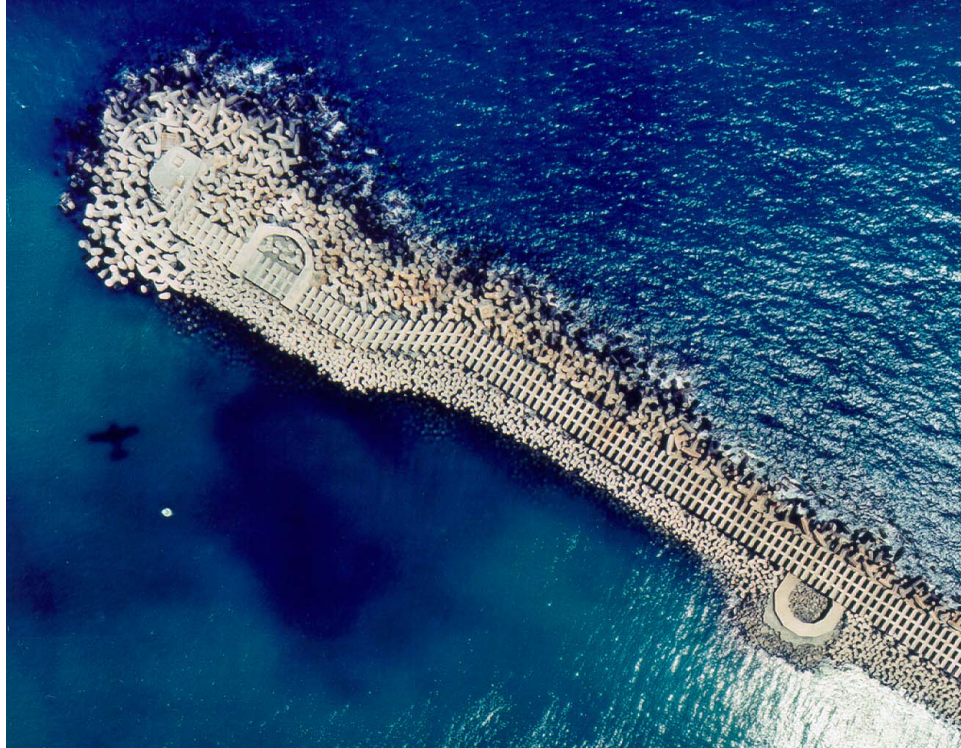
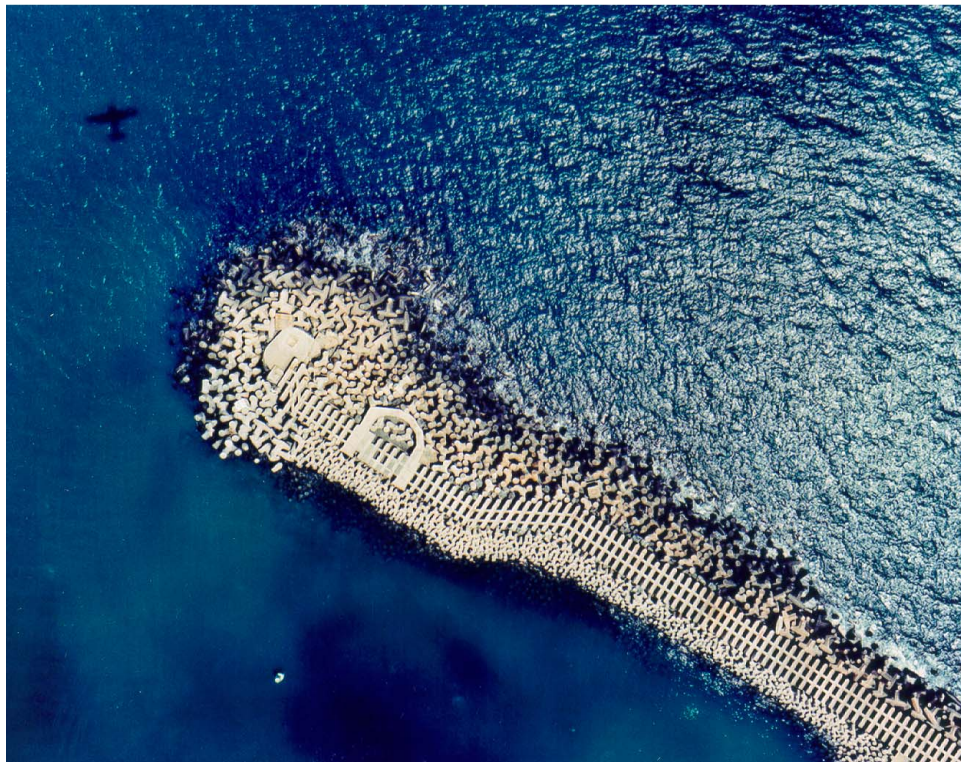
Figure 17. Stereo pair photographs of outer portion of Kahului east breakwater

When aerial photography is planned and conducted so that each photo image overlaps the next by 60 percent or more, the two photographs comprising the overlap area can be positioned under an instrument called a stereoscope, and viewed in extremely sharp three-dimensional (3-D) detail. If properly selected survey points on the ground have previously been targeted and are visible in the overlapping photography, accurate measurements of any point appearing in the photographs can be obtained. This technique is called photogrammetry.

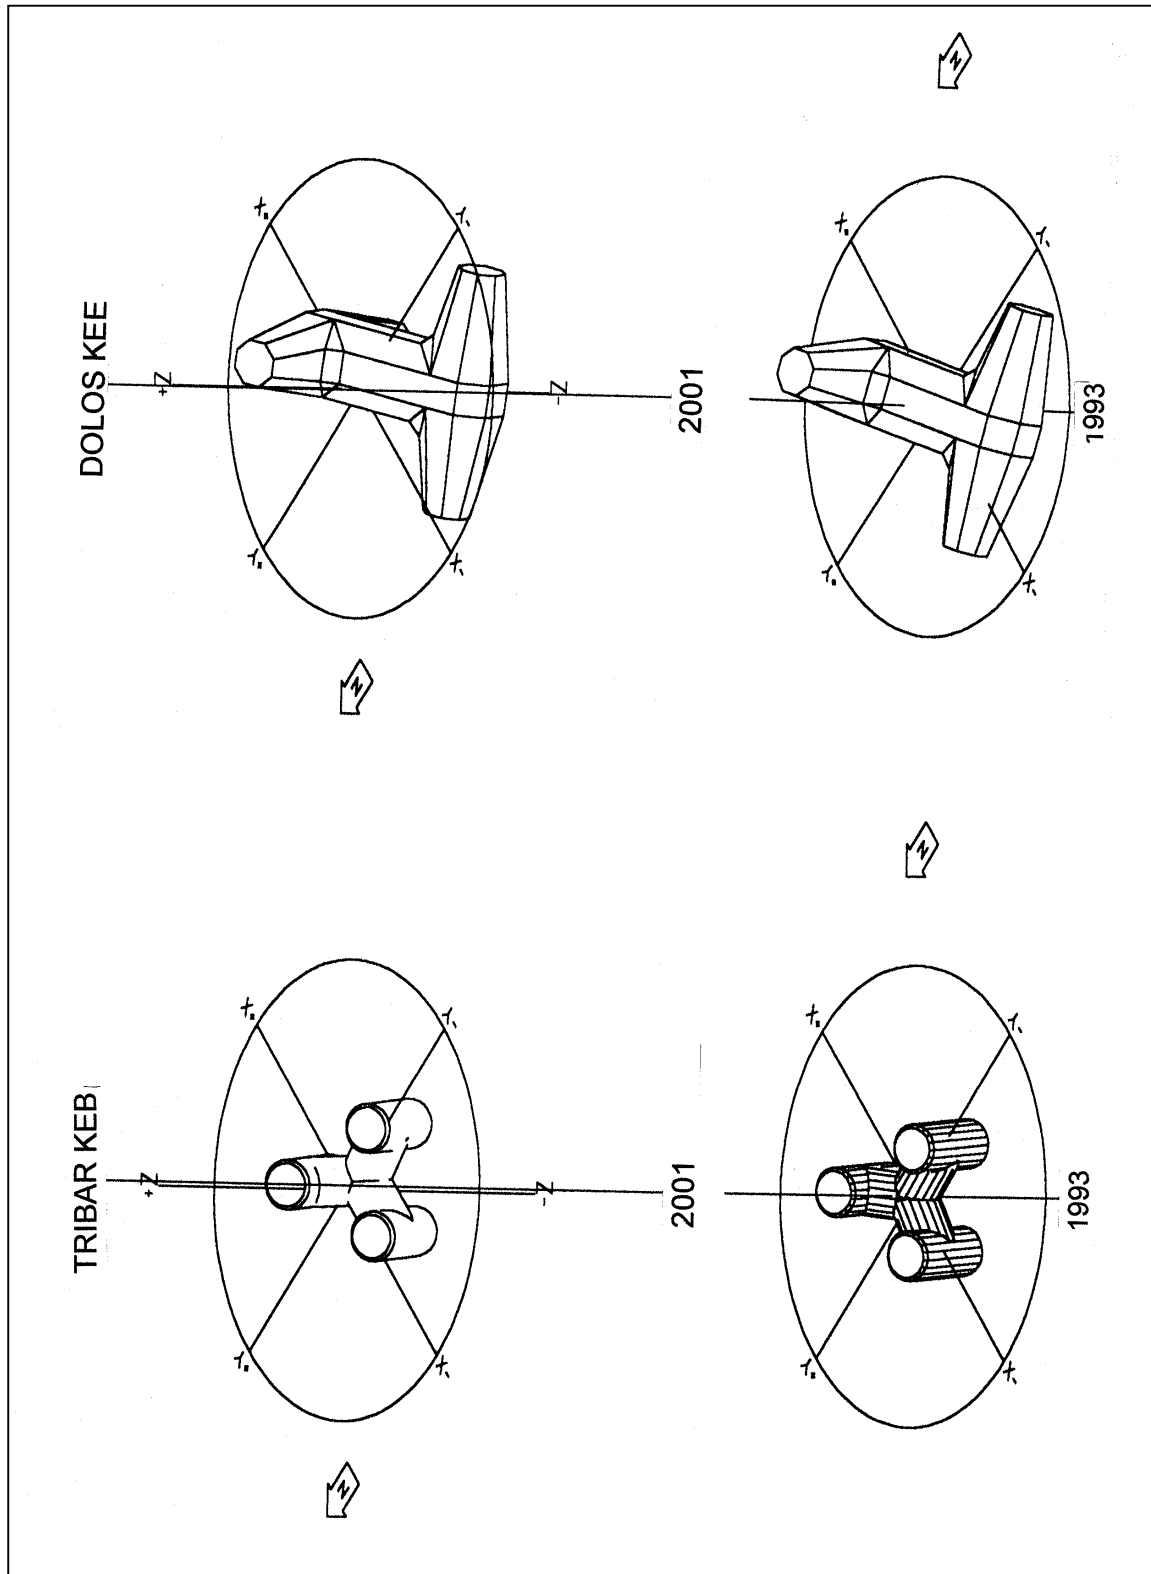
Figure 22. Comparison of representative targeted armor unit position relative to x, y, and z axes

With the x, y, and z (easting, northing, and el) coordinates defined for each target on the various armor units, the coordinates of the centroid (center of mass) of each targeted armor unit were computed for the 2001 aerial survey. In addition, the position of each armor unit relative to the x, y, and z axes was determined and compared with previous data. Figure 22 shows, in three dimensions, the orientation and comparison of representative armor units to the three axes for the two surveys. The centroid coordinates of each targeted armor unit on the Kahului east and west breakwaters and the Laupahoehoe breakwater are shown in Tables 5-7 and compared with the aerial survey results of 1992/ 1993. Maximum movement of the centroids for the Kahului east breakwater was 0.536 m (1.76 ft) and 0.671 m (2.2 ft) in the horizontal and vertical directions, respectively, while average movements were 0.119 m (0.39 ft) and 0.17 m (0.57 ft) in the horizontal and vertical directions. As noted earlier, data were not obtained for two targets (KED1 and KEE2) on the Kahului east breakwater, however, based on information available and known dimensions of these armor units, their centroid positions were calculated. For the Kahului west breakwater, maximum horizontal and vertical centroid movements, respectively, were 0.64 m (2.1 ft) and 0.186 m (0.61 ft), while average movements were 0.113 (0.37 ft) and 0.64 m (0.21 ft) in the horizontal and vertical directions. Maximum movement of the centroids for the Laupahoehoe breakwater was 0.091 m (0.3 ft) and 0.085 m (0.28 ft) in the horizontal and vertical directions, respectively, while average movements were 0.03 m (0.1 ft) and 0.034 m (0.11 ft) in the horizontal and vertical directions. The targeted armor units' orientation (rotation angle relative to the x, y, and z axes) are presented in Tables 8-10 for the east and west Kahului breakwaters and the Laupahoehoe breakwater and compared with the aerial survey results of 1992/ 1993. For the Kahului east breakwater, changes in the rotation angle of the targeted armor units varied from 0.03 to 24.57 deg with an average of 3.09 deg. Changes in rotation angles varied from 0.0 to 17.32 deg for the Kahului west breakwater with an average of 2.02 deg. For the Laupahoehoe breakwater, changes in rotation angles varied from 0.01 to 0.36 deg with an average of 0.1 deg.

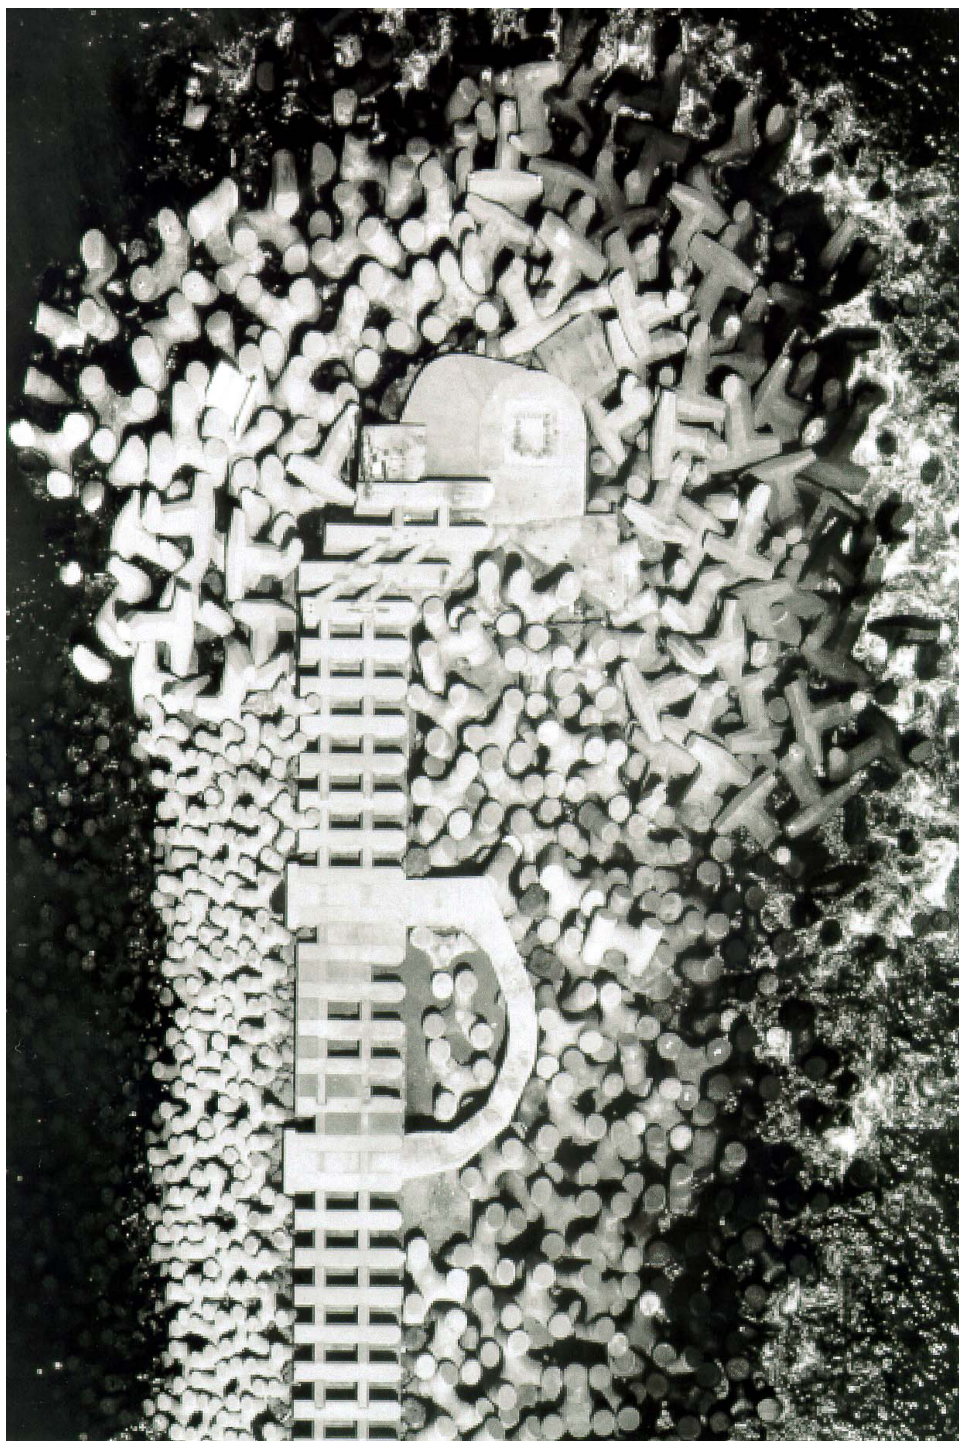
Figure 23. Photo map of head of Kahului east breakwater

Photo maps combine the image characteristics of a photograph with the geometric qualities of a map. The image is rectified and free from skewness and distortion, and therefore, precise horizontal measurements may be obtained using an engineer scale. Photo maps were prepared for the outer portions of the Kahului east and west breakwaters and the Laupahoehoe breakwater for the 2001 survey. They were produced on mylar sheets at a scale of 1:240. Examples of photo maps for the Kahului east and west breakwater heads and the Laupahoehoe breakwater are shown in Figures 23-25. In an effort to quantify horizontal movement of nontargeted concrete armor units on the Kahului and Laupahoehoe breakwaters, photo maps obtained for the 1992/1993 and 2001 were compared. Eight 27,215-kg (30-ton) dolosse around the seaward quadrant of the head of the Kahului east breakwater (including targeted units KED and KEE) appeared to have slightly changed positions. Movement appeared to be on the order of 0.3 to 0.9 m (1 to 3 ft). These units have not broken and are considered functional. Just a few additional units on the remaining portion of the Kahului east breakwater, as well as on the Kahului west breakwater, had moved slightly with no concentrations in any specific areas. Negligible movement of nontargeted units on the Laupahoehoe breakwater was detected between the surveys.
