Periodic Inspections of Kahului and Laupahoehoe Breakwaters, Hawaii

Armor Unit Monitoring for Period 1992/93-2001

Robert R. Bottin, Jr., and Daniel T. Meyers

August 2002

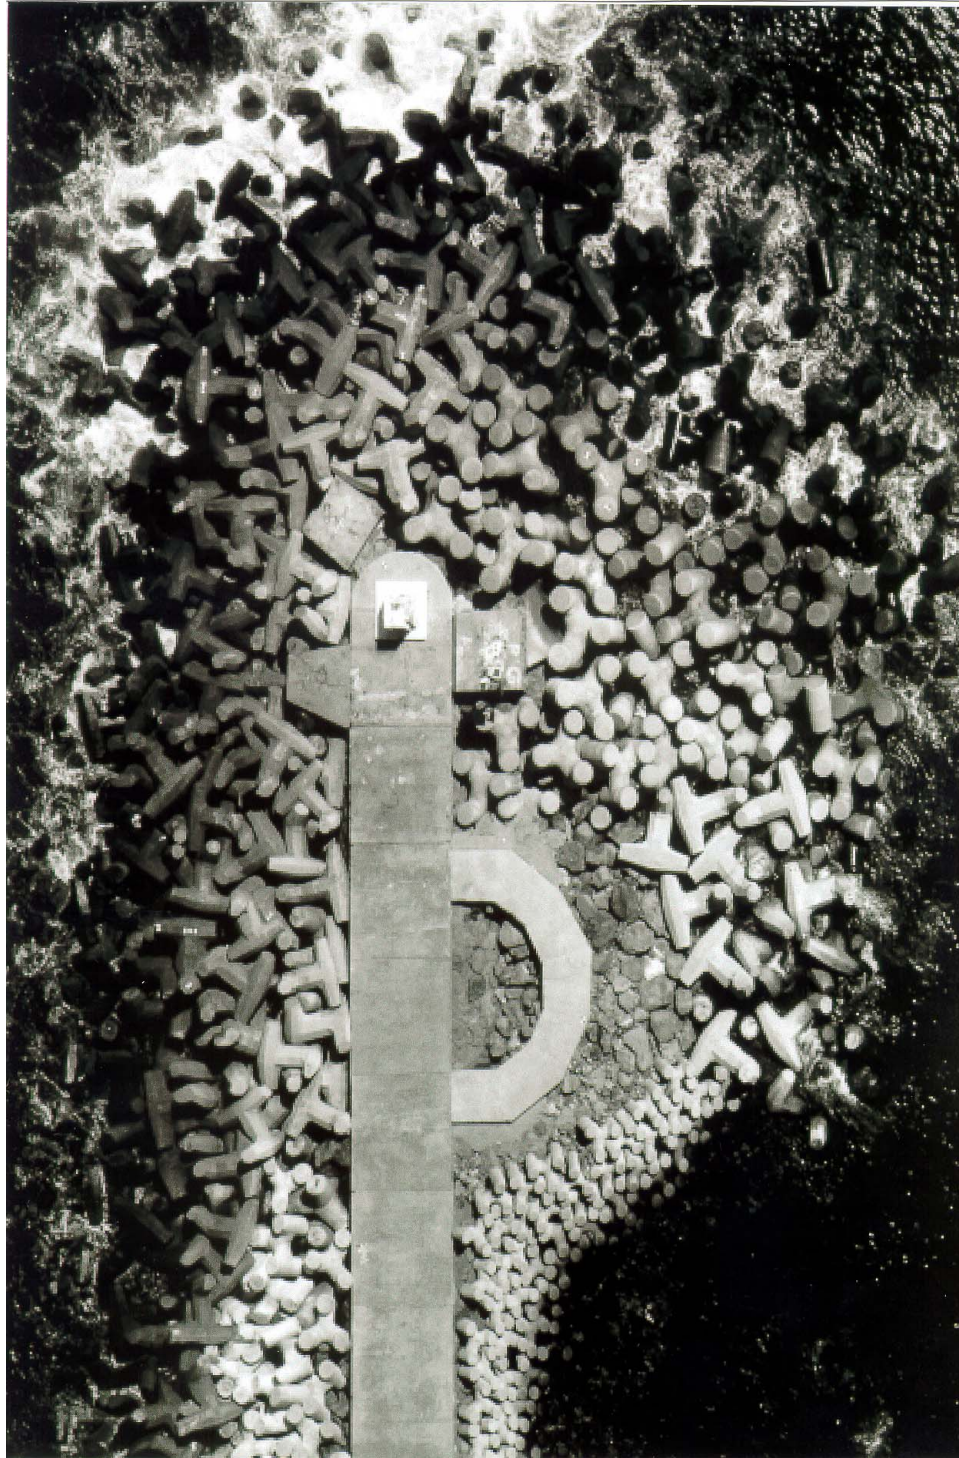
Figure 24. Photo map of head of Kahului west breakwater

Photo maps combine the image characteristics of a photograph with the geometric qualities of a map. The image is rectified and free from skewness and distortion, and therefore, precise horizontal measurements may be obtained using an engineer scale. Photo maps were prepared for the outer portions of the Kahului east and west breakwaters and the Laupahoehoe breakwater for the 2001 survey. They were produced on mylar sheets at a scale of 1:240. Examples of photo maps for the Kahului east and west breakwater heads and the Laupahoehoe breakwater are shown in Figures 23-25. In an effort to quantify horizontal movement of nontargeted concrete armor units on the Kahului and Laupahoehoe breakwaters, photo maps obtained for the 1992/1993 and 2001 were compared. Eight 27,215-kg (30-ton) dolosse around the seaward quadrant of the head of the Kahului east breakwater (including targeted units KED and KEE) appeared to have slightly changed positions. Movement appeared to be on the order of 0.3 to 0.9 m (1 to 3 ft). These units have not broken and are considered functional. Just a few additional units on the remaining portion of the Kahului east breakwater, as well as on the Kahului west breakwater, had moved slightly with no concentrations in any specific areas. Negligible movement of nontargeted units on the Laupahoehoe breakwater was detected between the surveys.

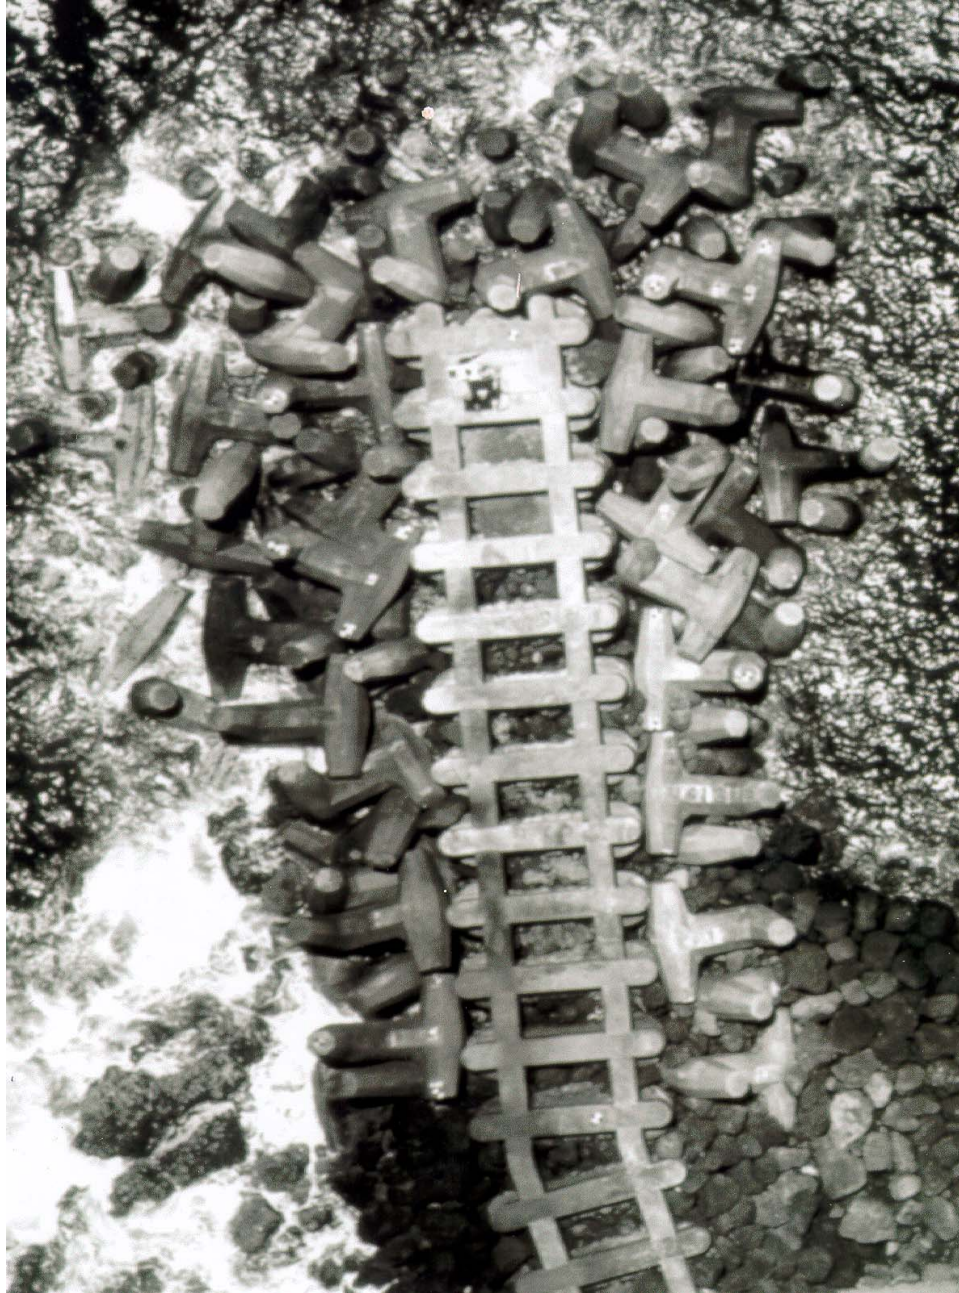
Figure 25. Photo map of Laupahoehoe breakwater

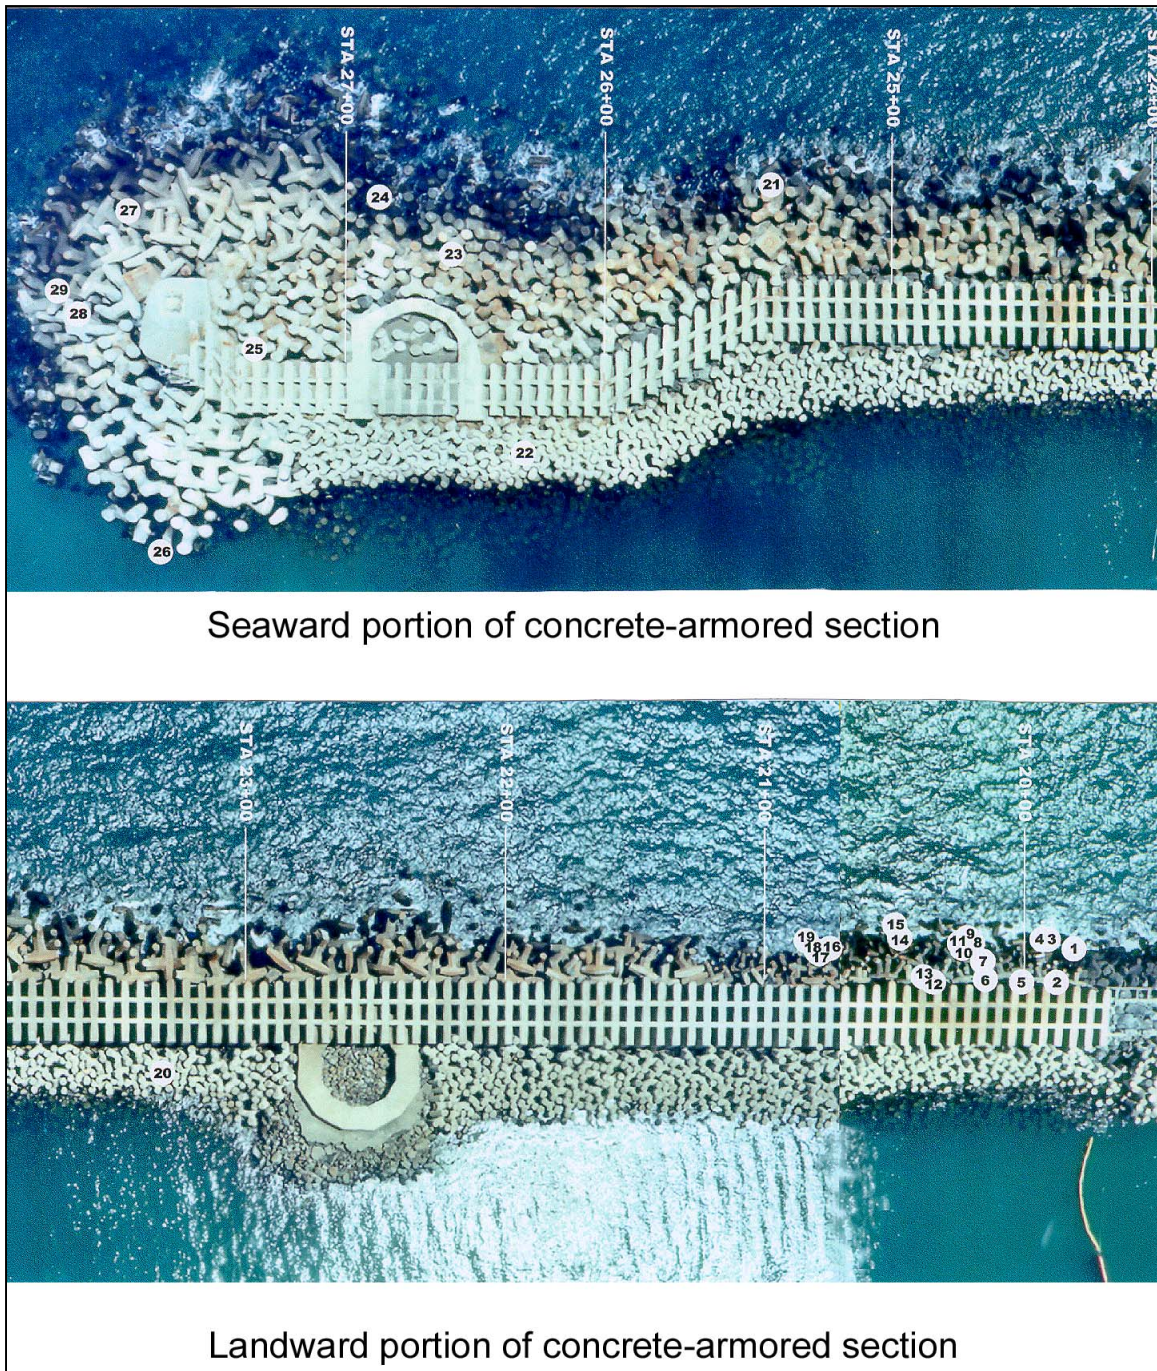
29 broken or cracked armor units were identified and 58 were observed on the Kahului west breakwater during the walking survey. No broken or cracked armor units were found on the Laupahoehoe breakwater .

Figure 26. Approximate locations of broken/cracked armor units along outer portion of Kahului east breakwater

The approximate locations of broken/cracked armor units along the Kahului east and west breakwaters are shown in Figures 26 and 27, respectively, and detailed data obtained during the broken armor unit inventory are shown in Table 11. Armor unit numbers identified in Figures 26 and 27 correspond to those listed in Table 11. Of the 29 broken armor units on the Kahului east breakwater, 19 were 5,445-kg (6-ton) dolosse; two were 8,165-kg (9-ton) tribars; four were 27,215-kg (30-ton) dolosse; and four were 31,750-kg (35-ton) tribars. The majority of the broken units (66 percent) were 5,445-kg (6-ton) dolosse located on the seaward side of the inner half of the concrete-armored portion of the structure. These broken units were concentrated between stas 19+60 and 20+84. Seventy-four percent of the broken 5,445-kg (6-ton) dolosse were located on the lower portion of the seaward slope in the active wave zone. Most the remaining broken units on the east breakwater were sporadically located around the head of the structure with no specific concentrations. Of the 58 broken armor units on the Kahului west breakwater, four were 5,900-kg (6.5-ton) tribars; one was a 9,980-kg (11-ton) tribar; 16 were 17,235-kg (19-ton) tribars; 18 were 18,145-kg (20-ton) dolosse; 11 were 27,215-kg (30-ton) dolosse; five were 29,940-kg (33-ton) tetrapods; and three were 31,750-kg (35-ton) tribars. On the west breakwater, 90 percent of the broken units were located on the seaward side of the outer half of the concrete-armored section of the breakwater. Concentrations of broken units occurred on the sea side of the breakwater between stas 20+50 and 21+50 and stas 22+50 and 23+50. Most broken units (66 percent) also were located on the lower portion of the seaward breakwater slope in the active wave zone.

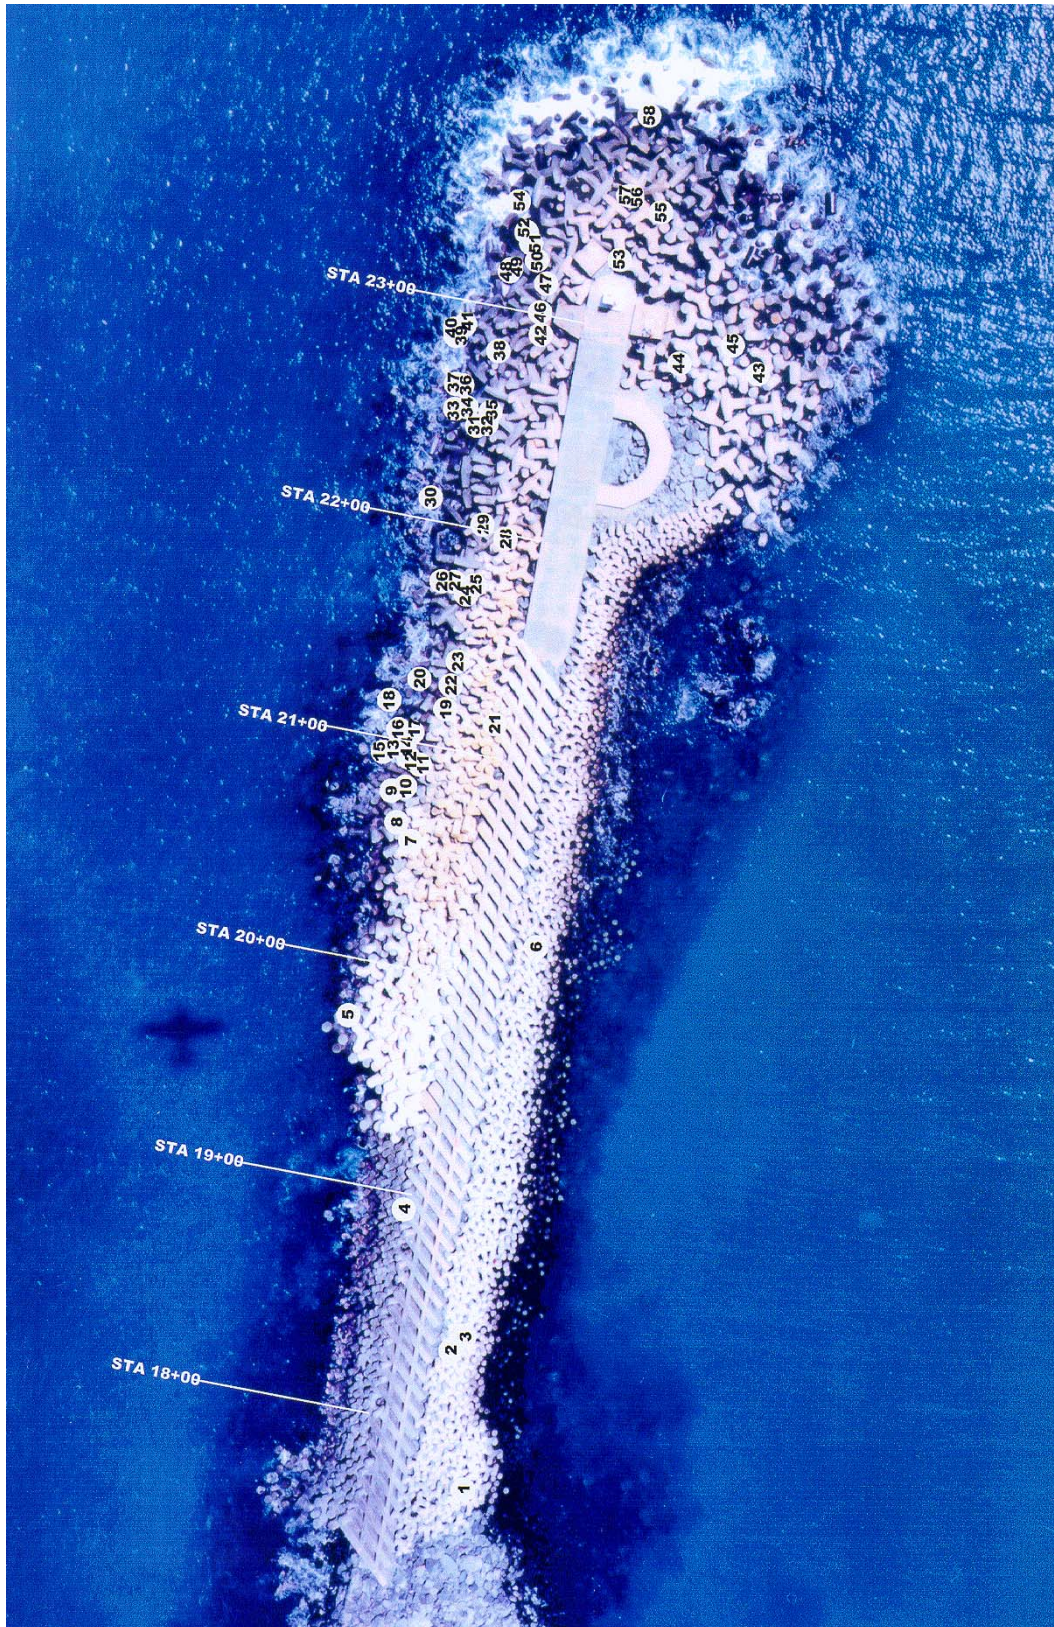
Figure 27. Approximate locations of broken/cracked armor units along outer portion of Kahului west breakwater

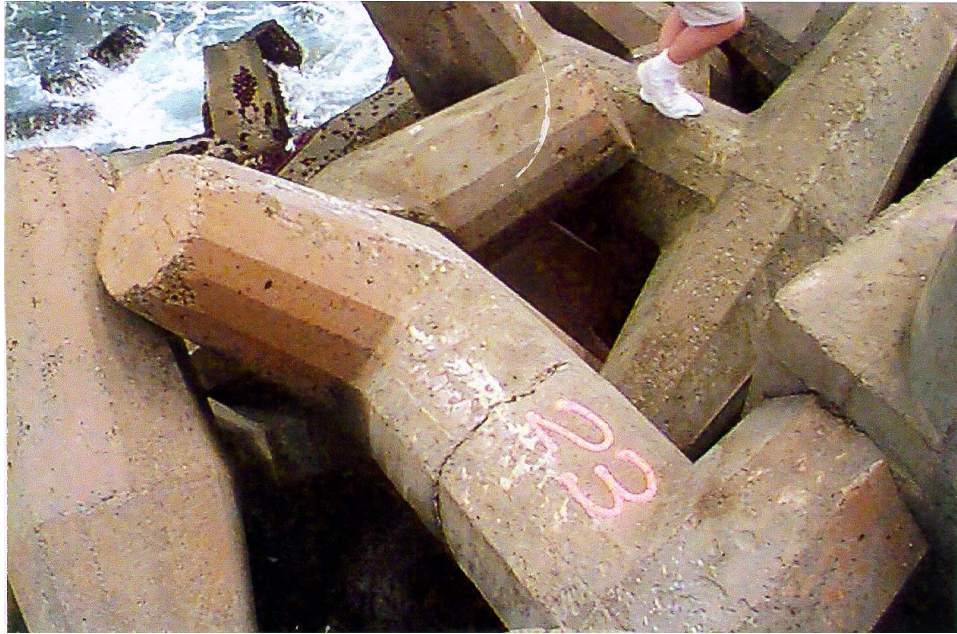
Types of breaks for the dolosse included shank and fluke breaks. These were characterized as mid-shank, shank-fluke (shank broken in vicinity of fluke), and fluke-shank (fluke broken off at junction with shank). Also recorded were straight breaks (broken straight across) and angled breaks (broken at some angle to the dolos limb). For the tribars and tetrapods, types of breaks included those through the center section of the unit where one or more legs were separated from the unit, and those in which just a portion of one of the legs was broken off.

Figure 28. Dolos with mid-shank crack

Views of representative types of breaks for the armor units are shown in Figures 28-31. Armor units with hairline cracks on one side were not counted, only those that were cracked all the way through were considered a break for recording purposes.

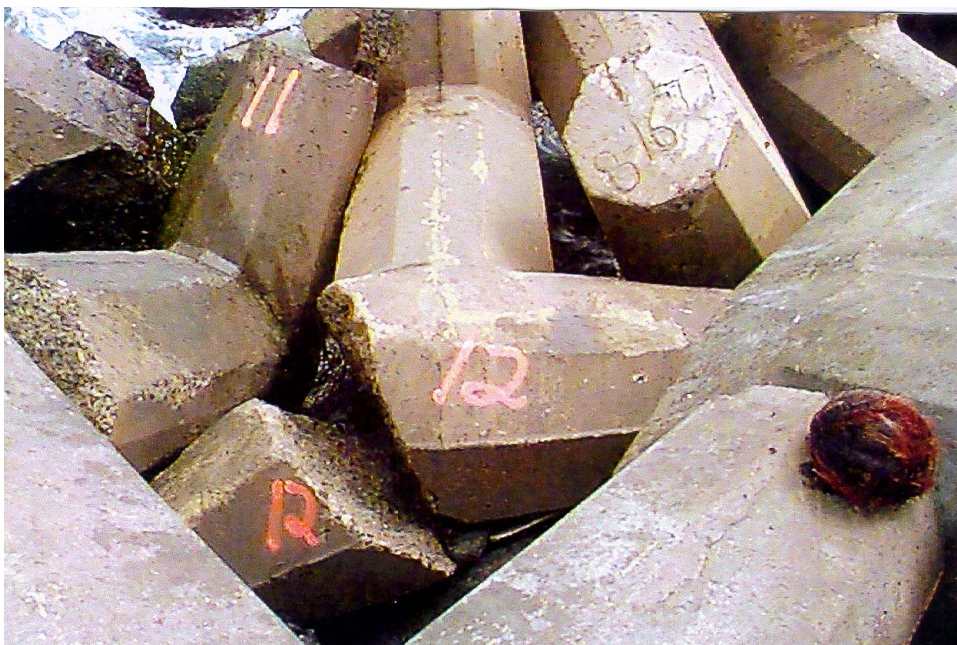
Figure 29. Dolos with fluke-shank break

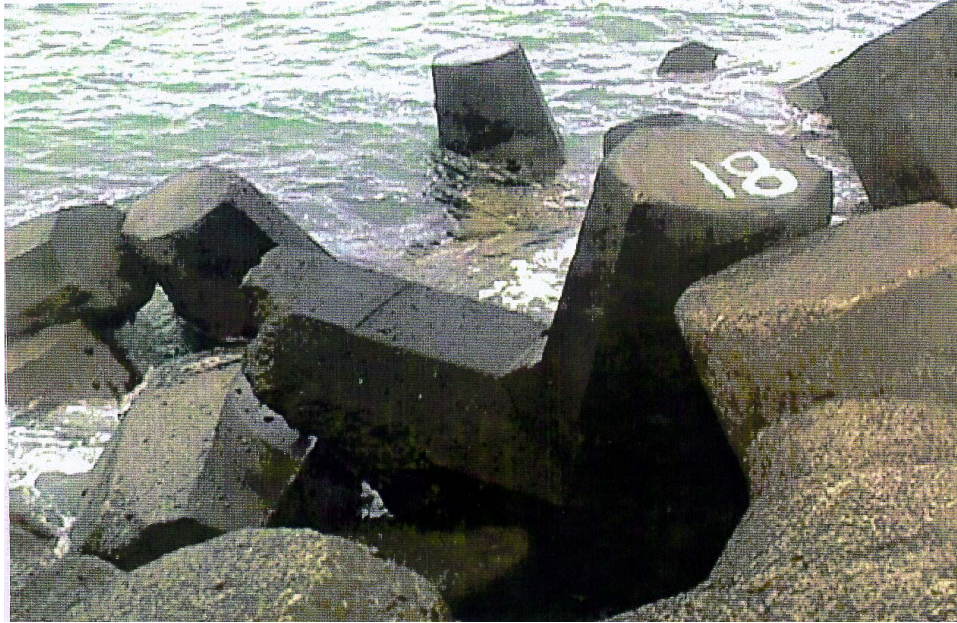
Figure 30. Dolos with shank-fluke break

Considering the types of breaks for the 52 broken dolosse on both the Kahului structures, 75 percent had shank-fluke breaks, 16 percent had fluke-shank breaks, and 9 percent had mid-shank breaks. Of the dolosse breaks recorded, 78 percent were straight and 22 percent were angled. Considering the types of breaks for the 35 tribars and tetrapods on the Kahului breakwaters, 89 percent included units with breaks through the center sections where one or more legs had separated, and 11 percent had just portions of a leg broken off the unit.

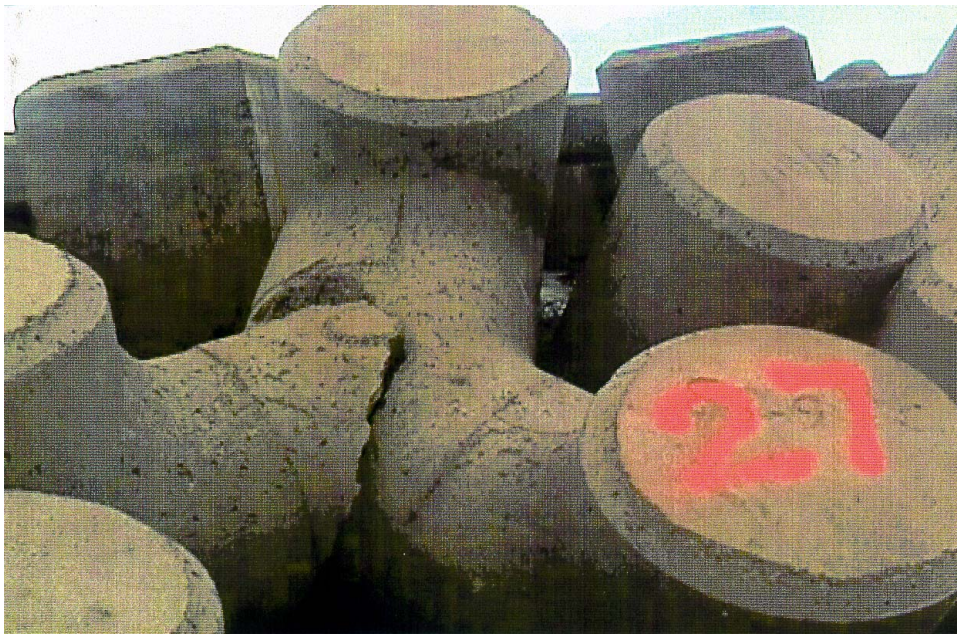
Figure 31. Tribar with break through center section of unit
