Technical Brief 18: Protecting Archeological Sites on Eroding Shorelines: A Hay Bales Approach

Robert M. Thorne, Pickering Environmental Consultants, Inc., Jackson, MS

Published by the DOI Departmental Consulting Archeologist/NPS Archeology Program, National Park Service, Washington, DC, July 2004.

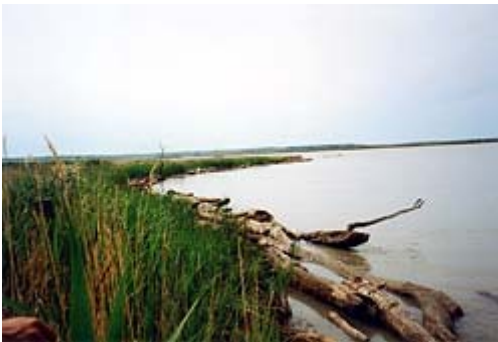
Figure 1. An Army Corps (WES) stabilization project using logs cabled in place and revegetation planted on bankline. Lake Sharpe, South Dakota, June 1994.

The revegetation effort at the lake—designed and directed by Hollis Allen—had already proved successful, alone and in combination with driftwood trees (Figure 1). The use of bales, which was untried previously, also proved effective. But the test setting—a relatively well protected bank sloping gently to the water’s edge—was not representative of conditions at Lake Sharpe (Figure 2). The revegetation techniques were common (e.g., Thorne 1990); their efficiency was really never in doubt. The primary purpose was to test the bales in actual conditions.

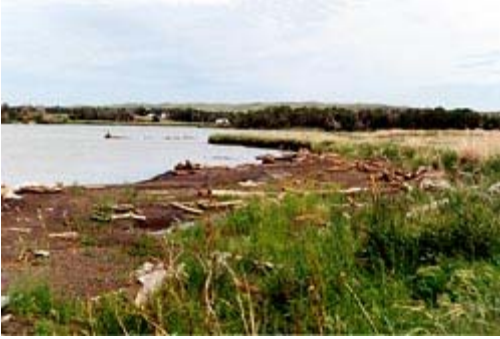
Figure 2. A beach development zone behind hay bales put in place in 1991. Lake Sharpe, South Dakota, June, 1994.

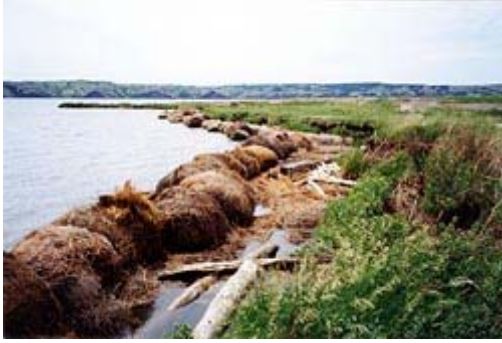
Figure 3. A farm where hay bales were put in place Sept/Oct of 1993. Note the height of the vertical cutbanks in the background, which are common to the entire lake. Lake Sharpe, South Dakota, June, 1994.

Most of the bales at Lake Sharpe were placed slightly opposite vertical banks, up to six feet high (Figure 3). Because of the near constant water level—and the lack of ebb and flow—there were few beaches to use as staging areas. Initially, the bales were lifted from the top of the banks by a crane or a dragline fitted with a clamshell bucket or specially designed clamp (Figure 4).

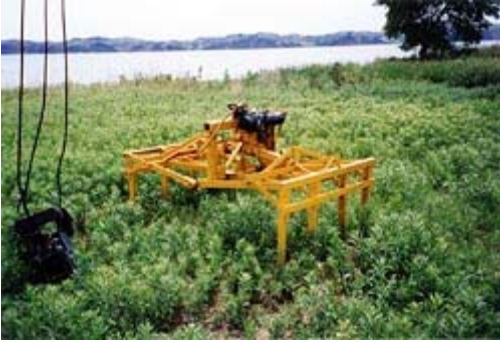
Figure 4. Commercially manufactured hay bale tongs for a crane. Were these actually attached to a crane, they would be hydraulically operated from inside the cab. Lake Sharpe, South Dakota, June, 1994.

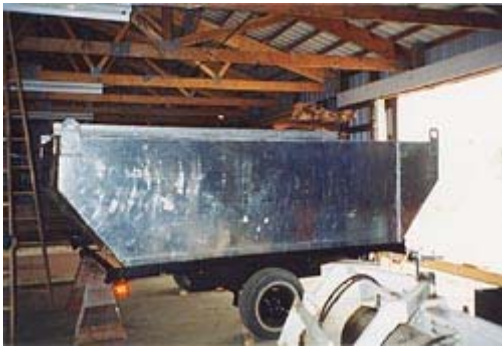
Figure 5. An Army Corps "shop built" barge for use with an airboat to place bales. Lake Sharpe, South Dakota, June, 1994.

For the Lake Sharpe project, a barge was designed to place bales in areas not accessible from the bank. This small, light, shallow-draft vessel, which was transported easily by trailer, also could be pushed or towed by boats with small motors (Figure 5). People wading alongside maneuvered it into position; a hydraulic lift dumped the bale in front of the vessel.

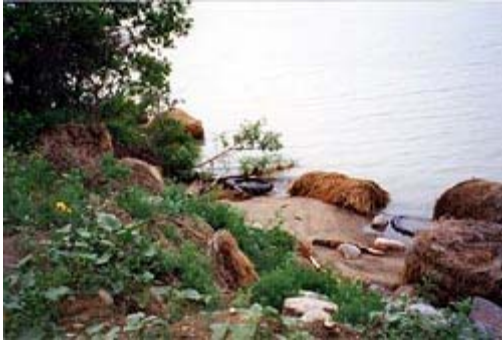
Figure 6. A stabilization at the Fort George Game & Fish Commission (with no Army Corps involvement) attempted to use tractor tires and hay bales. Note the sand buildup behind the center bale. Lake Sharpe, South Dakota, June, 1994.

As is the case with all stabilization techniques (Figure 6), no one approach is appropriate for every setting. This technique was not suited to the entire shoreline; in some places the bank was too high, in others the water too deep. Normally, the harsh environment may have disqualified this approach. In this case, however, it provided an excellent testing ground for developing and refining the technique. Winter temperatures are well below freezing, and the lake freezes to a depth of over three feet. This is not particularly destructive in and of itself, but during spring strong winds drive broken pieces of ice into the bales. At the least they could be pushed out of alignment; at the worst destroyed.

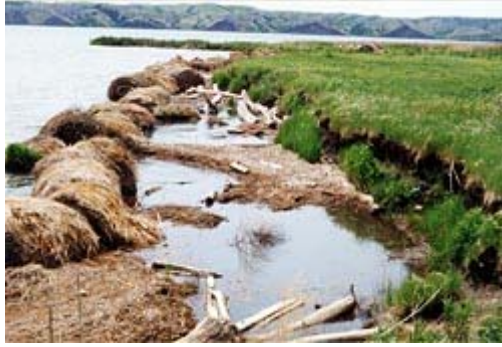
Figure 7. A south-by-southwest view of the farm. Lake Sharpe, South Dakota, June, 1994.

There have been no complaints that the barriers are unsightly, nor have any been vandalized. Less than a year later, fish were spawning in the basins; a mallard and her hatchlings were using one as a refuge (Figure 7). Even though some slumping continued, grass was growing in large patches. The benefit to the environment cannot be overemphasized.
