Sliding Seal Materials for Low Heat Rejection Engines

Kevin Beaty, James Lankford, and Shannon Vinyard
Southwest Research Institute

July 1989

Prepared for
NATIONAL AERONAUTICS AND SPACE ADMINISTRATION
Lewis Research Center
Under Contract DEN3-352

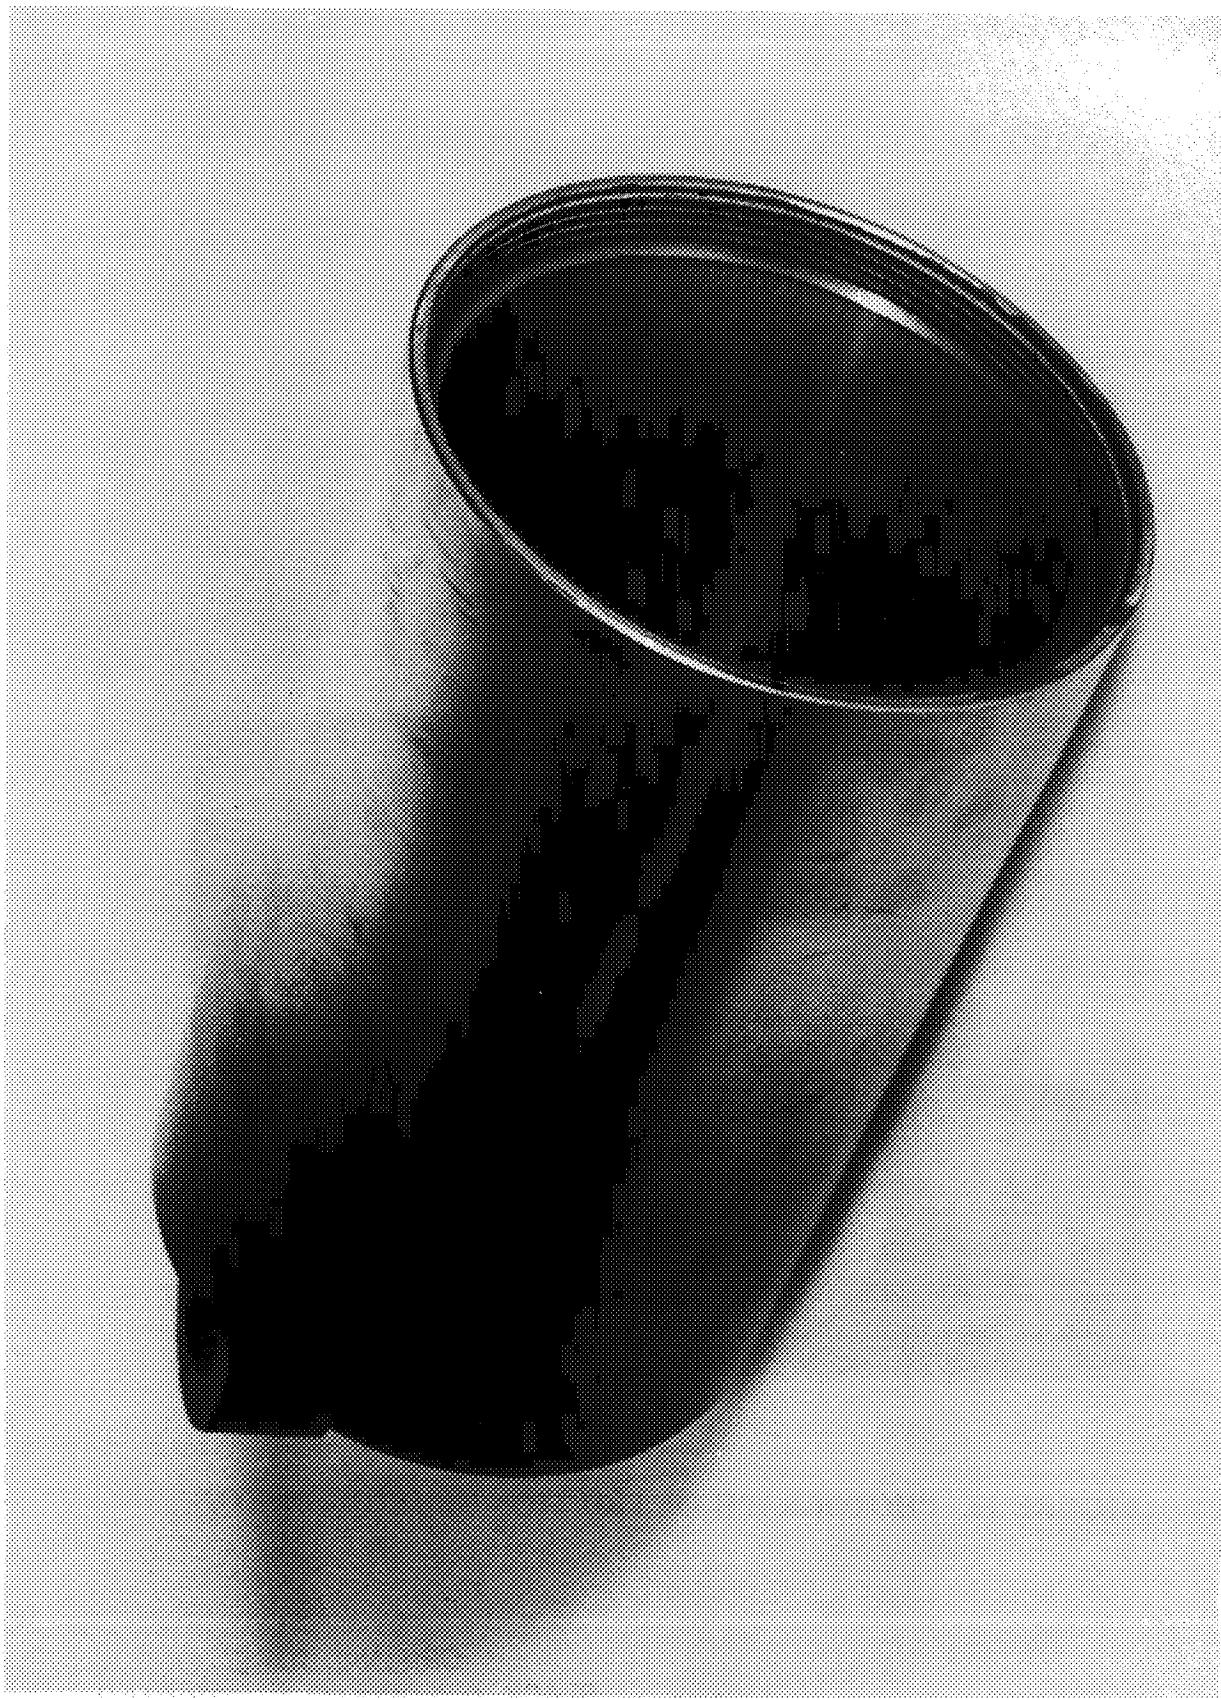
FIGURE 8. PHOTOGRAPH OF PSZ LINER BEFORE ION-IMPLANTATION
