# 8 PRESERVATION BRIEFS

## Aluminum and Vinyl Siding on Historic Buildings

### The Appropriateness of Substitute Materials for Resurfacing Historic Wood Frame Buildings.

U.S. Department of the Interior  
National Park Service  
Cultural Resources  
Heritage Preservation Services

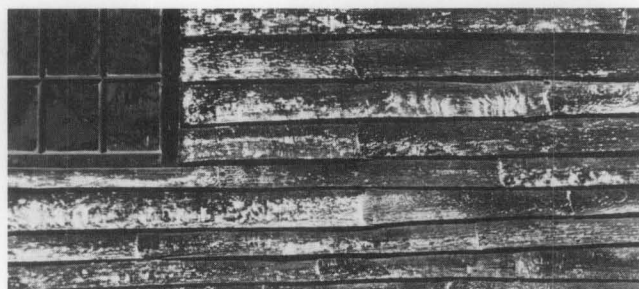
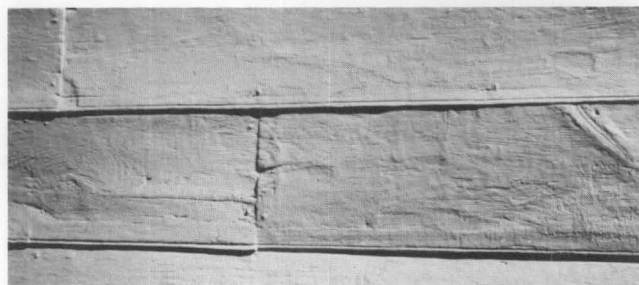
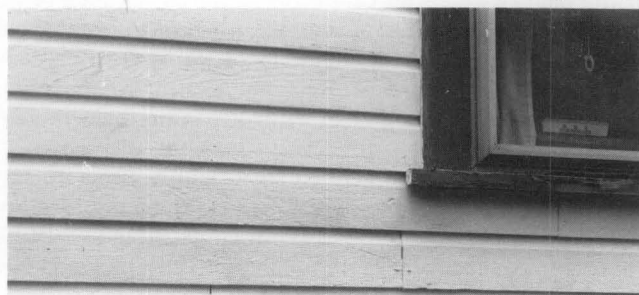
*Historic wood sidings exhibit rich and varied surface textures. They range from hand-split clapboards of short lengths with feather-edged ends, to pit or mill sawn boards which can be beveled, rabbeted, milled, or beaded.*

The variety of tools used, coupled with regional differences in design and craftsmanship, has resulted in a richness and diversity of wood sidings in America. For example, narrow boards with beveled, lapped joints called "clapboards" were used on New England frame dwellings. The size and shape of the "clapboards" were determined by the process of hand splitting or "riving" bolts of wood.

The width, the short lengths, the beveled lapping, the "feathered" horizontal joints, and the surface nailing of the clapboards created a distinctive surface pattern that is recognizable as an important part of the historic character of these structures.

The sawn and hand-planed clapboards used throughout the Mid-Atlantic and Southern states in the eighteenth and early nineteenth centuries, by contrast, have a wide exposure—generally between six and eight inches. The exposure of the siding, frequently coupled with a beaded edge, created a very different play of light and shadow on the wall surface, thus resulting in a different character. The "German" or "Novelty siding"—a milled siding that is thin above and thicker below with a concave bevel—was used throughout many parts of the United States in the late nineteenth and early twentieth century but with regional variations in material, profile, and dimensions. One variation of this type of milled siding was called "California siding" and was milled with a rabbetted or shiplap edge to insure a tight installation of the weatherboards. Shingles were also commonly used as an exterior cladding material, and in buildings such as the Bungalow style houses, were often an important character-defining feature of the exterior. Shingles were often applied in decorative patterns by varying the lap, thus creating alternating rows of narrow exposures and wide exposures. Shingles were also cut in geometric patterns such as diamond shapes and applied in patterns. This treatment was commonly used in the gable end of shingled houses. Siding and wood shingles were often used in combination with materials such as cobblestone and brick in Bungalow style buildings to create a distinctive interplay of surfaces and materials.

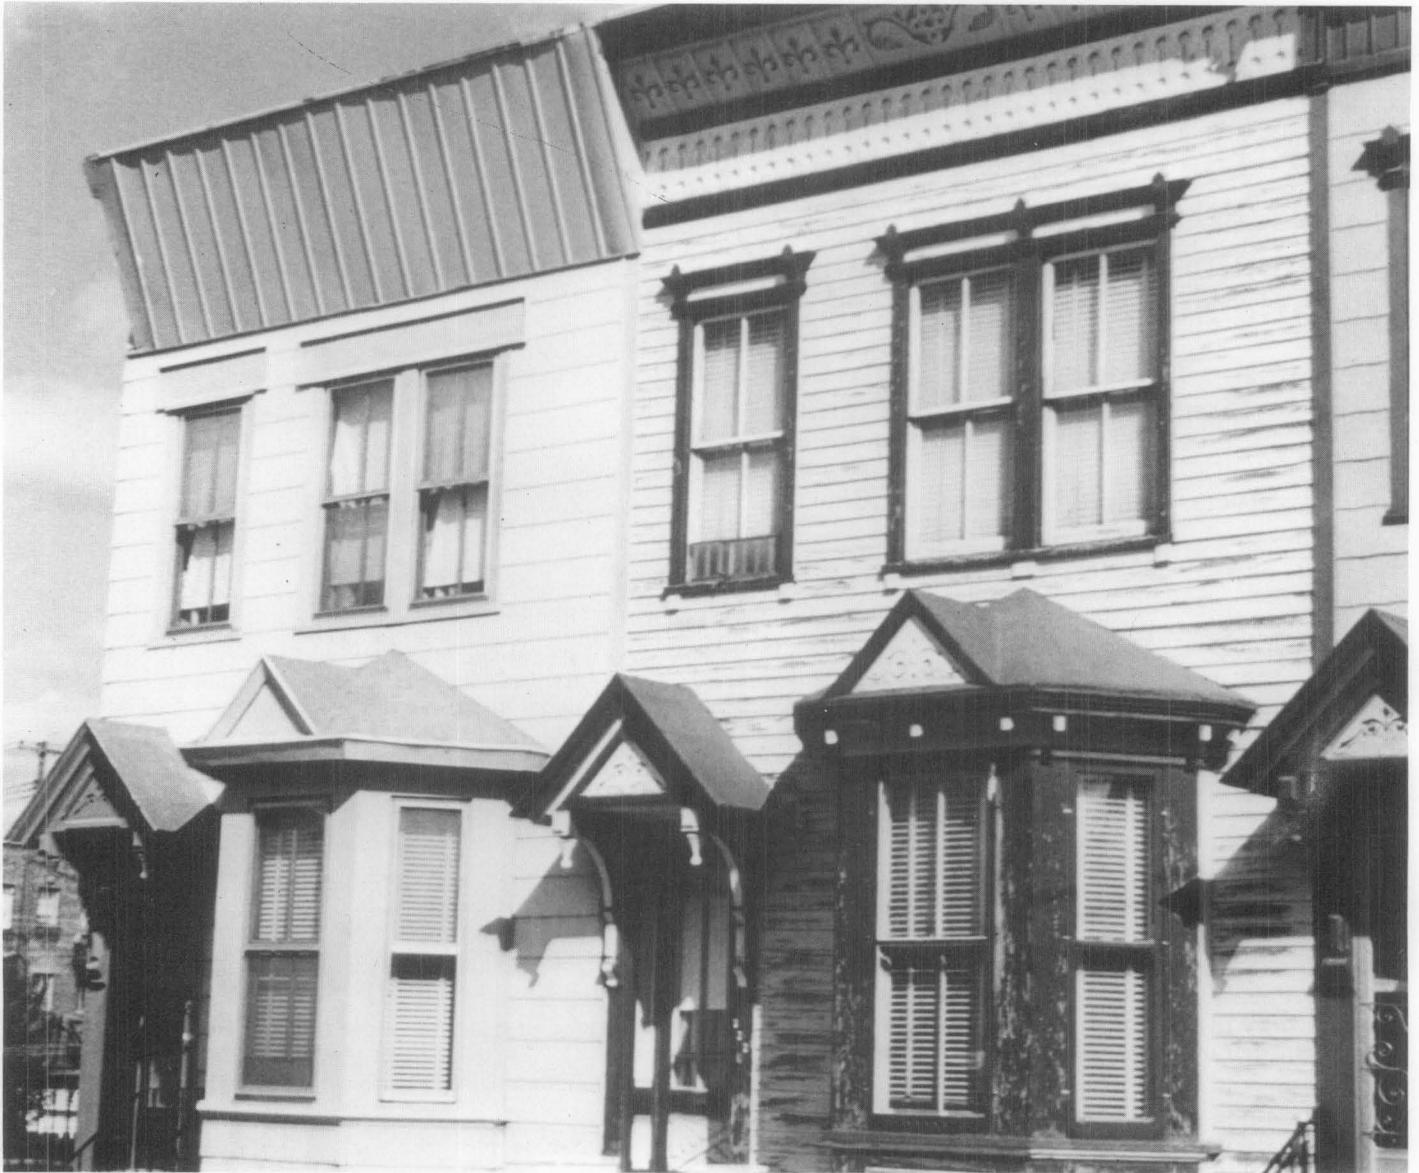
When a building is in need of maintenance, such as the house on the right which needs painting, some owners consider installing aluminum or vinyl siding. The result, like the house on the left, can be a complete loss of architectural character due to the covering of details (cornice), the removal of features (window trim), and a change of scale due to inappropriate siding dimensions.

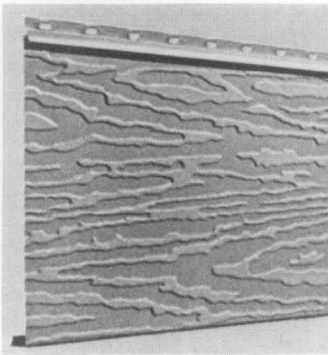
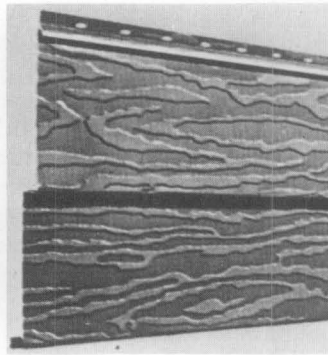
*Aluminum and vinyl siding are available in a variety of widths and colors, but the optional wood graining is not characteristic of real wood siding.*

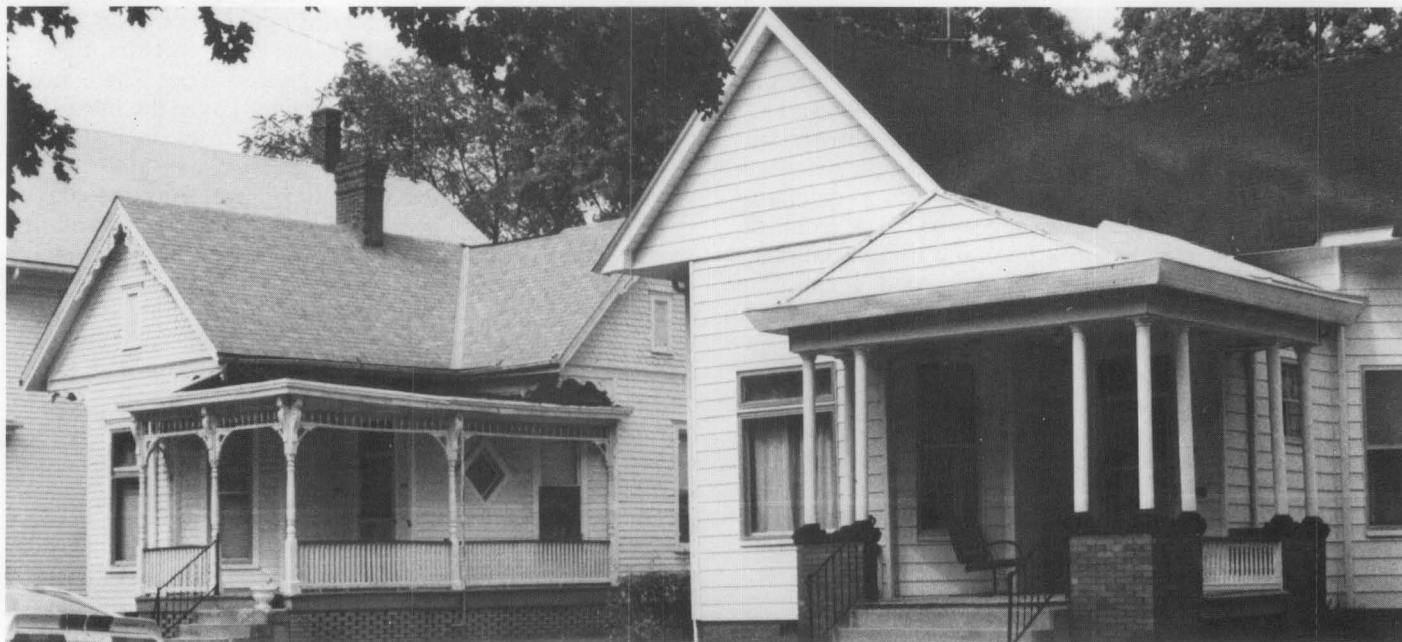
*Two originally similar houses. When aluminum was installed on the house on the right, the barge boards, scrollwork, columns, and railings were removed. The distinctive shingled gable and attic vent were covered, further compromising the building's architectural integrity.*

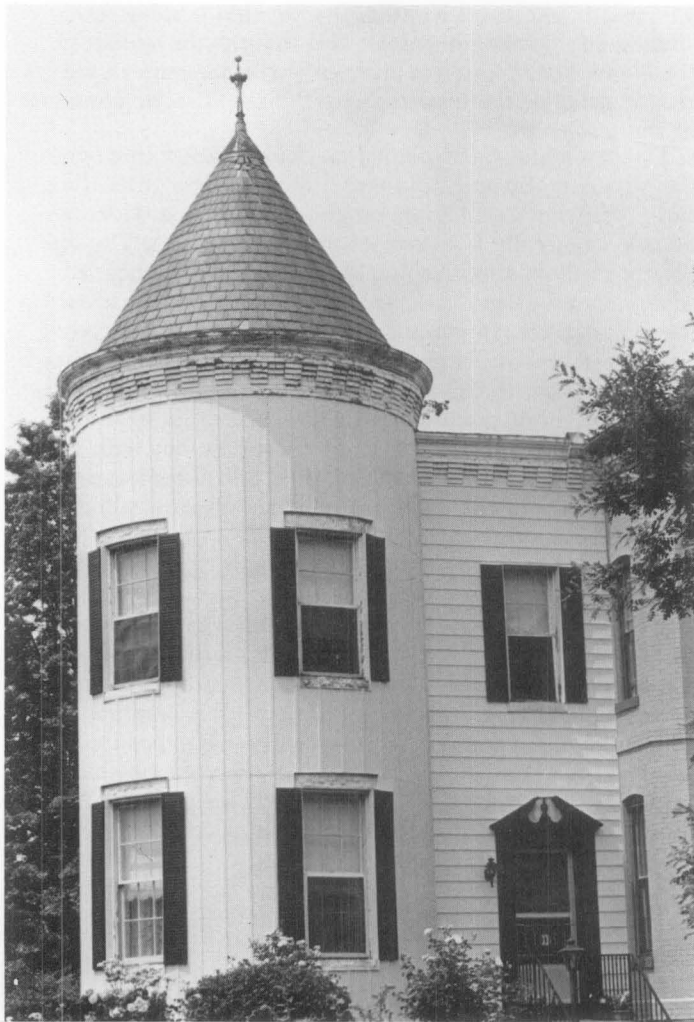
*This brick rowhouse was covered with vertical and horizontal aluminum siding. Such treatment is inappropriate for historic masonry buildings.*

The existing wall fabric is further damaged by the nailing necessary to apply siding. Either by nailing directly to the building fabric or by nailing the furring strips to the old siding, the installation of aluminum or vinyl siding will leave numerous holes in wood siding, molding, trim, window and door frames. When applied to brick or other masonry units, the nail penetrations attaching the furring strips and siding can cause irreversible cracking or spalling of the masonry. Although this reference to damaging masonry is included as a point of fact, the application of aluminum or vinyl siding is highly inappropriate to historic masonry buildings.
