15 PRESERVATION BRIEFS

Preservation of Historic Concrete

Paul Gaudette and Deborah Slaton

National Park Service
U.S. Department of the Interior
Heritage Preservation Services

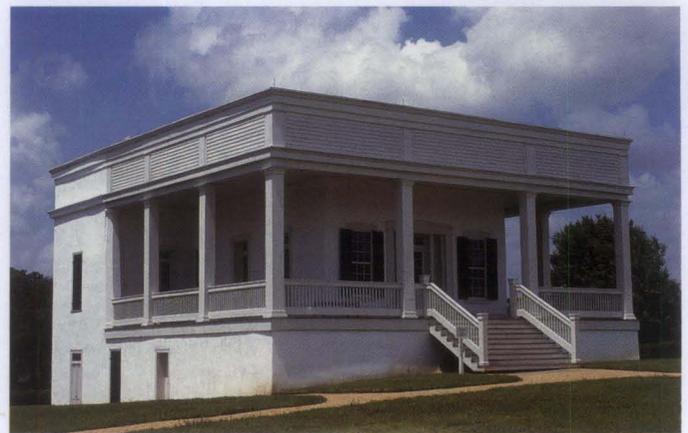
Figure 1. The Sebastopol House in Seguin, Texas, is an 1856 Greek Revival-style house constructed of lime concrete. Lime concrete or "limecrete" was a popular construction material, as it could be made inexpensively from local materials. By 1900, the town had approximately ninety limecrete structures, twenty of which remain. Photo: Texas Parks and Wildlife Department.

publicized in the second edition of Orson S. Fowler's *A Home for All* (1853) which described the advantages of "gravel wall" construction to a wide audience. The town of Seguin, Texas, thirty-five miles east of San Antonio, already had a number of concrete buildings by the 1850s and came to be called "The Mother of Concrete Cities," with approximately ninety concrete buildings made from local "lime water" and gravel (Fig. 1).

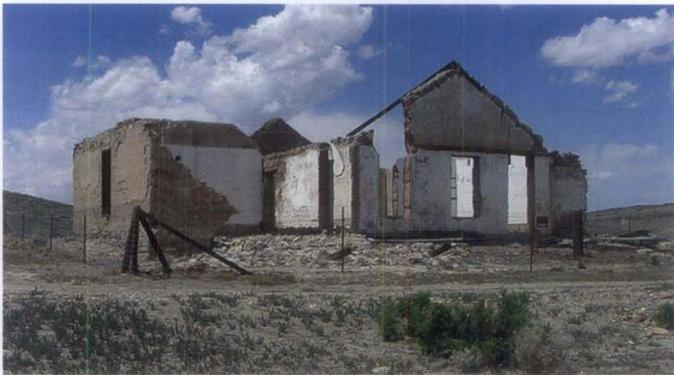
Figure 2. Chatterton House was the home of the post trader at Fort Fred Steel in Wyoming, one of several forts established in the 1860s to protect the Union Pacific Railroad. The walls of the post trader's house were built using stone aggregate and lime, without cement. The use of this material presents special preservation challenges.

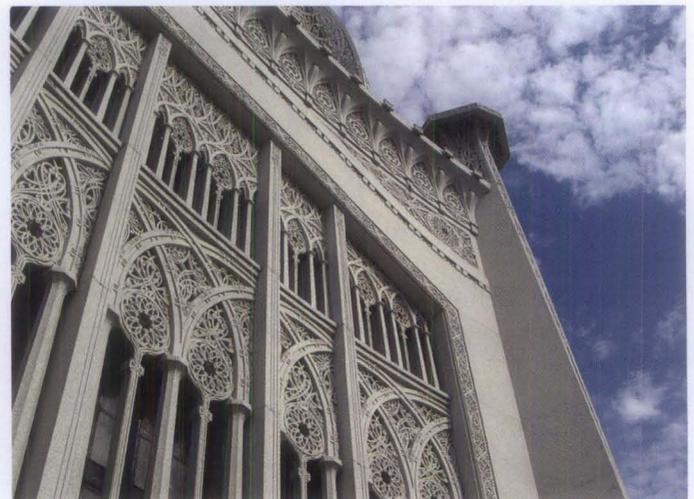
Figure 4. The highly ornamental concrete panels on the exterior facade of the Baha'i House of Worship in Wilmette, Illinois, illustrate the work of fabricator John J. Earley, known as "the man who made concrete beautiful."

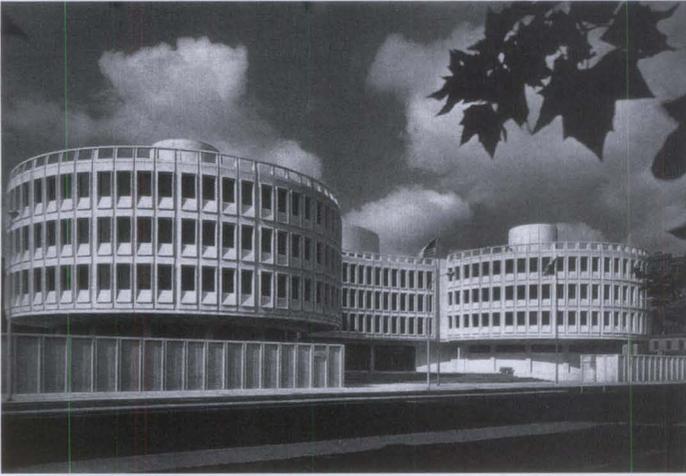
Figure 5. Following World War II, architects and engineers took advantage of improvements in concrete production, quality control, and advances in precast concrete to design structures such as the Police Headquarters building in Philadelphia, Pennsylvania, constructed in 1961. Photo: Courtesy of the Philadelphia Police Department.

During the early twentieth century, Ernest Ransome in Beverly, Massachusetts, Albert Kahn in Detroit, and Richard E. Schmidt in Chicago, promoted concrete for use in “Factory Style” utilitarian buildings with an exposed concrete frame infilled with expanses of glass. Thomas Edison’s cast-in-place reinforced concrete homes in Union Township, New Jersey (1908), proclaimed a similarly functional emphasis in residential construction. From the 1920s onward, concrete began to be used with spectacular design results: examples include John J. Earley’s Meridian Hill Park in Washington, D.C.; Louis Bourgeois’ exuberant, graceful Baha’i Temple in Wilmette, Illinois (1920–1953), for which Earley fabricated the concrete (Fig. 4); and Frank Lloyd Wright’s Fallingwater near Bear Run, Pennsylvania (1934). Continuing improvements in quality control and development of innovative fabrication processes, such as the Shockbeton method for precast concrete, provided increasing opportunities for architects and engineers. Wright’s Guggenheim Museum in New York City (1959); Geddes Brecher Qualls & Cunningham’s Police Headquarters building in Philadelphia, Pennsylvania (1961); and Eero Saarinen’s soaring terminal building at Dulles International Airport outside Washington, D.C., and the TWA terminal at Kennedy Airport in New York (1962), exemplify the masterful use of concrete achieved in the modern era (Fig. 5).

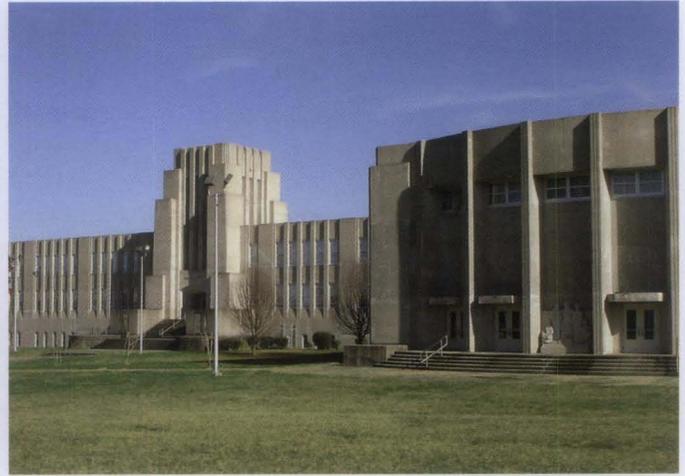
Figure 6. The Bailey Magnet School in Jackson, Mississippi, was designed as the Jackson Junior High School by the firm of N.W. Overstreet & Town in 1936. The streamlined building exemplifies the applicability of concrete to creating a modern architectural aesthetic. Photo: Bill Burris, Burris/Wagnon Architects, P.A.

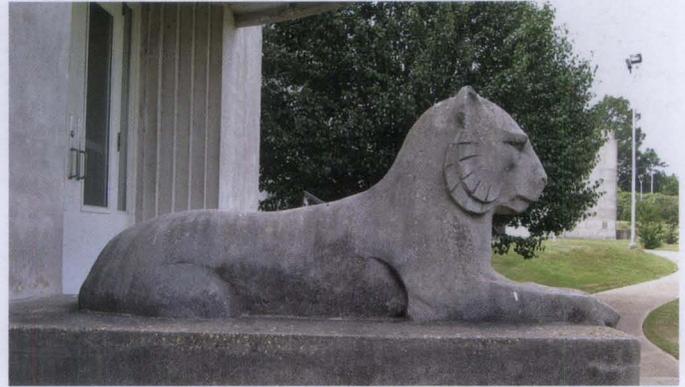
Figure 7. Detailed bas reliefs as well as sculptures, such as this lion at the Bailey Magnet School, could be used as ornamentation on concrete buildings. Sculptural concrete elements were typically cast in molds.

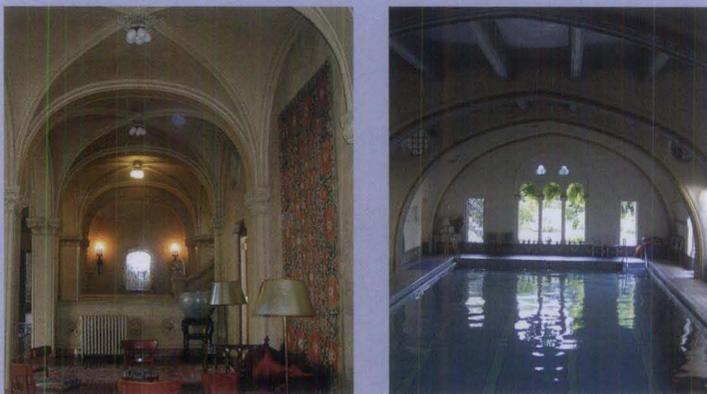
Figure 10. The Berkeley City Club has significant interior spaces and features of concrete construction, including the lobby and pool. Photos: Una Gilmartin (left) and Brian Kehoe (right), Wiss, Janney, Elstner Associates, Inc.

The expanded use of concrete provided new opportunities to create dramatic spaces and ornate architectural detail on the interiors of buildings, at a significant cost savings over traditional construction practices. The architectural design of the Berkeley City Club in Berkeley, California, expressed Moorish and Gothic elements in concrete on the interior of the building (Fig. 10). Used as a woman's social club, the building was designed by noted California architect Julia Morgan and constructed in 1929. The vaulted ceilings, columns, and ornamental capitals of the lobby and the ornamental arches and beamed ceiling of the "plunge" are all constructed of concrete.

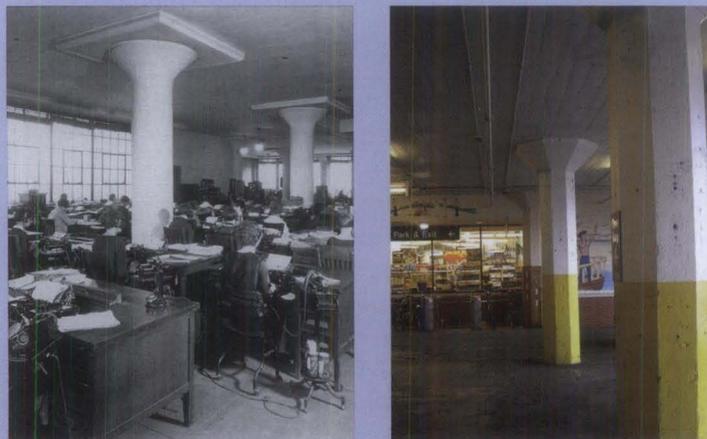
Figure 11. Whether in a circa 1925 office (left) or in a parking garage and retail facility (right), exposed concrete structures help characterize these building interiors. Photo: Minnesota Historical Society (left).

The historic character of a building's interior can also be conveyed in a more utilitarian manner in terms of concrete features and finishes (Fig. 11). The exposed concrete structure—columns, capitals, and drop panels—is an integral part of the character of this old commercial building in Minneapolis. In concrete warehouse and factory buildings of the early twentieth century, exposed concrete columns and formboard finish concrete slab ceilings are common features as seen in this warehouse, now converted for use as a parking garage and shops.

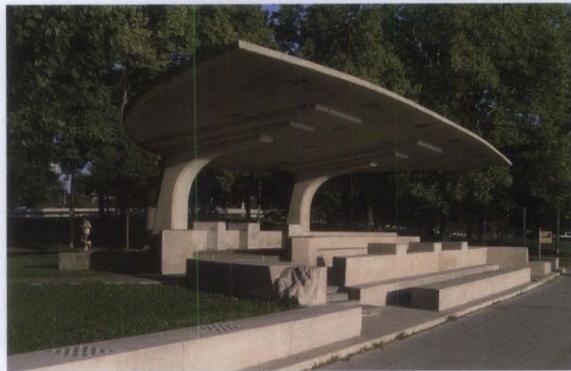
Figure 8. The Chess Pavilion in Chicago's Lincoln Park was designed by architect Morris Webster and constructed in 1956. The pavilion is a distinctive landscape feature, with its reinforced concrete cantilevered slab that provides cover for chess players.

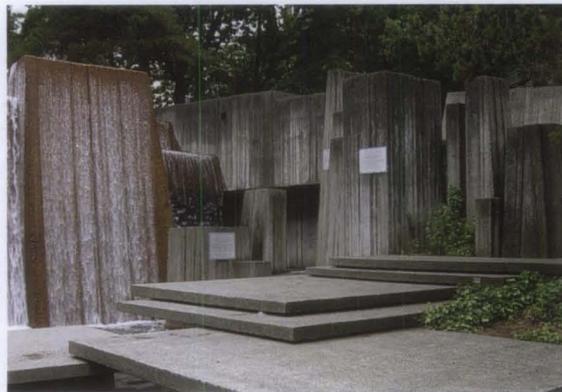
Figure 9. The Ira C. Keller Fountain in Portland, Oregon, was designed by Lawrence Halprin and constructed in 1969. The fountain is constructed primarily of concrete pillars with formboard textures and surrounding elements, patterned with geometric lines, which facilitate the path of water. Photo: Anita Washko, Wiss, Janney, Elstner Associates, Inc.

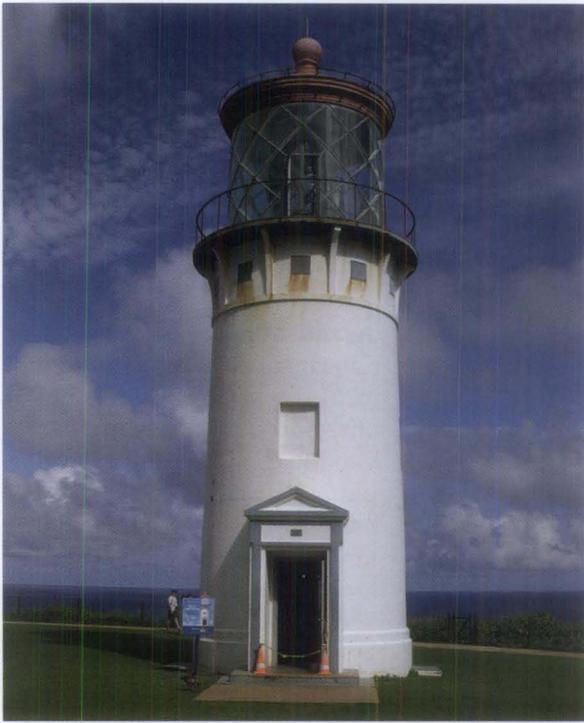
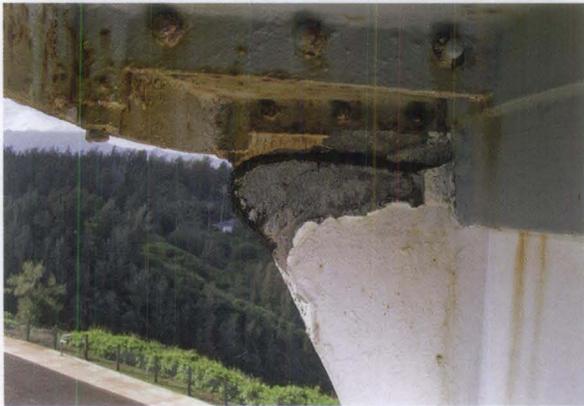
Figure 12. The concrete lighthouse at the Kilauea Point Light Station, Kilauea, Kauai, Hawaii, was constructed circa 1913. The concrete, which was a good quality, high strength mix for its day, is in good condition after almost one hundred years in service. Deterioration in the form of spalling related to corrosion of embedded reinforcing steel has occurred primarily in areas of higher ornamentation such as projecting bands and brackets (see close-up photo).

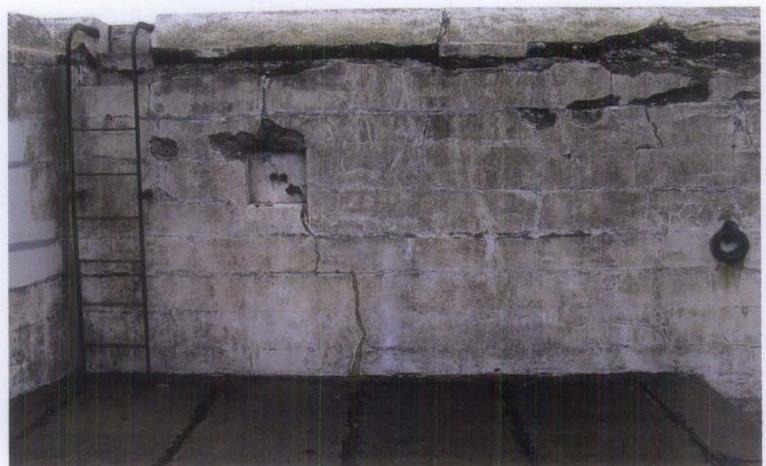
Figure 13. Fort Casey on Admiralty Head, Fort Casey, Washington, was constructed in 1898. The lift lines from placement of concrete are clearly visible on the exterior walls and characterize the finished appearance.

In concrete structures built prior to the First World War, concrete was often placed into forms in relatively short vertical lifts due to limitations in lifting and pouring techniques available at the time. Joints between different concrete placements (often termed cold joints or lift lines) may sometimes be considered an important part of the character of a concrete element (Fig. 13). However, wide joints may permit water to infiltrate the concrete, resulting in more rapid paste erosion or freeze-thaw deterioration of adjacent concrete in cold climates.

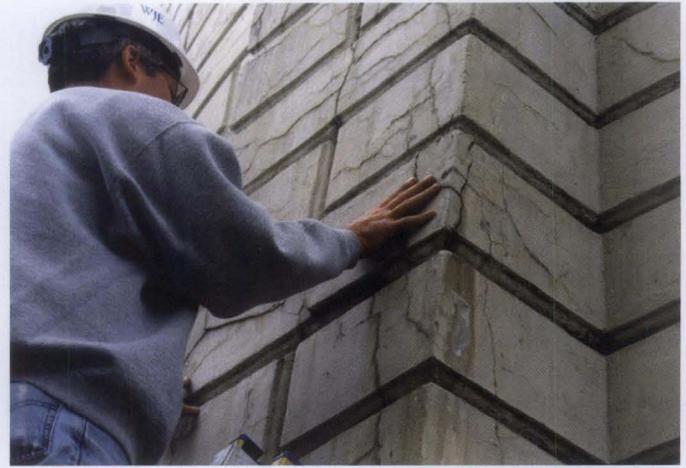
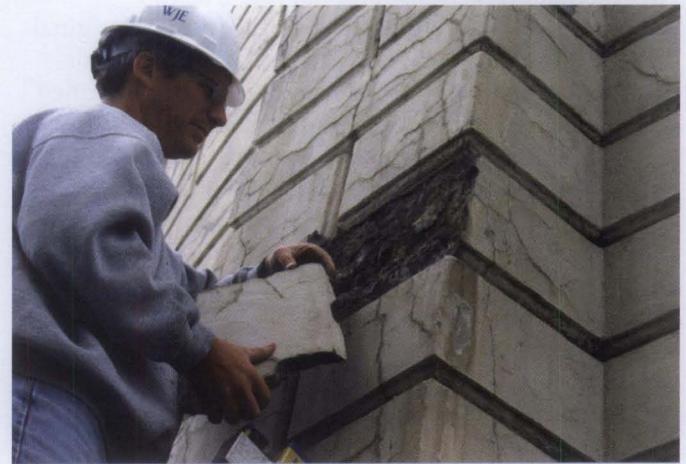
Figures 14. Layers of architectural concrete that have debonded (spalled) from the surface were removed from a historic water tank during the investigation performed to assess existing conditions. Photos: Anita Washko, Wiss, Janney, Elstner Associates, Inc.

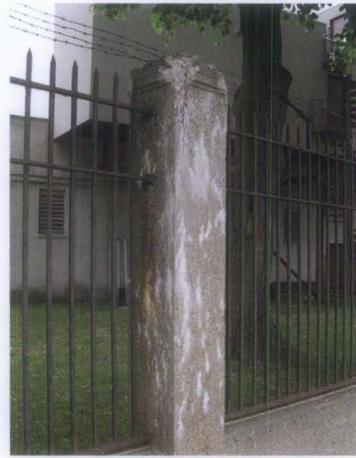
Figure 15. Evidence of moisture movement through concrete is apparent in the form of mineral deposits on the concrete surface. Cyclic freezing and thawing of entrapped moisture, and corrosion of embedded reinforcement, have also contributed to deterioration of the concrete column on this fence at Crocker Field in Fitchburg, Massachusetts, designed by the Olmsted Brothers.

Staining of the concrete surface can be related to soiling from atmospheric pollutants or other contaminants, dirt accumulation, and the presence of organic growth. However, stains can also indicate more serious underlying problems, such as corrosion of embedded reinforcing steel, improper previous surface treatments, alkali-aggregate reaction, or efflorescence, the deposition of soluble salts on the surface of the concrete as a result of water migration (Fig. 15).

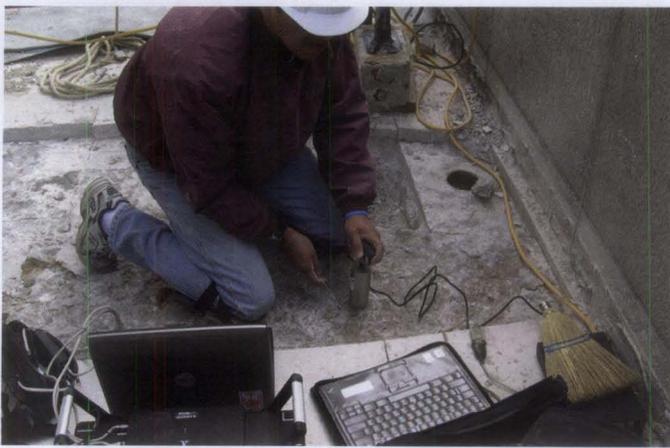
Figure 16. Impact echo testing is performed on a concrete structural slab to help determine depth of deterioration. In this method, a short pulse of energy is introduced into the structure and a transducer mounted on the impacted surface of the structure receives the reflected input waves or echoes. These waves are analyzed to help identify flaws and deterioration within the concrete.

A number of nondestructive testing methods can be used in the field to evaluate concealed conditions. Basic techniques include sounding with a hand-held hammer (or for horizontal surfaces, a chain) to help identify areas of delamination. More sophisticated techniques include impact-echo testing (Fig. 16), ground penetrating radar, pulse velocity, and other methods that characterize concrete thickness and locate voids or delaminations. Magnetic detection instruments are used to locate embedded reinforcing steel and can be calibrated to identify the size and depth of reinforcement. Corrosion measurements can be taken using copper-copper sulfate half-cell tests or linear polarization techniques to determine the probability or rate of active corrosion of the reinforcing steel.

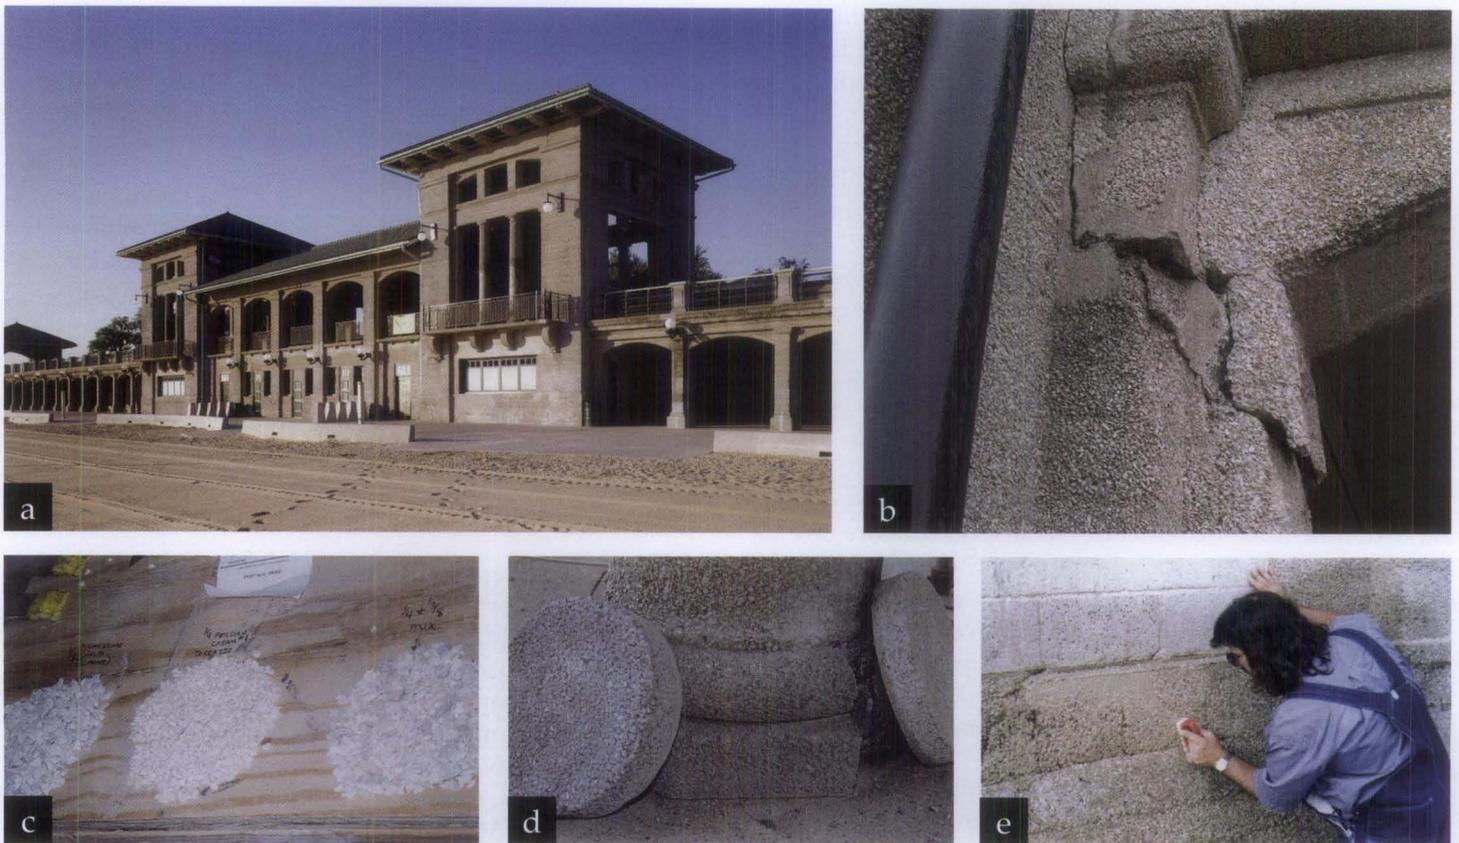
Figure 17. (a) The 63rd Street Beach House was constructed on the shoreline of Chicago in 1919. The highly exposed aggregate concrete of the exterior walls of the beach house was used for many buildings in the Chicago parks as an alternative to more expensive stone construction. Photo: Leslie Schwartz Photography. (b) Concrete deterioration included cracking, spalling, and delamination caused by corrosion of embedded reinforcing steel and concrete damage due to cyclic freezing and thawing. (c) Various sizes and types of aggregates were reviewed for matching to the original concrete materials. (d) Mock-ups of the concrete repair mix were prepared for comparison to the original concrete. Considerations included aggregate type and size, cement color, proportions, aggregate exposure, and surface finish. (e) The craftsman finished the surface to replicate the original appearance in a mock-up on the structure. Here, he used a nylon bristle brush to remove loose paste and expose the aggregate, creating a variable surface to match the adjacent original concrete.

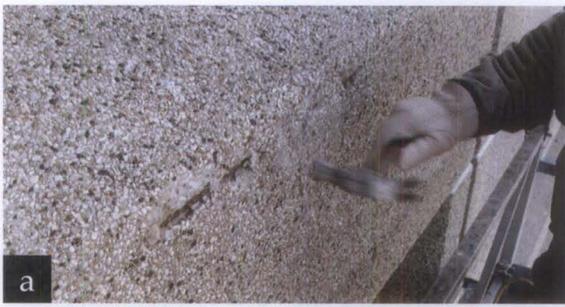
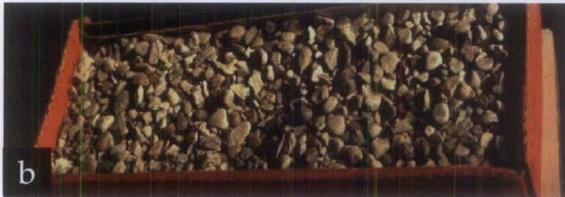
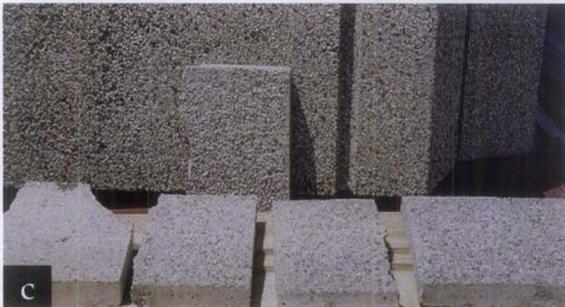
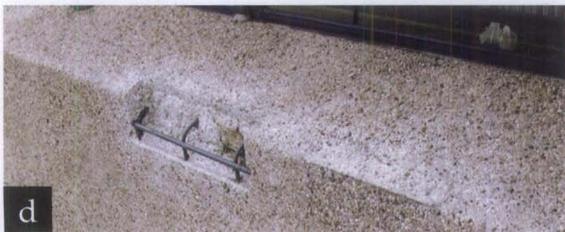
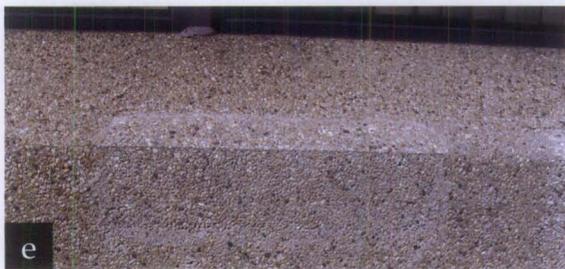
Figure 18. (a) Exposed aggregate precast concrete is sounded with a hammer to detect areas of deterioration. Corrosion of the exposed reinforcing steel bar has led to spalling of the adjacent concrete. (b) Samples of aggregate considered for use in repair concrete are compared to the original concrete materials in terms of size, color, texture, and reflectance. (c) Various sample panels are made using the selected concrete repair mix design for comparison to the original concrete on the building, and the mix design is adjusted based on review of the samples. (d) After removal of the spall, the concrete surface is prepared for installation of a formed patch. (e) Prior to placement of the concrete, a retarding agent is brush-applied to the inside face of the formwork to slow curing at the surface. After the concrete is partially cured, the forms are removed and the surface of the concrete is rubbed to remove some of the paste and expose the aggregate to match the original concrete.

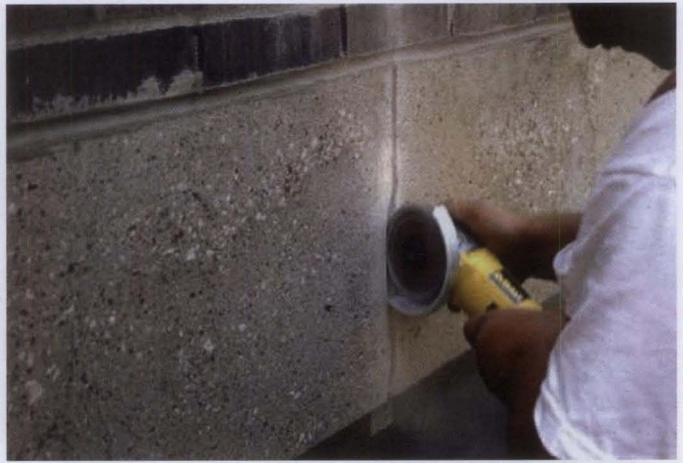
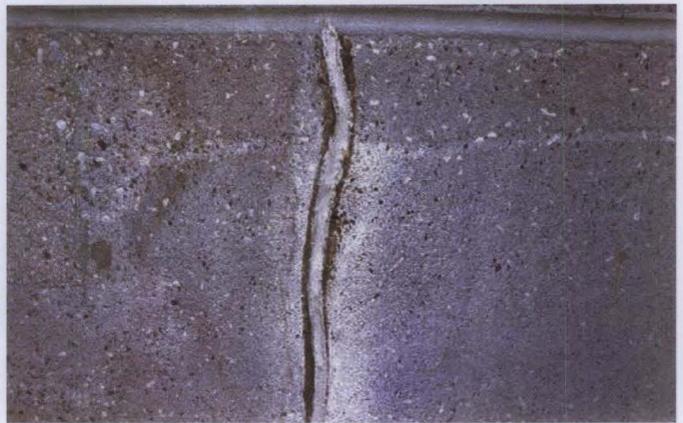
Figure 19. A high-speed grinder is used to widen a crack in preparation for installation of a sealant. This process is called "routing." After the crack is prepared, the sealant is installed to prevent moisture infiltration through the crack. Although sealant repairs can provide a durable, watertight repair for moving cracks, they tend to be very visible.

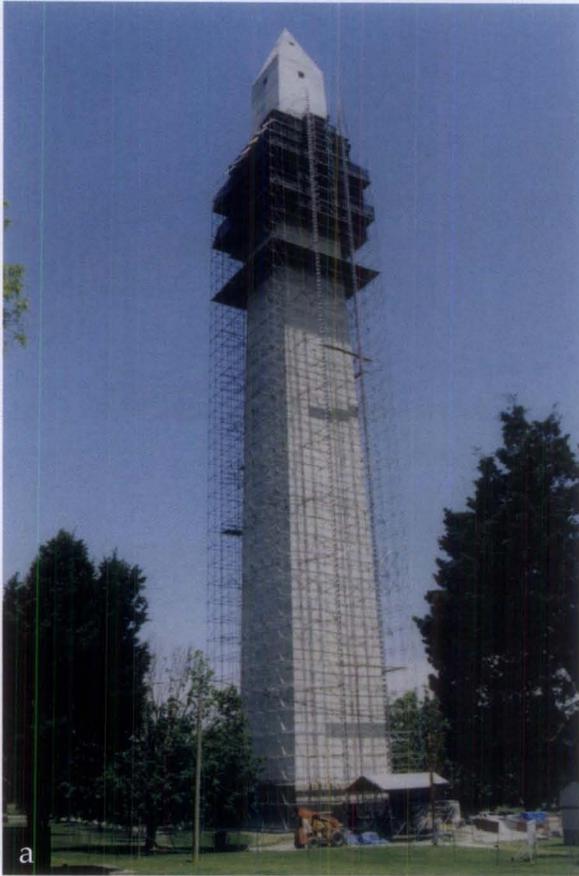
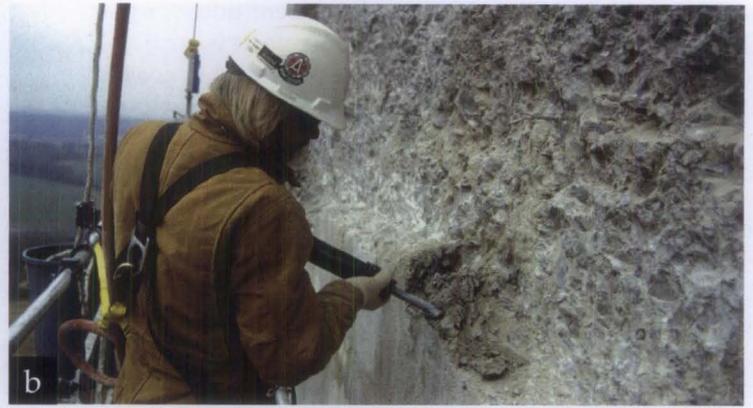
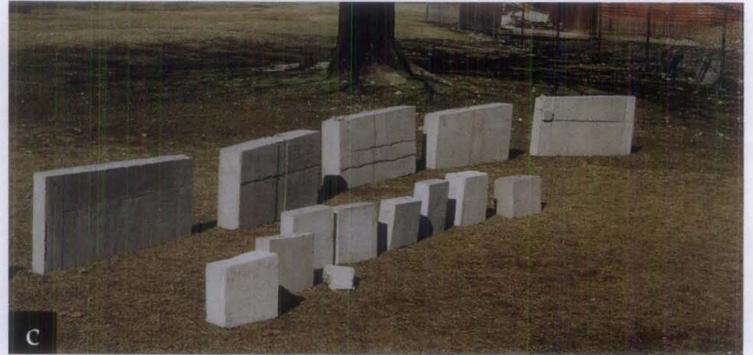
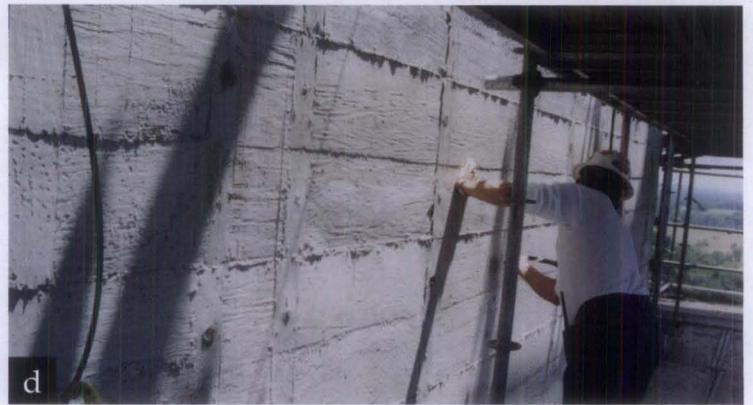
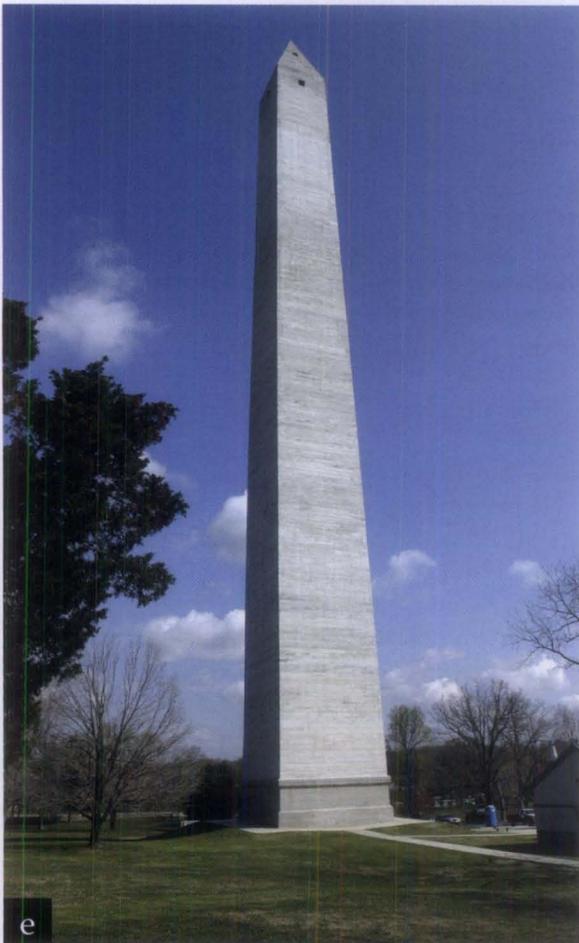
Figure 20. (a) The Jefferson Davis Memorial in Fairview, Kentucky, constructed from 1917–1924, is 351 feet tall and constructed of unreinforced concrete. The walls of the memorial are 8 feet thick at the base and 2 feet thick at the top of the wall. Access to the monument for investigation was provided by rappelling techniques, while ground supported and suspended scaffolding was used to access the exterior during repairs. (b) The concrete was severely deteriorated at isolated locations, with spalling and damage from cyclic freezing and thawing of entrapped water. In addition, previous repairs were at the end of their service life and removal of deteriorated concrete and failed previous repairs was required. Light duty chipping hammers were used to avoid damage to adjacent material when removing deteriorated concrete to the level of sound concrete. (c) Field samples were performed to match the color, finish, and texture of the original concrete. A challenge in matching of historic concrete is achieving variability of appearance. (d) The completed surface after repairs exhibits intentional variability of the concrete surface to match the appearance of the original concrete. Some formwork imperfections that would normally be removed by finishing were intentionally left in place, to replicate the highly variable finish of the original concrete. (e) The Jefferson Davis Memorial after completion of repairs in 2004. Photo e: Joseph Lenzi, Senler, Campbell & Associates, Inc.

due to original construction techniques, architectural design, or differential exposure to weather. Trial repairs and mock-ups are used to evaluate the proposed replacement concrete work and to refine construction techniques (Fig 20).
